## **NATIONAL TRANSPORTATION SAFETY BOARD**

### **Group Chairman's Factual Report**

# **AIR TRAFFIC CONTROL**

DCA19FA089

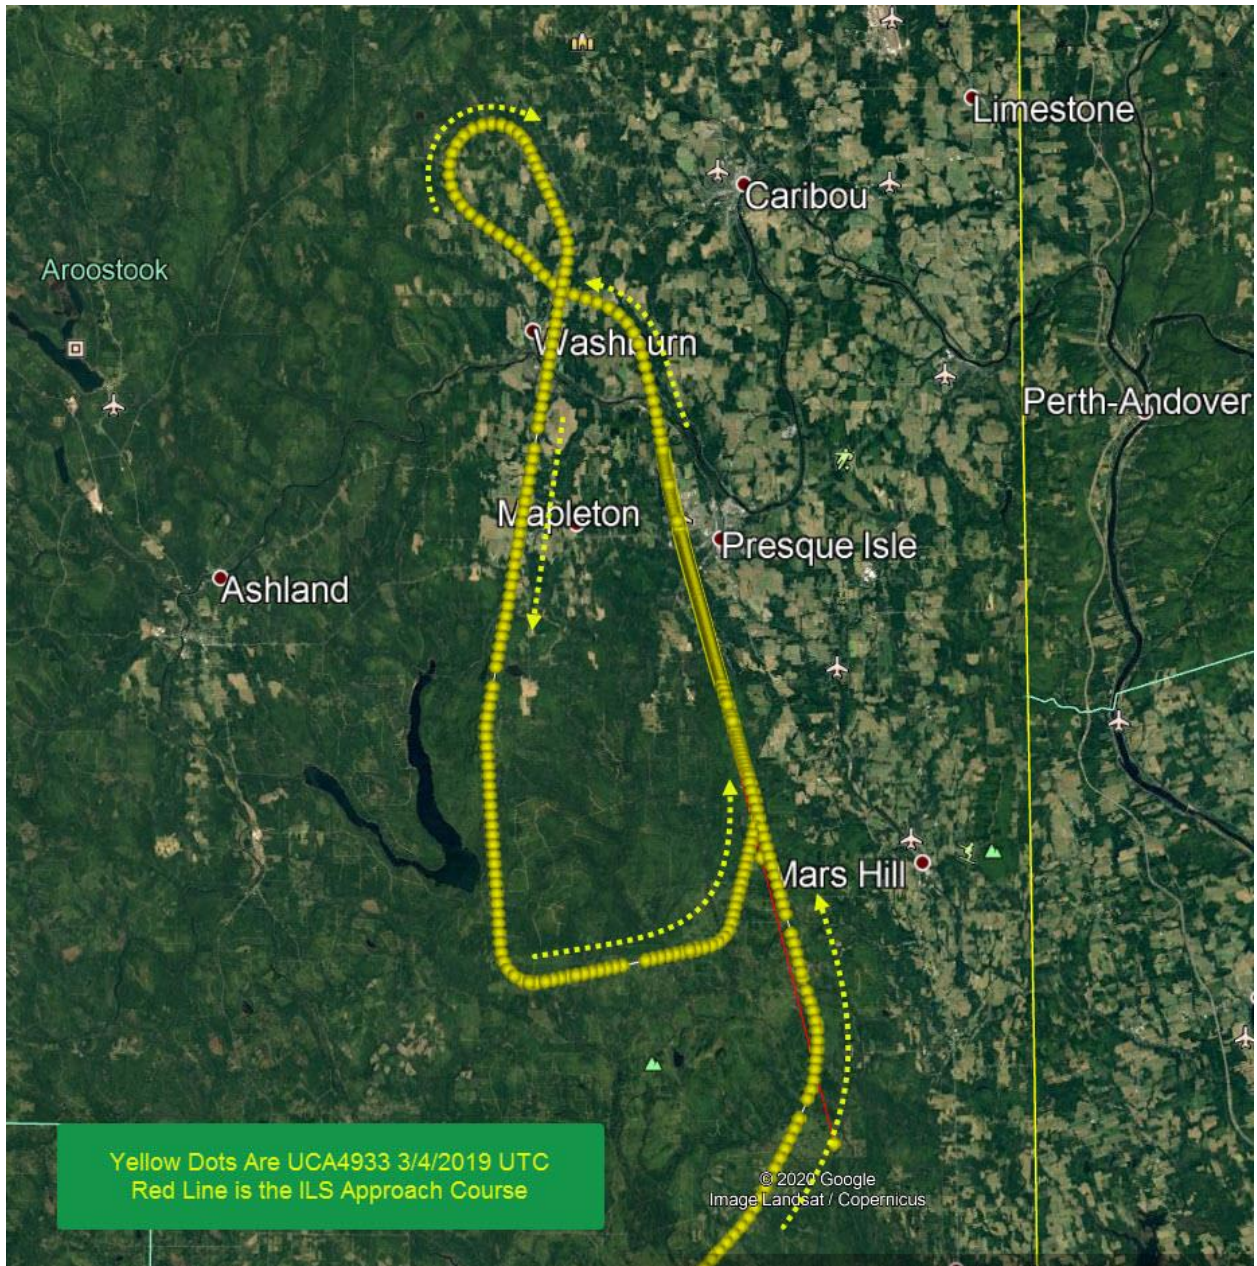
Figure 1 illustrates the ADS-B track of the accident flight as it made the first attempt on the ILS followed by a missed approach and second ILS approach. Figure 2 illustrates a close-up of the ADS-B data for UCA4933 on the first ILS approach as the airplane flew along the final approach course adjacent to the runway centerline for runway 1. ADS-B data indicated the airplane overflew the grassy area between the runway and the parallel taxiway A before executing a missed approach.

Figure 1 - Graphic showing the accident airplanes flight track as it conducted the two ILS approaches.

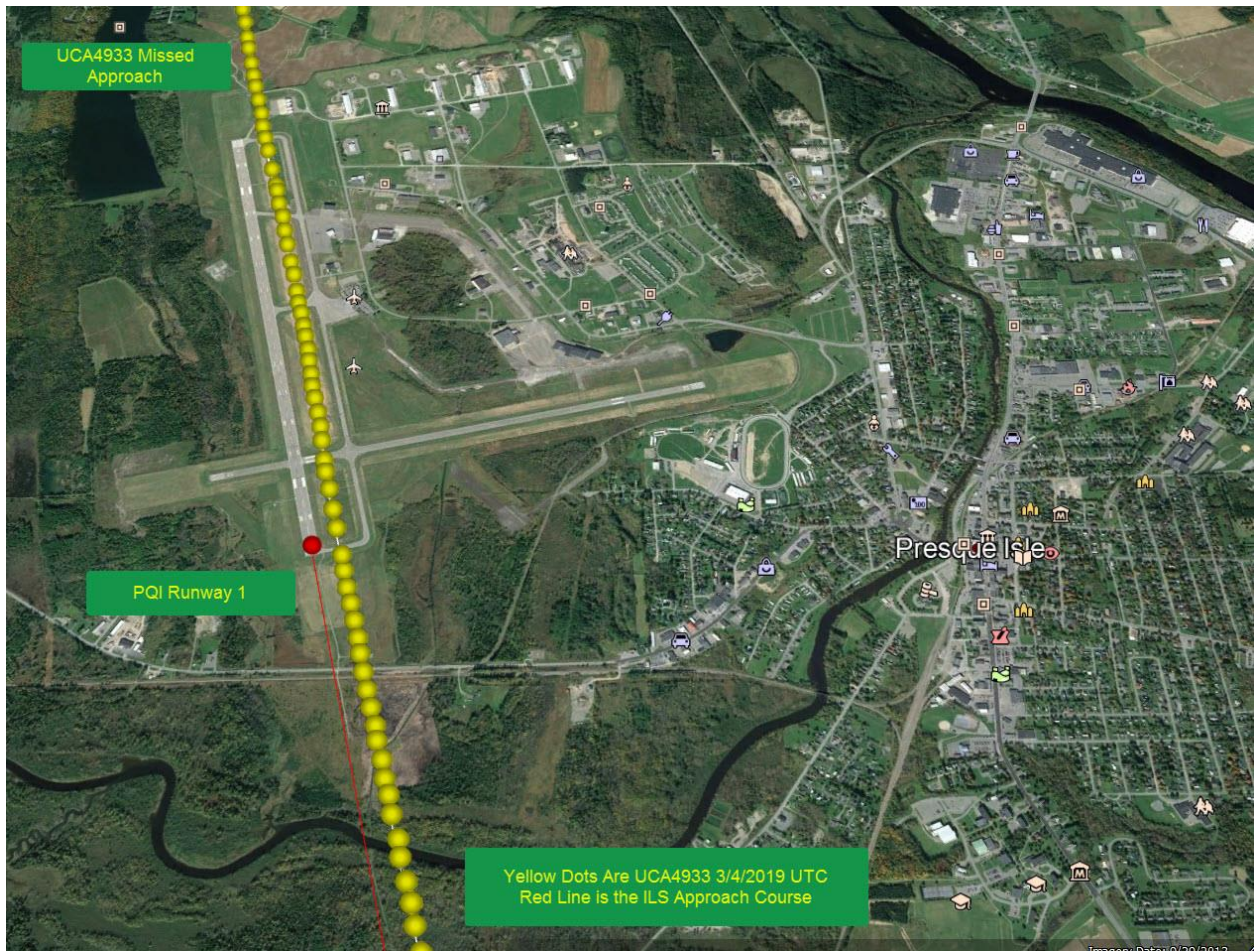
**Figure 2** - ADS-B data showing the first approach to the grassy area between the runway and taxiway A followed by a missed approach.

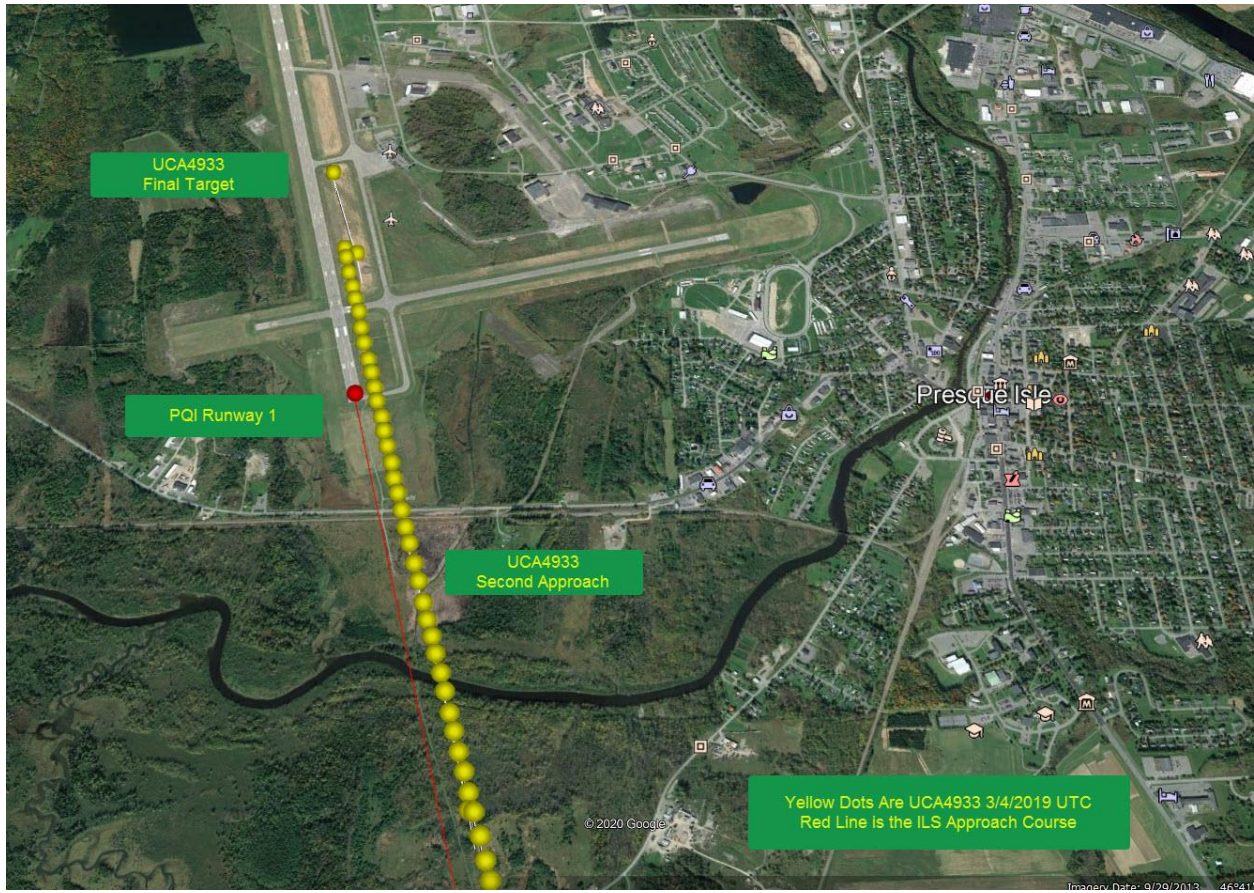
Figure 3 illustrates a close-up of the ADS-B data for UCA4933 on the second attempt for the ILS as it flew along the final approach course adjacent to the runway centerline for runway 1. The accident occurred after completing the second ILS, and the final ADS-B target was in the grassy area just short of taxiway C. Figure 4 illustrates the airfield diagram and taxiway identifiers.

**Figure 3 - ADS-B data showing the second approach grassy area between taxiway A and the runway ending at the accident site.**

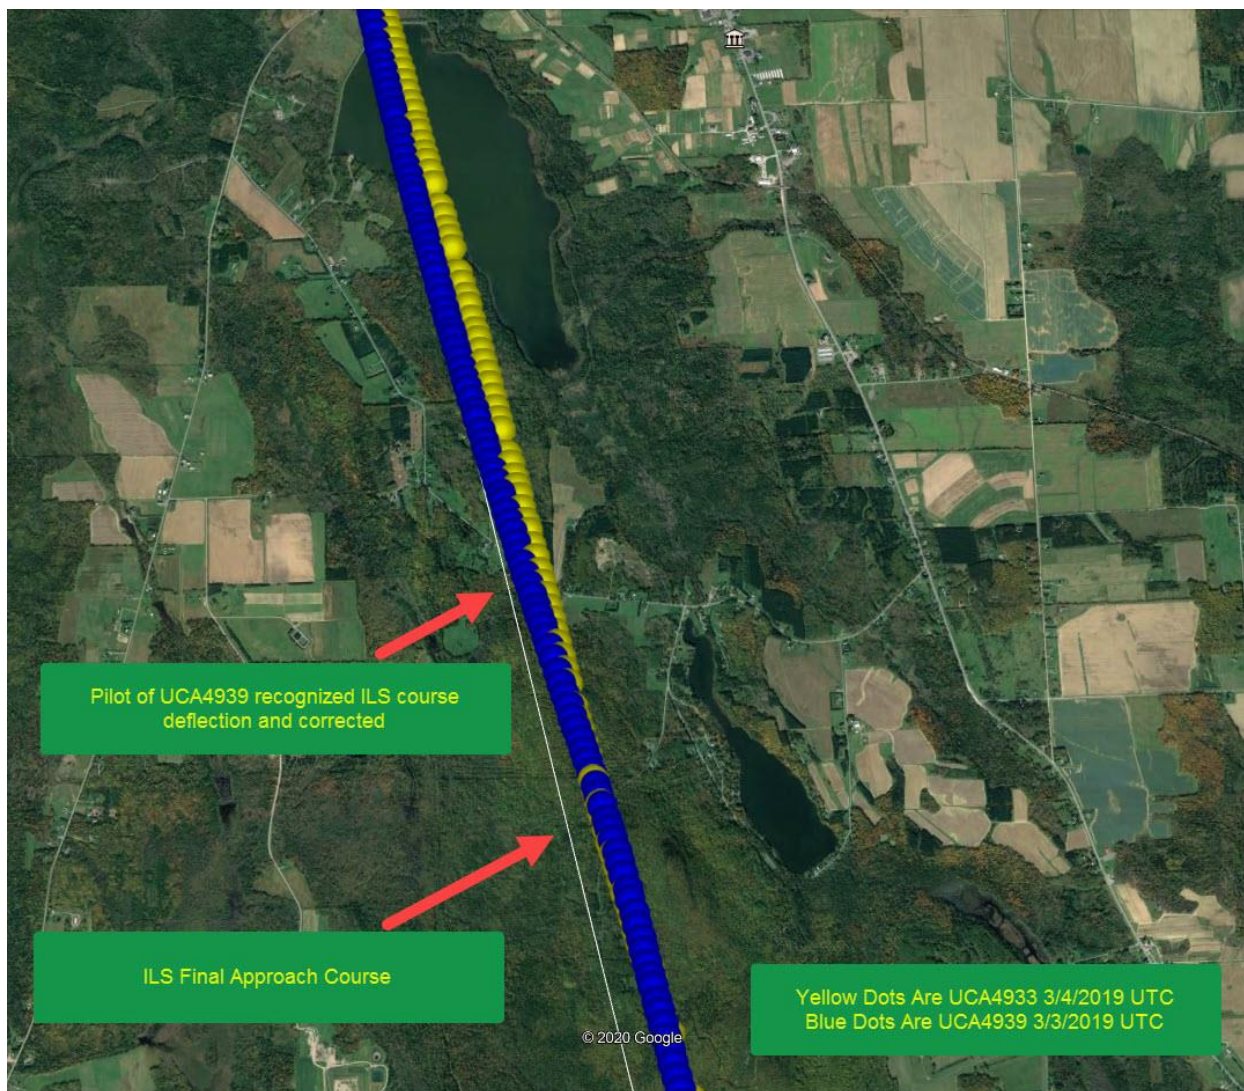
On March 2, 2019 at about 2345 EST, UCA4939 conducted an ILS Runway 01 approach to KPQI (see attachment 4) runway 1. The pilot reported that as the aircraft was descending through 2,500 feet msl, it appeared the aircraft was aligned right of the runway centerline with the airplanes ILS indicating it was centered on the runway (see figure 6). The pilot discontinued the ILS approach when the runway was acquired visually. Once visually aligned with the runway centerline, the pilot noted that the airplane ILS instrument was indicating three quarters of a “dot” off course. Once on the ground, the First Officer called and advised the R16 controller of the ILS discrepancy. According to the pilot, the ZBW R16 controller advised “that he will forward that information onward.”

A review of ATC communications from March 2, 2019 between the pilot of UCA4939 and the R16 controller indicated the pilot reported there was a “good offset about ah half dot from the centerline”. He went on to add “there was a good offset to the right of the localizer there all the way down ah became visual about ah two thousand five hundred or so and ah once we were center with the runway ah the localizer was about half dot off all the way to the ground”. The R16 controller acknowledged the report and advised they would pass it on.

**Figure 6** - Flight track of UCA4939 as it was established on the ILS Runway 01 and right of course.
