NATIONAL TRANSPORTATION SAFETY BOARD

Group Chairman's Factual Report

OPERATIONAL FACTORS

DCA19FA089

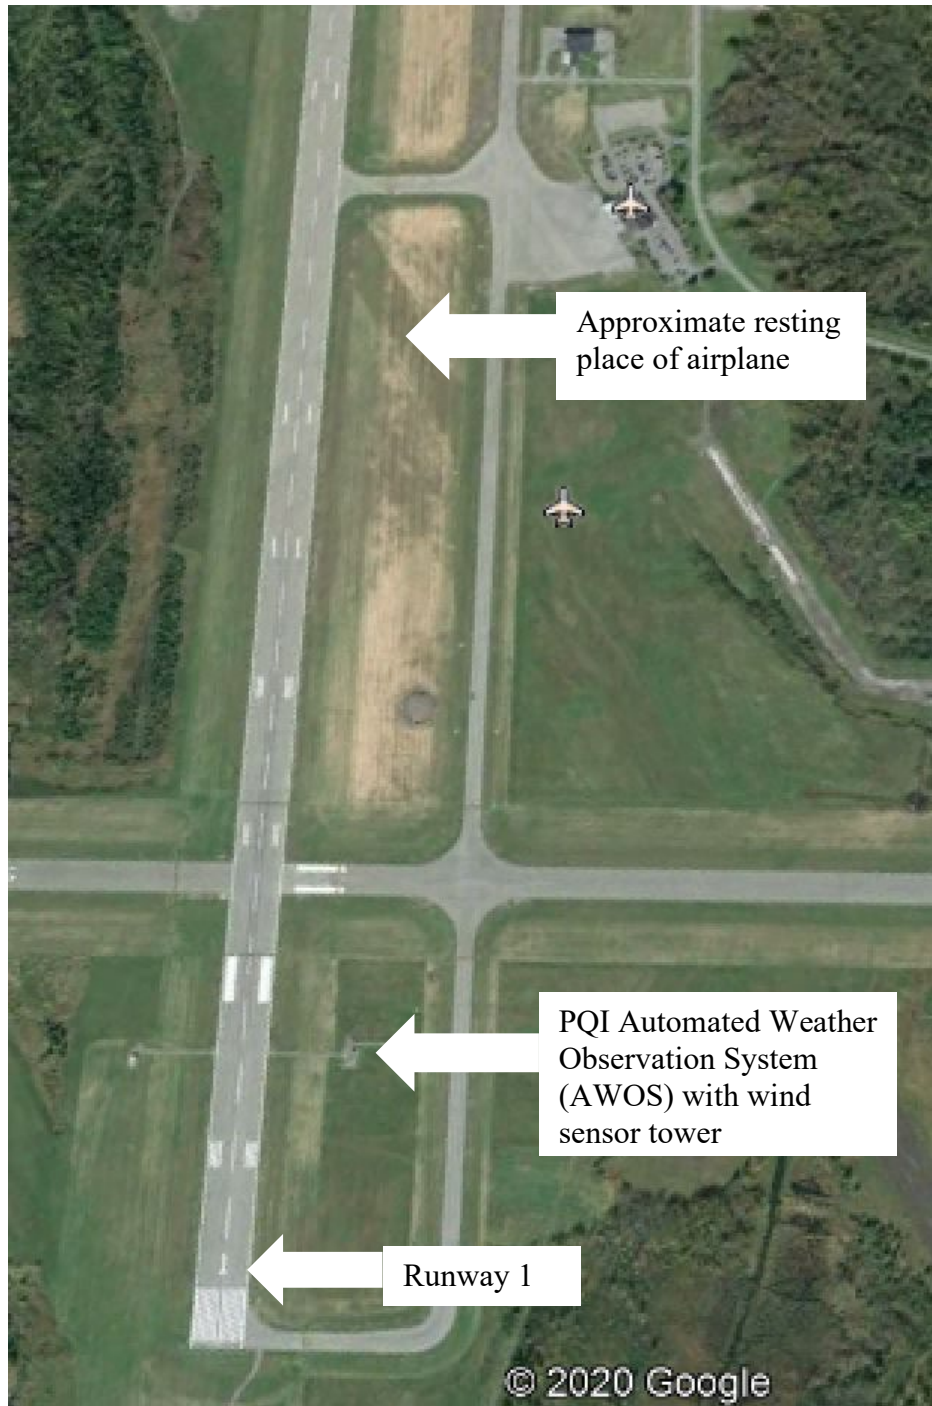
Figure 4 PQI runway 1 segment (source: Google Earth)

Runway 1 was 7439 ft. in length, and 150 ft. wide. The airplane came to rest about 3600 ft. from the runway threshold, in the grassy area between the runway and the taxiway, about 305 ft. right of the runway centerline, and 230 feet from the right edge of runway.

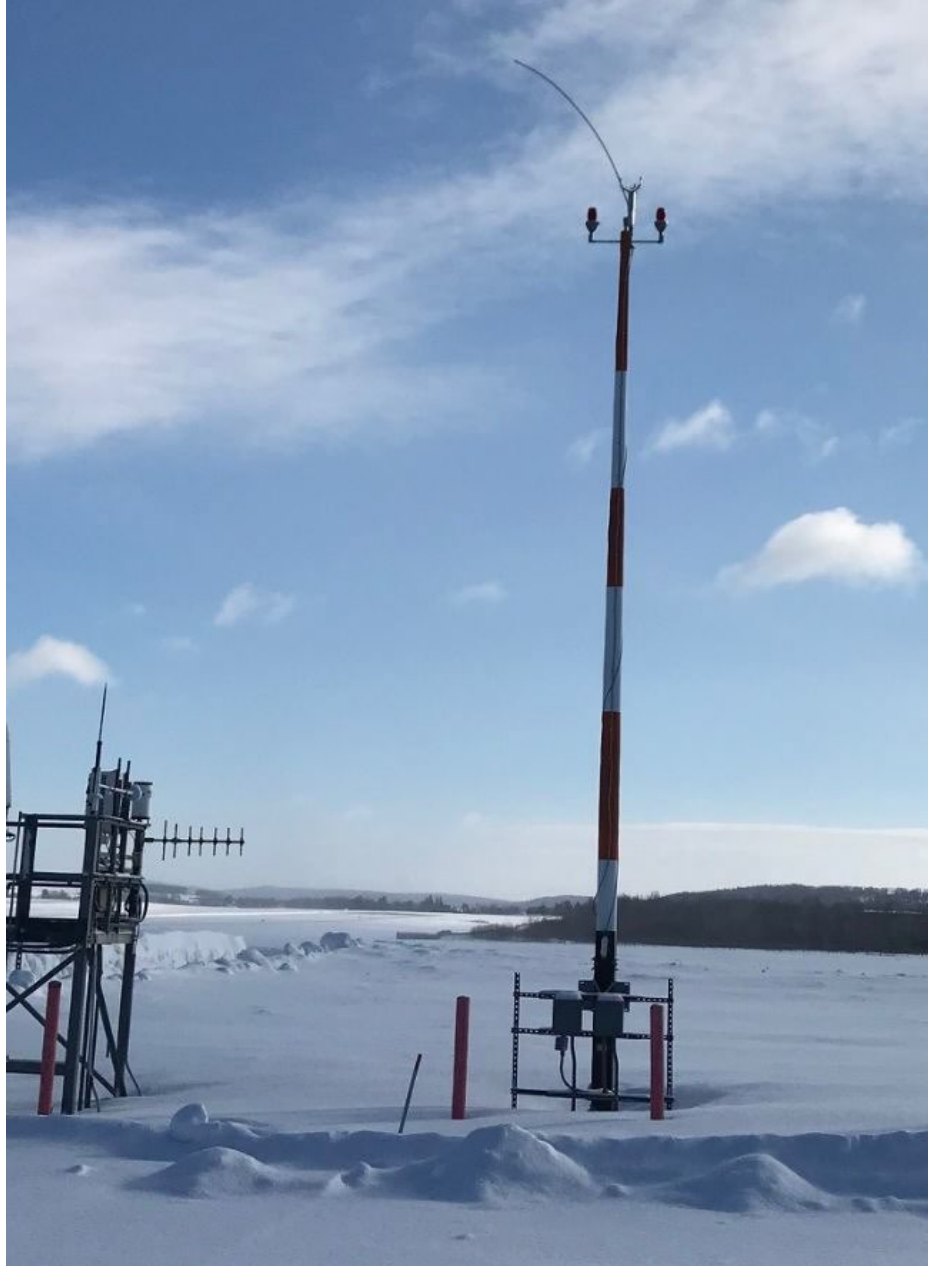
Figure 5 AWOS wind sensor tower (source: NTSB)

About 870 feet from the threshold of runway 1 and offset to the right of the runway centerline by about 325 feet was the airport's Automated Weather Observation System, which included a wind sensor tower with a lightning arrester mounted on the top. The location of the system is shown in figures 3 and 4, and the tower in figure 5. According to FAA Advisory Circular Advisory Circular No. 150/5220-16, the nominal height of an AWOS tower is 30 to 33 feet.
