**National Transportation Safety Board**  
Office of Research and Engineering  
Washington, D.C. 20594

**Airplane Performance Study**

**Location:** Presque Isle, Maine  
**Date:** March 4, 2019  
**Time:** 1629 GMT (1129 EST)  
**Airplane:** EMB-145XR, N14171  
**NTSB Number:** DCA19FA089

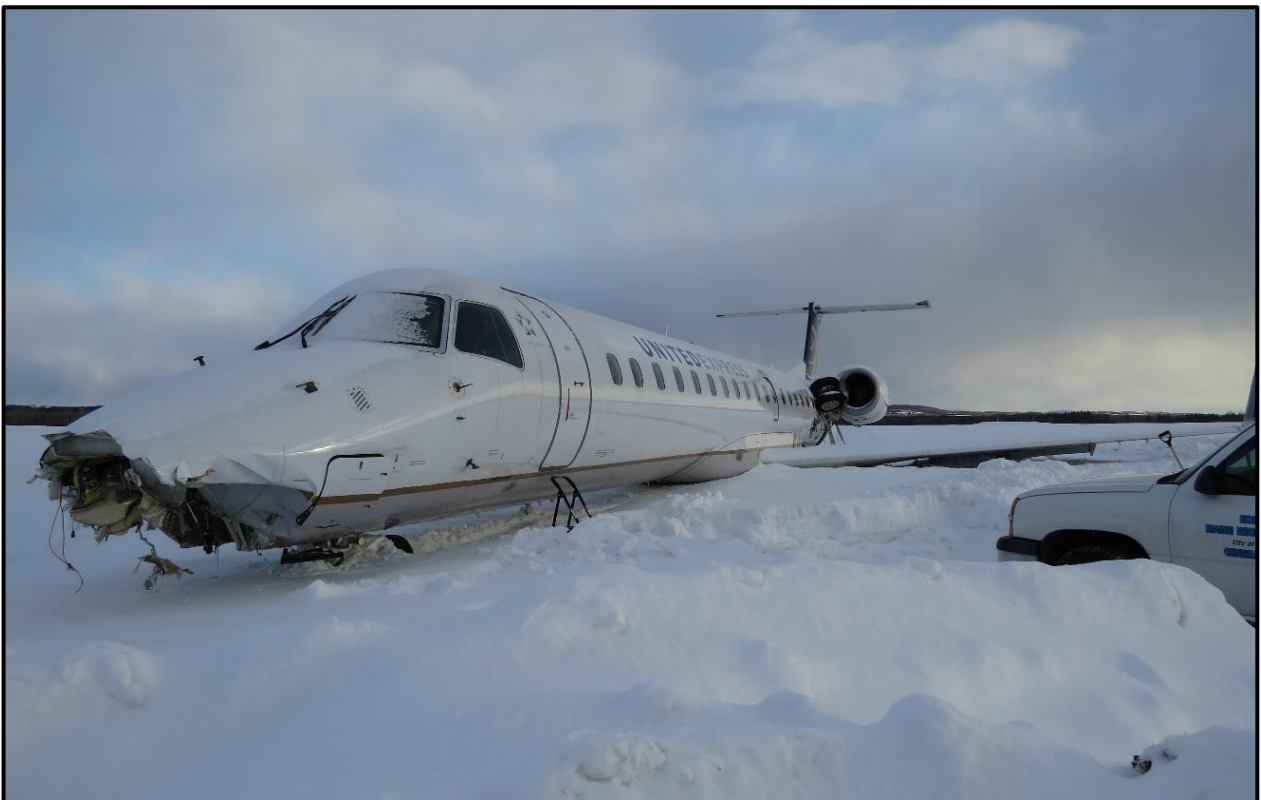
**Figure 2: N14171 After the Accident**

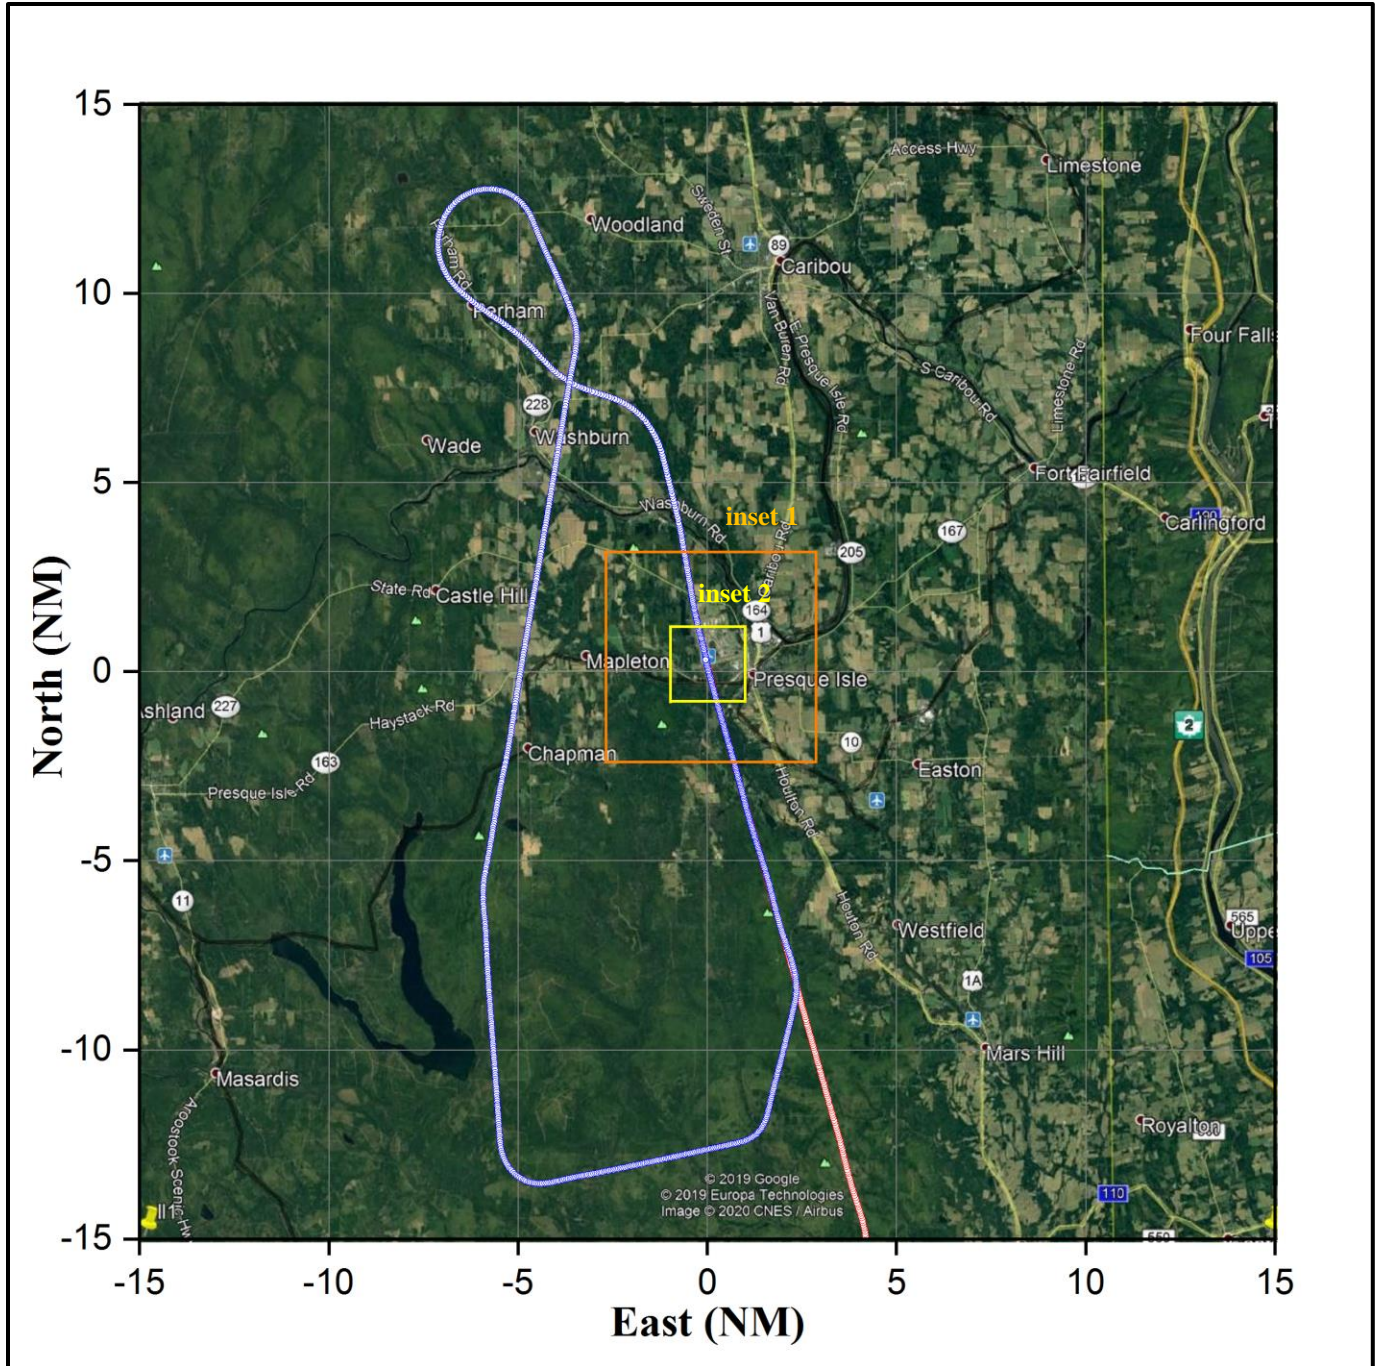
Figure 3 is the approach plate for the ILS 01 at KPQI. Figure 4 is an overview of the airplane's ground track in the vicinity of Presque Isle Airport and captures the initial approach and second landing attempt on KPQI's runway 1. (Note the 17° magnetic variation between the approach course of 6° and the true course of 349° to runway 1 depicted in the figure.)

Figures 5 and 6 include insets outlined in Figure 4 for more detail. In addition, Figure 5 includes paraphrased cockpit voice recorder (CVR) comments from the final minute of flight. The ADS-B data show the airplane was aligned slightly right of runway 01 during both approaches.

**Figure 4: Initial Approach (red) and Missed Approach (blue) Ground Tracks from ADS-B**

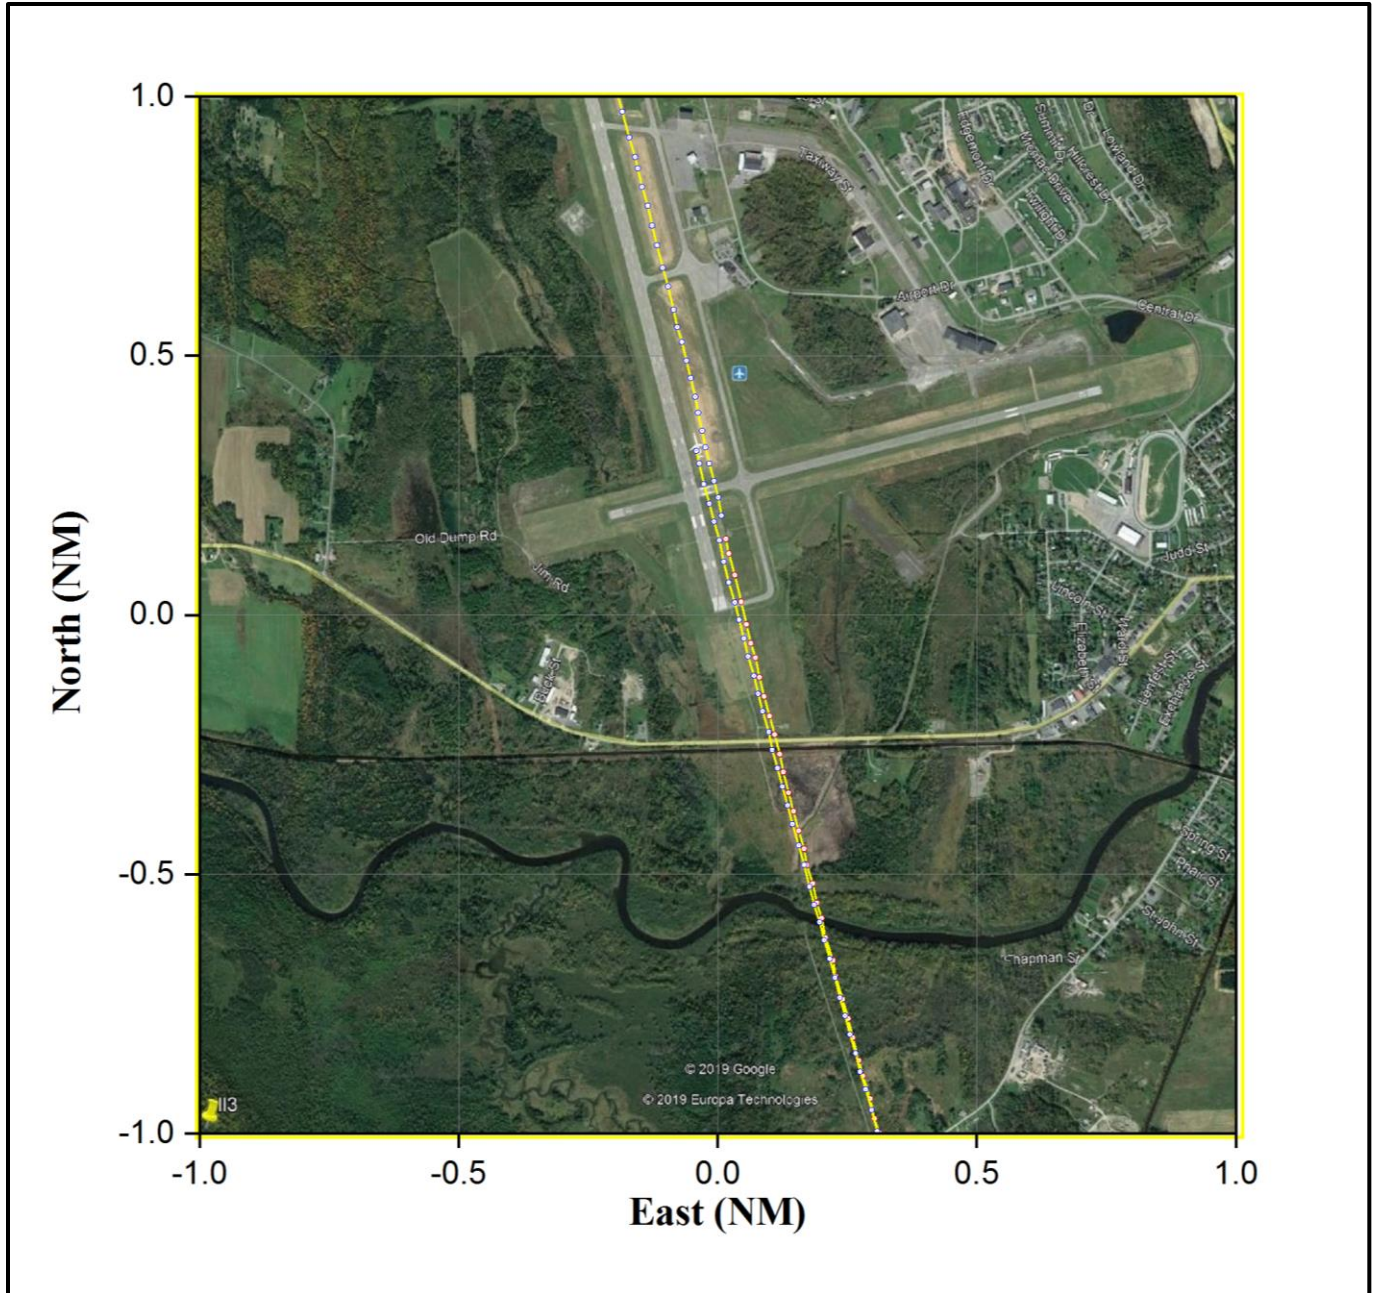
**Figure 6: inset 2 - Initial Approach (red symbols), Missed Approach (blue symbols), and Landing (blue symbols) Ground Tracks from ADS-B (Airplane symbol shows the approximate location of the wreckage.)**

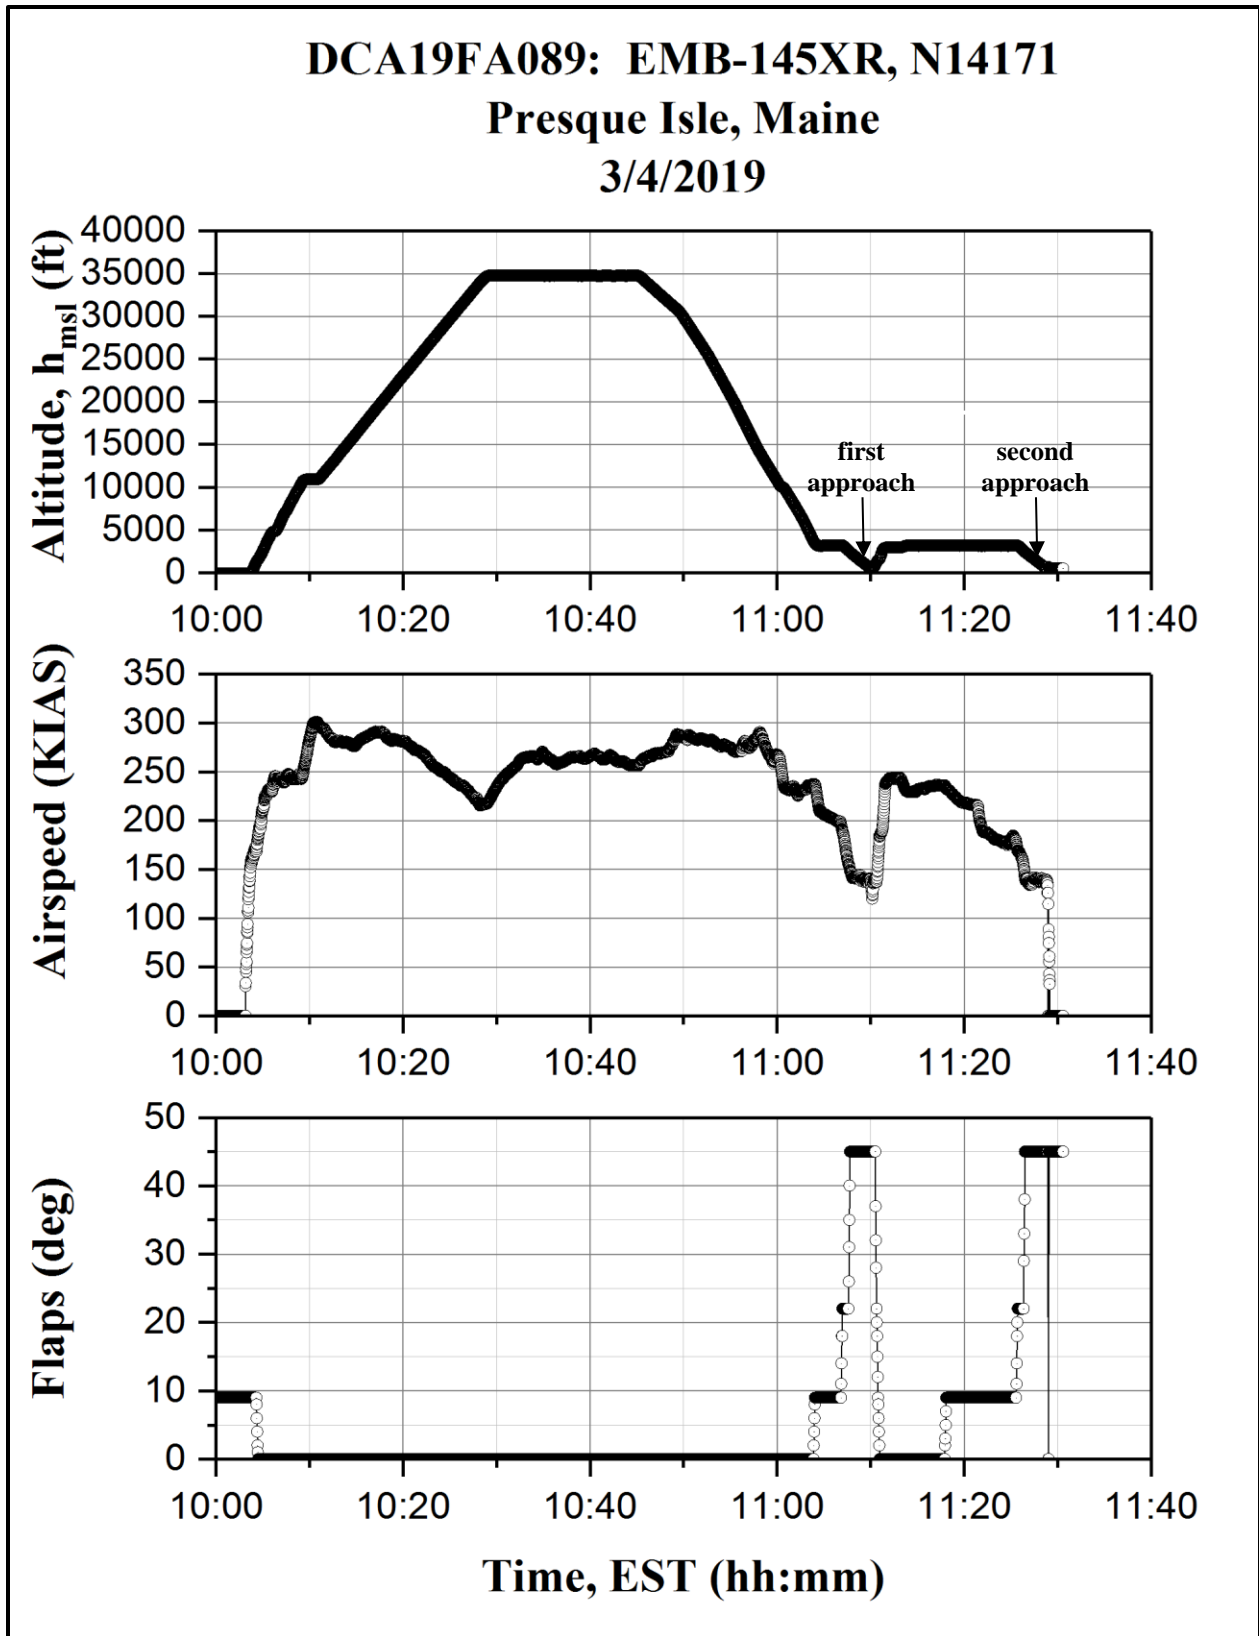
Figure 7 shows the altitude and airspeed recorded on the FDR for the entire flight. While the first approach resulted in a missed approach, and the second approach resulted in the accident, altitude and airspeed for both approaches were similar<sup>2</sup>. The crew used 10° approach flaps followed by 45° landing flaps during both landing attempts.

Figure 7: Altitude and Airspeed for Entire Flight Based on FDR Data

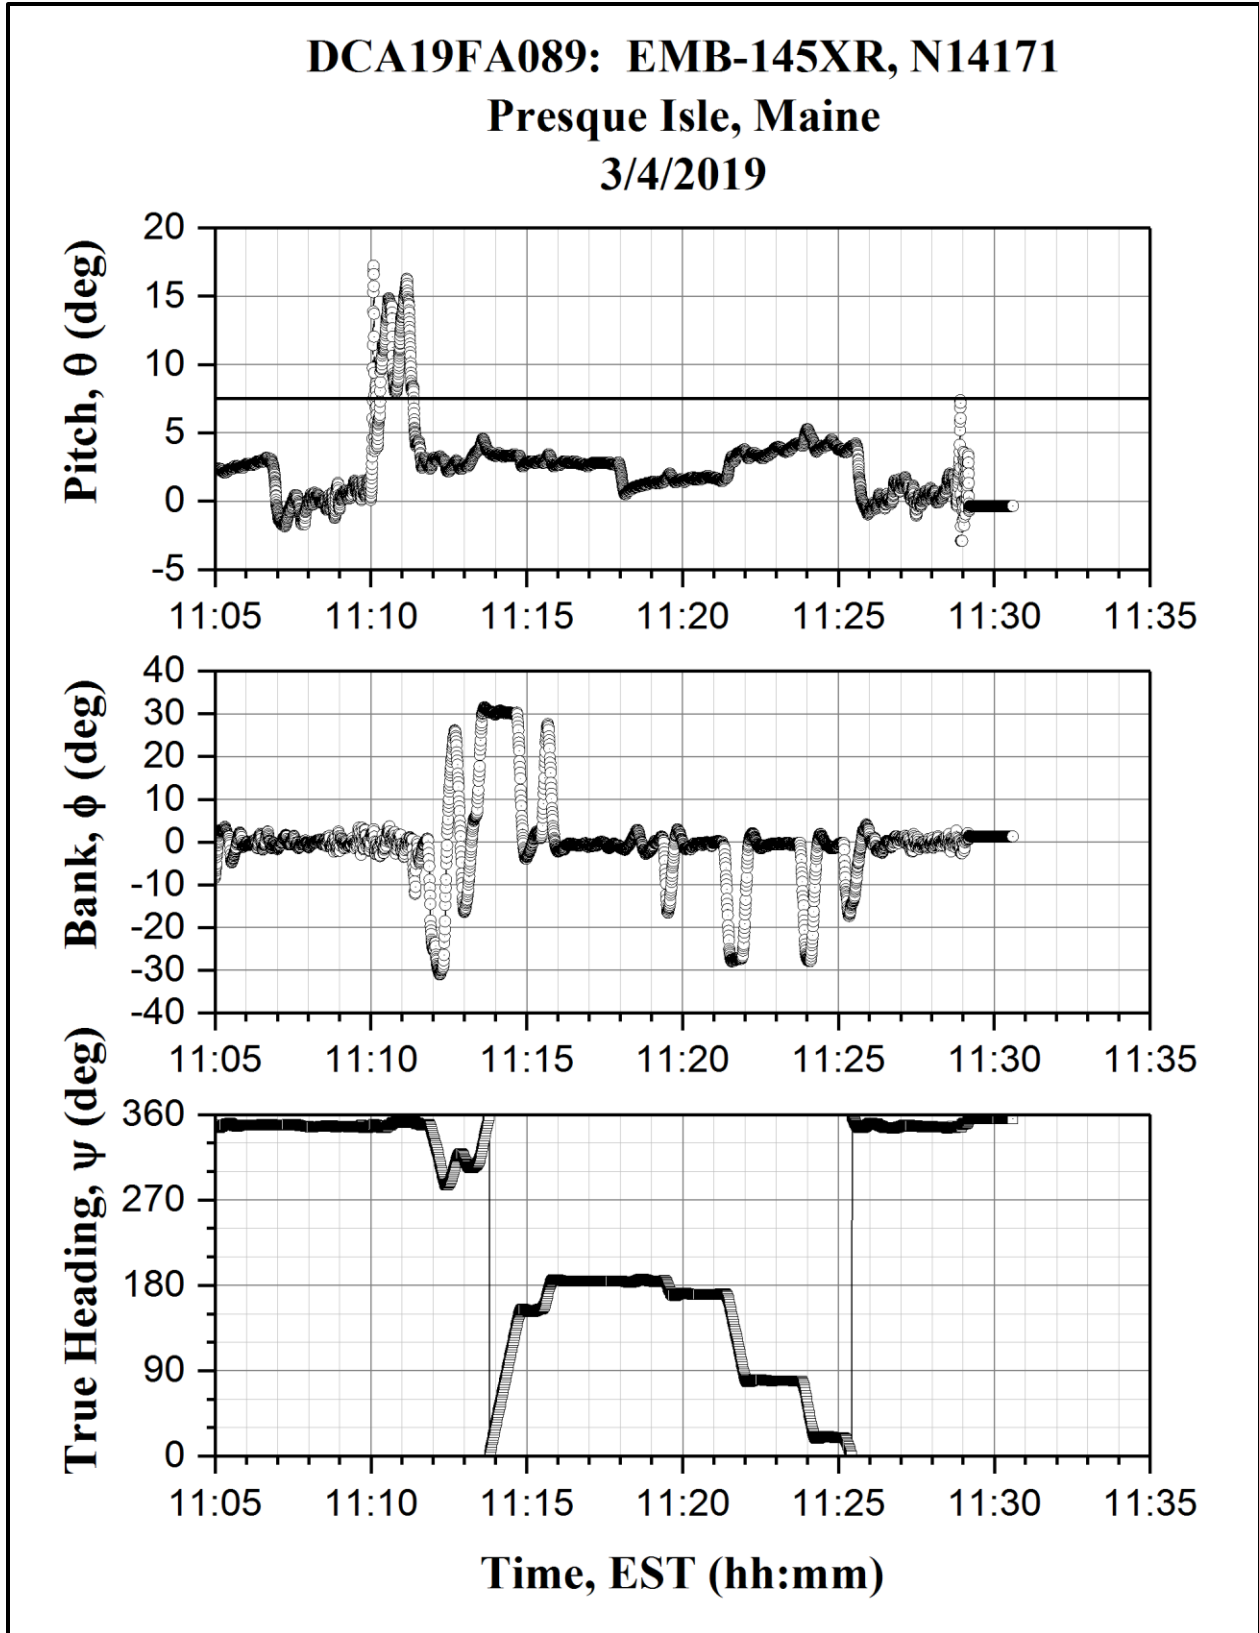
The recorded airplane attitude for the final 30 minutes is shown in Figure 9, and the engine power settings are shown in Figure 10. Both the attitudes and engine data appear normal.

Figure 9: Pitch, Bank, and True Heading for Final 30 Minutes Based on FDR Data

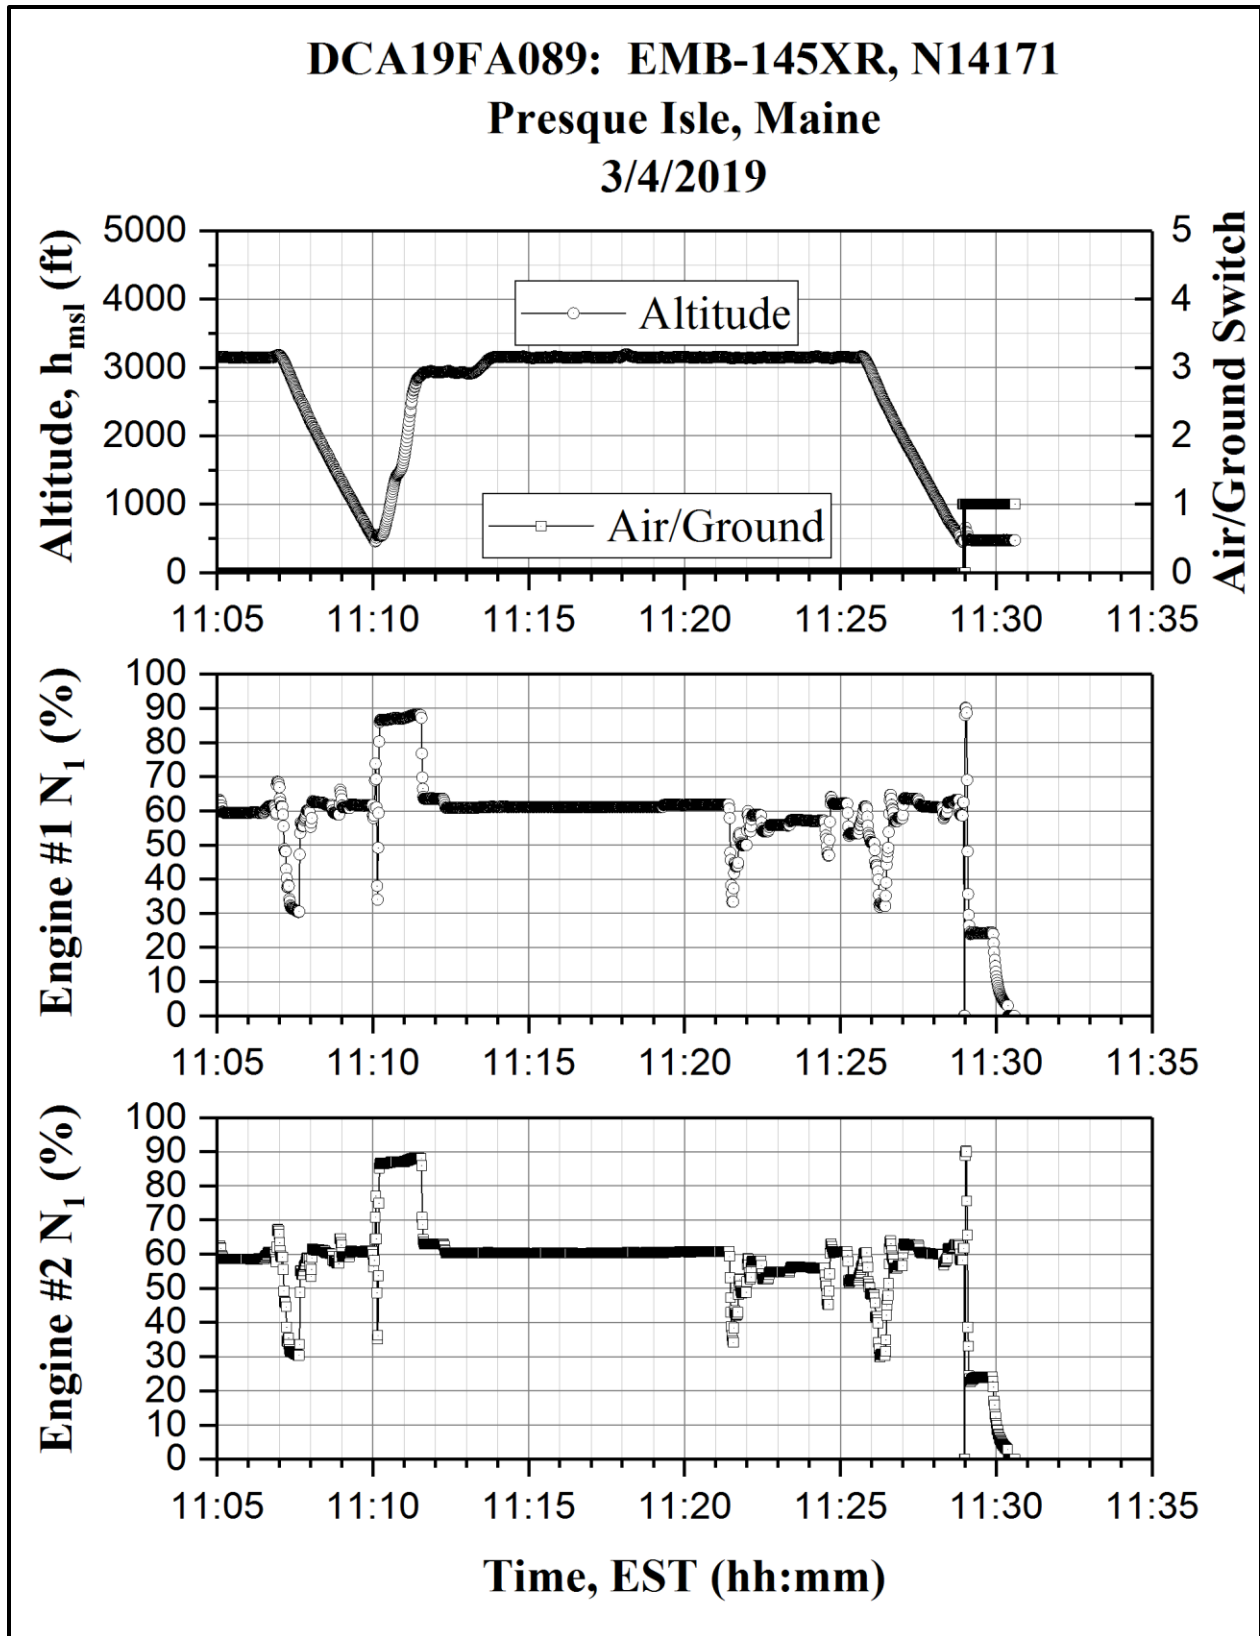
Figure 10: Engine Speed for Final 30 Minutes Based on FDR Data

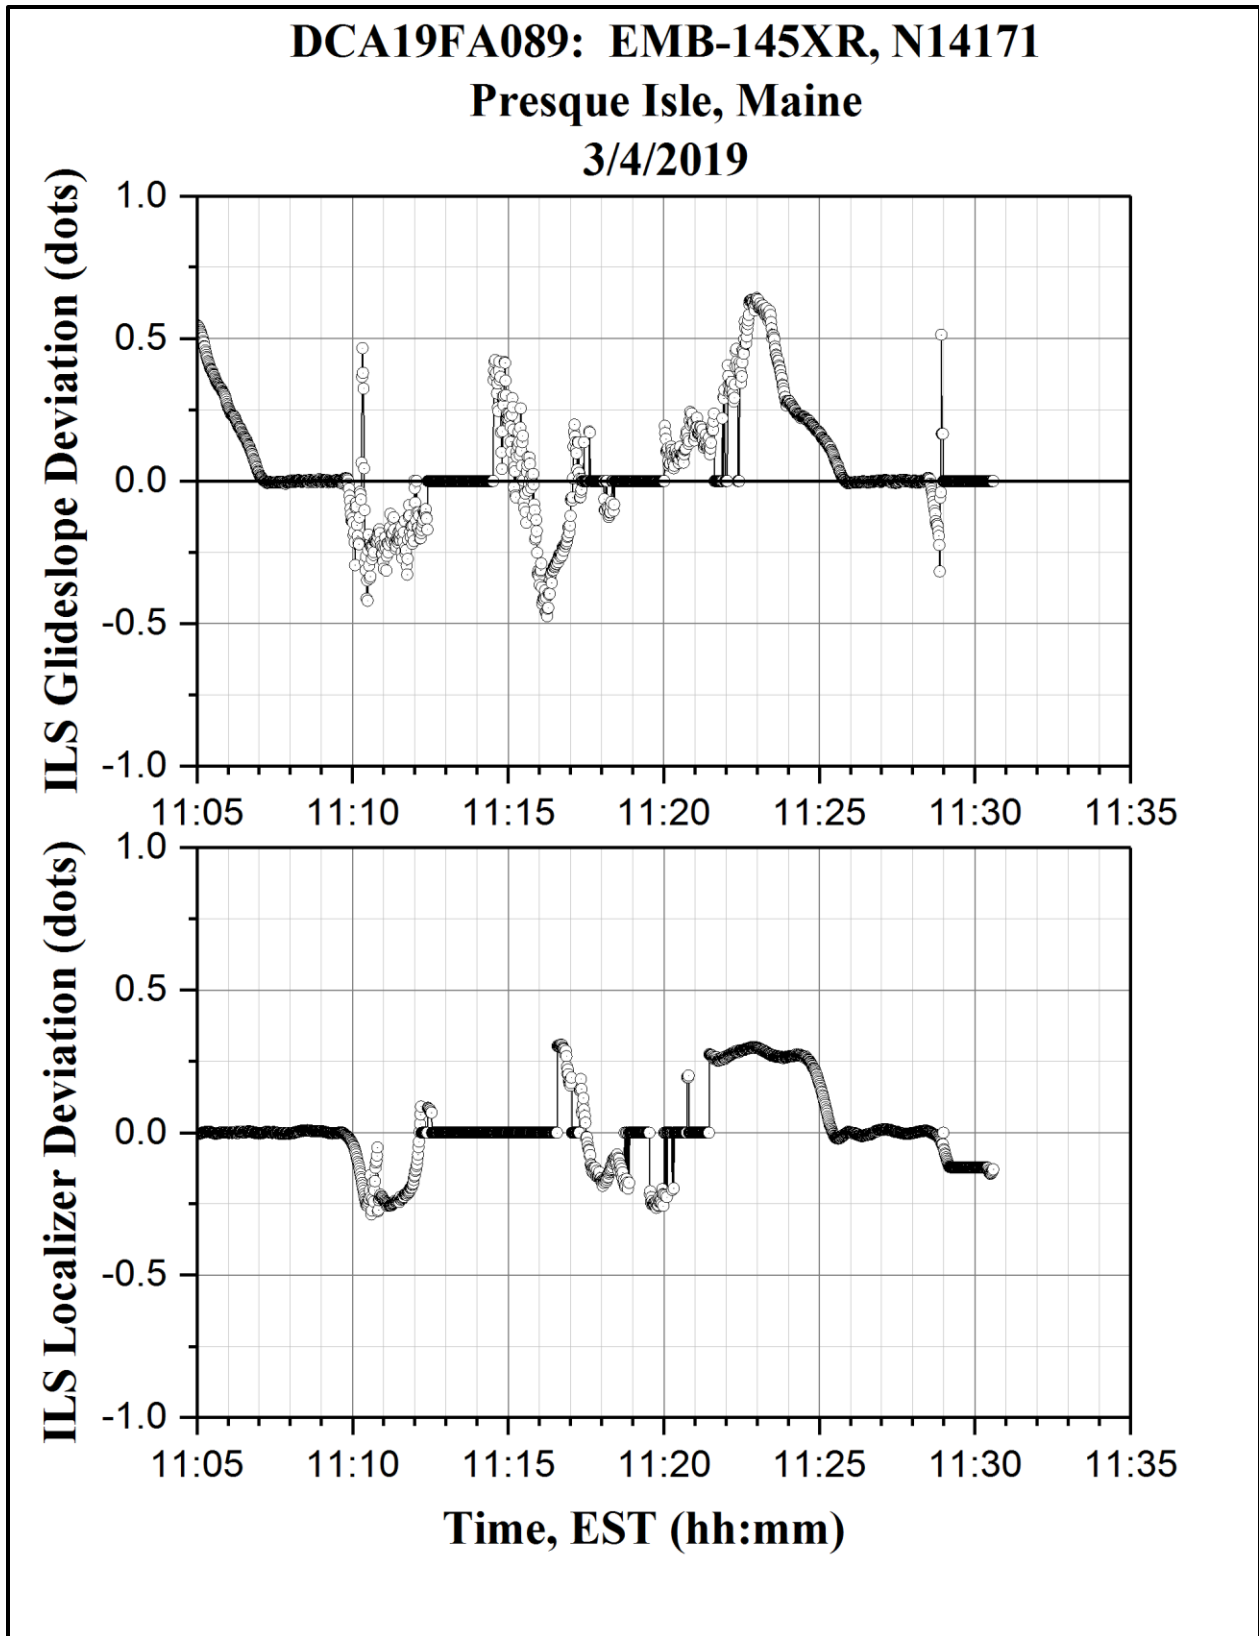
While the ADS-B data show the airplane was offset to the right of the runway centerline for both landing attempts, recorded FDR data indicate that flight deck instruments were largely “centered” for both the localizer and glideslope with only small deviations consistent with normal pilotage. See Figure 11.

In the days following the accident, an FAA Flight Check determined that the offset was the result of an erroneous signal from the localizer ground equipment. The ILS was immediately taken out of service and a NOTAM issued.

Figure 11: ILS 01 Deviations for Final 30 Minutes Based on FDR Data
