Boeing Commercial Airplanes Equipment Quality Analysis Report

Examination of Control Stand Thrust Lever Assembly

MODEL NUMBER: 767-300BCF

SUBJECT: *Examination of Control Stand Thrust Lever Assembly*

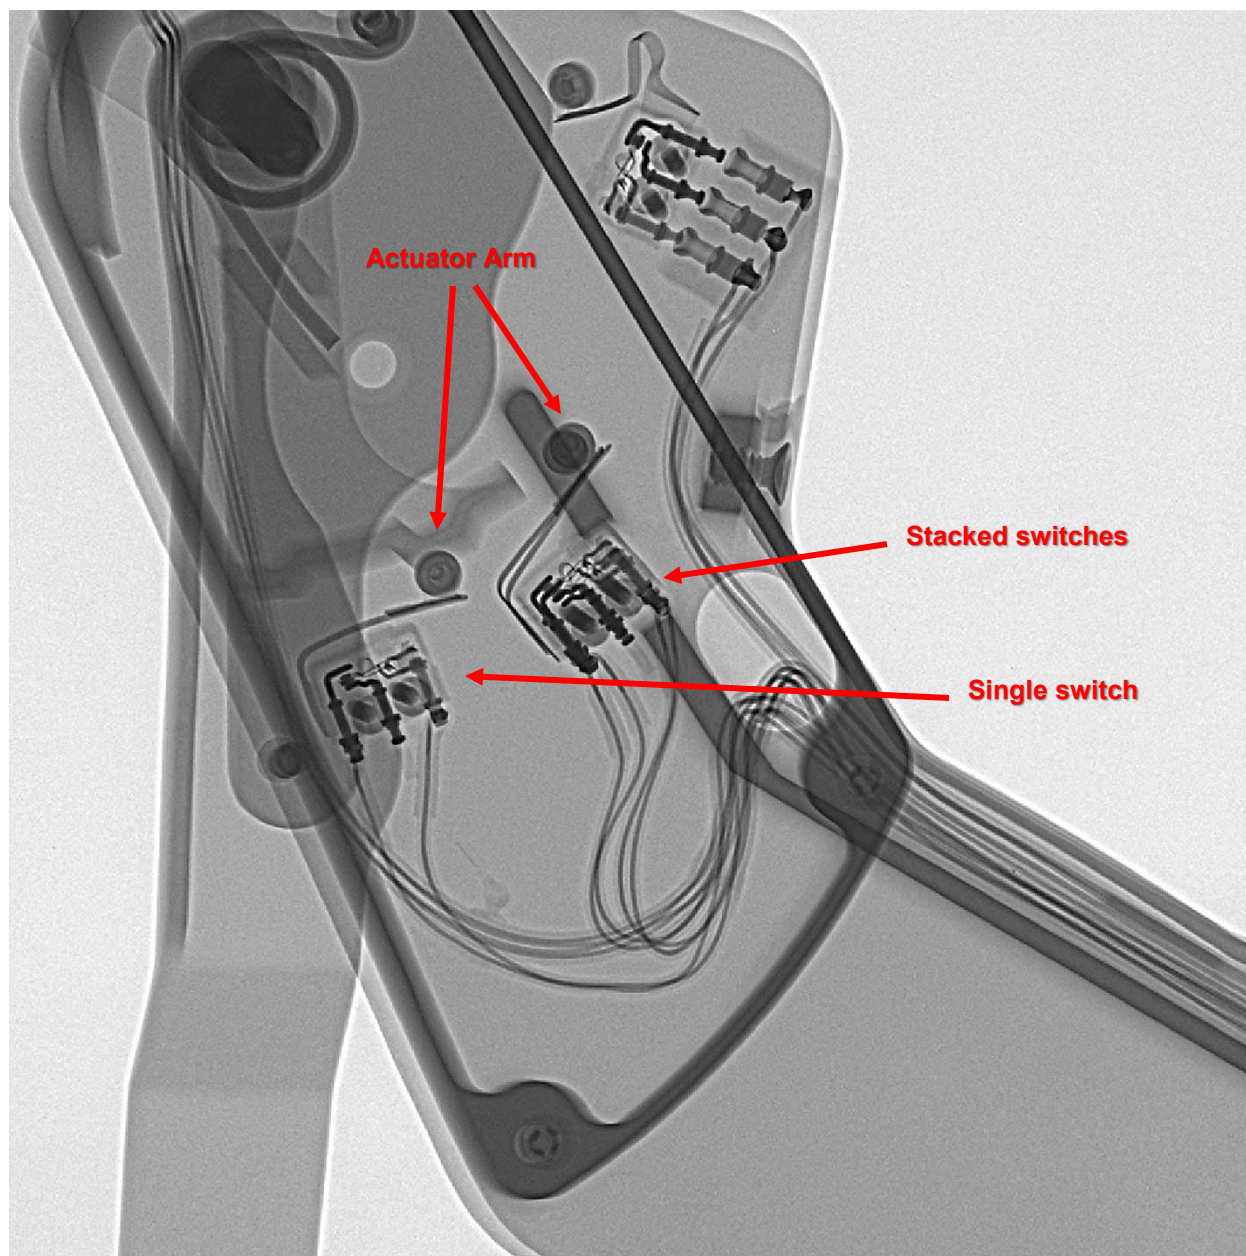
The primary focus of the DR examination was on the go-around switches in each throttle lever and the associated wiring, as seen in Figure 7 through Figure 13. It was noted that the actuator arm on the right throttle single switch was depressed, depressing the associated switch, as seen in Figure 7. There was also high density material noted in the right throttle where the wiring leaves the switch cavity of the handle, shown in Figure 12. No other anomalies were observed during examination of the go-around switches and switch wiring.

Figure 7 – Right throttle lever

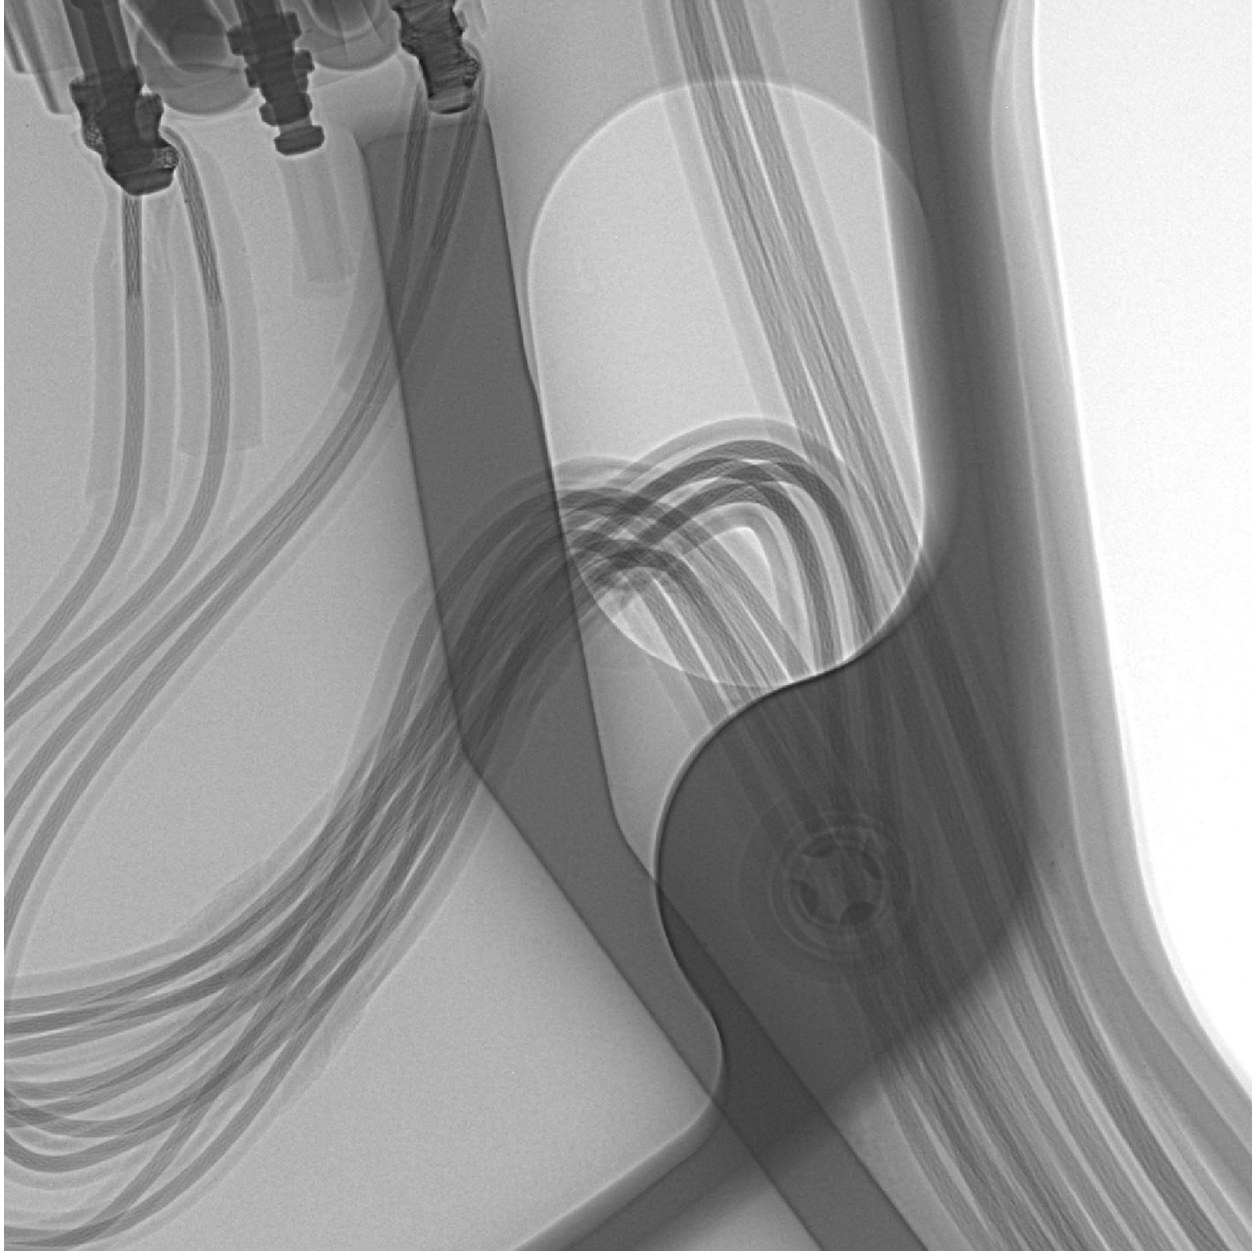
Figure 8 – Right throttle lever – no anomalies noted

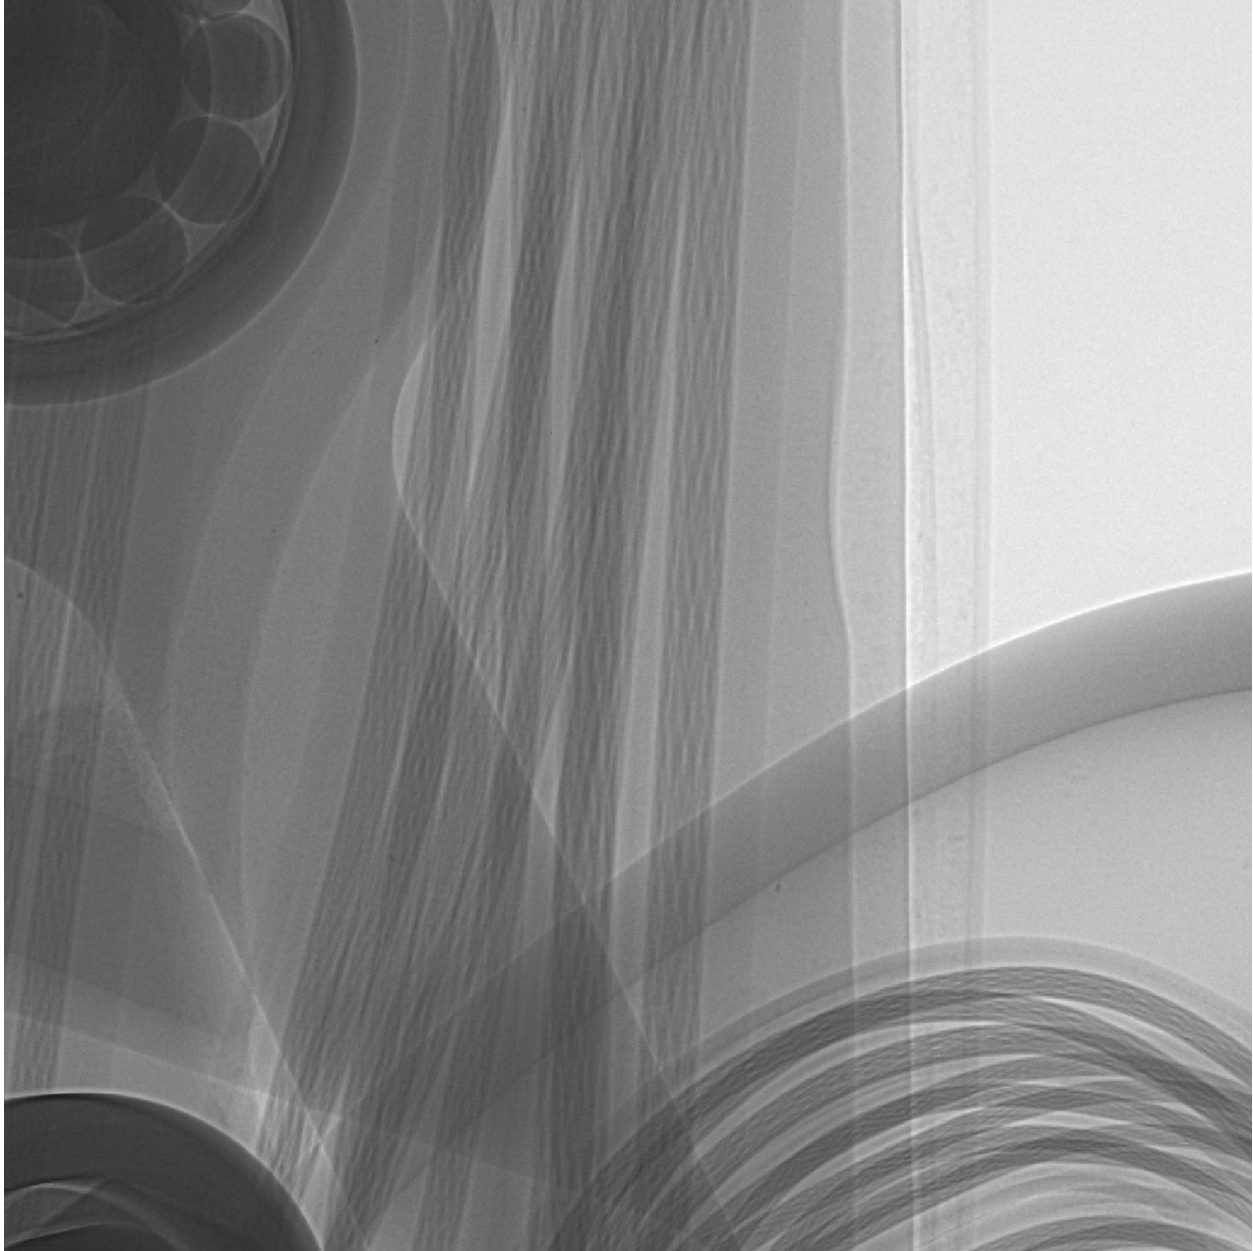
Figure 9 – Right throttle lever – no anomalies noted in the wiring

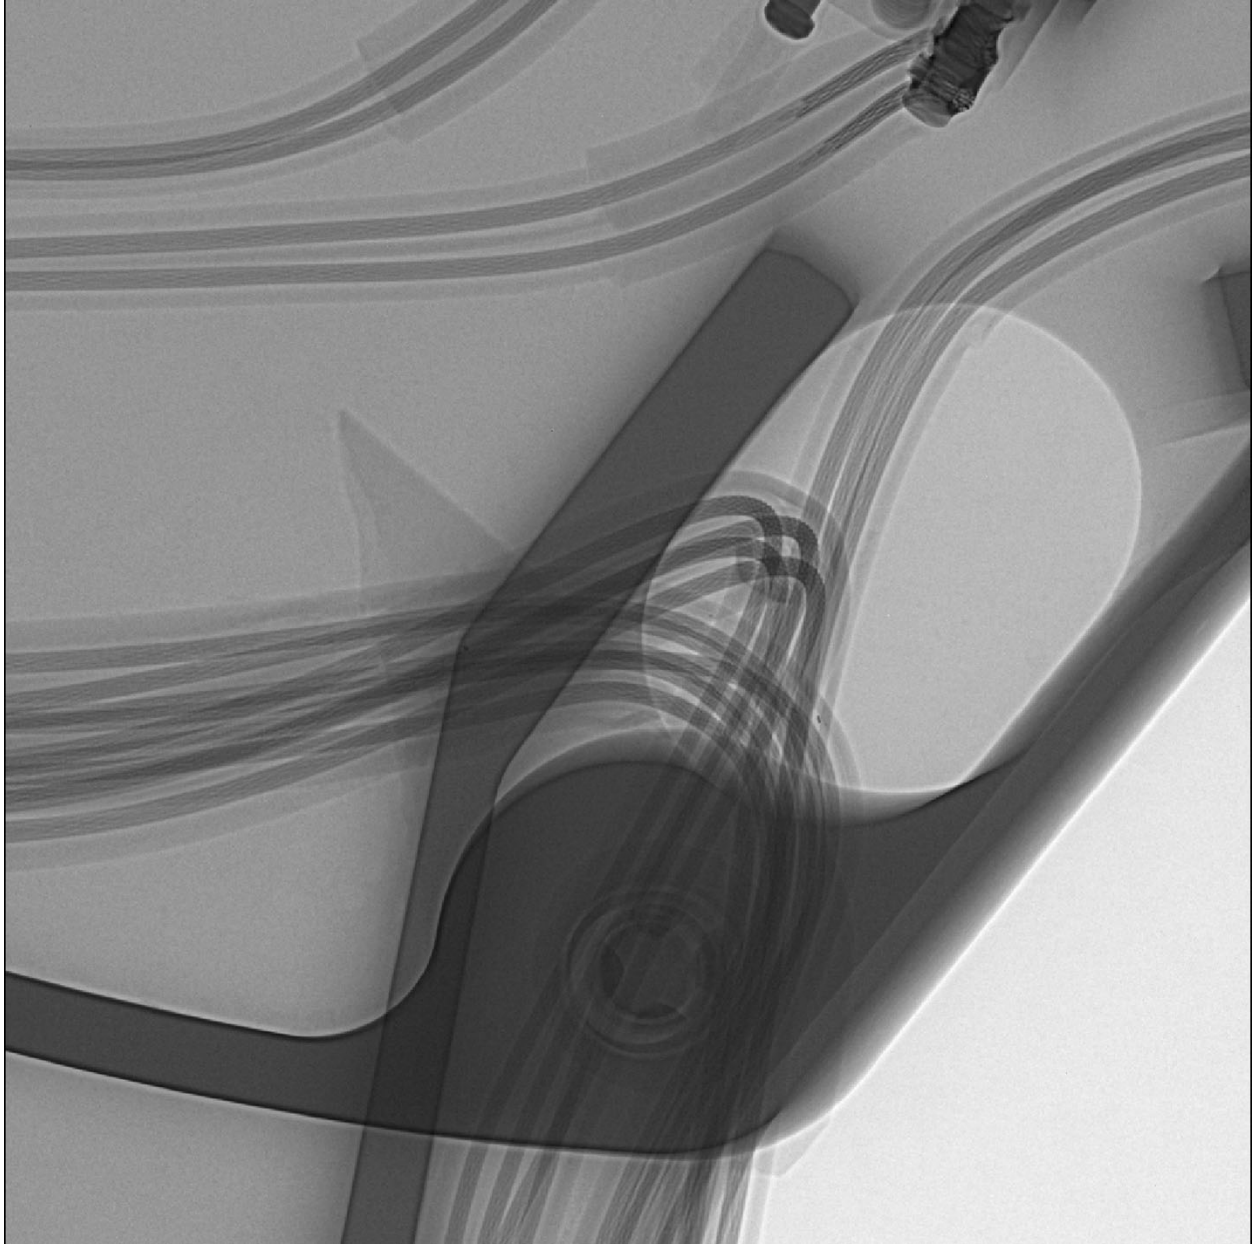
Figure 11 - Left throttle lever – particulates noted around the bend in the wires

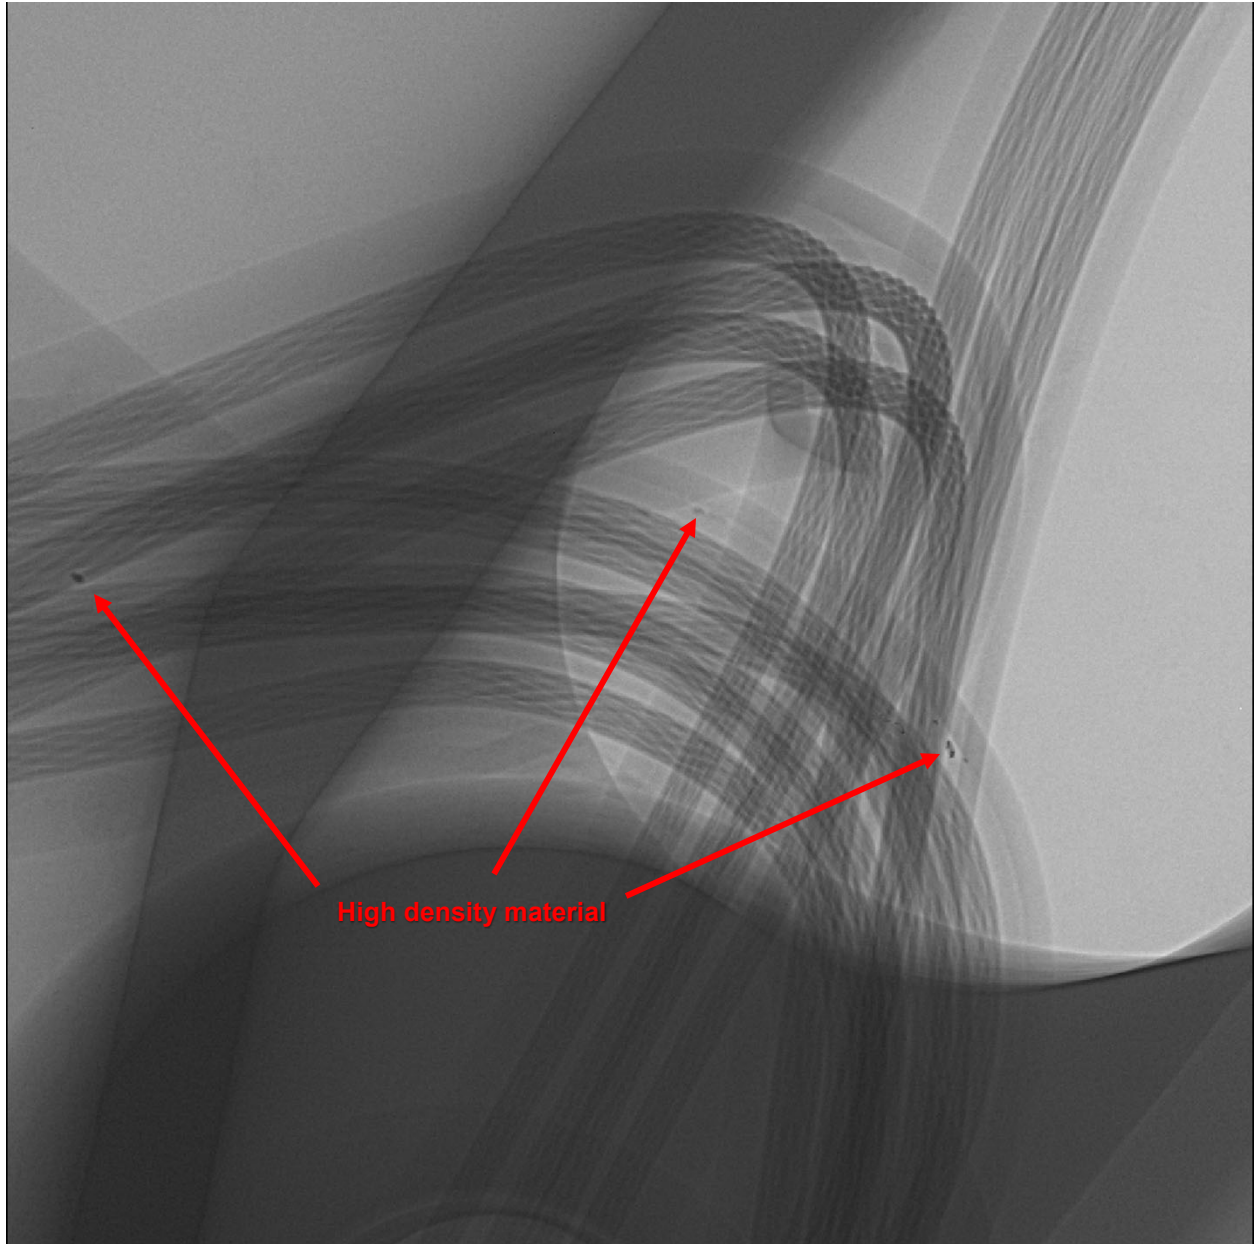
Figure 12 - Left throttle lever – particulates identified

The high density material noted in Figure 12 was determined to be outside of the wire insulation and not making contact with the adjacent wiring, as shown in Figure 15.

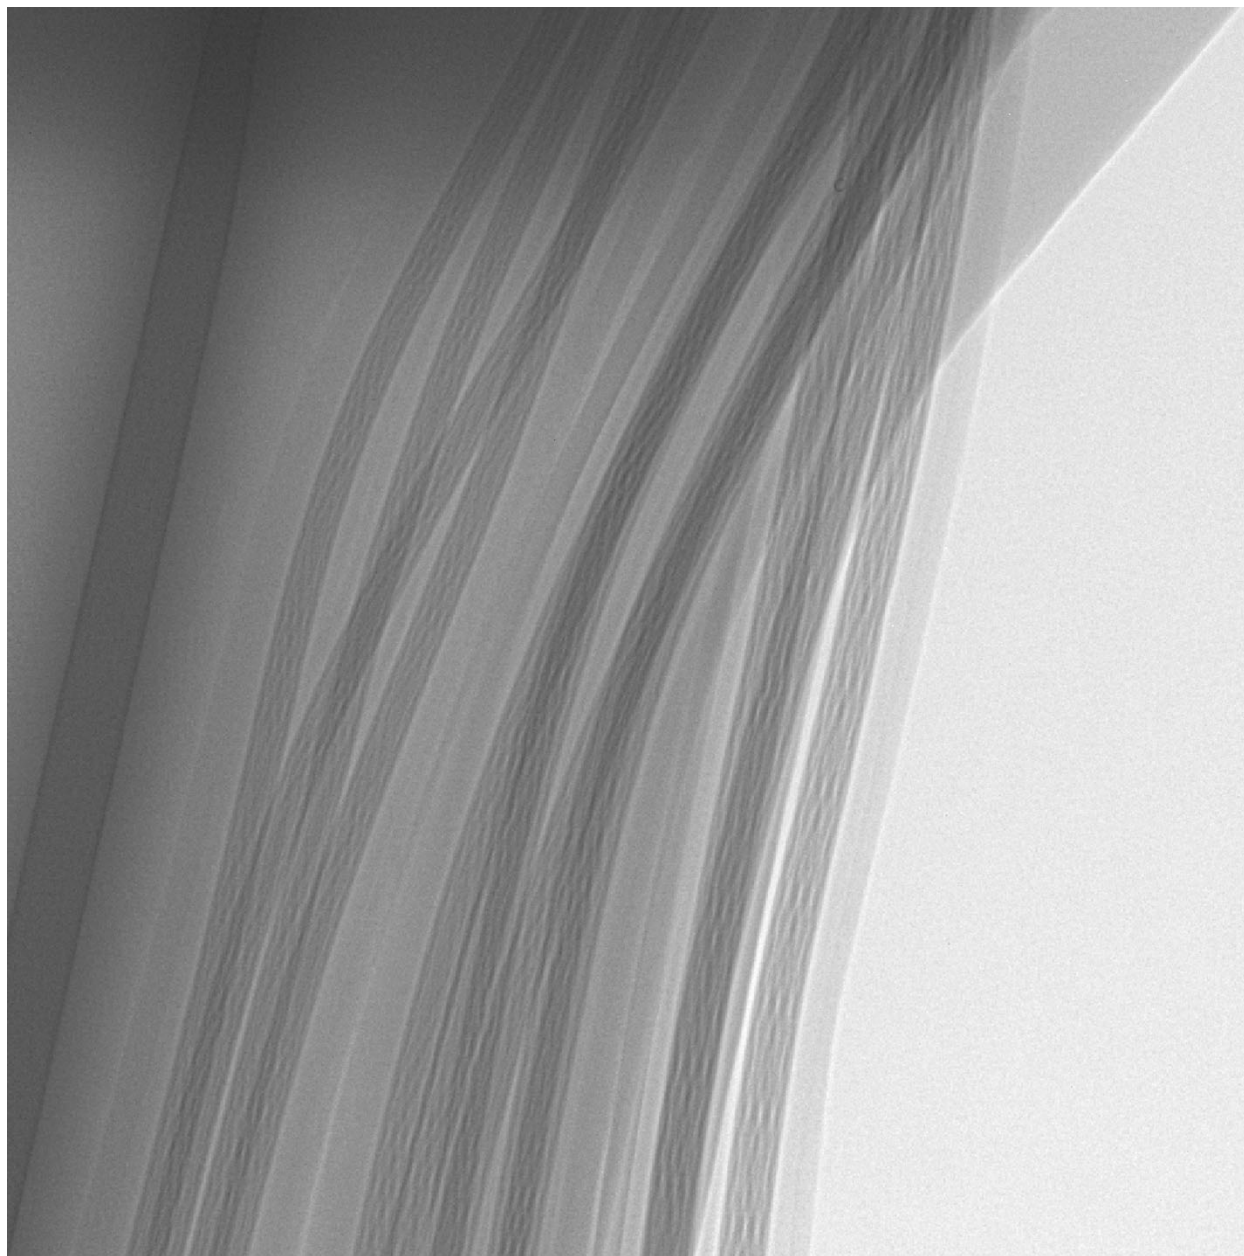
Figure 13 - Left throttle lever – no anomalies noted in the wiring

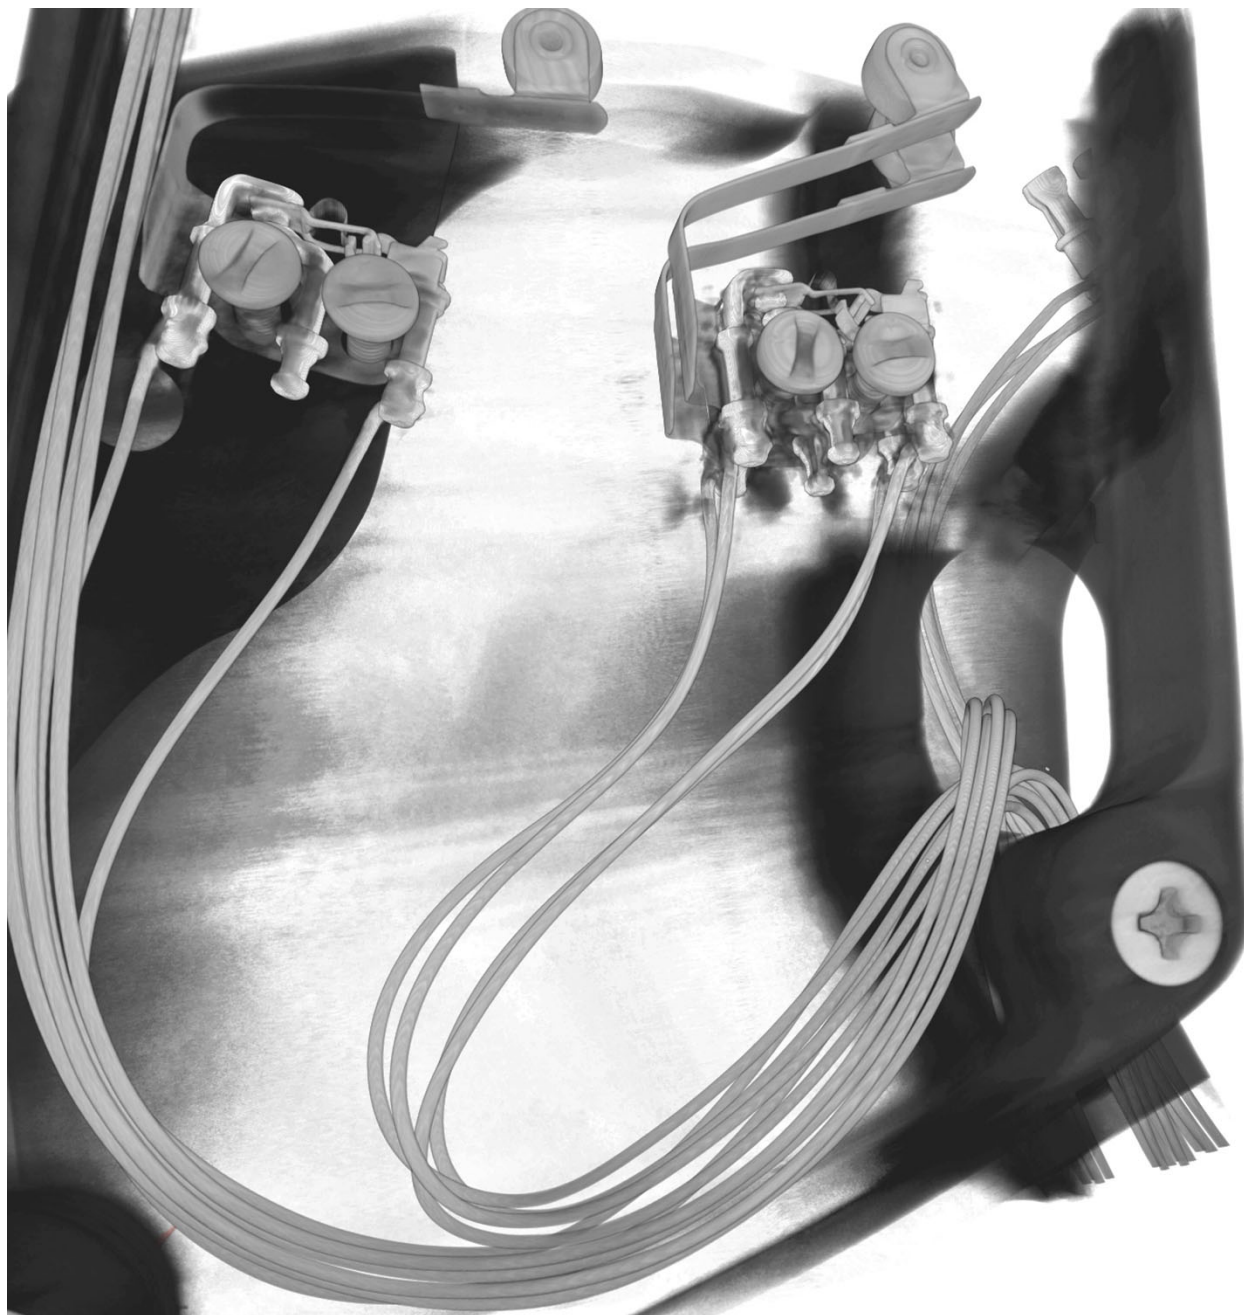
Computed Tomography (CT) scans were captured of the go-around switch areas of the left and right throttles, shown in Figure 14 through Figure 20. No anomalies were observed concerning the switch bodies, solder joints, and associated wiring, as shown in Figure 14 and Figure 18. CT cross sections of the switch assemblies, Figure 16, Figure 17, Figure 19, and Figure 20, revealed no anomalies or discrepancies. The depressed actuator arm, shown in Figure 7, was depressing the single switch, Figure 19, actuating the internal components and closing the normally open contacts.

Figure 14 – CT of left go-around switches

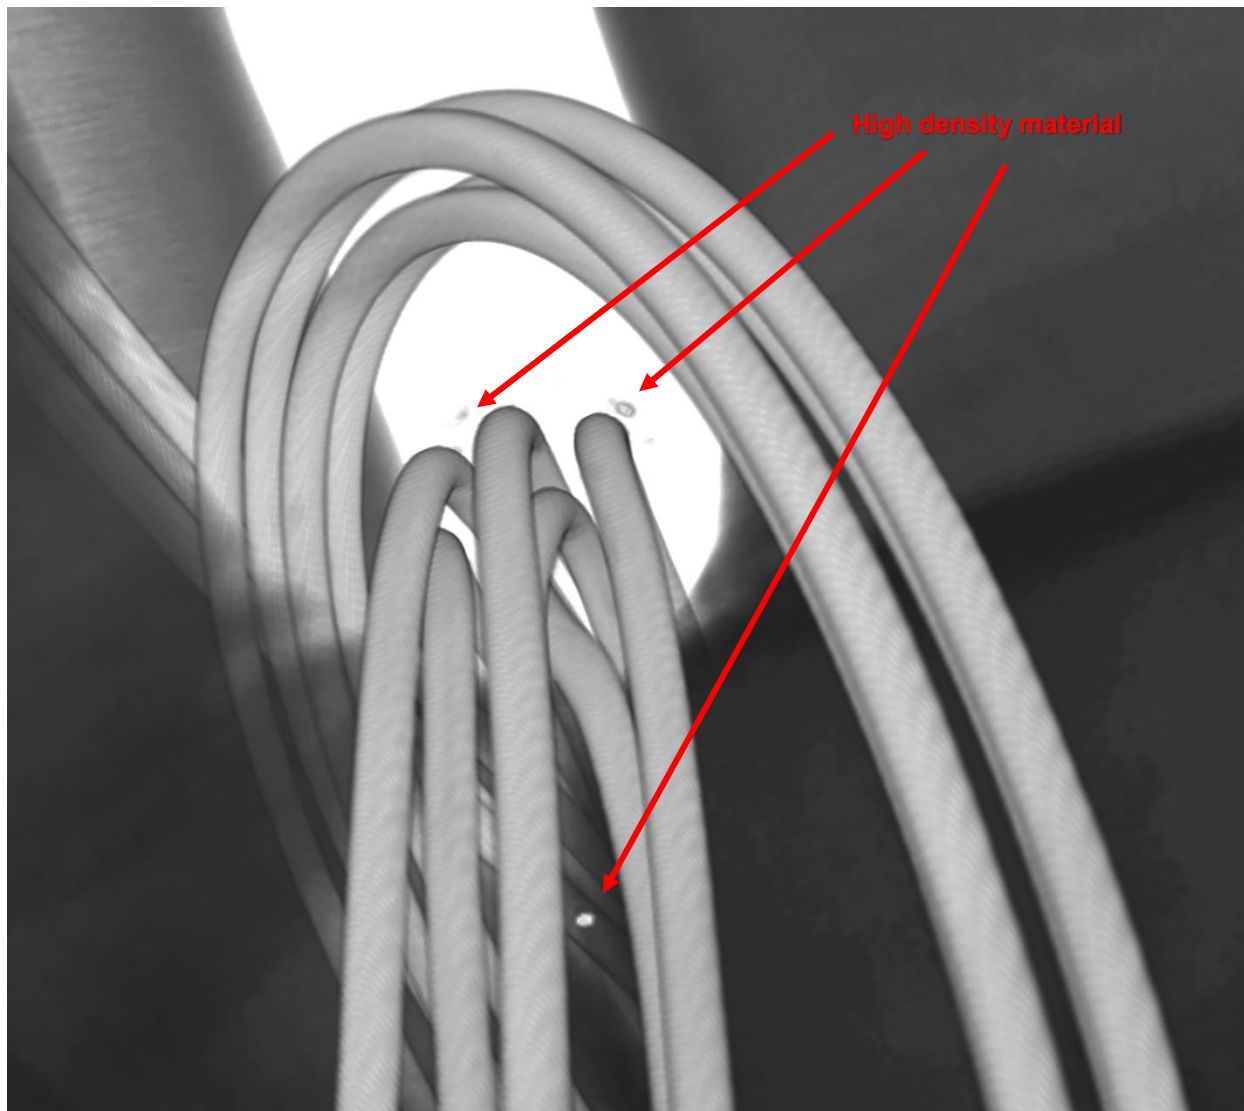
Figure 15 – CT of left go-around switch wiring

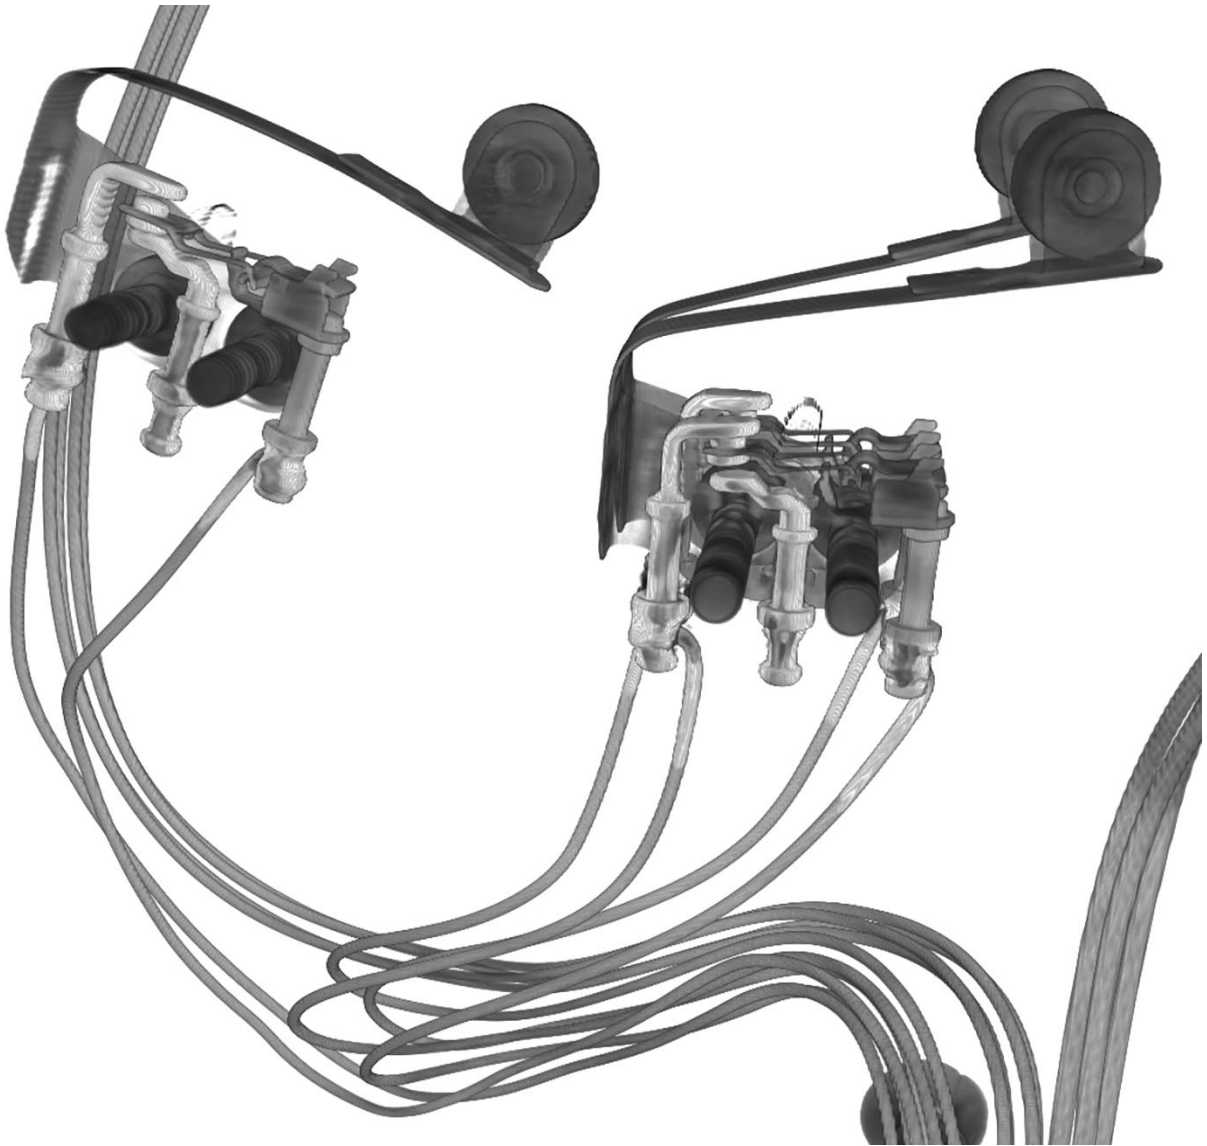
Figure 18 – CT of right go-around switches

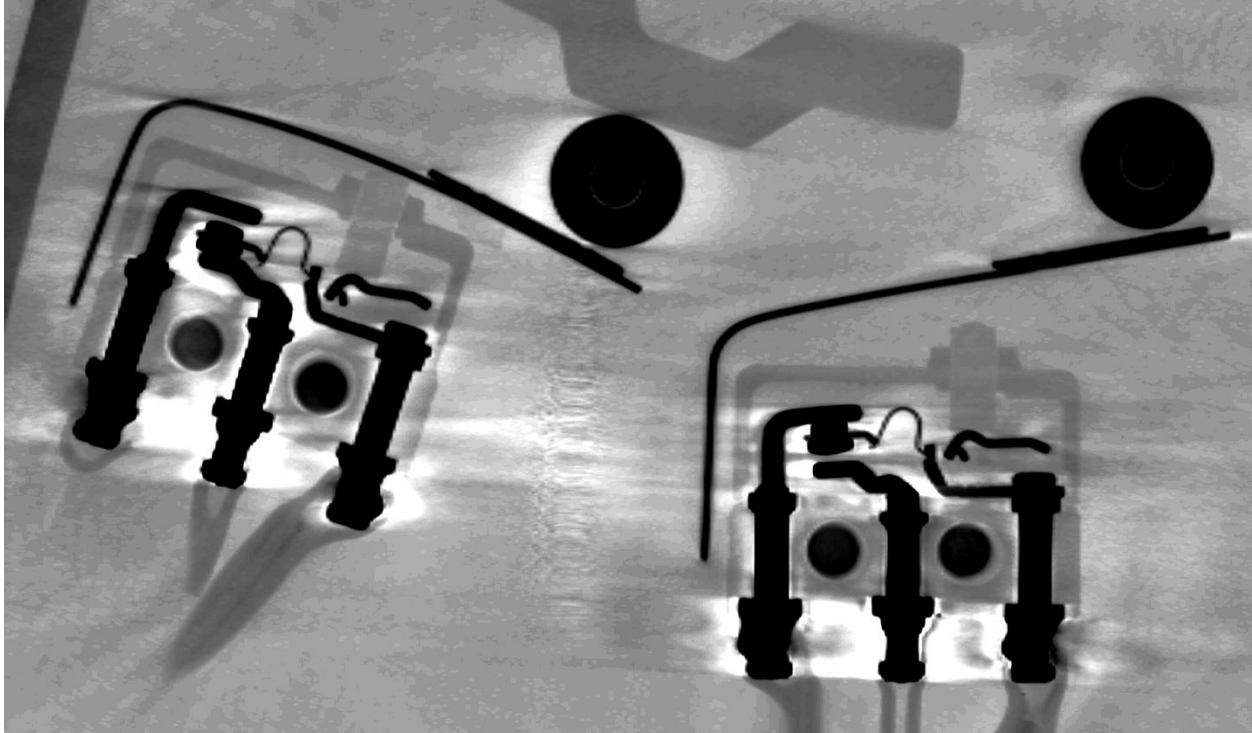
Figure 19 – CT cross section of right go-around switches

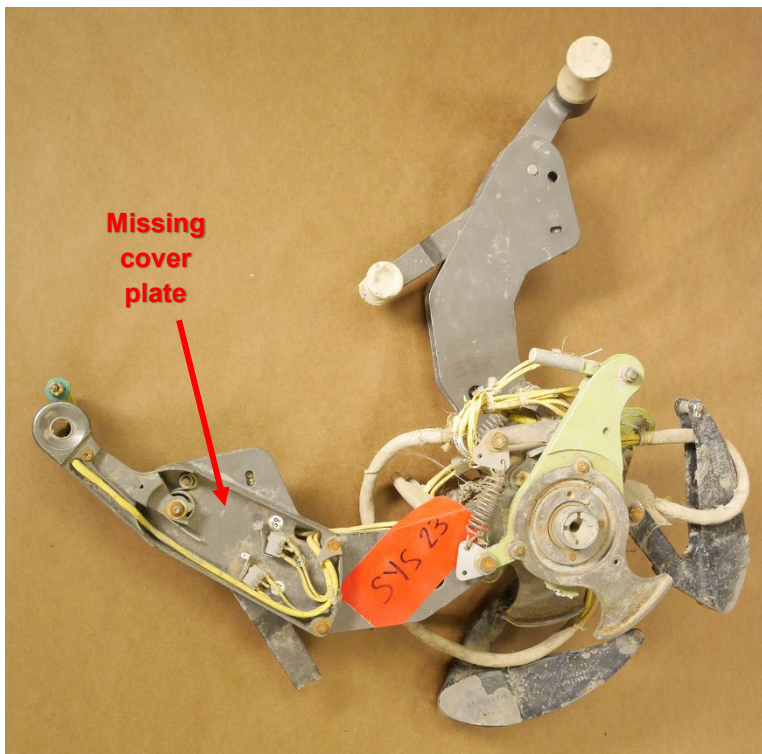
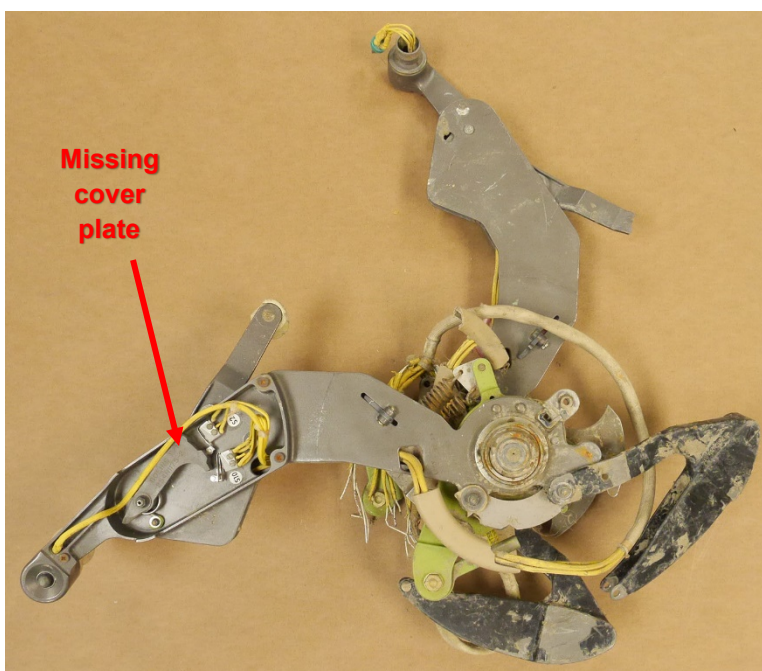
Physical examination of the TLA was conducted under direction of the NTSB, and in the presence of representatives from the NTSB, the FAA, and the International Brotherhood of Teamsters, on August 15, 2019. All work was performed using reference (b) as a guide. The plates covering the three go-around switches on both throttles were missing, shown in Figure 21 and Figure 22.

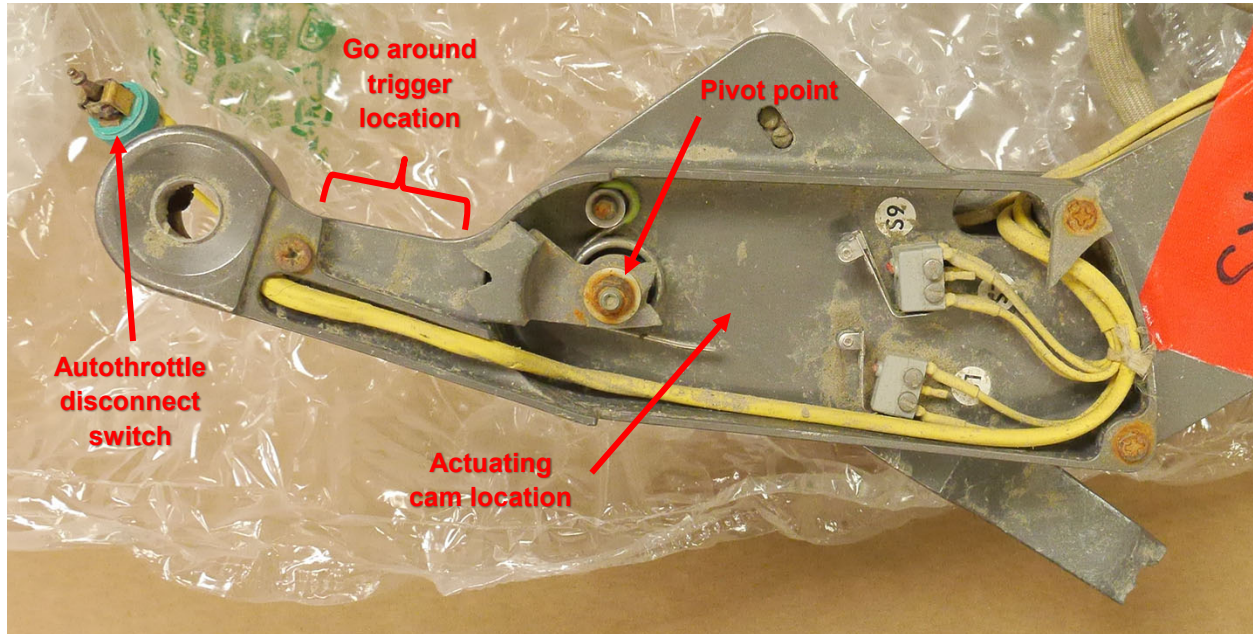
Figure 23 – Left throttle lever

On the left throttle lever, the go-around trigger was missing except for a portion above the pivot point, and the actuating cam of the trigger assembly was also missing; see Figure 23. The left autothrottle disconnect switch, Figure 23, was noted as separated from the throttle knob but still connected by the wires.

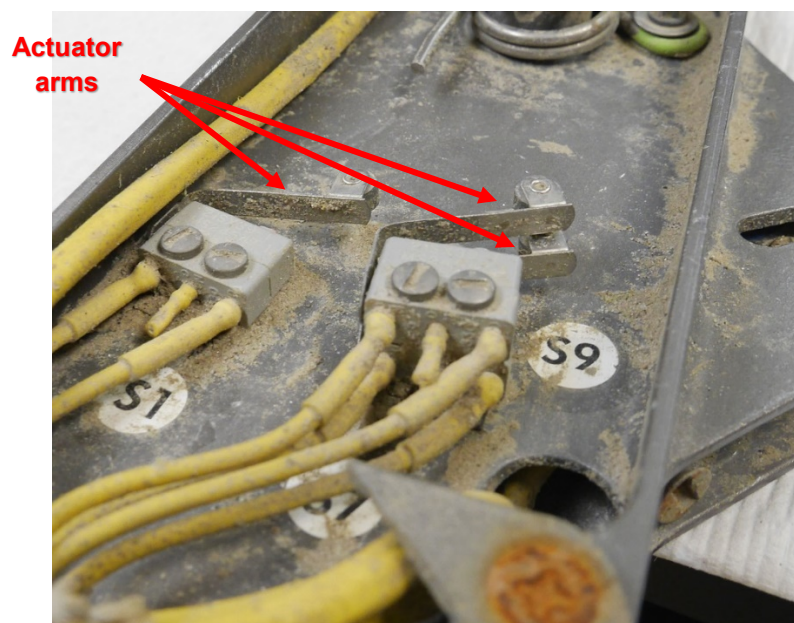
Figure 24 – Left throttle lever

The actuator arm on the S1 go-around switch was misaligned outboard and the S7 actuator arm was bent outboard and contacted the S9 actuator arm, see Figure 24. The S9 actuator arm did not appear misaligned.

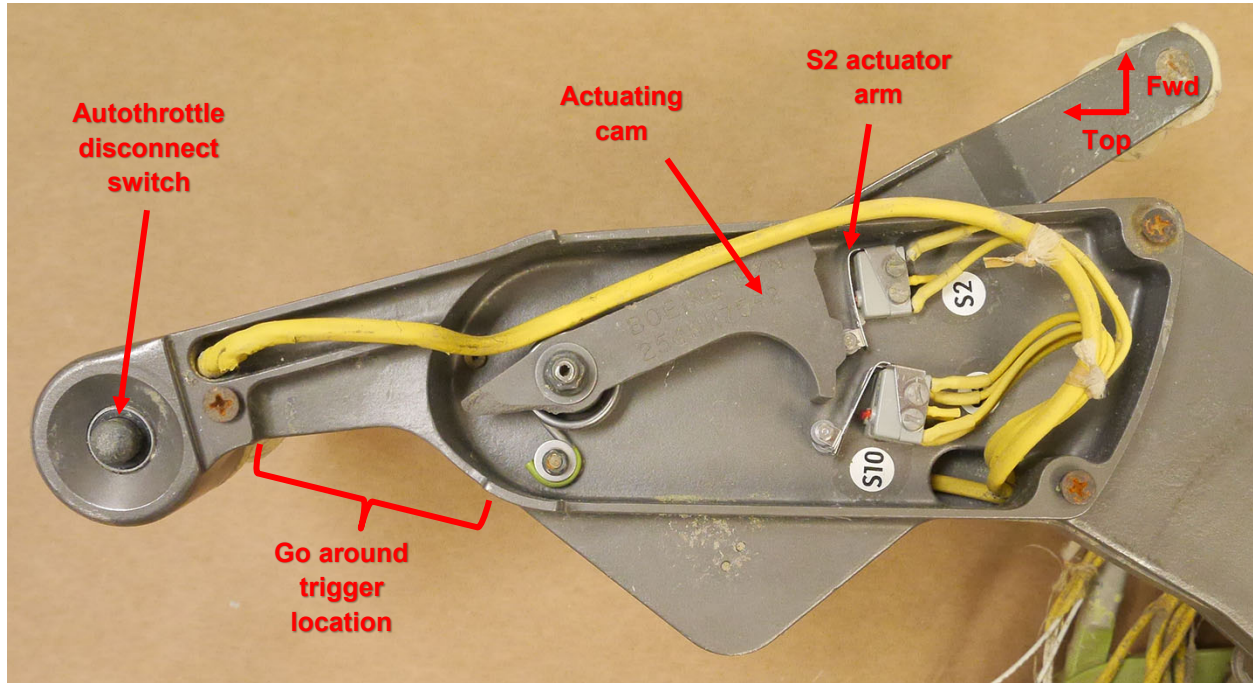
Figure 25 – Right throttle lever

On the right throttle, it was noted that a portion of the cam end of the go-around trigger was rotated "forward" and wedged against the front wall of the lever, see Figure 25. The portion of the trigger also jammed/depressed the S2 switch actuator arm. The right autothrottle disconnect switch, Figure 25, was found intact in the throttle knob.

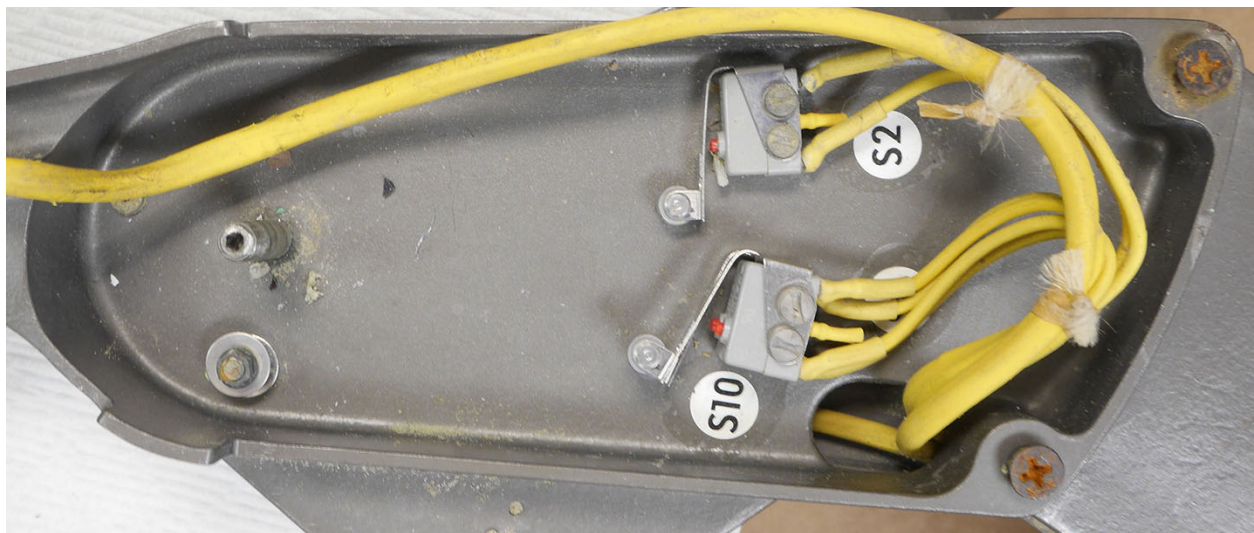
The cam end portion of the go-around trigger was removed under direction of the NTSB and the S2 switch actuator arm was released, see Figure 26. Once released, the S2 actuator arm was free to move and appeared to be properly aligned.

Figure 26 – Right throttle lever with cam removed

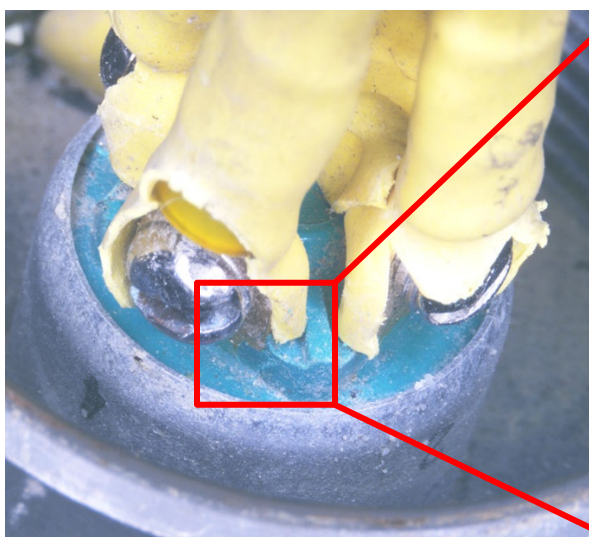
The switch was examined under a digital microscope and cracking was noted at the base of one of the terminals, shown in Figure 29 and Figure 30.

Figure 29 – Right autothrottle disconnect switch

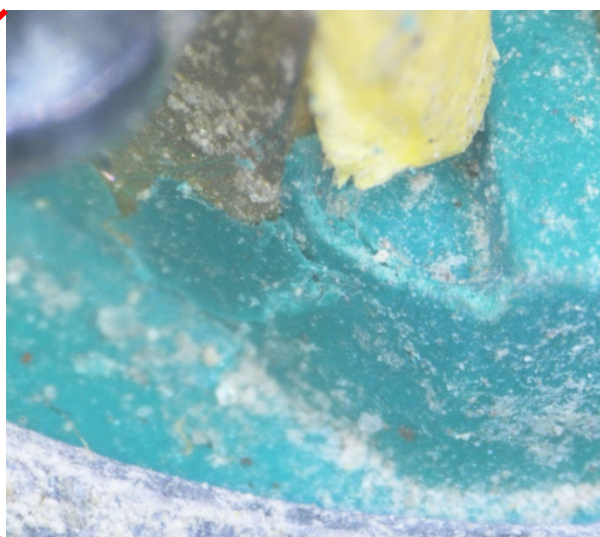
Figure 30 – Cracking noted in switch base

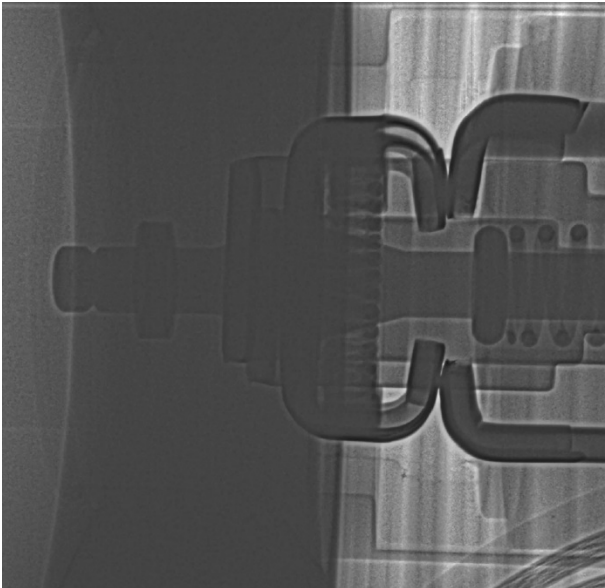
Further examination of the right autothrottle disconnect switch using DR imagery indicated possible misalignment or area of low density between the normally closed contacts, shown in Figure 31 and Figure 32.

Figure 31 – DR of right autothrottle switch

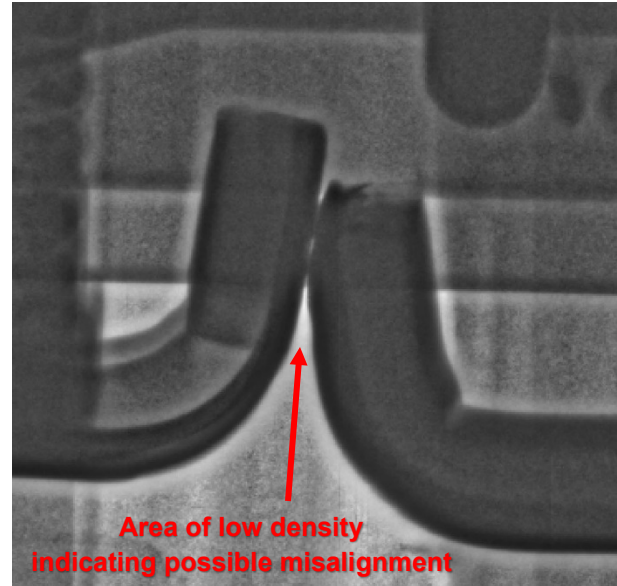
Figure 32 – Magnified view of contacts
