**NATIONAL TRANSPORTATION SAFETY BOARD**  
Office of Aviation Safety  
Washington, D.C. 20594

**Systems Group Chairman's Factual Report**

**A.    ACCIDENT            **DCA19MA086****

Location:            Trinity Bay, Texas  
Date:                February 23, 2019  
Time:                1239 central standard time  
Aircraft:            Atlas Air flight 3591, a Boeing 767-375BCF, registration N1217A

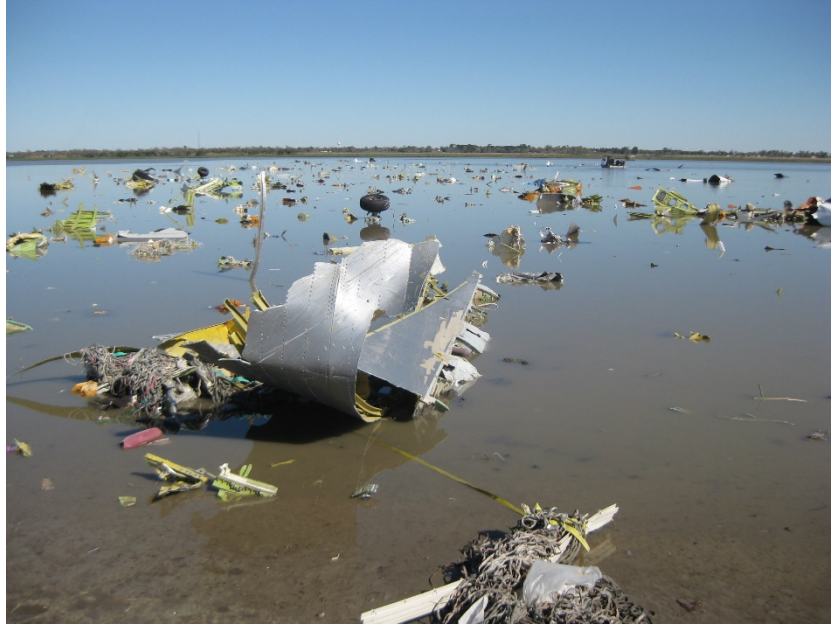
Figure 1 - View of portion of the wreckage in Trinity Bay, prior to recovery.

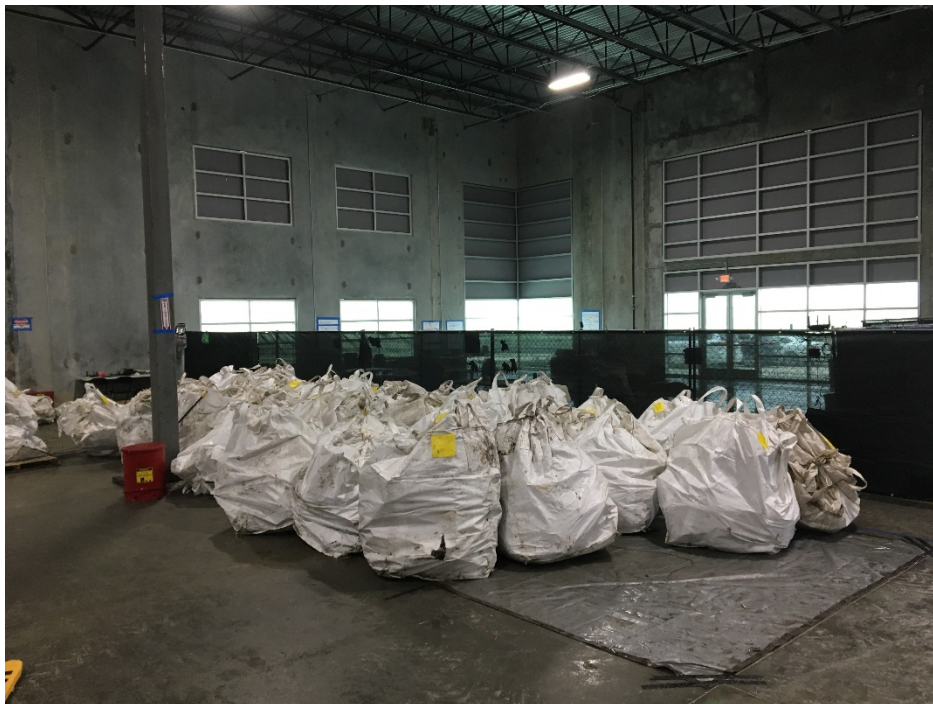
Figure 2 - Bags of wreckage in warehouse waiting to be searched.

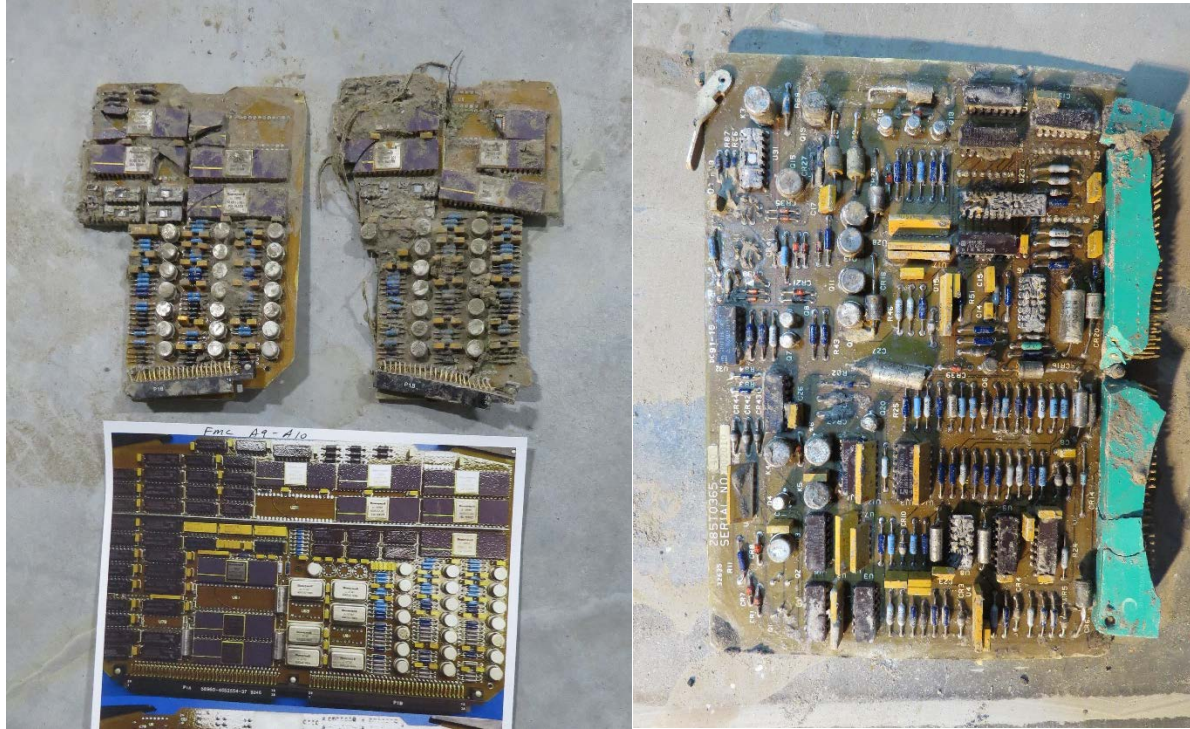
The CCAs were documented for any identification – assembly numbers, serial numbers, etc. (See Figures 3a and 3b). The cards were then examined for non-volatile memory components. Several CCAs were identified (see below) but the micro-chips on each of the cards were too damaged for additional examination. The following were identified:

Figure 3a (left) and 3b (right) - Examples of circuit card assemblies as recovered at warehouse. Figure 3a compares the recovered segments against an intact card.

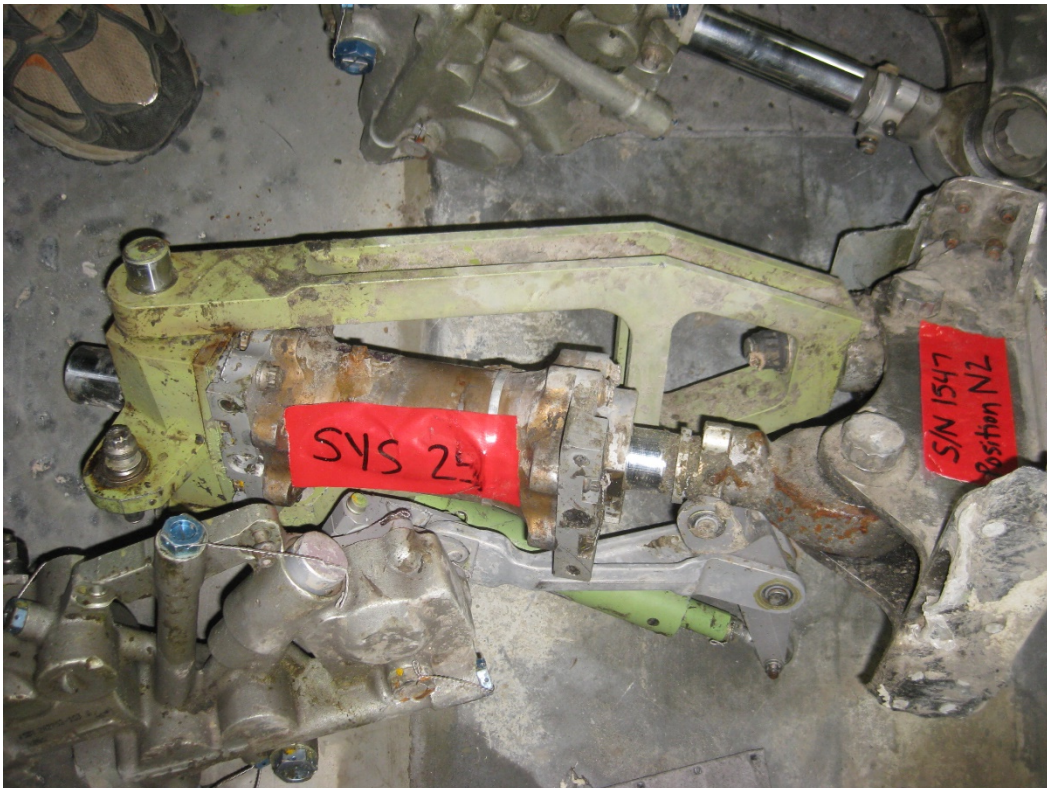
- These were database items SYS25 and SYS25D. See Figure 6.
- According to Atlas records, this elevator PCA was installed as the center PCA on the left outboard elevator.
- Parker part number: 282700-1009, Boeing Specification Number: S525T801-4.
- Manufacturing Date: 2Q88
- The elevator hinge bracket and connecting hardware were still attached.
- A measured 0.750” chrome extension on actuator side, from housing base.
- Hydraulic manifold separated from the actuator attach mounting, held on by interconnect linkage.

- The change notice tag and data plate for the modifications and service bulletin data is still attached.
- The interconnect linkage still has green linkage attached.
- Removed both ¾” diameter bolts from the elevator hinge.
- Due to a broken bracket, the -4 bolt at the stabilizer side attach fitting on reaction arm was removed.
- Removed the broken interconnect rod from the hydraulic manifold input arm
- Removed the manifold assembly from the input arm, as the manifold was completely detached from PCA and only attached to overall unit by input arm.

Figure 6 - Elevator PCA Serial Number 1547, as recovered in warehouse.

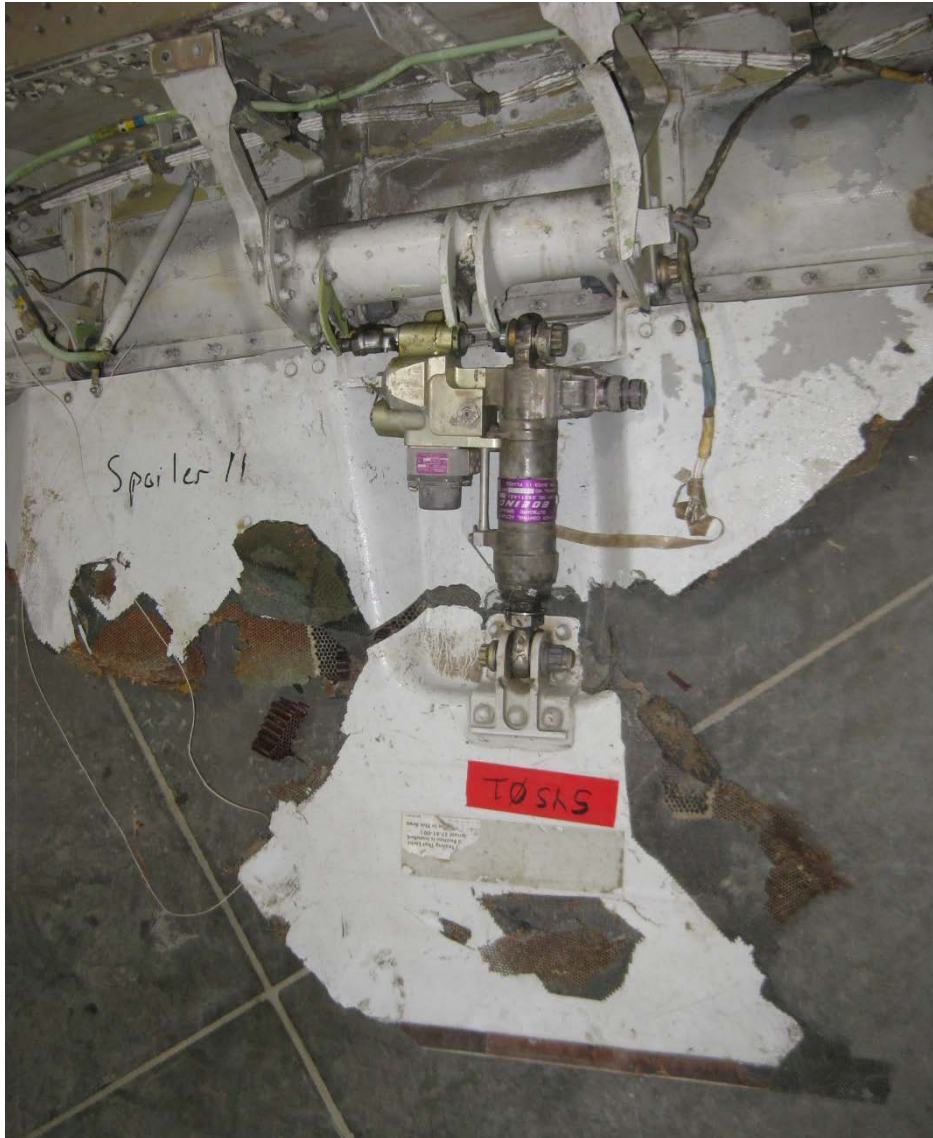
- SYS001 appeared to attach into spoiler position #11. The spoiler fit the spoiler surface and the connection hardware fracture on the associated torque tube attachment. The associated wing structure was RW043. See Figure 8.
- The hydraulic connections for SYS001 were sheared and the cannon plug was still attached. The associated electrical wires, pulled from the actuator, were located within the mating wing structure.
- Based on the identified actuators, the spoiler in position #9 was the spoiler actuator not recovered.

Figure 8 - Spoiler Number 11, as recovered and identified in the warehouse. Note that a portion of the spoiler flight control surface is still attached to the actuator, and the actuator is still attached to right wing structure.

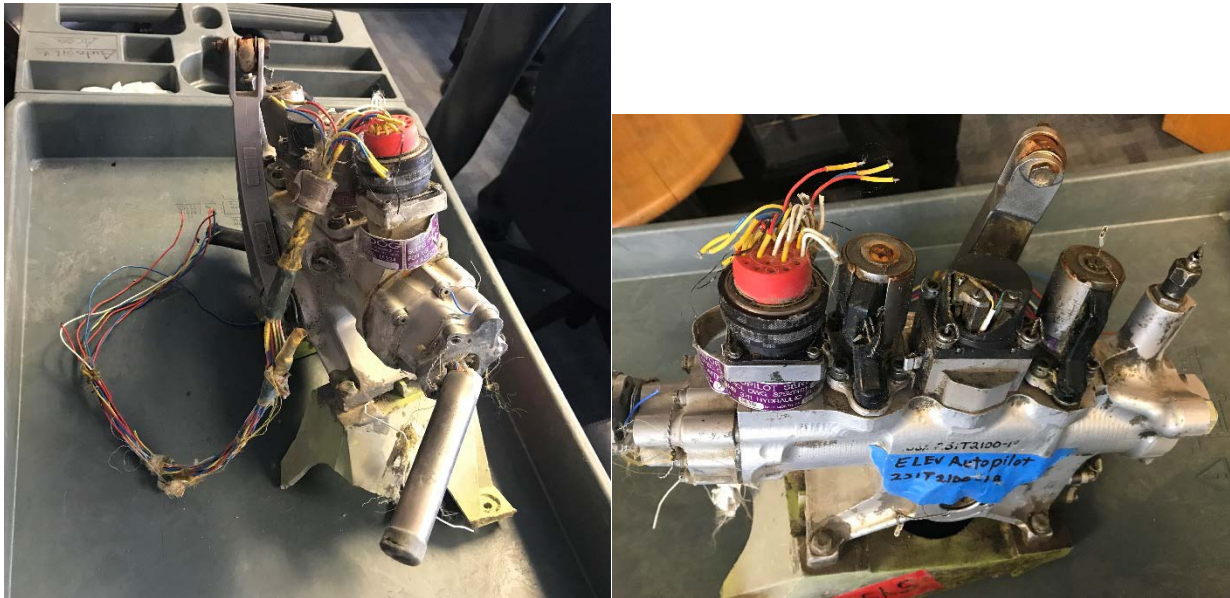
- Identified as the Center Autopilot Elevator Servo. See Figures 10a and 10b.
- Manufacturer: Moog Aircraft Group
- Moog Part Number: A28321-12
- Serial Number: 1418
- Boeing Spec Control Drawing: S252T401-8
- Model Number: 17-334
- Revision Level: L-12
- Manufacture Date: 1191
- The identification sticker on associated structure indicated Boeing position M521, which is identified as center stab position transmission module.
- The servo was retained for further examination.

Figure 10a and 10b - The Center Autopilot Elevator Servo.

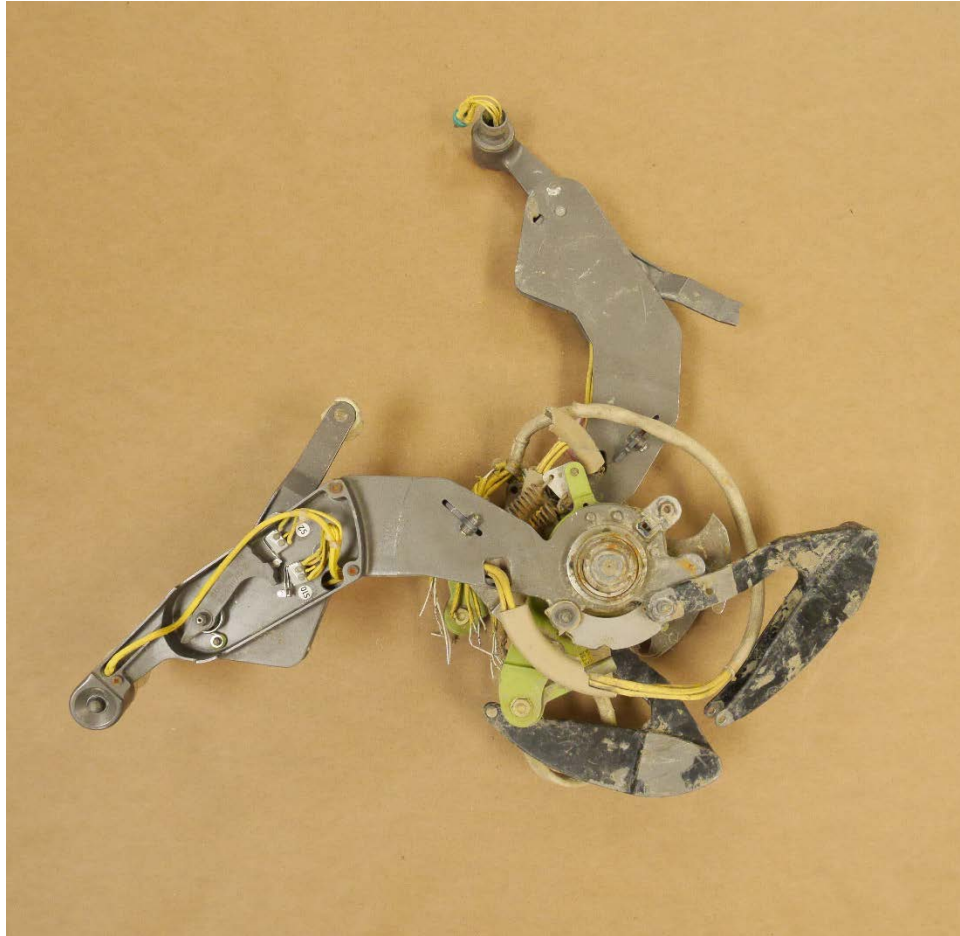
Figure 14 - Control Stand Thrust Lever Assembly and associated structure, as received at the Boeing EQA Laboratory.

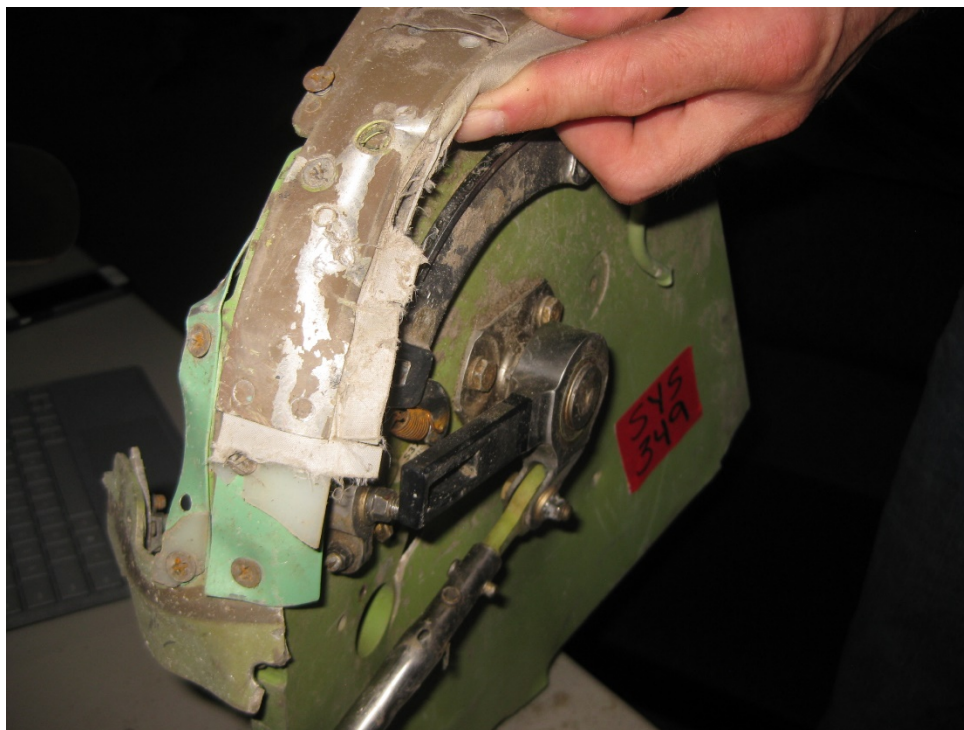
- The circumference of the lever speed brake rail was 7". There was a bent, compressed area of the outer frame just above the speed brake rail that corresponded to approximately 1.5" aft of the forward/stowed detent – 1.5" is the most aft portion of the bent outer frame. The center of the compressed frame was ~3/4" aft of the forward/stowed detent. See Figure 15.

Figure 15 - Speed Brake Rail with finger pointing to the compressed area of the outer frame.

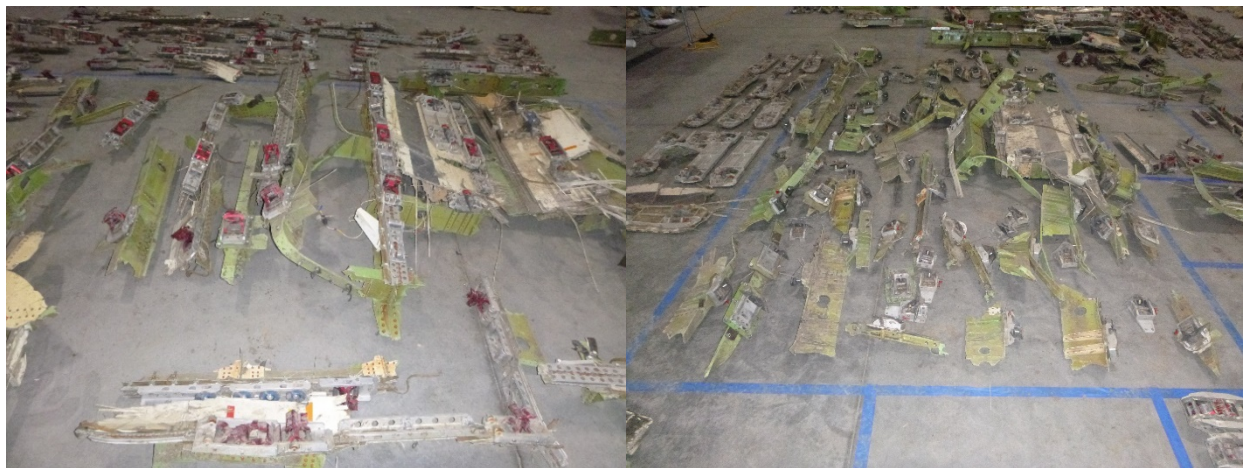
During the recovery of the airplane from Trinity Bay, parts identified as components of the cargo containers, cargo loading, and securing systems were separated and examined. No evidence of any pre-impact failures was noted. See Figures 20a and 20b.

Figure 20a and b: Examples of the Cargo Loading and Securing System Components, as recovered in the Baytown warehouse.
