NATIONAL TRANSPORTATION SAFETY BOARD

Group Chairman's Factual Report

DCA19MA143

**Appendix A – Figures
(9 pages)**

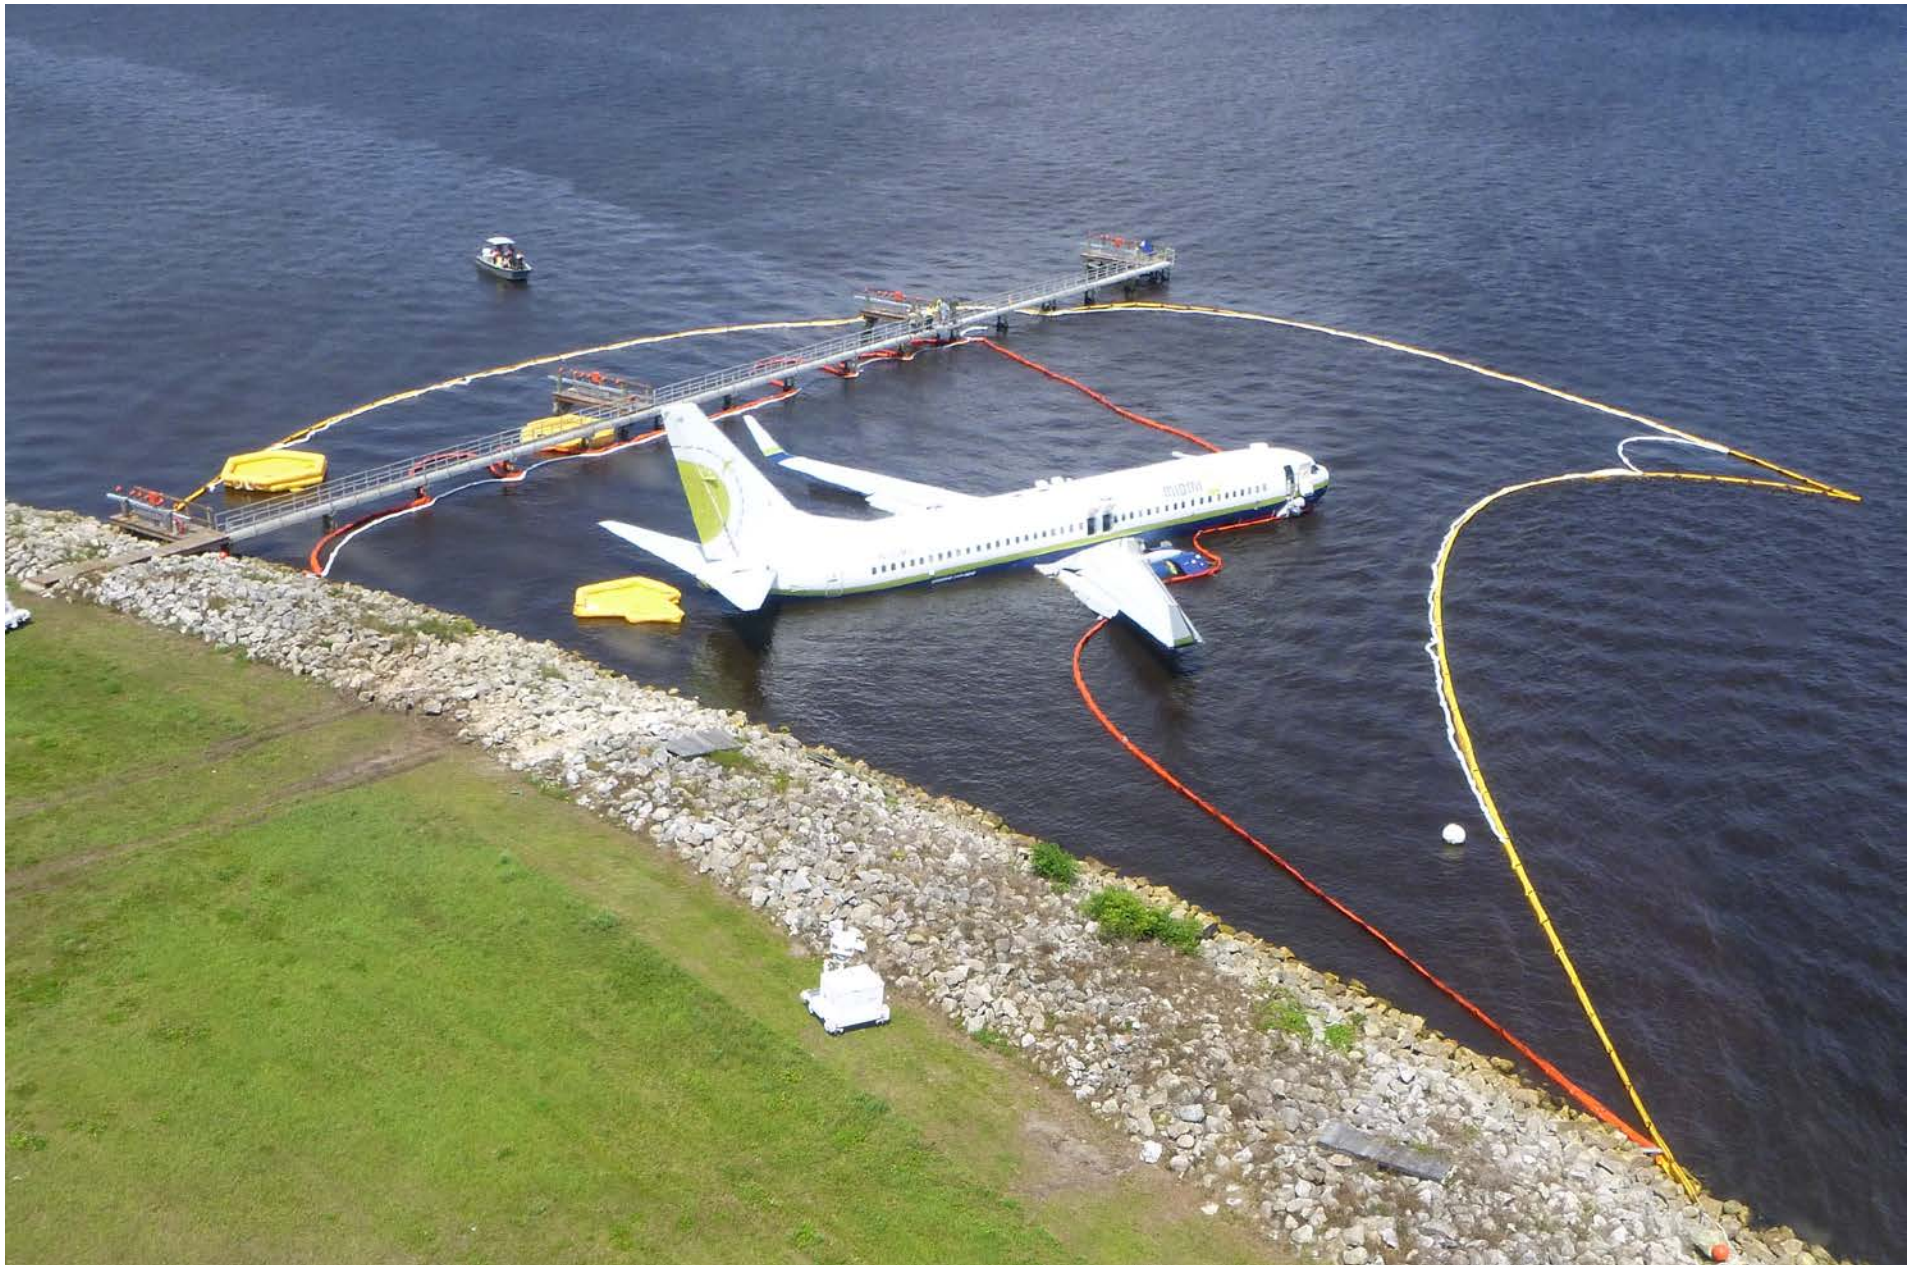
Figure 4 – Aerial view of the accident airplane in the St. Johns River

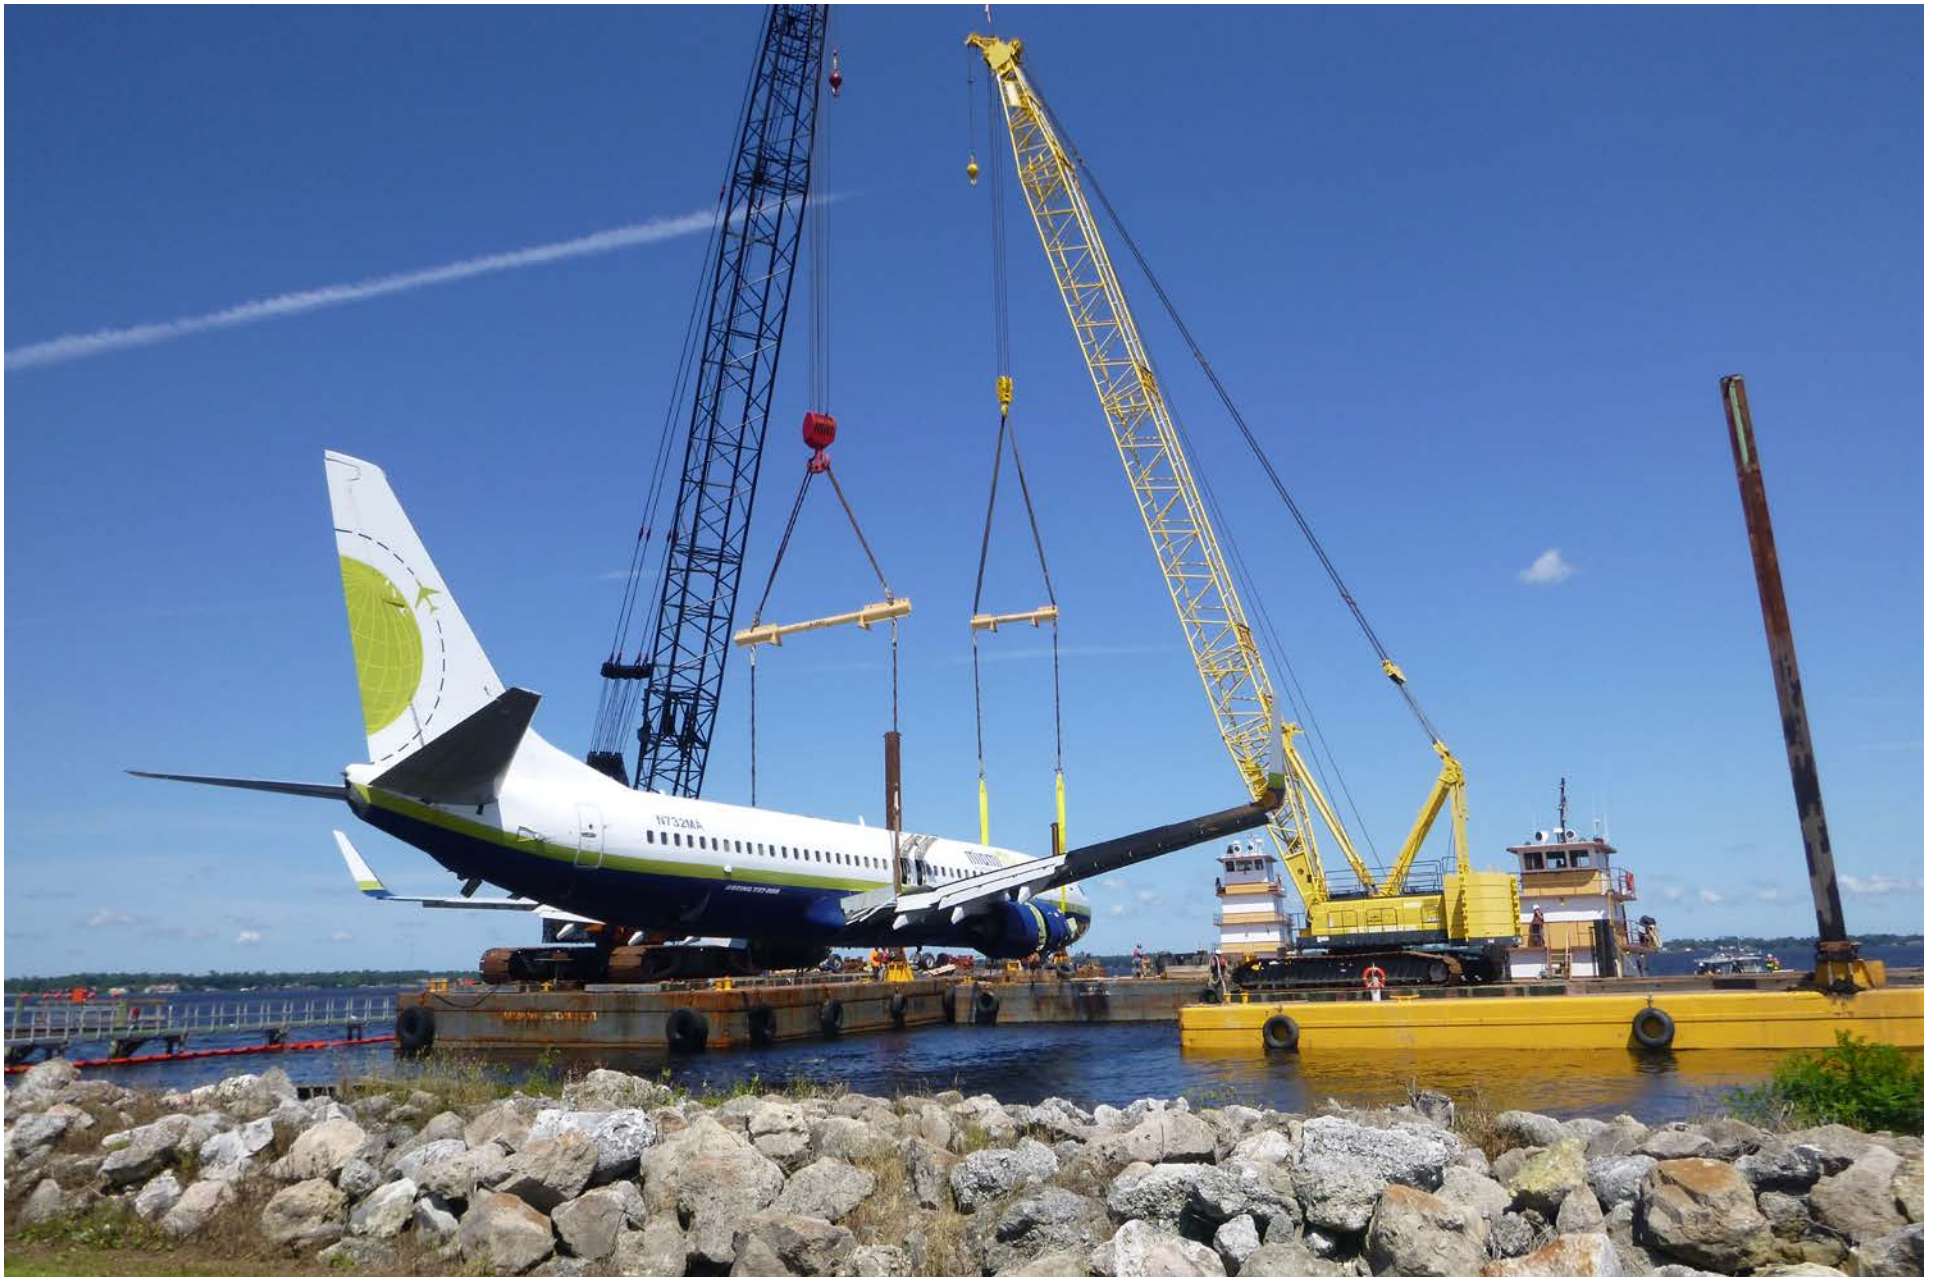
Figure 5 – Accident airplane being lifted from the water

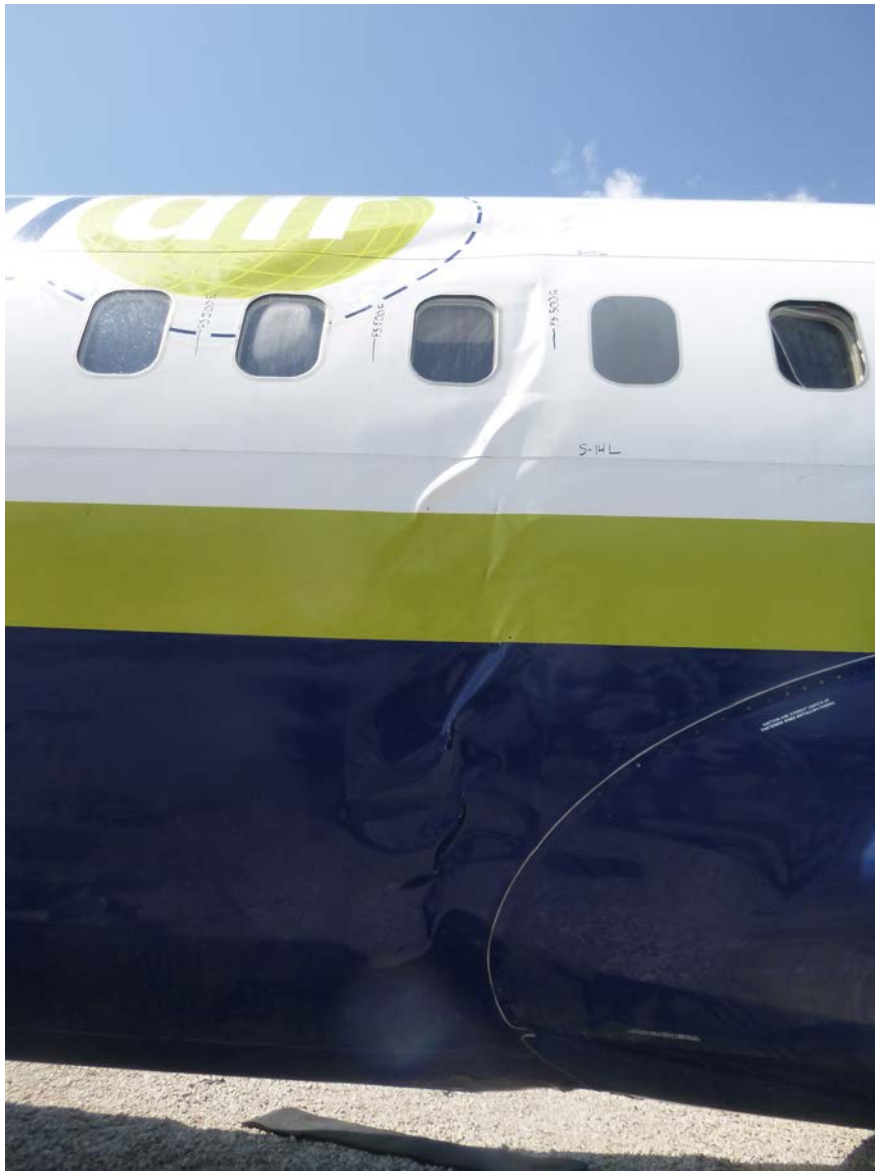
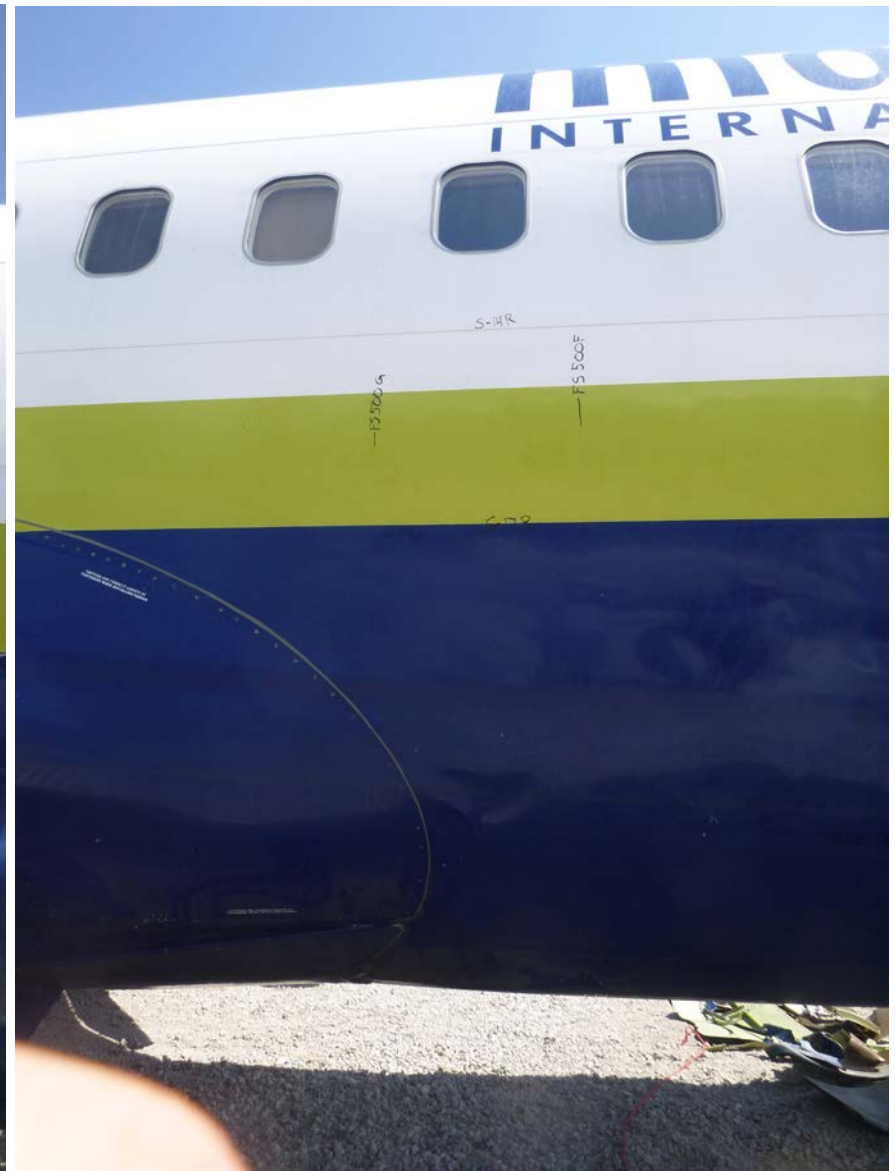
Figure 6 – Fuselage buckling on the left and right sides of the airplane

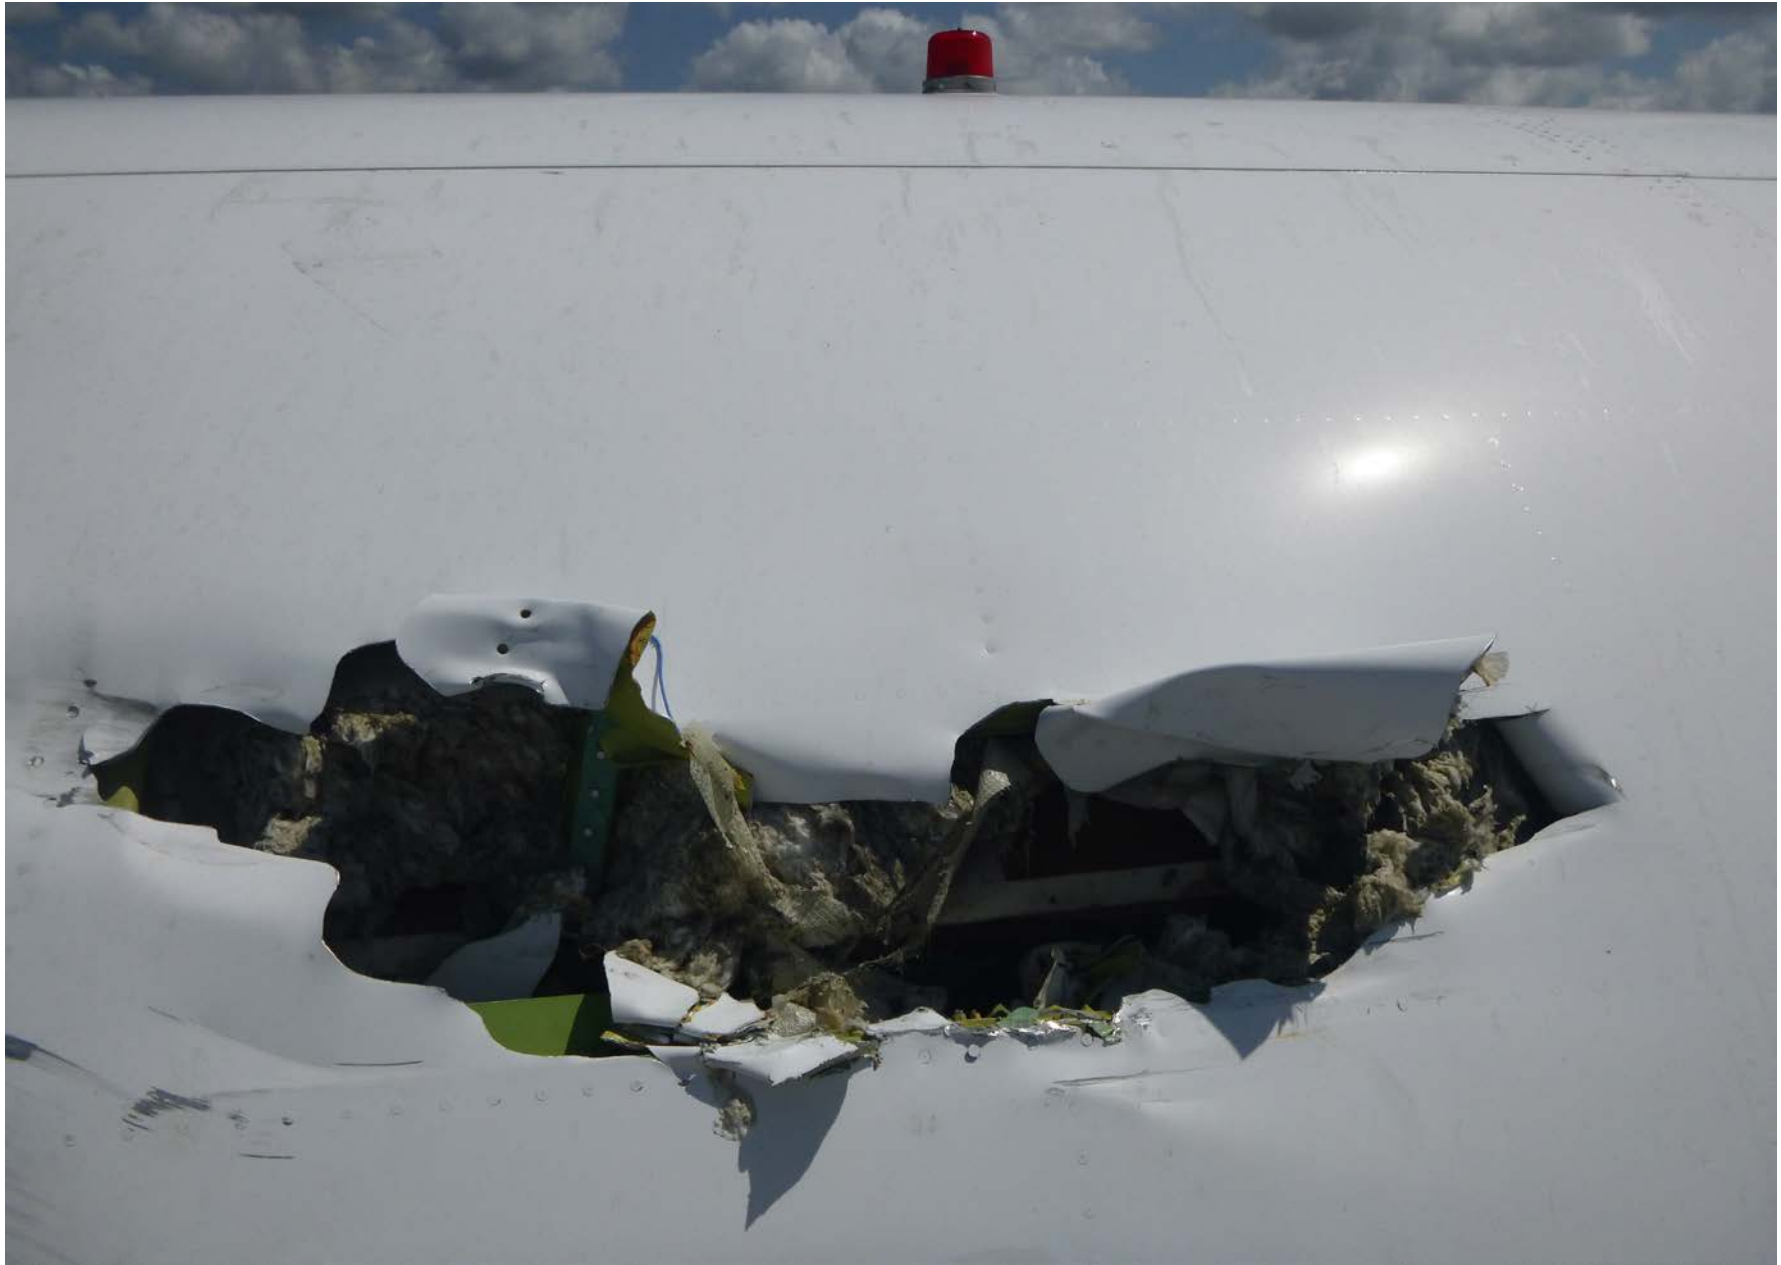
Figure 7 – Hole in fuselage above right forward overwing emergency exit

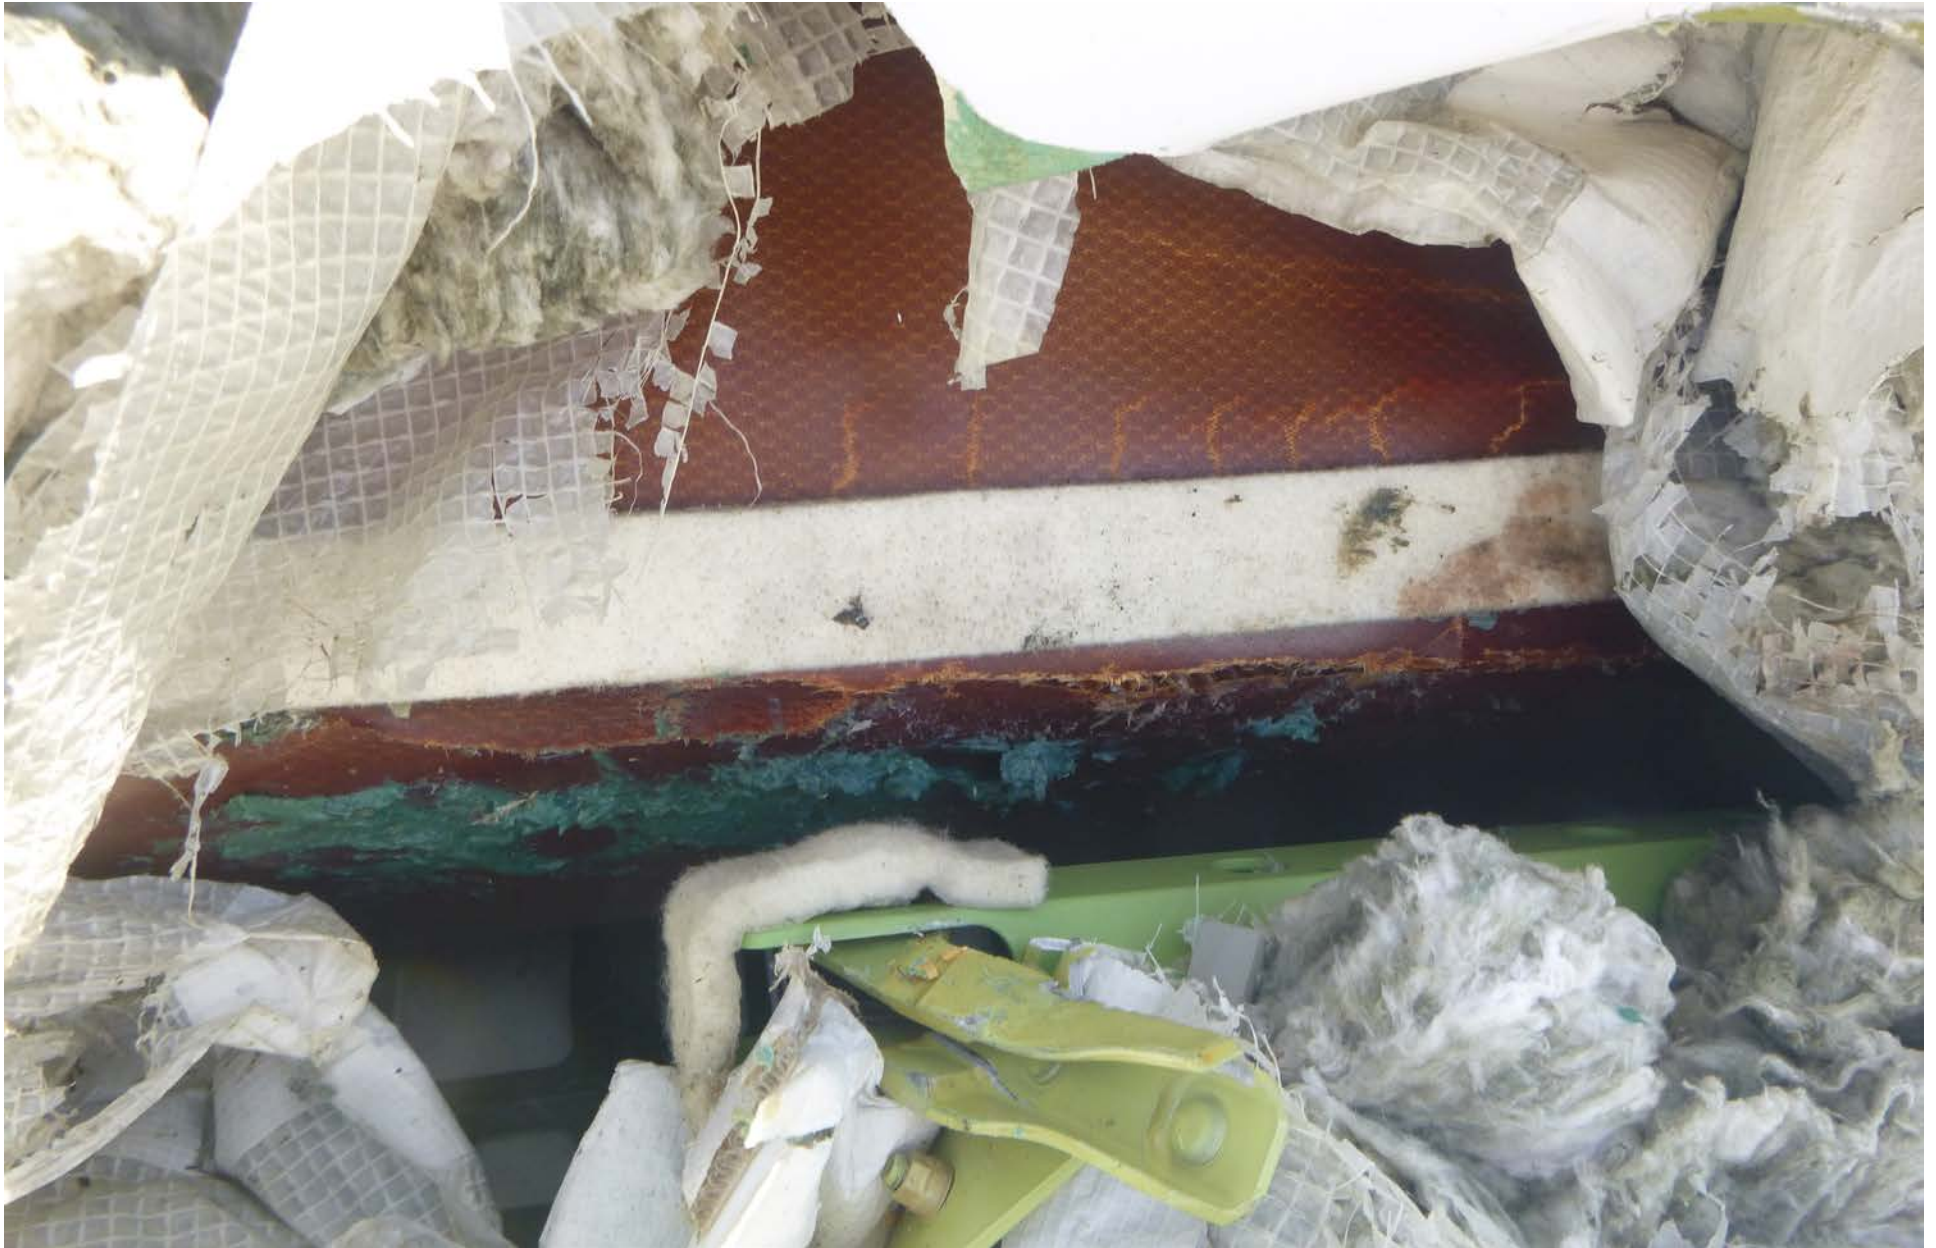
Figure 8 – Blue grease splatter inside fuselage hole

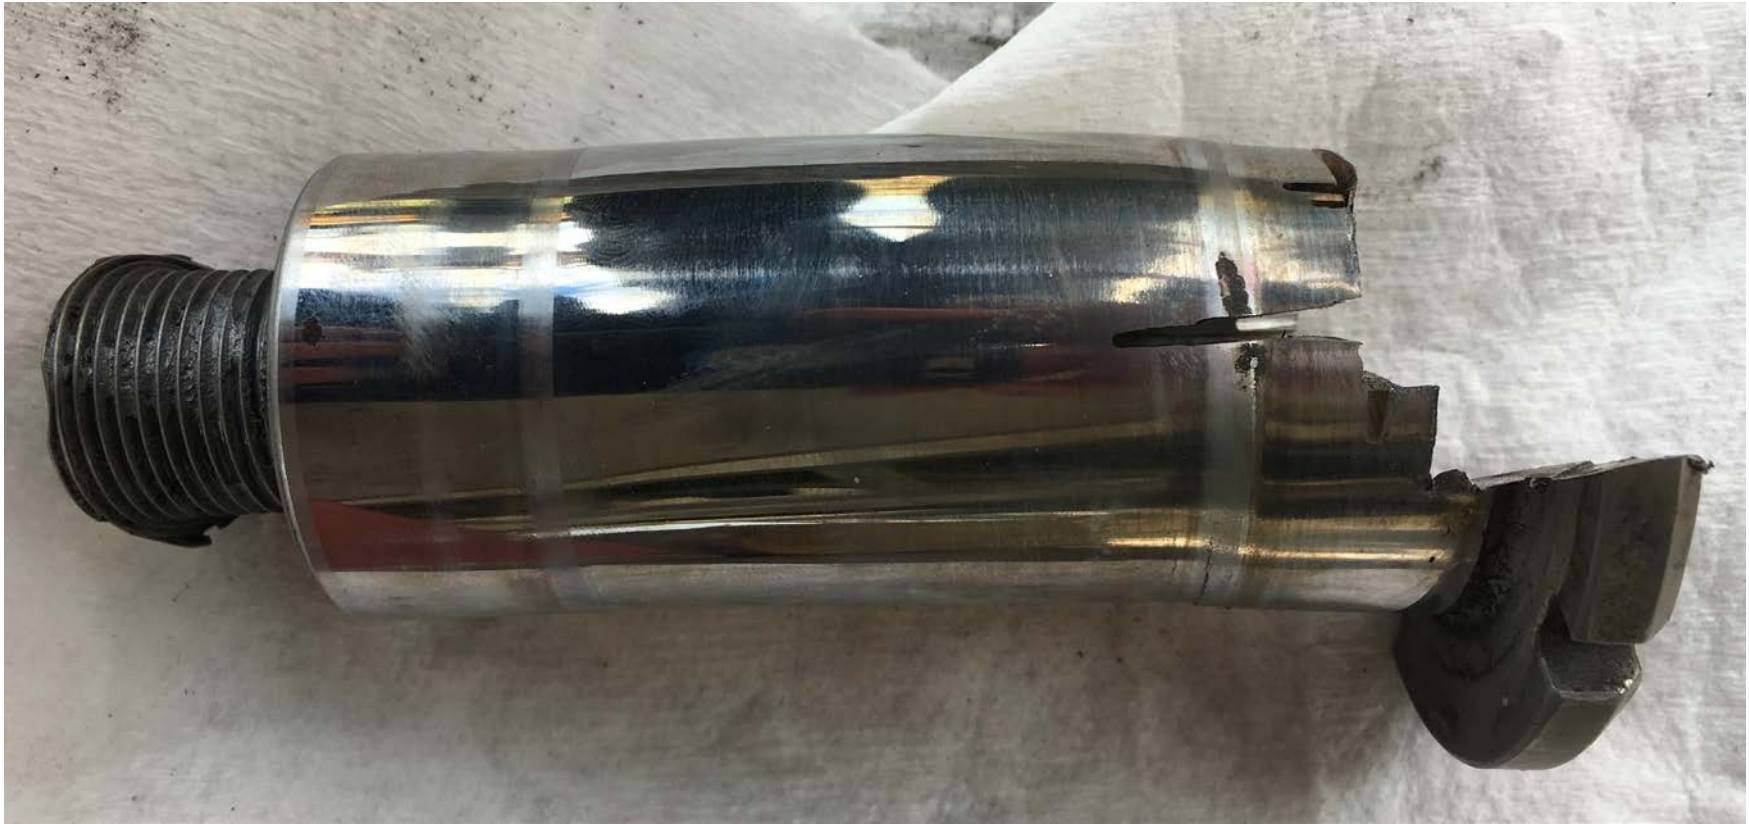
Figure 9 – Left pylon inboard aft upper spar fitting (R4) fuse pin

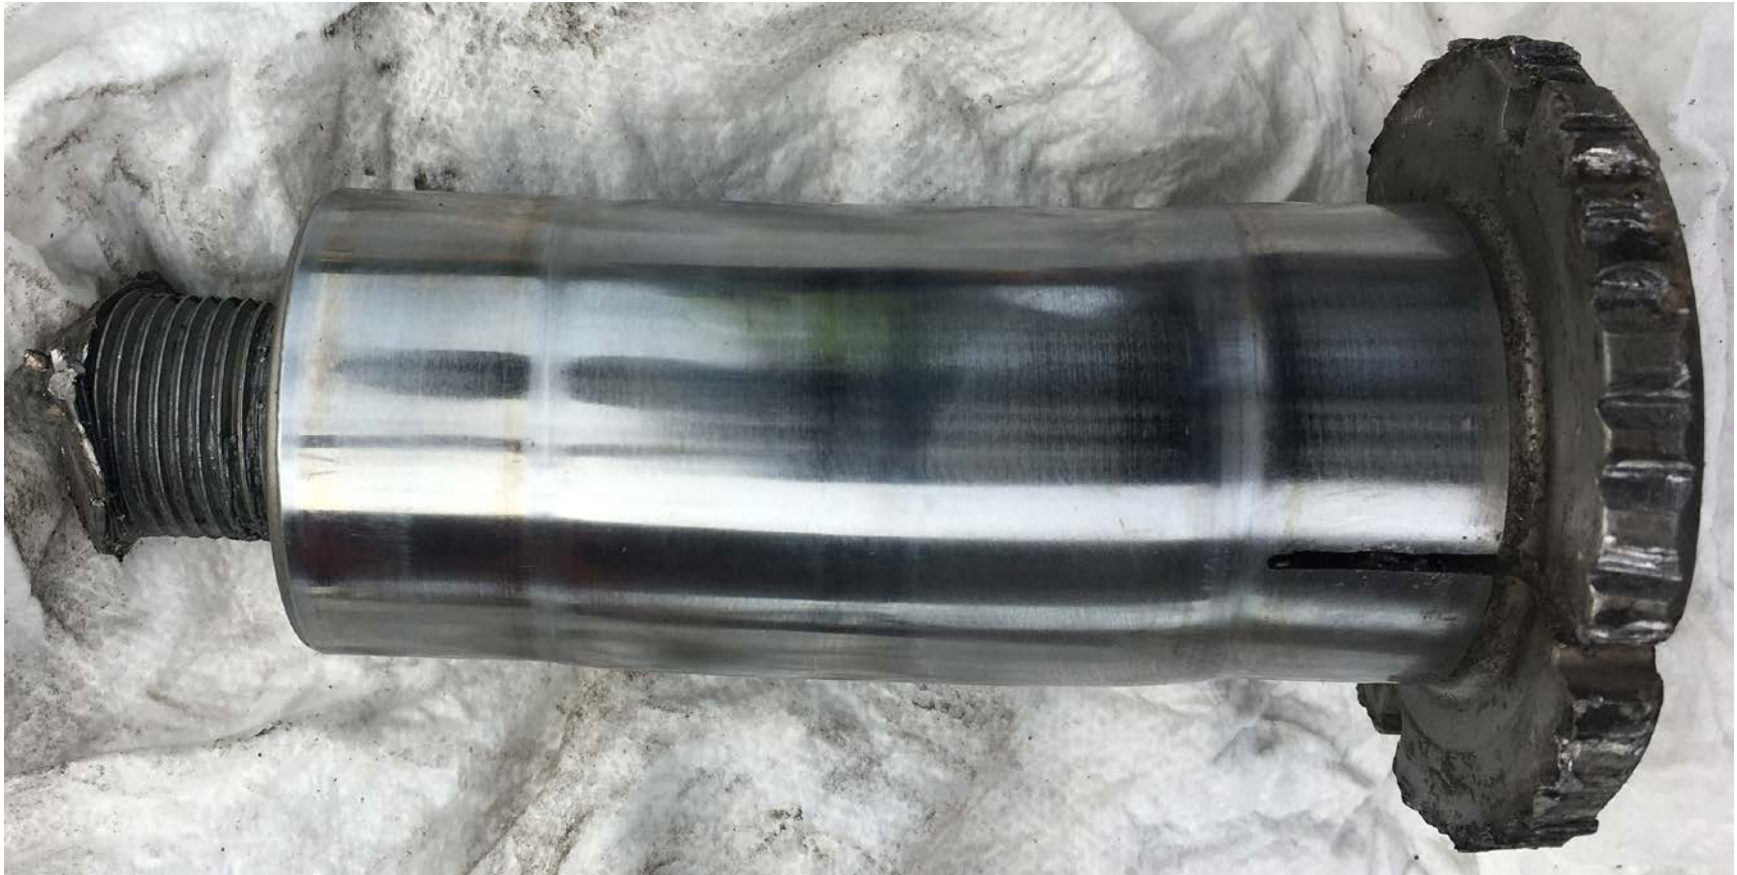
Figure 10 – Right pylon outboard aft upper spar fitting (R3) fuse pin
