## **NATIONAL TRANSPORTATION SAFETY BOARD**

# **STRUCTURES**

**DCA19MA143**

**SUBJECT:**      ***Right Main Landing Gear Wire and Grease Samples***

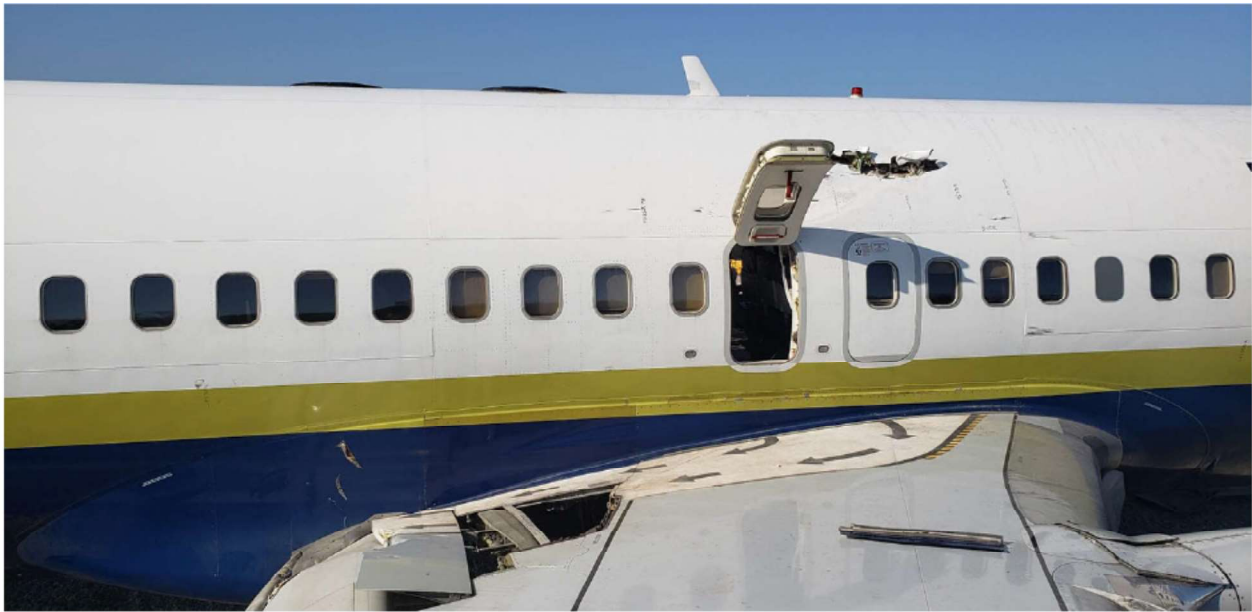
On site investigators noted damage above the window belt between fuselage station (FS) 559 and FS 597, as shown in Figure 1. It was reported that the RMLG was discovered under water and forward of the right wing. A section of blue wire was removed from the folded over skin section in the upper aft area of the fuselage damage, shown in Figure 2. A dollop of grease was found on the back side of the overhead storage bins and was collected from the outside of the aircraft through the damage area. Investigators removed a three-wire harness from the RMLG that had a full length red and yellow wire, and a fractured blue wire. A grease sample was also collected from one of the attachment bearings of the RMLG.

Figure 1 – Image of fuselage showing damage area provided by Boeing ASI

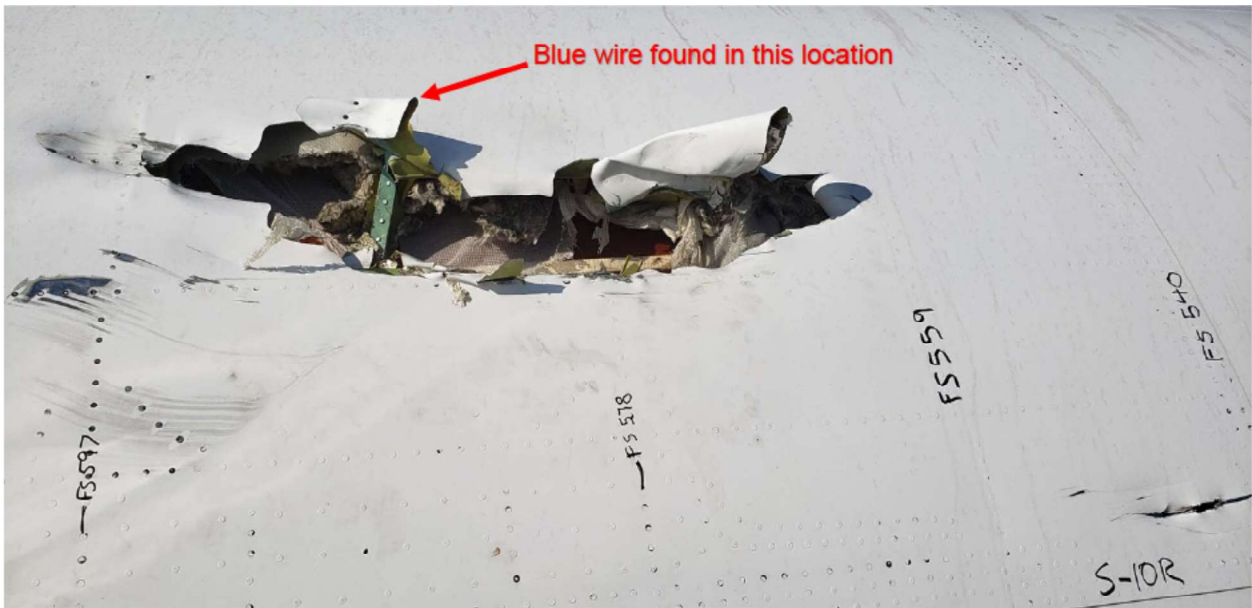
Figure 2 – Image of damage area provided by Boeing ASI

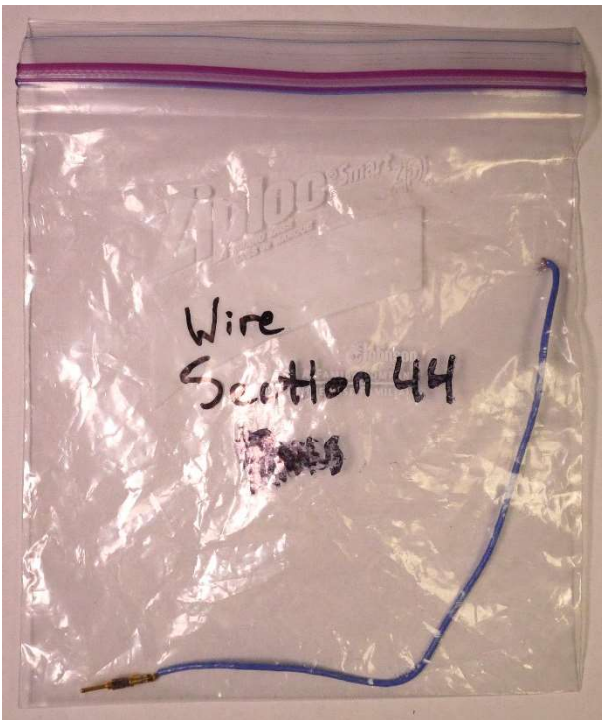
The section of blue wire removed from the fuselage is shown in Figure 3, referenced as Wire Section 44. The three-wire harness from the RMLG is shown in Figure 4, labeled RMLG Wires.

**Figure 3** – Blue wire removed from fuselage

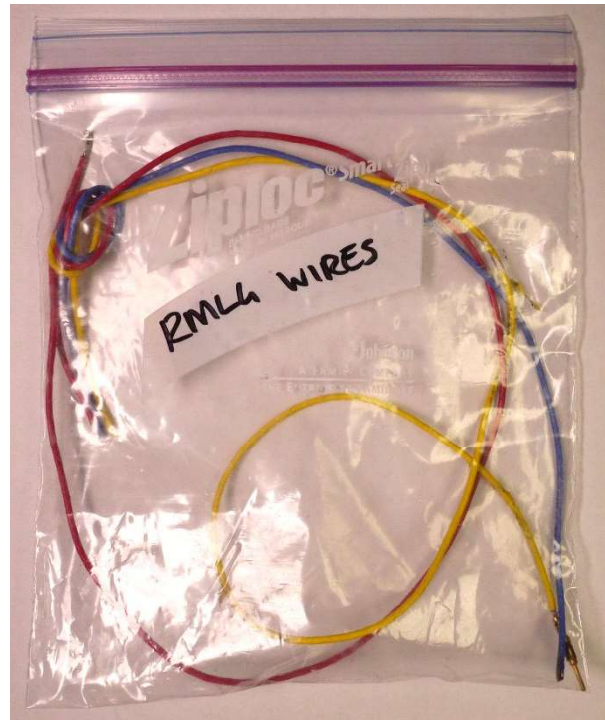
**Figure 4** – RMLG wire harness

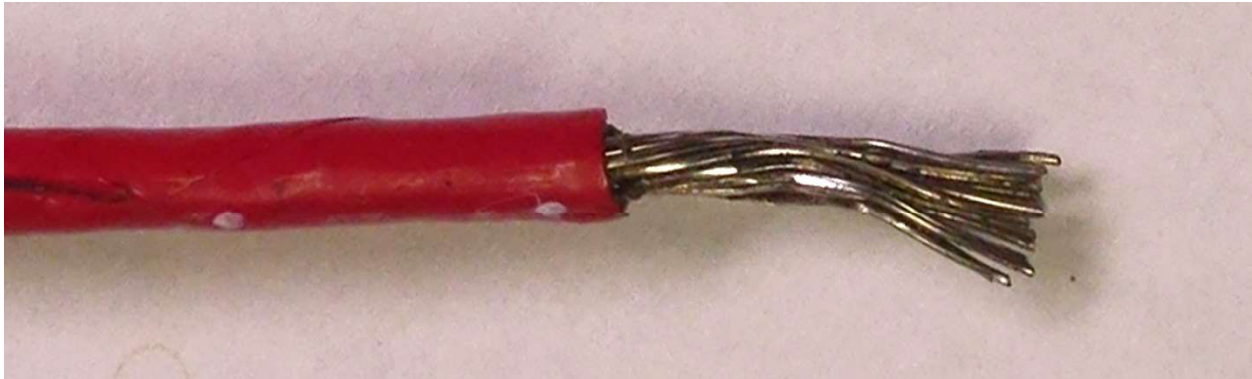
The end of the red wire opposite the cut end had 0.375 inches of stripped jacket, shown in Figure 9, and was measured to be 26.750 inches in length from the cut end to the end of the stripped wire. One area of damage was noted in the jacket of the red wire.

**Figure 9** – RMLG red wire stripped end

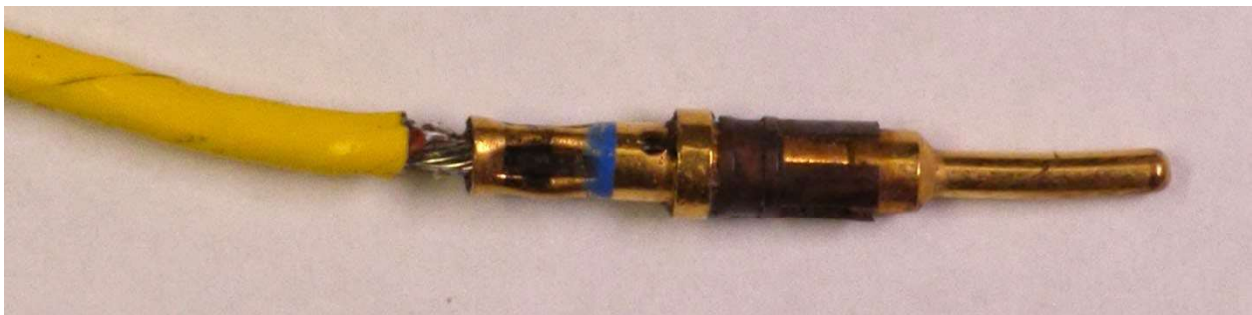
The RMLG yellow wire had a pin contact opposite the cut end, shown in Figure 12, and was measured to be 27.250 inches from the cut end to the end of the pin contact.

**Figure 12** – RMLG yellow wire contact end

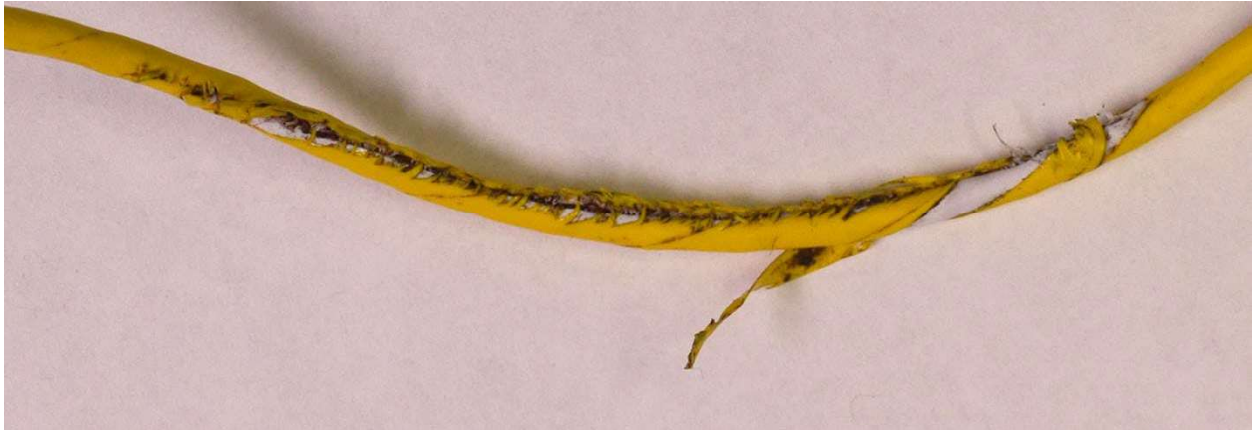
Three areas of jacket damage were noted on the RMLG yellow wire, an example of which is shown in Figure 13. There were no other defects or noteworthy items on the yellow RMLG wire. No visible wire label was noted.

**Figure 13** – RMLG yellow wire example of jacket damage

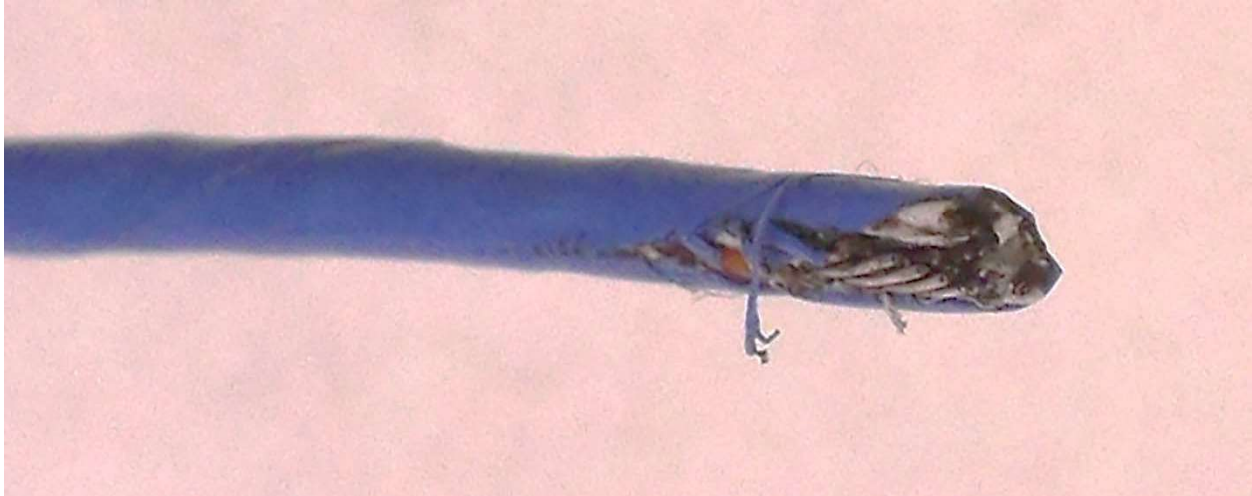
The RMLG blue wire was fractured opposite the cut end, shown in Figure 14 and Figure 15, and was measured to be 17.125 inches from the cut end to the fractured end. The blue wire fractured end was coated with particulates from reportedly being submersed in brackish water for several days after the incident, as shown in Figure 14 and Figure 15. No visible jacket damage or wire label was noted on the blue wire.

**Figure 14** – RMLG blue wire fractured end

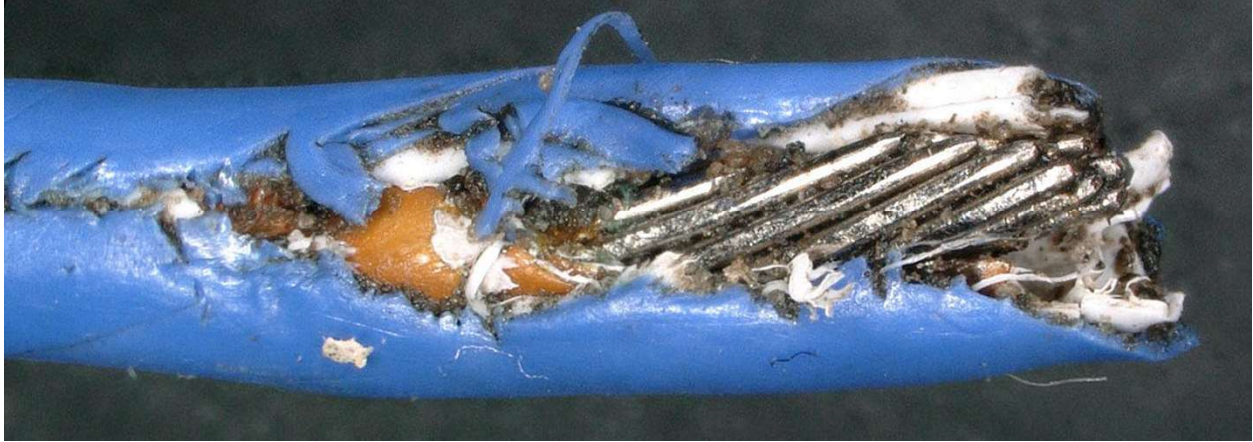
**Figure 15** – RMLG blue wire fractured end

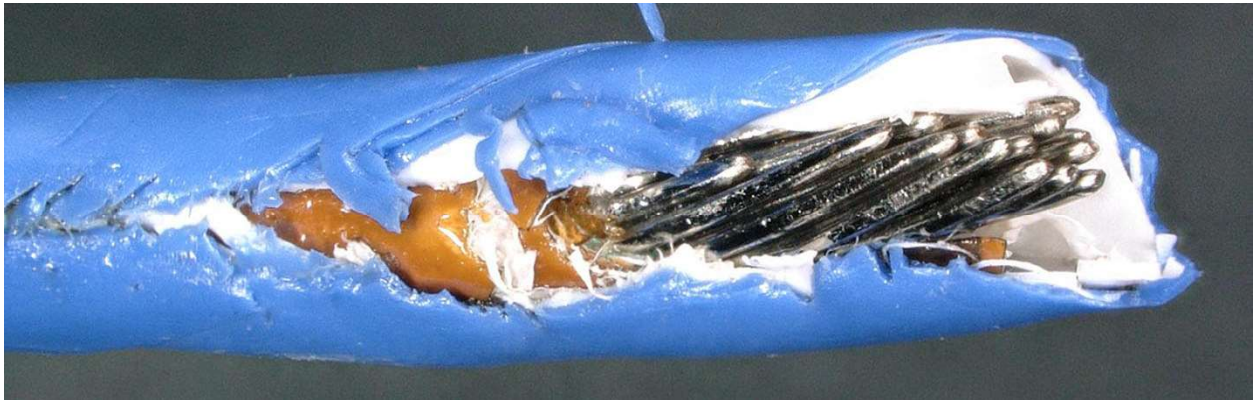
**Figure 16** – RMLG blue wire fractured end after cleaning

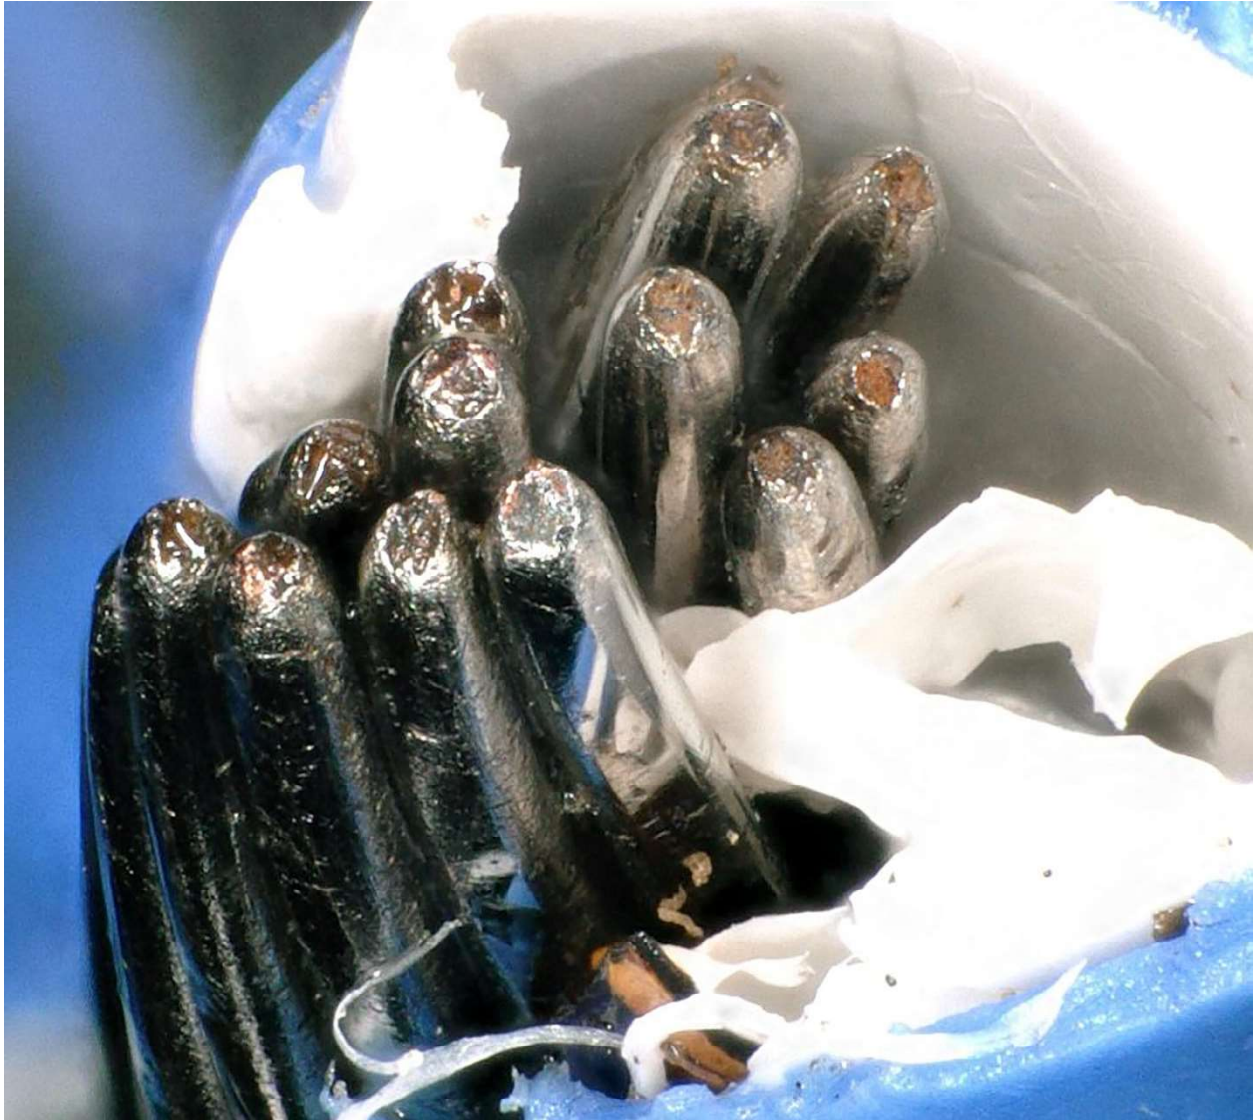
All visible wire strands were described by ASI and NTSB as showing evidence of necking, or tapering of the wire from being stretched, shown in Figure 17 and Figure 18. There was also evidence of ductile overload, where the stresses applied to the wire exceed the ultimate tensile strength and the material fails quickly, as shown in Figure 17 and Figure 18.

**Figure 17** – RMLG blue wire fractured end showing necking and ductile overload

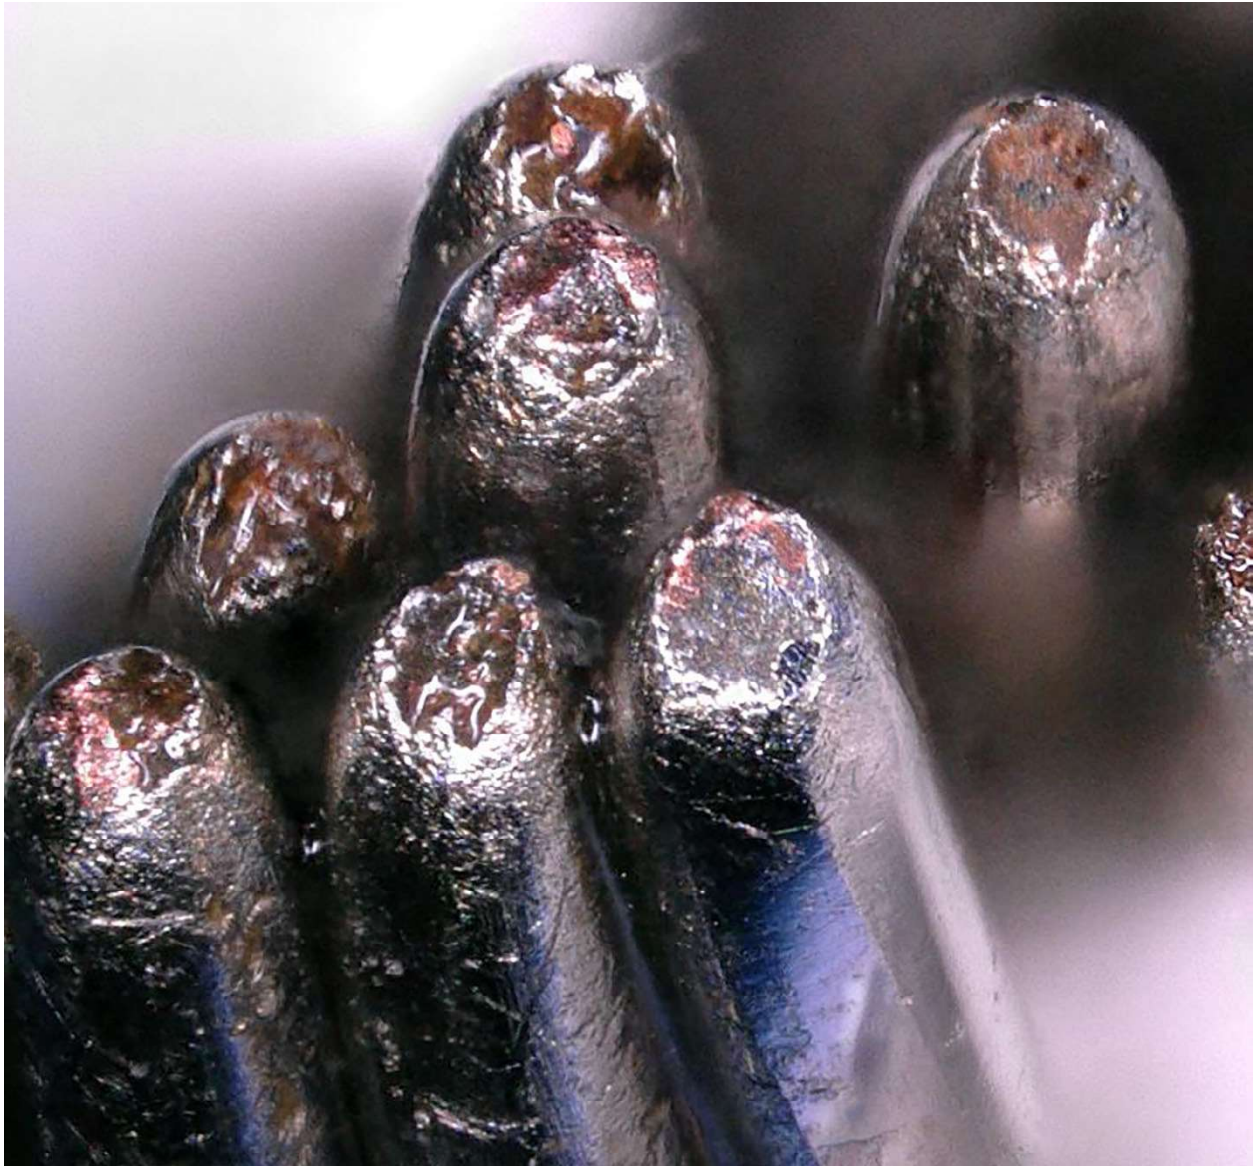
**Figure 18** - RMLG blue wire fractured end showing necking and ductile overload

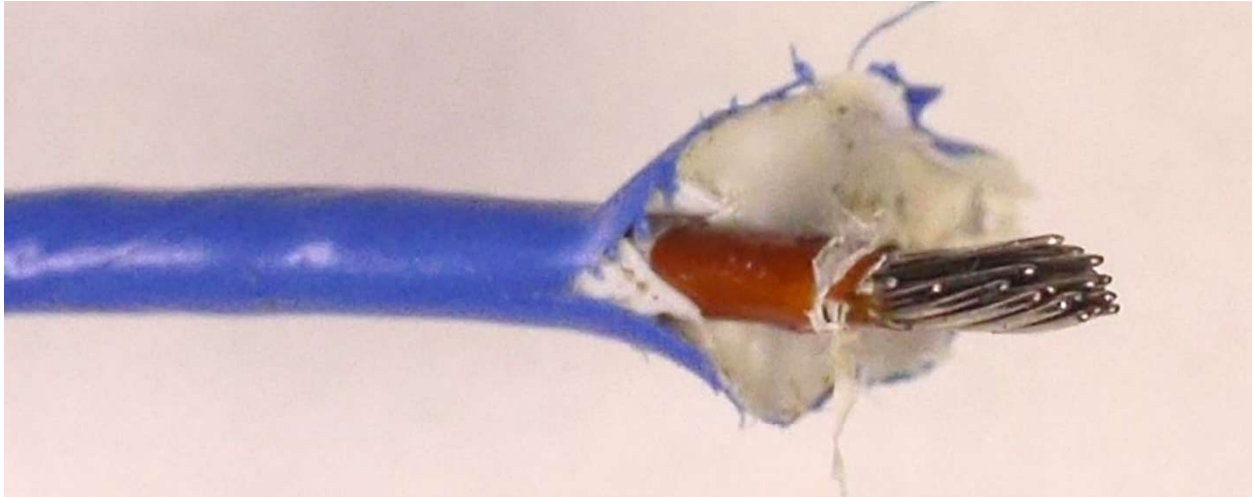
**Figure 19** - RMLG blue wire fractured end with jacket peeled back

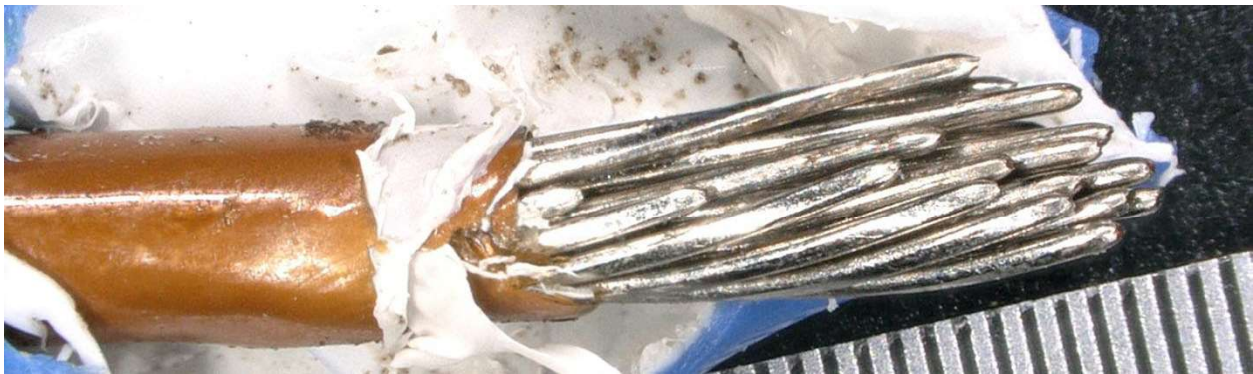
**Figure 20** - RMLG blue wire fractured end with jacket peeled back

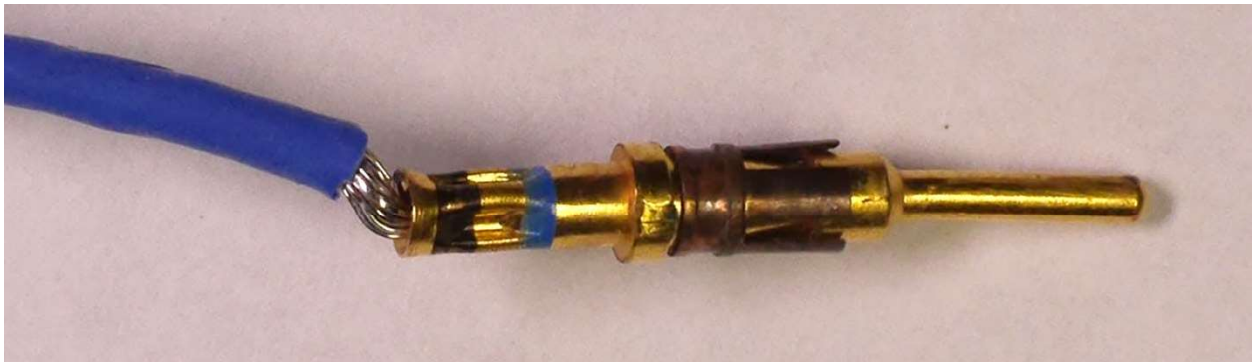
Wire section 44 was noted to have a pin contact on one end, Figure 22, with the opposite end fractured and bent to approximately ninety degrees, Figure 23. The wire was measured at 9.875 inches from the bent fracture end to the end of the pin contact, approximately 10 inches with the fractured end straightened. Two areas of damage to the wire jacket were noted.

**Figure 22** – Wire section 44 pin contact

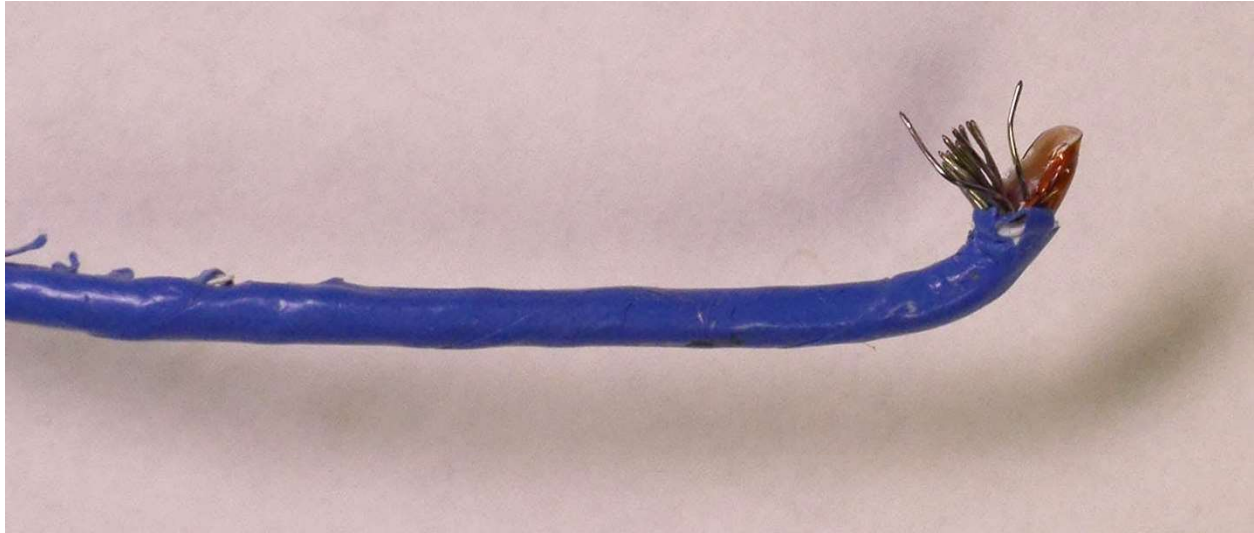
**Figure 23** – Wire section 44 fractured end

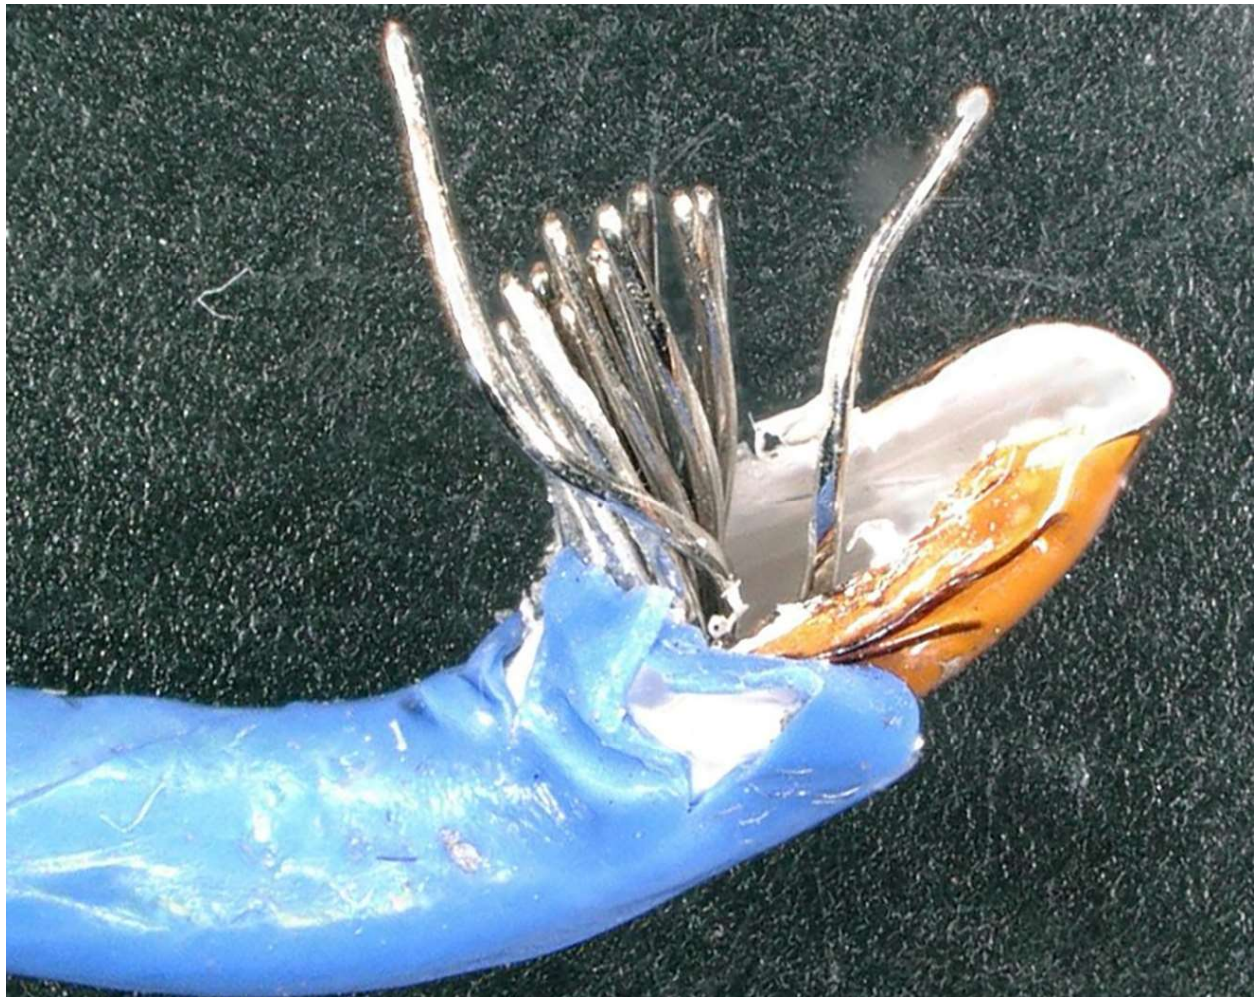
**Figure 24** – Wire section 44

Digital microscopic images of the fractured end of wire section 44 are shown in Figure 24 and Figure 25.

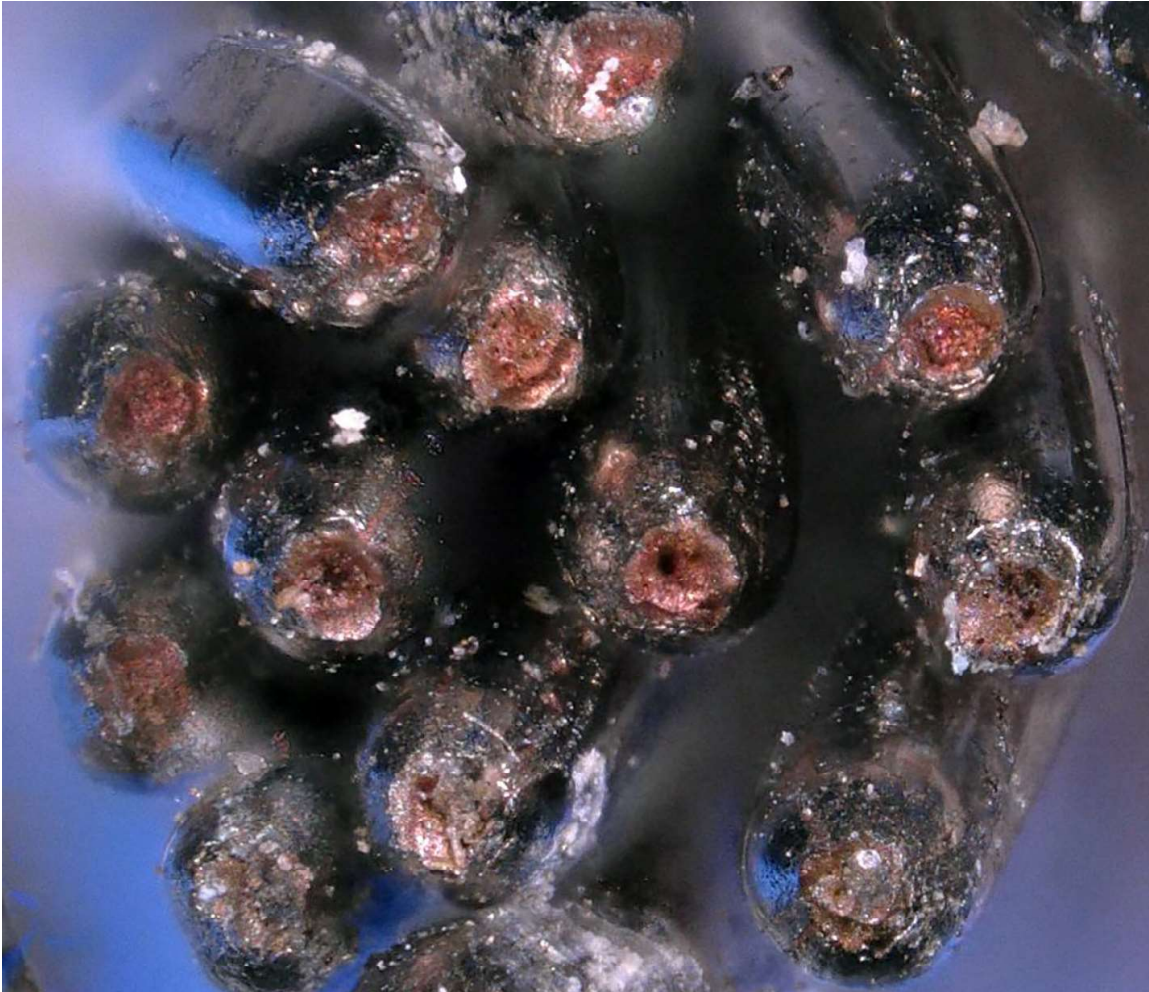
All nineteen wire strands were described by ASI and NTSB as showing signs of necking and ductile overload, as shown in Figure 25.

**Figure 25** – Wire section 44 showing necking and ductile overload

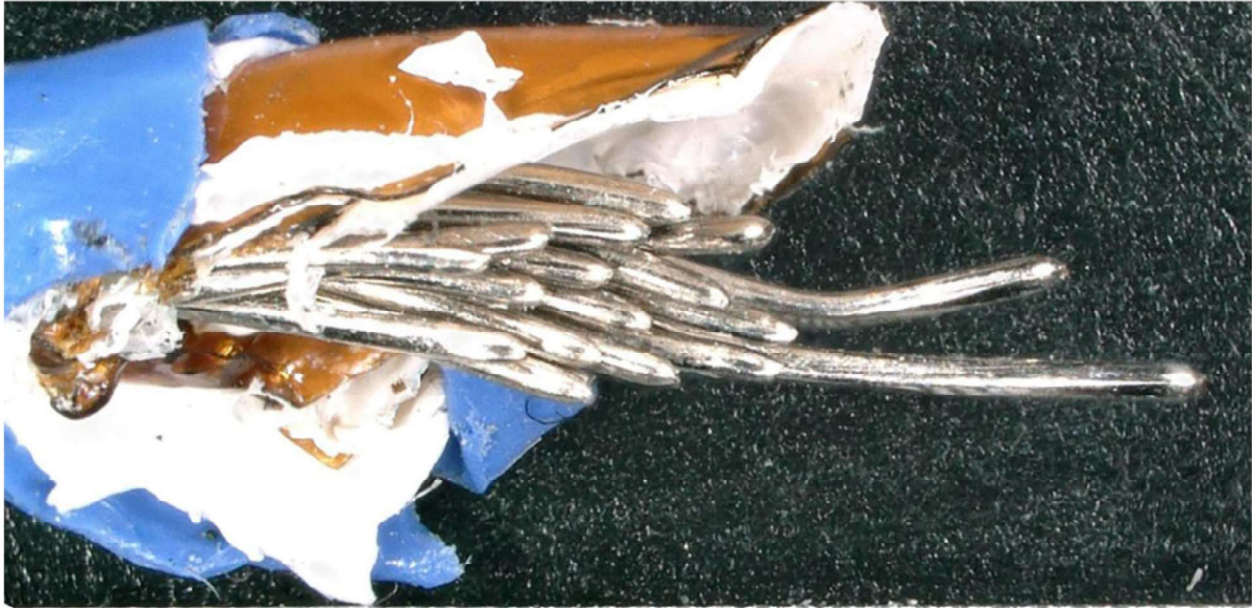
The fractured end was straightened and two of the wire strands were noticeably longer than the other seventeen.

Figure 26 – Wire section 44 after straightening

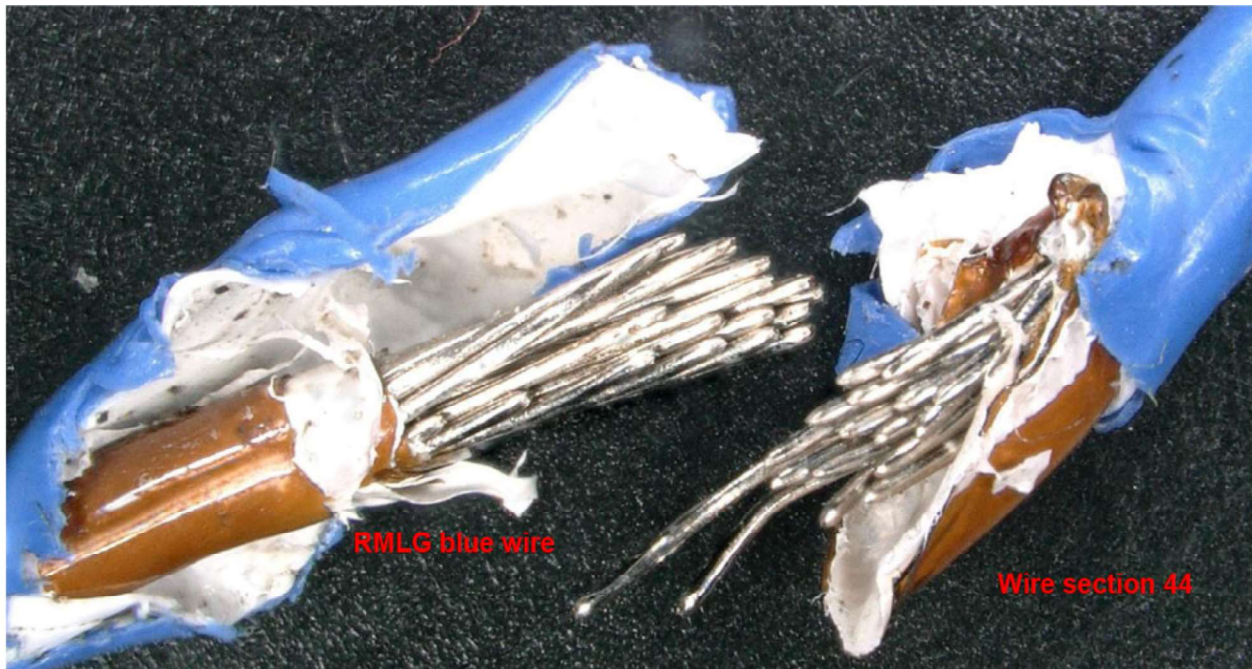
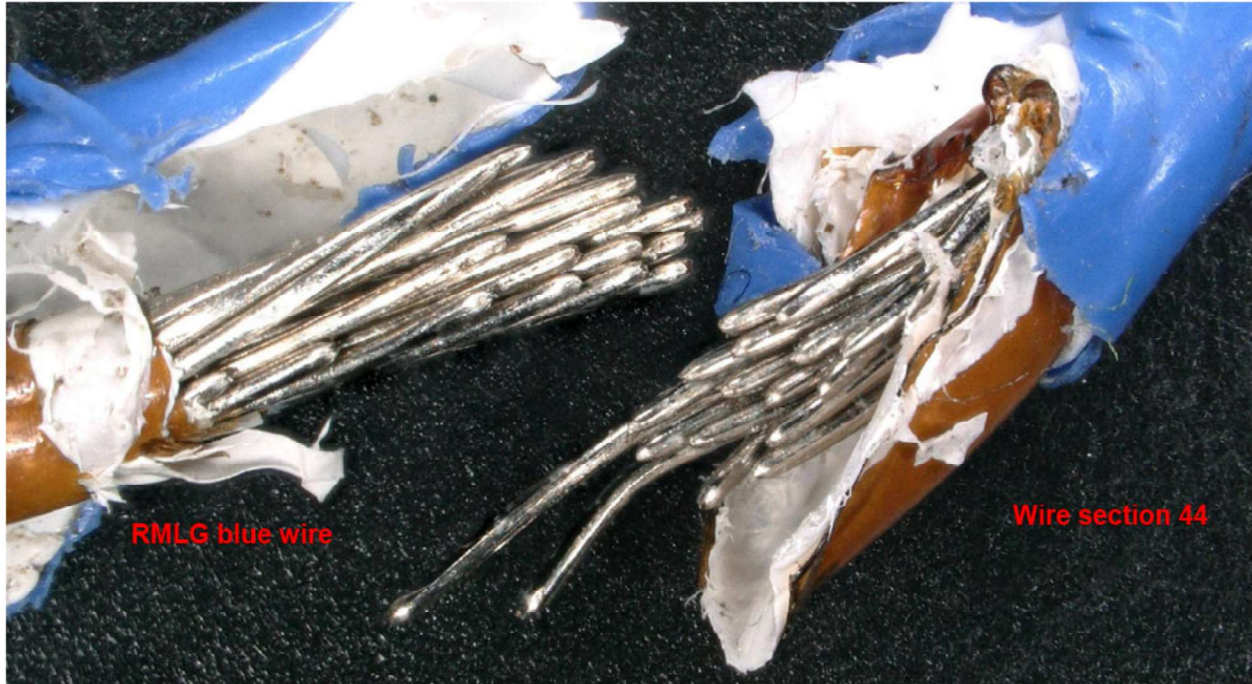
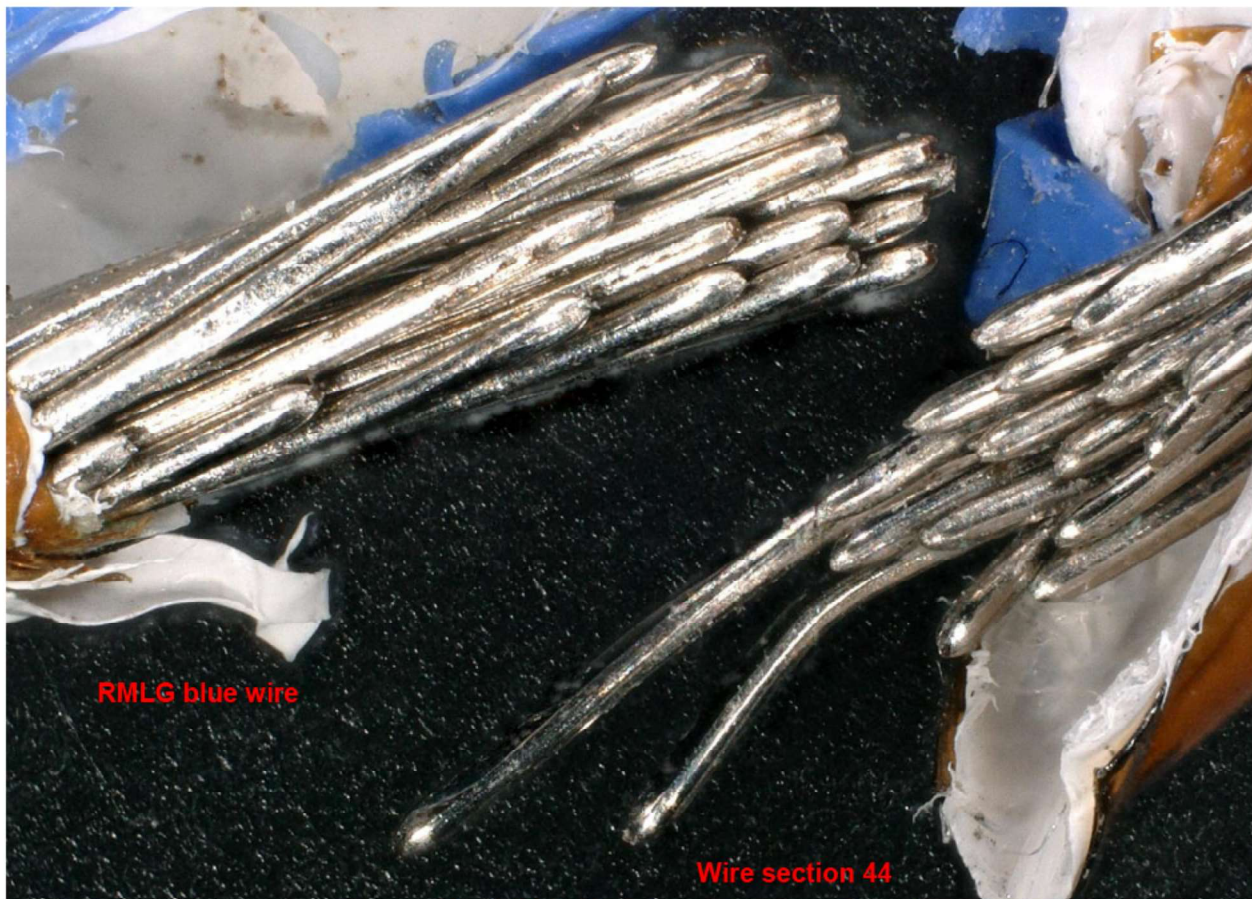
The fractured ends of wire section 44 and the RMLG blue wire were lined up for comparison, shown in Figure 27 through Figure 29. It was noted that the two long wire strands from wire section 44 closely coincide with two short wire strands of the RMLG blue wire.

The two blue wire lengths, when combined, were noted as being similar in measurement to the RMLG red and yellow wires. Table 1 shows the wire lengths for ease of comparison.

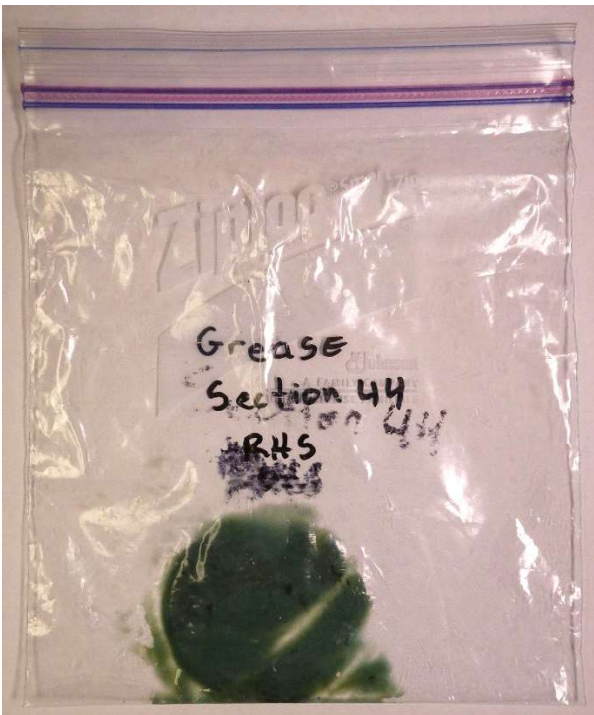
Two grease samples were provided to Boeing Research & Technology (BR&T) for analysis. The grease sample from the fuselage is shown in Figure 30, labeled Grease Section 44 RHS. The grease sample from the RMLG attach bearing is shown in Figure 31, labeled Grease RHS MLG. It was reported that the landing gear was greased approximately 5 weeks prior to the incident, on March 26, 2019, and the aircraft was returned to service following the Phase Inspection at the end of April, approximately one week prior to the incident. The RMLG was found forward of the right wing, and was reportedly submersed in brackish water for two to three days prior to recovery.

**Figure 30** – Grease sample from fuselage

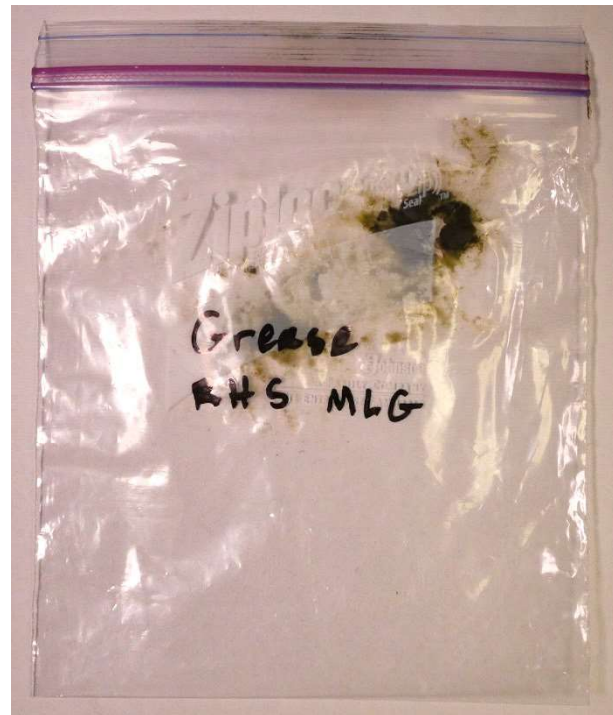
**Figure 31** – Grease sample from RMLG

Both greases were similar in chemistry and are consistent with BMS3-33; however, the "Grease RHS MLG" contains copper, which wasn't observed in the "Grease Section 44 RHS" sample.

It is the opinion of Chemical Technology that the grease sample taken from the main landing gear still had sufficient lubricating properties.

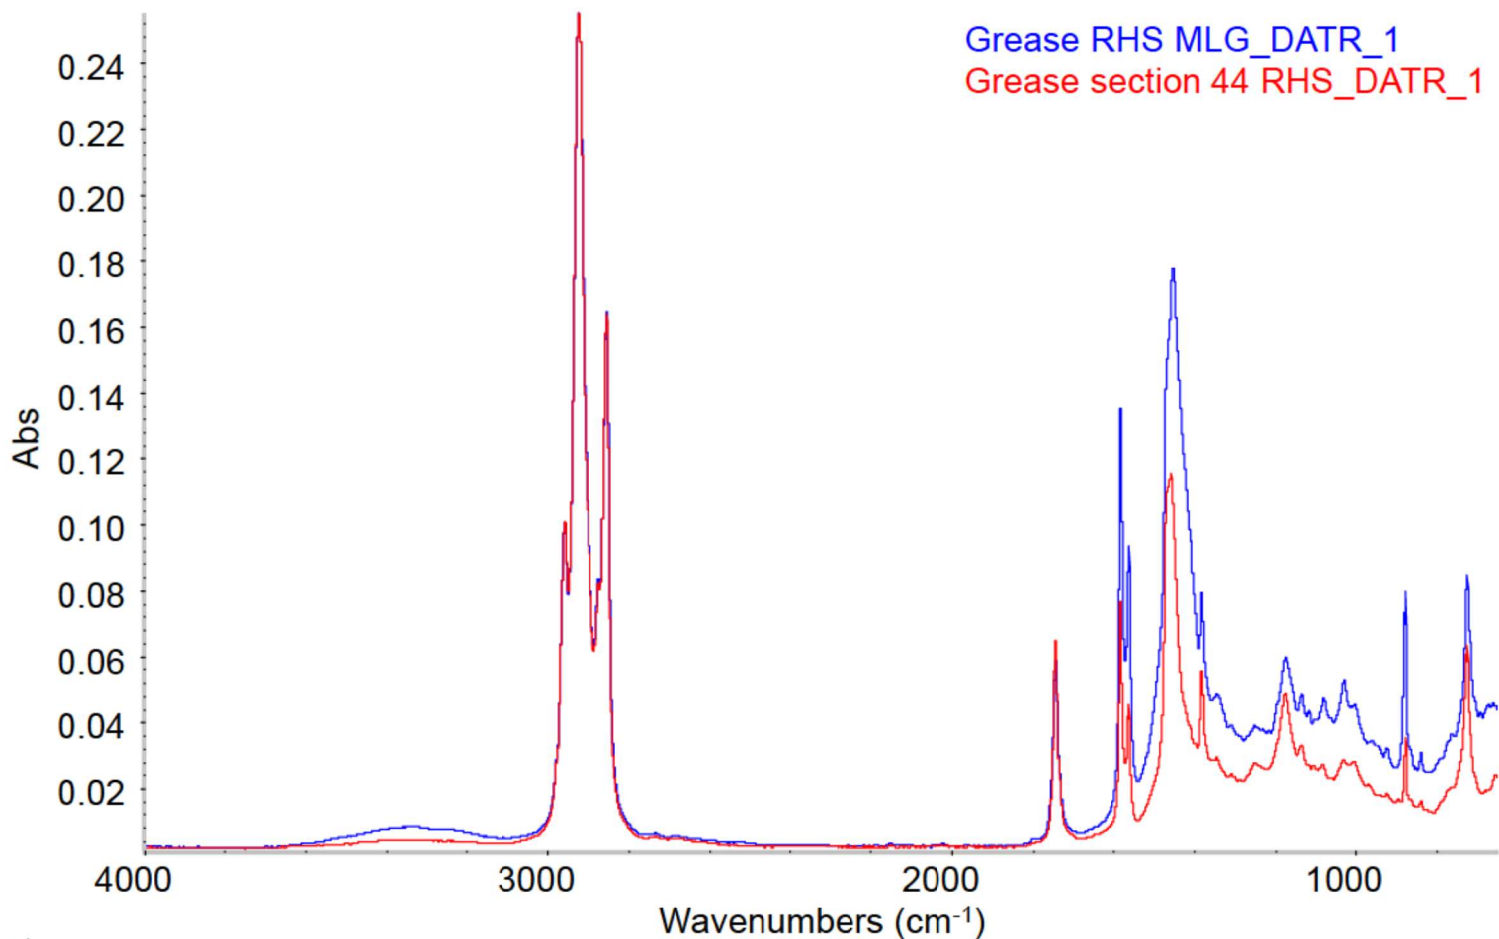
Both grease samples are consistent with a grease with an ester-modified saturated hydrocarbon base oil and lithium soap complex thickener such as BMS3-33 grease.

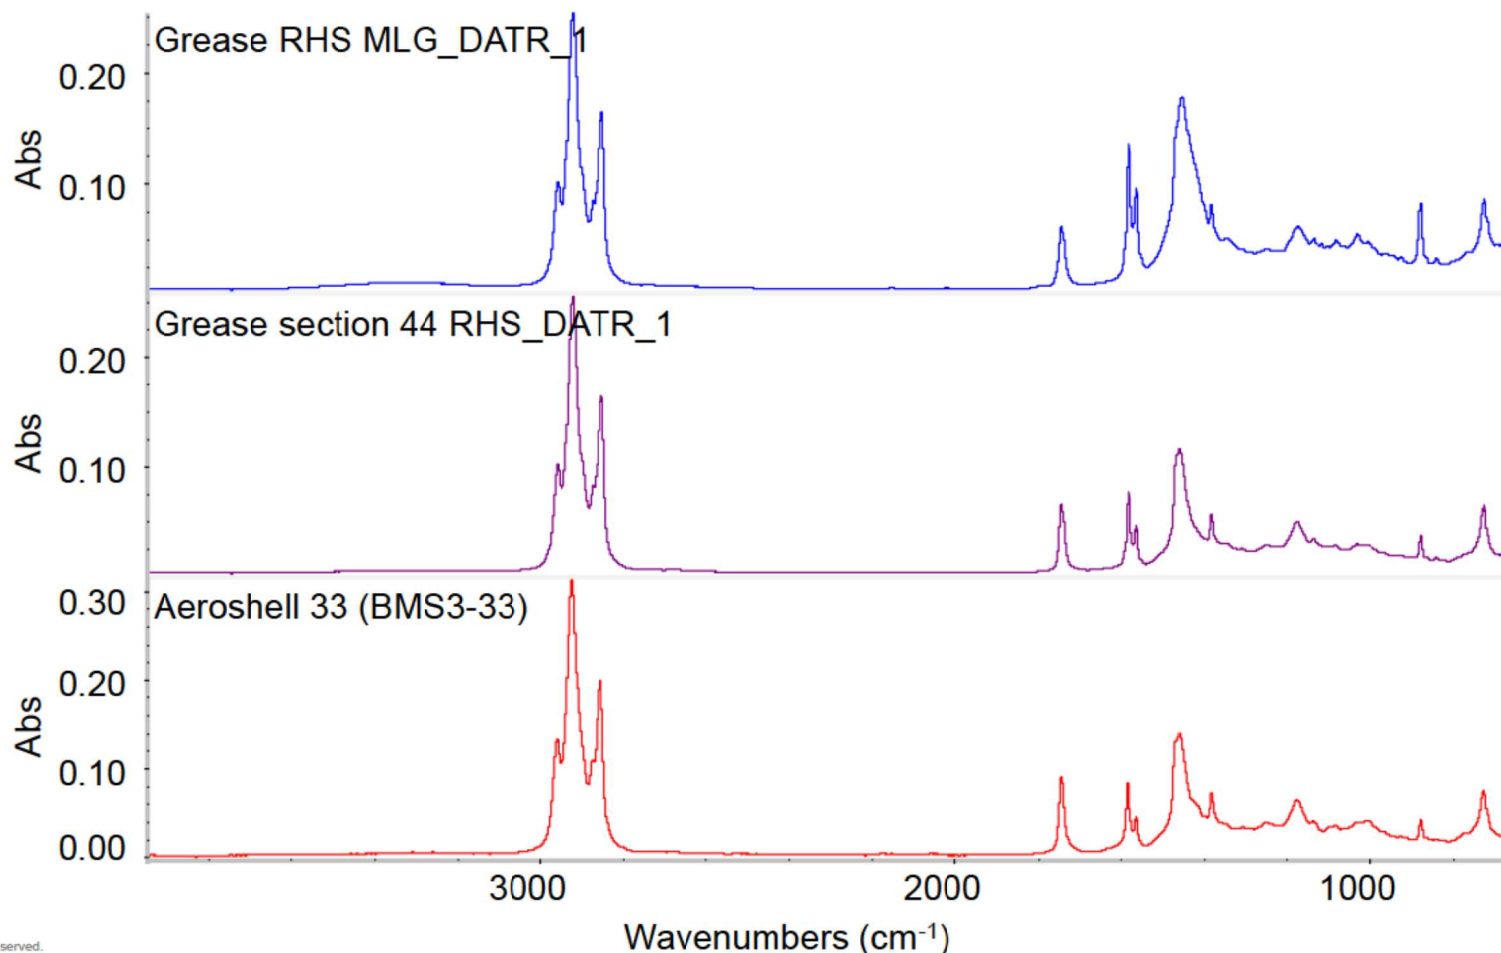
Both greases were similar in chemistry and are consistent with BMS3-33; however, the “Grease RHS MLG” contains copper which wasn’t observed in the “Grease Section 44 RHS” sample

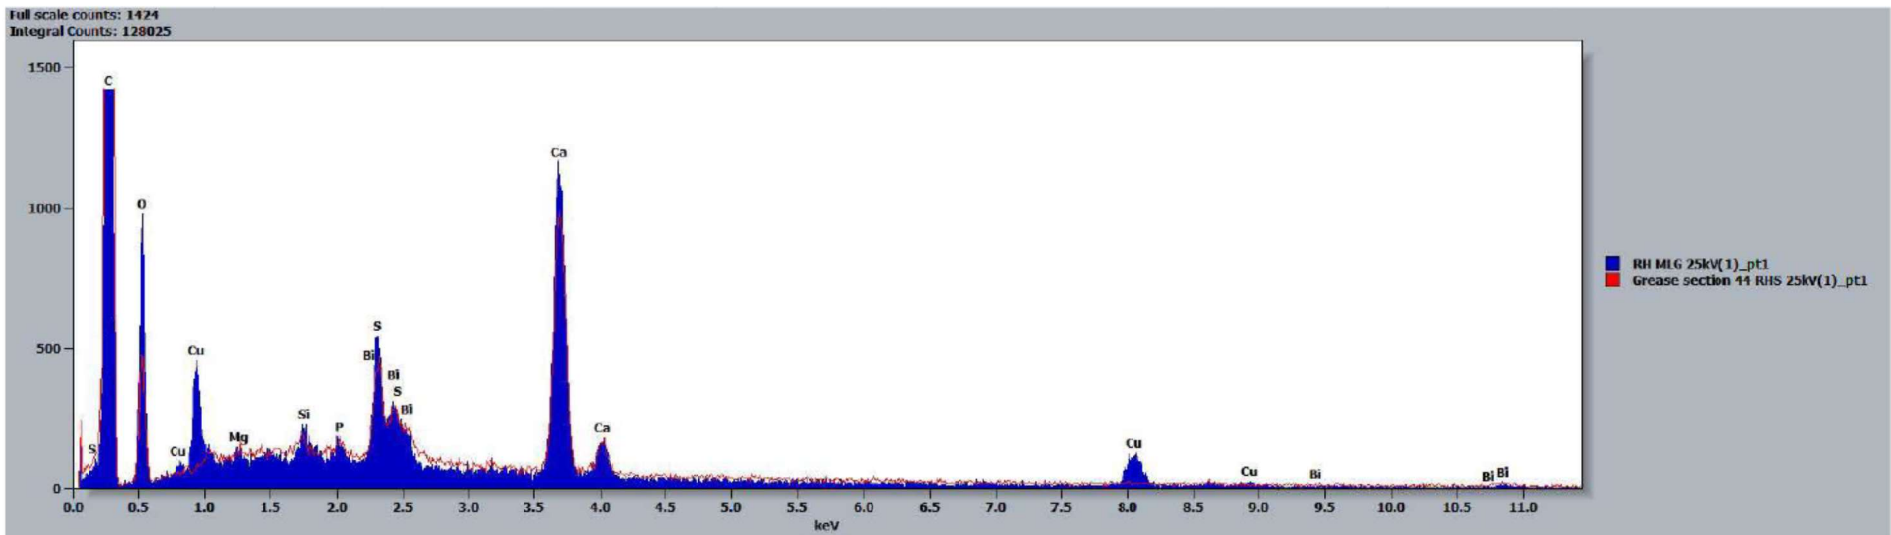
Both greases are consistent with BMS3-33.
