NATIONAL TRANSPORTATION SAFETY BOARD

Factual Report

METEOROLOGY

DCA19MA143

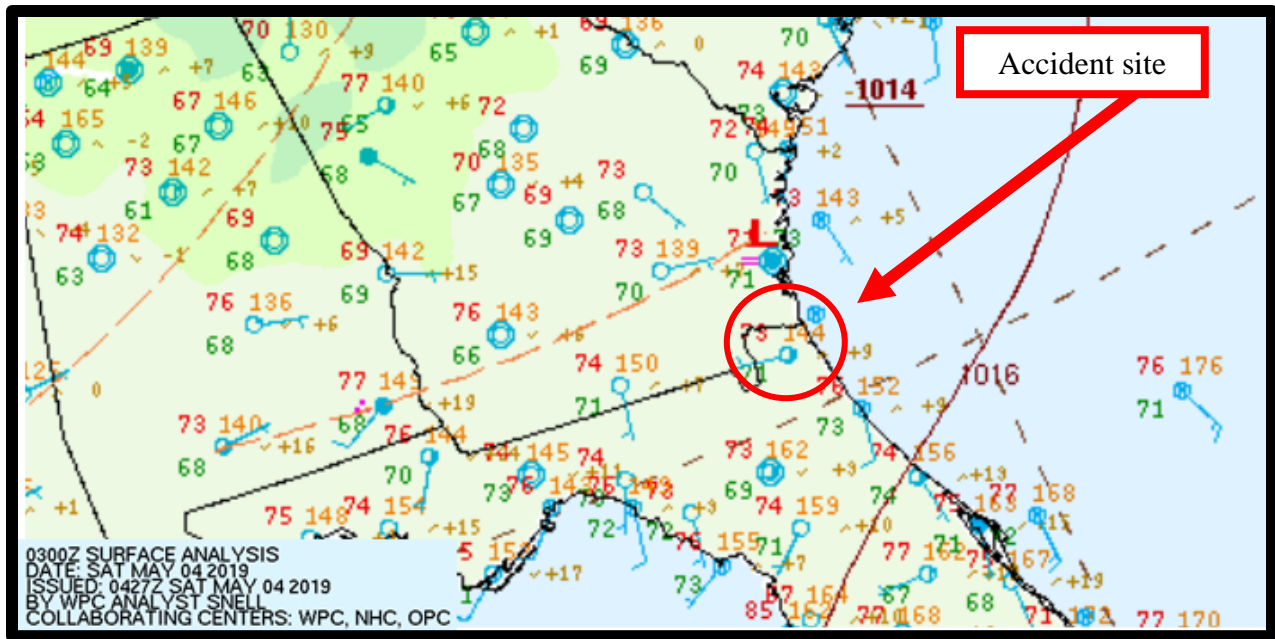
The southeast section of the NWS Surface Analysis Chart for 2300 EDT is provided as figure 1 with the approximate location of the accident site marked within the red circle. The chart identified a surface low pressure center located over southeastern Georgia with a surface pressure of 1014-hectopascals (hPa) with a trough² extending westward across southeastern Georgia stretched to the west into southern Alabama. Troughs can act as lifting mechanisms to produce clouds and precipitation if sufficient moisture is present.

Figure 1 – NWS Surface Analysis Chart for 2300 EDT

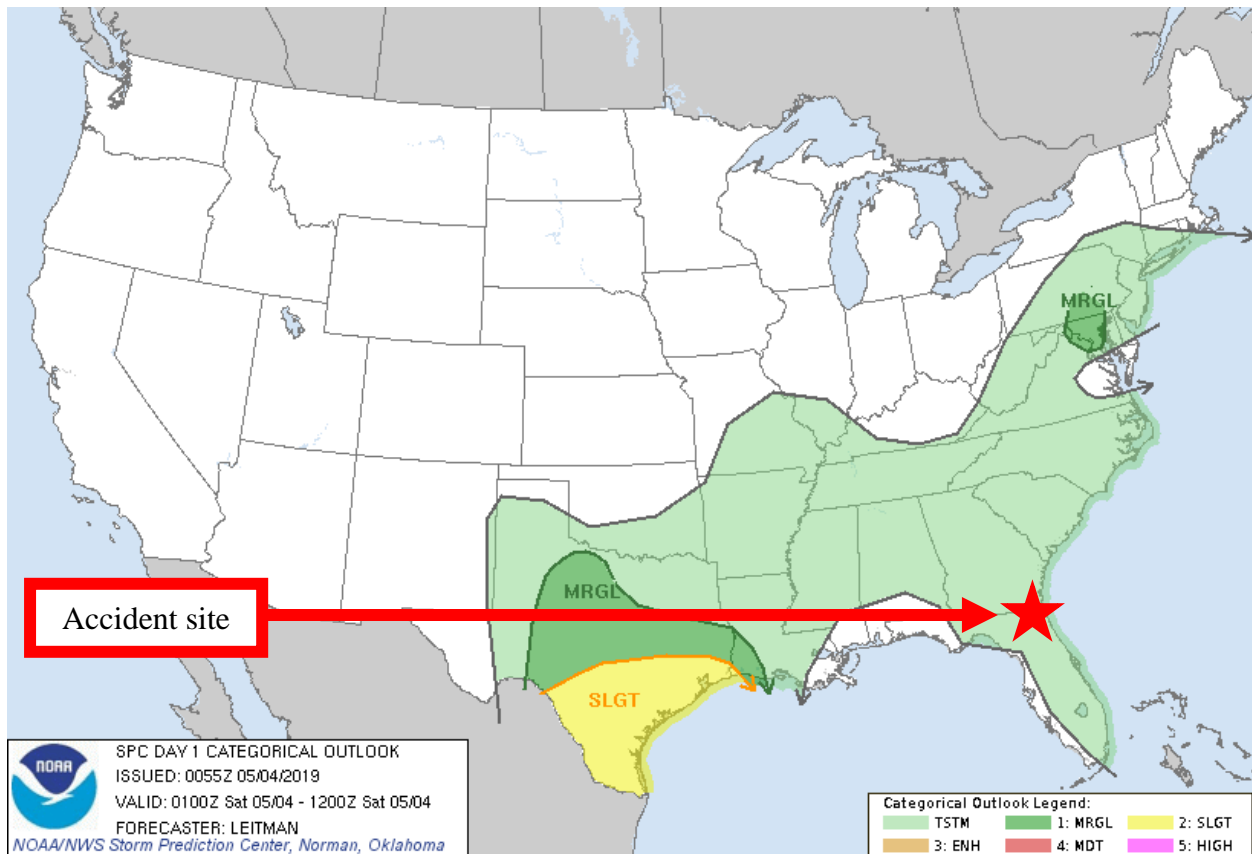
SPC issued the following Day 1 Convective Outlook at 2055 EDT (figure 7) with areas of general thunderstorms forecast for the accident site. SPC defines the “TSTM” area as an area that encloses where a 10% or higher probability of thunderstorms is forecast during the valid period. The SPC Day 1 Convective Outlook text follows figure 7:

Figure 7 – SPC day 1 Convective Outlook valid at the time of the accident

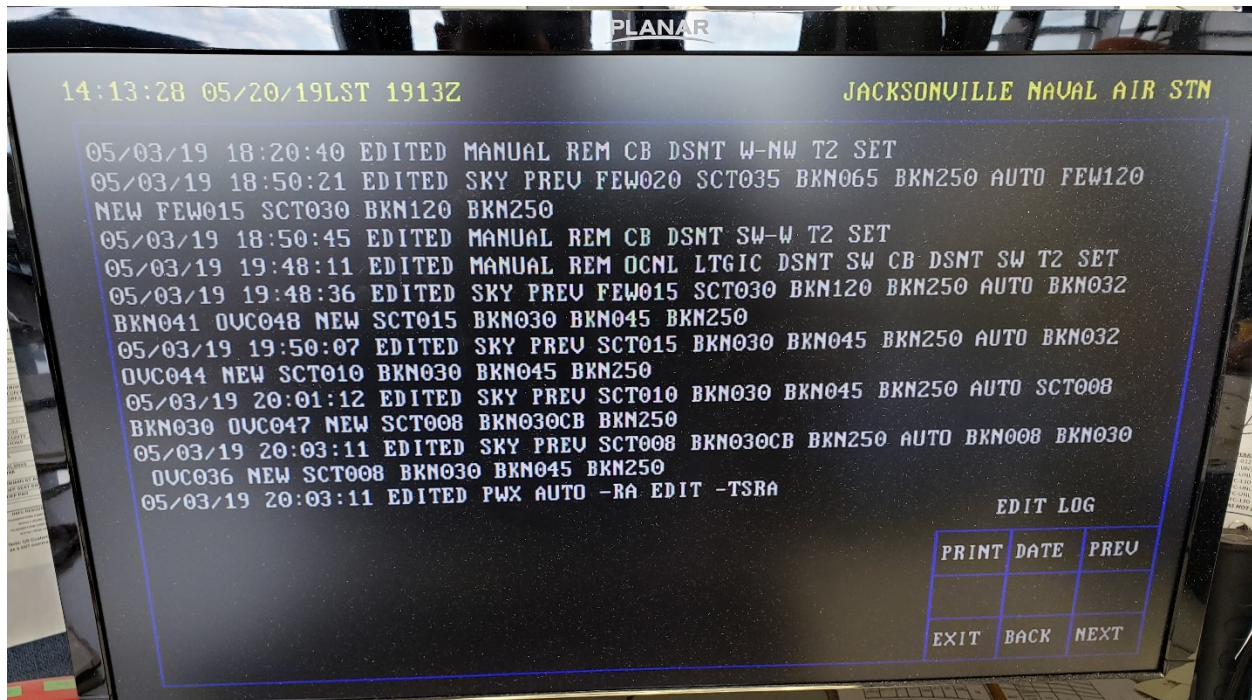
Figure 9 – KNIP edit log files from 1920 to 2103 EDT

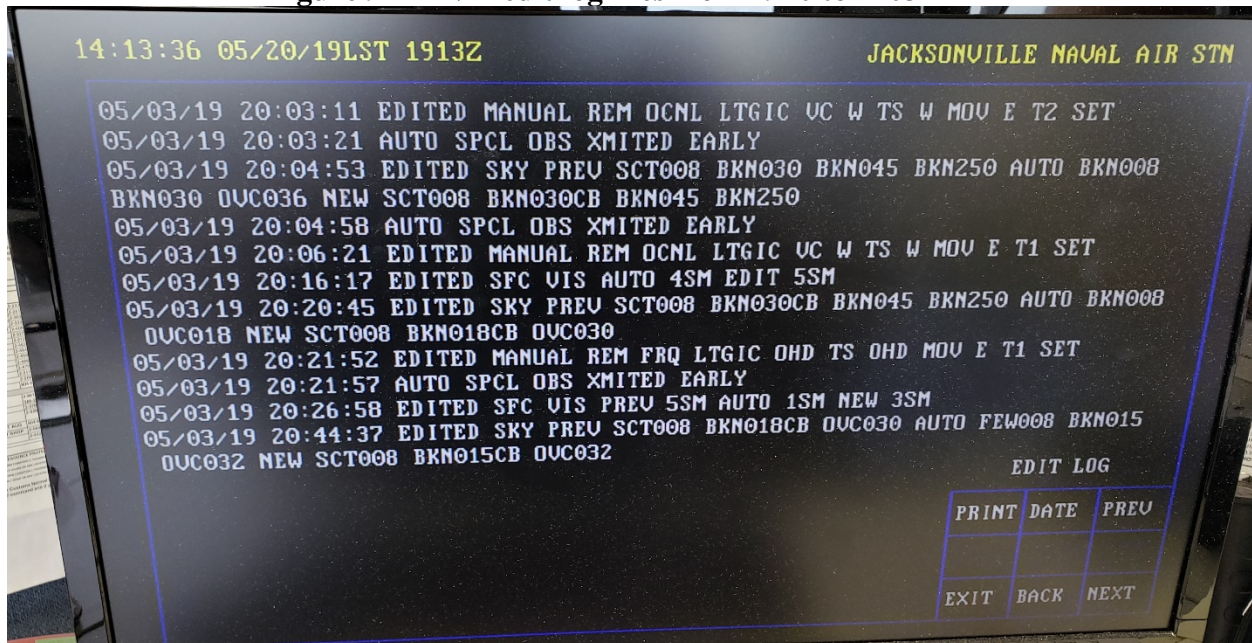
Figure 10 – KNIP edit log files from 2103 to 2145 EDT

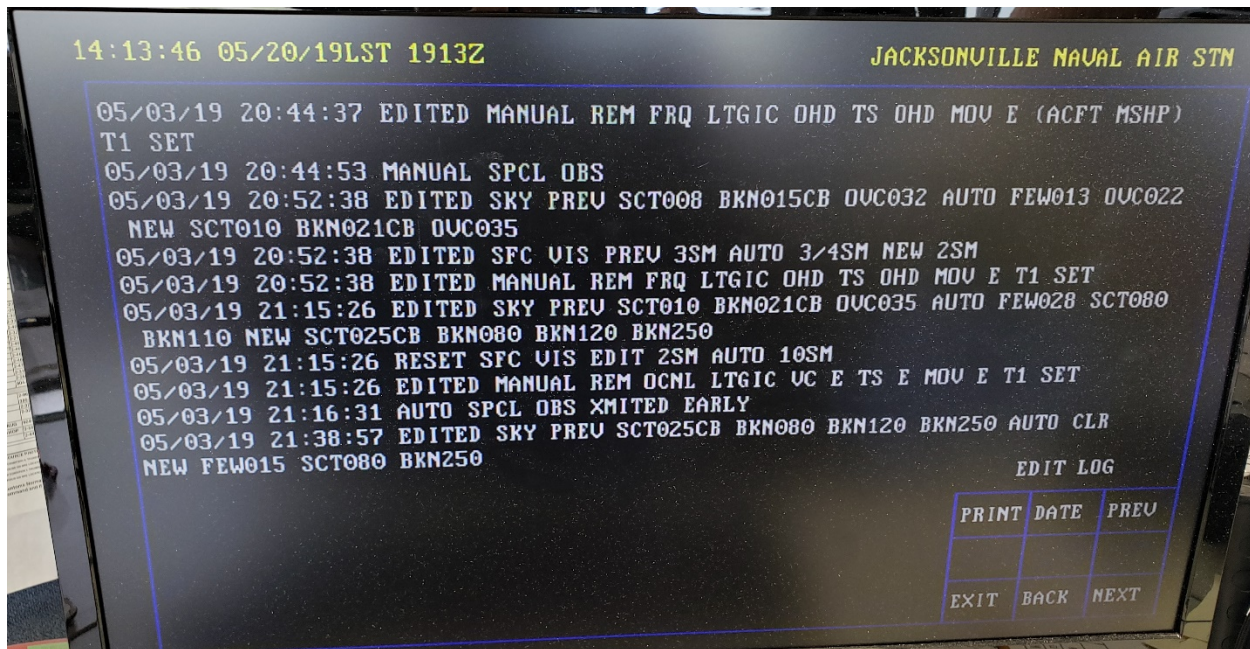
Figure 11 – KNIP edit log files from 2145 to 2239 EDT

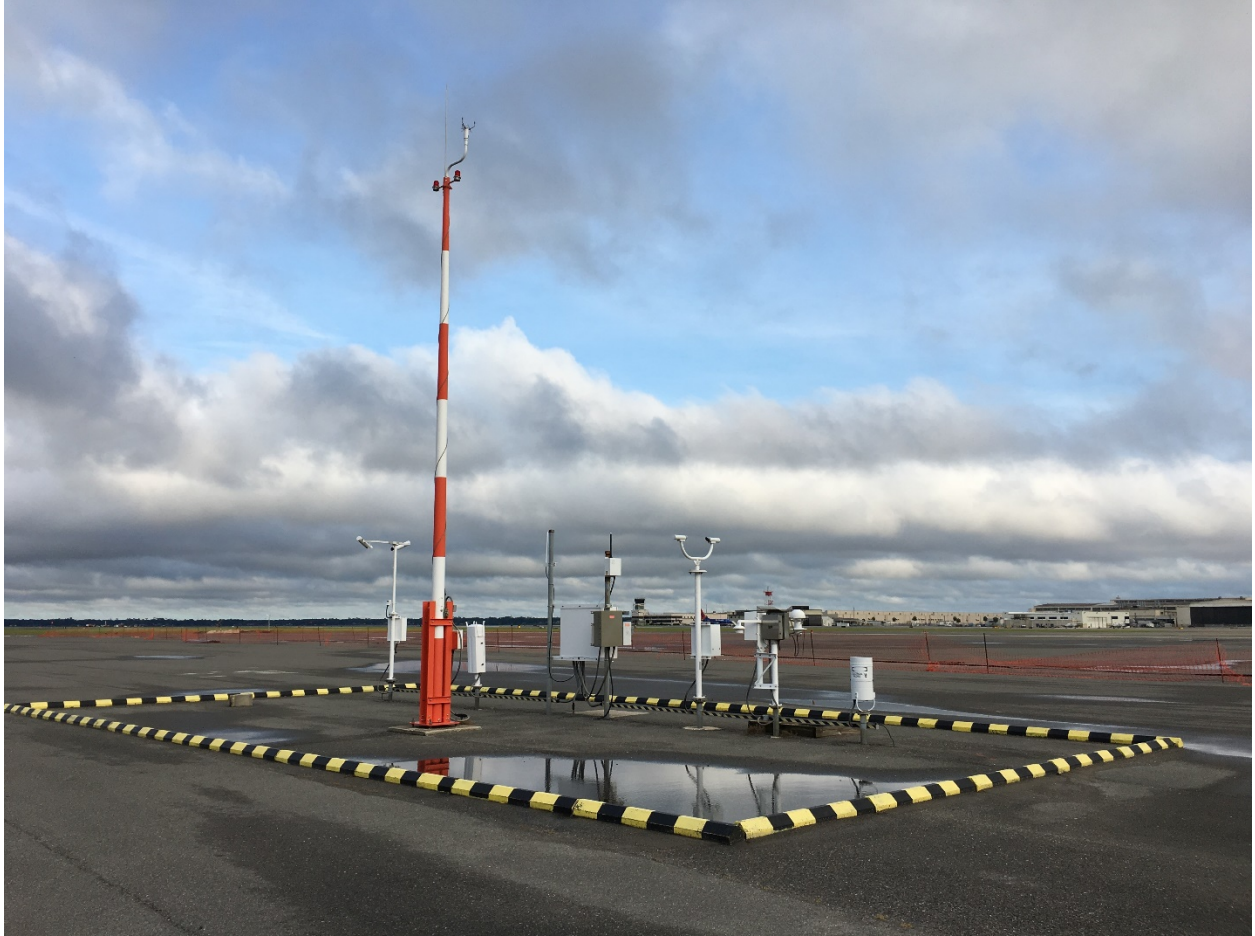
The KNIP ASOS and back up wind sensor locations were noted relative to the location of the runways and accident site (figures 12 and 13). The KNIP ASOS was located 4,500 ft west-northwest of the accident site and in between the runways. The KNIP back up wind sensor was located 4,000 ft west-northwest of the accident site (in between the runways) and the wind sensor does not provide archived weather information.

Figure 12 – KNIP ASOS equipment with the image facing east-southeast towards the accident site

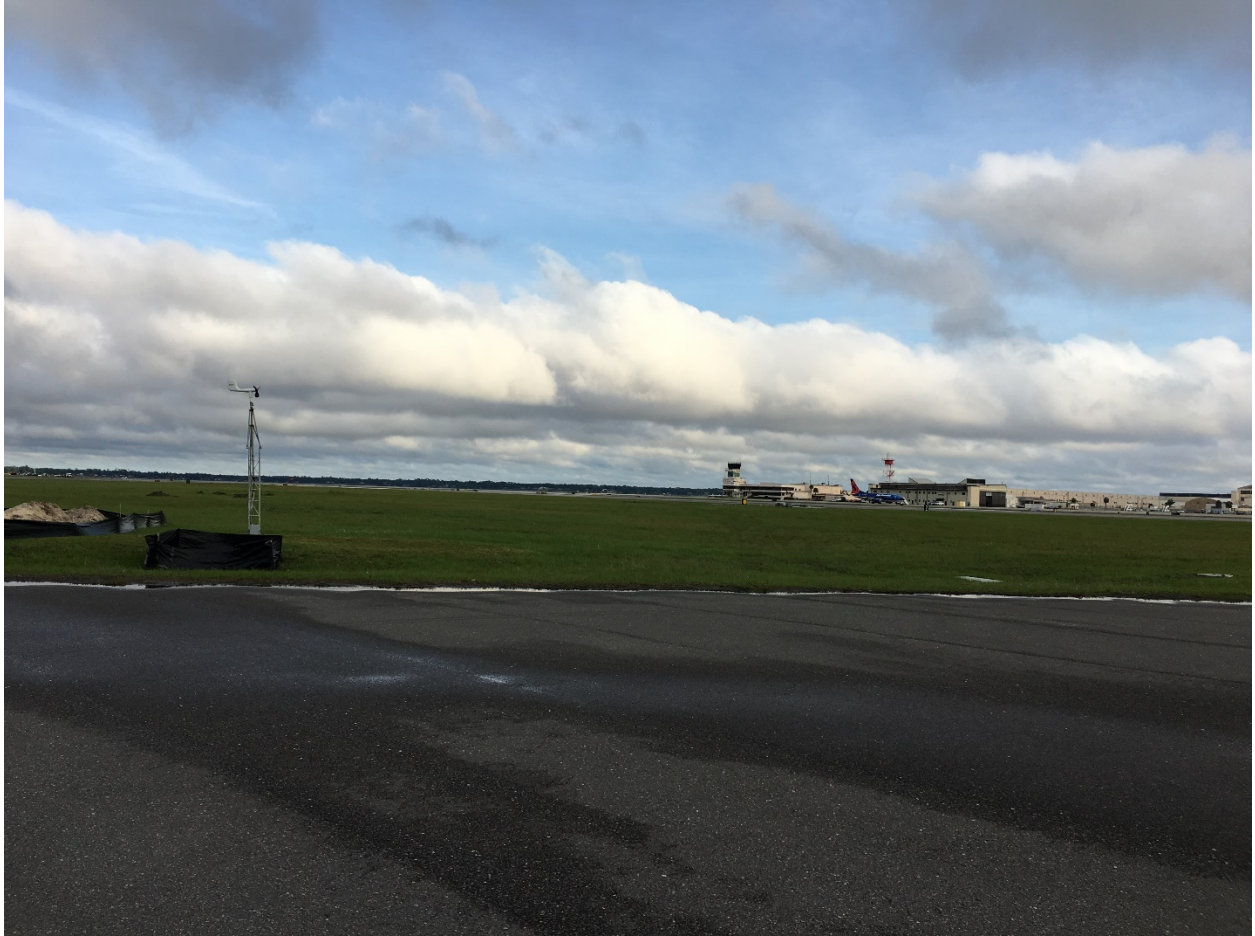
Figure 13 – KNIP backup wind sensor with the image facing east-southeast towards the accident site

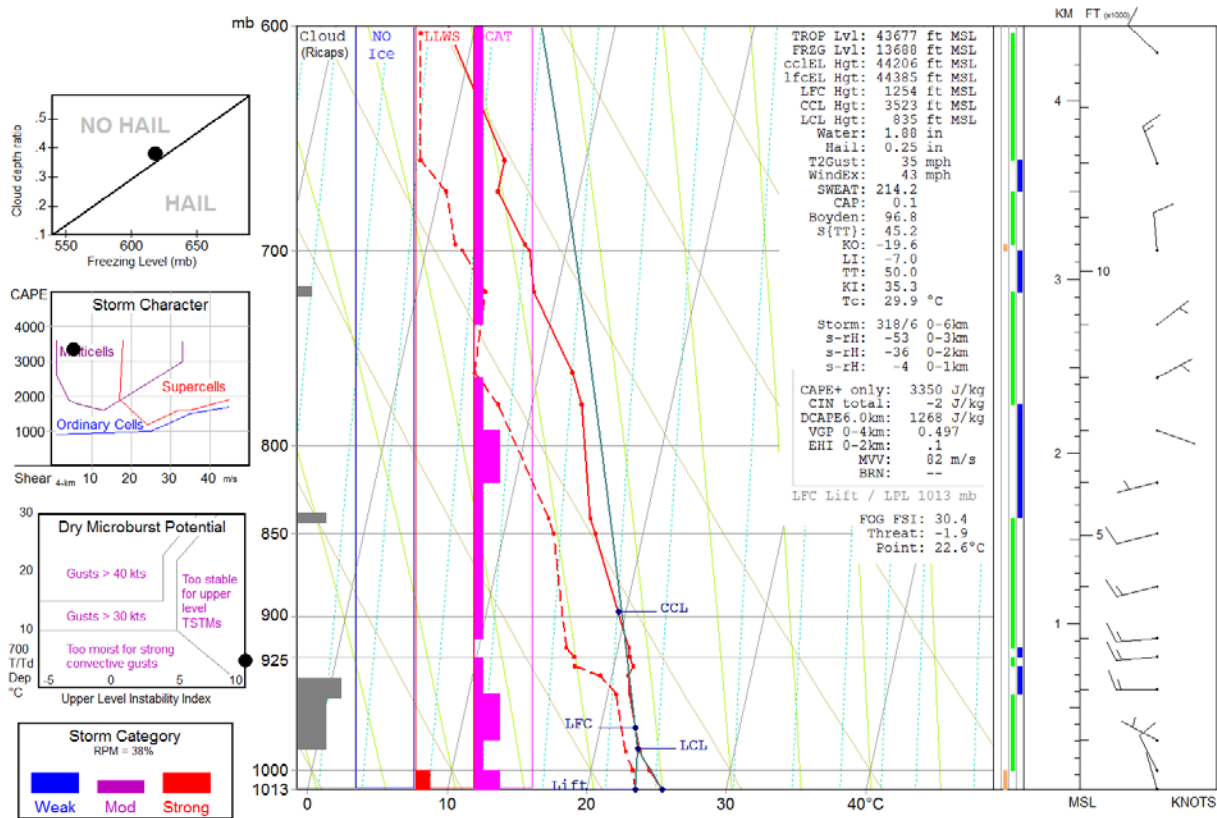
Figure 14 – 2000 EDT KJAX sounding

The 2000 EDT KJAX sounding indicated a conditionally unstable environment from the surface through 14,000 ft. RAOB identified the possibility of clouds from 1,000 ft msl through 2,000 ft msl. Additional small layers of clouds were identified by RAOB at 6,000 ft and 10,000 ft msl. 3,350 Joules/kilogram (J/kg) of CAPE¹² were indicated on the sounding and the maximum vertical velocity (MVV) for this atmosphere was calculated as 82 meters/second (about 16,142 ft per minute).¹³ Given the environment, RAOB indicated a high probability of multicell thunderstorm development was possible with no hail or severe thunderstorm activity (wind, tornadoes, hail, etc...) at the surface. Downdraft CAPE (DCAPE; 6 kilometers agl)¹⁴ was measured at 1,268 J/kg. If rain showers or thunderstorms formed in this environment, the 2000 EDT KJAX sounding indicated that the strongest wind speeds possible at the surface (due to, for example, a microburst, outflow boundary, or gust front) would have been 43 mph (37 knots) according to the WindEx parameter.

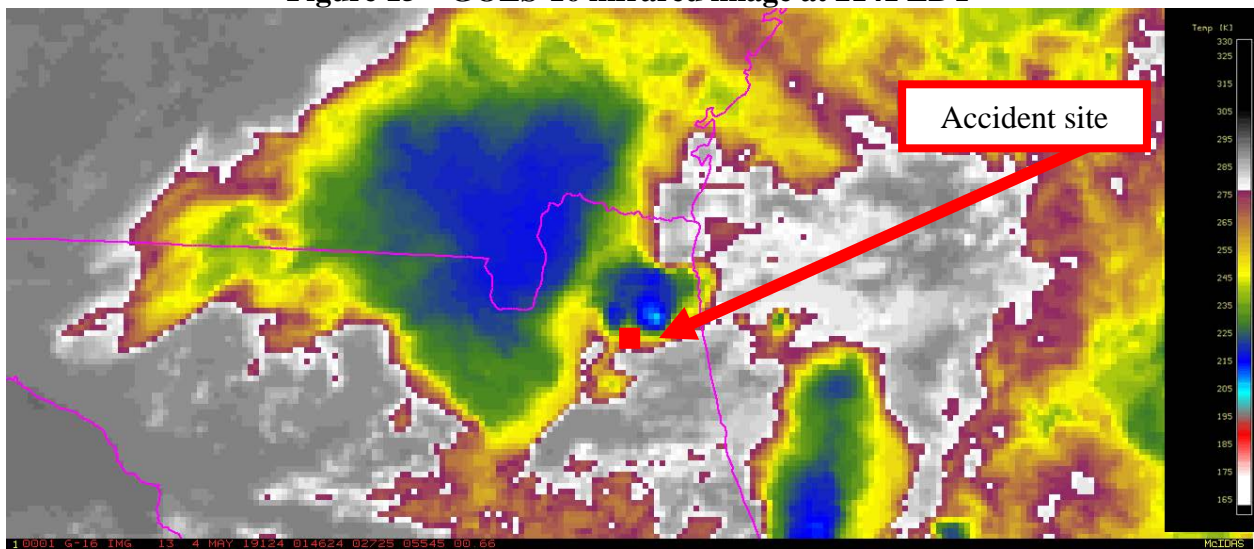
top heights over the accident site were 24,000 ft at 2146 EDT (253° Kelvin). It should be noted these figures have not been corrected for any parallax error.

Figure 16 – GOES-16 infrared image at 2146 EDT

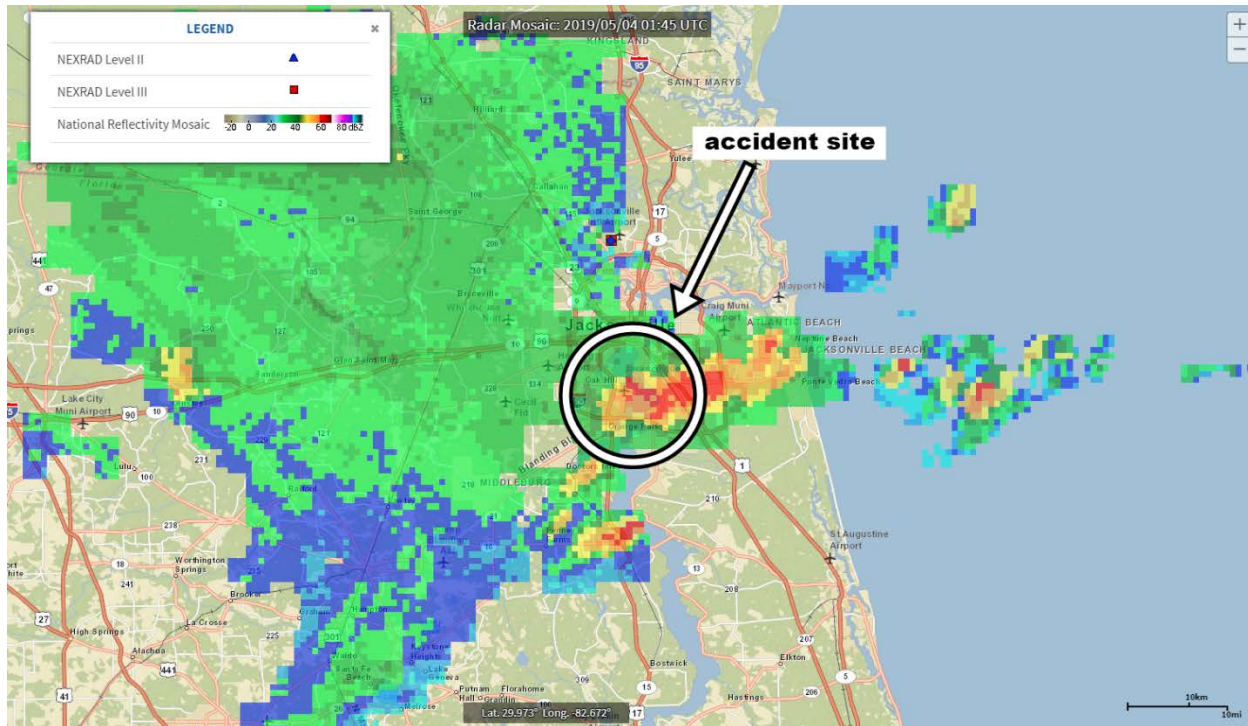
A regional view of the NWS national composite radar mosaic is included as figure 18 for 2145 EDT with the approximate location of the accident site marked within a white circle. The image depicted an area of echoes extending east-to-west over the Jacksonville area from echoes of 45 to 55 decibels (dBZ¹⁶) echoes above the accident site.

Figure 18 – Regional Composite Reflectivity image for 2145 EDT

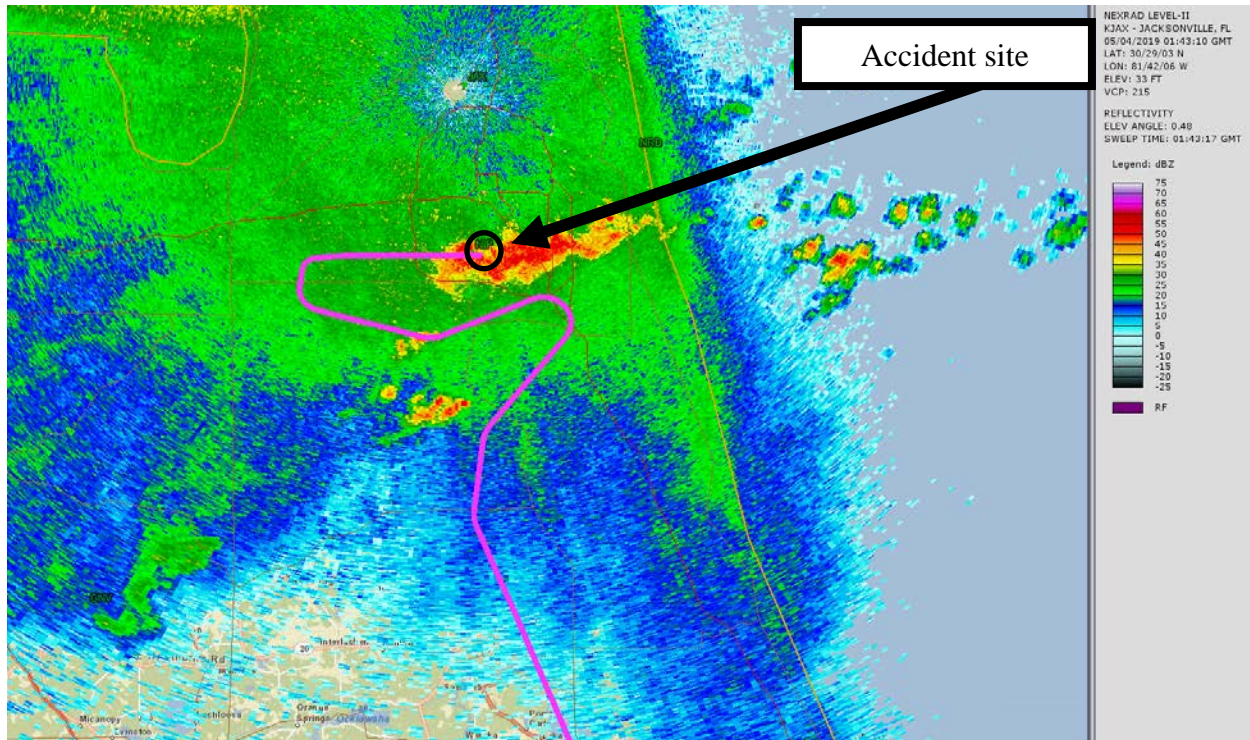
Figure 23 – KJAX WSR-88D reflectivity for the 0.5° elevation scan initiated at 2143:17 EDT with the accident site marked with black circle and the accident flight track in pink

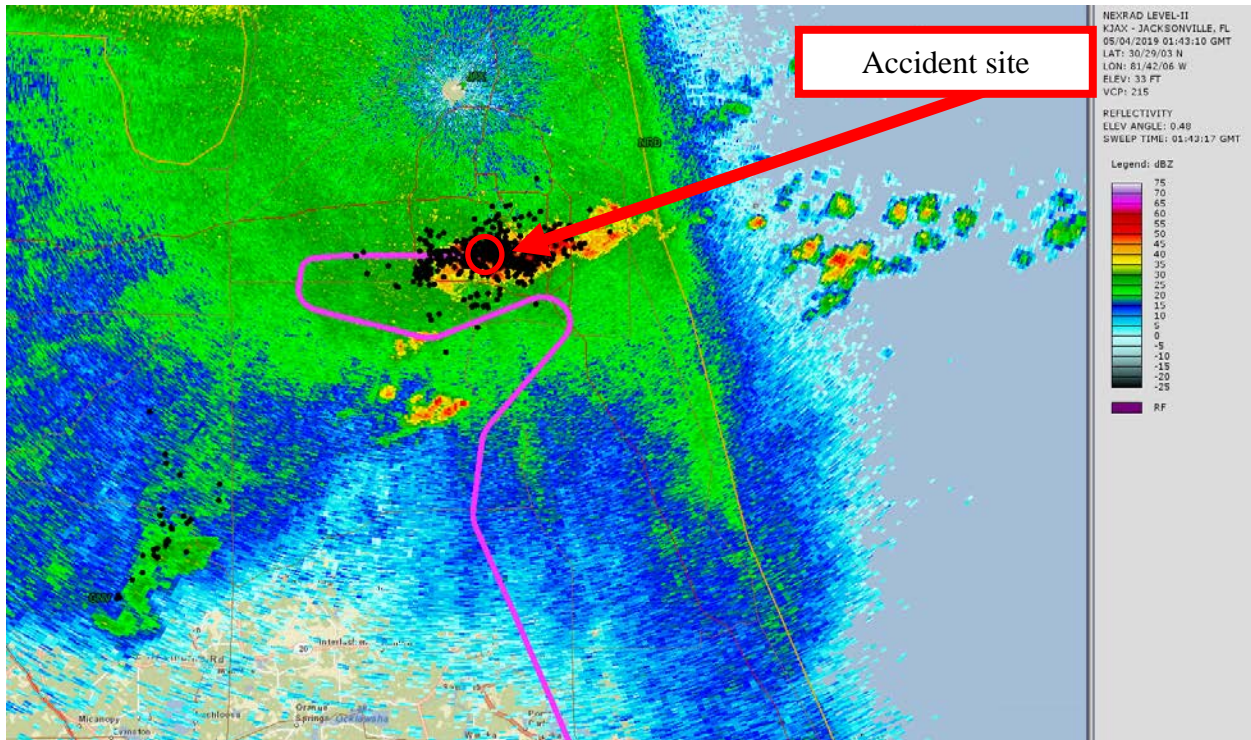
There were 714 lightning flashes²³ between 2125 and 2145 EDT and the lightning flashes are plotted as black dots on figure 24.²⁴ The closest lightning flash to the accident flight occurred at 2141:17 EDT with the lightning flash located 1,637 ft north of the flight track.

Figure 24 – KJAX WSR-88D reflectivity for the 0.5° elevation scan initiated at 2143:17 EDT with the accident site marked with red circle, the accident flight track in pink, lightning flashes marked as black dots

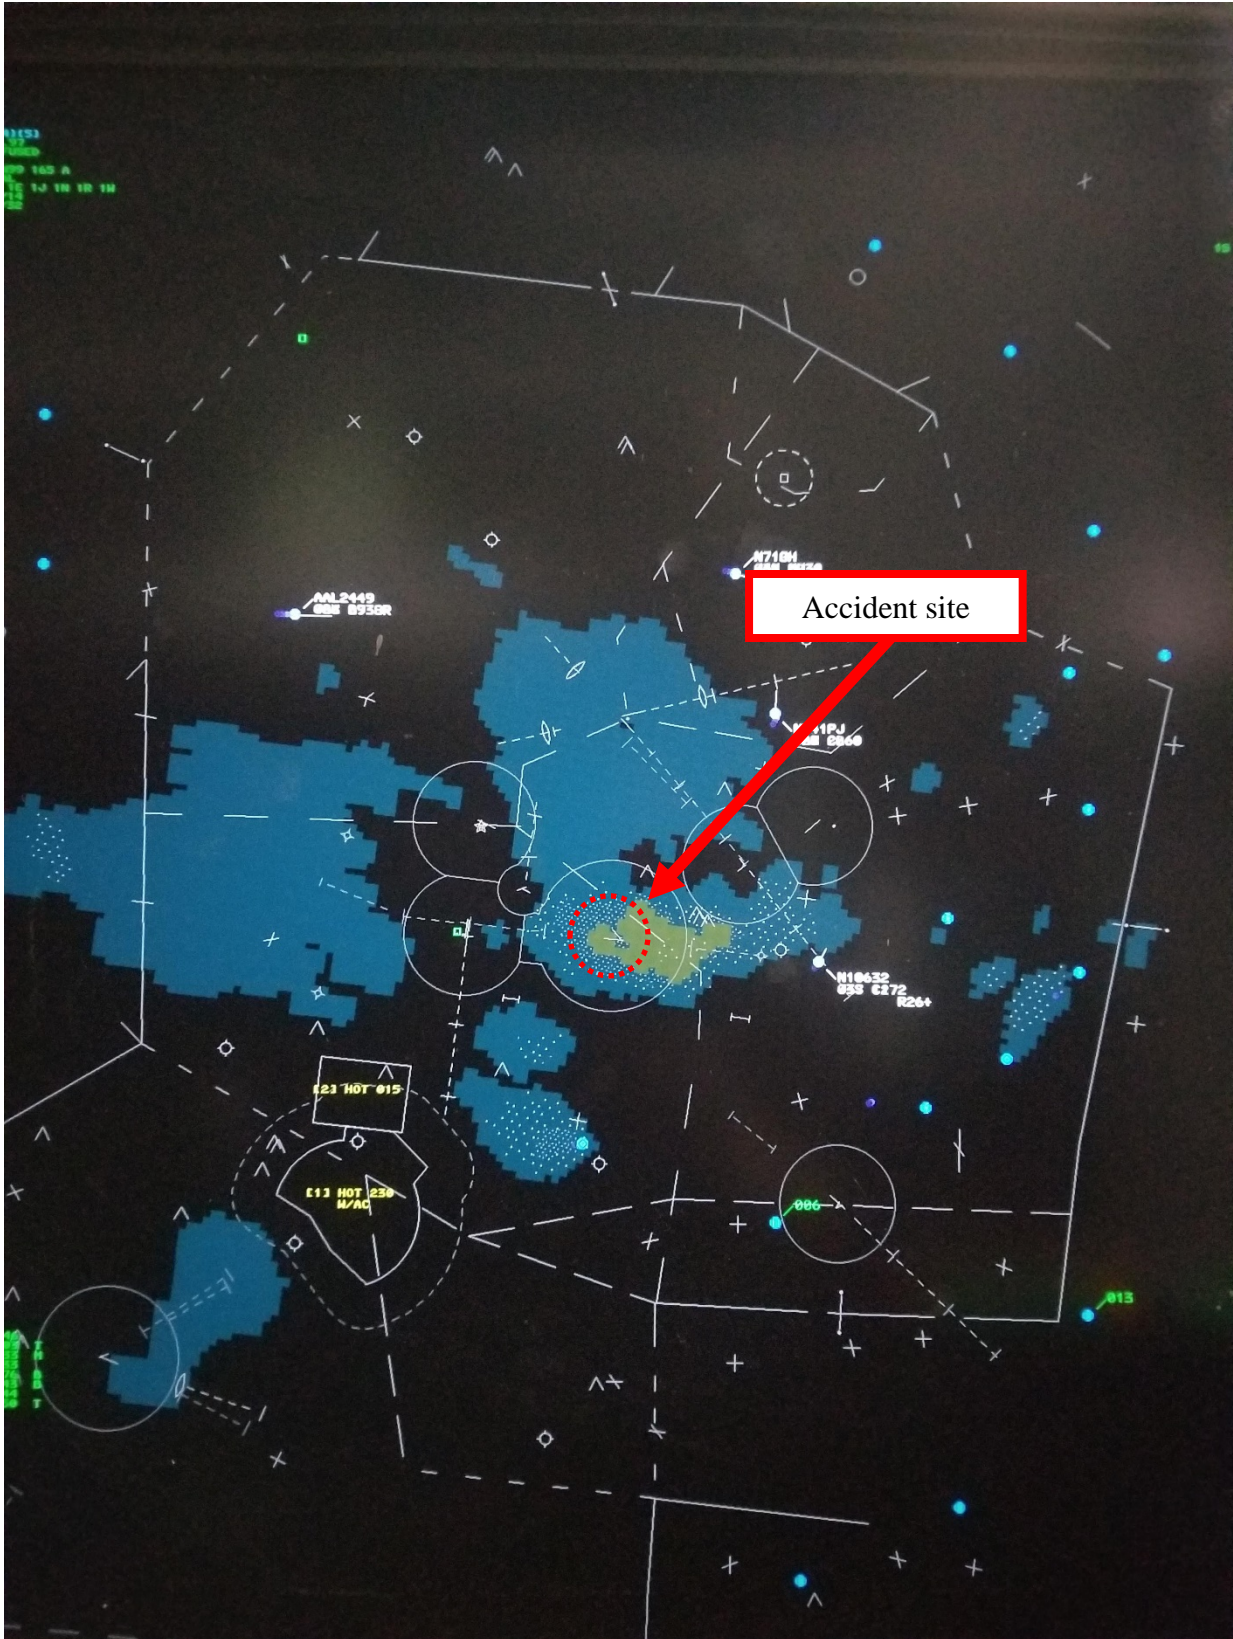
Figure 34 – STARS weather and precipitation level display for 2142 EDT

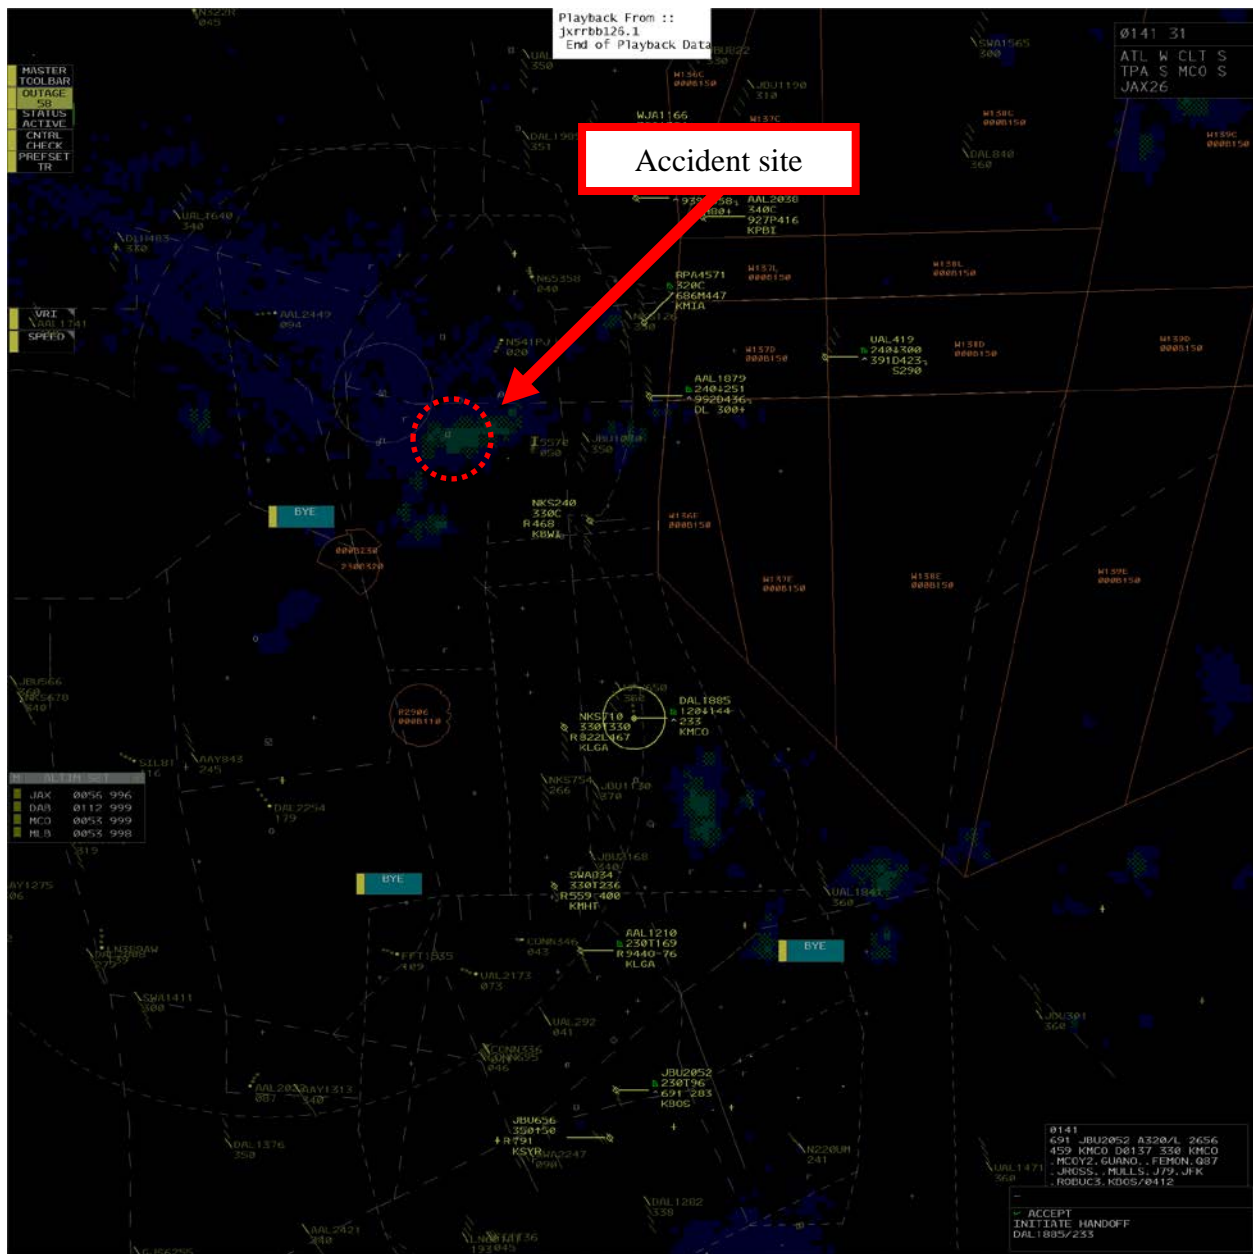
The ZJX ATC's radar display of Weather and Radar Processor (WARP)³⁰ weather derived imagery, weather radar representation, settings, and aircraft movement of the accident aircraft is provided in figures 36 through 41 with images from 2120, 2124, 2128, 2132, 2138, and 2141:31 EDT, respectively. Each minute screen capture of WARP weather imagery is displayed in attachment 13. An exemplar image of WARP weather derived imagery precipitation levels is provided as figure 35. The ZJX radar display of WARP weather derived imagery indicated heavy to extreme precipitation above KNIP and the accident site at 2120 EDT (figure 36) with the area of extreme precipitation continuing to grow in areal coverage through 2142 EDT (figure 41) and remaining above the accident site and KNIP (attachment 13). For more WARP imagery please see attachment 13. The STARS display of weather and precipitation levels at the accident site did not match the WARP display of weather and precipitation levels, with WARP display of weather and precipitation indicating extreme precipitation above the accident site and KNIP as early as 2120 EDT.

Figure 41 – Screenshot of the ZJX air traffic controller’s radar display at 2141:31 EDT with WARP derived weather displayed
