**NATIONAL TRANSPORTATION SAFETY BOARD**  
Vehicle Recorder Division  
Washington, DC 20594

## **Onboard Image Recorder**

**Specialist's Summary Factual Report**  
**By Sean Payne**

Location: Destrahan, LA  
Date: January 26, 2020  
Vessel: *Cooperative Spirt*  
Flag State: United States  
Official Number: 569226  
Operator: American River Transportation Co.  
NTSB Number: DCA20FM012

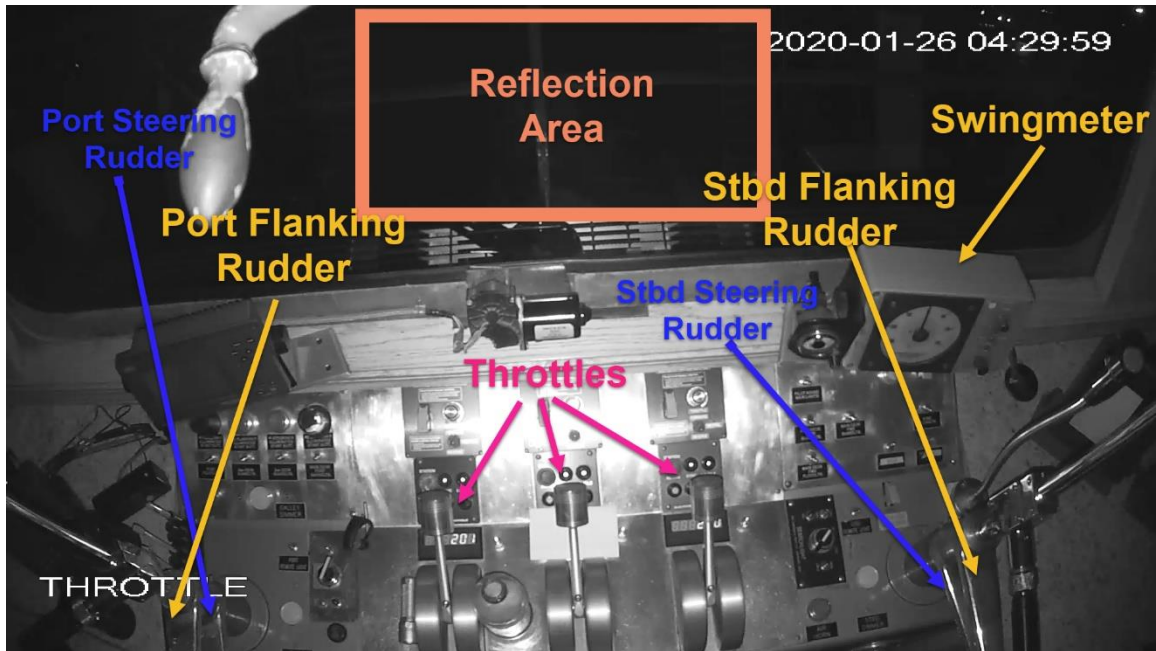
The camera provided a view of a portion of the wheelhouse. The camera's view is shown in figure 1. The figure is annotated to show some of the controls that are referenced in the summary.

Figure 1. The field of view from the camera installed above the operator's position on the *Cooperative Spirit*. The operator's reflection is not apparent at this time.
