NATIONAL TRANSPORTATION SAFETY BOARD

Onboard Image, Audio, and Data Recorder

Specialist's Factual Report
By Sean Payne

Location: Camp Dwyer, Afghanistan
Date: April 20, 2020
Aircraft: Sikorsky S-61N
Registration: N908CH
Operator: Construction Helicopters Incorporated (CHI)
NTSB Number: ERA20LA100

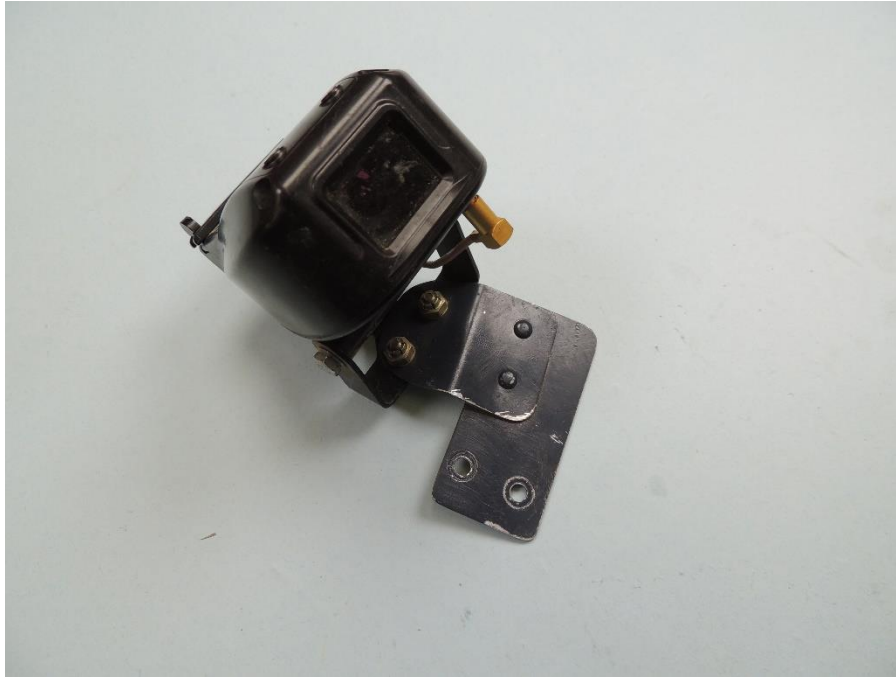
Upon arrival at the NTSB Vehicle Recorder Division, the Vision 1000 unit was noted to have light impact damage, but was otherwise in good condition. The unit did not have its associated SD card installed. The associated SD card was not located in the wreckage.

Figure 1. The Appareo Vision 1000 device as received. The associated SD card is not pictured.

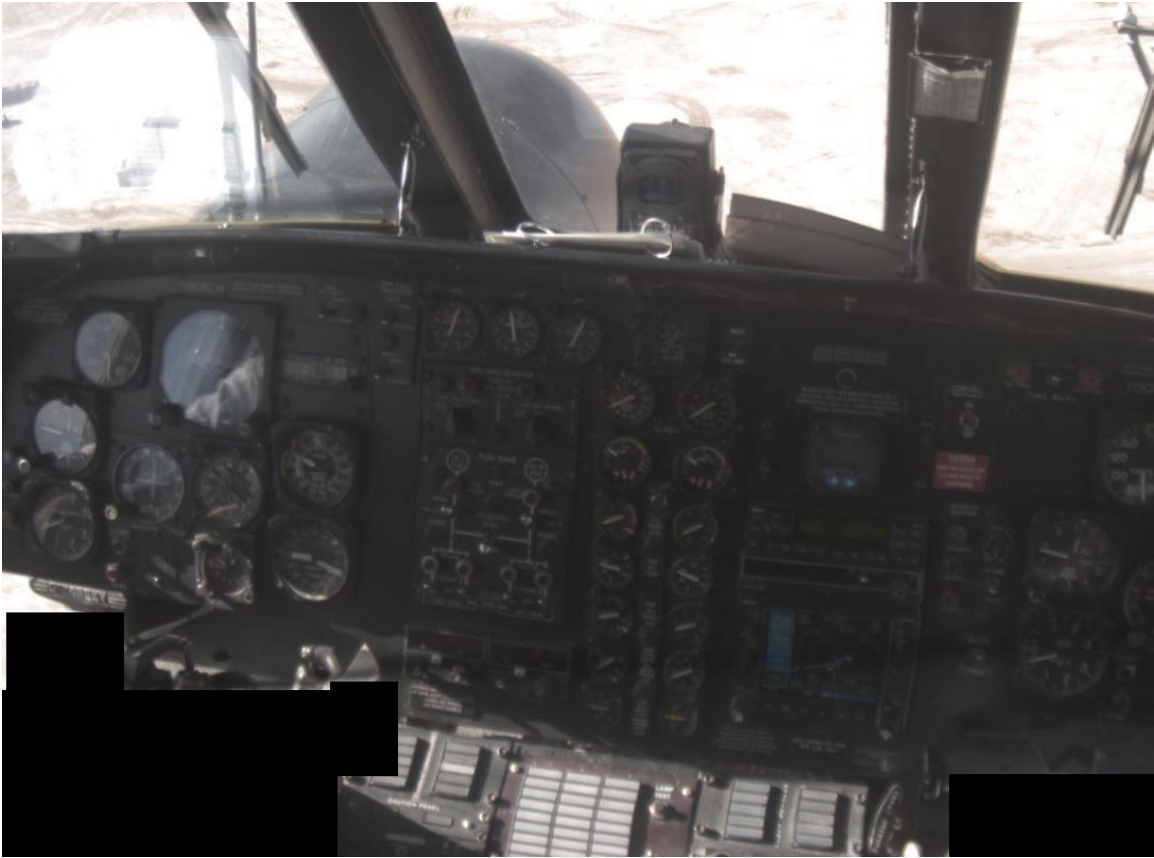
Figure 2. An example image recorded by the Vision 1000 in the accident helicopter from the accident flight. The crew is redacted.

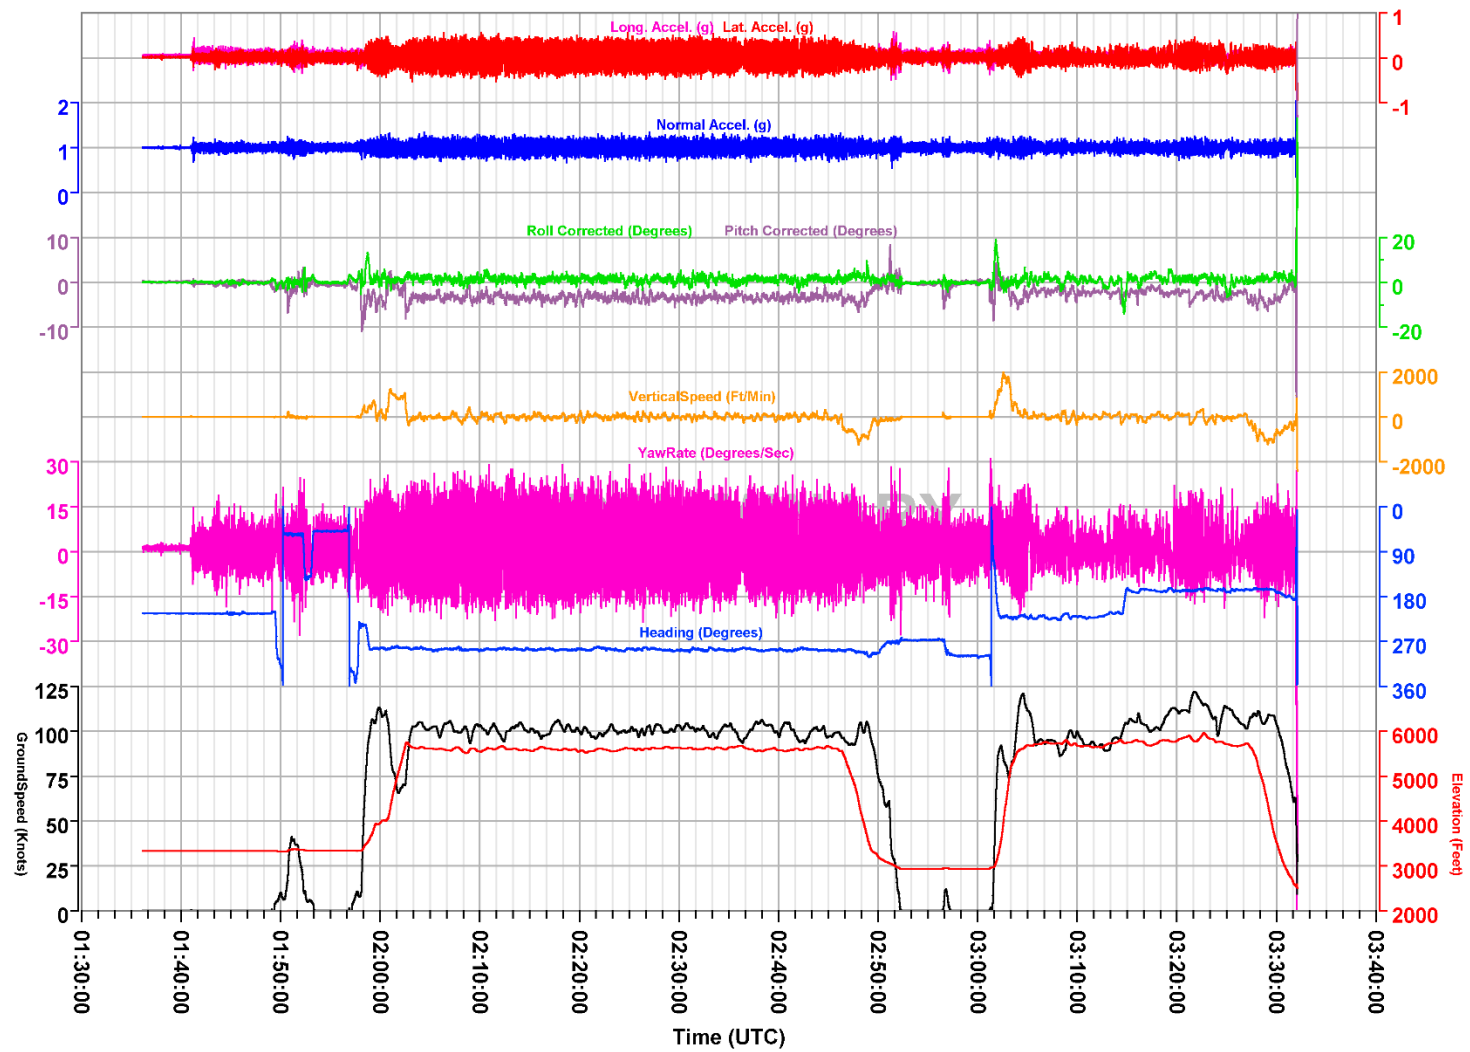
Figure 3 is a plot of select recorded parameters for the entire accident flight.

Figure 3. A plot of basic recorded parametric data for the entire accident flight.

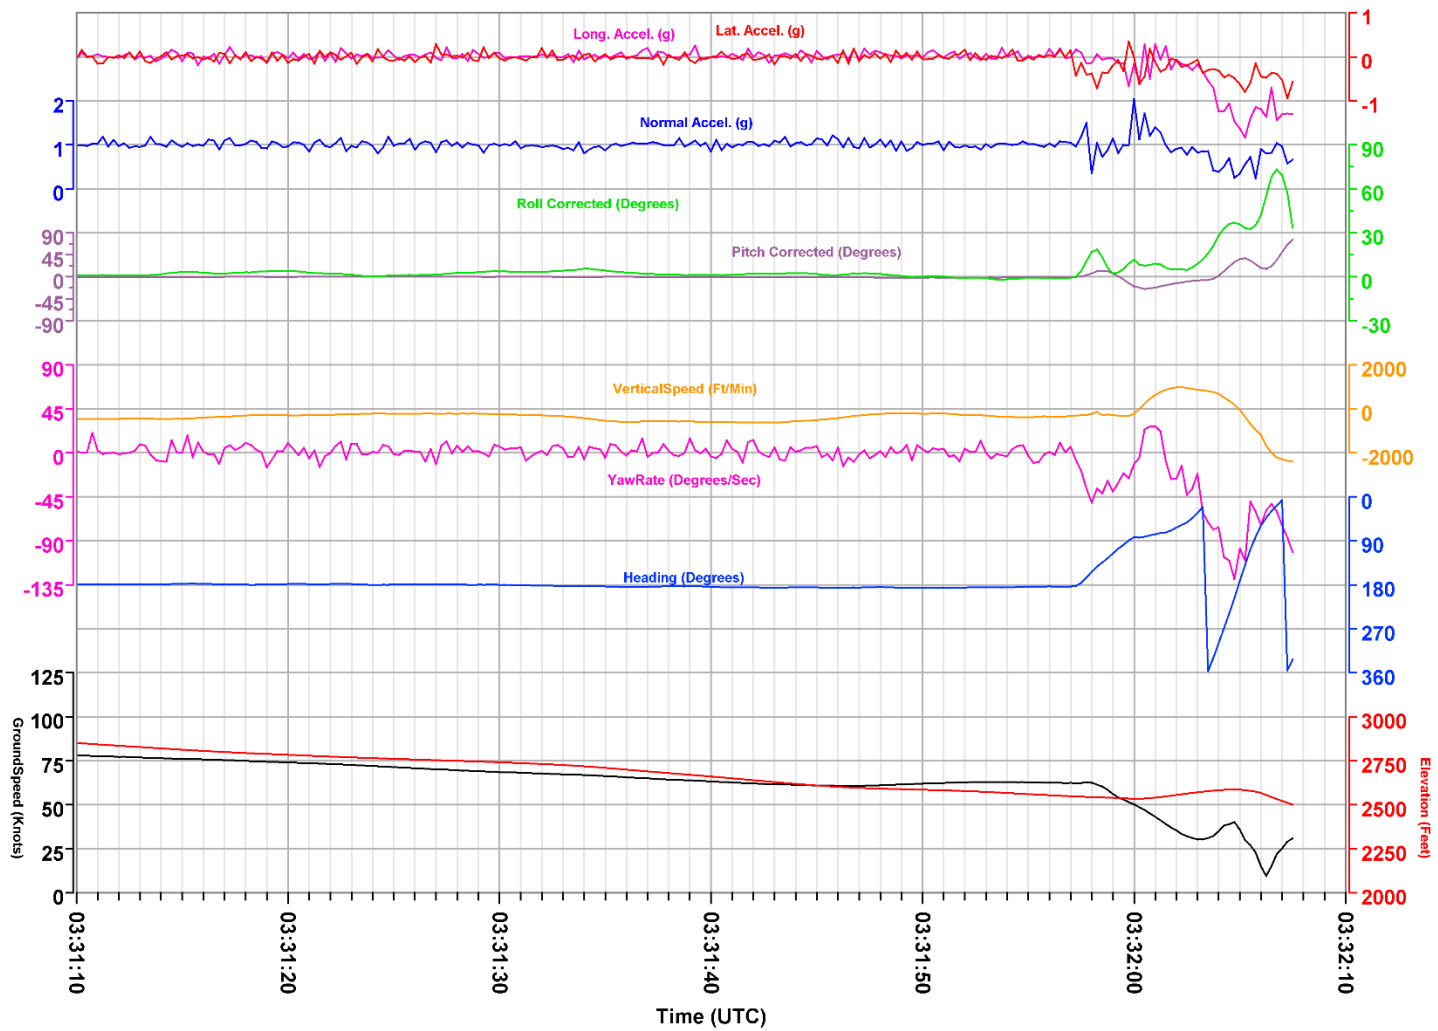
Figure 4 is a plot of select recorded parameters for the last minute of the accident flight.

Figure 4. An expanded time range plot of basic recorded parametric data for the time interval between 03:31:10 UTC and the end of the accident recording.

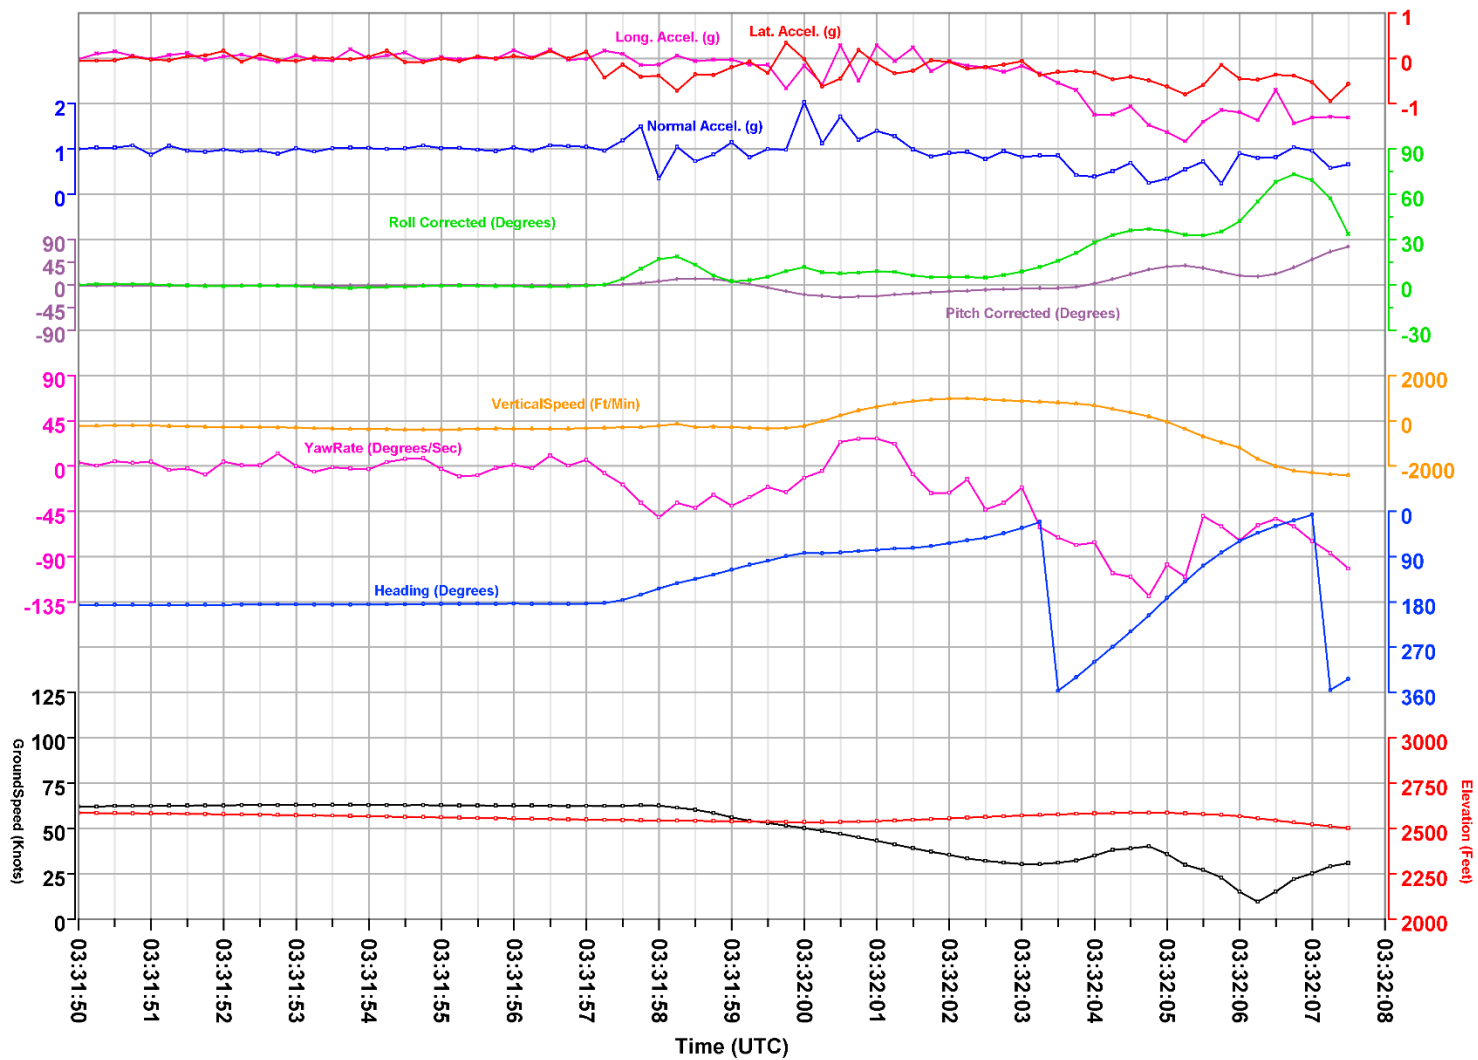
Figure 5 is a plot of select recorded parameters for the last 17.500 seconds of recorded data.

Figure 5. An expanded time range plot of basic parameters for the final moments of the accident recording.
