NATIONAL TRANSPORTATION SAFETY BOARD

Group Chairmen's Factual Report

OPERATIONAL FACTORS/HUMAN PERFORMANCE

DCA20MA002

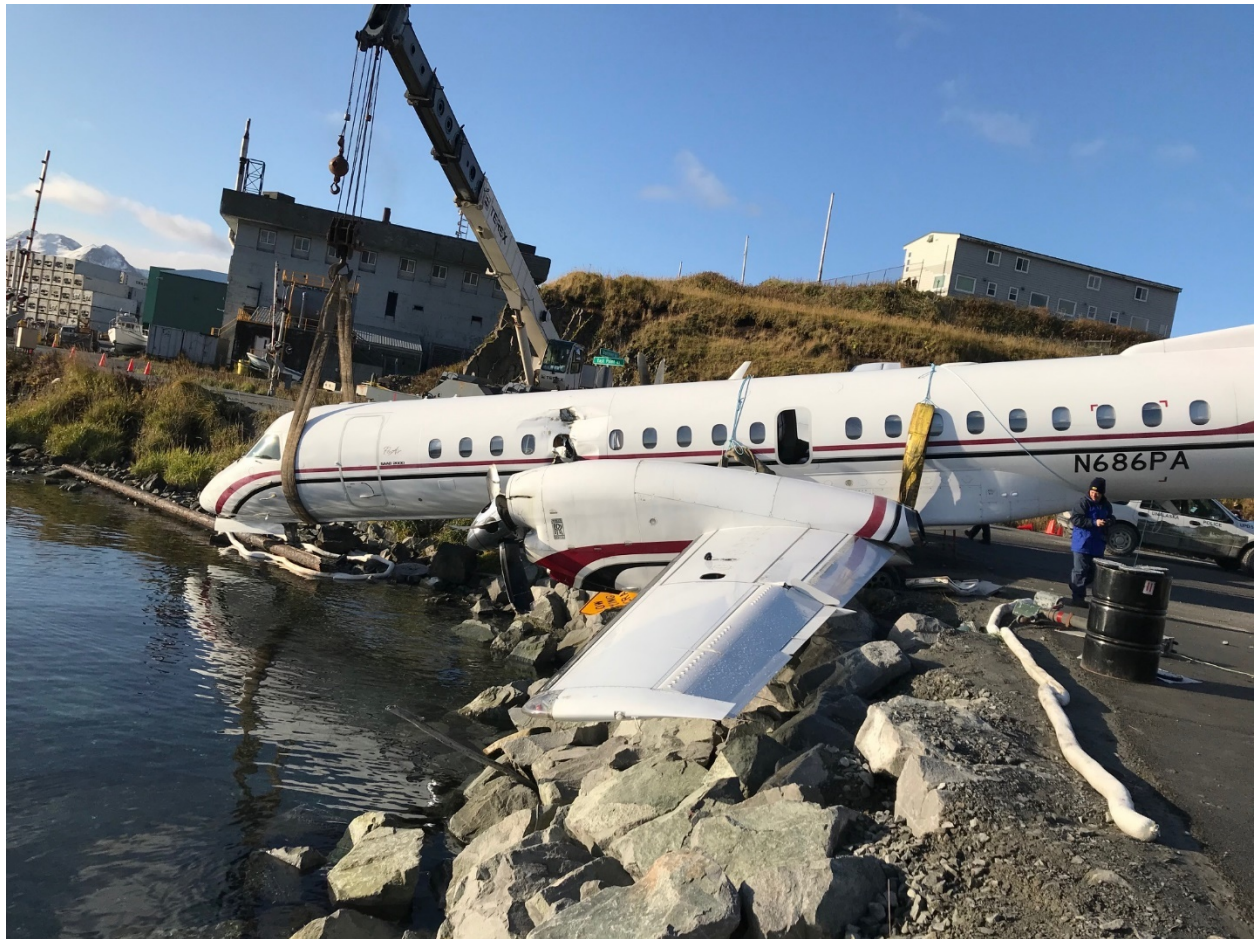
between the runway centerline and the right edge of the runway as it crossed the runway 31 threshold and then departed the overrun area. It then drifted further right, crossed a road that was just beyond the paved runway surface, and stopped on a rocky embankment abutting the road, with the nosewheel in Dutch Harbor, and the remainder of the airplane resting on the rocks.

Figure 3. Final resting spot of the aircraft (source: NTSB).
