**NATIONAL TRANSPORTATION SAFETY BOARD
OFFICE OF AVIATION SAFETY
WASHINGTON, D.C. 20594**

Systems and Structures Group Chairman's Factual Report

DCA20MA002

Operator: PenAir
Aircraft: Saab 2000
Location: Dutch Harbor, AK
Date: October 17, 2019
Time: 1740 ADT

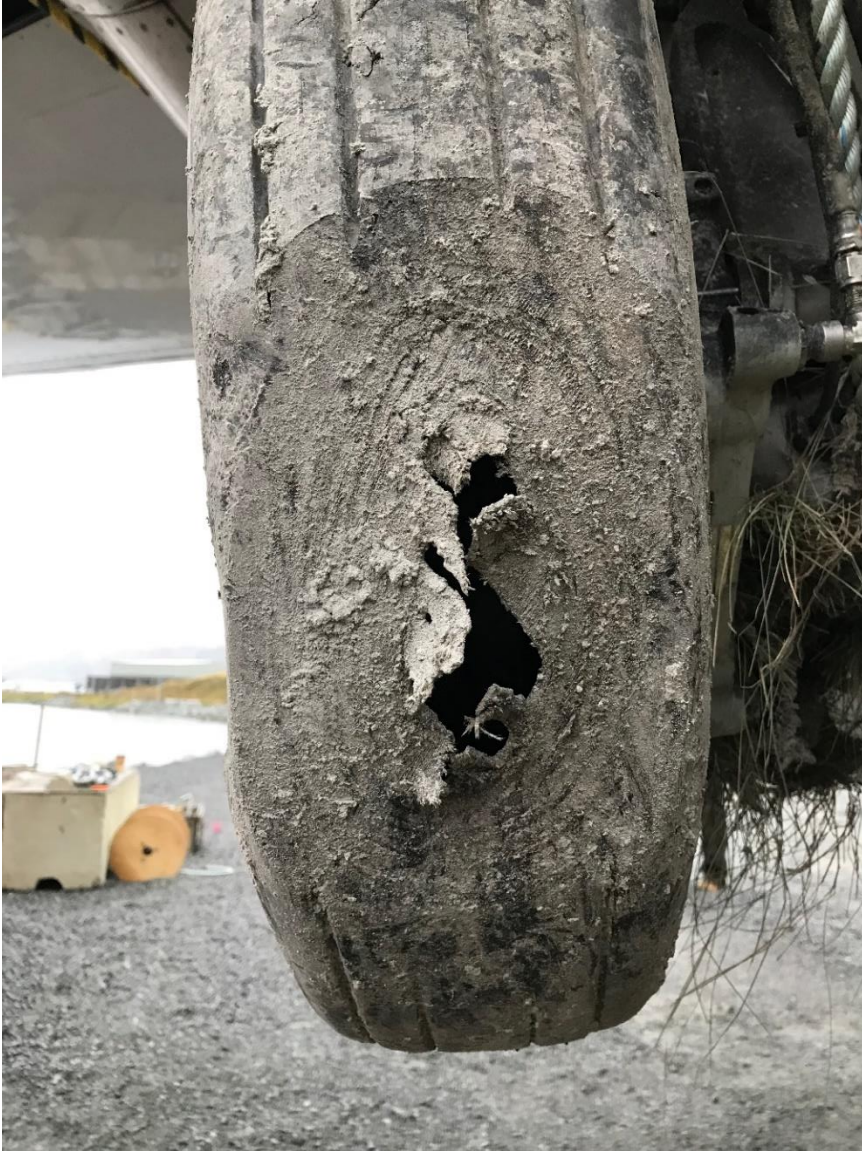
The #1 tire was found to be deflated and had an area approximately 11 inches in length which was ground flat all the way through the tire, Figures 12-13. There was a hole in the sidewall of the tire near the flat spot, and an oval shaped worn area approximately 180 degrees from the ground flat area, Figure 14. The runway was inspected and there was a long skid mark on the left side of the runway past the touchdown area.

Figure 13 Hole in left outboard tire

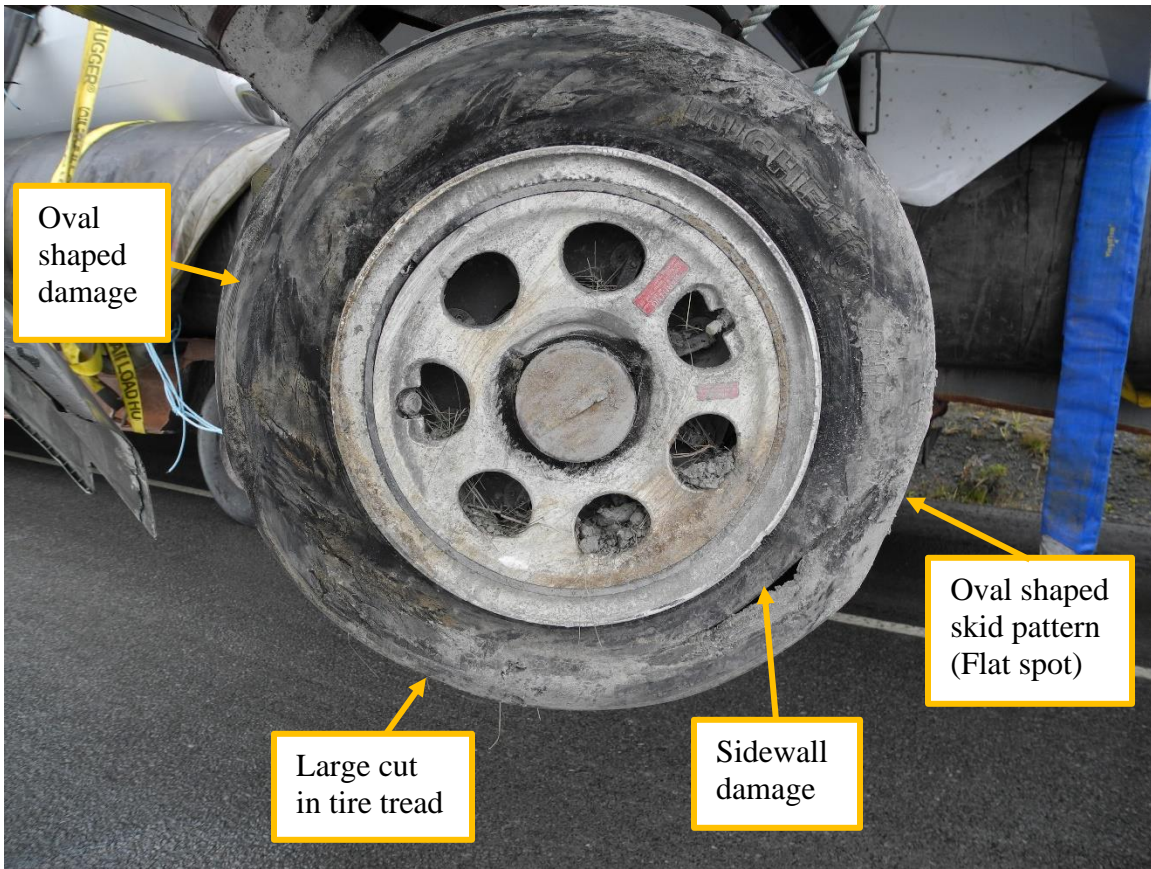
Figure 14 Damage to left outboard tire

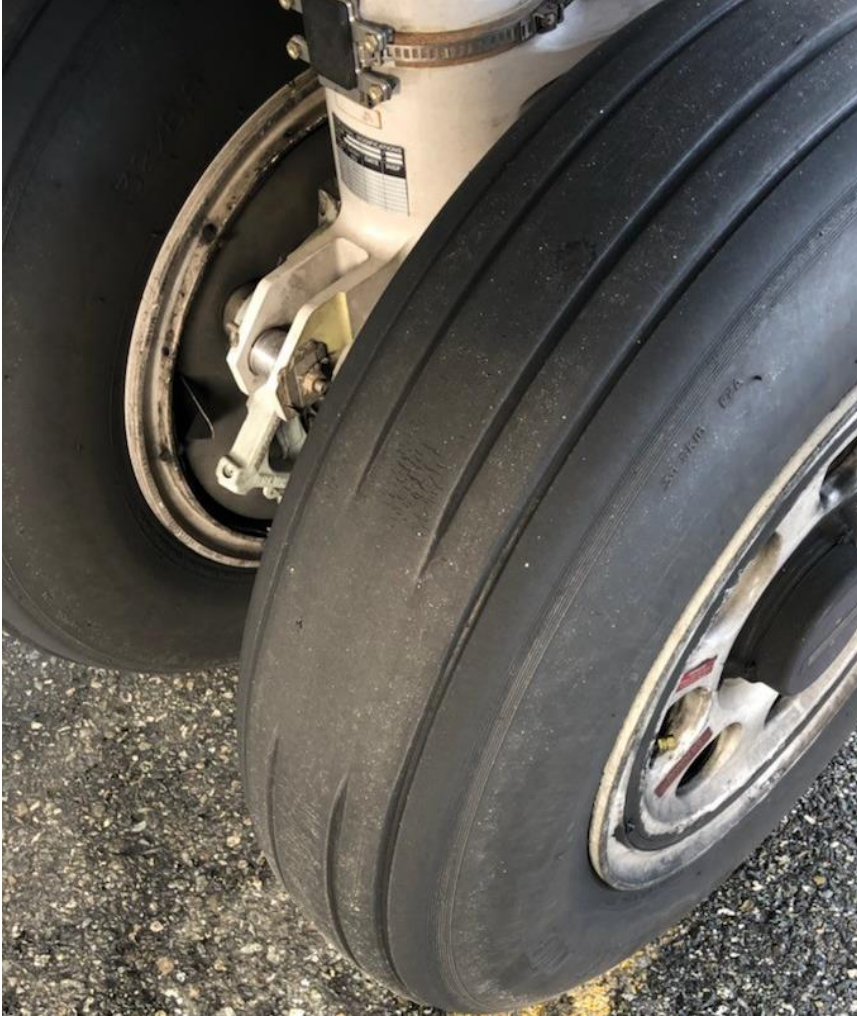
During the interviews of the flight crew it was revealed that the #1 tire had a flat spot prior to departure of the accident flight, Figure 15. It did not appear that the wear exposed any of the reinforcing plies.

Figure 15 Flat spot on #1 tire prior to accident flight

- The small amount of fragments appear to be from the area of the initial skid, Figure 20. The small screw was not part of the tire.
- With regard to the flat spot prior to dispatch, if there were no reinforcing plies visible the tire was serviceable in that condition.

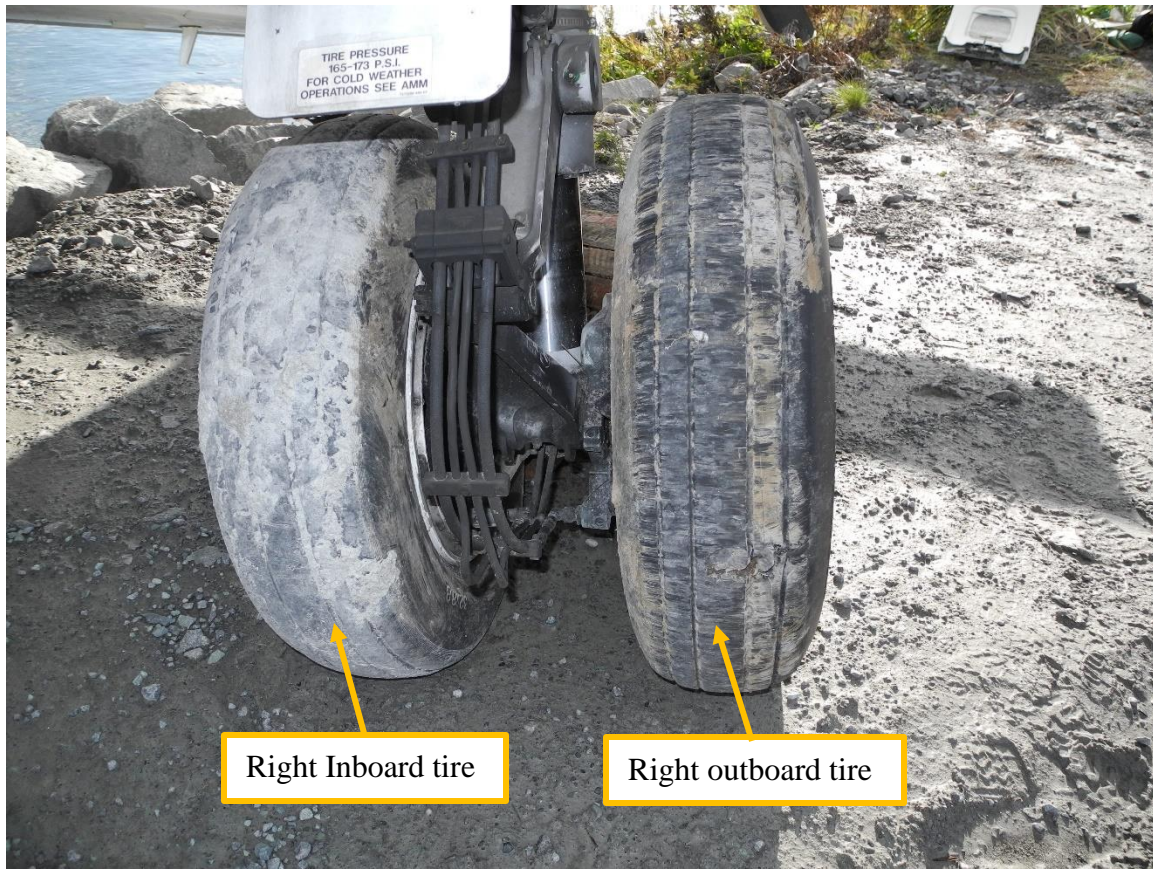
Tires 2-4 were intact and pressurized. The pressure in the tires was checked at the accident site, prior to lifting the airplane onto the barge. The #2 tire was at 135 psi. The #3 and #4 tires, Figure 16, were at the maximum reading of the available gauge, which was 160 psi. A placard on the landing gear door indicated that the allowable pressures were between 165-173 psi. The tires were later cleaned with water and rags to remove the bulk of the dirt to reveal the condition of the tread. These tires had numerous abrasions and cuts in the tires but did not have any flat spots, and all had significant tread remaining.

Figure 16 Right main gear tires

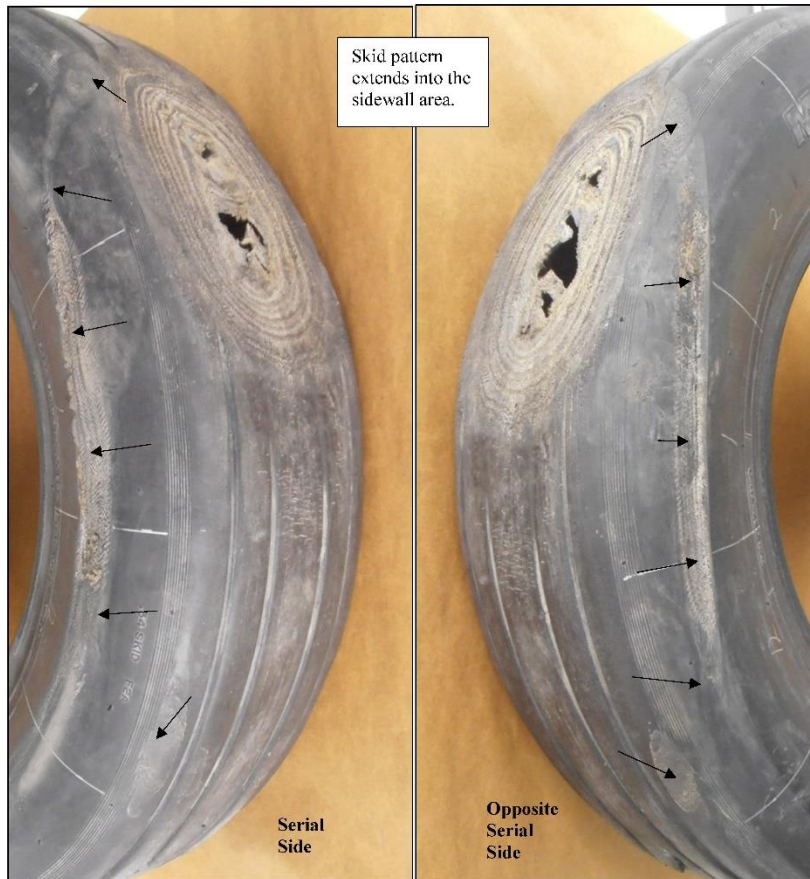
RGA 020-001 Photo E

- After complete pressure loss, the skid pattern showed the tire skid footprint increased to include the sidewall damage in that area of the tire. This was the result of the tire collapsing and skidding on both of the sidewalls, Figure 17.

Figure 17 Flat spot and sidewall damage

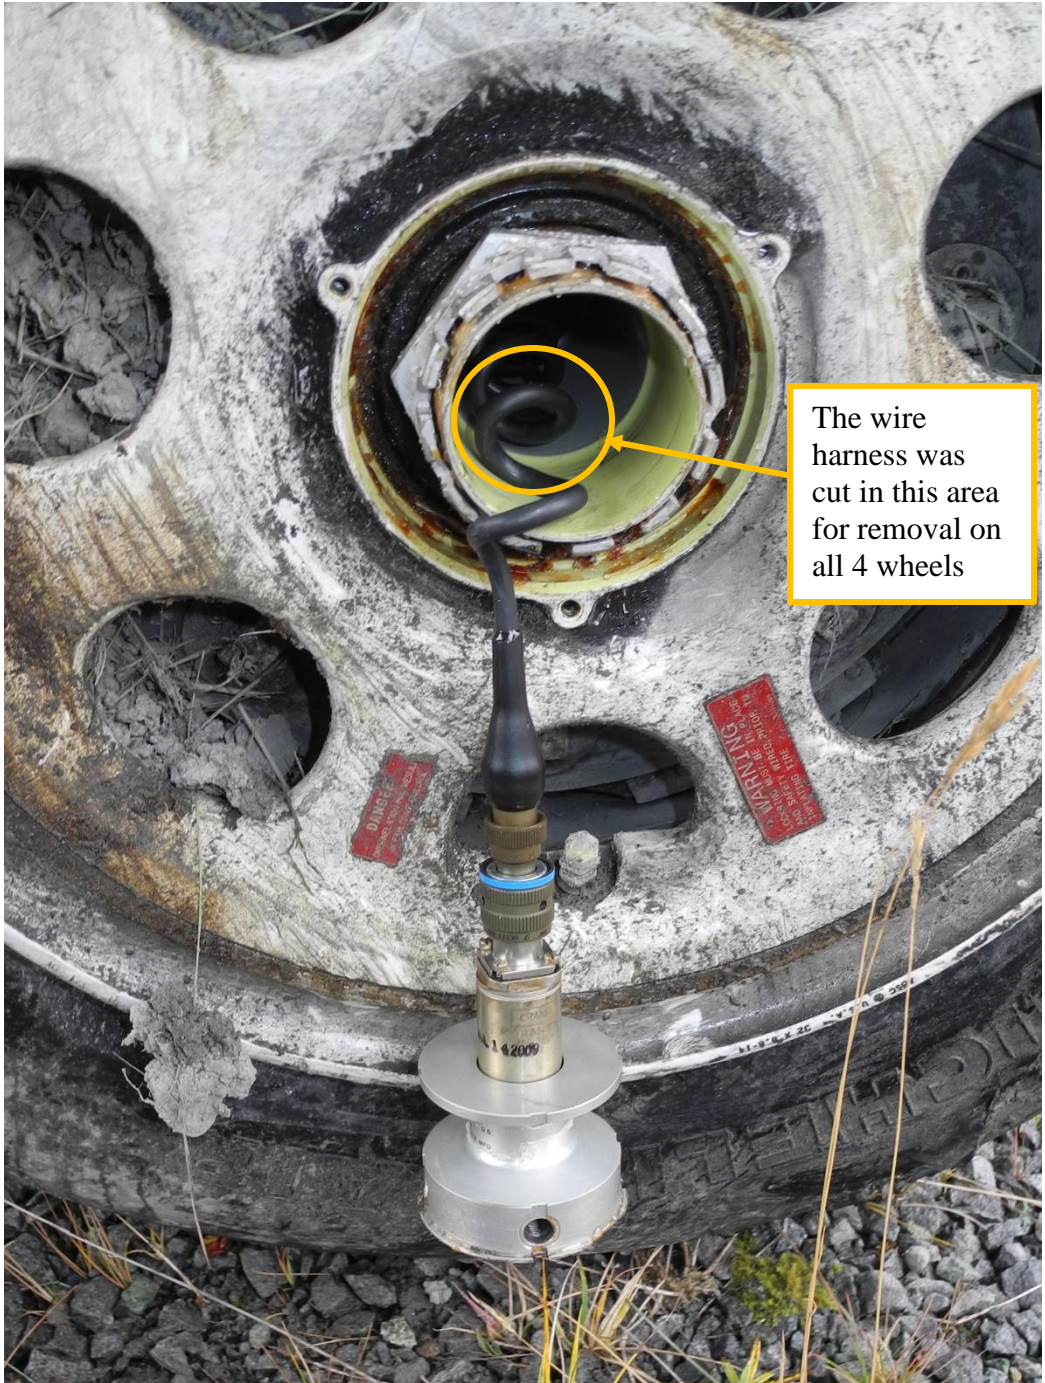
The wire harness was cut in this area for removal on all 4 wheels

Figure 29 #1 wheel speed transducer removed from axle

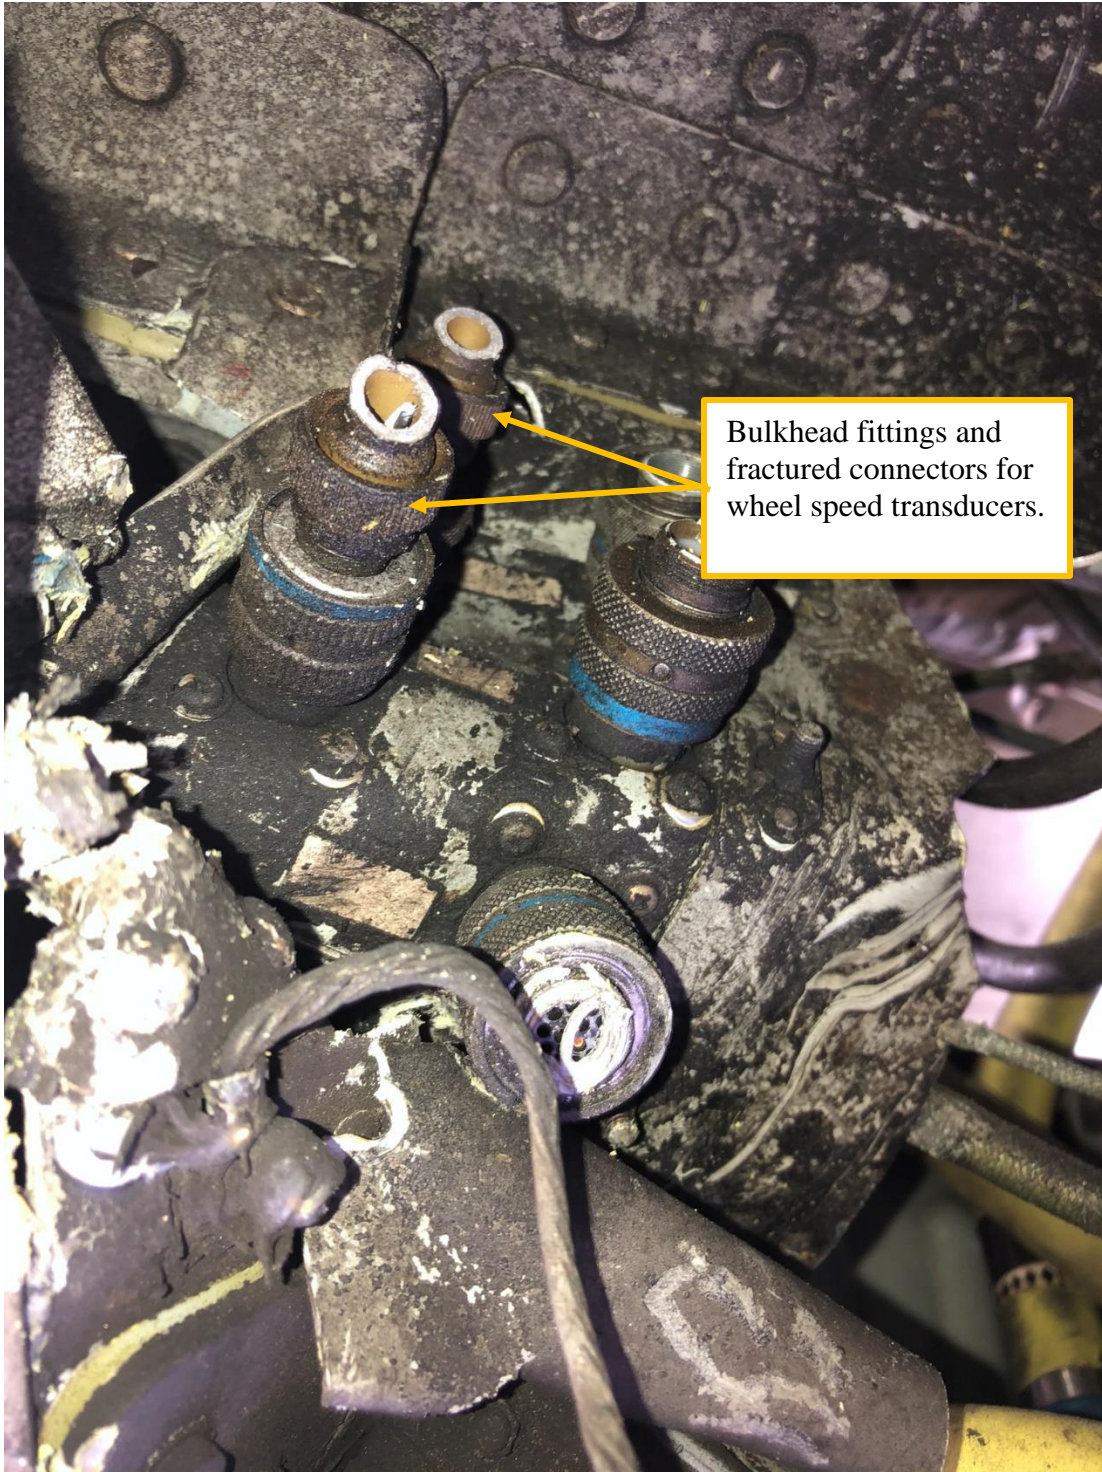
The impact damage to the left main gear fractured both wheel speed transducer wire harnesses and the bulkhead fittings in the wheel well. During the initial on-scene work, the #1 wheel speed transducer wire harness was removed. It was intact to the top of the strut but fractured with no connector at the top end. The #2 harness was also removed, but only the lower portion to the first fracture, which was near the midpoint of the strut. Because of the damage, it was difficult to access the bulkhead fittings, so they were not removed and not all the wire harness portions were recovered. It was not possible initially to determine which wire harness was connected to which bulkhead fitting in the wheel well. To determine if the wiring was correct, the #1 wire harness was cut open to reveal the wire numbers. However, it was found that the landing gear manufacturer did not place wire numbers on the wires. The team then contacted the manufacturer, Heroux Devtek to better understand the construction of the wire harnesses.

Bulkhead fittings and fractured connectors for wheel speed transducers.

Figure 35 Left wheel well wheel speed transducer bulkhead fittings

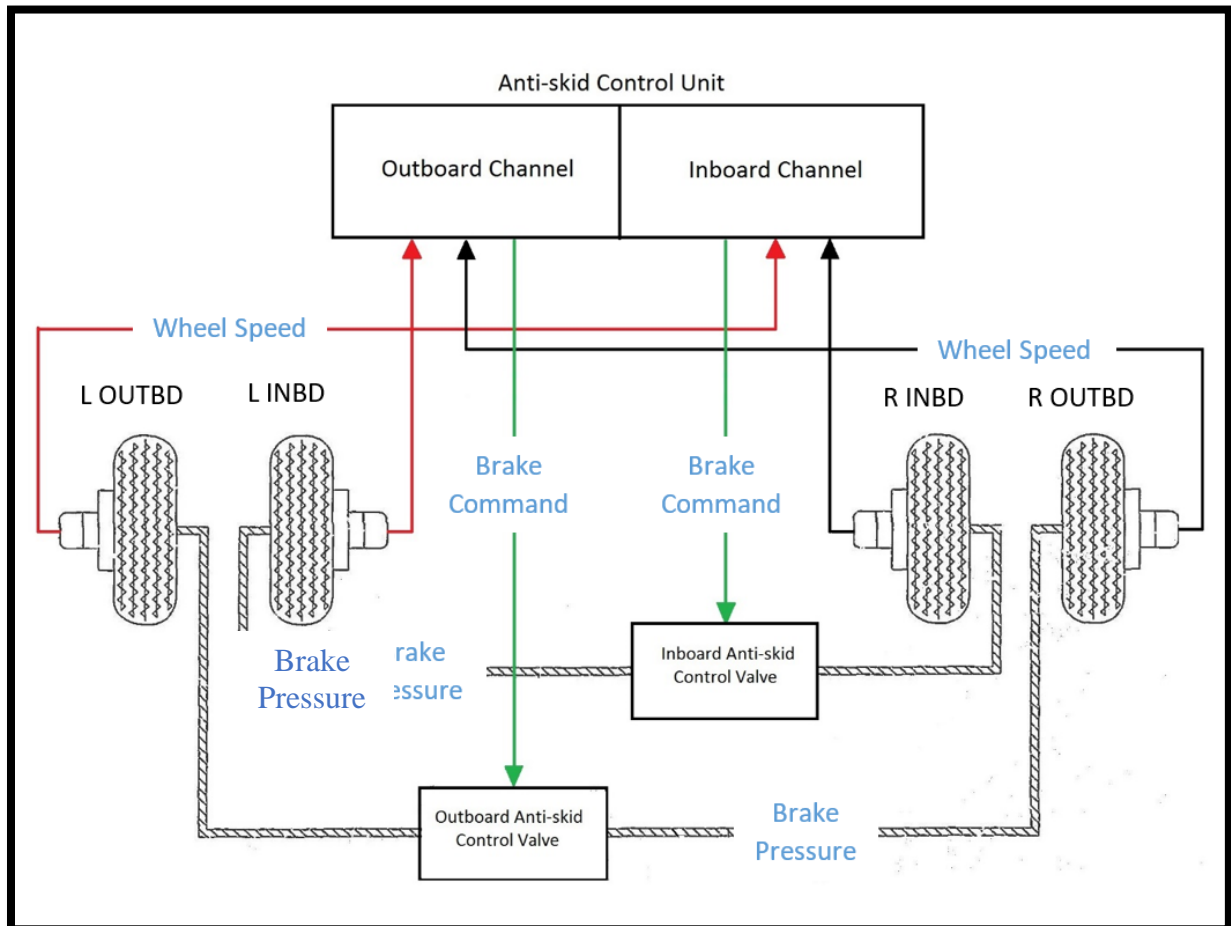
The crossed wire scenario is indicated by the red lines in Figure 39. The effect of the crossed wiring is further examined in the four scenarios below.

Figure 39 Anti-skid wheel speed transducers cross wired

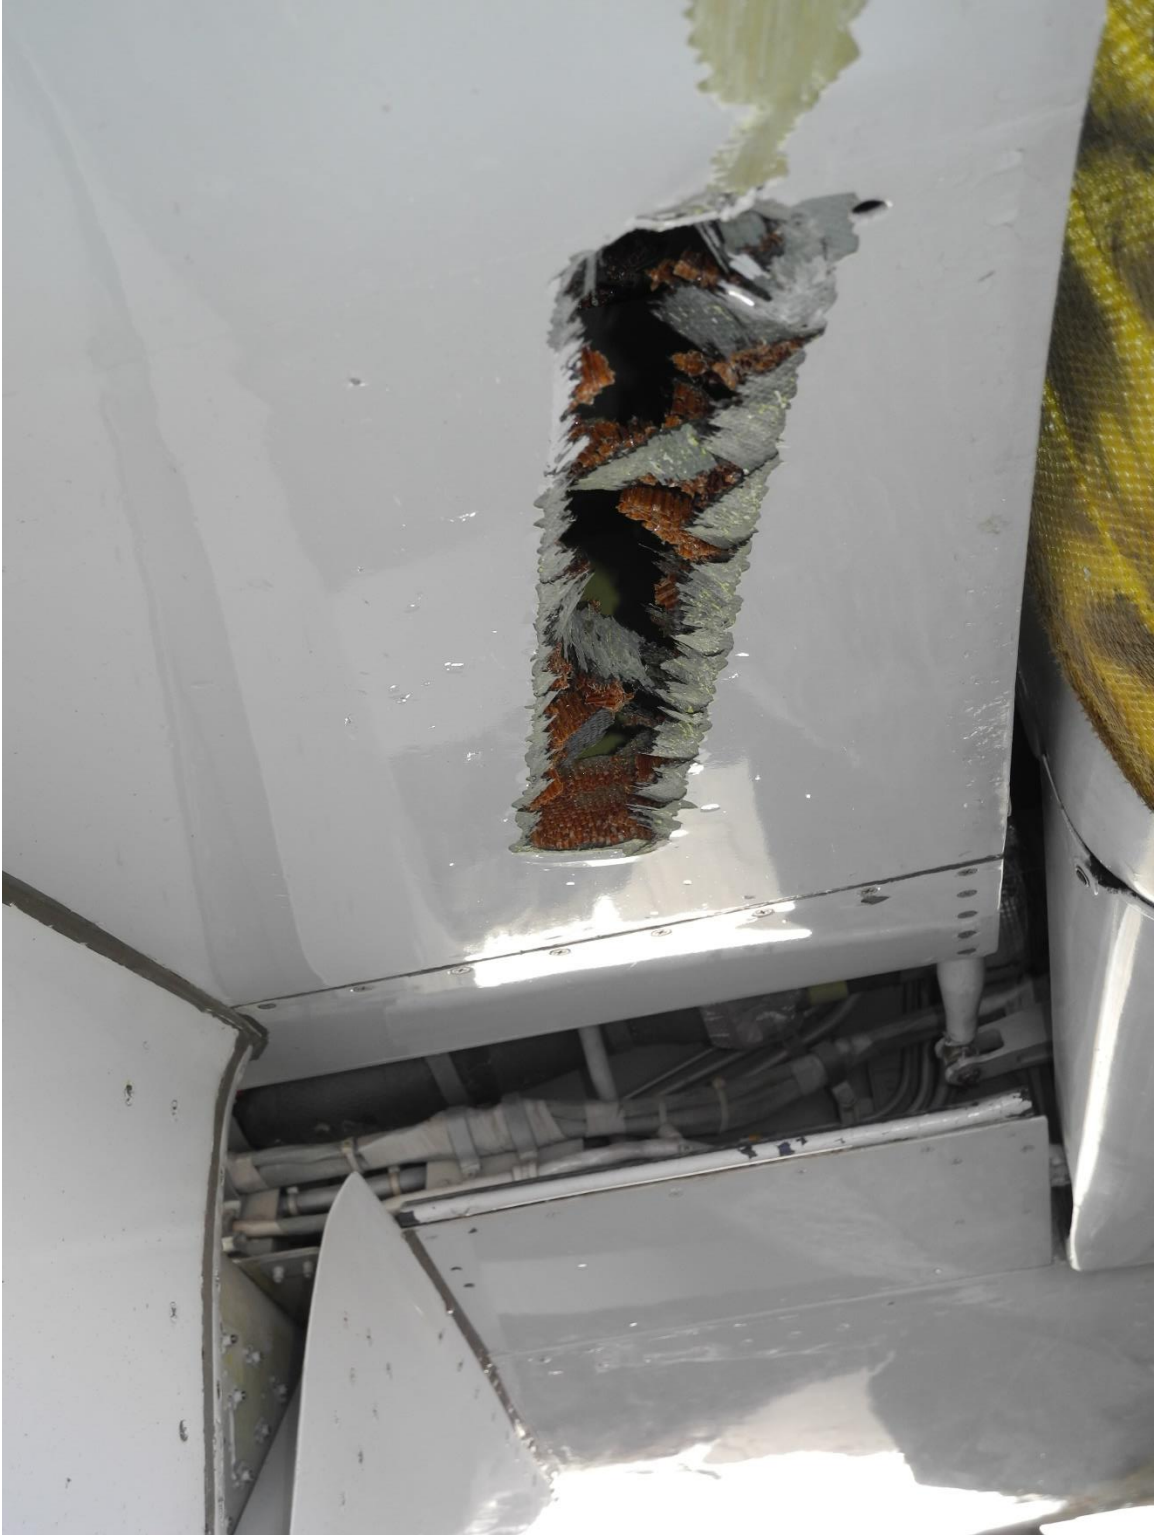
The wing was intact and had only minor impact marks on the leading edge, Figure 40. There was no damage to the wing tip. During recovery the tip impacted a telephone pole which caused scrapes and damage to the static wick. The aileron and aileron trim surfaces were intact, Figure 41. The flaps were intact and partially extended to a similar position as the right flap, Figure 42. There was an impact mark on the bottom inboard portion of the flap, Figure 43, which extended through to the top.

Figure 43 Damage to bottom inboard portion of flap

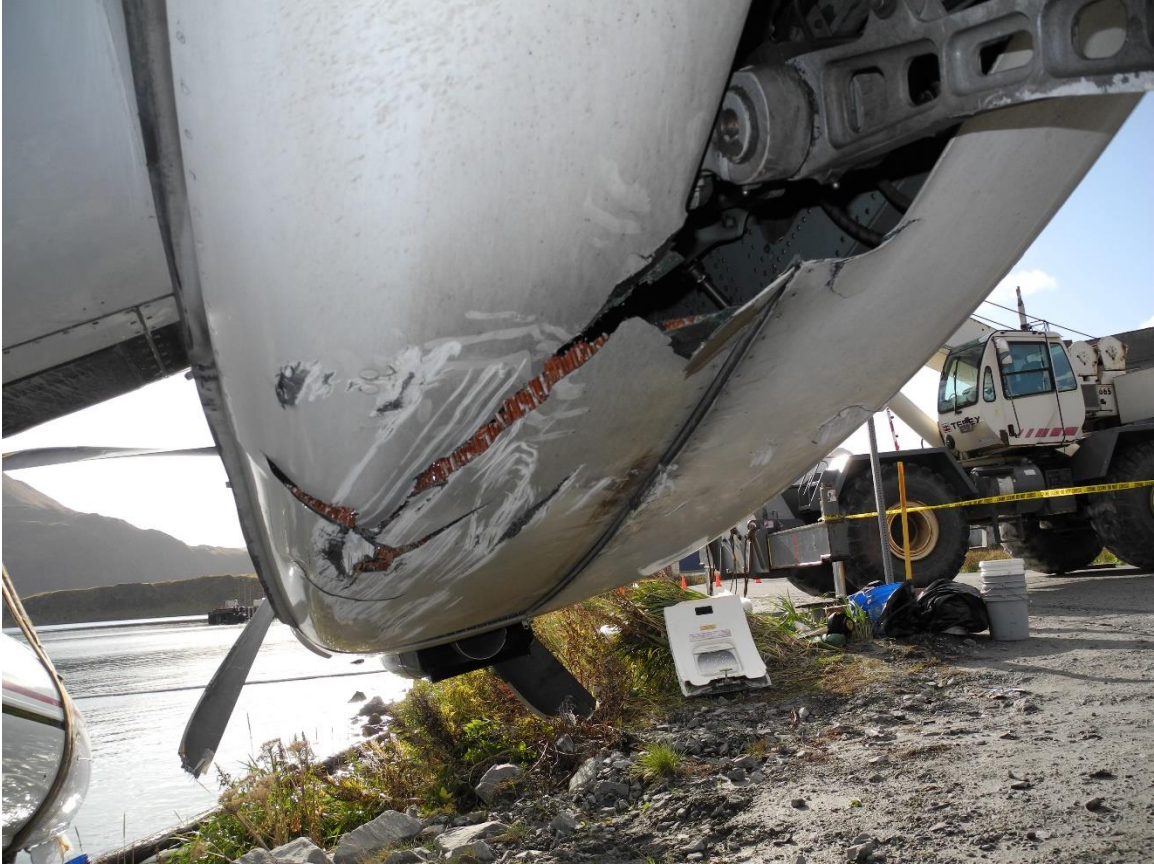
The wing was intact and had no apparent damage, Figures 44-45. During recovery the wing tip scraped a hillside which caused damage. The aileron and aileron trim surfaces were intact. The flaps were intact and partially extended to a similar position as the left flap. The right gear doors had impact damage and could not be opened by pulling the release mechanism, Figure 46.

Figure 46 Right main gear door damage

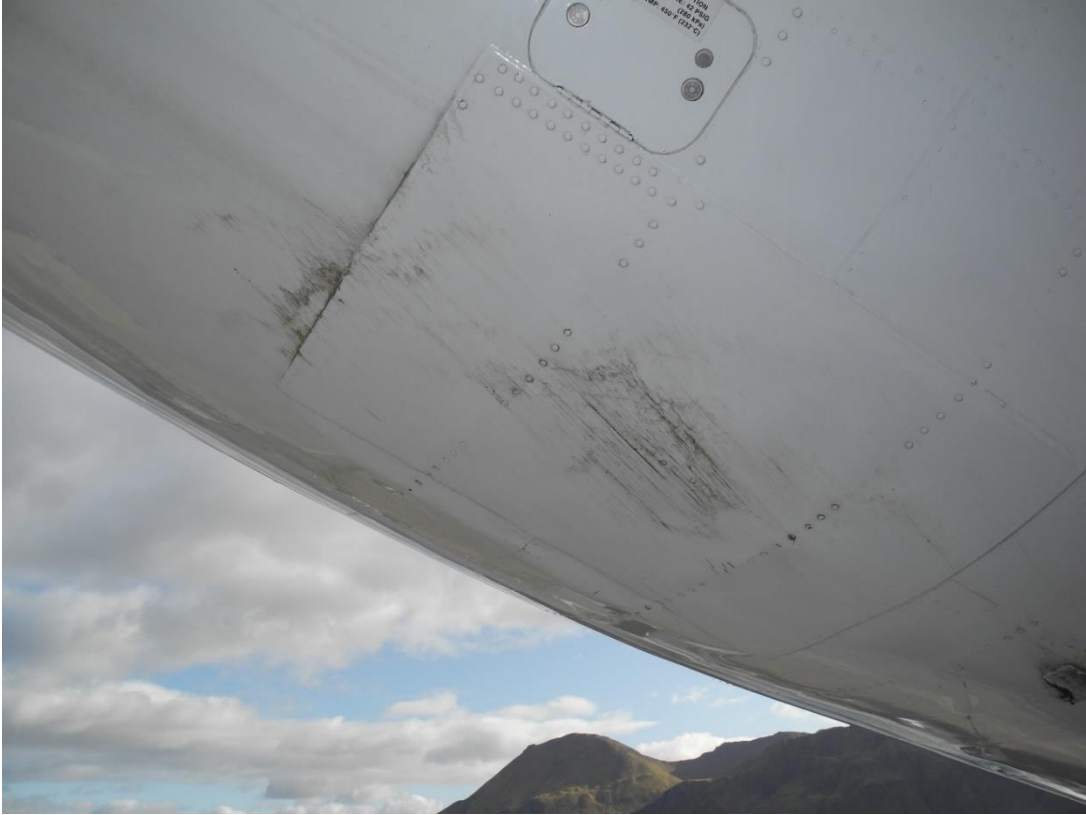
The fuselage has scrape marks and dirt on the lower portion of the fuselage near the tail where it appears there was a previous repair, Figure 49. Just forward and on the left of this area was a scratch along a similar line, Figure 50.

Figure 49 Scrapes on lower aft fuselage

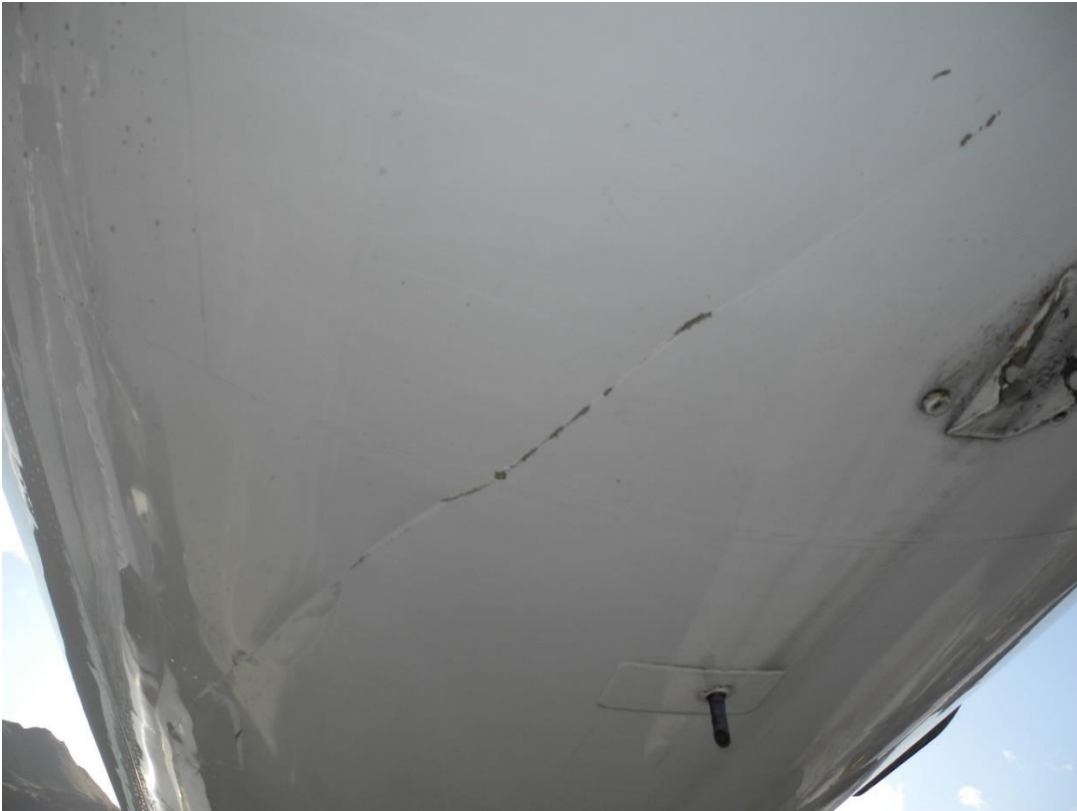
Figure 50 Scrape aft lower left fuselage

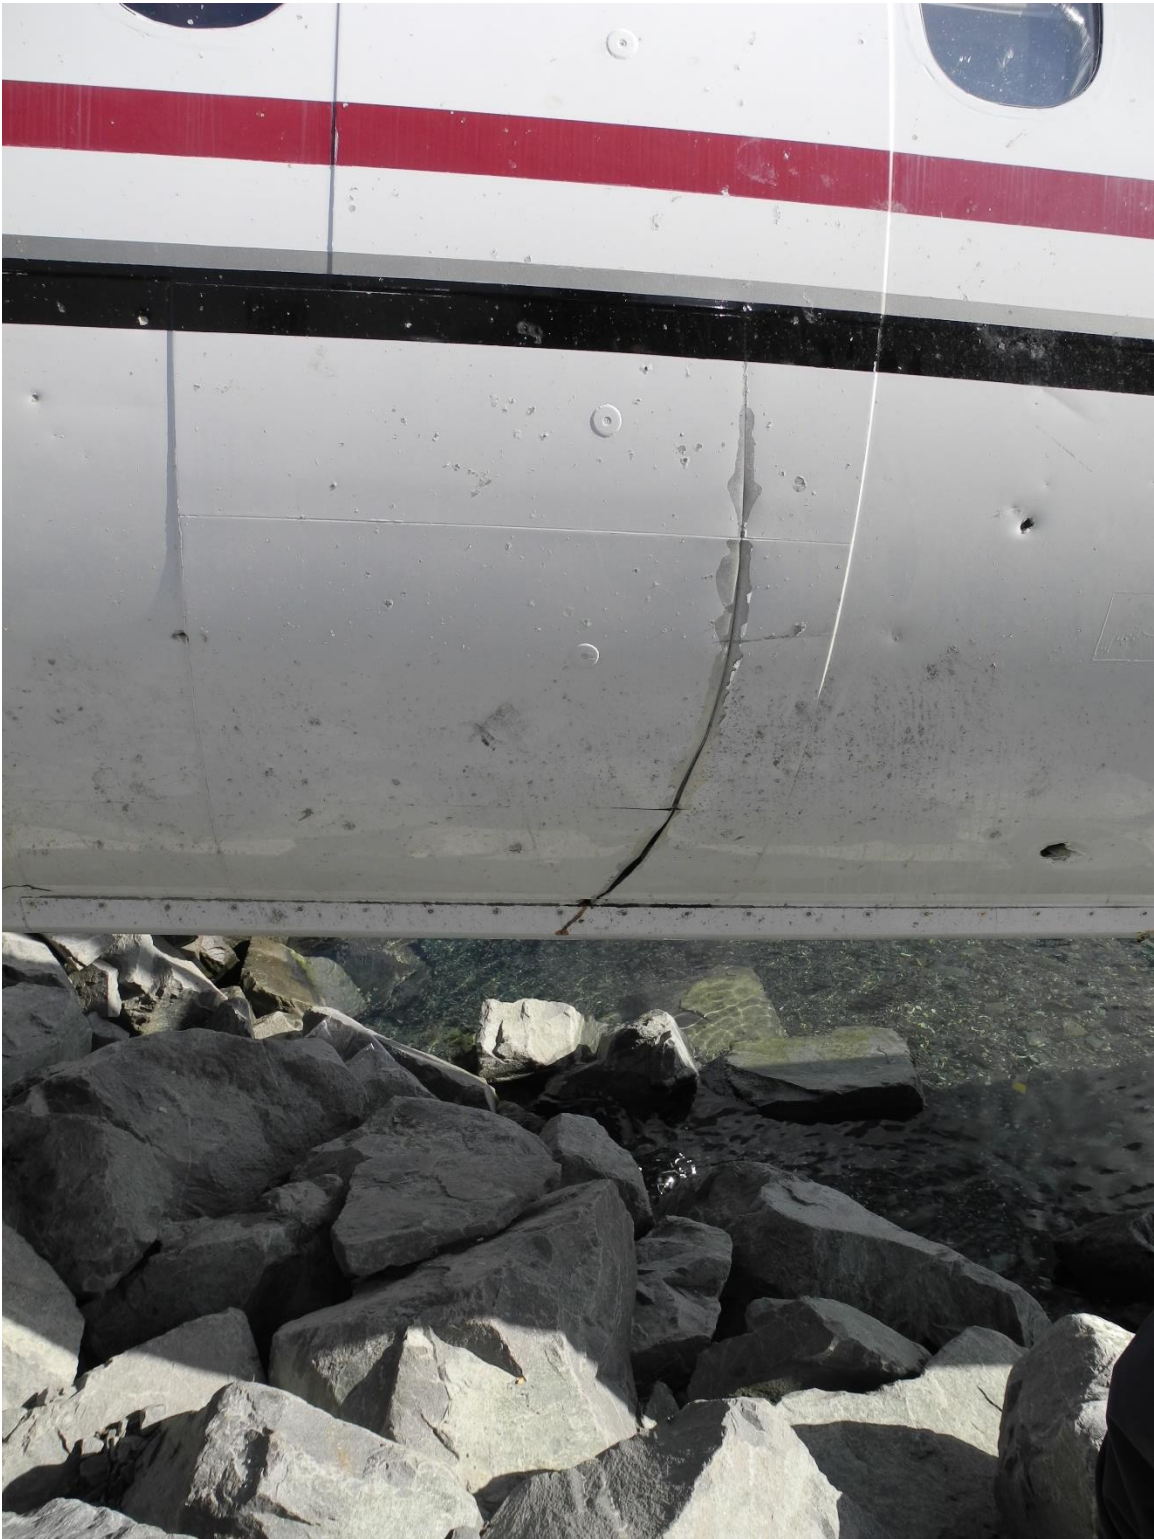
On the right side forward of the wing there was an impact mark which started shallow on the top and got deeper toward the bottom on a trajectory in line with the propeller blades, Figure 51. There were also three punctures and numerous small dents in the skin in this area.

Figure 51 impact, punctures and dents, right side forward of wing.

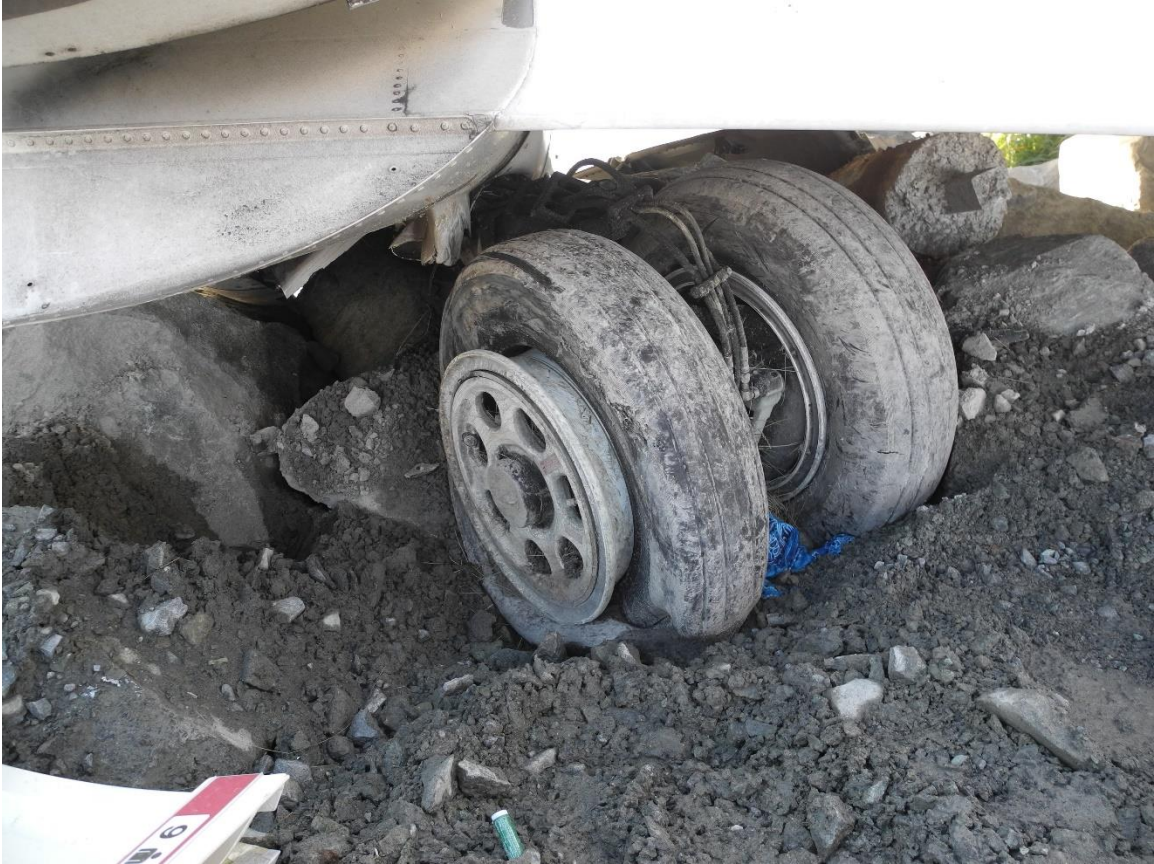
The left main was collapsed and pushed aft and inboard, Figure 53. The gear doors were damaged, and the left could not be opened. There were broken and bent linkages, Figures 54-57.

Figure 53 Left main gear

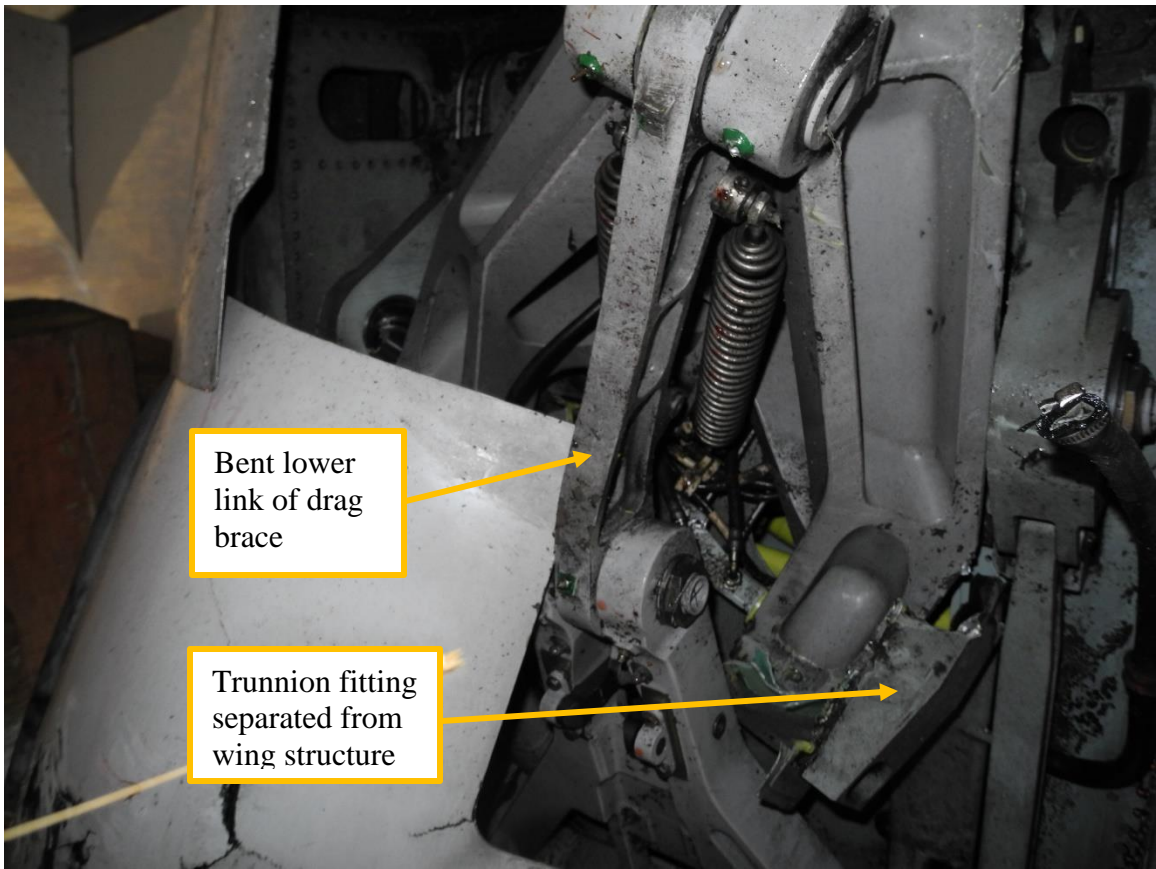
Bent lower
link of drag
brace

Figure 55 Left main gear bent and broken linkage

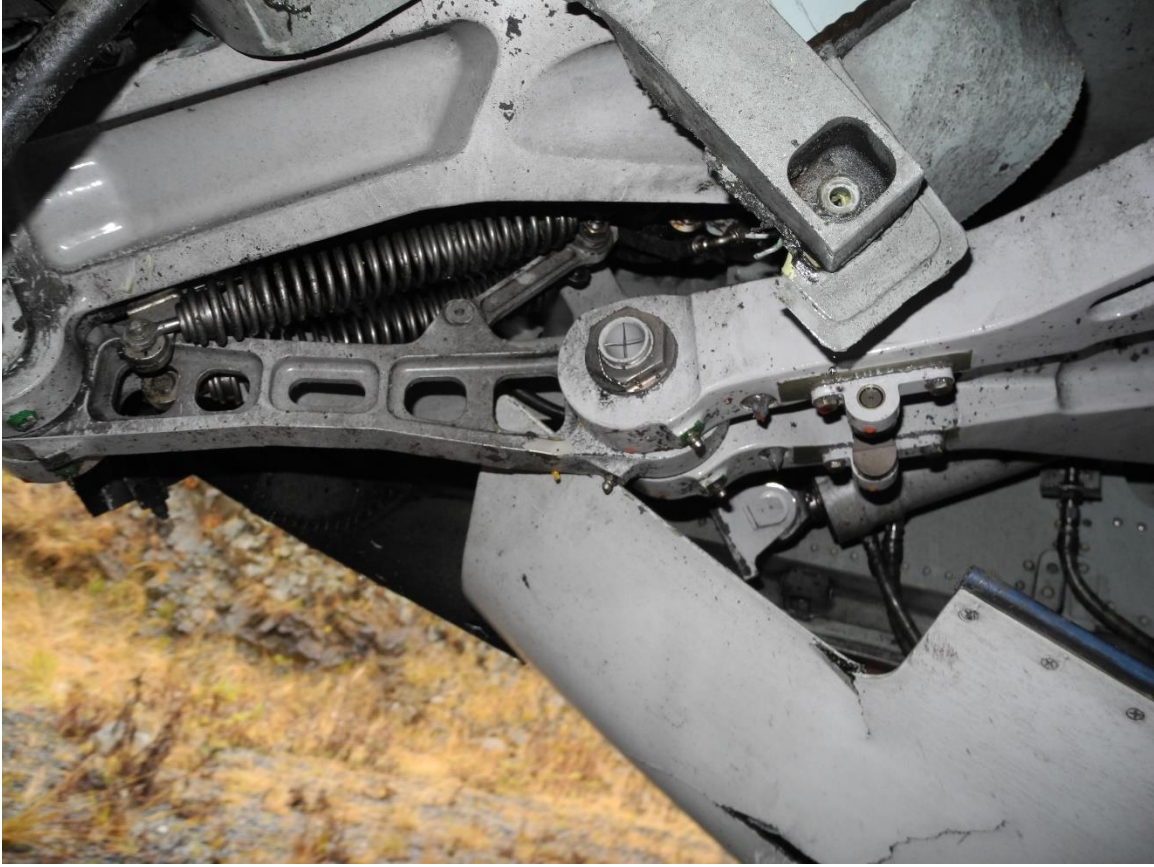
Figure 56 Left main gear drag brace

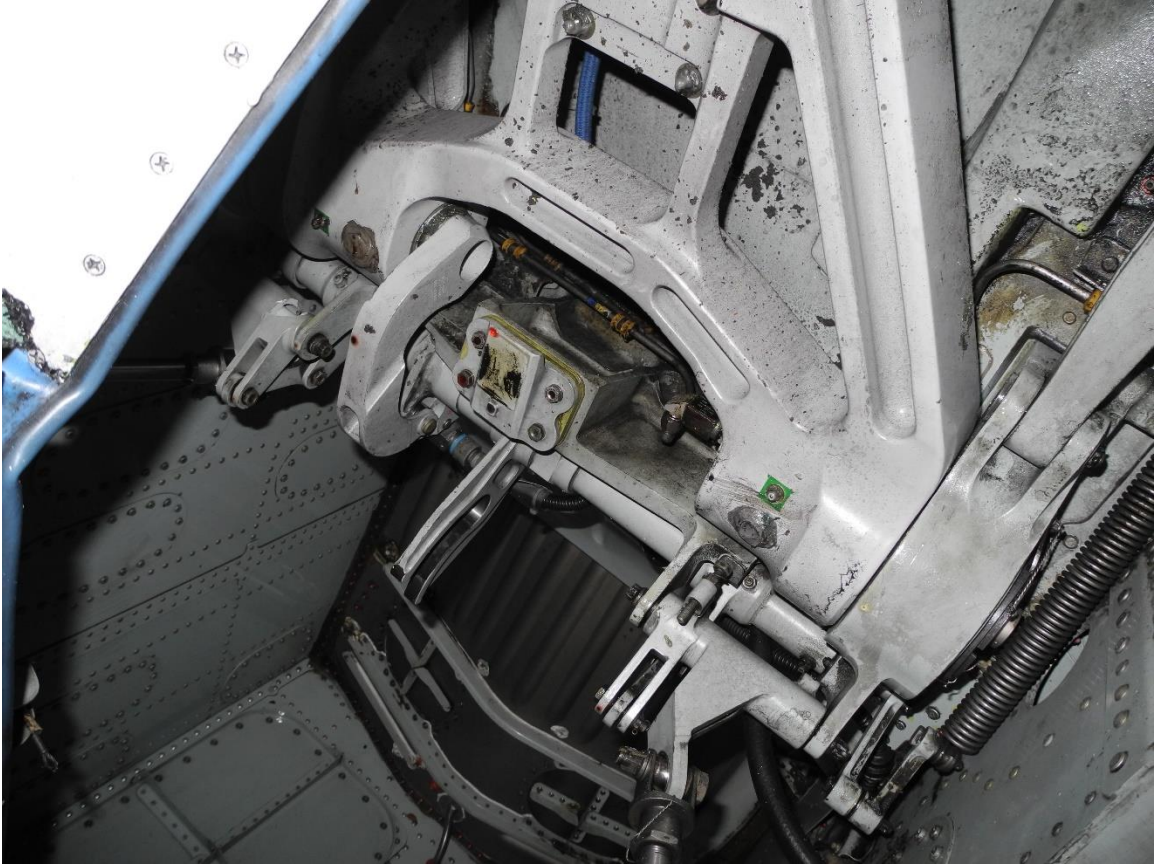
Figure 57 Left main gear upper drag brace

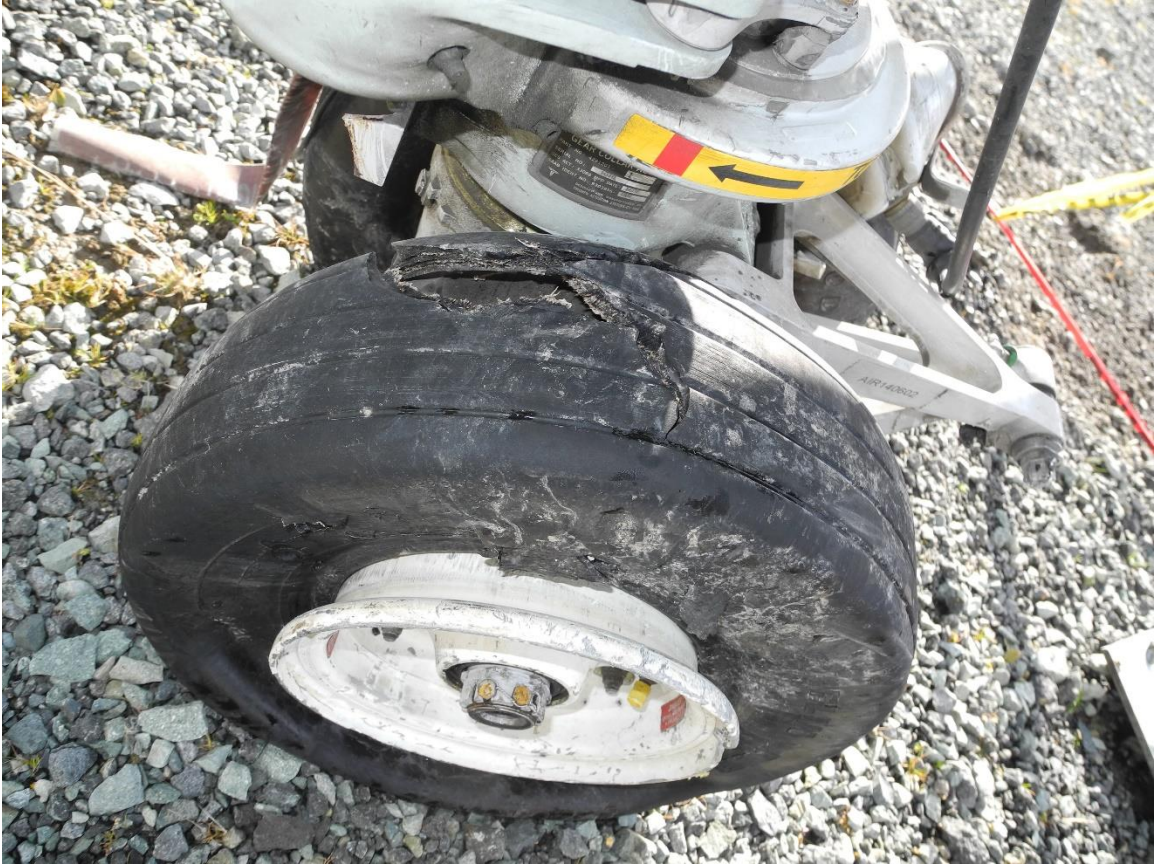
Figure 61 Punctured left tire

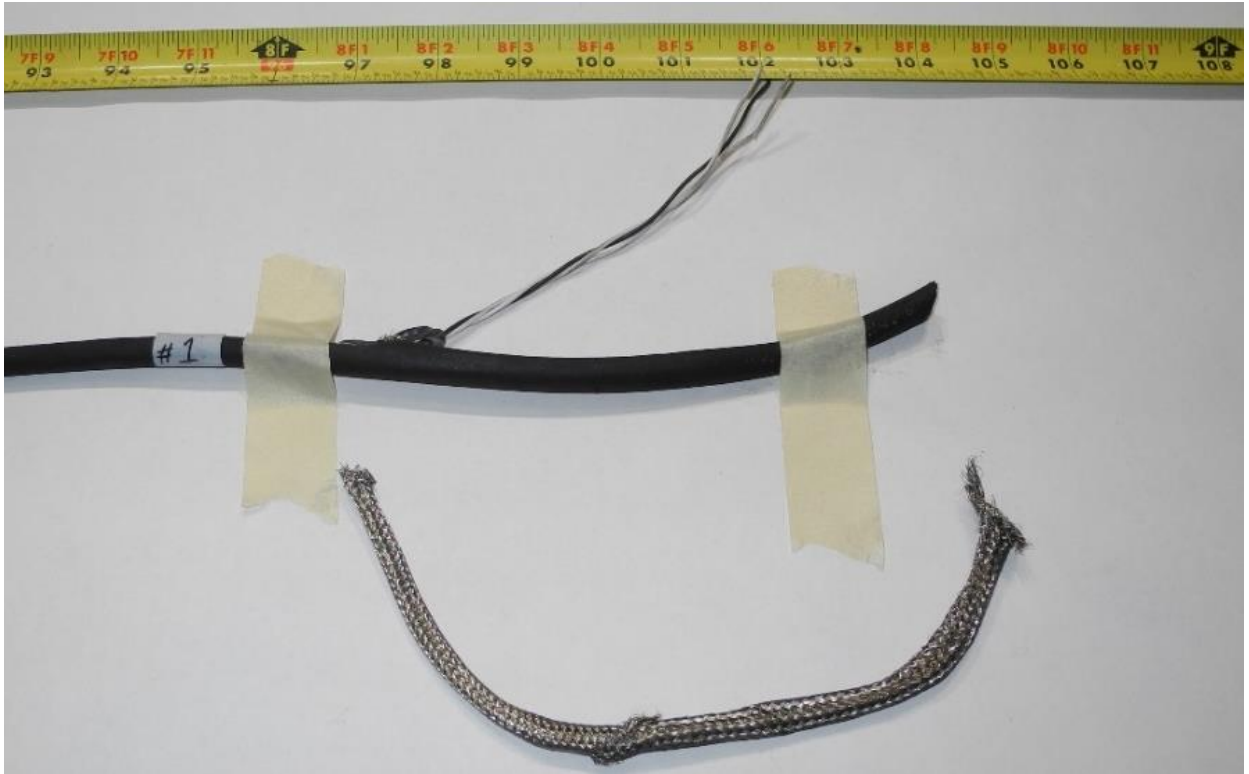
Figure A3 #1 wire harness fractured end showing 3 total wires
