**NATIONAL TRANSPORTATION SAFETY BOARD
OFFICE OF AVIATION SAFETY
WASHINGTON, D.C. 20594**

Systems and Structures Group Chairman's Factual Report

DCA20MA002

Operator: PenAir
Aircraft: Saab 2000
Location: Dutch Harbor, AK
Date: October 17, 2019
Time: 1740 ADT

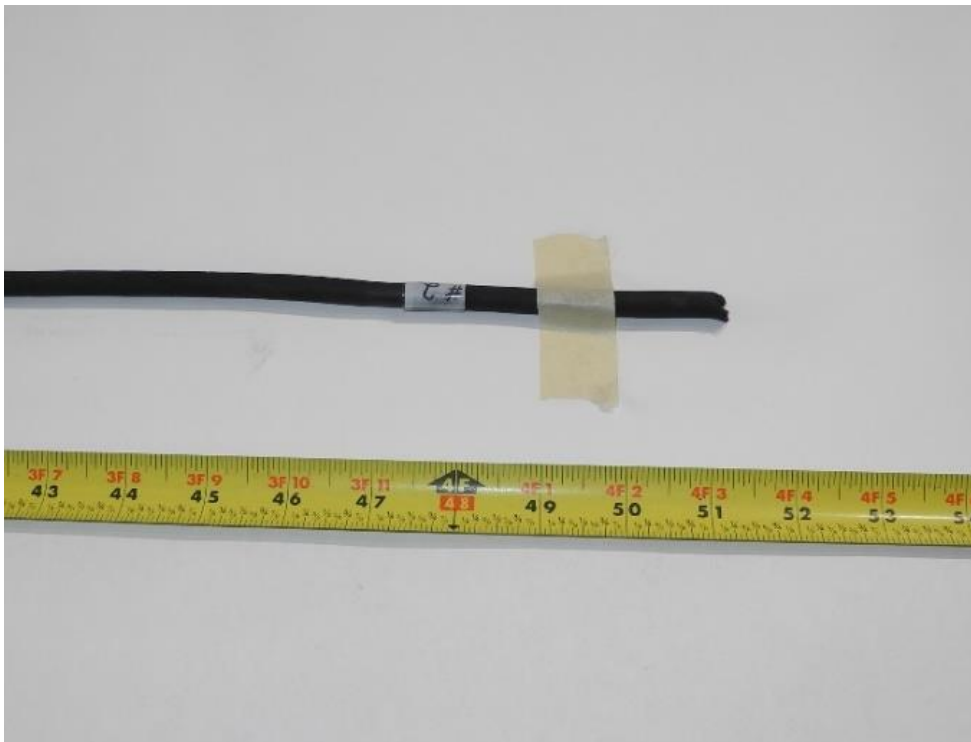
Figure A4 #2 wire harness fractured end

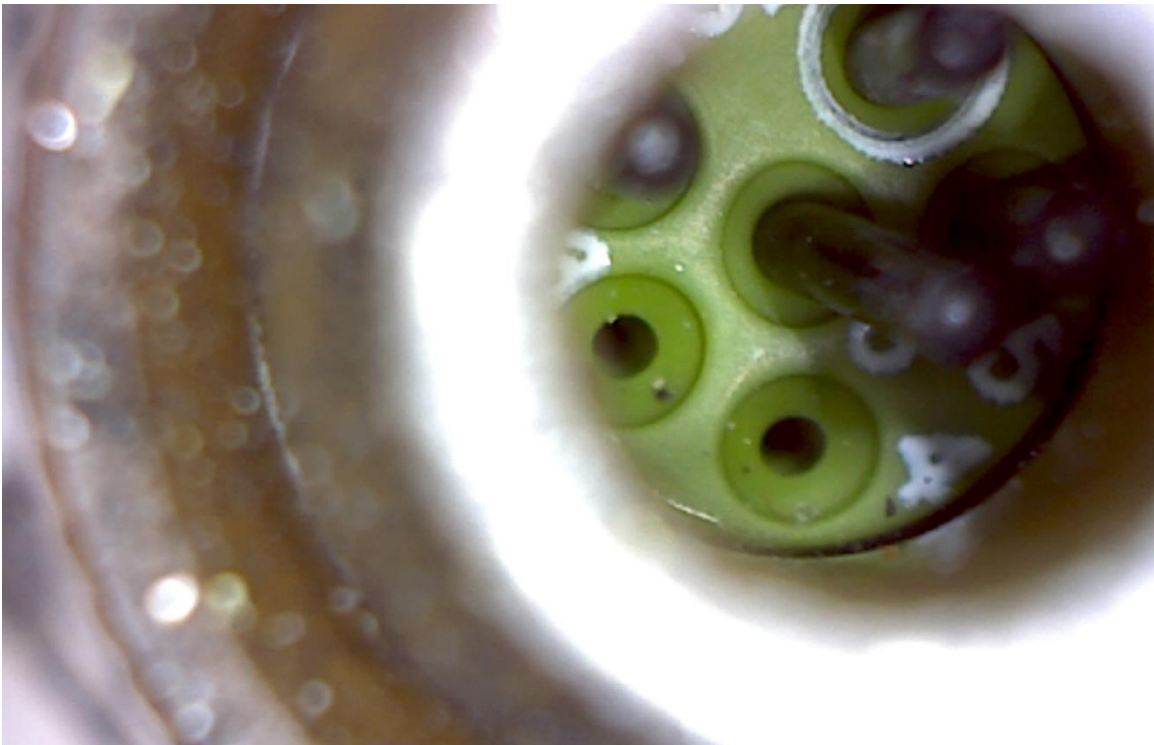
The connector labelled “#1 left upper position” was removed, Figures A15-A17. This was the connector attached to the upper bulkhead fitting in the wheel well. The connector number was MS27467T9B35P. The connector was missing pins 3 and 4.

Figure A17 Upper connector pins missing

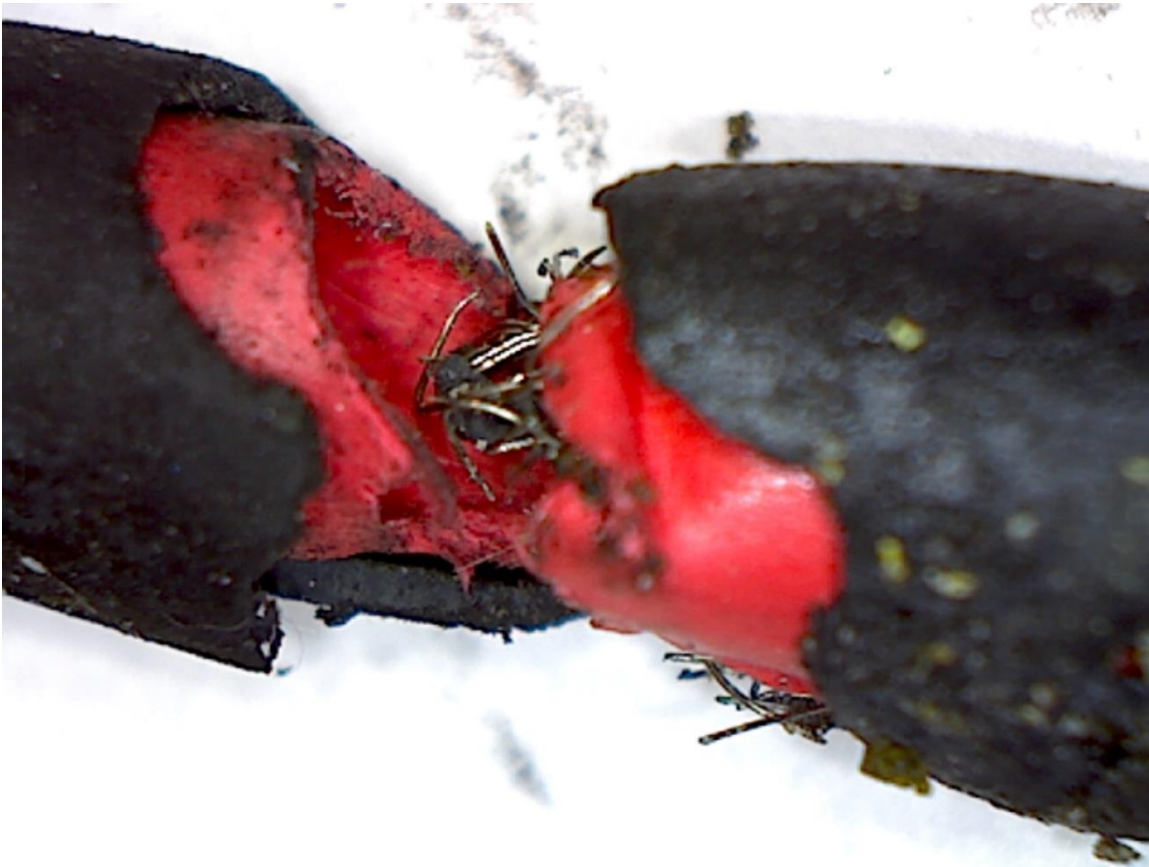
The short segment was placed adjacent to the #1 wire harness segment fractured end, Figure A21. The two appear to have similar contours.

Figure A21 #1 wire harness fracture end (left) and short segment fracture end (right)

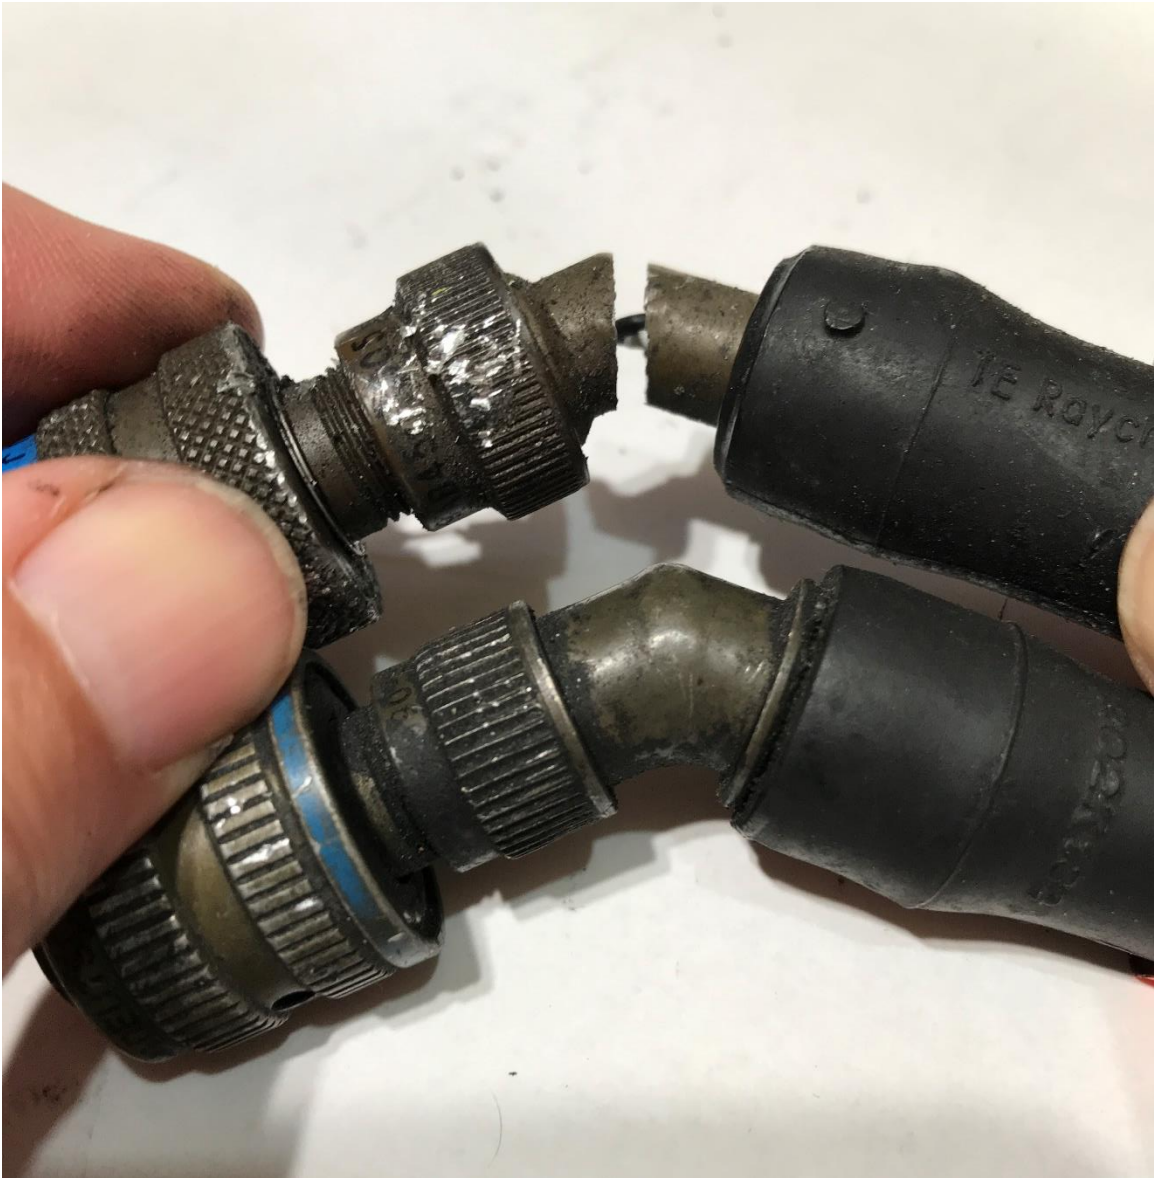
The upper connector portion was placed adjacent to the short segment connector end, along with the #4 harness end, Figure A22. The short segment had the two wires which this connector was missing. The two together form a 45-degree elbow like the elbows on the #3 and #4 wire harnesses. It appeared this elbow fractured along the brazed joint of the elbow.

Figure A22 Fracture surfaces of connectors formed 45 degree elbow

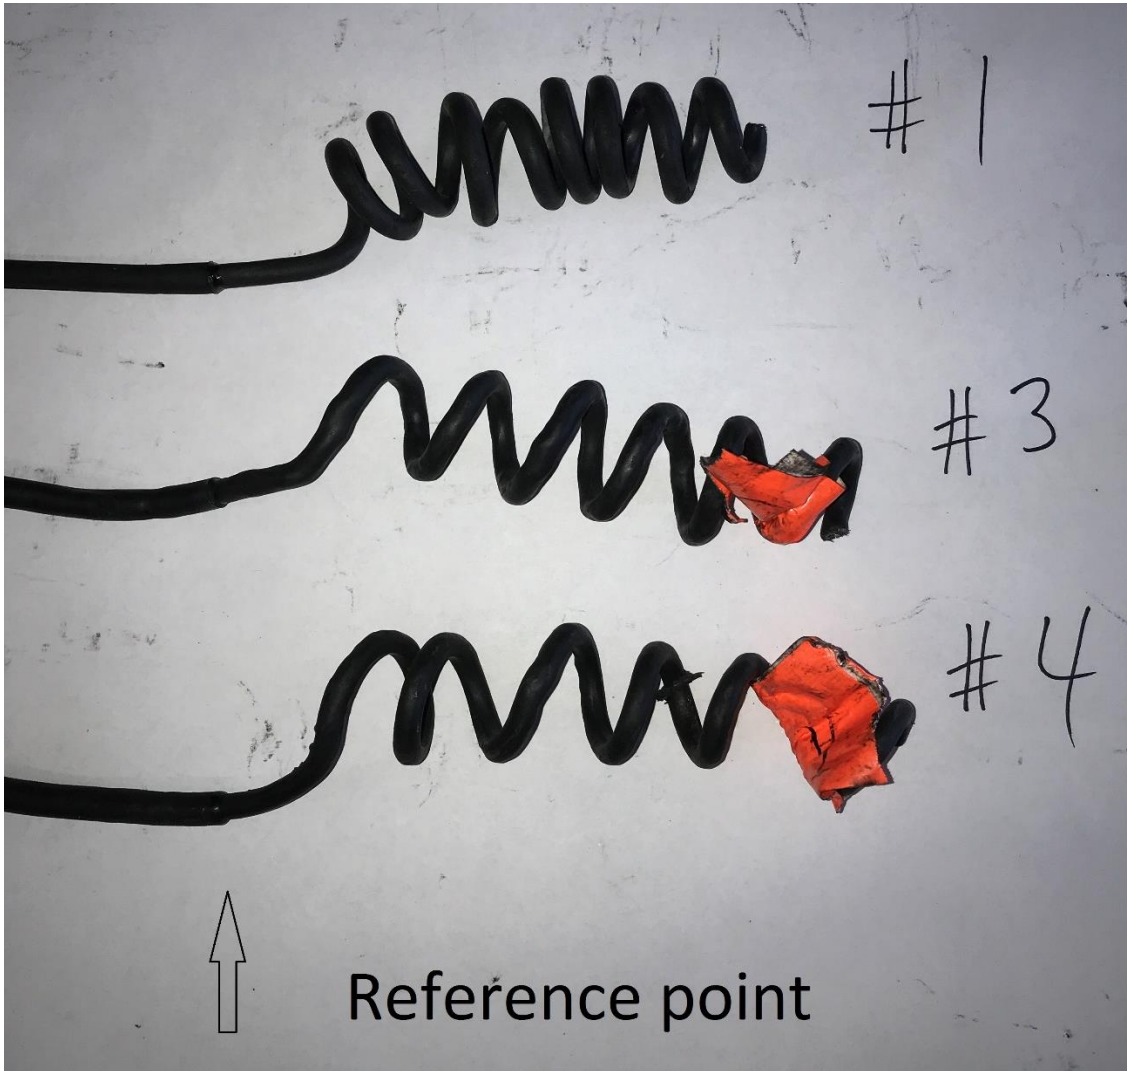
Figure A23 Elongated coils and reference measurement point
