Runway Overrun During Landing PenAir Flight 3296 Saab 2000, N686PA

Unalaska, Alaska
October 17, 2019

Accident Overview

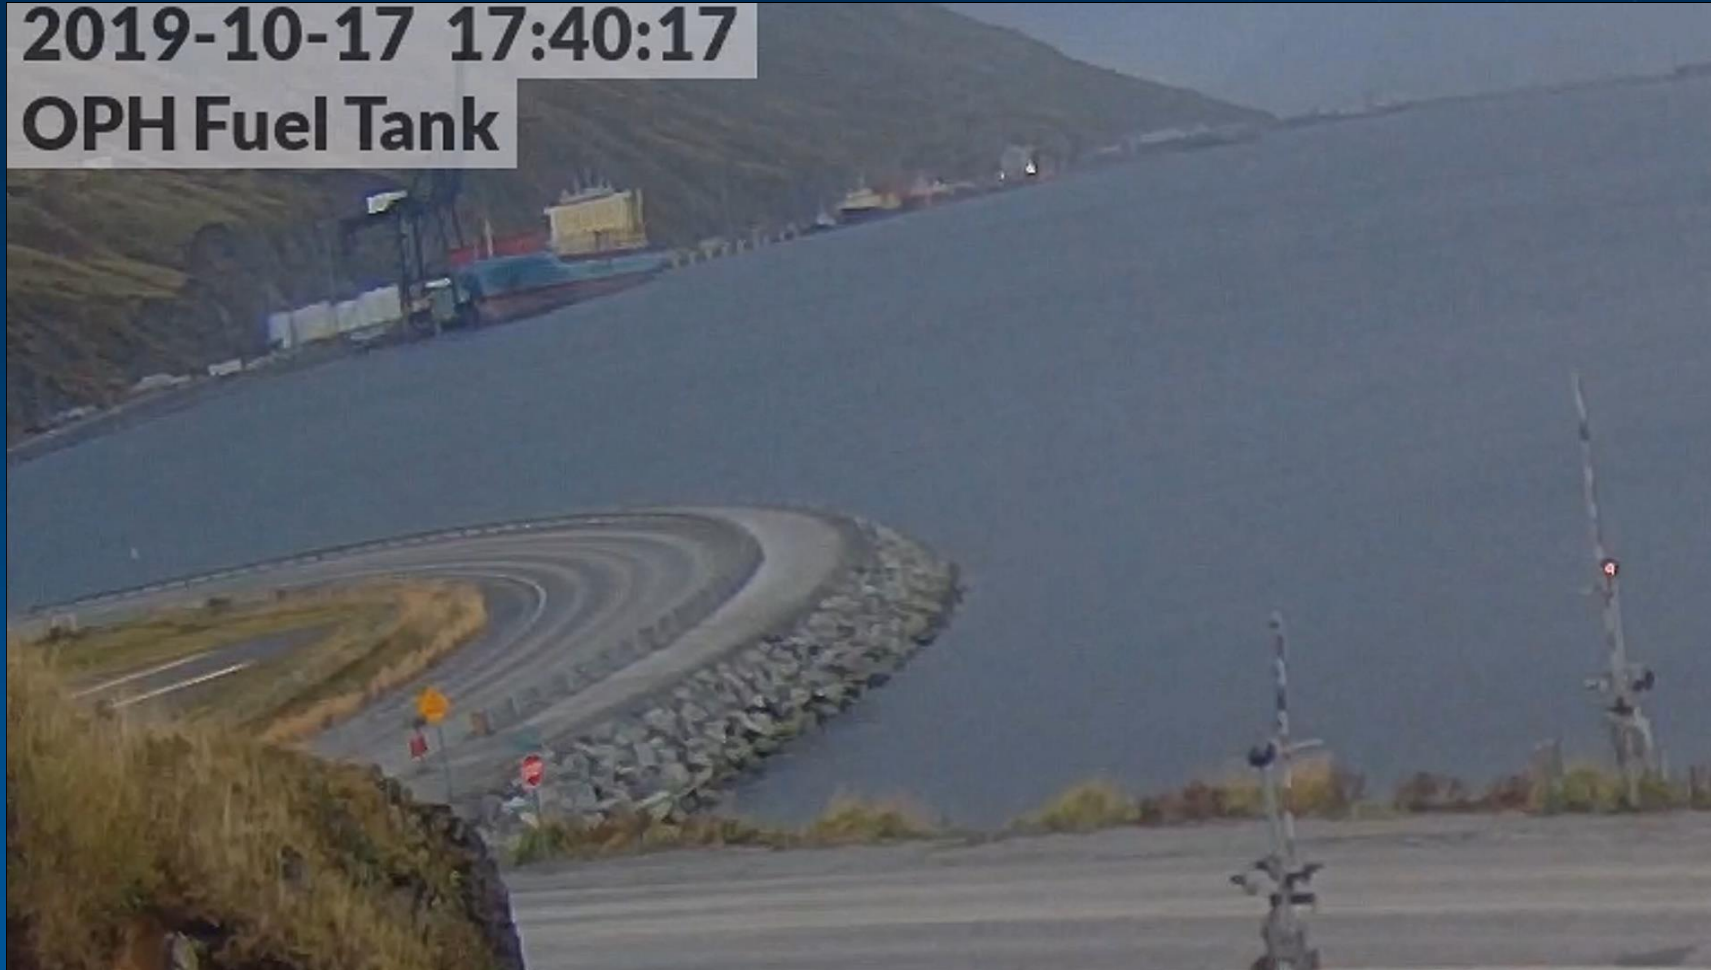
Security Camera Video

2019-10-17 17:40:17

OPH Fuel Tank

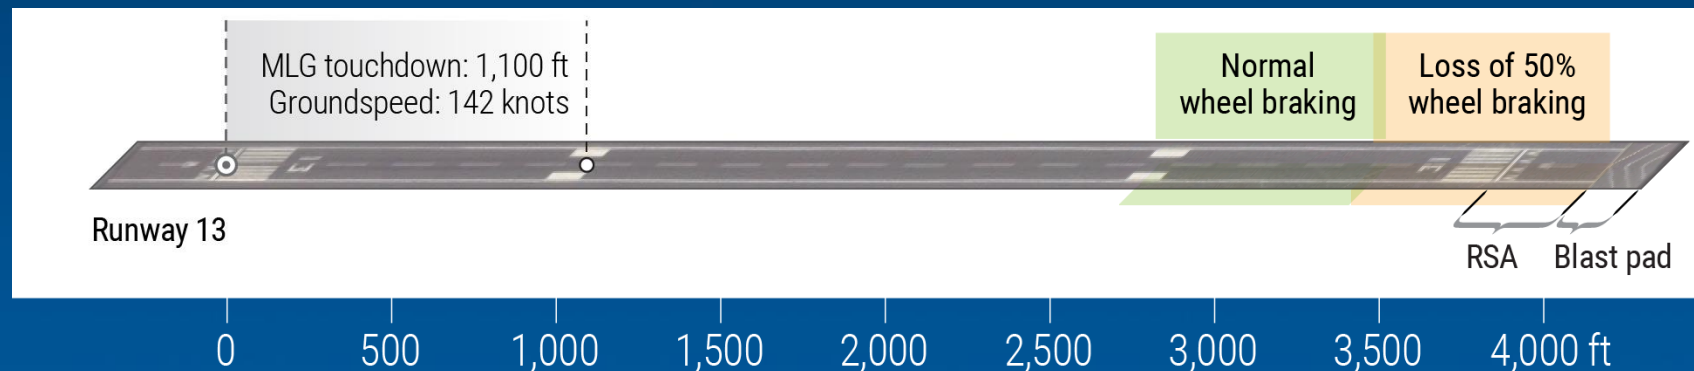
Aircraft Performance Study

- Determined 15-knot tailwind existed at touchdown
- Calculations indicated airplane should have safely stopped with
 - Flaps: 20° or 35°
 - Wheel braking: Normal or up to 50% loss
- Deceleration during accident rollout worse than expected; skid marks and tire burst evidence indicated wheel brake system anomaly

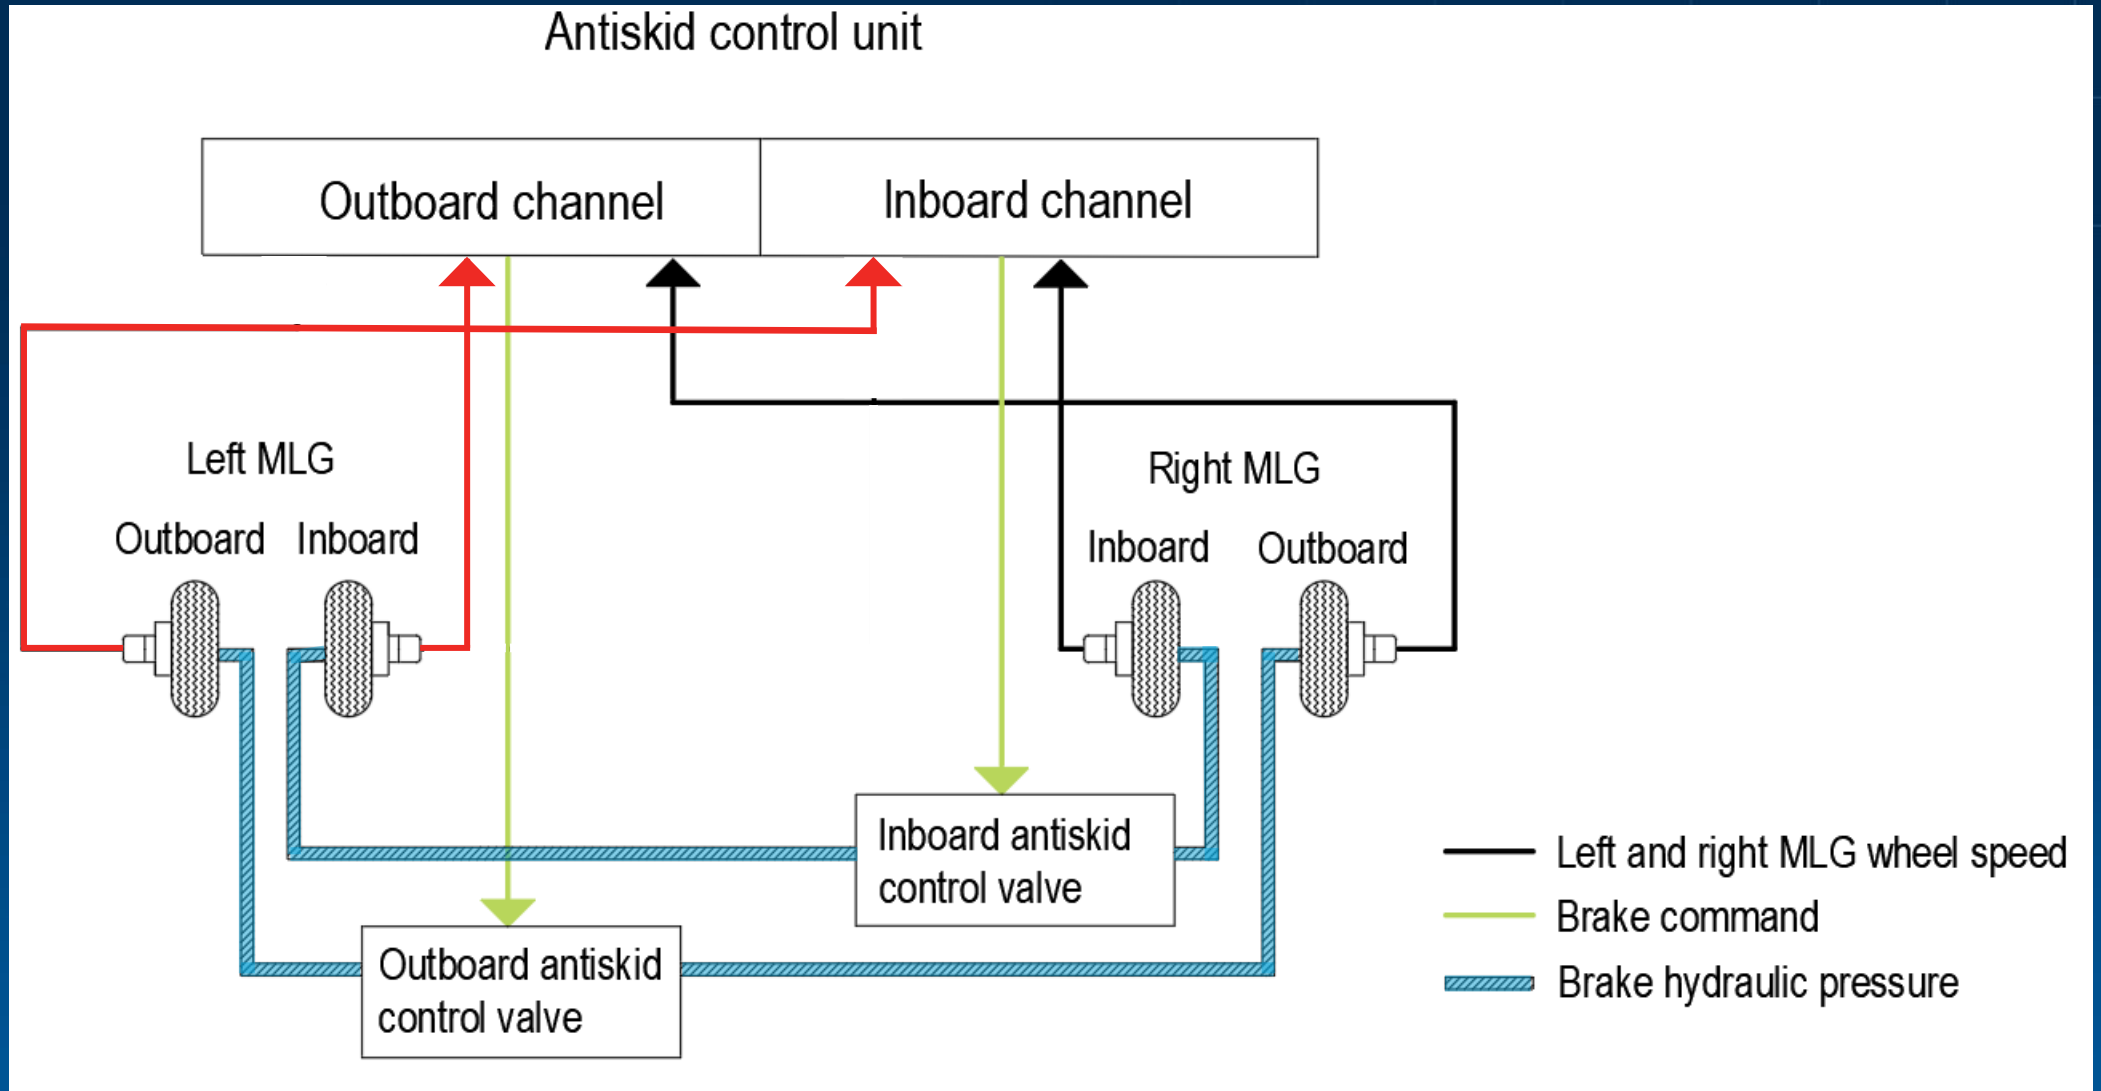
Accident Airplane Cross-Wiring Condition

Incorrectly routed wire harnesses on left MLG significantly affected braking performance during skid

- Left outboard tire skid not relieved, so tire burst
- Left and right inboard tire pair commanded to near-zero brake pressure
- Result was loss of braking capability on three of four wheels after tire burst

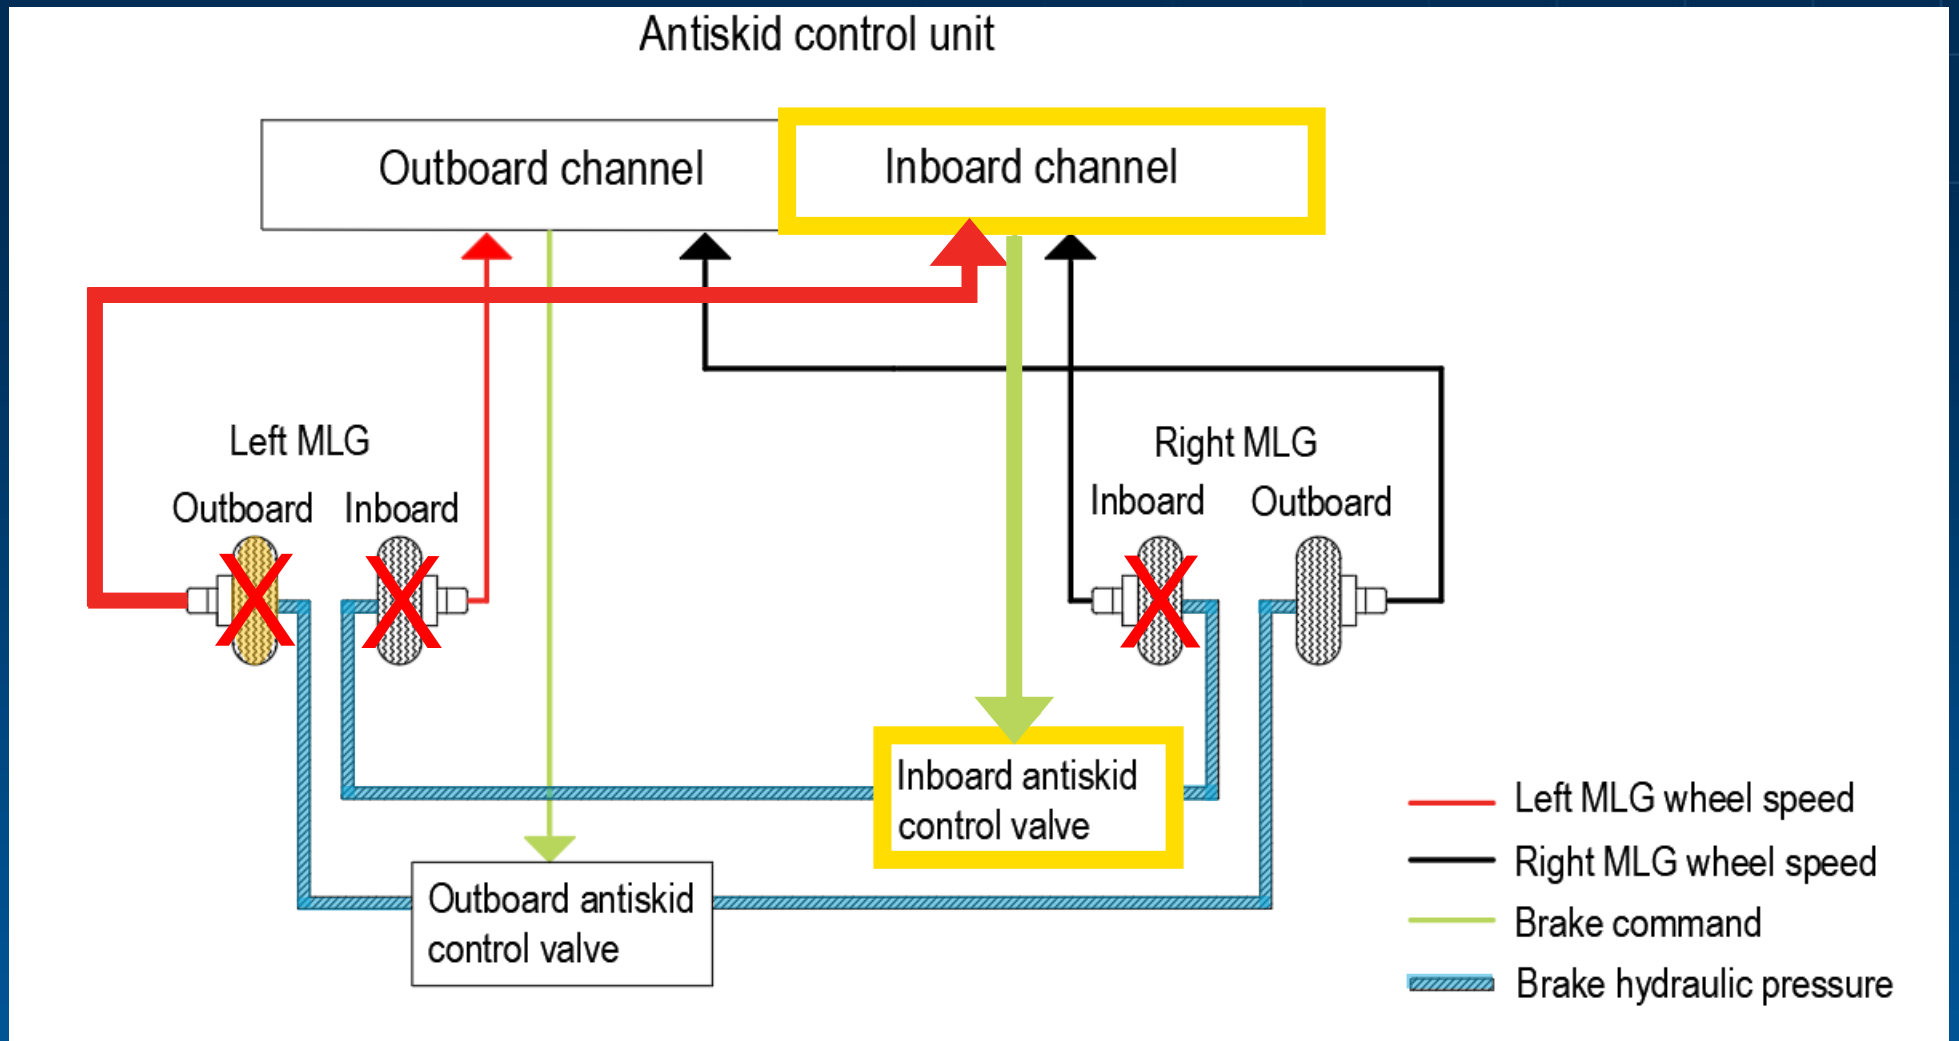
Accident Airplane Cross-Wiring Condition

Inboard channel senses low wheel speed

Commands antiskid control valve to reduce brake hydraulic pressure to inboard wheels

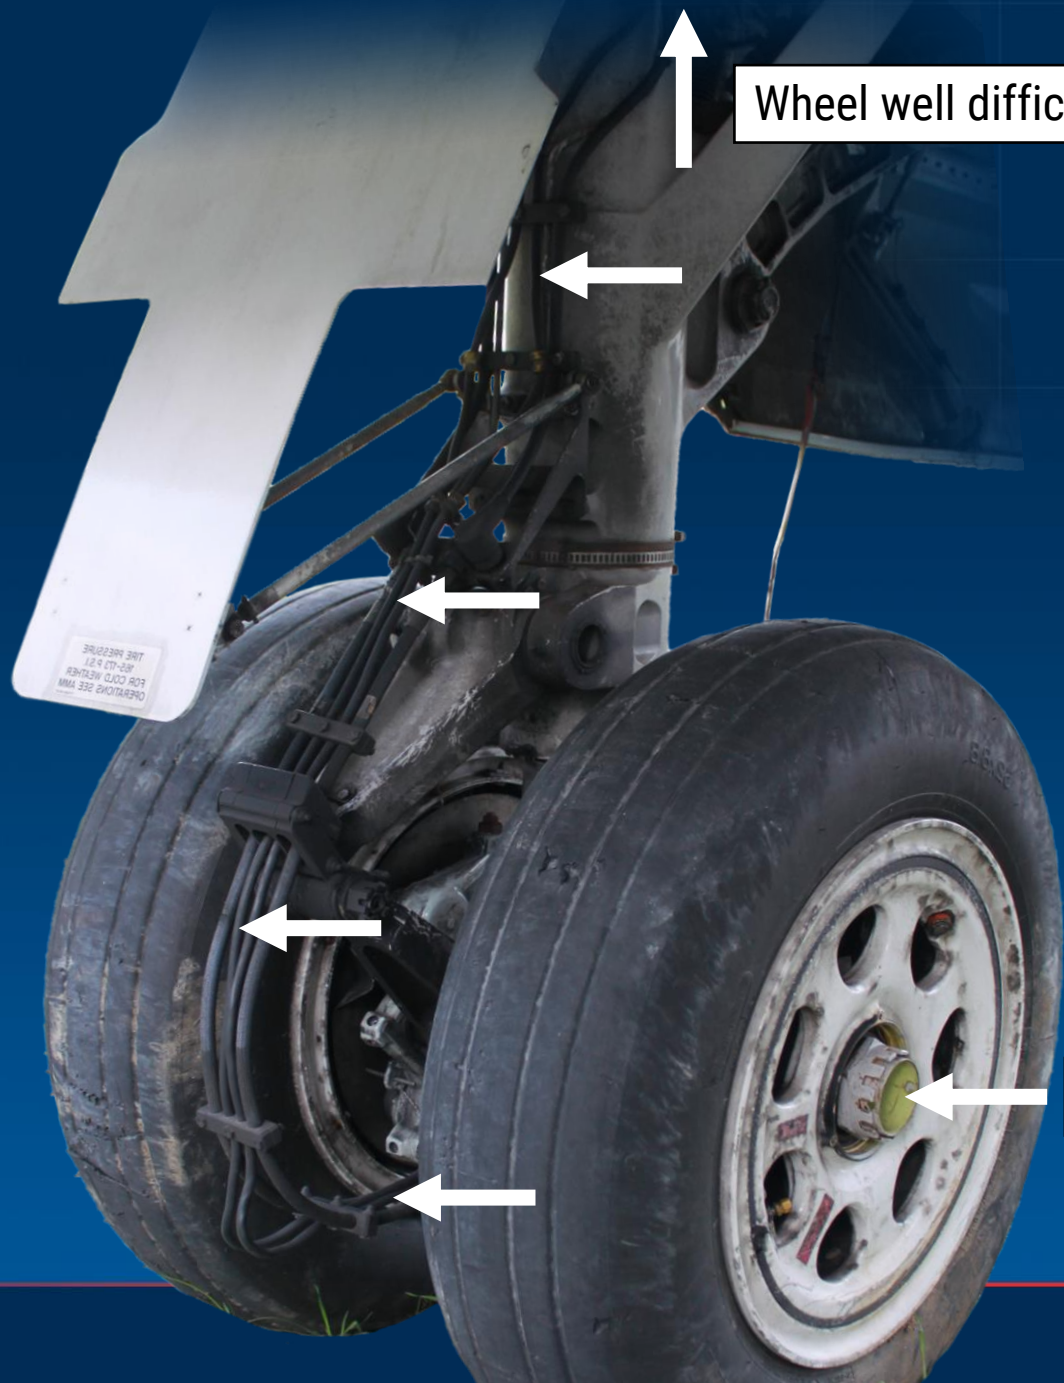
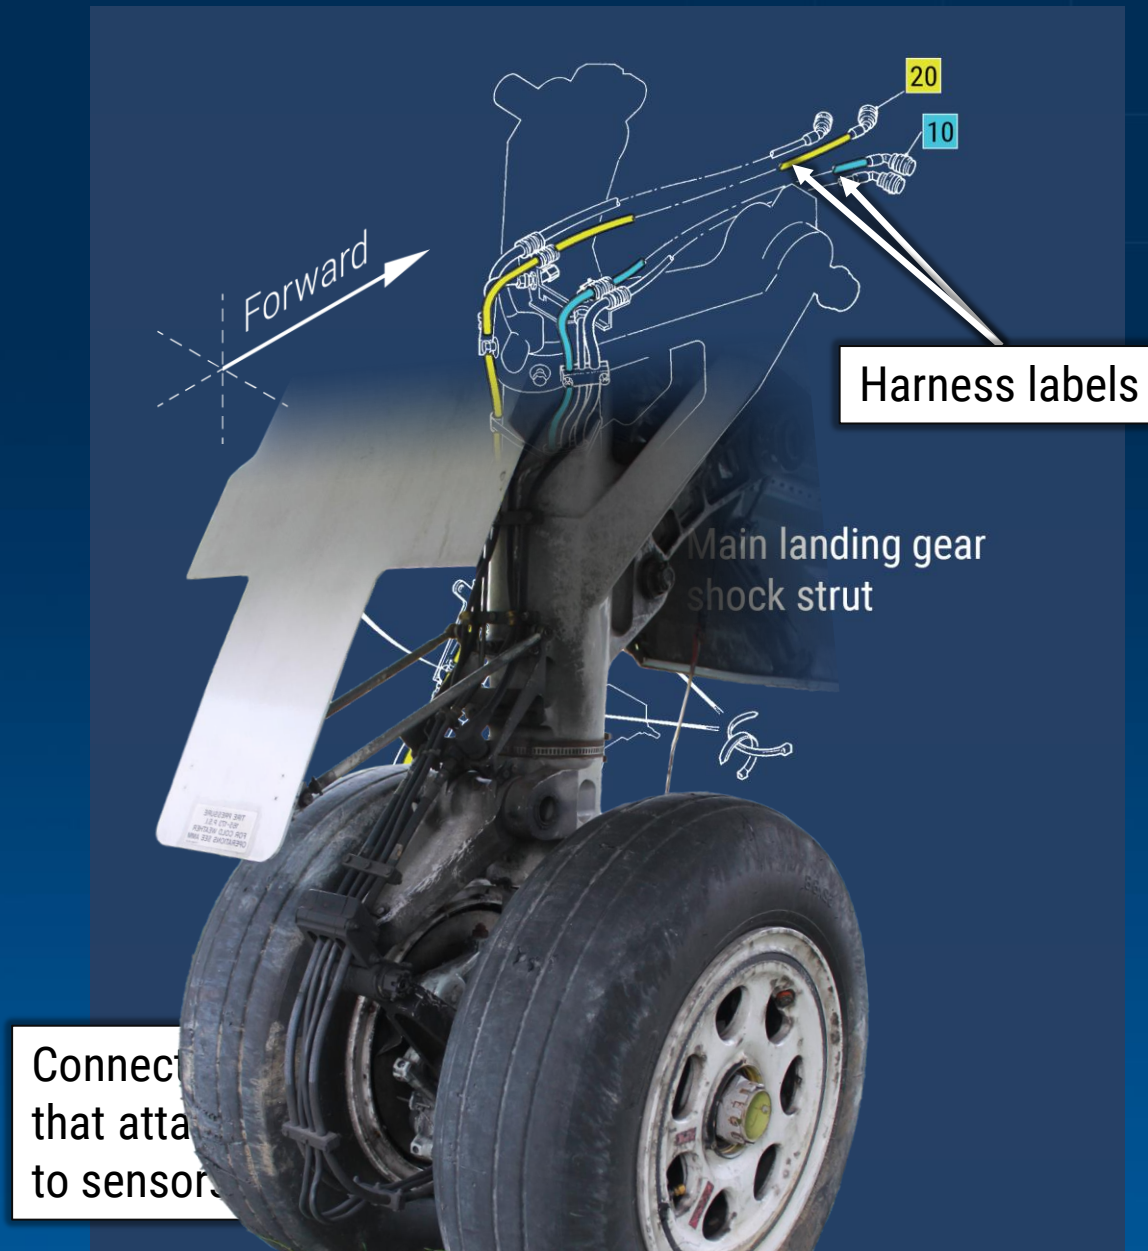
Wheel well difficult to access

Sensor connects here

- Inadequate labeling and difficult access could still lead to incorrect harness routing
- If incorrect routing occurs, no troubleshooting procedure to resolve fault message recorded by antiskid system
- What we propose: **One recommendation to Saab**

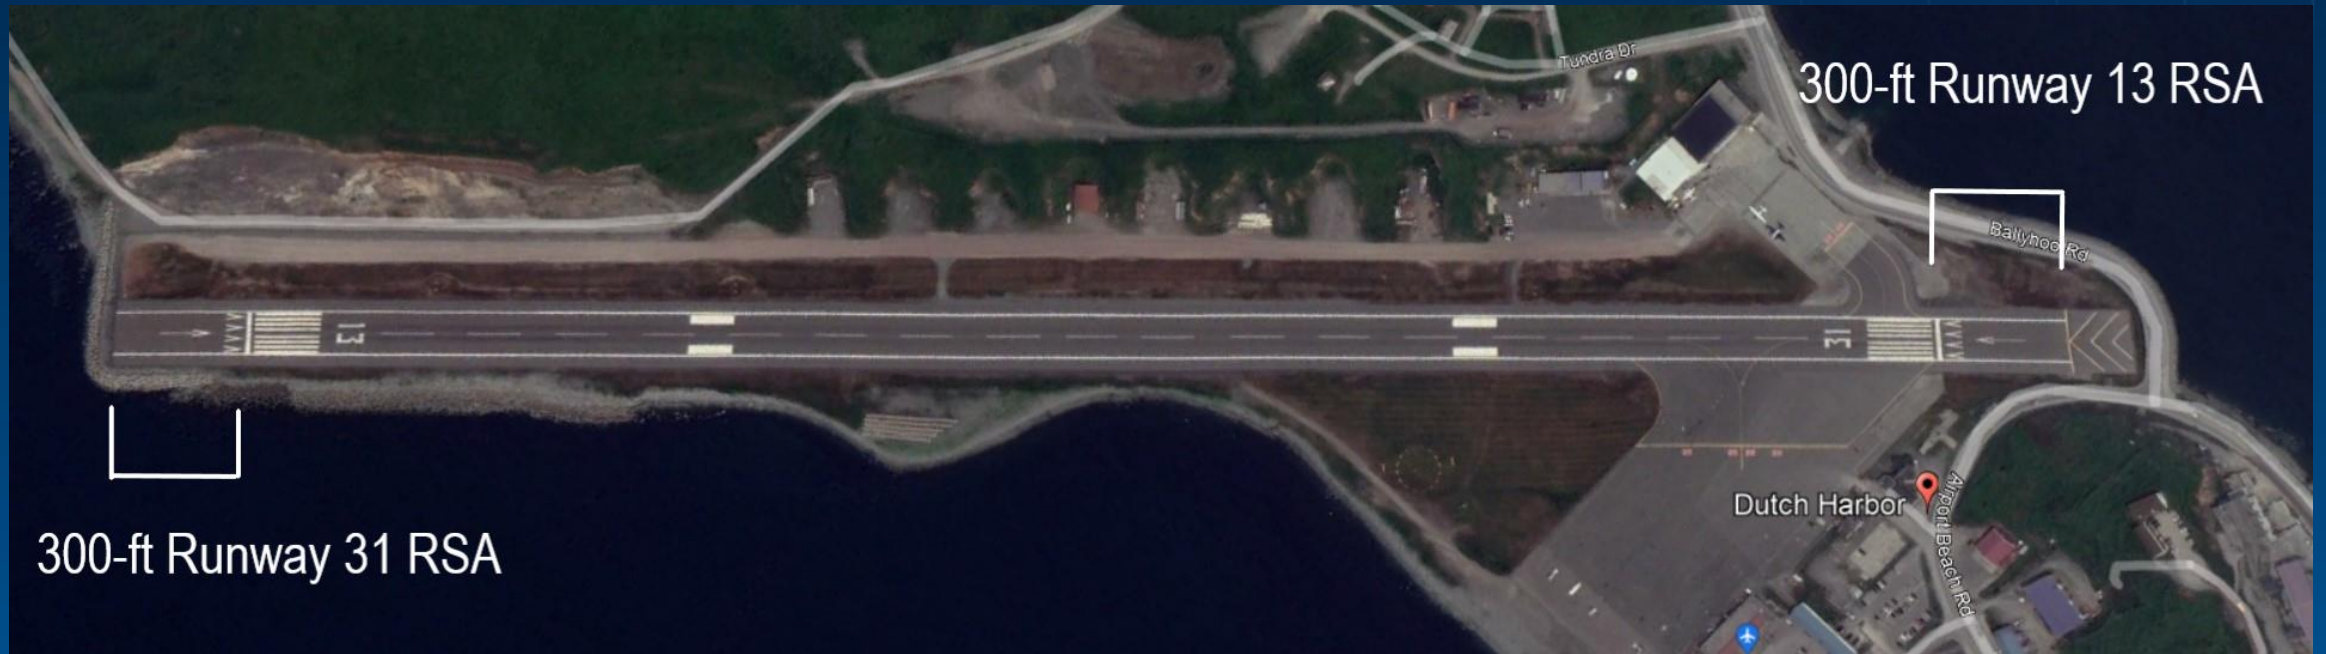
Runway Safety Areas at DUT

- RSA length at DUT did not match 1,000-ft length specified for Saab 2000
- Reduced safety margin in case of overrun
- No evidence that PenAir or FAA was aware of this inconsistency
- Accident airplane would have stopped within RSA appropriate for Saab 2000

- No guidance exist for FAA oversight personnel to consider RSA when approving airplanes to operate at airports
- What we propose: **One recommendation to FAA**
