NATIONAL TRANSPORTATION SAFETY BOARD

Group Chairman's Factual Report

AIRWORTHINESS

DCA20MA059

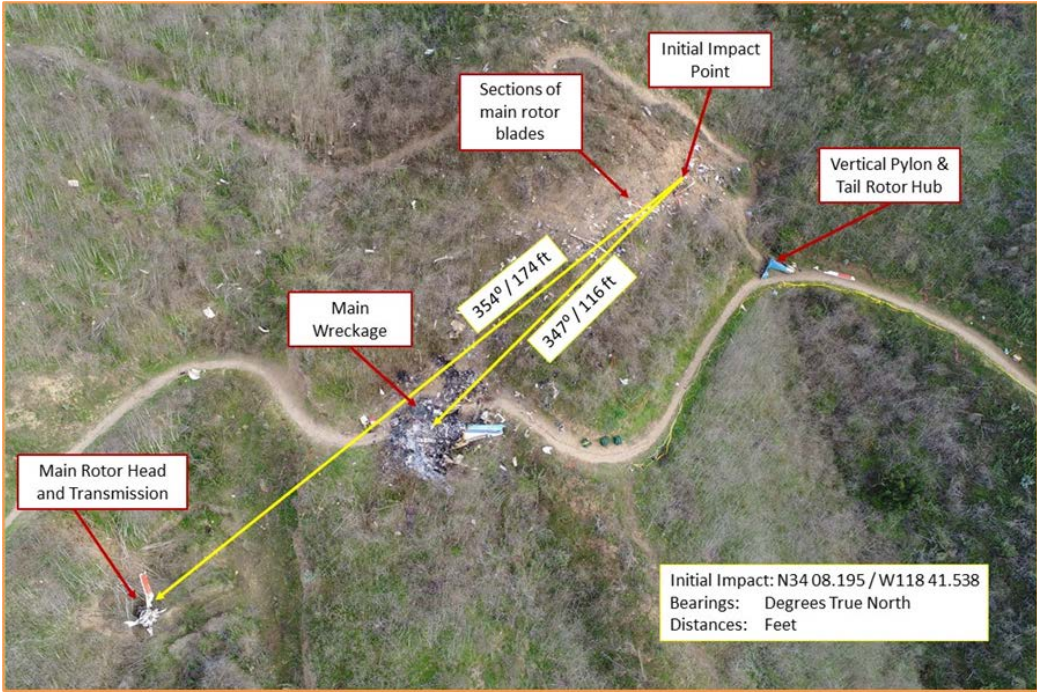
Figure 3 - Wreckage diagram. Overall view of initial impact area and wreckage path with select measurements and significant items.

The initial point of impact was on a 36-degree sloped terrain and consisted of highly fragmented cabin and cockpit debris. The vertical pylon and horizontal stabilizer were located about 40 feet below (downhill) from the impact crater. The impact crater measured 24 feet long, 15 feet wide, and about 2 feet in depth. A witness mark consistent with the length and width of a rotor blade was positioned perpendicular to the direction of the debris line and directly above the impact crater. The witness mark contained fragments of rotor blade skin and honeycomb blade core. One piece of 2-inch diameter tree branch was cut cleanly in 3 locations (similar to saw cuts) at ground level about 30 feet behind the initial impact crater.

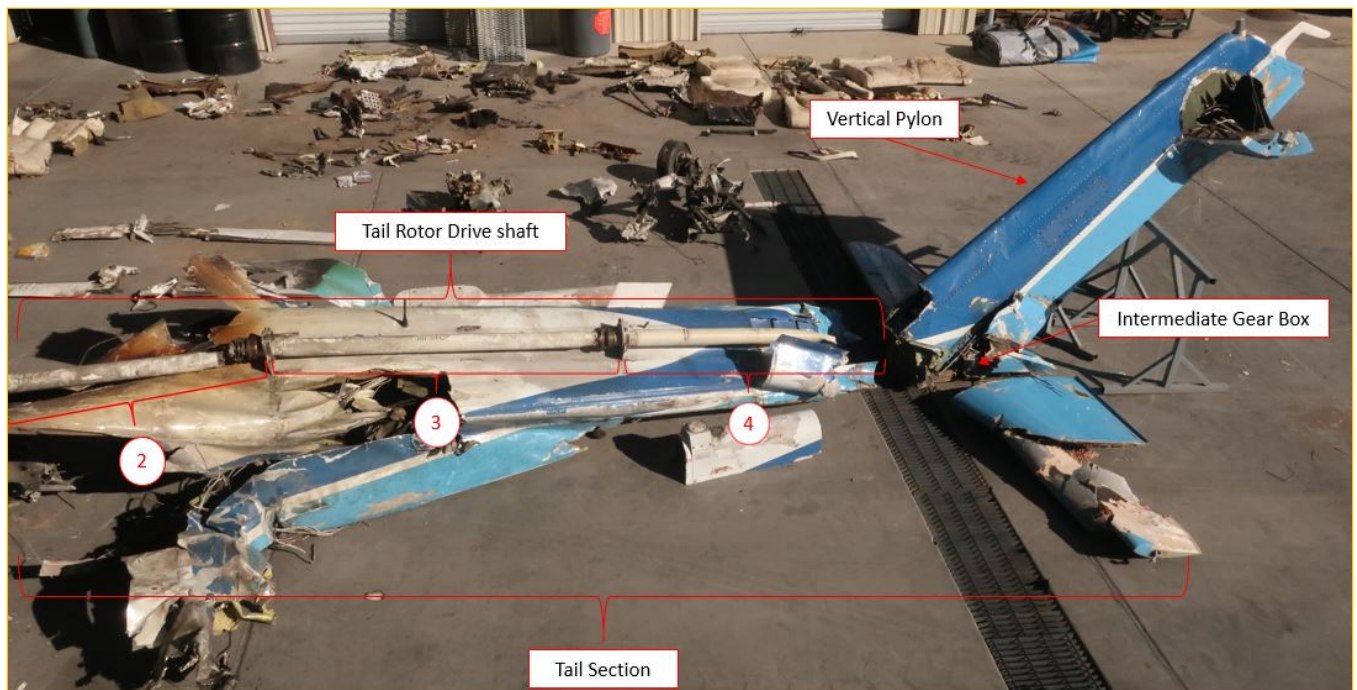
The right-side baggage door had separated from the fuselage at the hinges and the latch pin was extended. The two integrated fuel tanks were highly fragmented. Portions of the fuel lines and two fuel level probes were identified. There was no evidence of fire in this section of the airframe. The tail was crushed/collapsed along the longitudinal axis. The tail had separated from the cabin at the cabin-tail transition as a result of the post-crash fire. Both left and right main landing gear as well as the nose gear had separated from the airframe.

Photo 1- Tail Section with tail rotor drive shaft segments annotated.

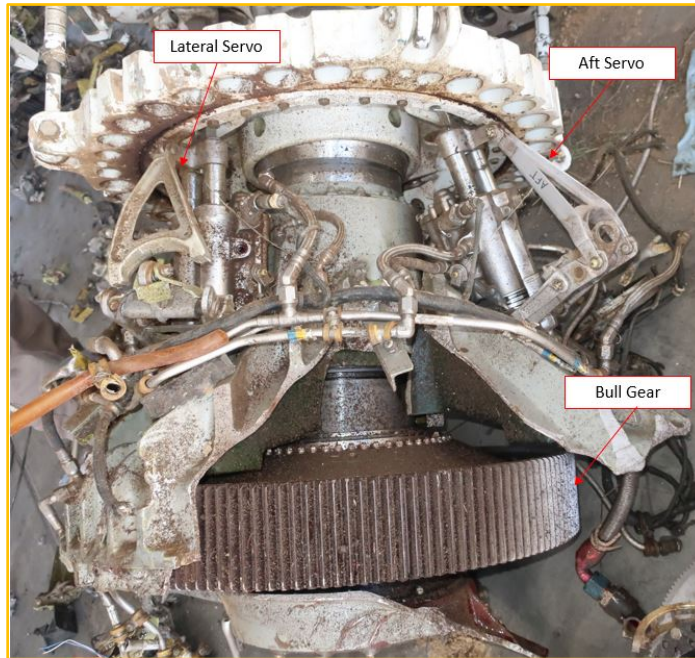
Photo 2 - Main Gear Box

The main gear box (MGB) had been liberated from its airframe mounts. Half the magnesium transmission case had fractured leaving large gaps in the case and revealed the bull gear. The chip detector located on the lower half of the case was missing along with major portions of the lower case. The left spiral bevel gear and spur pinion assembly had separated from the transmission. The right spiral

bevel gear and spur pinion assembly was not recovered. Both engine power input shafts and the two hydraulic pumps were present. The tail rotor drive gear with attached rotor brake disk and drive shaft segment was also present. Examination of the rotor brake disk and calipers showed no evidence of high temperature or overheating.

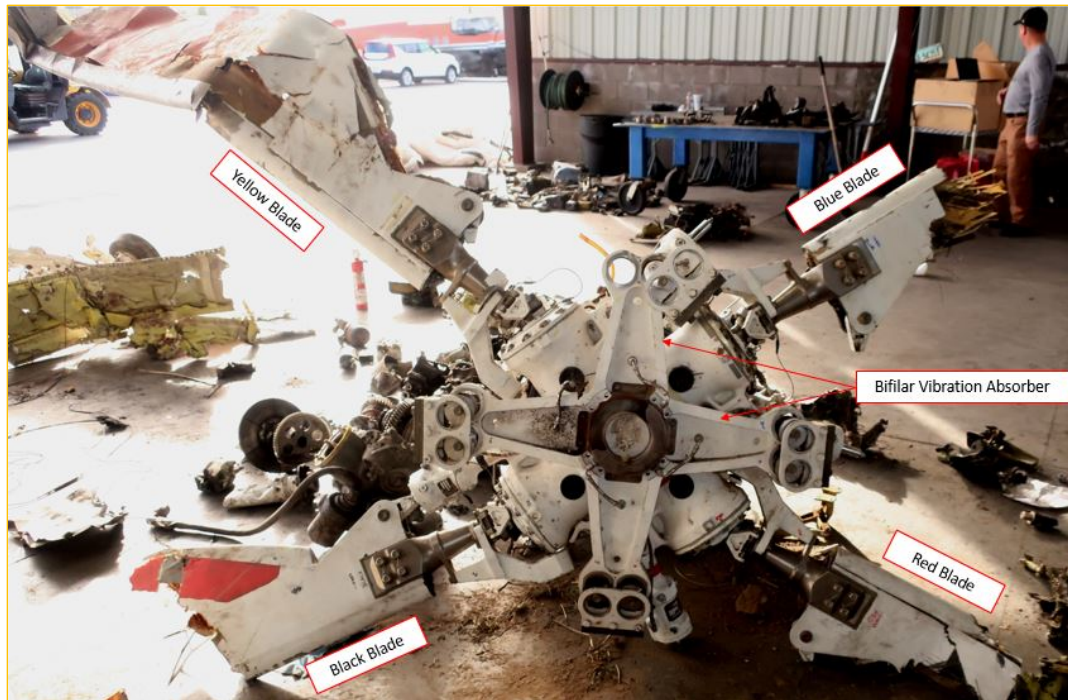
The rotor head remained attached to the main rotor shaft and main gear box. All 4 pitch control rods remained attached to the rotating swash plate and to all 4 blade pitch control horns. The Red, Blue, and Yellow blade dampers had fractured from the blade rod end in tension. The Black blade damper remained attached to the Black blade root. All 4 spindles remained attached to the rotor head. The Yellow blade had 86 inches of blade attached. The other three blades had approximately 18 inches of blade attached. The 3-per revolution bifilar vibration absorber remained attached to the top of the rotor head.

Photo 3-Rotor head with blade sections annotated.

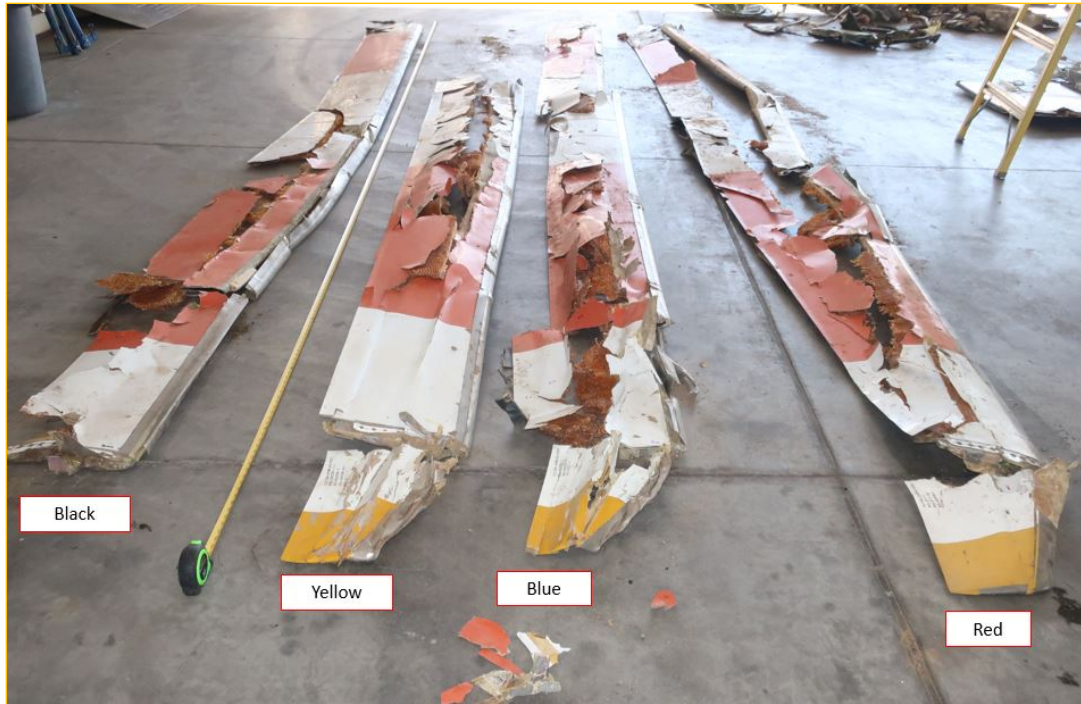
Photo 4-Main rotor blades.

Approximately 95% of the main rotor blades were recovered. All four blades exhibited similar damage consisting of mid span bending, pocket separation, pocket and tip cap compression, blade tip separation, and leading edge indentations & scuffing.

Red	SN: A086-01833
Blue	SN: A086-01831
Yellow	SN: A086-02625
Black	SN: A086-01834

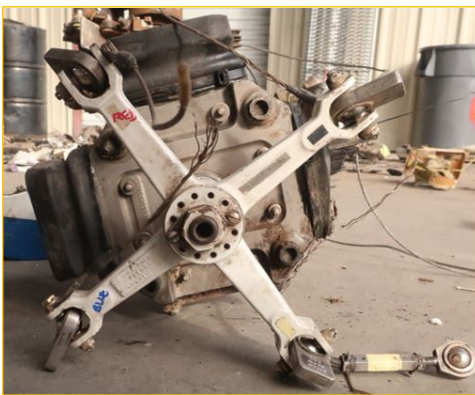
Photo 5-Tail rotor hub pitch beam.

Four segments of the tail rotor drive shaft remained attached to the tail. The intermediate gear box (IGB) remained in its installed location at the base of the vertical pylon. The IGB magnetic drain plug was examined, no chips or debris were observed. Continuity was present through the IGB. 30 inches of the #1 tail rotor drive shaft remained attached to the transmission tail rotor drive gear and exhibited fire damage. The #2 drive shaft had separated from the rear flex coupling. The #3 drive shaft remained attached at both bearings. The #4 drive shaft had separated in torsional shear just forward of the IGB. The drive shaft from the IGB to the tail rotor gear box remained in place and had rotational scoring on the end nearest the tail rotor gear box (TGB). The TGB had separated from the tail mount and continuity was present through the TGB. The vertical pylon had separated from the tail. The right horizontal stabilizer remained attached to the vertical pylon. The left horizontal stabilizer separated from the pylon at the root. The tail rotor control cable was traced from the upper forward quadrant, through the tail pylon to the aft quadrant (tail rotor servo on the TGB). The tail rotor control cable was severed in several locations. The TGB had separated from the tail pylon at the mounting bolt casting. The magnetic drain plug was examined with no chips or debris observed. The tail rotor control servo remained attached to the TGB. The two yaw trim SAS actuators were attached to the upper and lower control arms and the control servo. The tail rotor drive input flex coupling was attached to the TGB drive input. The Blue, Black, and Yellow tail rotor blade cuffs and pitch horns were recovered, but the Red cuff and pitch horn were not recovered. All four blades had separated from the rotor head. The Yellow pitch link was attached to the pitch change beam and the blade attach rod end was on the link. The Black pitch change link was attached to the pitch change beam and the blade rod end had separated. The Red and Blue pitch links were not present on the pitch beam, but both rod ends were attached. All four tail rotor blades fractured near the retention plates, two blades had blade tip separation and two blades remained relatively intact.
