NATIONAL TRANSPORTATION SAFETY BOARD

Group Chairman's Factual Report

DCA21FA085

SUBJECT: *Right Engine Fan Blade Out and Inlet/Fan Cowl Departure – Examination of recovered Inlet Cowl, Fan Cowls, and Thrust Reversers*

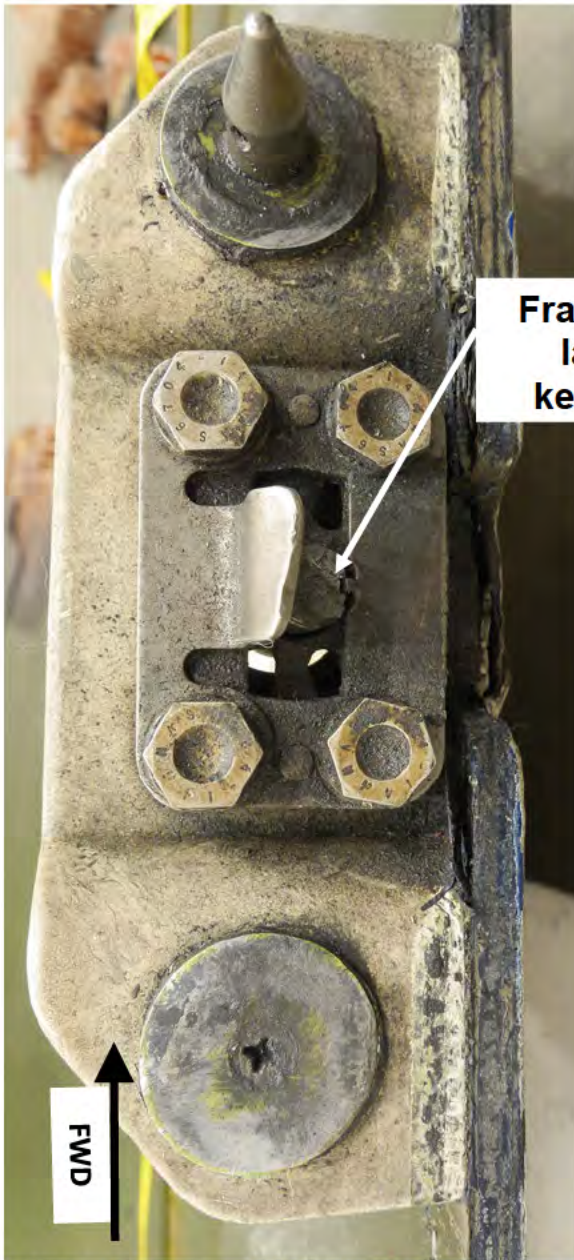
Figure 27: Inboard Fan Cowl Latch Keepers - #1 and #4 keepers were mostly intact, #2 and #3 keepers were fractured as shown in figures 29 and 30.

Figure 29: Fan cowl #2 latch keeper, fractured.

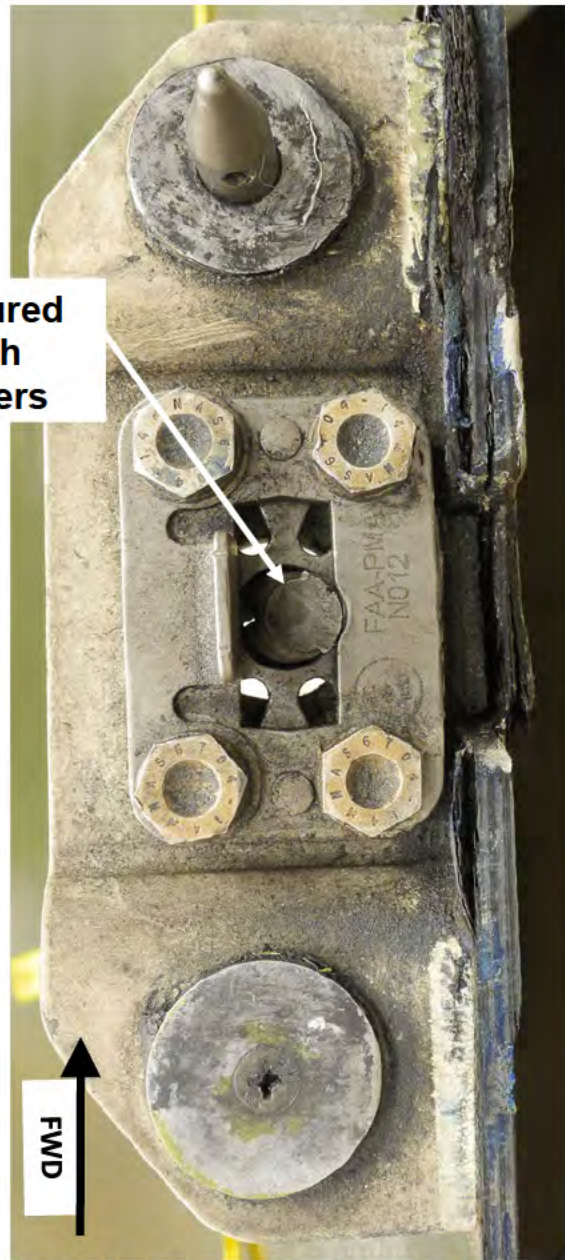
Figure 30: Fan cowl #3 latch keeper, fractured.

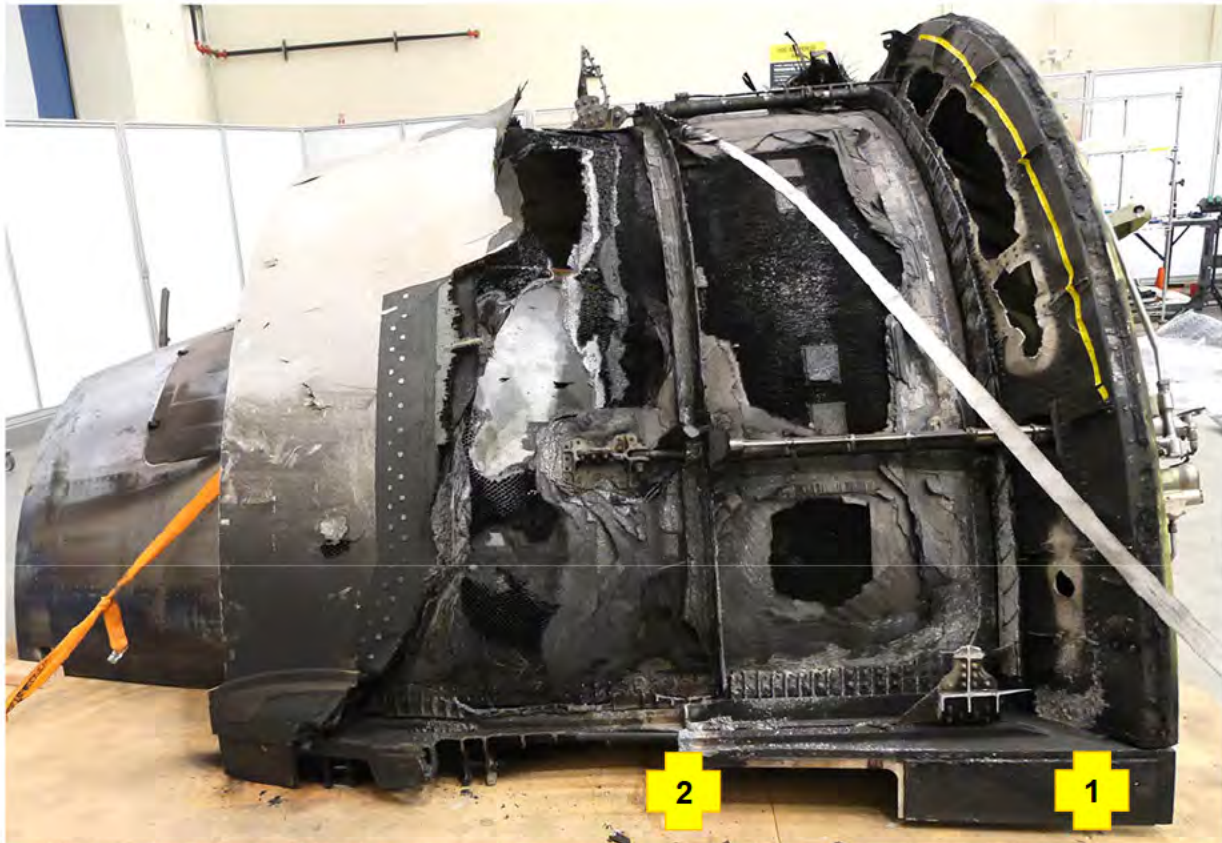
Figure 40: Outboard thrust reverser, damage to latch beam, translating sleeve and cascades (view looking up).

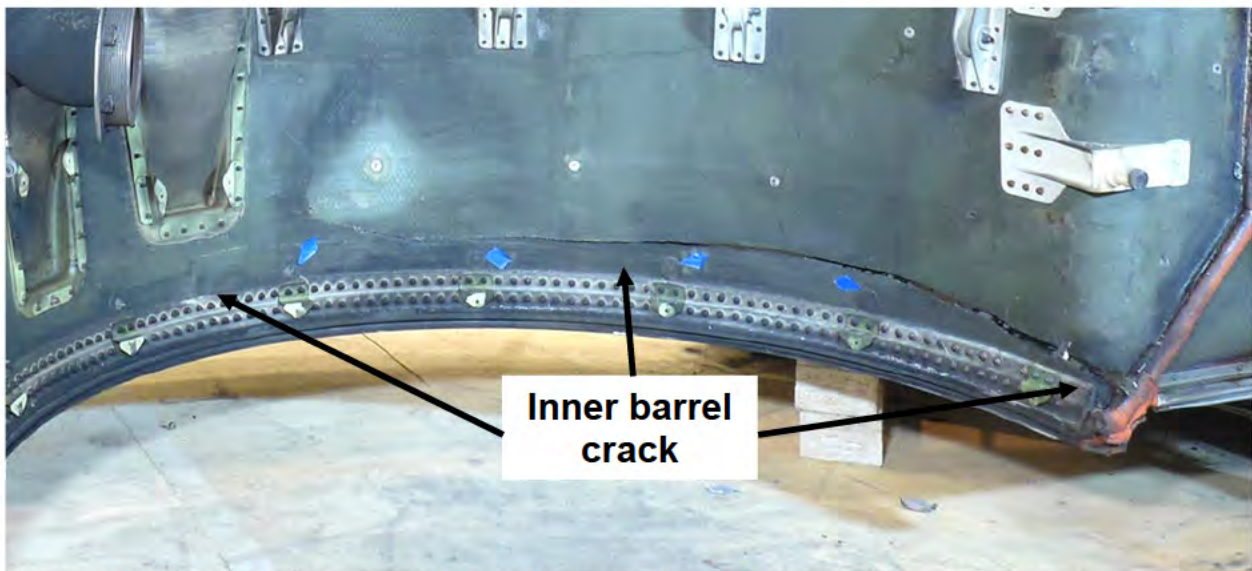
Figure 44: Outboard thrust reverser inner surface, heat blankets removed, inner barrel crack.

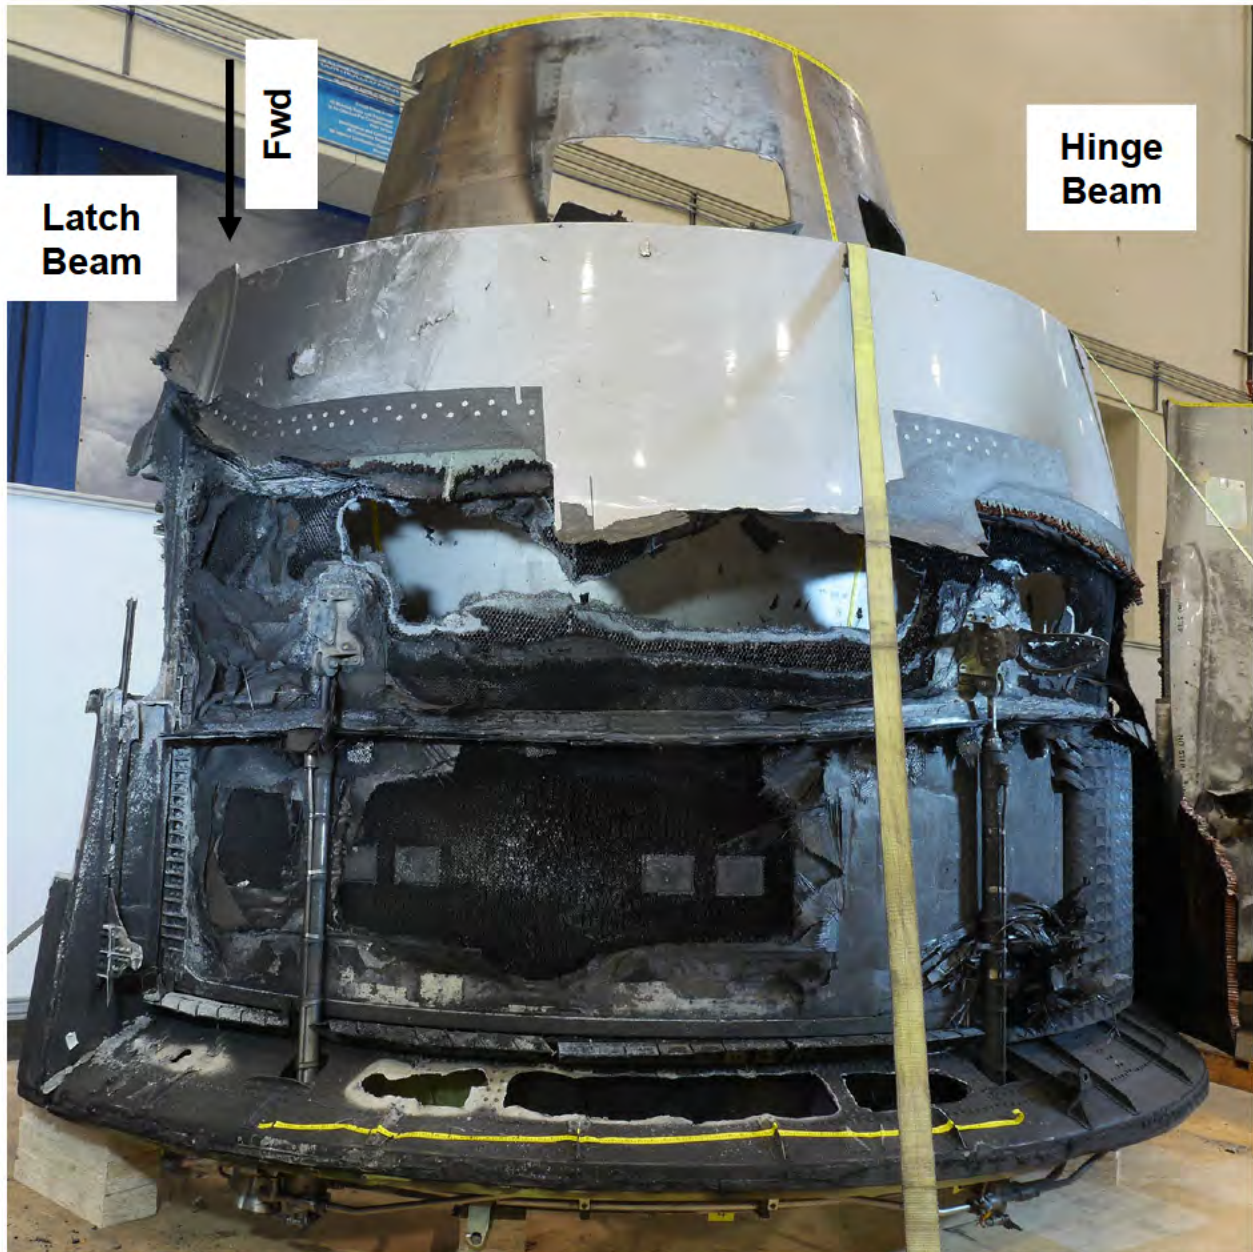
Figure 45: Outboard thrust reverser outer surface, placed on forward edge, view of damage to latch beam, translating sleeve and cascades.

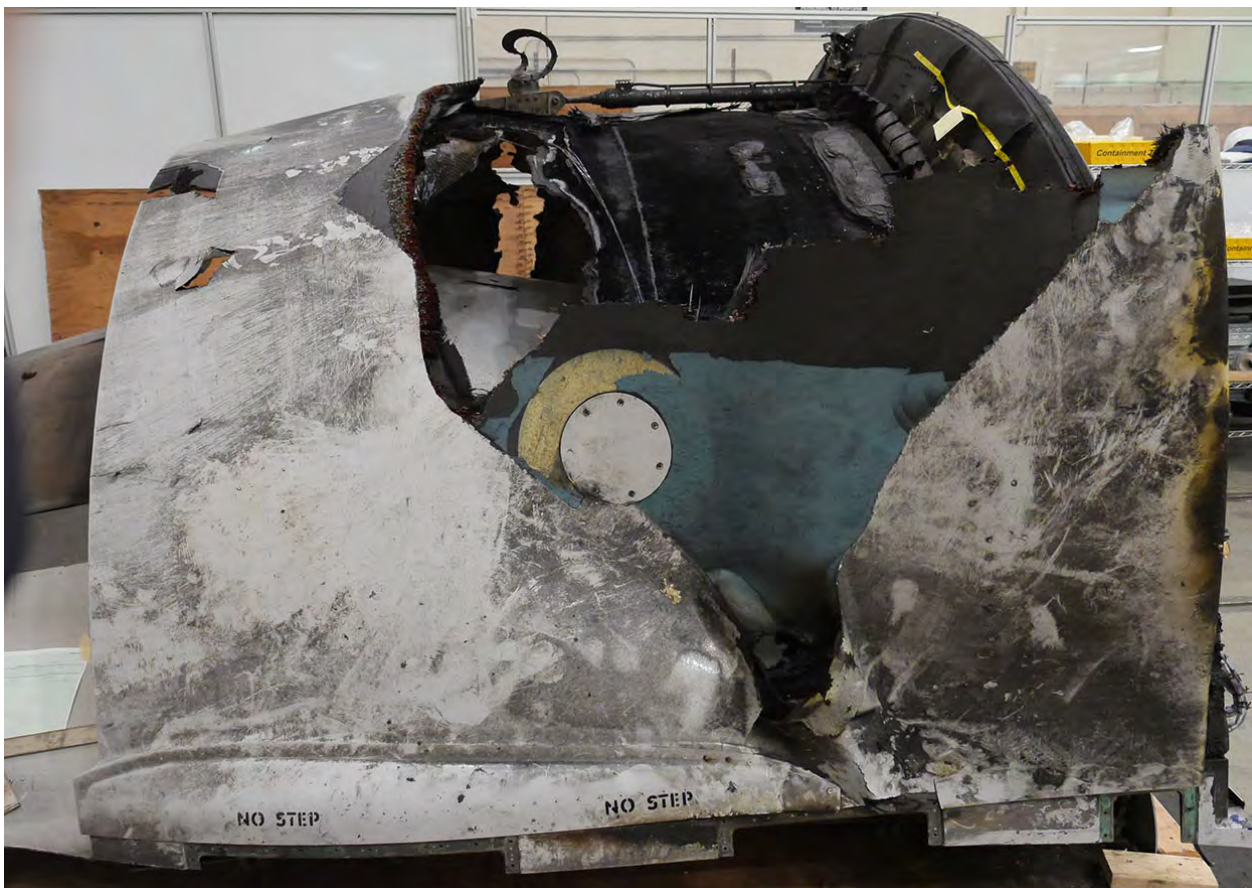
Figure 67: Inboard thrust reverser hinge beam, showing damage to translating sleeve and cascades (view looking down).

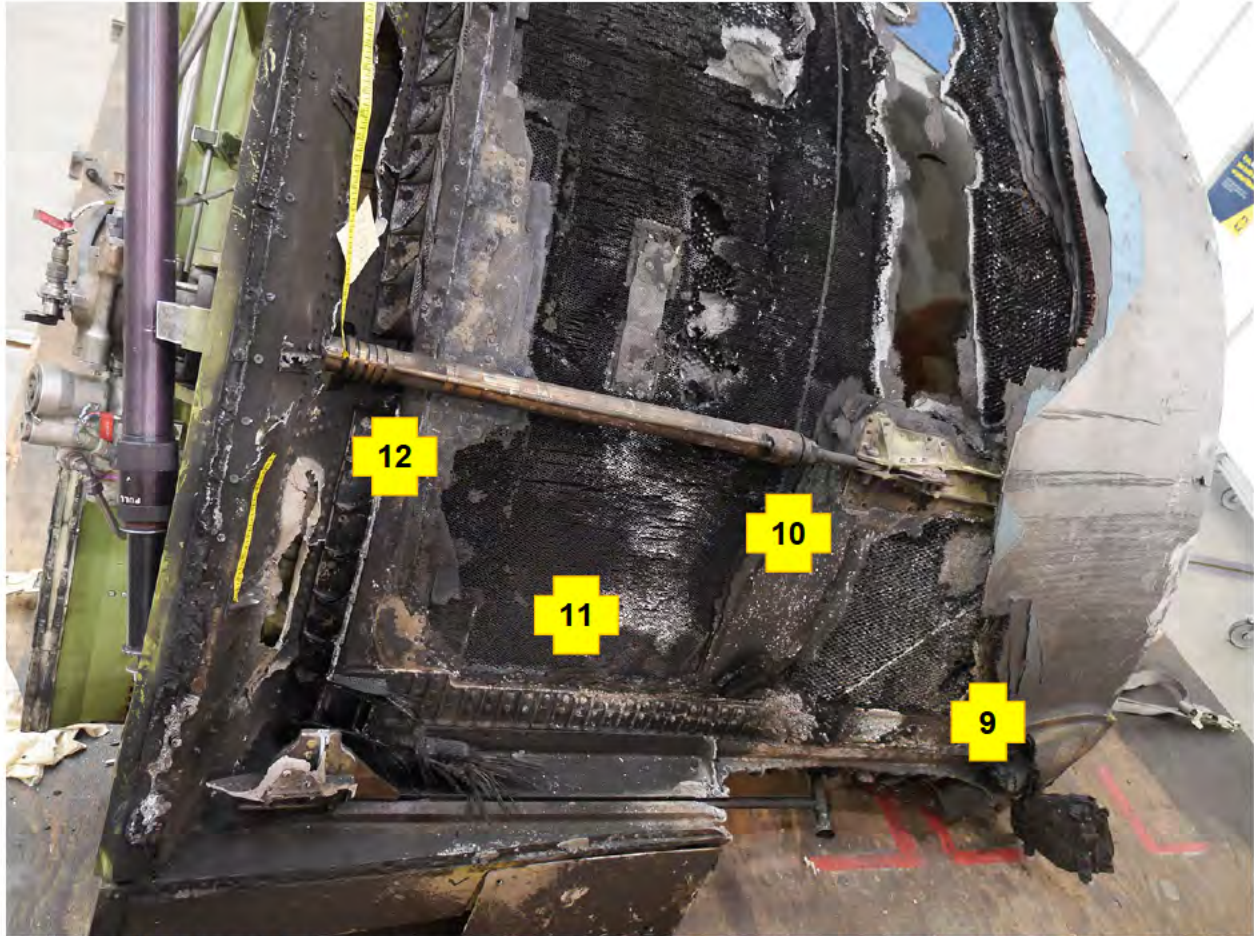
Figure 68: Inboard thrust reverser, showing damage to latch beam, translating sleeve and cascades (view looking up).

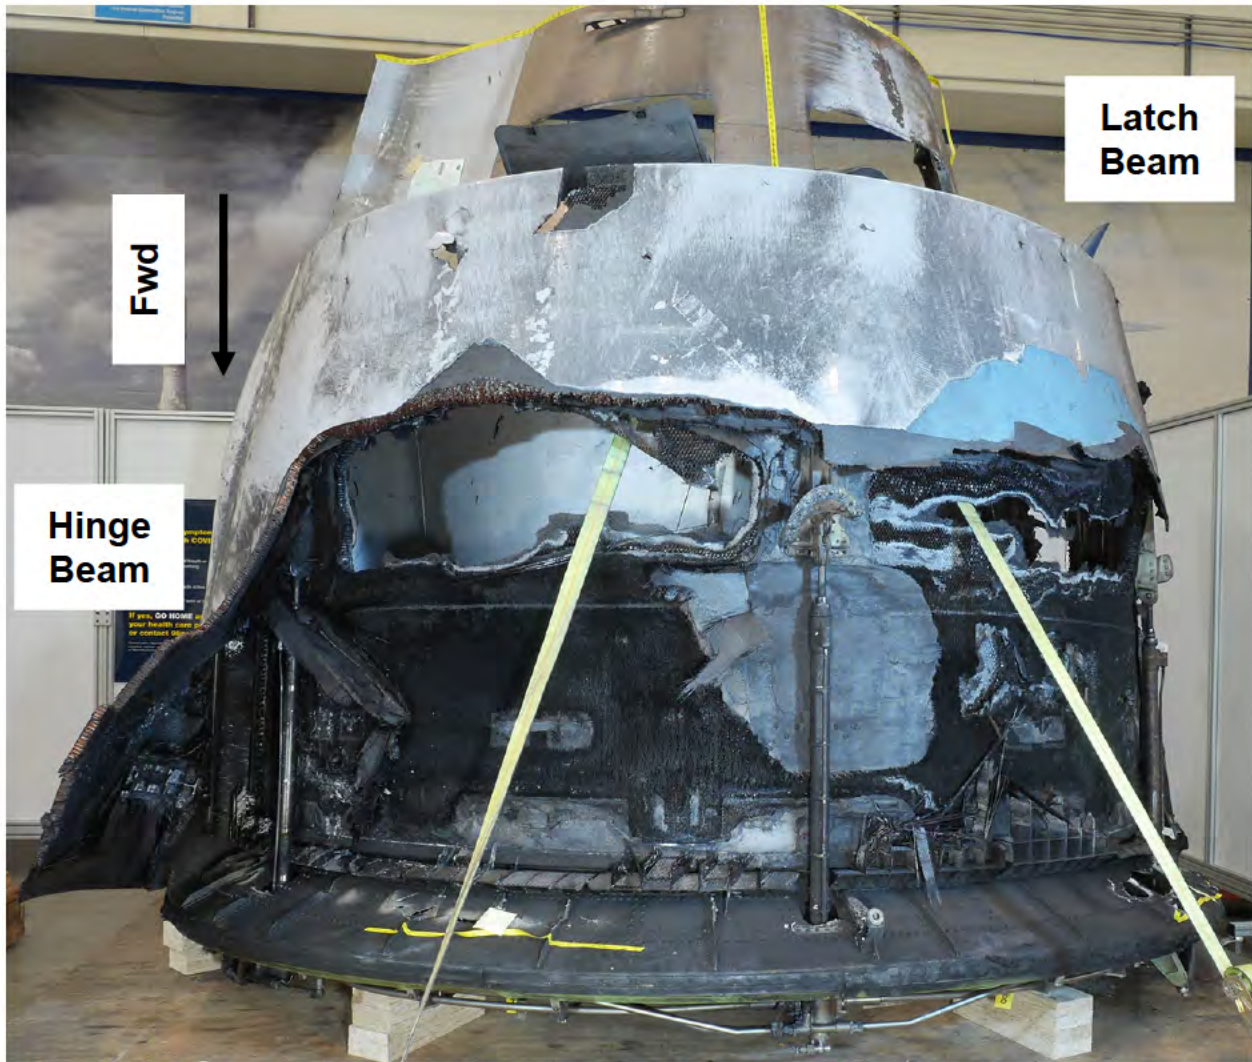
Figure 72: Inboard thrust reverser outer surface showing damage to translating sleeve and cascades.

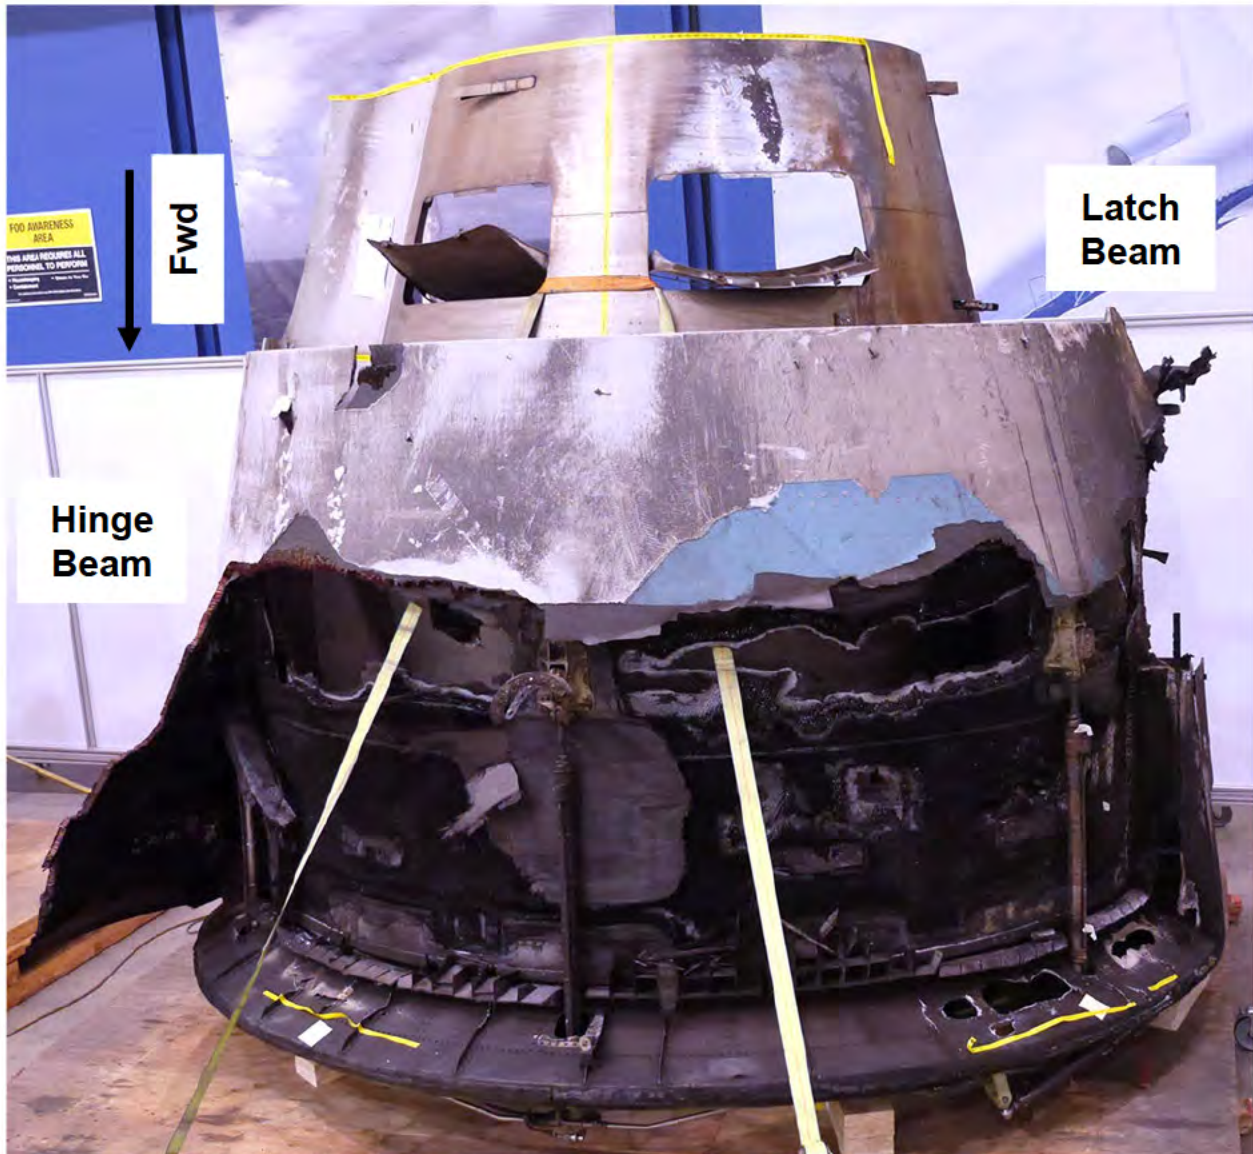
Figure 73: Inboard thrust reverser outer surface, damage to translating sleeve and cascades.

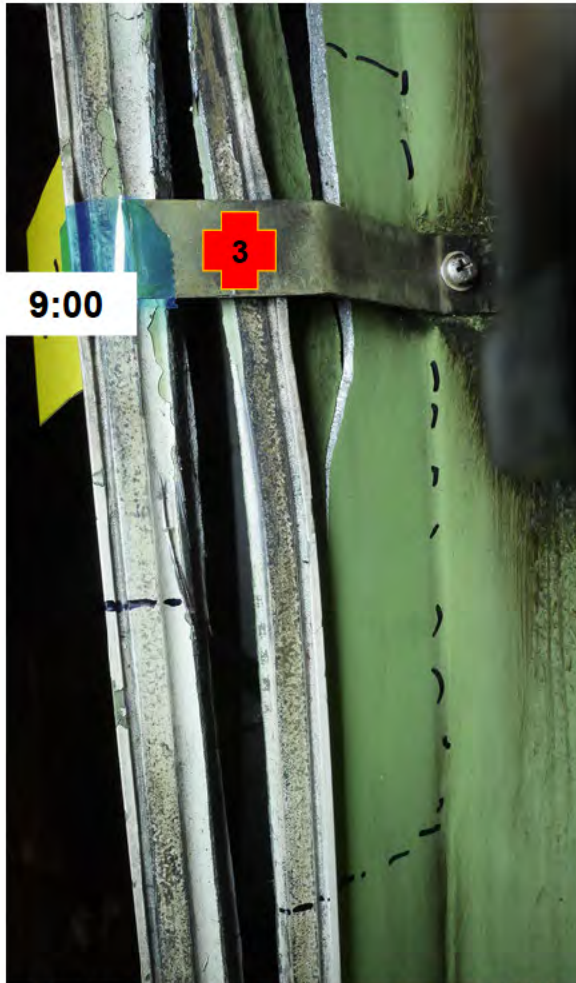
Figure 87: Inboard (left) thrust reverser 9:00 crack.

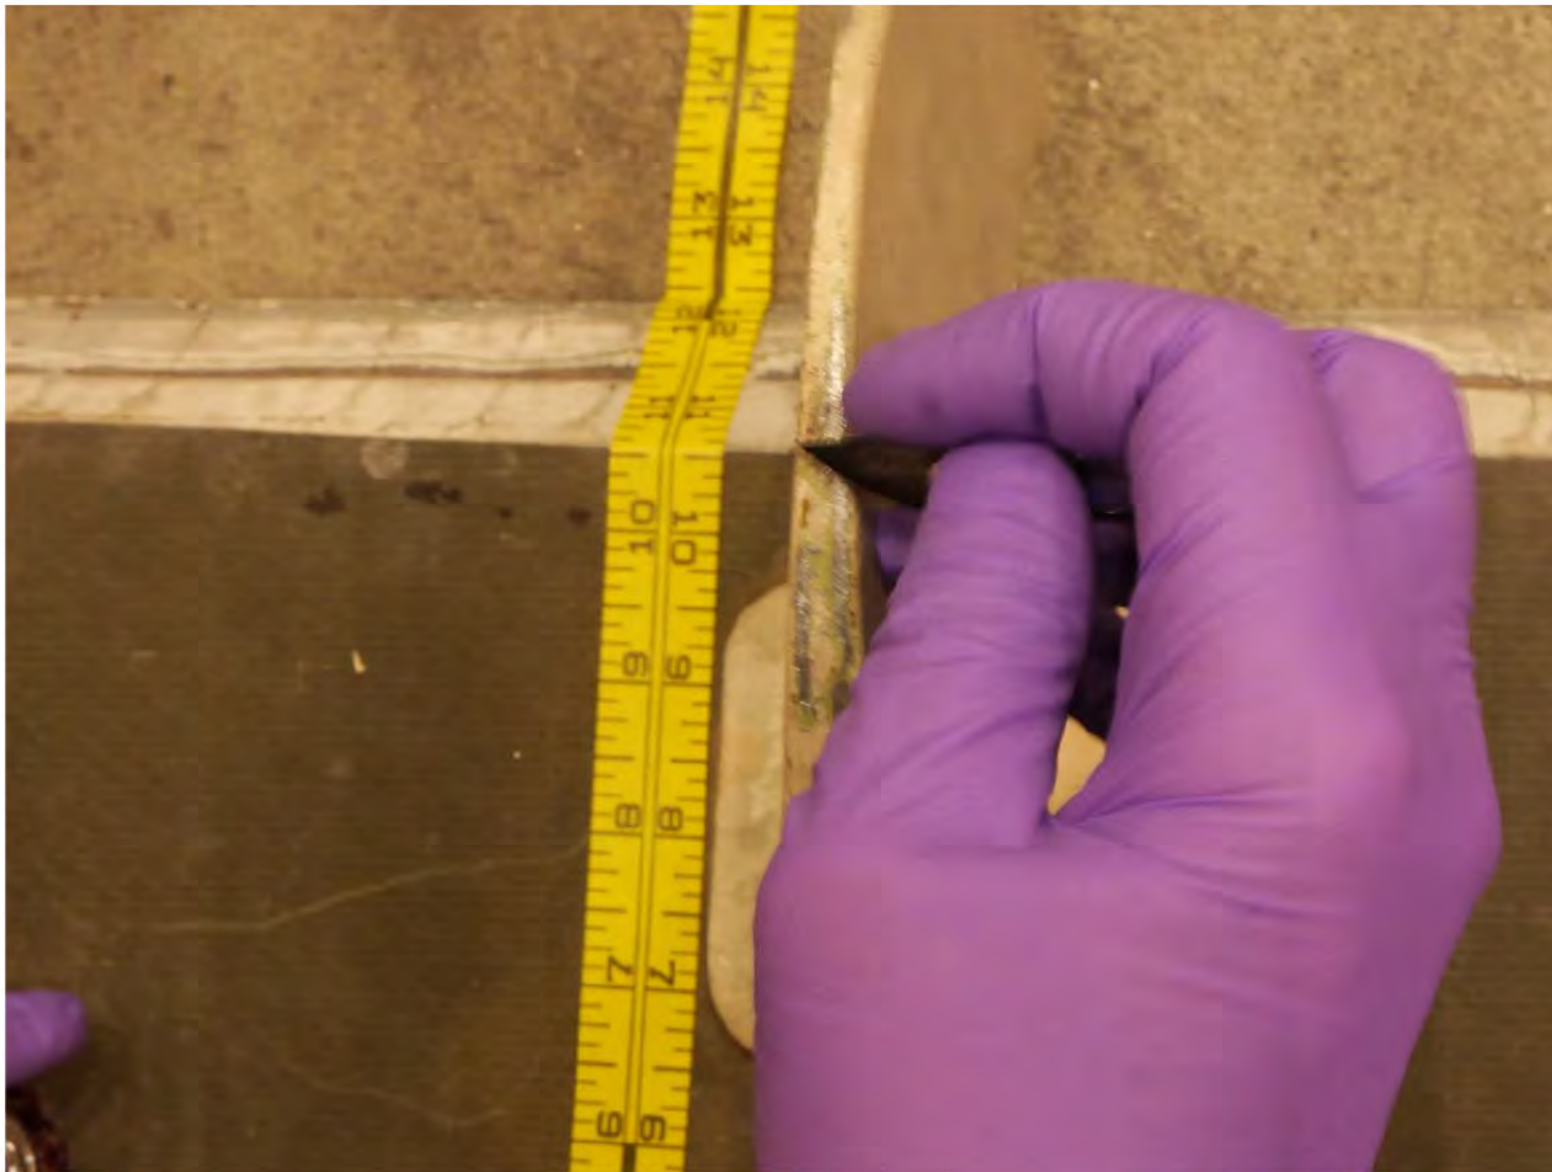
Sample #17 Left and cowls number 2 hinge

#17 residue on #2 fan cowl hinges was consistent with a mixture of calcium carbonate and an acrylic polymer, possibly an acrylic caulk? The acrylate could also be due to an adhesive residue. No Kevlar was observed.

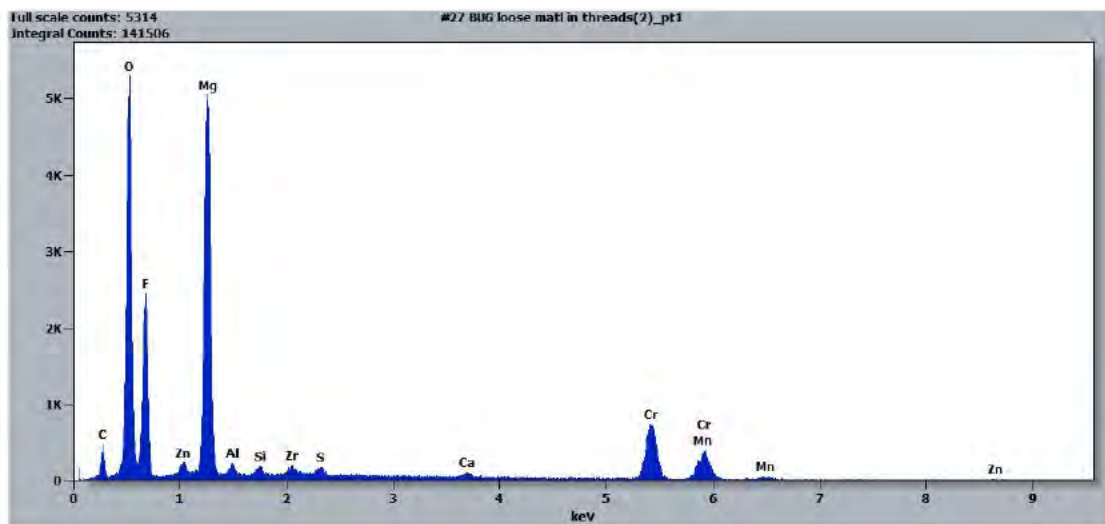
#27 BUG loose material in threads cont. – consistent with magnesium oxidation products

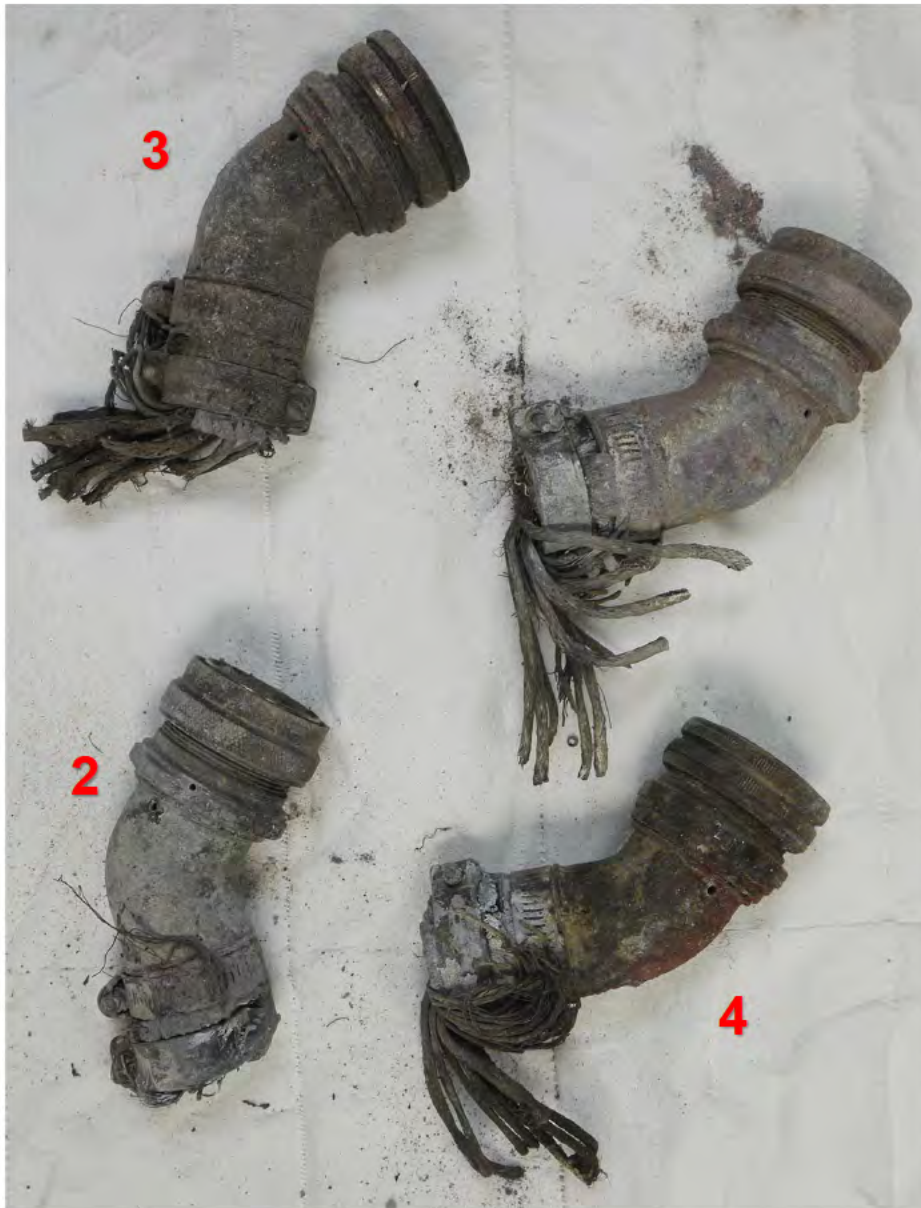
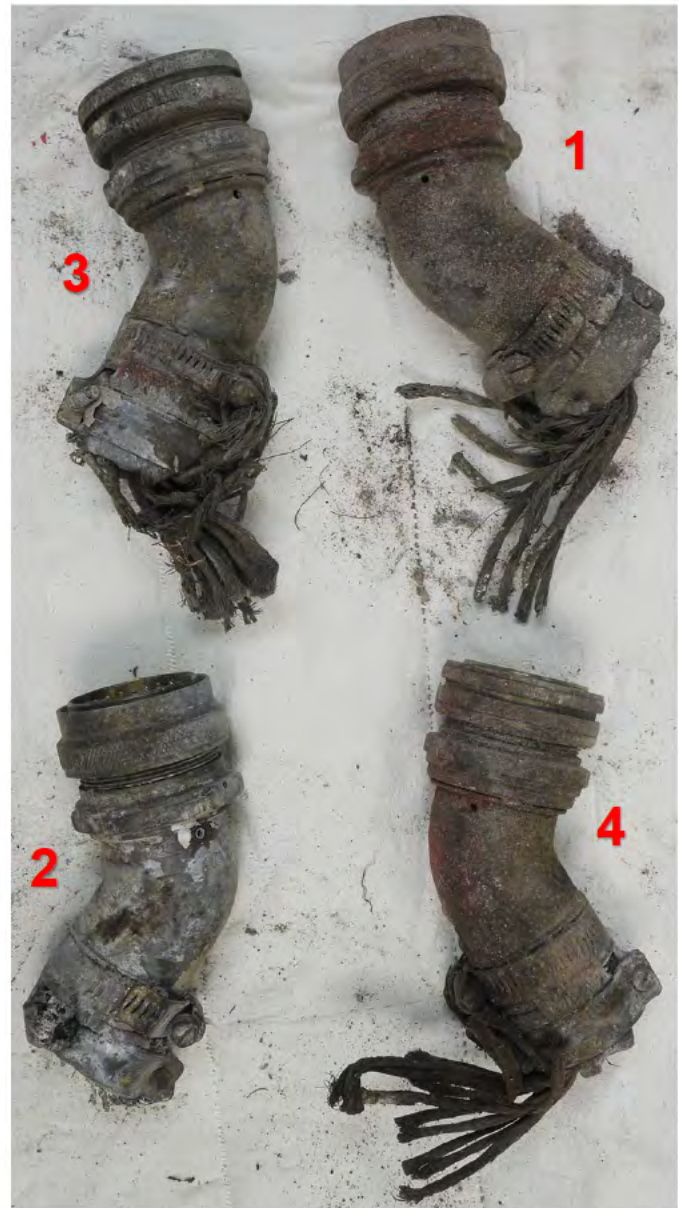
#29 electrical connector (1) – corrosion products and an inorganic silicon compound

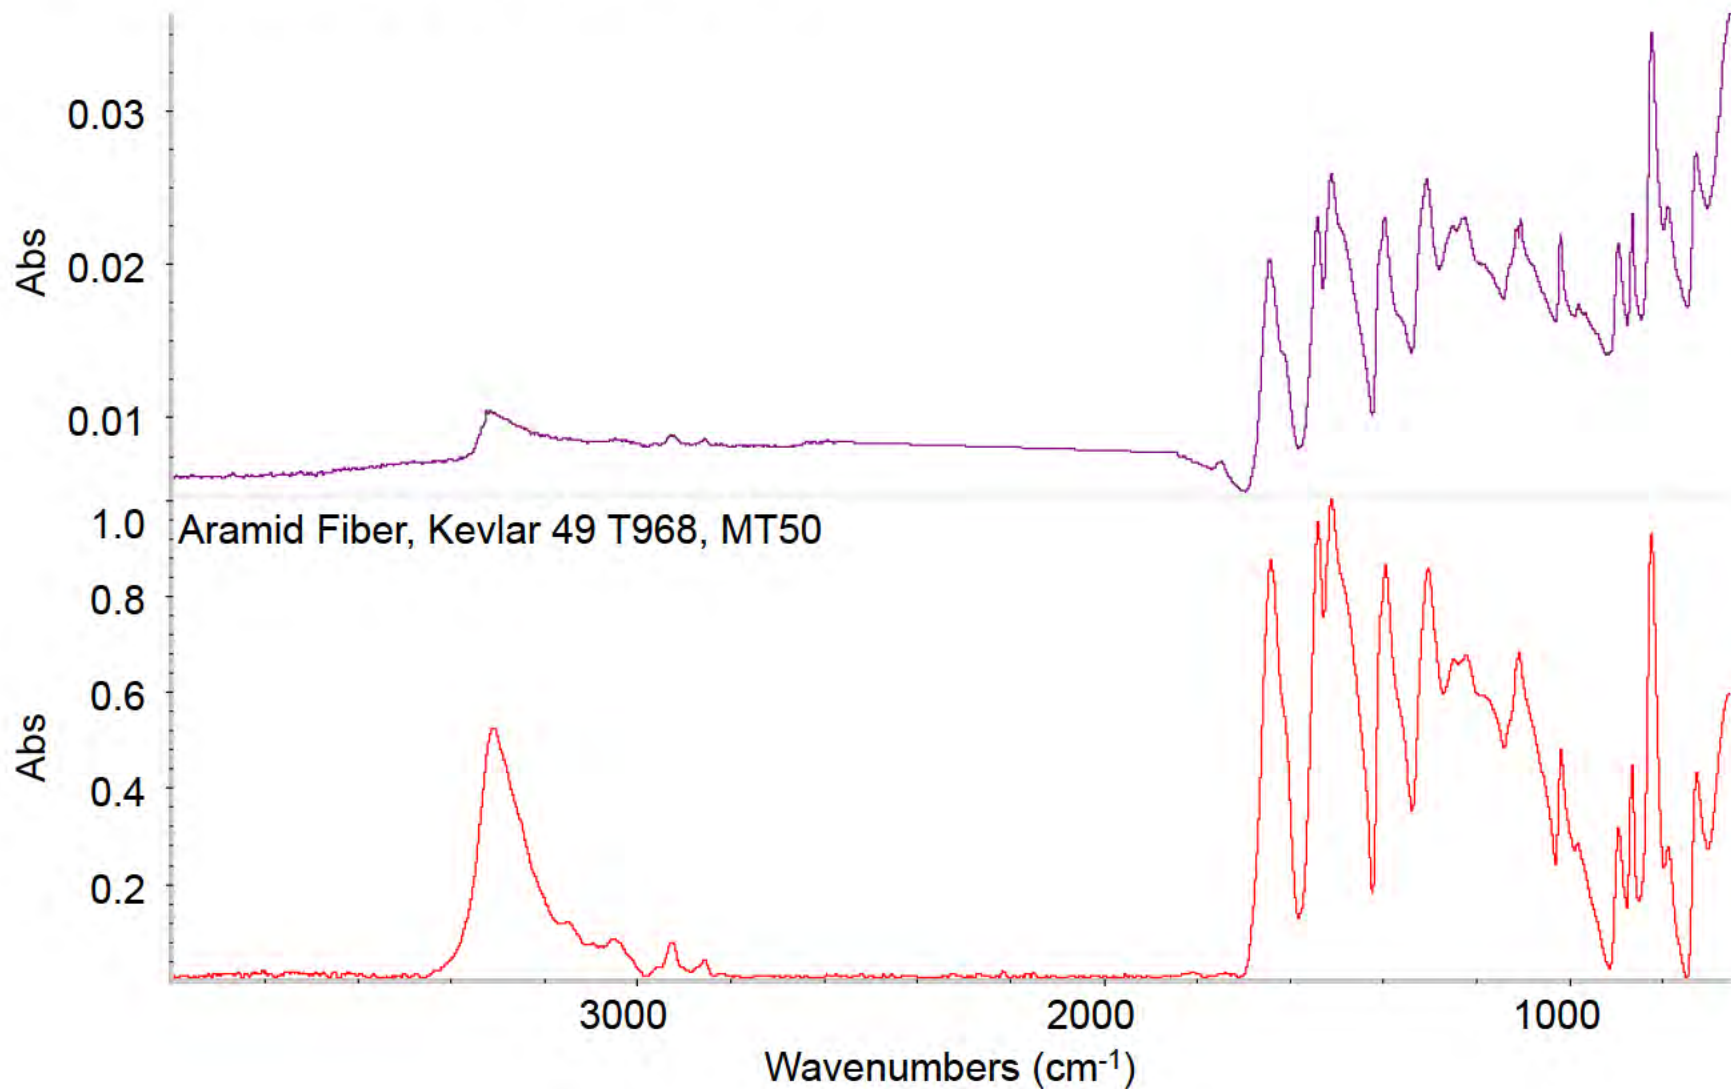
#30 - The yellow fibers reinforcing the epoxy were consistent with aramid, such as Kevlar.

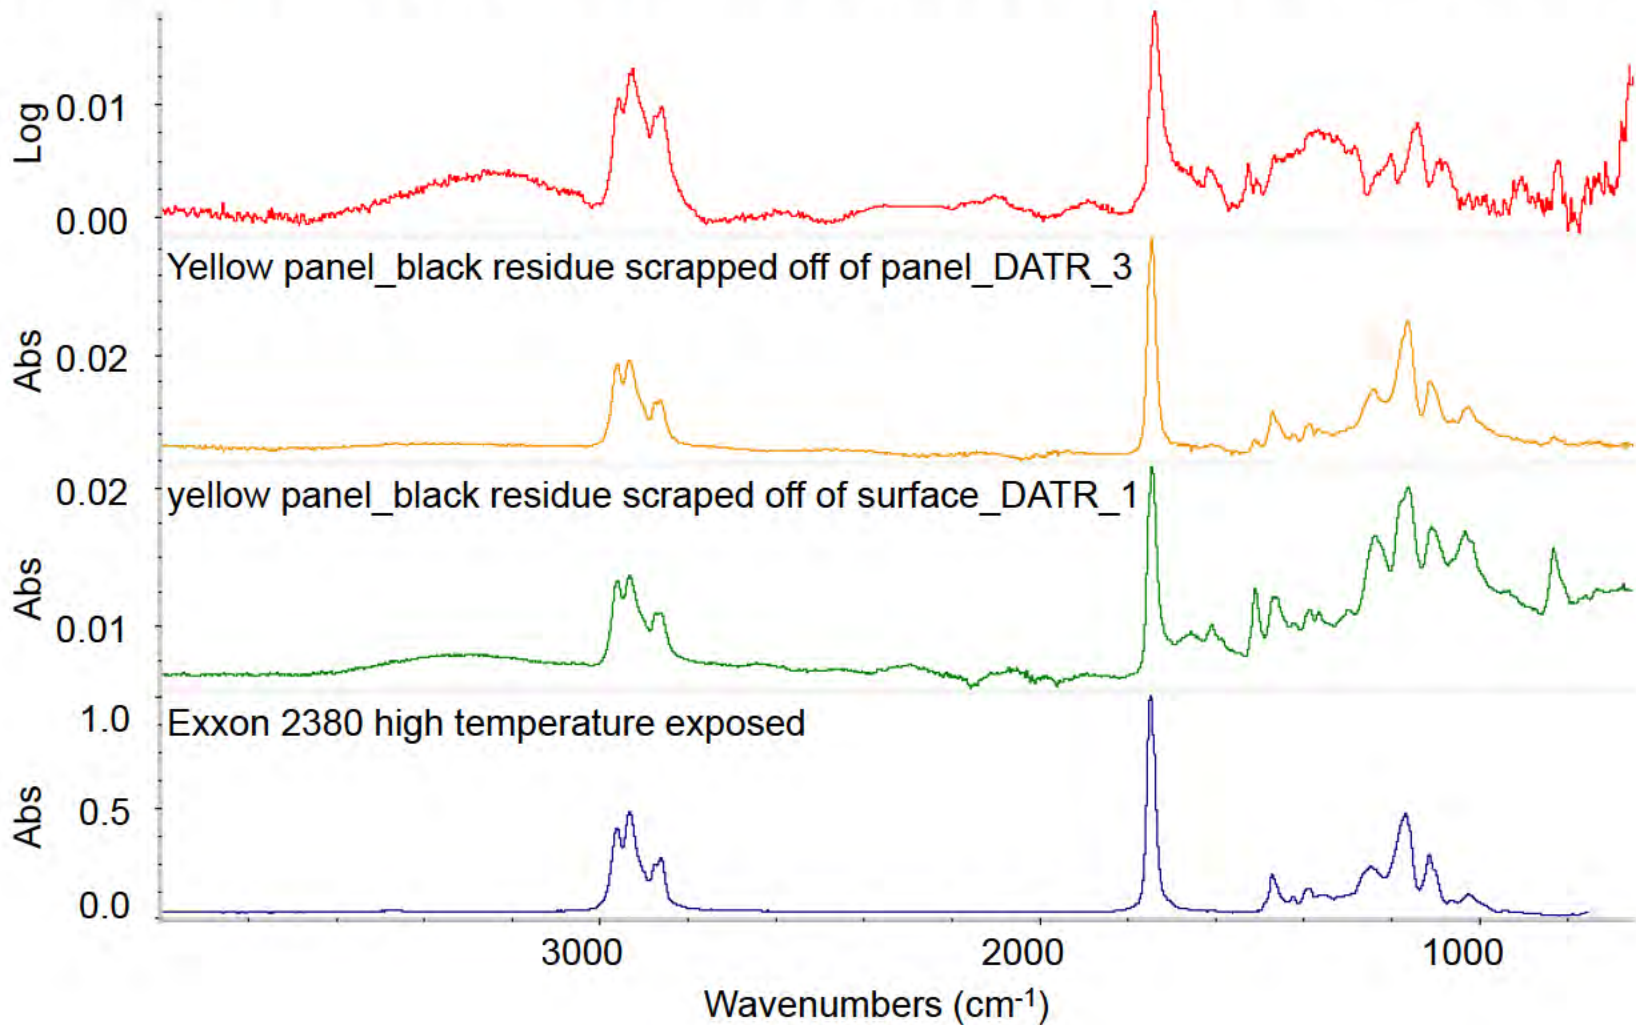
#30 - The black soot looking material on the panel was consistent with engine oil coking deposits. The deposits consisted of varying levels of thermally degraded engine oil.

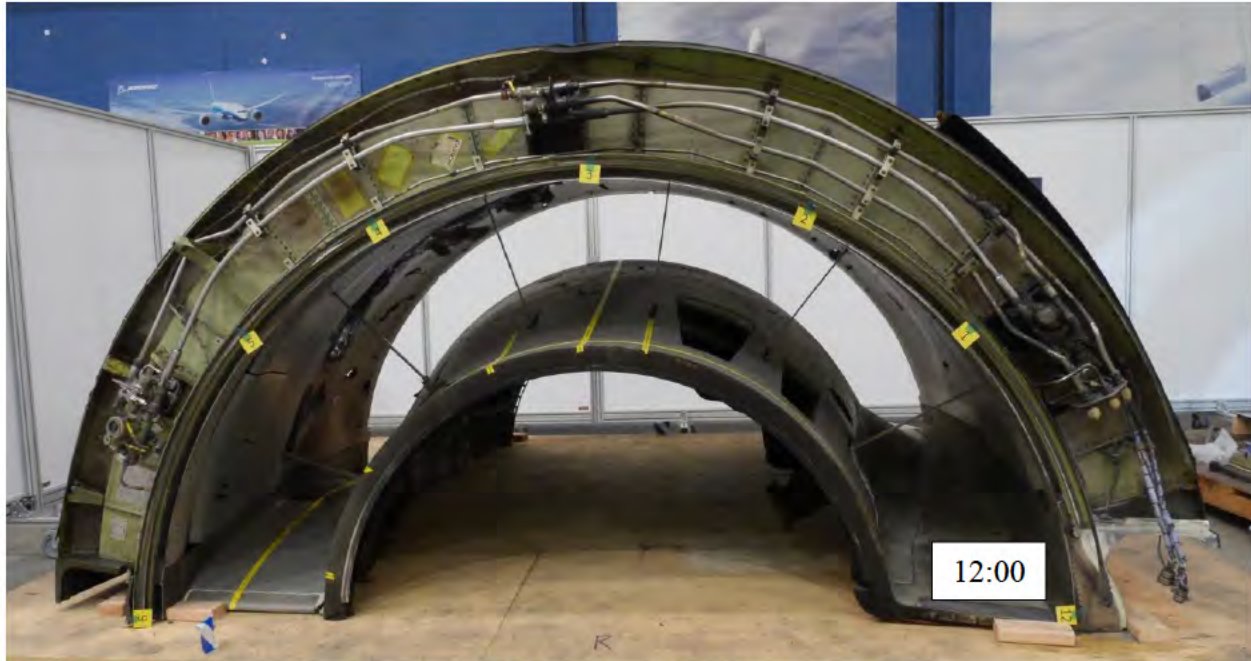
Figure 1 shows the Right Thrust Reverser (P/N 315W3001-4AA) before sectioning. An approximately 1.5 inch crack extended from the edge of the part in the 12:00 region and was excised for analysis (Figures 2 – 4). Figure 5 contains SEM images of the fracture surface of this portion of the crack. Some portions of the fracture surface were obscured by post fracture damage, but in the undamaged area the fracture mode was entirely ductile separation, consistent with a single event and showing no signs of fatigue or crack advancement after the event.

Figure 1. Right Thrust Reverser (P/N 315W3001-4AA SN 000002). A short fracture runs from the edge of the part at the 12:00 clock position, extending for approximately 1.7 inches.

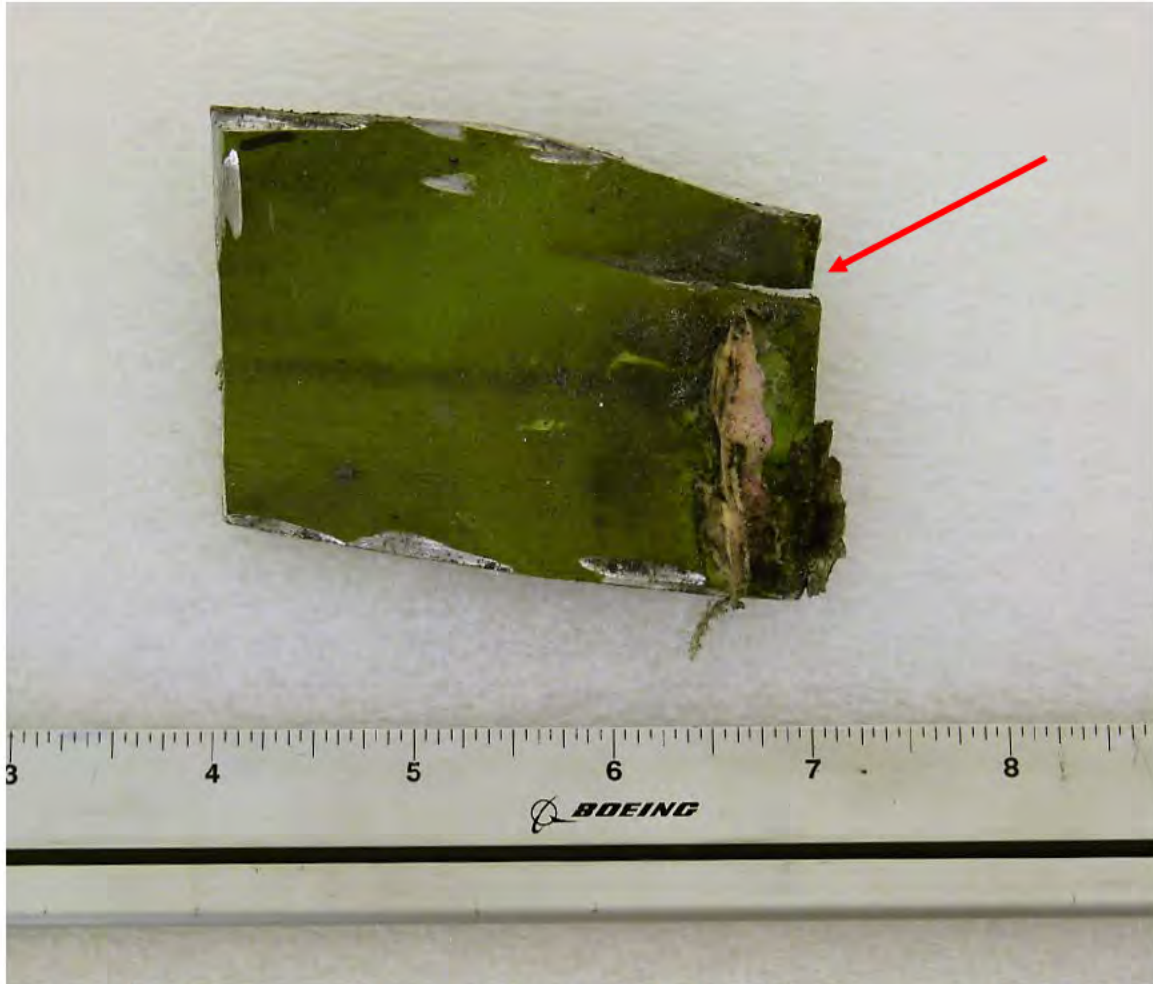
Figure 3. Right Thrust Reverser fracture at the 12:00 clock position after removal. The 1.5 inch long crack is indicated by the red arrow.

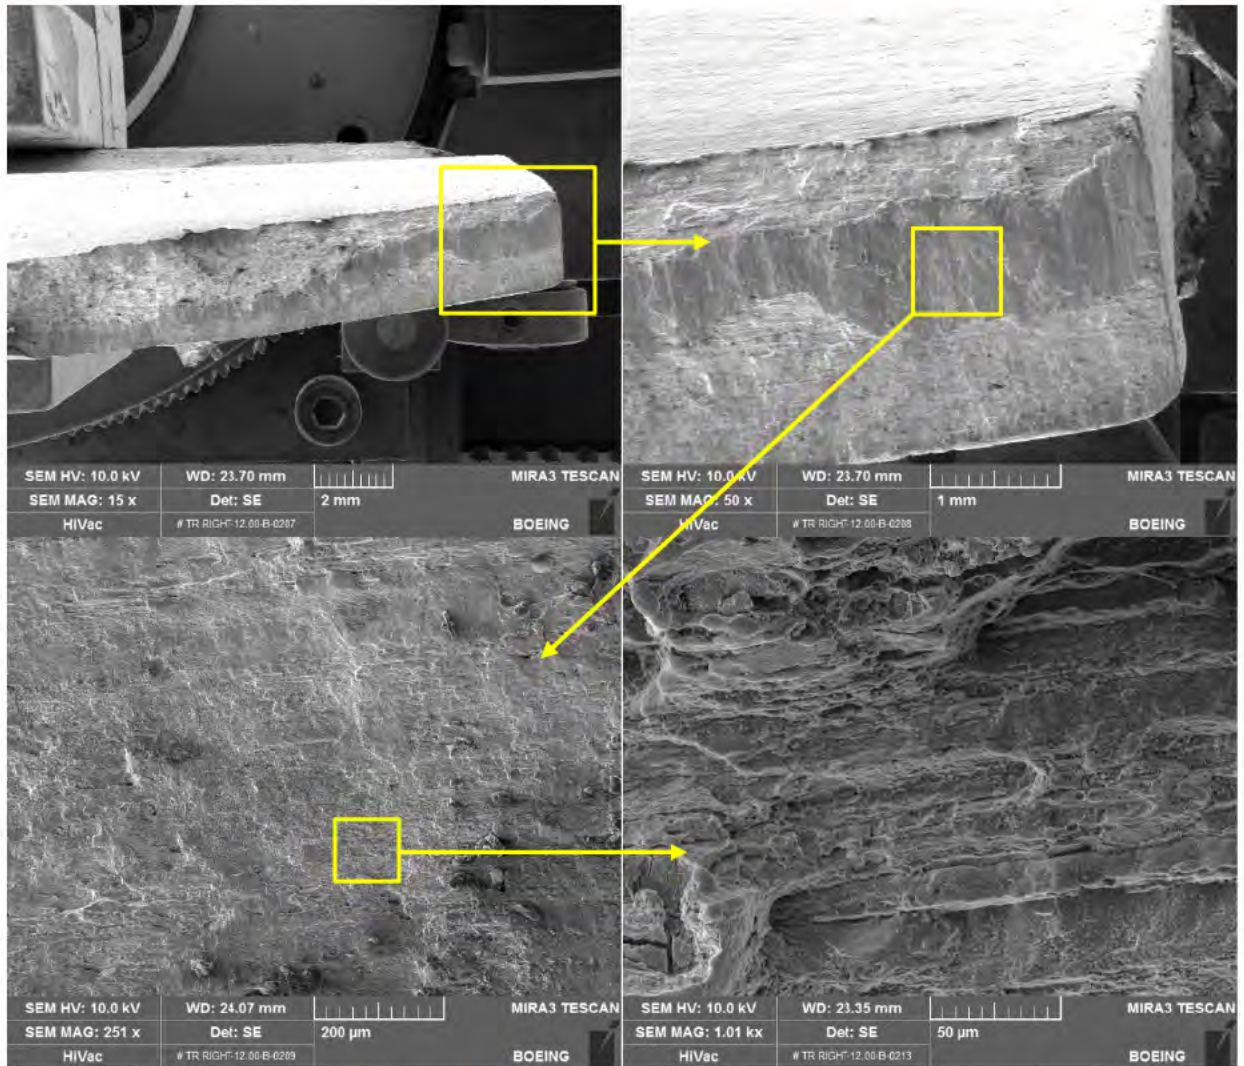
Figure 5. SEM images of increasing magnification of the Right Thrust Reverser Fracture, taken at the end of the part. Post fracture damage obscured portions of the fracture surface, the fracture mode visible was entirely ductile separation.
