NATIONAL TRANSPORTATION SAFETY BOARD

Group Chairman's Factual Report

DCA21FA085

SUBJECT: *Right Engine Fan Blade Out and Inlet/Fan Cowl Departure – Examination of recovered Inlet Cowl, Fan Cowls, and Thrust Reversers*

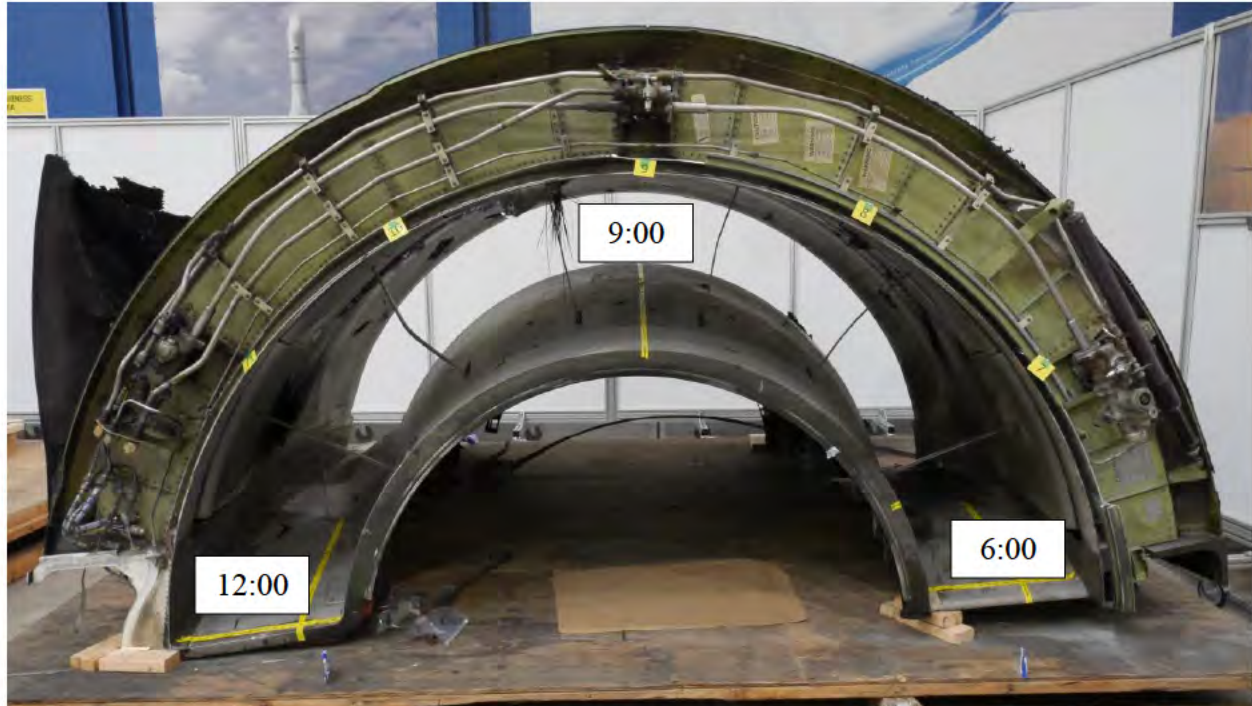
Figure 6 shows the Left Thrust Reverser (P/N 315W3001-3AA) before sectioning. Significant cracking ran from the edge of the part at the 6:00 position to the 9:00 region (Figures 7 and 15) and a smaller crack was identified in the 12:00 location.

Figure 6. Left Thrust Reverser (315W3001-3AA SN 000002). A short fracture was located at the 12:00 position, a longer fracture ran from the end of the part at the 6:00 position to 9:00.

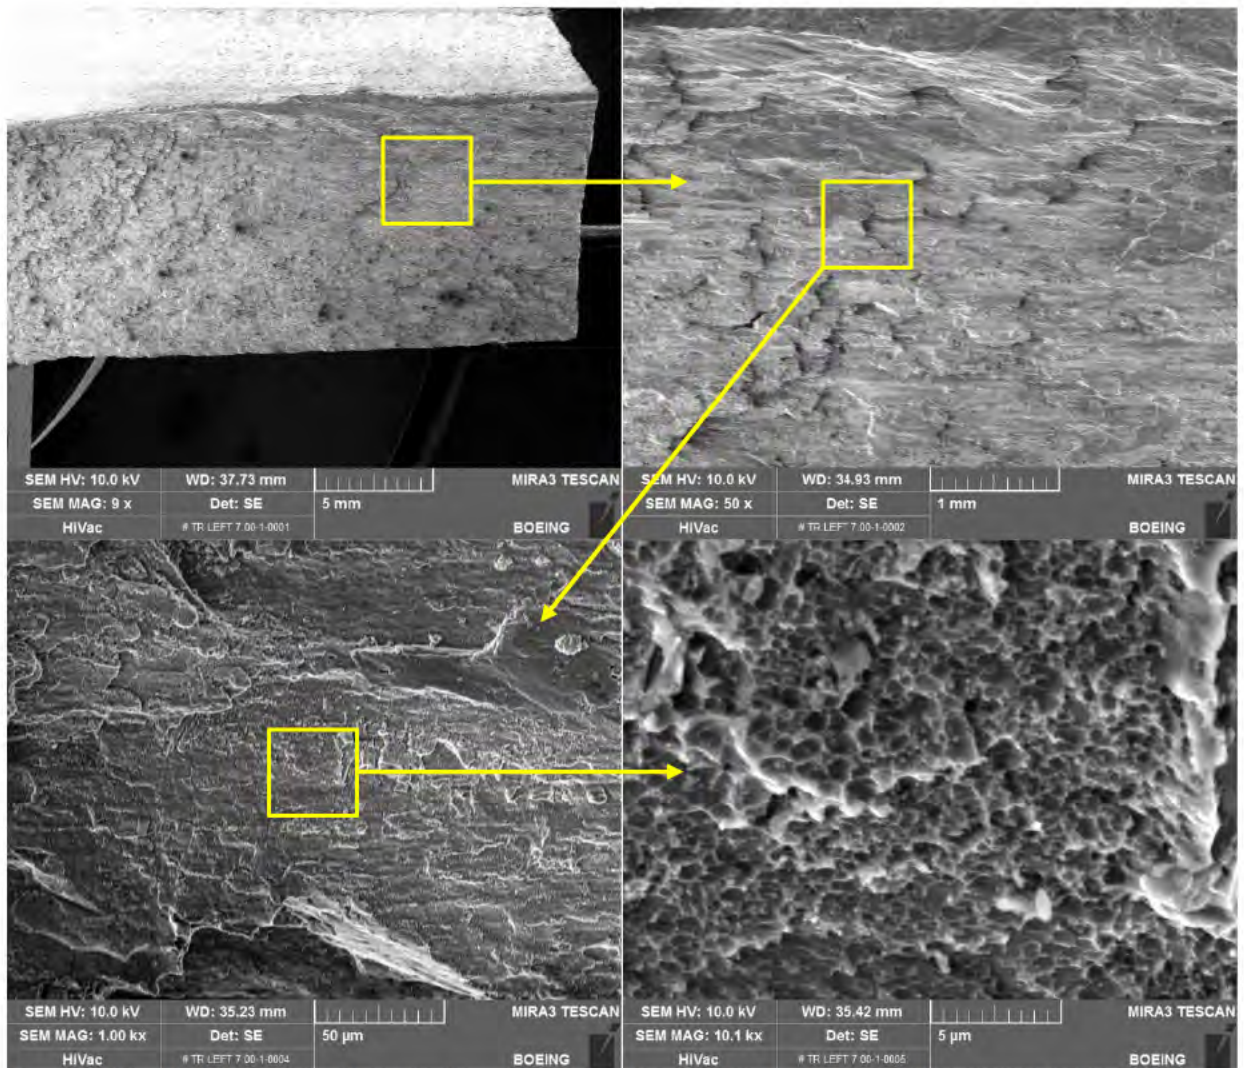
Figure 10. SEM images of increasing magnification of the Left Thrust Reverser fracture at 7:00, Section 1. Some portions of the fracture surface were obscured by post fracture damage, but where visible the fracture mode visible was entirely ductile separation.

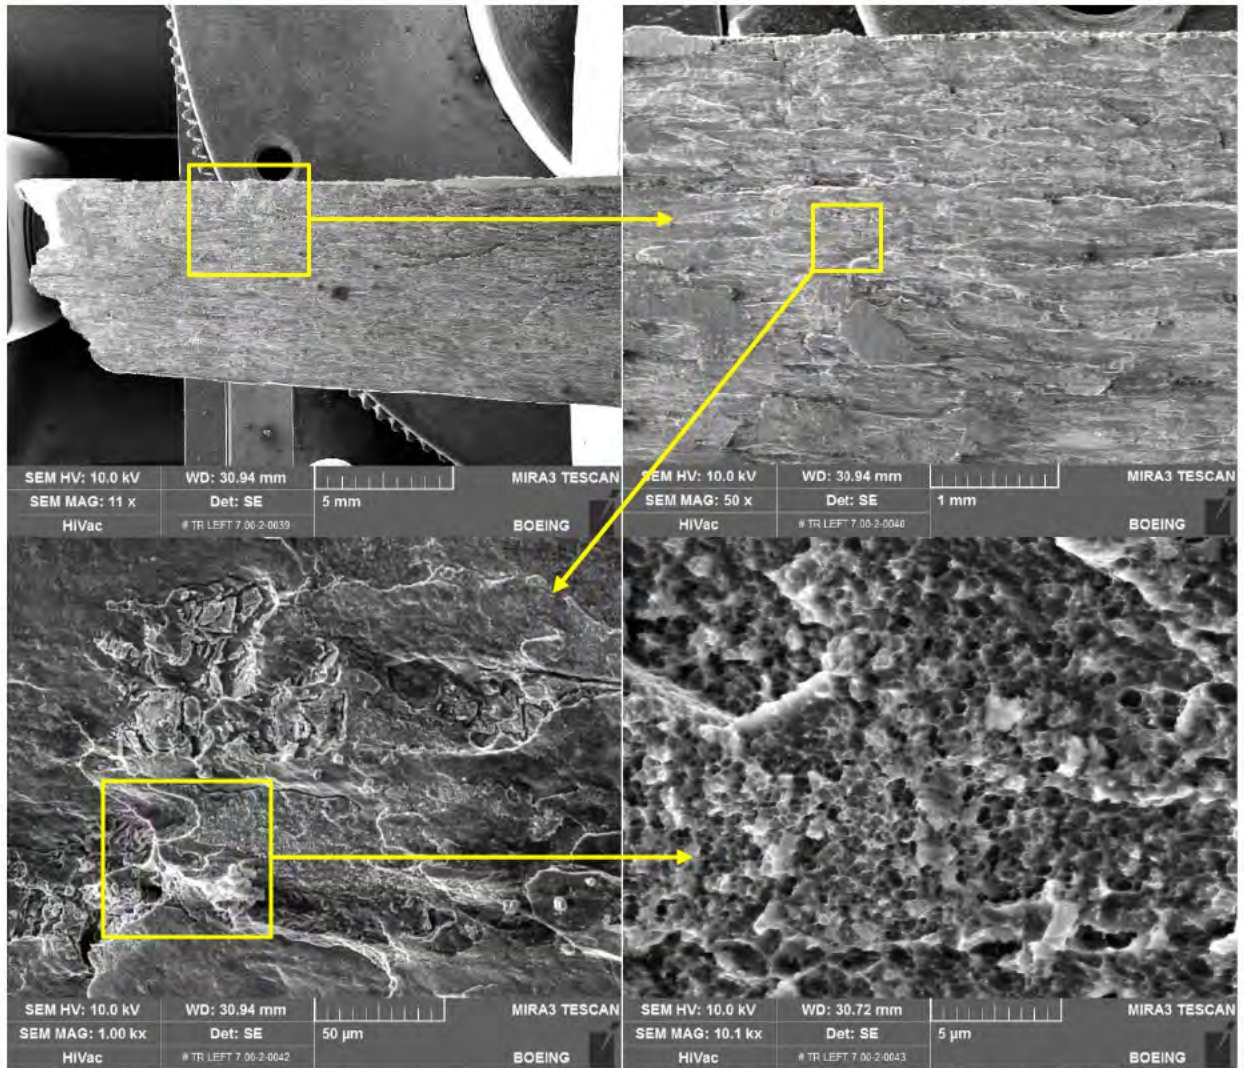
Figure 11. SEM images of increasing magnification of the Left Thrust Reverser fracture at 7:00, Section 2. Significant post fracture damage obscured portions of the fracture surface, the fracture mode visible was entirely ductile separation.

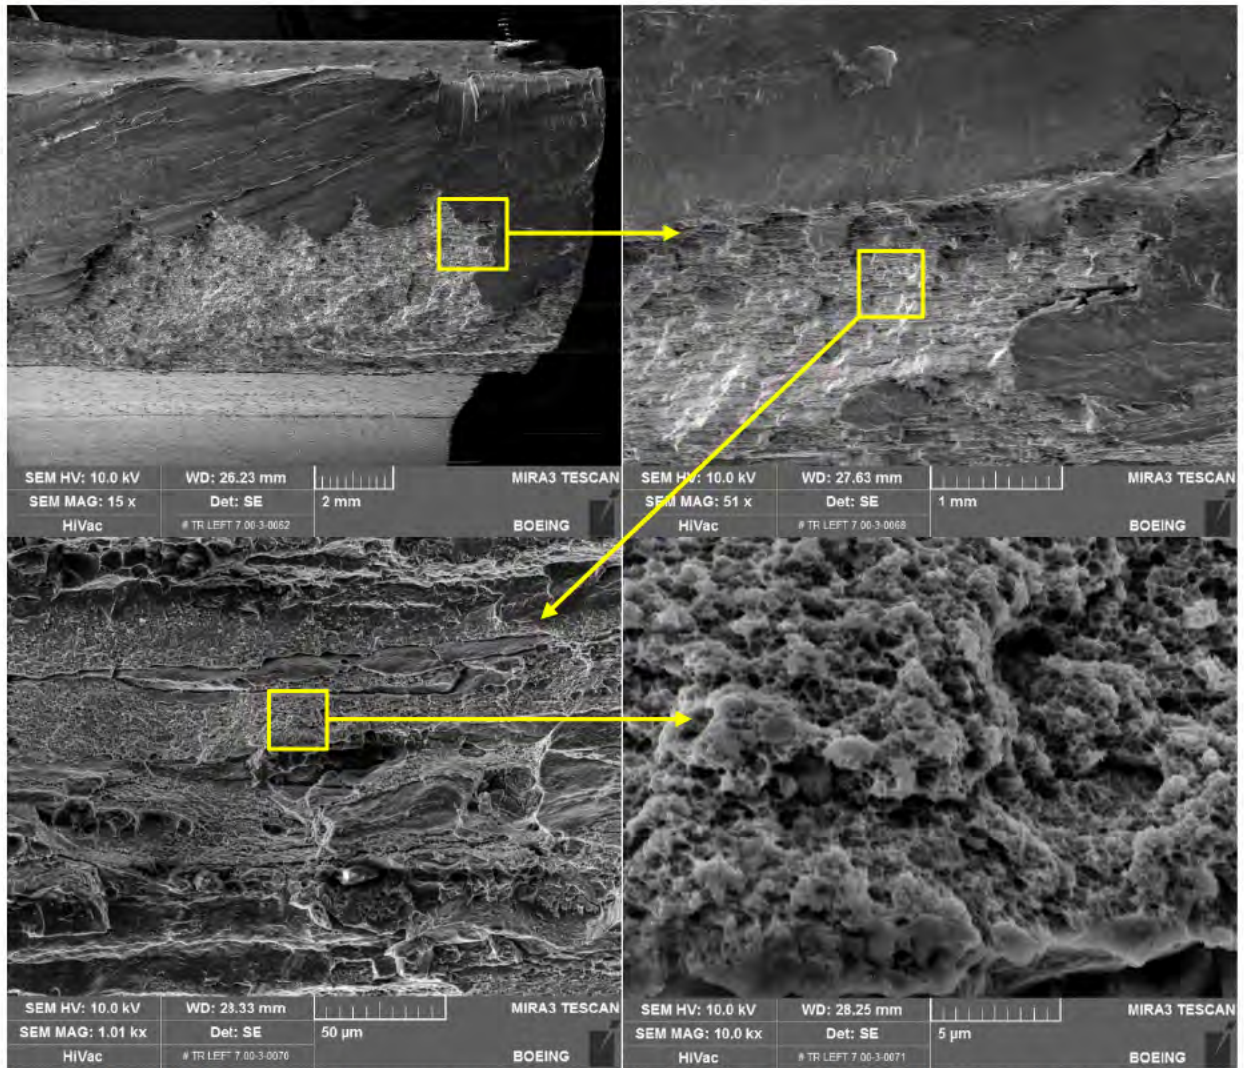
Figure 12. SEM images of increasing magnification of the Left Thrust Reverser fracture at 7:00, Section 3. Significant portions of the fracture surface were obscured by post fracture damage, but where visible the fracture mode visible was entirely ductile separation.

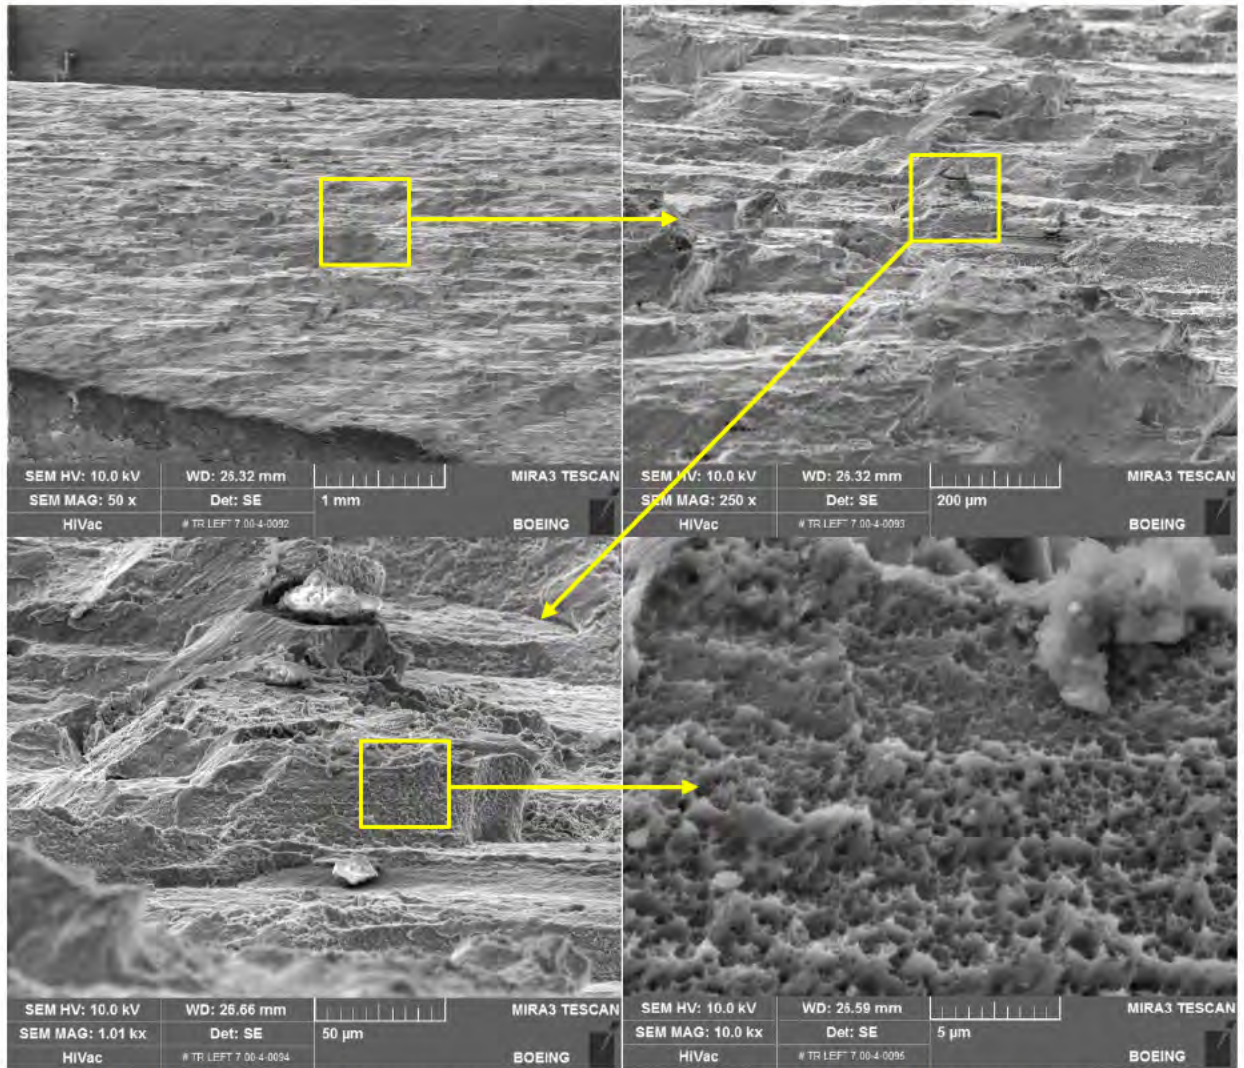
Figure 13. SEM images of increasing magnification of the Left Thrust Reverser fracture at 7:00, Section 4. The fracture mode visible was entirely ductile separation.

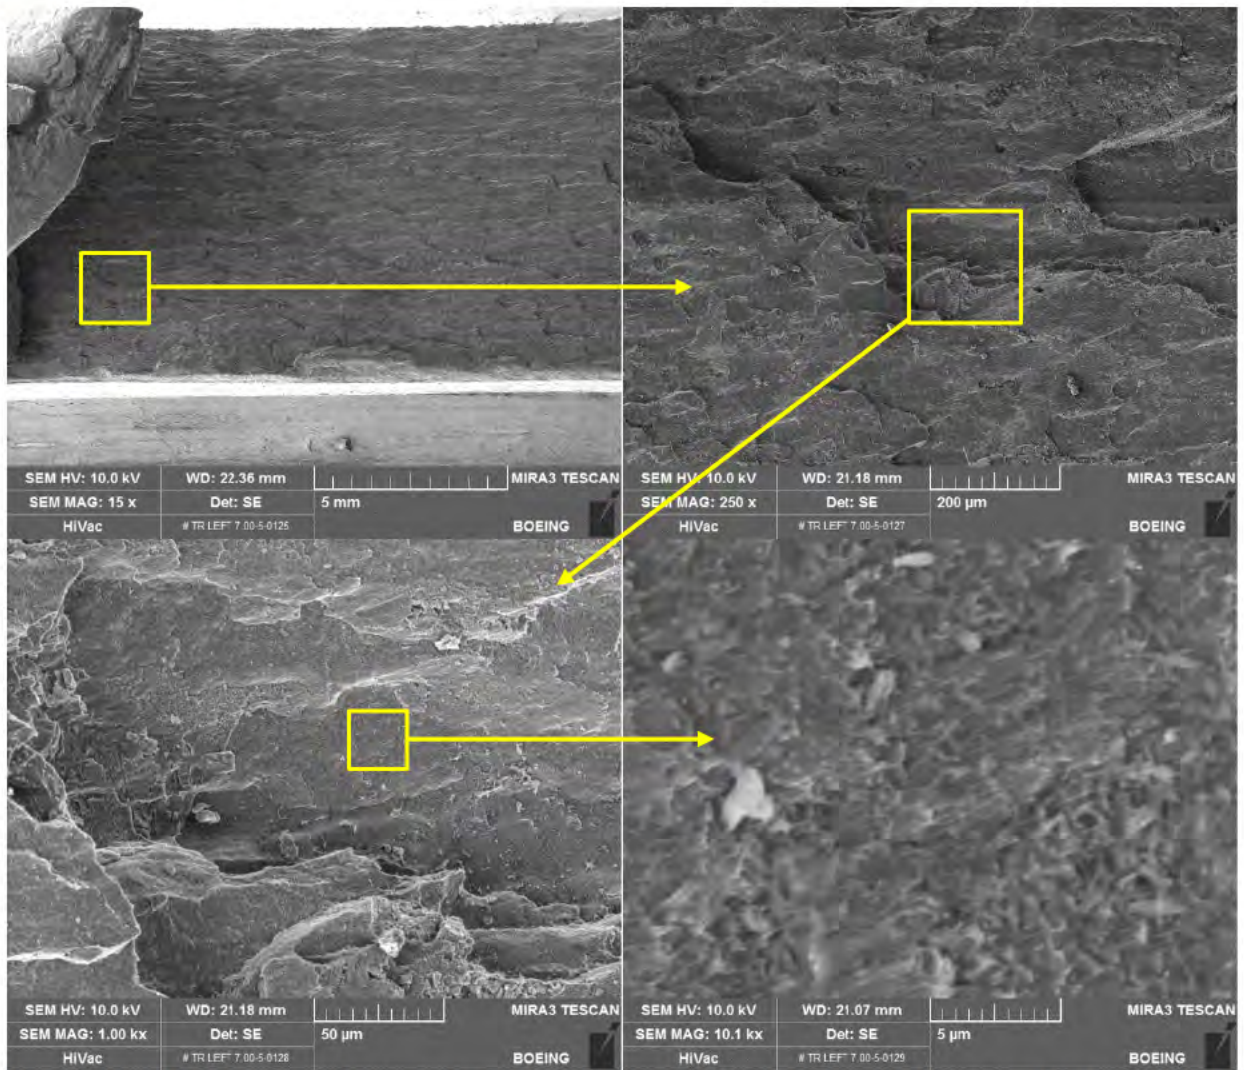
Figure 14. SEM images of increasing magnification of the Left Thrust Reverser fracture at 7:00, Section 5. The fracture surface were obscured by post fracture damage and oxidation, but appears consistent with ductile separation.

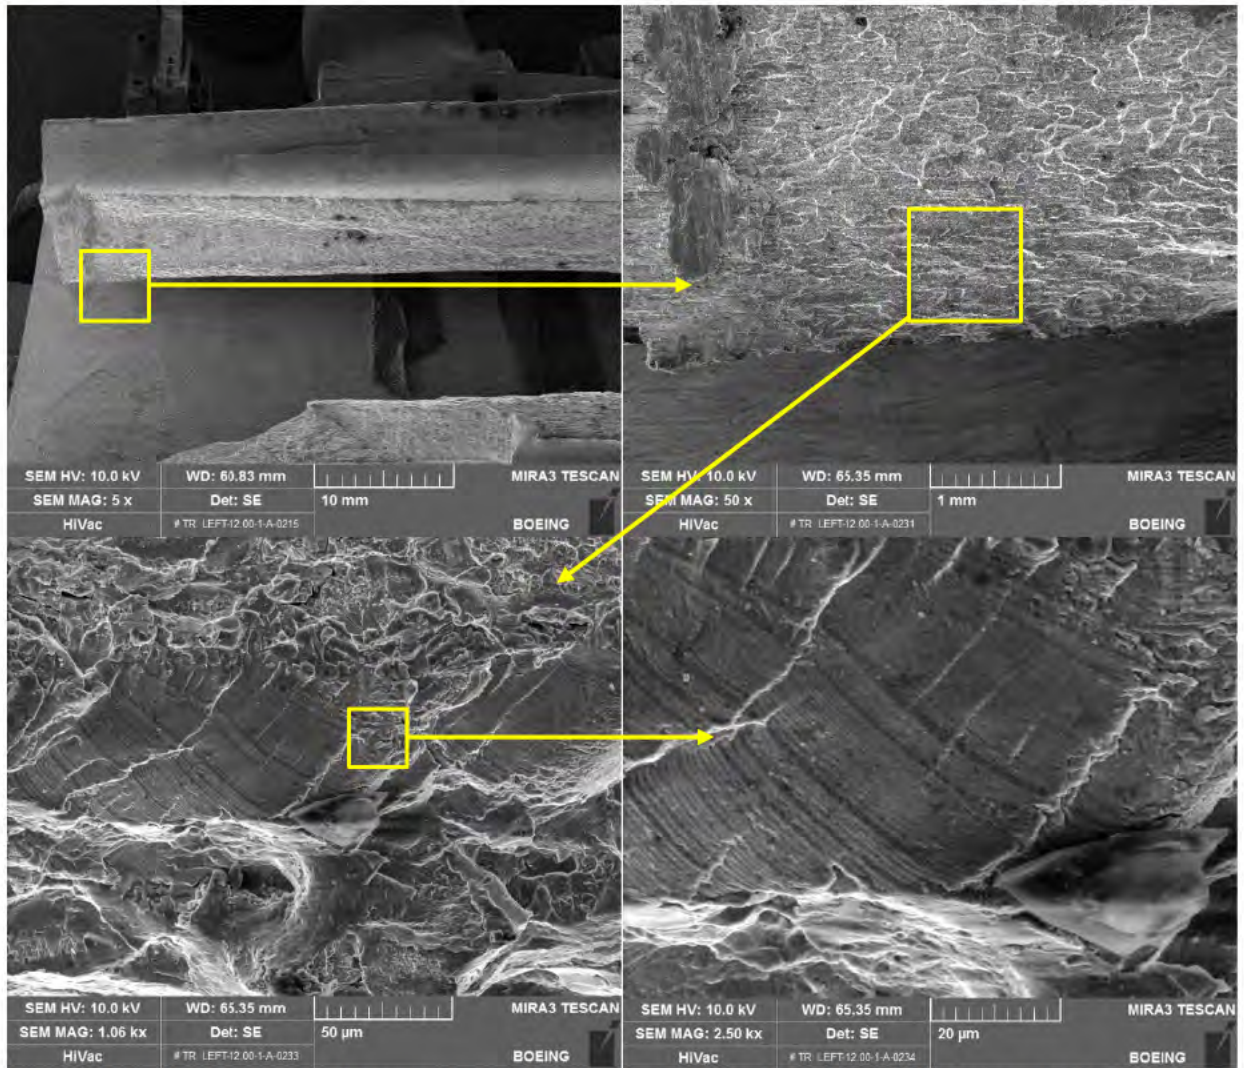
2. The fatigue in the Left Thrust Reverser 9:00 position section 1 was located in the lower region of the fracture and propagated in the down direction.

Figure 18. SEM images of increasing magnification of the Left Thrust Reverser fracture at 9:00, Section 1. These images are from the lower portion of the section, striations are clearly visible in the lower images, confirming fatigue as the fracture mode in this region.

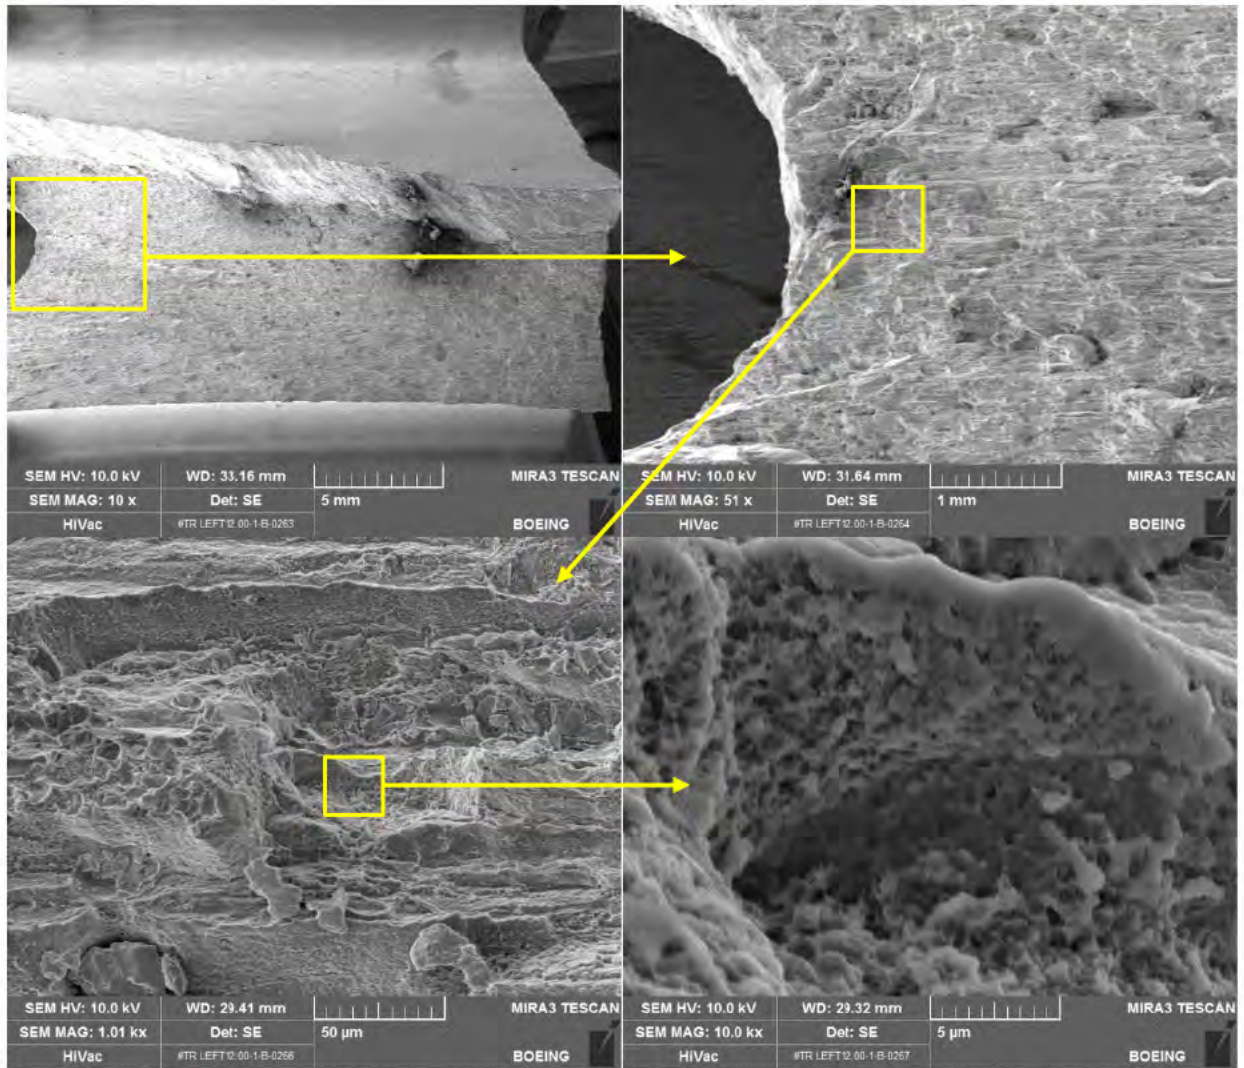
Figure 19. SEM images of increasing magnification of the Left Thrust Reverser fracture at 9:00, Section 1. These images are from the upper portion region of the section, where the fracture mode was ductile separation.

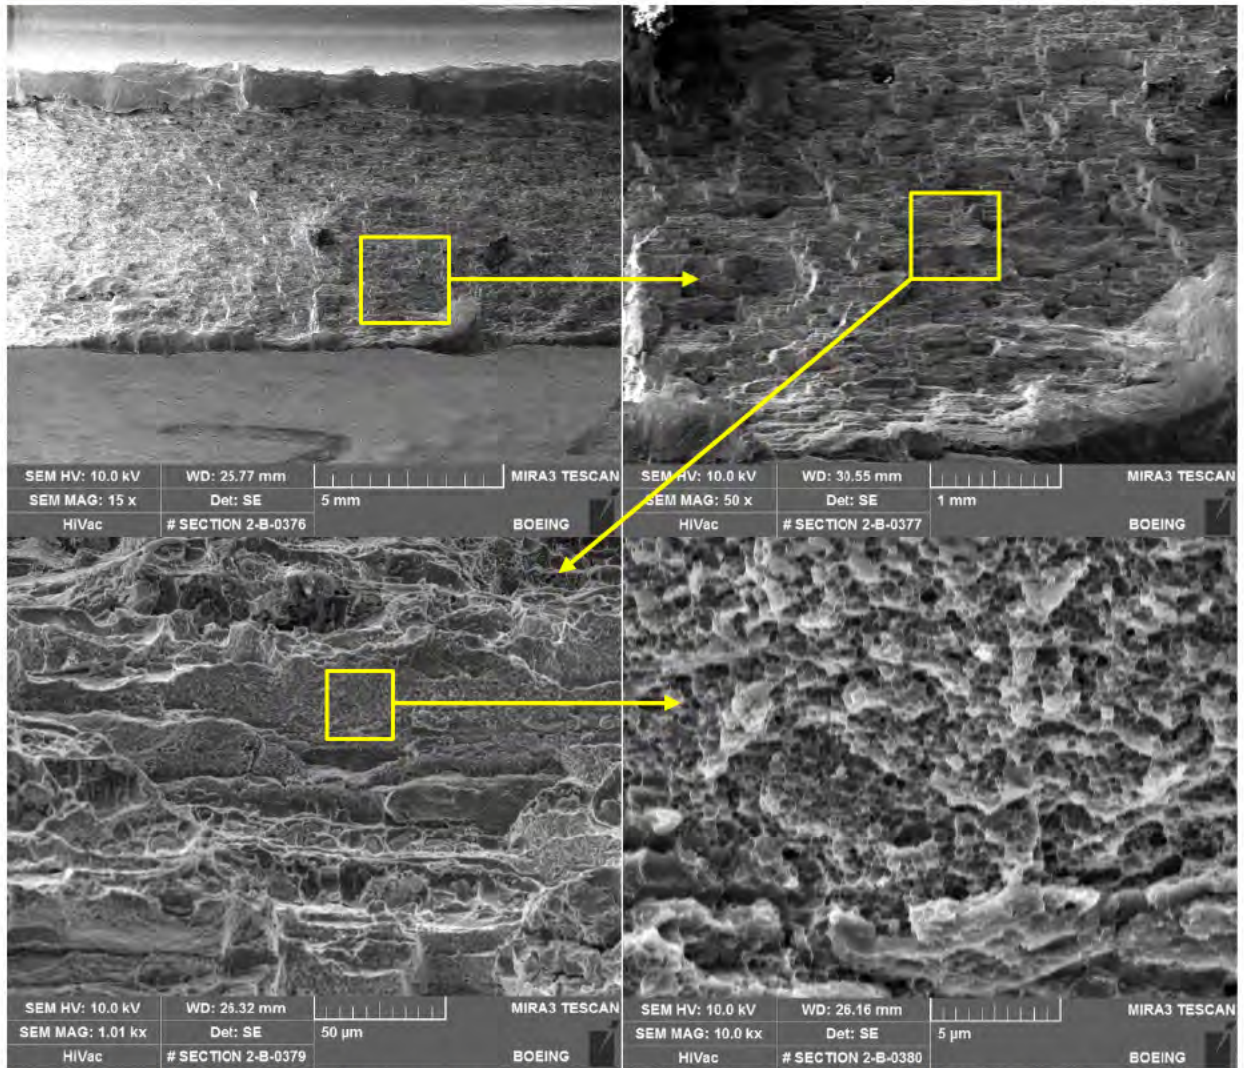
Figure 20. SEM images of increasing magnification of the Left Thrust Reverser fracture at 9:00, Section 2. The fracture mode visible was entirely ductile separation.

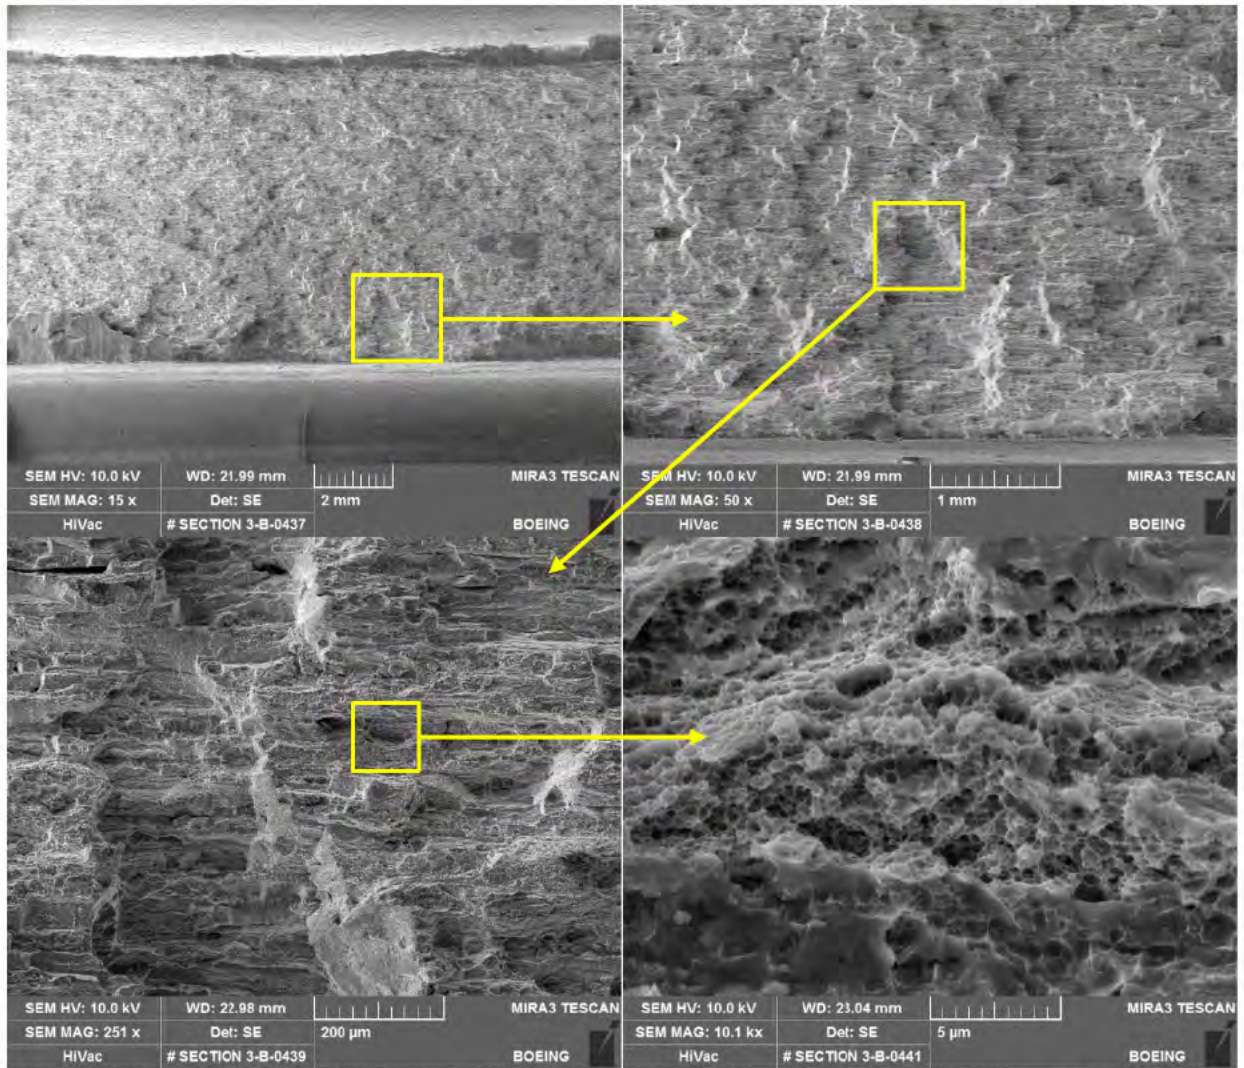
Figure 21. SEM images of increasing magnification of the Left Thrust Reverser fracture at 9:00, Section 3. The fracture mode visible was entirely ductile separation.

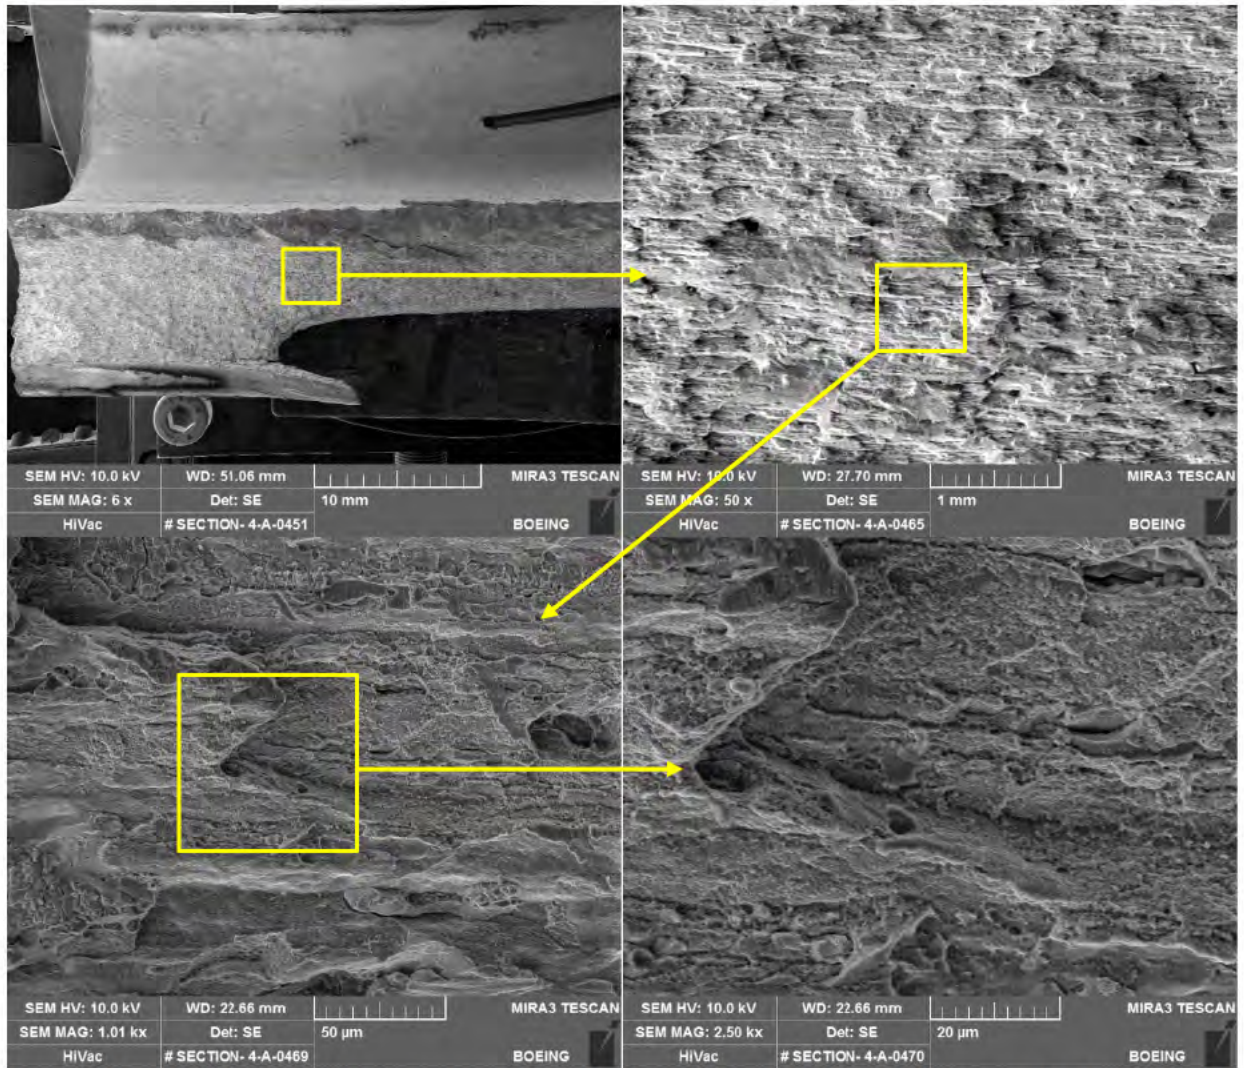
Figure 22. SEM images of increasing magnification of the Left Thrust Reverser fracture at 9:00, Section 4. Some portions of the fracture surface were obscured by post fracture damage, but where visible the fracture mode visible was entirely ductile separation.

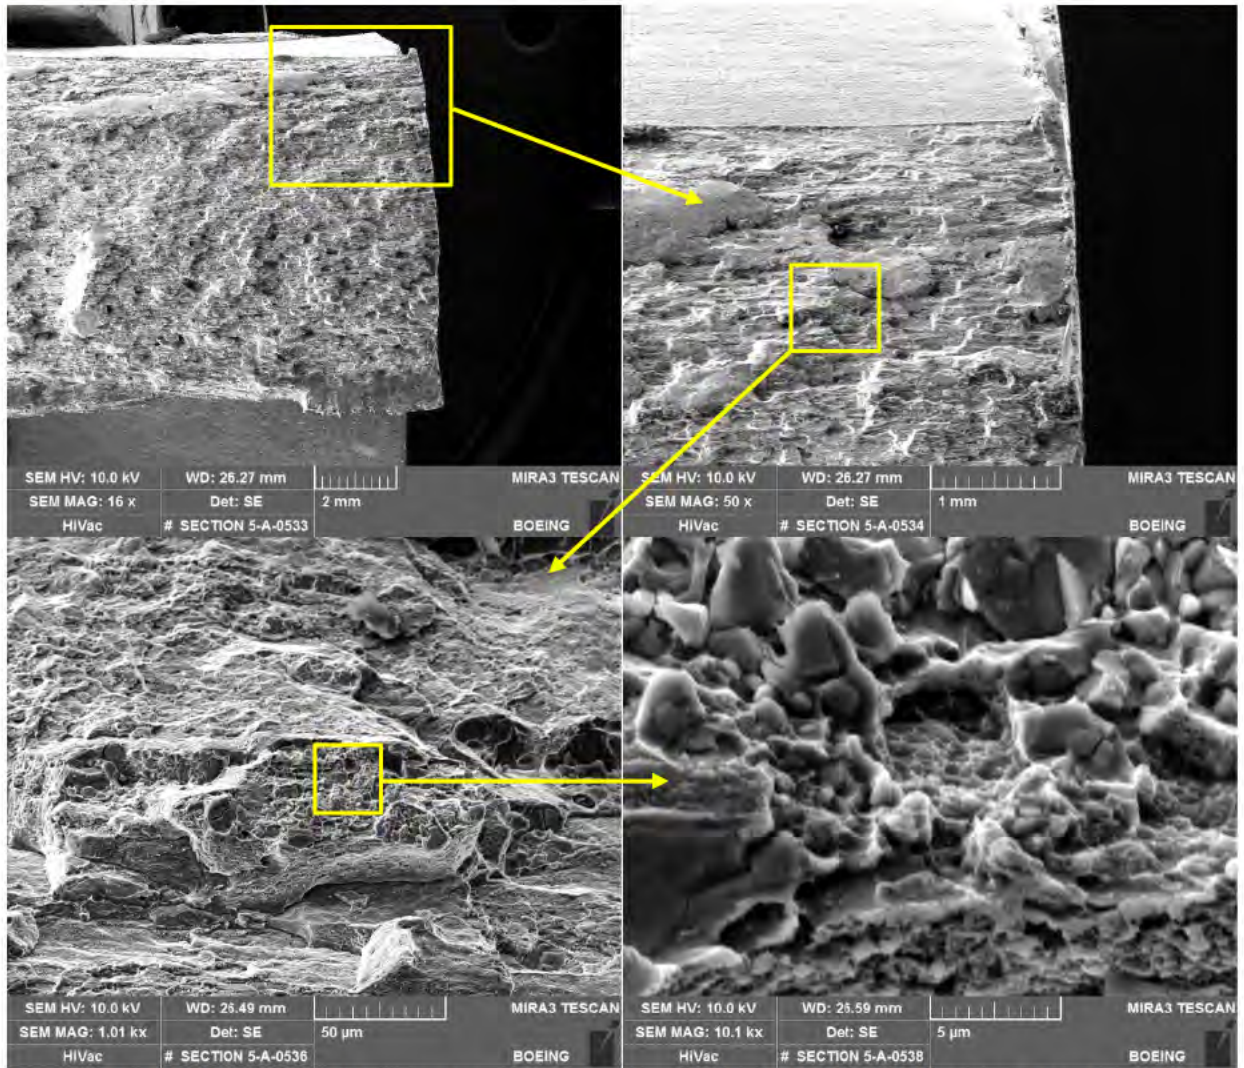
Figure 23. SEM images of increasing magnification of the Left Thrust Reverser fracture at 9:00, Section 5. The fracture mode visible was entirely ductile separation.

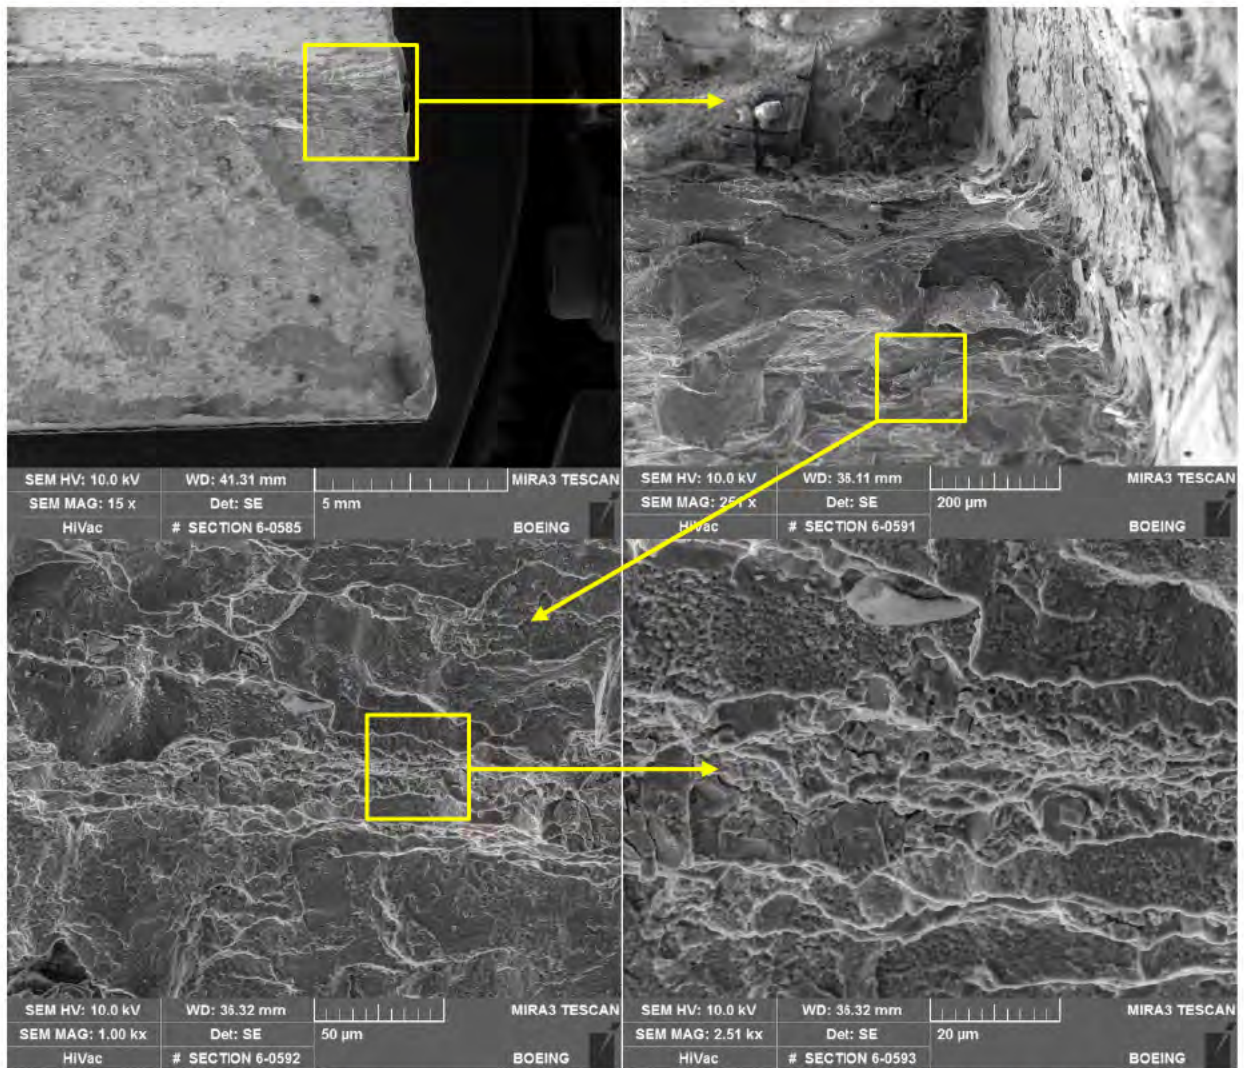
Figure 24. SEM images of increasing magnification of the Left Thrust Reverser fracture at 9:00, Section 6. Some portions of the fracture surface were obscured by post fracture damage, but where visible the fracture mode visible was entirely ductile separation.

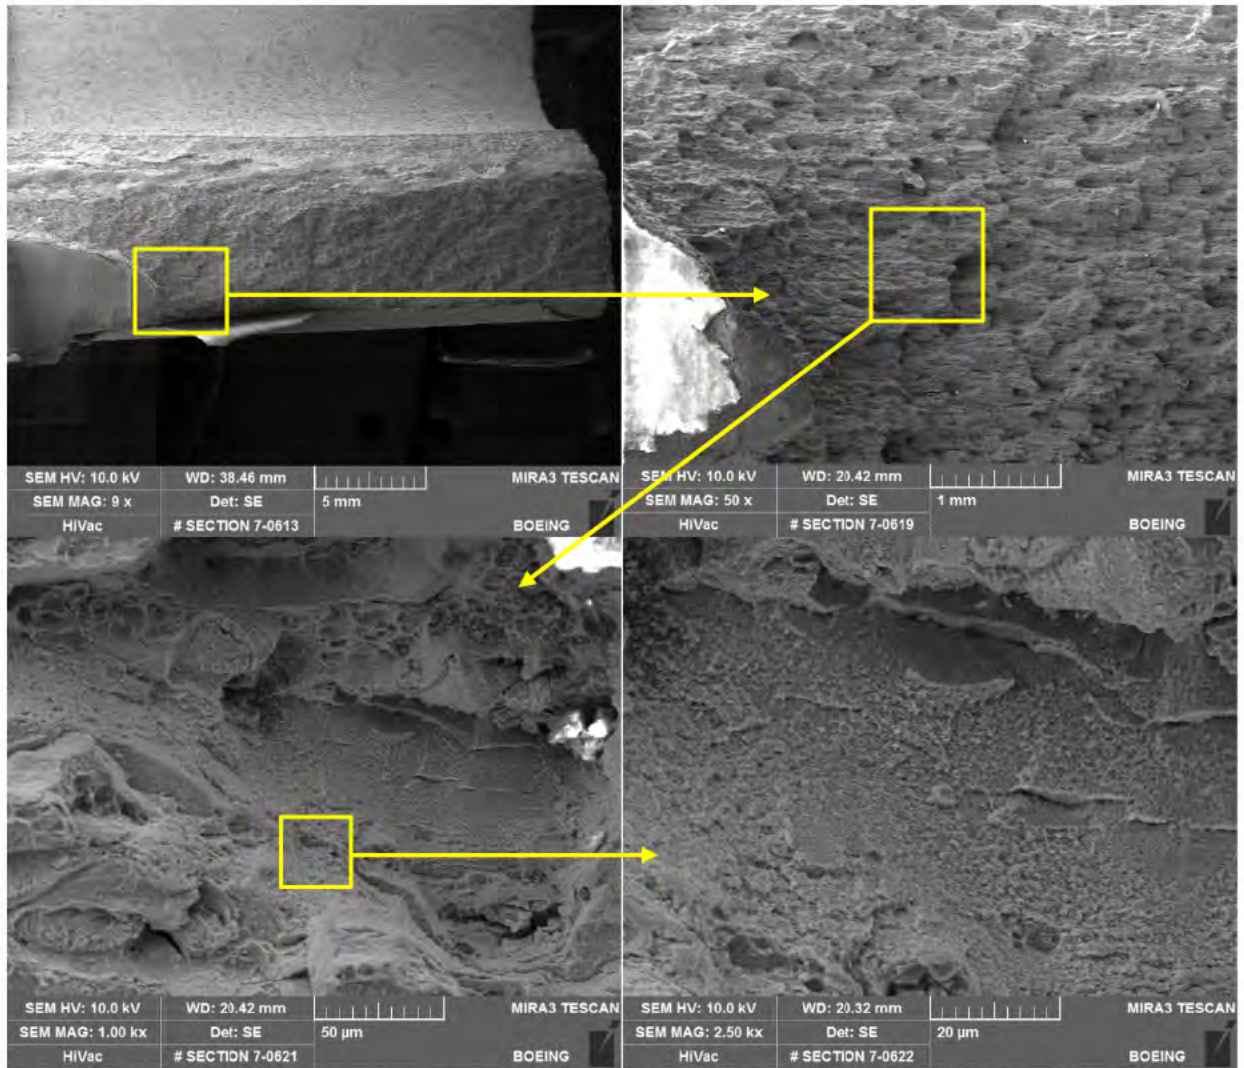
Figure 25. SEM images of increasing magnification of the Left Thrust Reverser fracture at 9:00, Section 7. The fracture surface were obscured by post fracture damage and oxidation, but appears consistent with ductile separation.

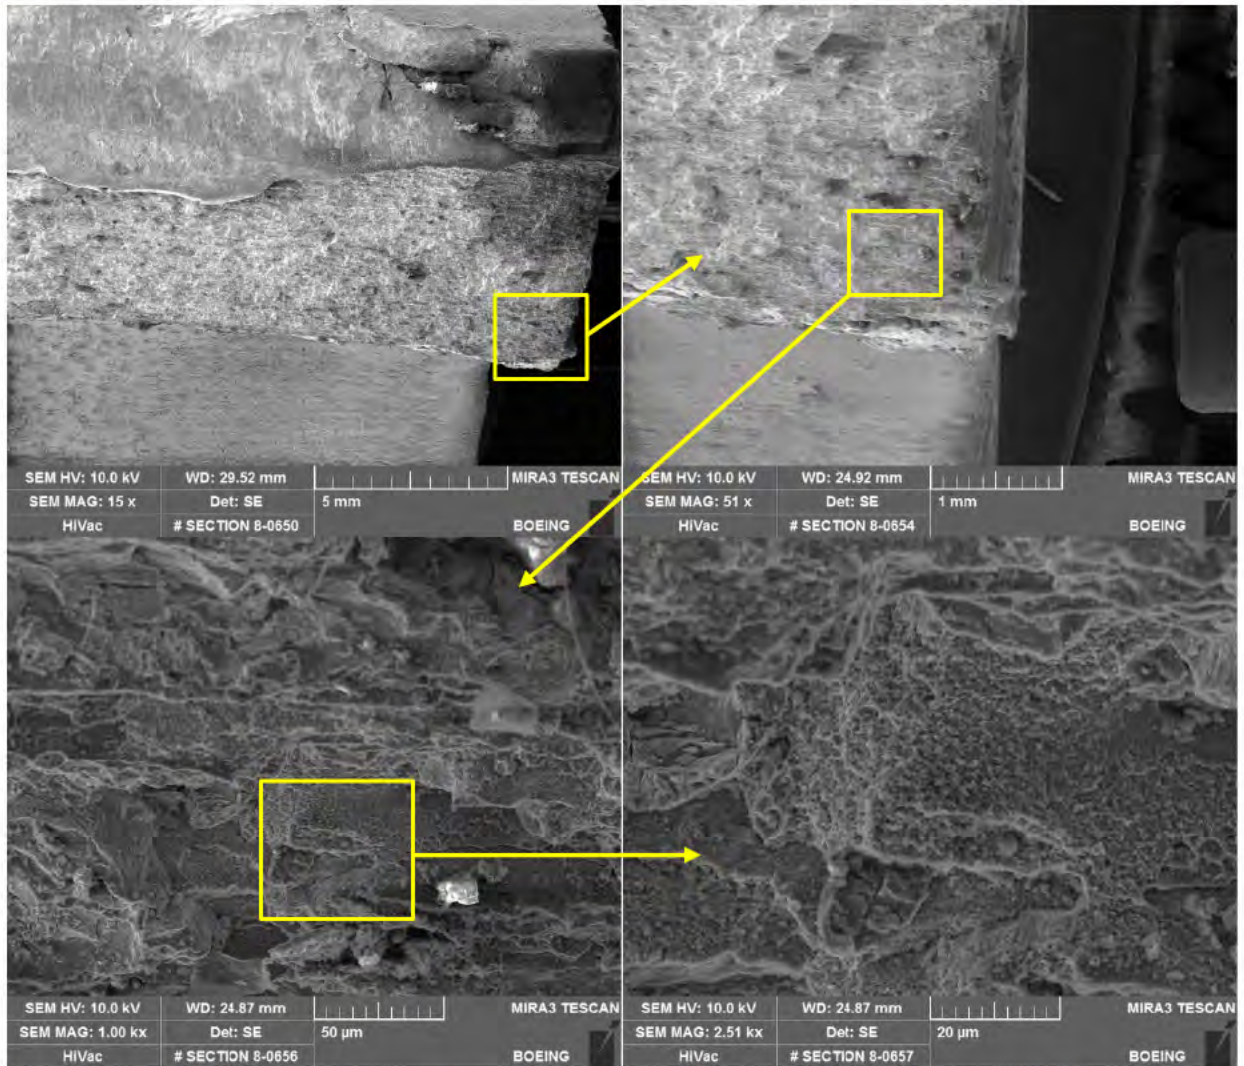
Figure 26. SEM images of increasing magnification of the Left Thrust Reverser fracture at 9:00, Section 8. The fracture surface were obscured by post fracture damage and oxidation, but appears consistent with ductile separation.

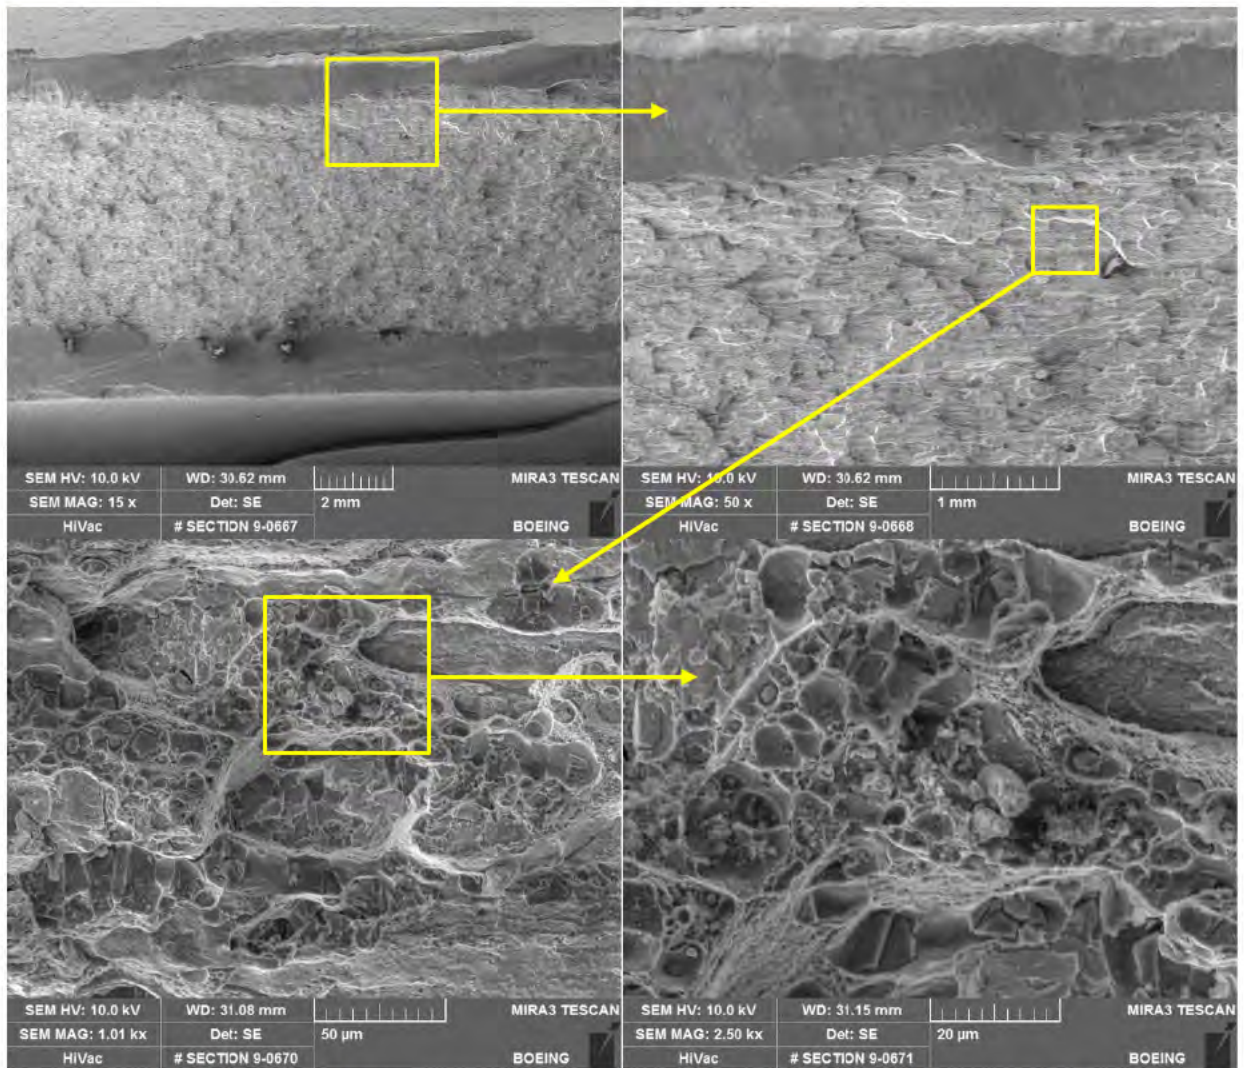
Figure 27. SEM images of increasing magnification of the Left Thrust Reverser fracture at 9:00, Section 9. Significant portions of the fracture surface were obscured by post fracture damage, but where visible the fracture mode visible was entirely ductile separation.
