NATIONAL TRANSPORTATION SAFETY BOARD

Group Chairman's Factual Report

DCA21FA085

SUBJECT: *Right Engine Fan Blade Out and Inlet/Fan Cowl Departure – Examination of recovered Inlet Cowl, Fan Cowls, and Thrust Reversers*

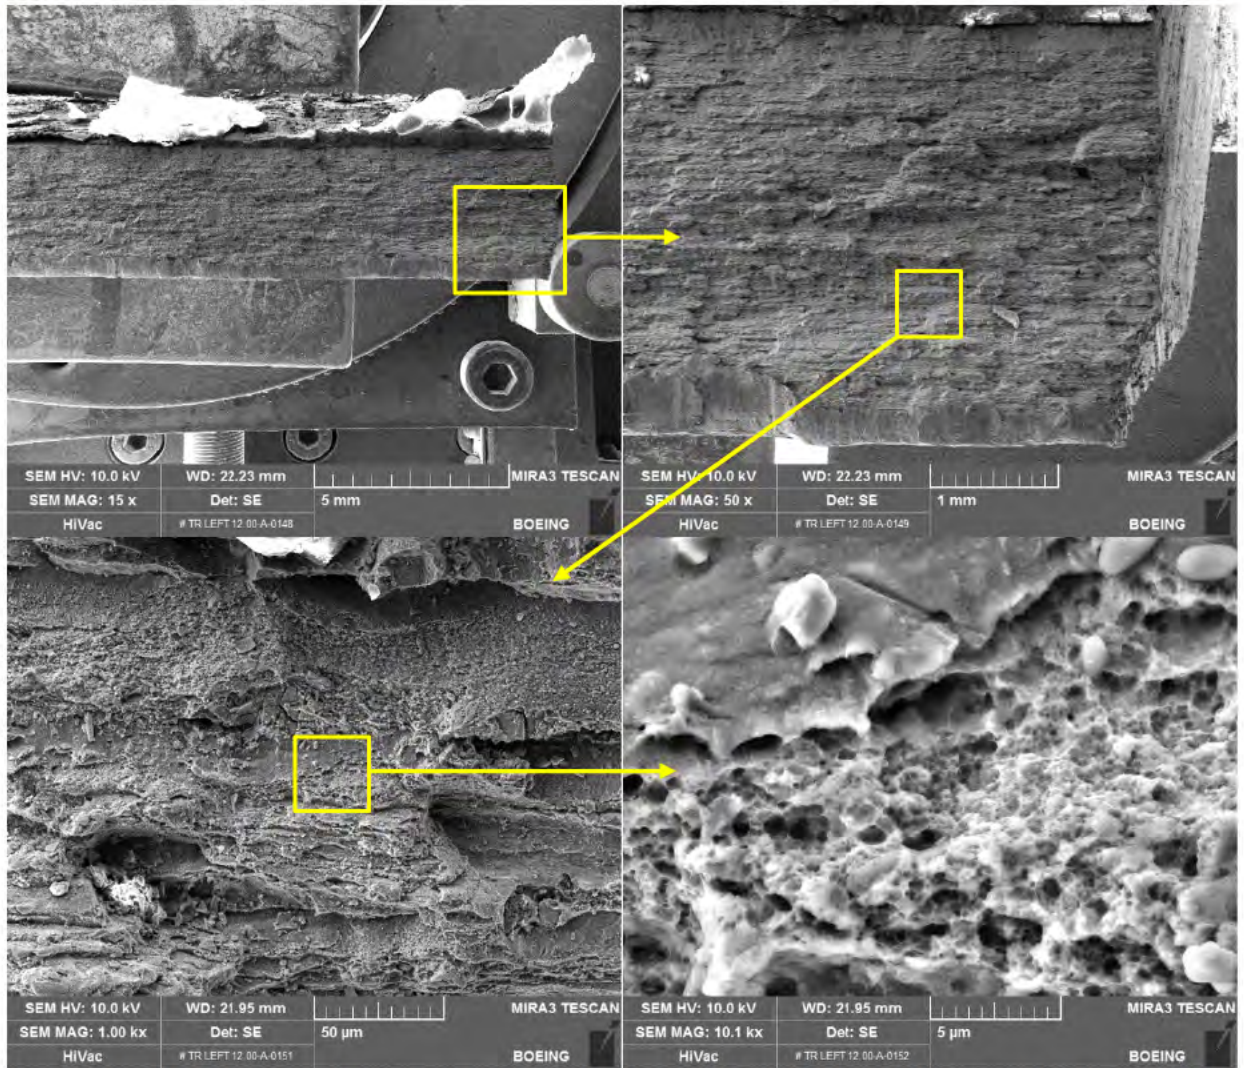
Figure 28 shows the smaller crack from the 12:00 location excised for examination. Figure 29 contains SEM images of the fracture surface of this portion of the crack. Some portions of the fracture surface were obscured by post fracture damage, but in the undamaged area the fracture mode was entirely ductile separation, consistent with a single event.

Figure 29. SEM images of increasing magnification of the Left Thrust Reverser fracture at 12:00. Some portions of the fracture surface were obscured by post fracture damage, but where visible the fracture mode visible was entirely ductile separation.

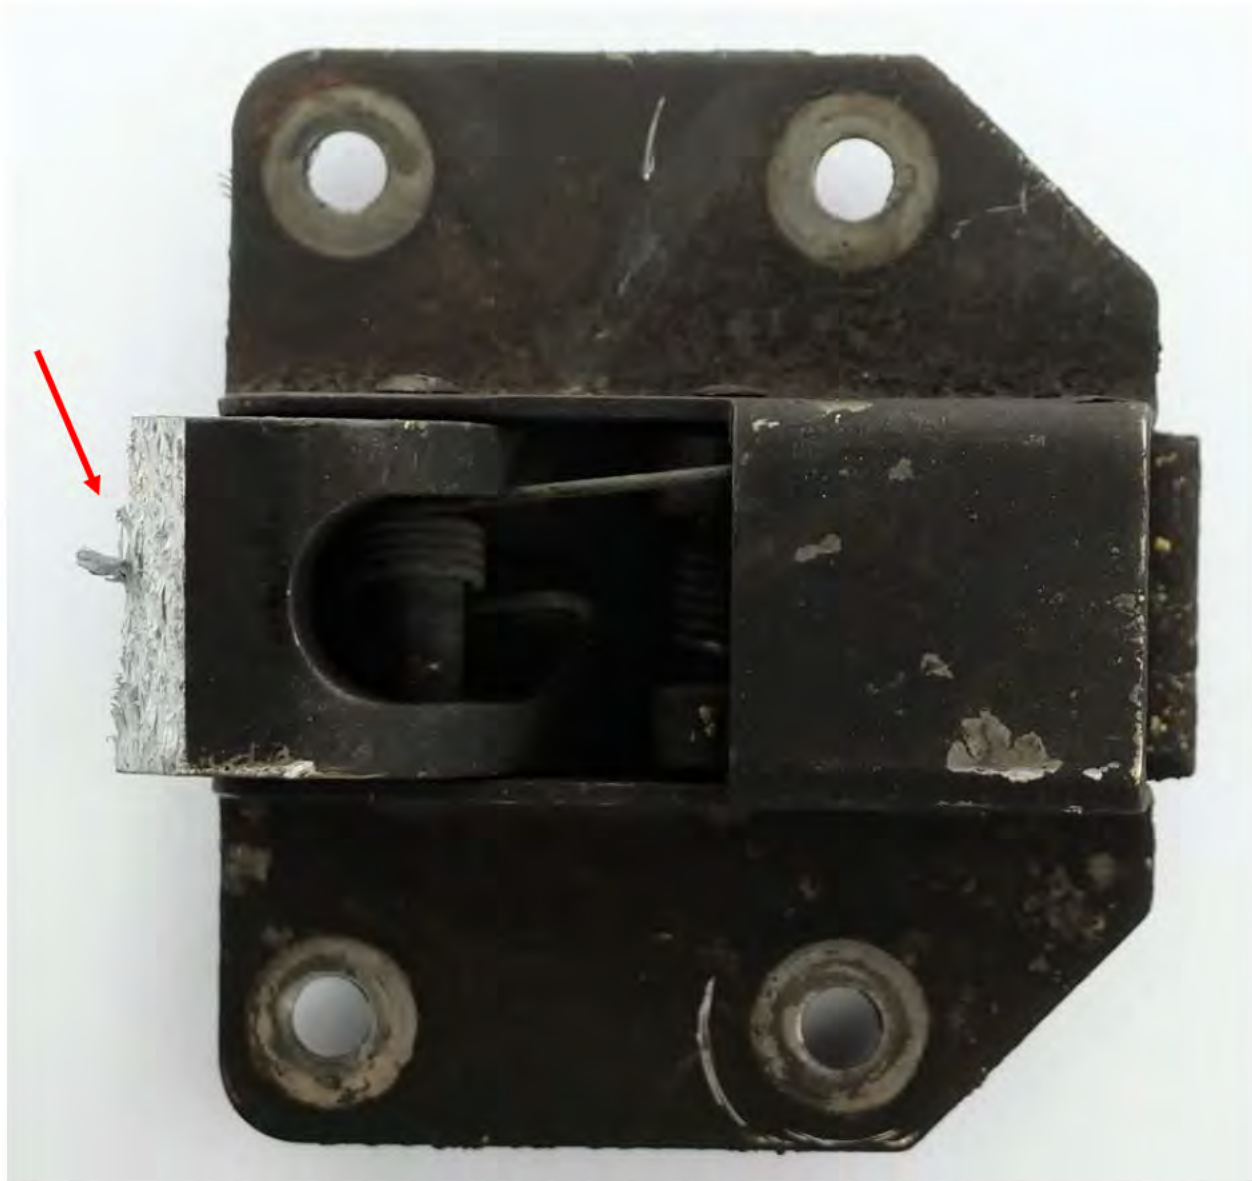
Three fractured components from drain access door assembly (P/N 315W3008-9) were removed from the structure for further evaluation. All showed significant discoloration from heat and/or soot (Figures 30, 32, and 34). SEM fractography confirmed ductile separation as the fracture mode in all fracture surfaces in the access door components (Figures 31, 33, and 35). EDS was used to check the chemistry of the access door components on the fracture surfaces. All were found to be similar to the drawing requirements, but did not exactly match the specifications, typical of fracture surfaces exposed to temperature and environment. Hardness and conductivity measurements were taken of the door components to evaluate the heat treatment. The Latch (P/N 9476-1) met the drawing requirements for 2024-T3511 aluminum. Both the Gooseneck Assembly (P/N 315W3422-12) and Depressor (P/N 315W3419-3) did not meet the requirements, which could indicate significant exposure to heat.

Figure 30. As received latch (P/N 9476-1) from Door Access Panel Assembly. The fracture is indicated by the red arrow.

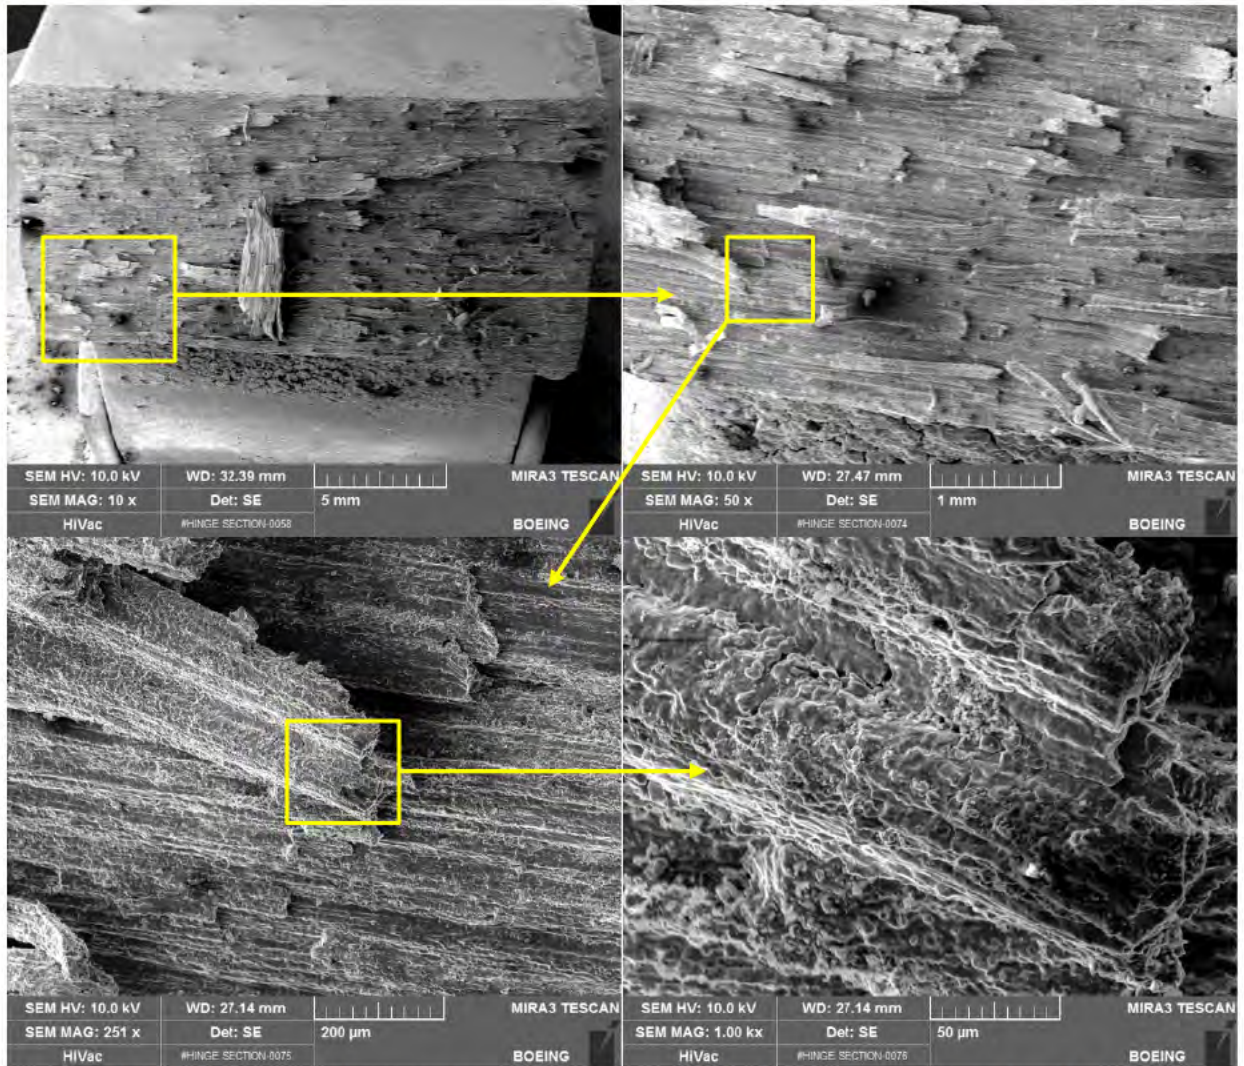
Figure 31. SEM images of increasing magnification of the fracture surface on the Door Access Panel Assembly latch. The fracture surface were obscured by post fracture oxidation, but appears consistent with ductile separation.

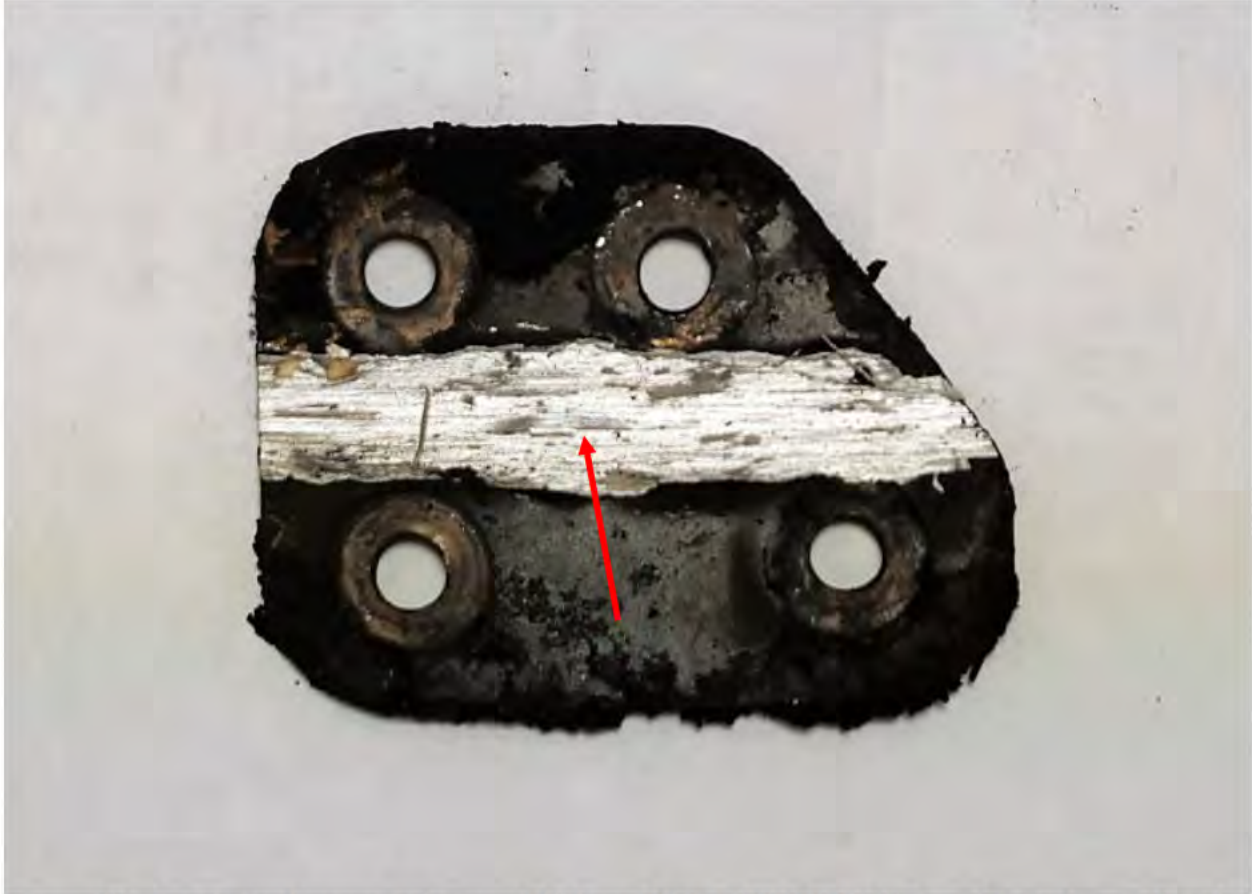
Figure 32. As received gooseneck assembly base (P/N 315W3422-13) from Door Access Panel Assembly. The fracture is indicated by the red arrow.

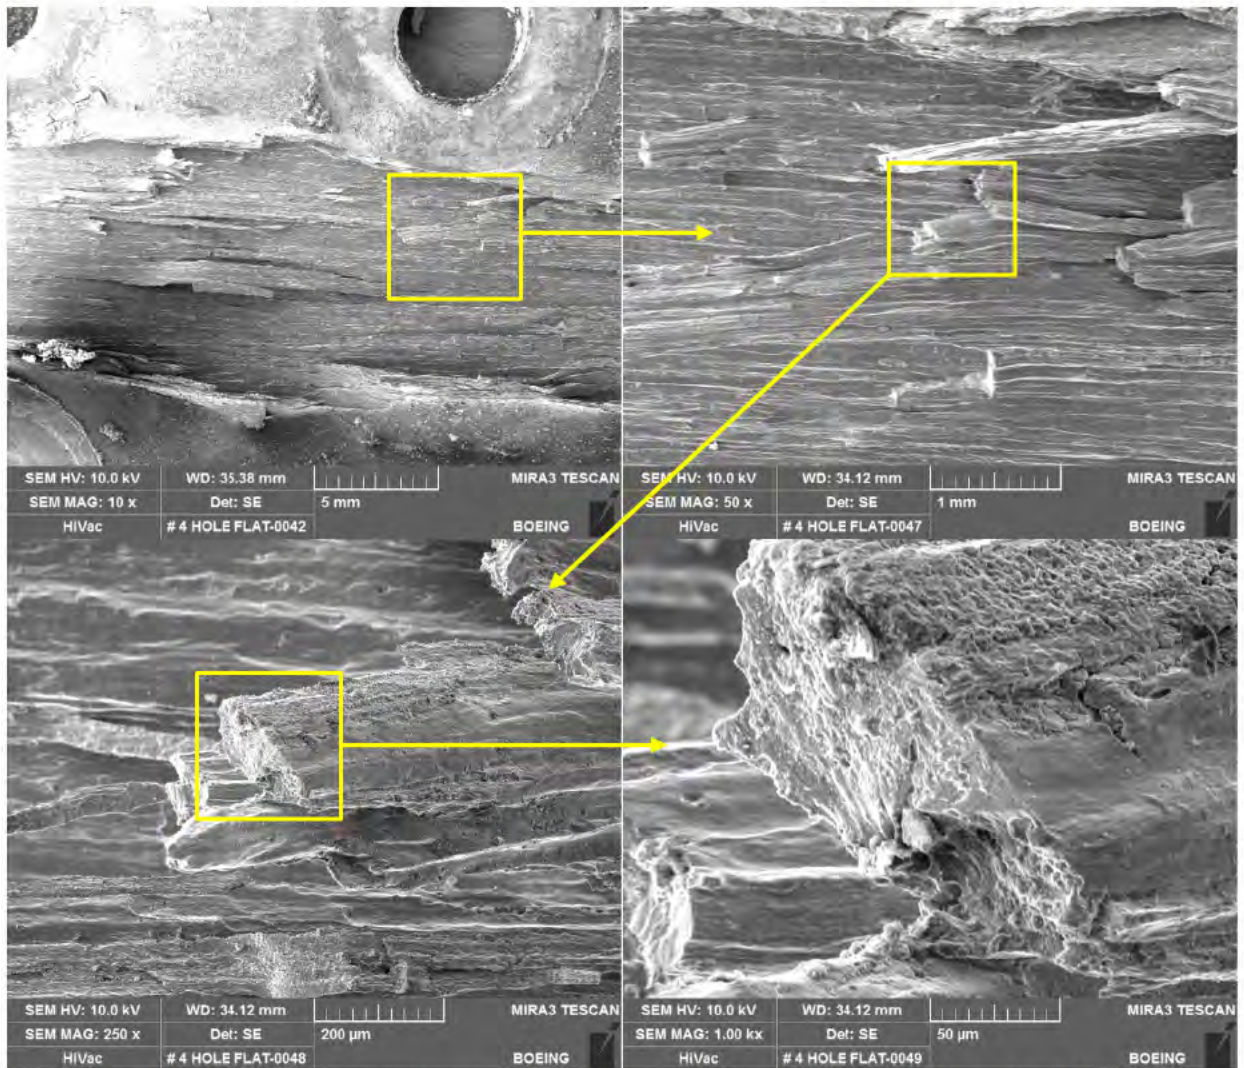
Figure 33. SEM images of increasing magnification of the fracture surface on the Door Access Panel Assembly gooseneck base. The fracture surface were obscured by post fracture oxidation, but appears consistent with ductile separation.

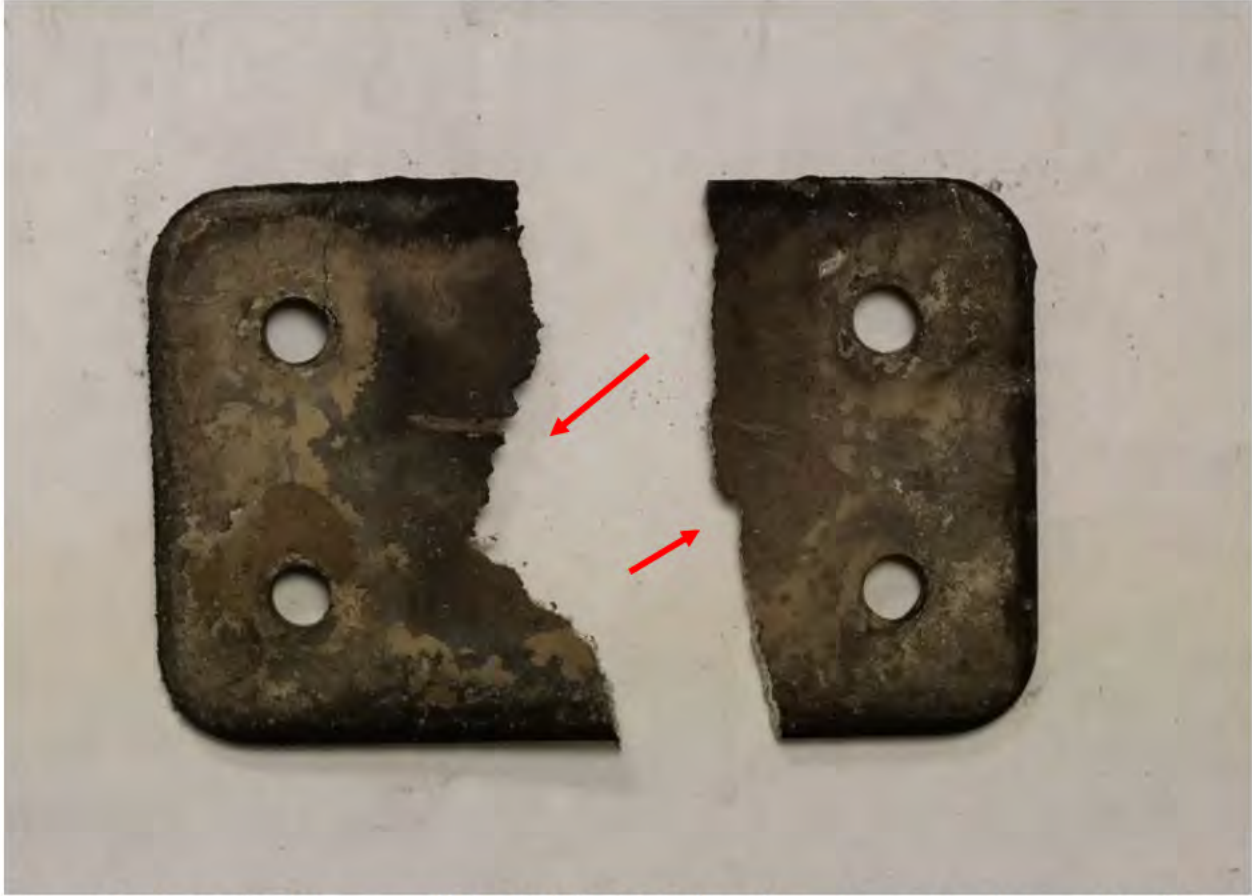
Figure 34. As received depressor (P/N 315W3419-3) from Door Access Panel Assembly. The fractures are indicated by the red arrows.

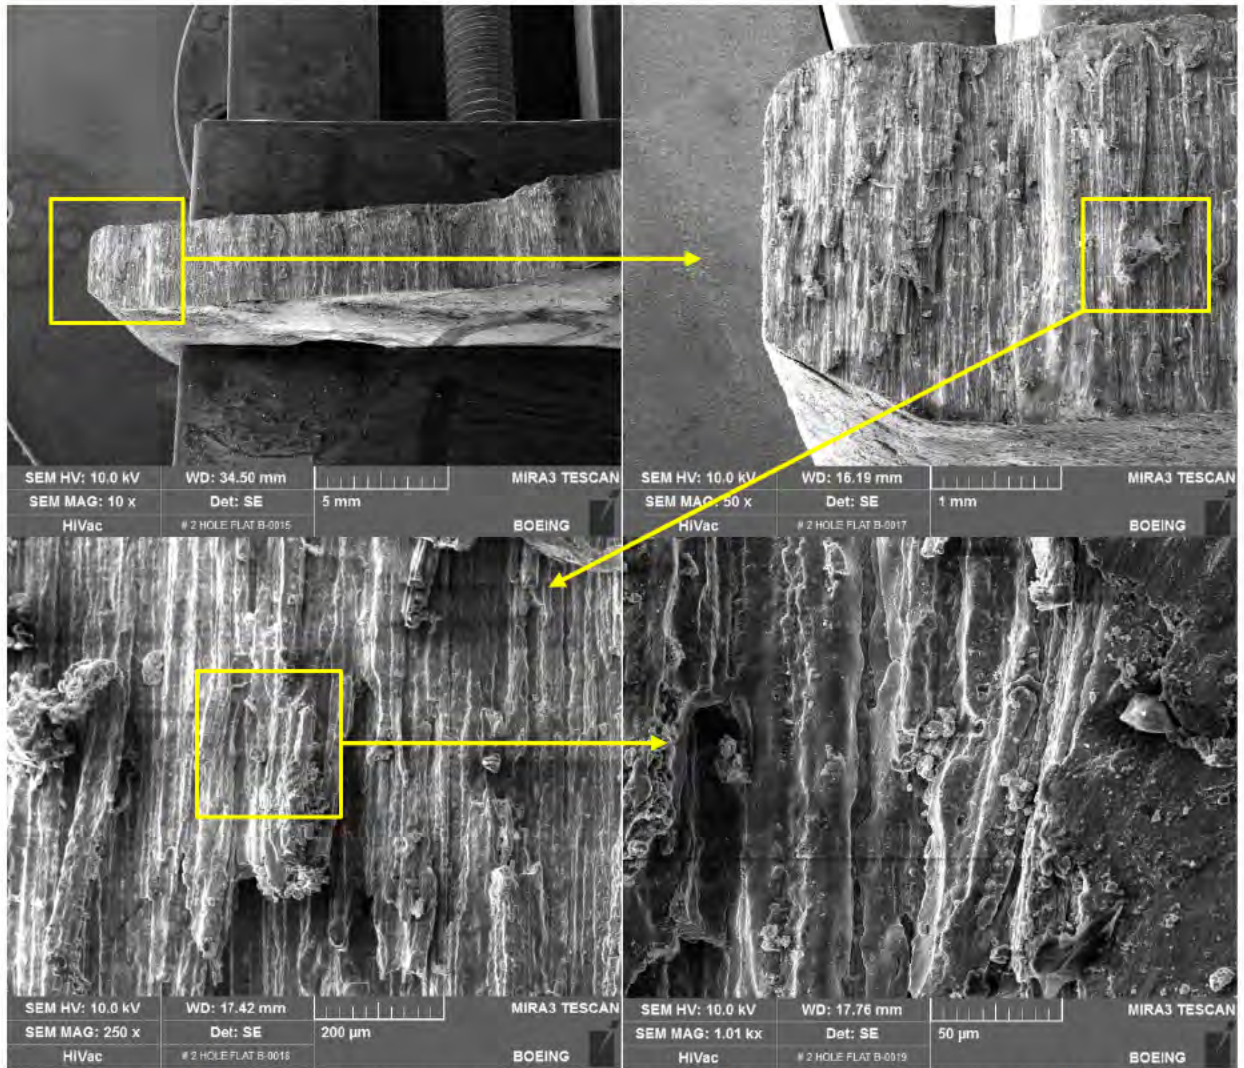
Figure 35. SEM images of increasing magnification of the fracture surface on the Door Access Panel Assembly depressor. The fracture surface were obscured by post fracture oxidation, but appears consistent with ductile separation.
