NATIONAL TRANSPORTATION SAFETY BOARD

Group Chairman's Factual Report

AIRWORTHINESS

DCA21FA085

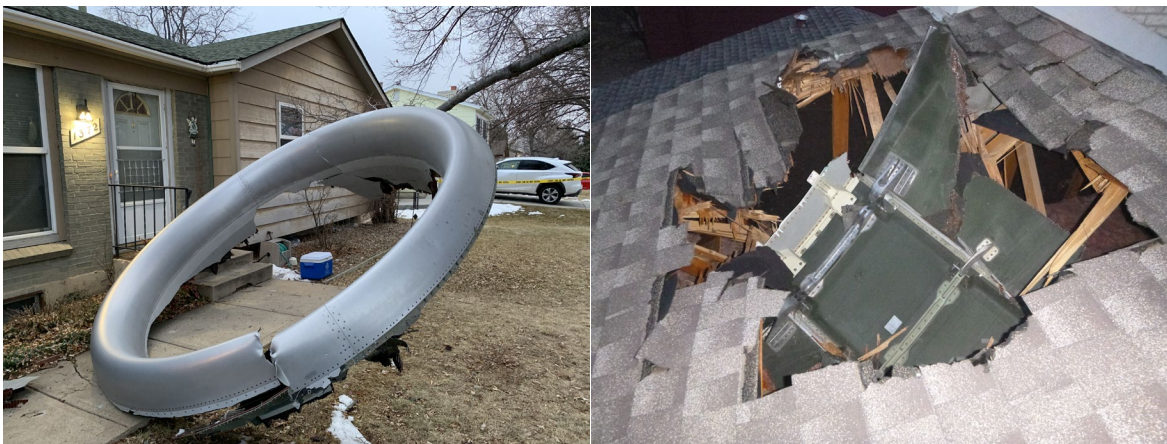
Figure 6 - Inlet lip skin(left) and fan cowl support beam (right) as found

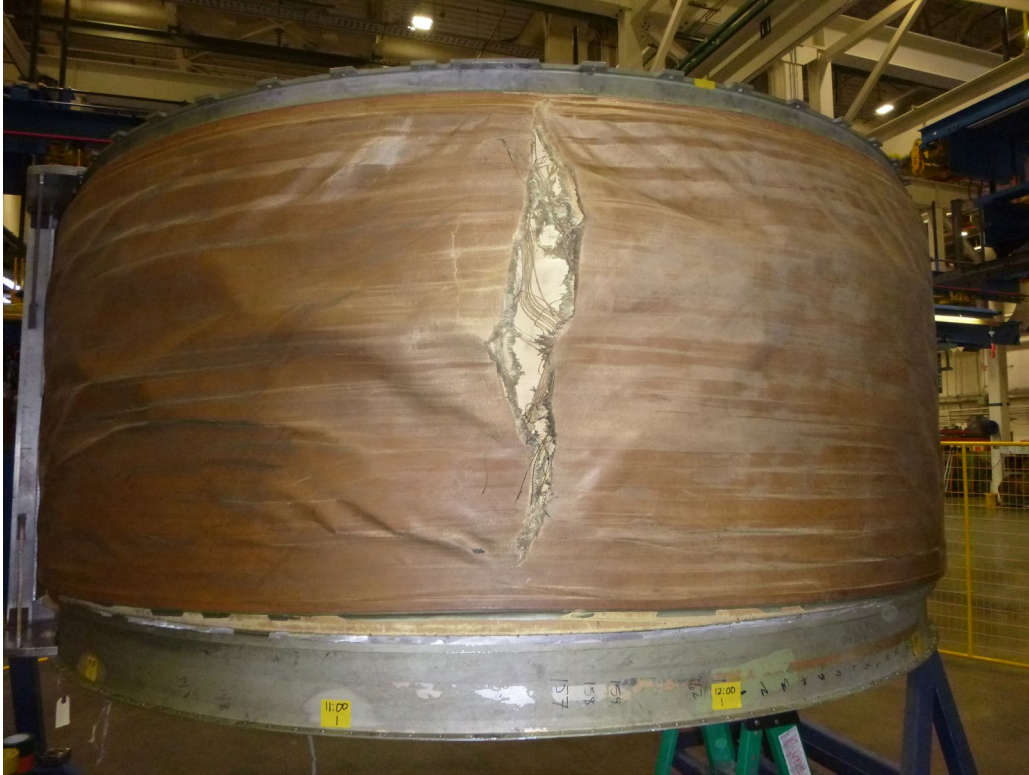
The outer two layers of the Kevlar® containment belt, inclusive of the environmental wrap, were torn with split and frayed fibers along the edges (Figure 8). The tear near the 11:30 position extended aft about 34 inches axially starting about 1 inch aft of the forward edge. There was a hole in the third layer of Kevlar® from the outside that measured about 5 inches axially and 3.5 inches circumferentially. All the remaining Kevlar® layers were penetrated by an embedded piece of fan blade that was centered about 15 inches aft of the A-flange near the 11:30 position. The hole through the layers measured 1 inch axially and 1.5 inches circumferentially. The Kevlar® containment belt layers were displaced outward about 3 inches from their nominal position with the blade fragment still in place.

The forward edge of the containment belt was displaced aft between 11:15 and 12:00 with a maximum displacement about 0.5 inch centered near 11:30 that cracked the sealant. The sealant bead on the aft edge of the containment belt was cracked and displaced forward from 9:00 to 1:30. The maximum displacement was about 1.75 inches between 11:15 and 11:45. The inner 3 layers of the containment belt remained in place while the rest were displaced forward. There was red sealant on the aft edge between 1:45 and 7:00 and between 8:00 and 9:45.

Figure 8 - Tear in outer layers of containment belt near 11:30 position

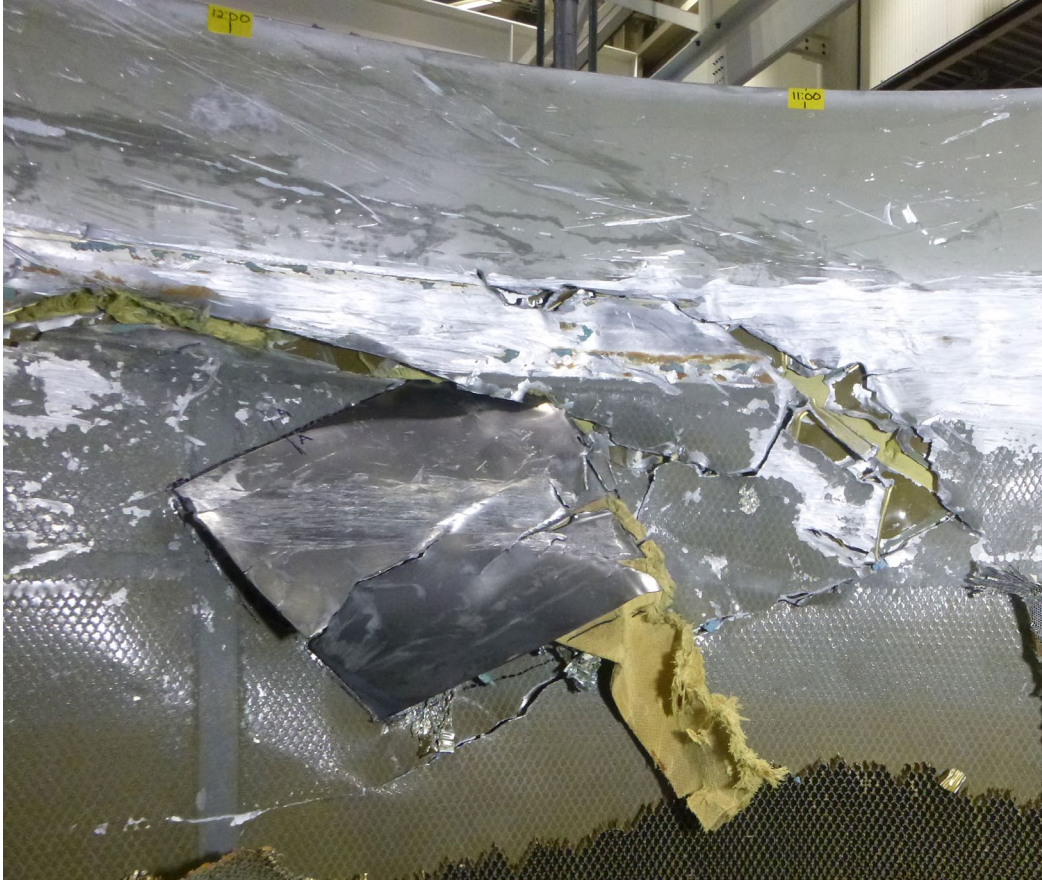
There was a rectangular puncture of the aluminum isogrid that measured 13.5 inches long by 1 inch wide oriented about 35° from the plane of rotation centered near 11:00. Sections of aluminum isogrid were missing adjacent to the puncture in an area about 11 inches by 5 inches. The forward end of the puncture was located about 13 inches aft of A-flange and the aft end of the puncture was located about 21.5 inches aft of A-flange. There was a fracture of the aluminum isogrid from the forward end of the puncture that extended about 13 inches circumferentially clockwise. There was a fracture of the aluminum isogrid from the aft end of the puncture that extended about 45 inches in the clockwise direction that was oriented about -23° from the plane of rotation. A section of fan blade about 18 inches spanwise by 16 inches chordwise was lodged in the aluminum isogrid between 11:15 and 12:05 (Figure 10). The radial axis of the fan blade was oriented about -30° from the plane of rotation. The fan blade piece orientation was leading edge forward and the root section leading with respect to rotation direction. There was a fracture of the aluminum isogrid extending about 45 inches circumferentially clockwise from the leading edge of the fan blade. There was a fracture of the aluminum isogrid about 5 inches long between the fan blade and the puncture described earlier from 10:45 to 11:15. The fan case was cut axially in two places from the A-flange aft to the embedded blade in order to remove the blade fragment.

Figure 10 - Fan blade fragment lodged in fan case

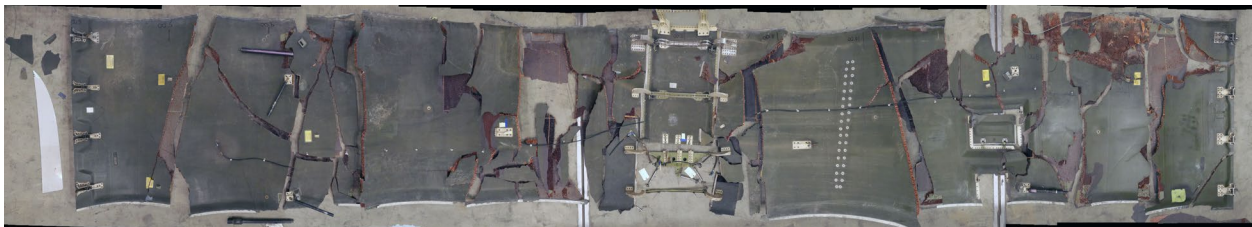
A majority of the inboard and outboard fan cowl doors were recovered but had fractured into many pieces. The recovered fan cowl door fragments were placed on the floor in a 2-dimensional reconstruction. The items were first reconstructed with the inner surface up and then turned over with the outer surface up. Figure 14 shows a stitched photo of the reconstructed fan cowl inner surface. Large format photos of both the inner surface and outer surface can be found in Appendix B. There was an area on the inboard fan cowl door near the forward edge between 6:30 and 8:30 that was visibly more fragmented than elsewhere. A small section of the leading edge in this area was found embedded in the wing-to-body fairing. The eye bolts on the center two latch keepers on the inboard fan cowl door were fractured. The forward and aft latch keepers were mostly intact. The fan cowl latches on the outboard fan cowl door were mostly intact.

Figure 14 - Fan Cowl reconstruction, inner surface

The fan cowl fragments were inspected for fluid ingress using a handheld infrared camera. One area had evidence of fluid ingress into the honeycomb located on the inboard fan cowl door near 10:30 where the strake was installed.

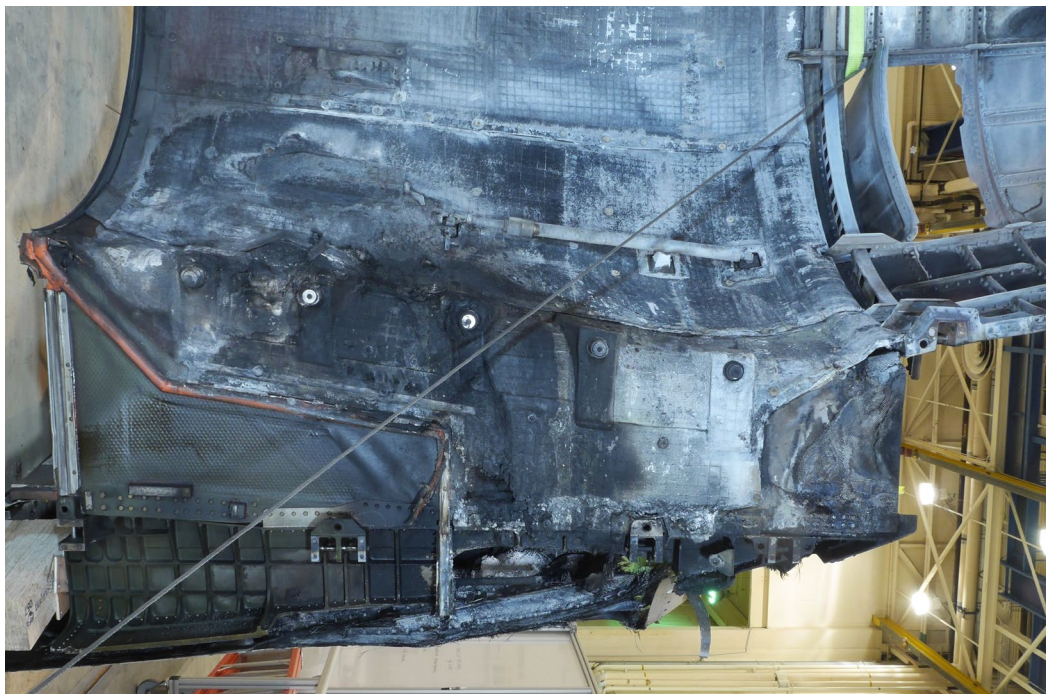
Figure 15 - Outboard thrust reverser lower bifurcation with blankets installed

The outboard TR inner wall with thermal blankets installed was sooted around the entire circumference with the heaviest signs of thermal damage being in the lower half. The inner wall thermal blankets were installed and mostly intact. The

blanket face sheet was sooted between about 12:00 and 3:00 and was charred between about 3:00 and 6:00. The aft end of the lower bifurcation aft of the thermal blankets was charred and the composite was delaminated. The lower bifurcation fire seal was mostly intact. The aft vertical leg of the lower fire seal was charred, detached, and partially missing. The upper bifurcation fire seal was intact and installed.

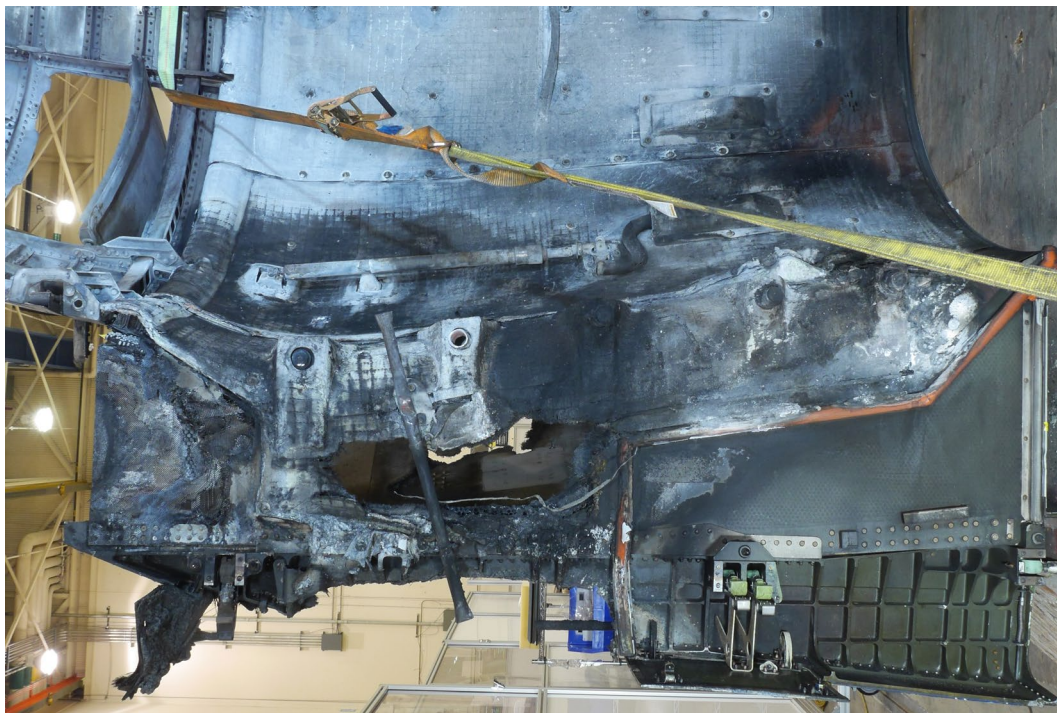
The inboard TR translating sleeve was missing the outer skin from about 11:00 to 6:00 from the leading-edge connection with the torque box to the aft edge of the translating sleeve inner cavity. The aftmost 26-inches of the outer skin of the translating sleeve remained. The upper portion of the outer skin panel between 11:00 and 12:00 remained attached at the aft and upper edges, but the leading edge was detached, separated, and peeled back from the torque box. The translating sleeve within the sleeve cavity was burned and charred with the inner skin and honeycomb completely burned away and the composite material delaminated. The heaviest thermal damage was between about 6:00 and 8:00. Almost all the cascades were missing between 6:00 and 12:00. Some small sections of the cascades at the forward edges remained. The CFRP honeycomb sandwich inner skin in the area of the missing cascade vanes was burned and delaminated. The outer face sheet was missing except for a section about 2-feet by 2-feet near 9:00 under the middle TR hydraulic actuator. The translating sleeve inner skin had three burn throughs in the area aft of the cascade vanes between about 7:00 and 11:30. The three holes measured 43-inches circumferentially by 7-inches axially between about 7:00 and 8:30, 48-inches circumferentially by 13-inches axially between about 9:00 and 11:00, and 14-inches circumferentially by 22-inches axially near 11:30. The aft 26-inches of the translating sleeve was intact, sooted, and mostly undamaged except for 6 small impact holes located randomly around the sleeve. The latch beam in the lower bifurcation had significant thermal damage and about 24-inches was missing in the area adjacent to the under cowl drain masts (Figure 16). There was metal slag deposited on the outboard face of the latch beam, the lower surface of the translating sleeve, and on the aft side of the torque box around and forward of the missing area.

Figure 16 - Inboard thrust reverser lower bifurcation with blankets installed

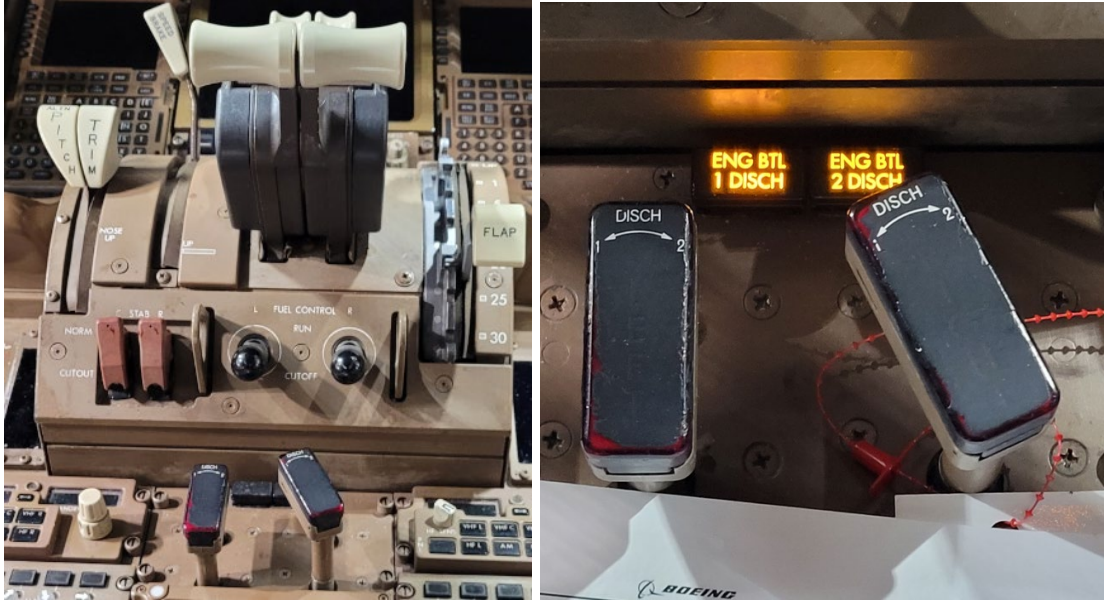
The right engine fire switch was observed in the flight deck P8 panel to be pulled and turned to the DISCH 1 position after the event (Figure 18). Both left and right engine fuel control switches were in the CUTOFF position. Both fire bottle discharge lights were observed to be illuminated when power was applied to the airplane.

Figure 18 - Engine Fire Switches on incident airplane

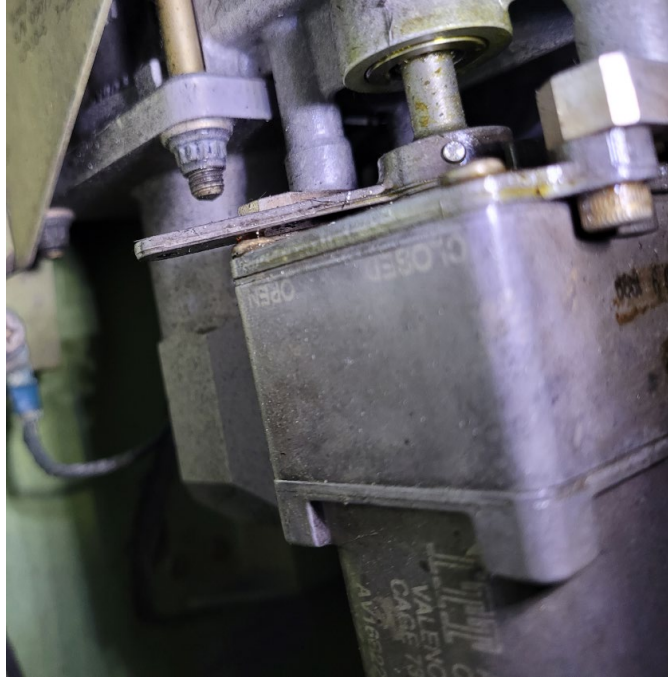
The right EDP Supply Shutoff Valve on the event airplane was observed to be in the OPEN position with the right engine fire switch pulled (Figure 20).

Figure 20 - Right Engine Driven Pump Supply Shutoff Valve on incident airplane

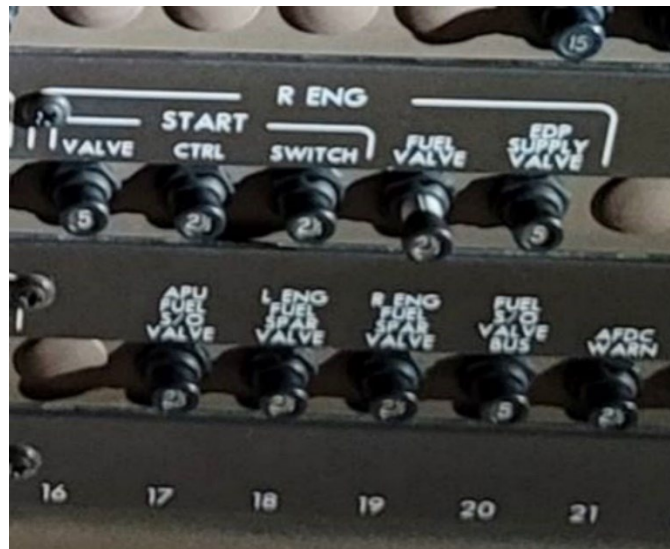
The circuit breaker (C29602 R ENG-EDP SUPPLY VALVE) associated with this valve was found to be in the closed position on the P11 overhead panel in the flight deck (Figure 21).

Figure 21 - Right EDP Supply Valve circuit breaker on incident airplane

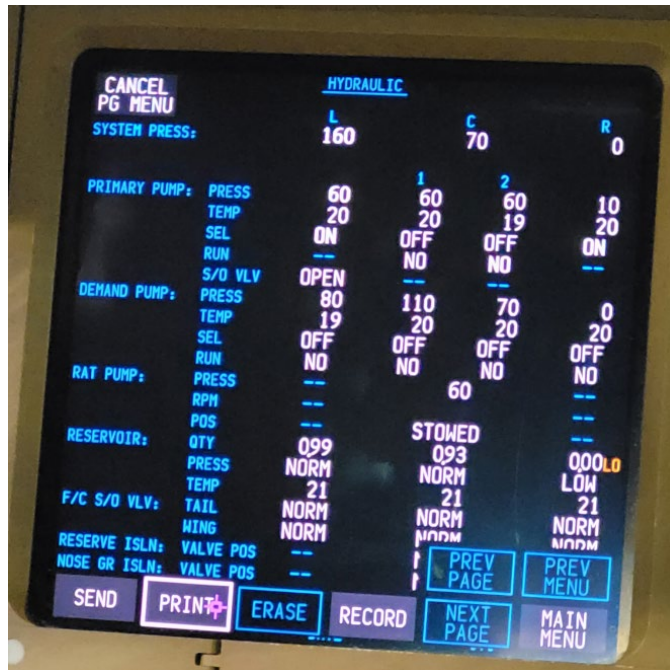
The ATA 29 maintenance page accessible from the primary display system in the flight deck showed blank for the R S/O VLV indication with circuit breaker C29602 in both the closed and open positions (Figure 22). Maintenance message 29-10750 "Supply shutoff valve (EDP R) is not in commanded position" was active in the central maintenance computer existing faults (Figure 23). The valve, P/N S271W741-22, S/N T50052, was removed and retained for further examination and testing. See the Systems Group Chairman's Factual Report for the details of the valve testing.

Figure 22 - ATA 29 Hydraulic System Maintenance page on incident airplane

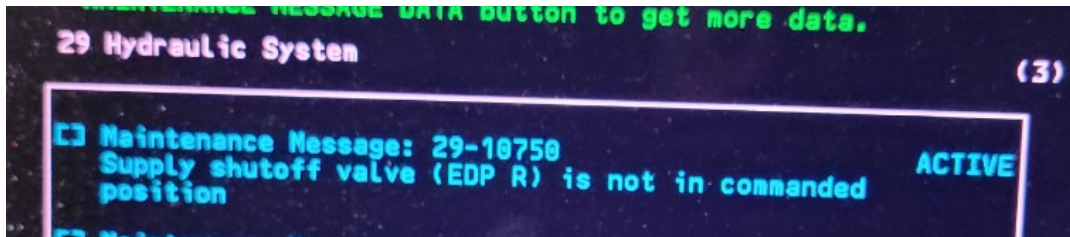
Figure 23 - Central Maintenance Computer message on incident airplane

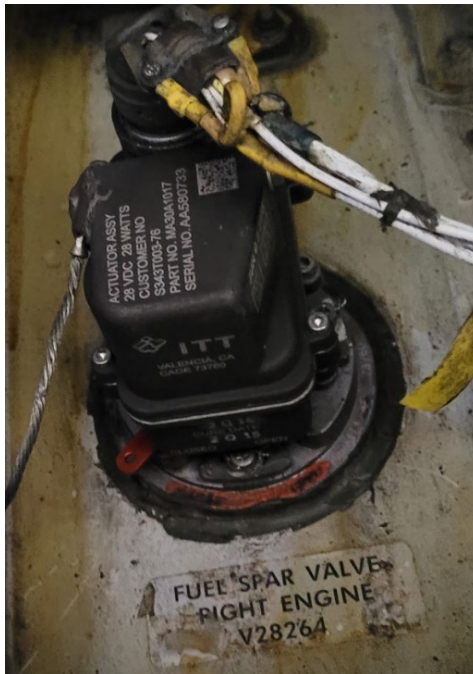
The fuel control switches control relays to open and close the fuel spar valves. The engine fire switch must be down to permit power to get through the relays to the spar valve. The fire switch also has a direct circuit to the spar valve. This closes the valve when the fire switch is pulled. The right fuel spar valve was found to be in the CLOSED position with the right engine fire switch pulled on the incident airplane (Figure 24).

Figure 24 - Right fuel spar valve on incident airplane

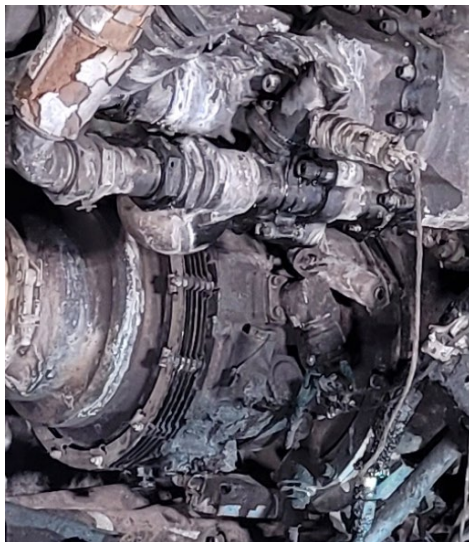
The engine main gearbox turns the EDP when the engine turns. A solenoid valve in each EDP controls the pressurization and depressurization of the pump. When the depressurization solenoid valve is not energized, pump pressure output goes to the hydraulic system. When the pump is turned off, the depressurization solenoid valve gets electrical power. The solenoid valve blocks the pump output flow when the pump is turned off. This blockage removes the pressure from the EDP. The right EDP depressurization solenoid valve on the right engine was damaged by fire and the wiring leading to the electrical connector was found to be broken (Figure 25).

Figure 25 - Solenoid valve on engine driven pump on incident airplane

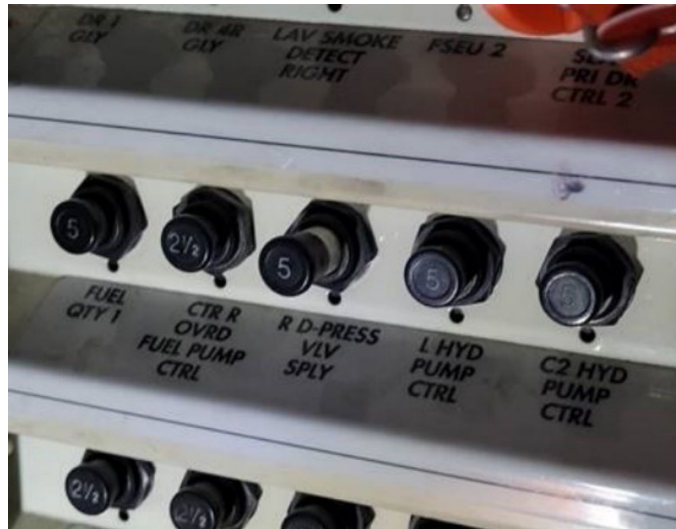
The circuit breaker (C29600 R D-PRESS VLV SPLY) for this valve was found to be tripped on the P210 panel in the EE bay (Figure 26).

Figure 26 - Depressurization solenoid valve circuit breaker on incident airplane

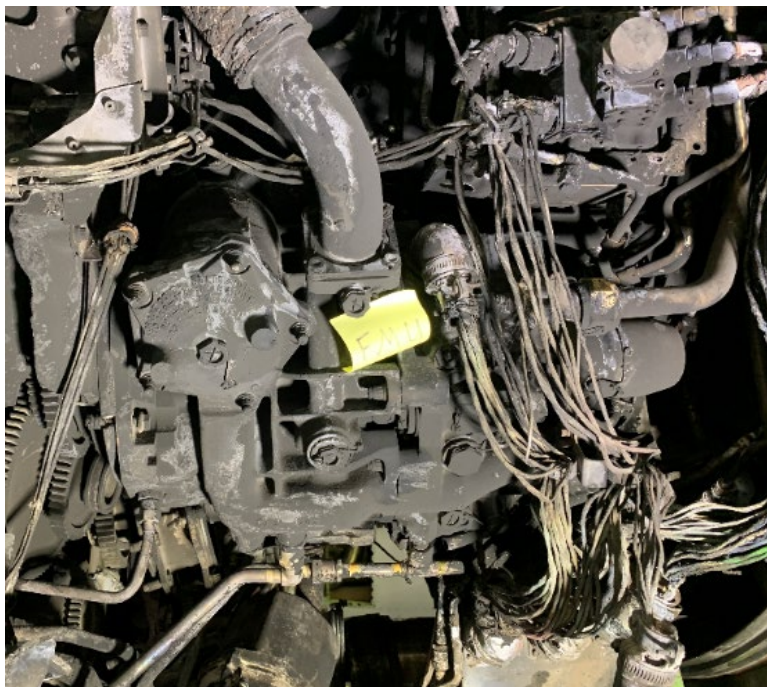
The fire switch permits FMU control power to go to the engine relay unit (ERU) when the switch is in its normal position (in). If the switch is pulled out, power connects directly to the FMU cutoff solenoid to stop metered fuel flow to the nozzles. The right engine FMU and associated wire harnesses were damaged by fire (Figure 27).

Figure 27 - Right engine fuel metering unit on incident airplane

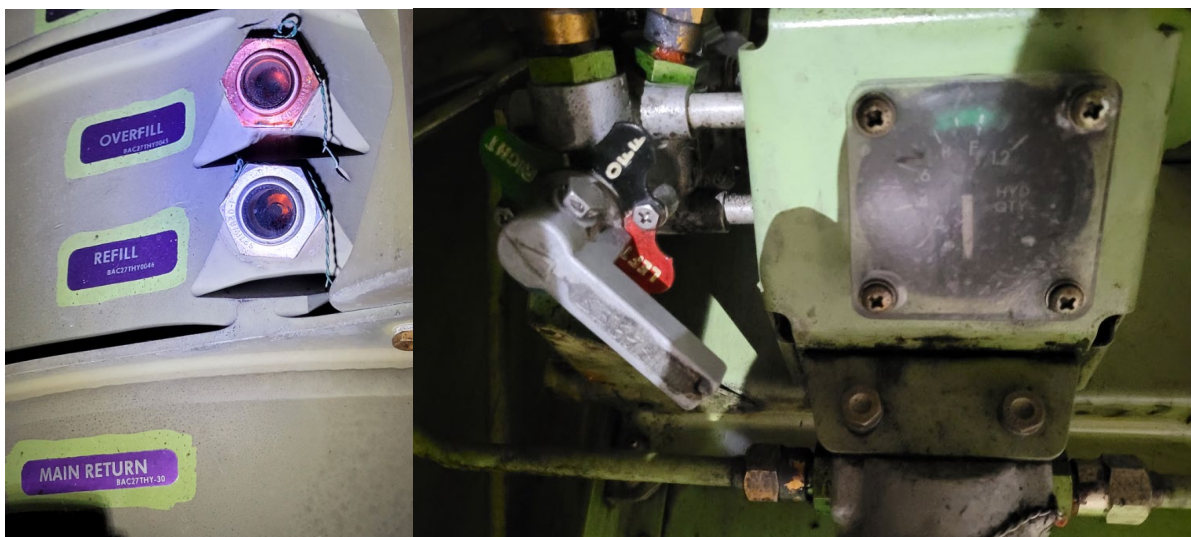
No fluid was observed in the upper and lower sight glasses of the right hydraulic system reservoir indicating the reservoir needs to be refilled. The reservoir quantity gage in the ground service bay also indicated a quantity of 0 when the right hydraulic system was selected (Figure 28). The ATA 29 maintenance page showed a right hydraulic reservoir quantity of 0.00 and an amber LO indication (Figure 22) when examined about 24 hours after the incident. The right hydraulic system continued to operate throughout the flight. A reservoir quantity about 90-95% was recorded at the time of the engine failure and a quantity about 65% was recorded at the time of the landing.

Figure 28 - Right hydraulic system reservoir (left) and quantity gage (right) on incident airplane

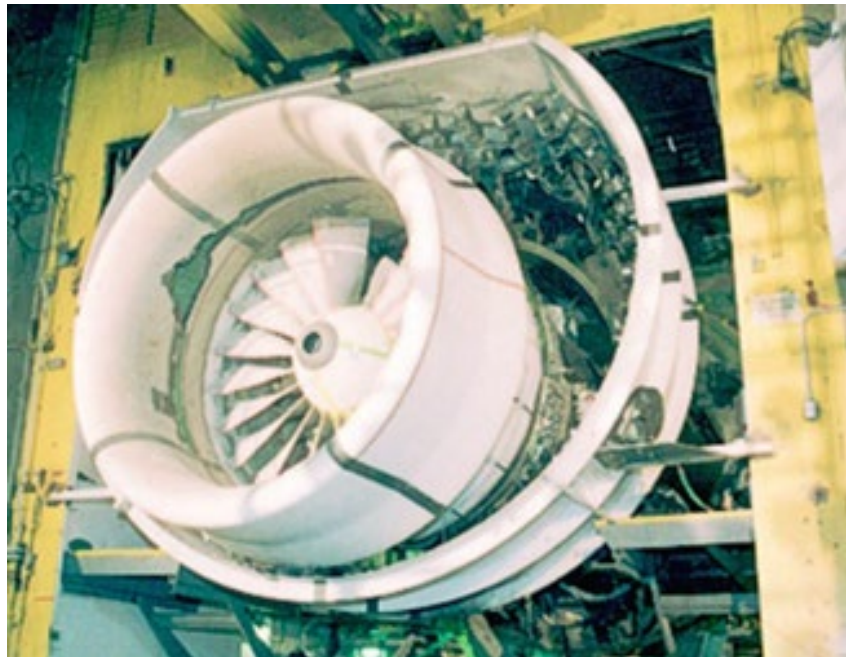
test, the inlet installed was of a different design than the production inlet and included an aluminum aft bulkhead, instead of the CFRP aft bulkhead, and a fiberglass and aluminum outer barrel, instead of the CFRP outer barrel installed on production units. During the test the intended blade was released near the blade root and a portion of the following blade also fractured and separated. The containment case successfully retained the blade fragments. Within about two revolutions after blade release, fan blade segments traveled forward of the fan case, sliced through and separated about half of the inlet inner barrel, and one blade fragment exited the inlet inner and outer barrels (Figure 29). After design changes and analysis to show the observed failure effects relevant to 14 CFR Part 33 compliance were addressed to the satisfaction of the FAA Engine Certification Office, the engine was approved without repeating the fan blade out test. However, at least some of the other failure effects observed in that test that were relevant to the airplane compliance with 14 CFR Part 25 do not appear to have been brought to the attention of the FAA Seattle Aircraft Certification Office. At the time, there was no anticipated transmittal of impact displacements from the Kevlar® wrapped containment case to the inlet while the loss of the inner barrel load path from a single fan blade fragment was anticipated.

Figure 29 - Certification FBO test engine and inlet damage

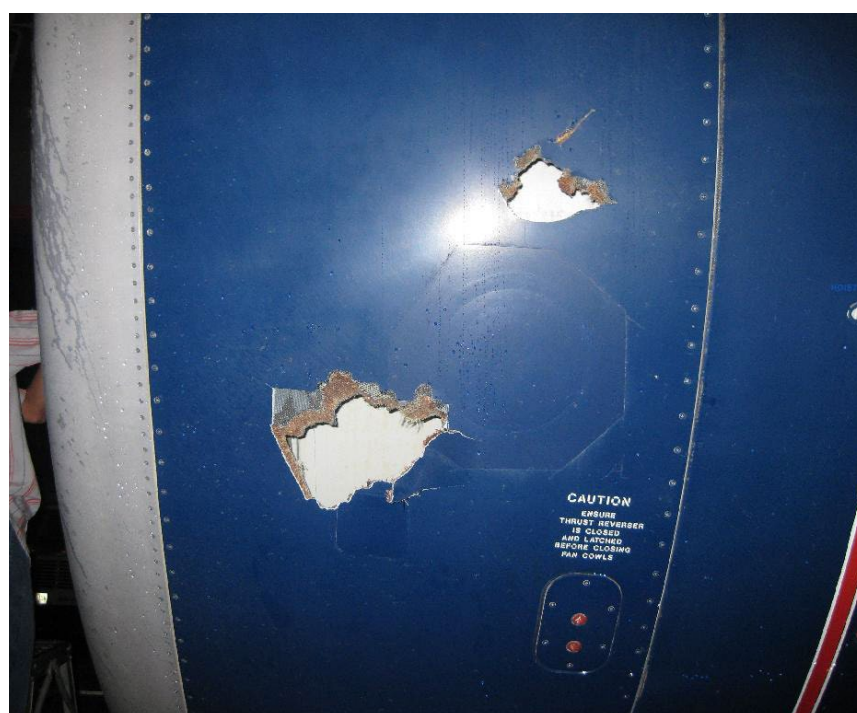
fragments traveled forward of the fan case. The inlet inner barrel had damage around about half the circumference and was penetrated in 3 locations. The inlet outer barrel was penetrated in two places in the lower outboard quadrant (Figure 30). Several fan exit guide vanes also separated during the event, damaging the thrust reversers. The inlet and fan cowls did not separate from the airplane during the event. The NTSB was notified of the event and gathered data but did not perform an investigation due to the lack of substantial damage received by the airplane.

Figure 30 - UAL 2 inlet outer barrel punctures

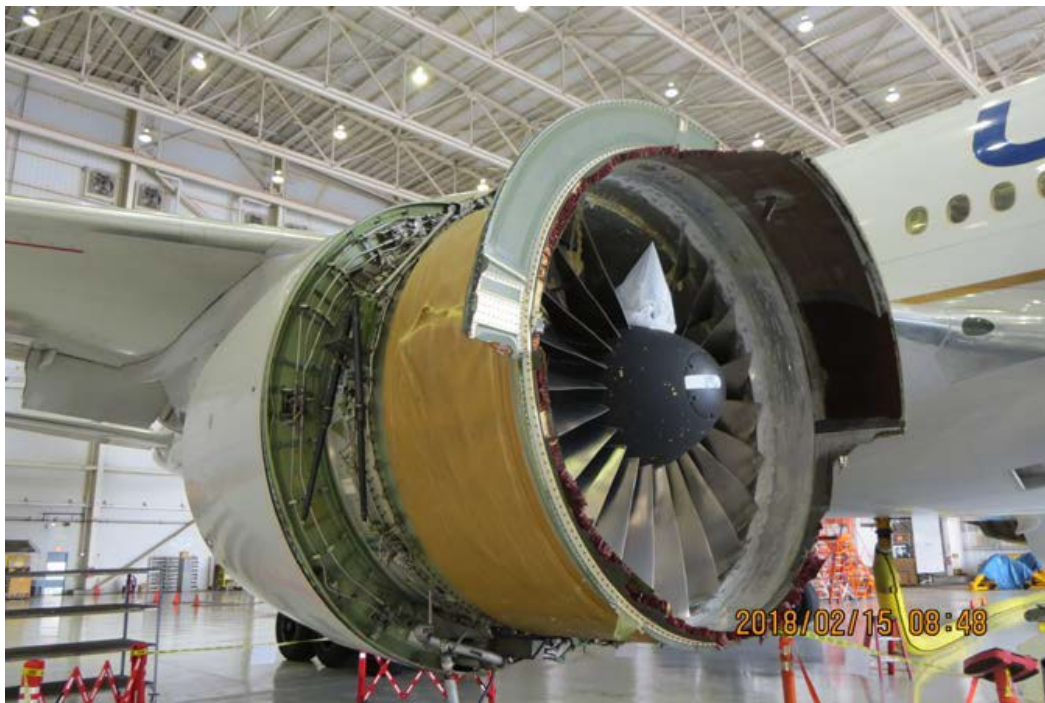
31). Examination of the fan case showed three distinct blade trajectory paths that spiraled forward across the A-flange. There were also two small punctures in the right fuselage below the window belt.

Figure 31 - UAL 1175 left engine, fan cowl, and inlet damage

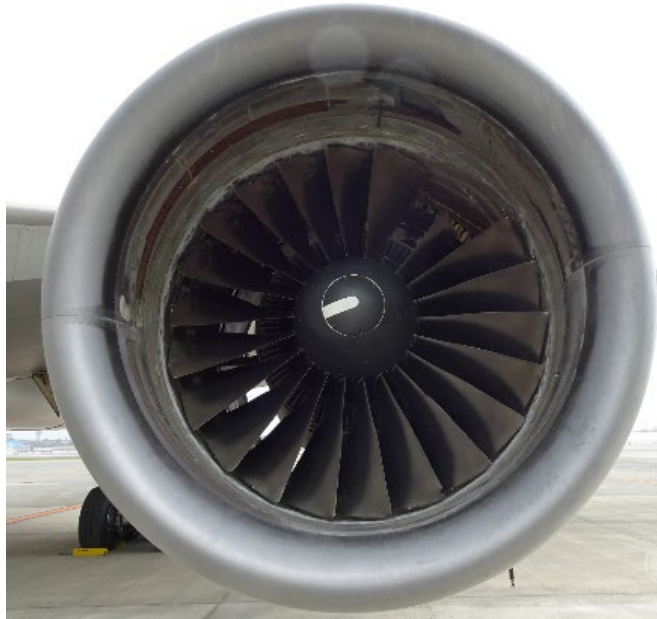
On December 4, 2020, Japan Airlines flight 904, a PW4074 equipped Boeing 777-289 airplane, JA8978, suffered a fan blade failure on the left engine during climb out from Naha, Okinawa, Japan. The airplane returned to the airport and landed safely. The incident is being investigated by the Japan Transport Safety Board (JTSB) and the NTSB is participating in the investigation as the accredited representative for the state of design and manufacture under ICAO Annex 13. Examination of the airplane showed that portions of two fan blades separated during the event damaging the inlet, fan cowls, and TRs. Portions of the left fan cowl separated during the event but most of the right fan cowl, the fan cowl support beam, and inlet remained attached. The containment case successfully retained the blade fragments, but some fragments traveled forward of the fan case. The inlet was mostly intact after the event (Figure 32). There was evidence of 5 distinct blade path trajectories that damaged the inlet inner barrel and there was significant fracturing of the inner barrel. Two of these fragments penetrated the inner barrel but did not penetrate the outer barrel. The inlet aft bulkhead was fractured from 9:45 to 11:45 but remained attached. The damaged inlet, fan cowls, and TRs were shipped to the Boeing EQA lab for further examination.

Figure 32 - JAL 904 left engine and inlet damage
