National Transportation Safety Board

DCA21FA085

OPERATIONAL FACTORS

Group Chair's Factual Report

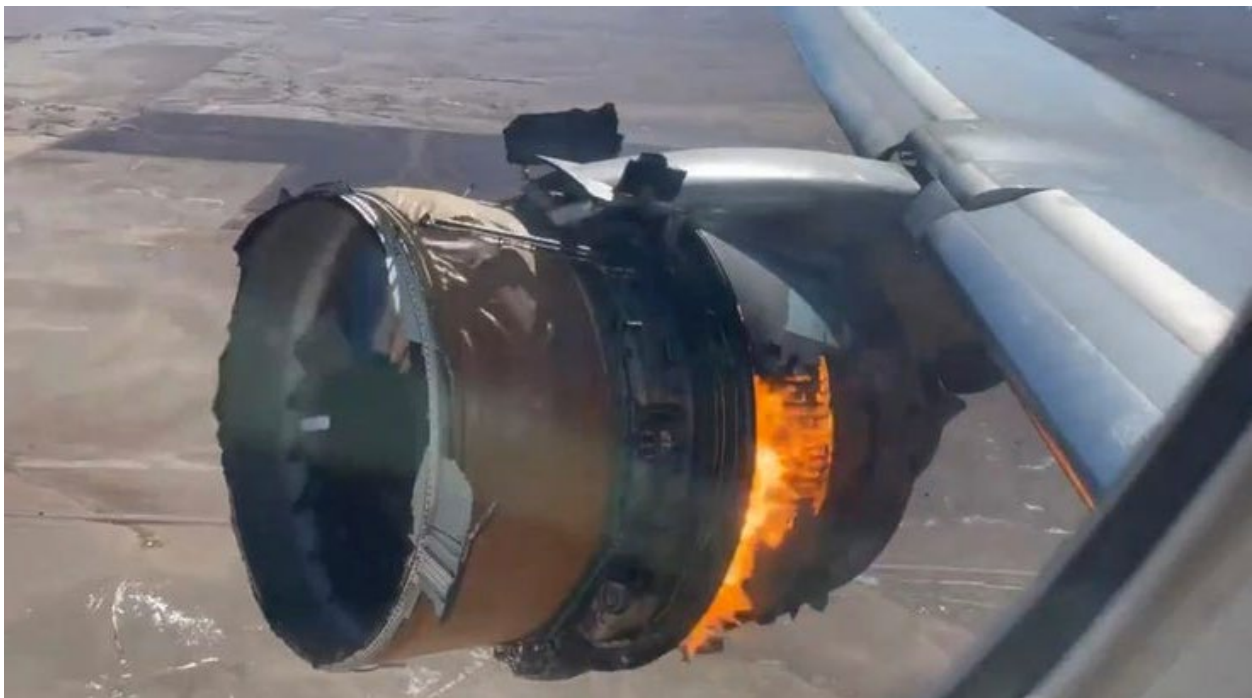
Photo 3. Picture of accident airplane, right engine (Source YouTube)

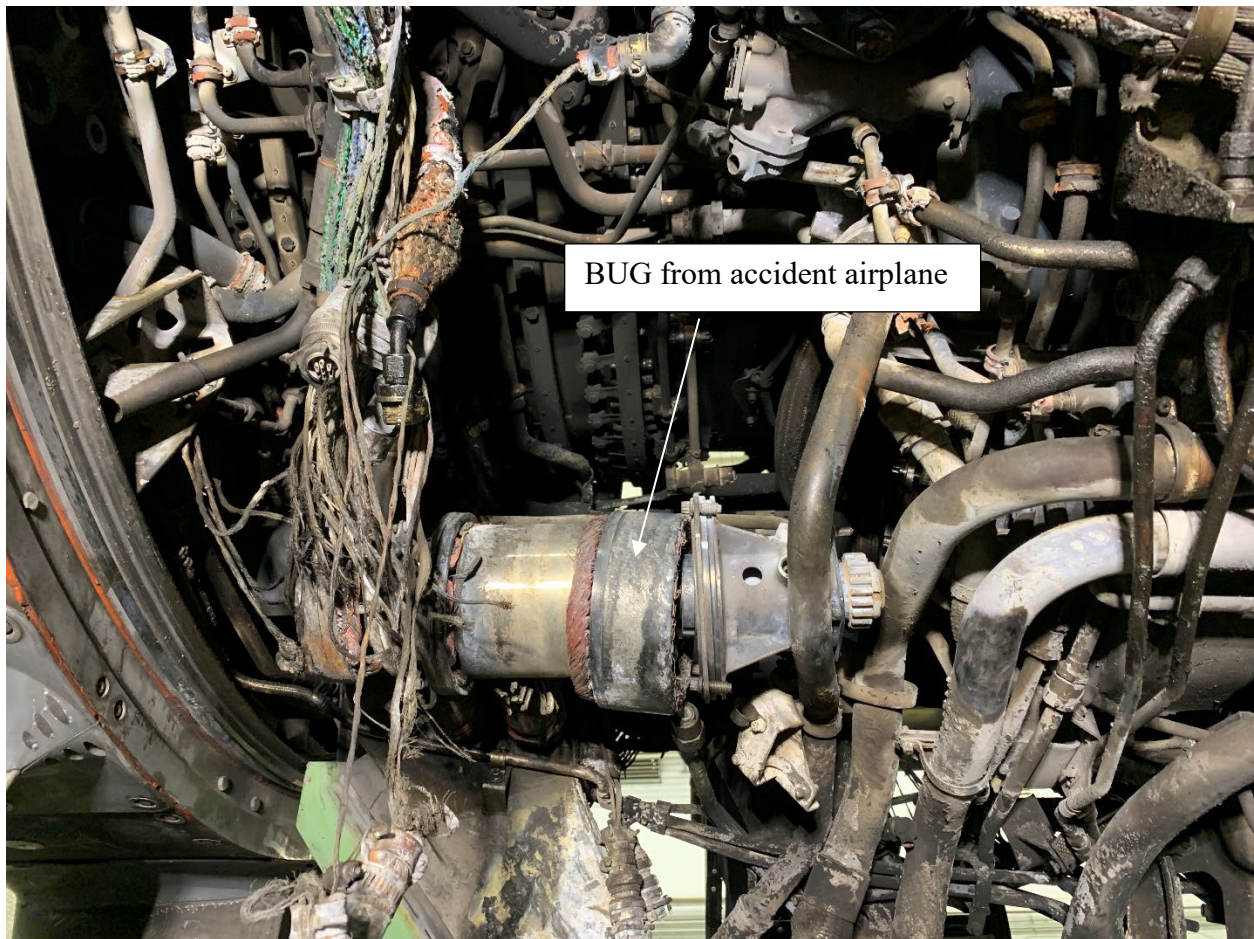
Photo 4, Back Up Generator, from the accident airplane. Source: NTSB photo
