NATIONAL TRANSPORTATION SAFETY BOARD

Group Chairman's Factual Report

POWERPLANTS

DCA21FA174

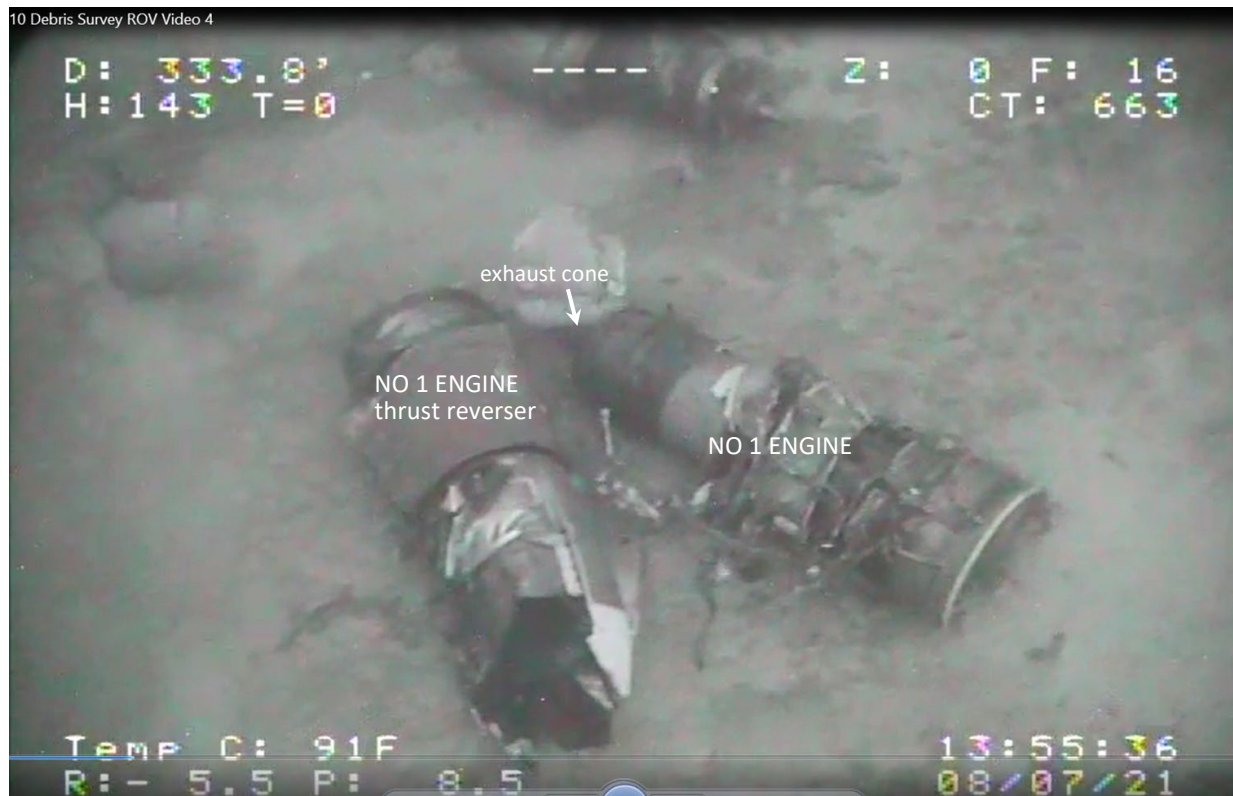
Figure 2 No 1 engine and thrust reverser

The engine components were identified in video images recorded on July 8, 2021. The engine that was later confirmed as the No. 1 engine appeared intact from the inlet case to the turbine exhaust case (TEC) and exhaust cone.⁷ A thrust reverser lying nearby was identified by its stang fairing configuration as the No. 1 thrust reverser. The thrust reverser was in the unactuated (closed) position. See Figure 2.

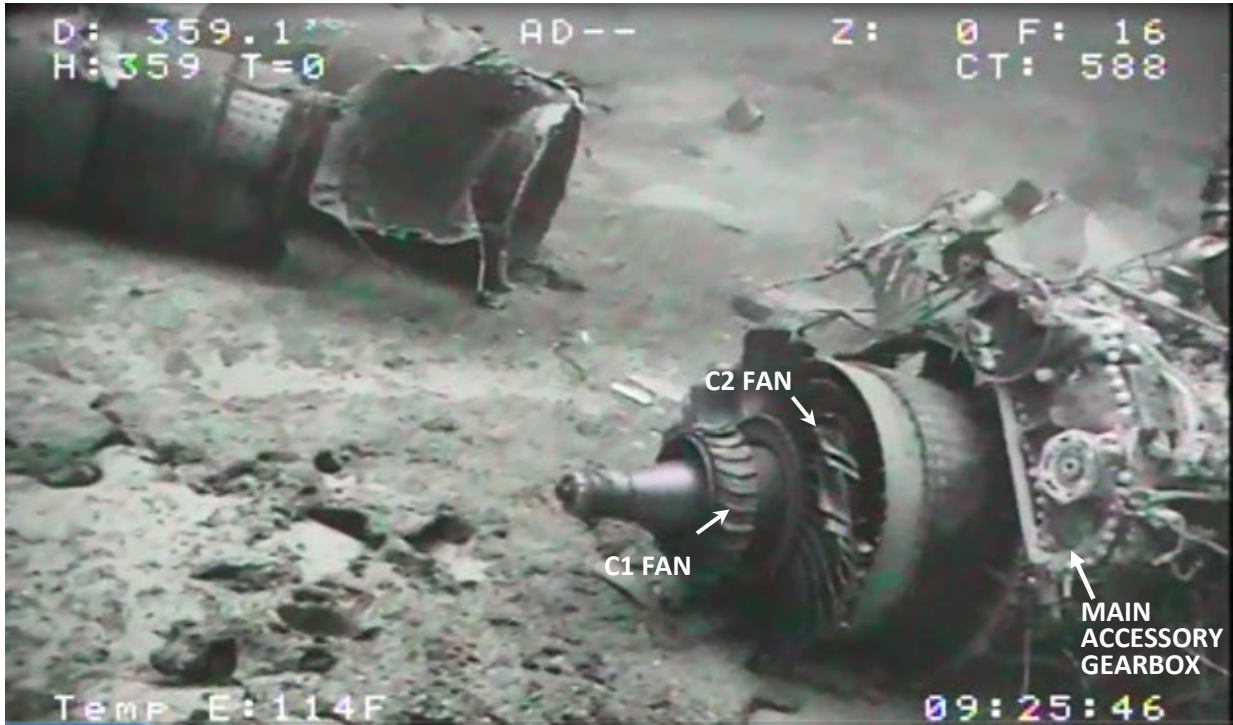
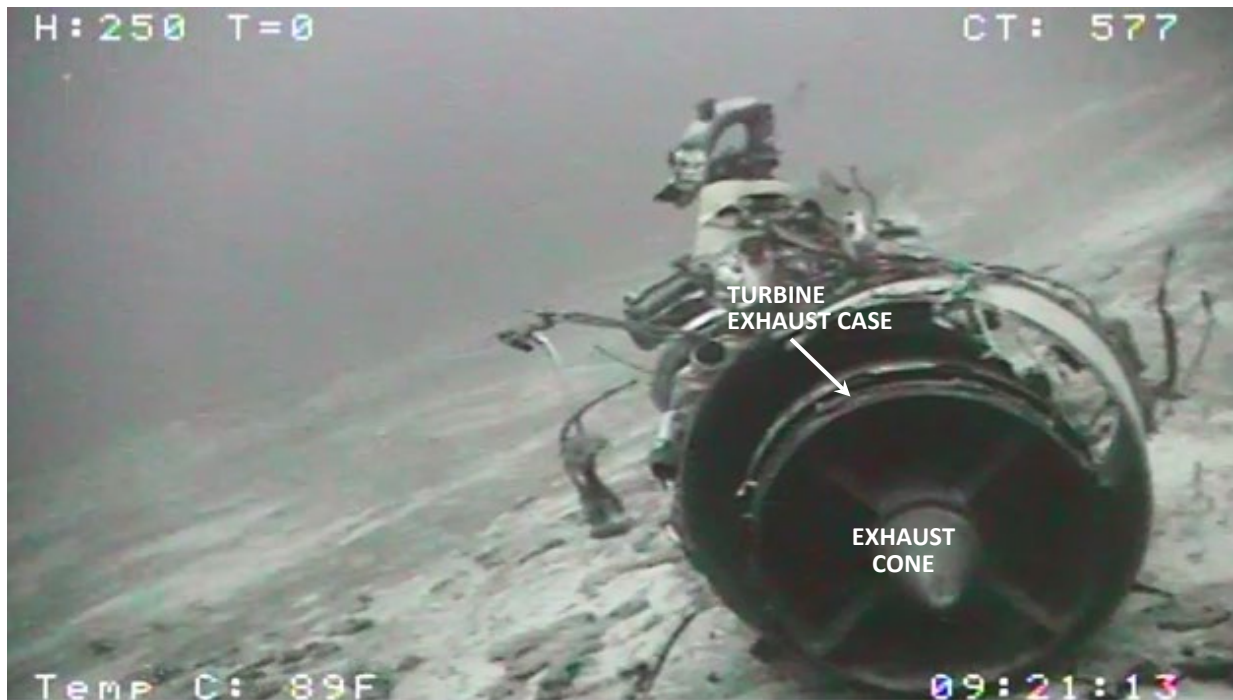
The engine later confirmed as the No. 2 engine was missing its inlet case, forward fan case, and rear fan case, exposing the fan (C1, C2) stages. The C1 blades were fractured near the platform. Visible C2 blades were bent in the direction opposite rotation. The main accessory gearbox (MGB) was visible, indicating that the engine was inverted. The engine was otherwise intact from the fan rotor to the TEC and exhaust cone. See Figures 3 and 4.

Figure 3 No. 2 engine, inverted, showing exposed fan and MGB

Figure 4 No. 2 engine, rear view

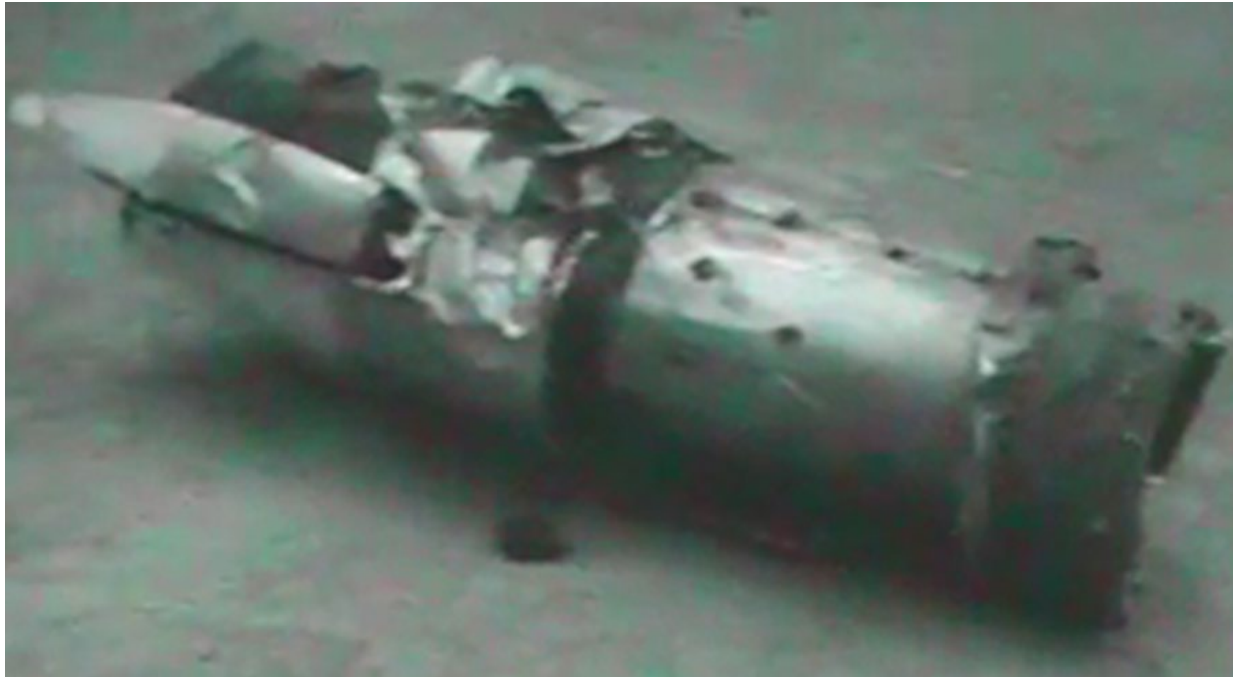
Figure 5. Unactuated No. 2 engine thrust reverser

The liberated No. 2 engine inlet/fan casing section, the No. 2 engine thrust reverser and both nose cowls were also identified. The No. 2 engine thrust reverser was in the closed, unactuated position. See Figure 5.

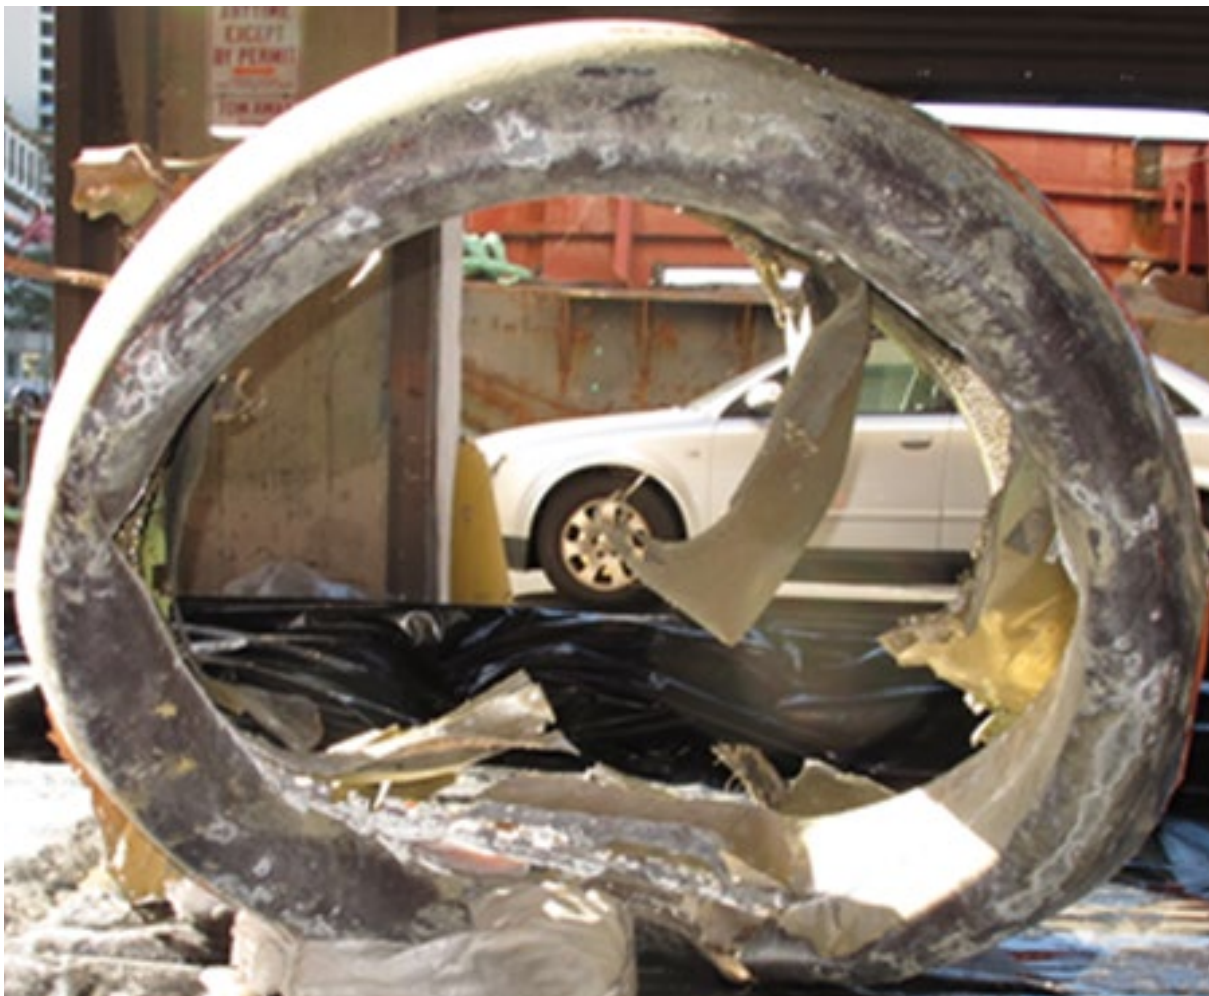
Figure 6 No. 1 engine nose cowl, front view

The No. 1 nose cowl inlet lip was creased at 3 and at 9 o'clock, crushed aftward and axially split at 6 o'clock, and crushed aftward between 3 and 9 o'clock.⁸ Most of the structure aft of the lip was missing between 4 and 8 o'clock. The nose cowl attach flange was missing between 3 and 11 o'clock. Intact areas of the inlet lip displayed no notable soft body impact damage. See Figure 6.

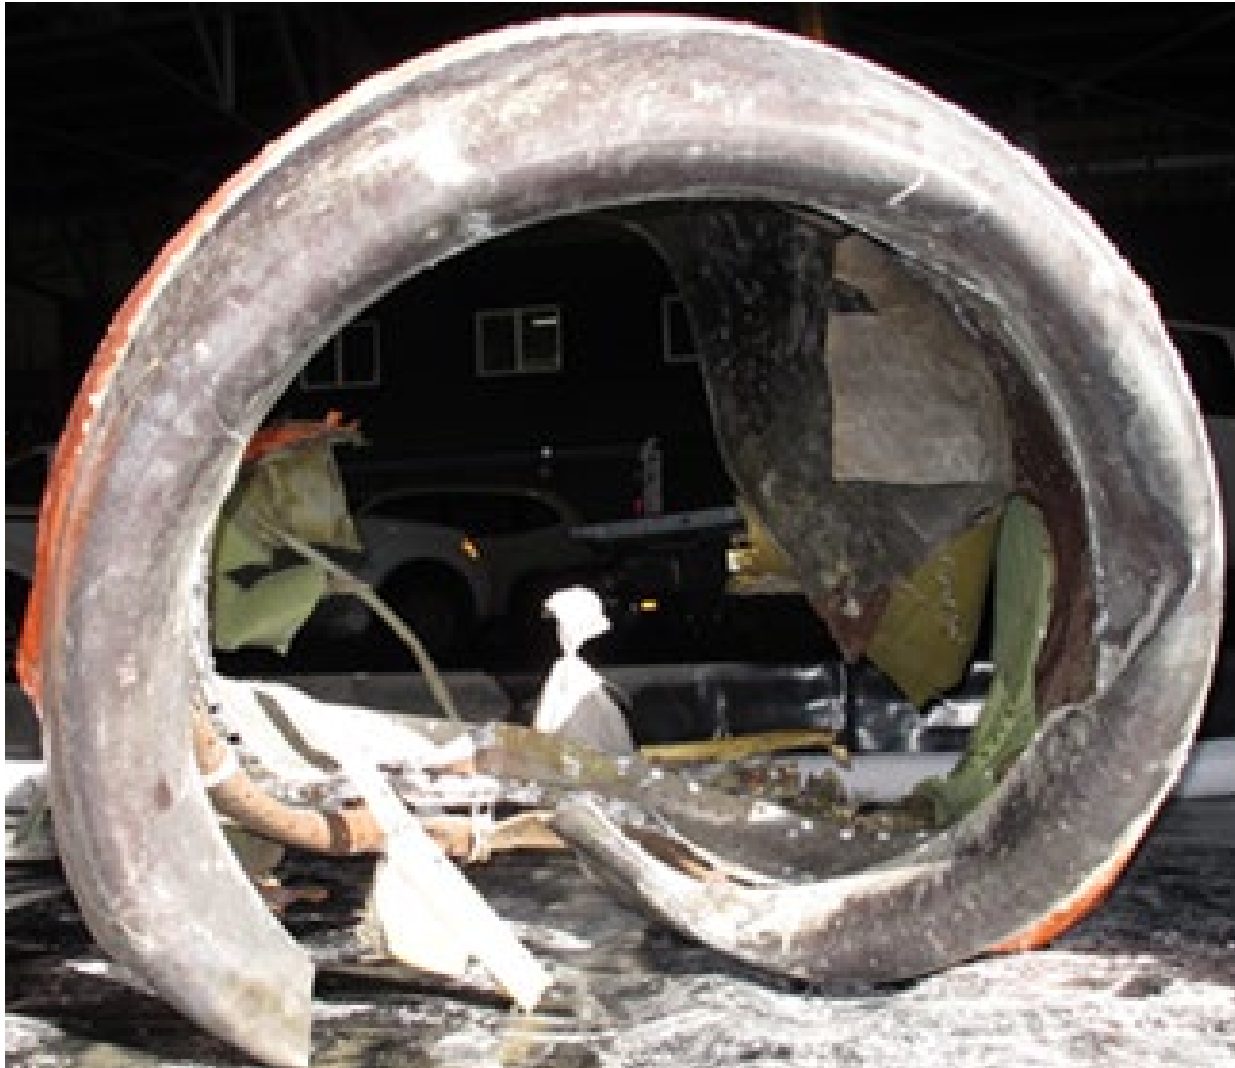
Figure 7 No. 2 nose cowl, front view

The No. 2 engine nose cowl inlet lip was axially split at 6 o'clock and creased at 9 o'clock. The lip was crushed aftward between 4 and 8 o'clock and most of the structure aft of the lip in this area was missing. Intact areas of the inlet lip displayed no notable soft body impact damage. The aft bulkhead was cracked and split at 12 o'clock. The aft flange was fractured and missing between 1 and 9 o'clock. See Figure 7.

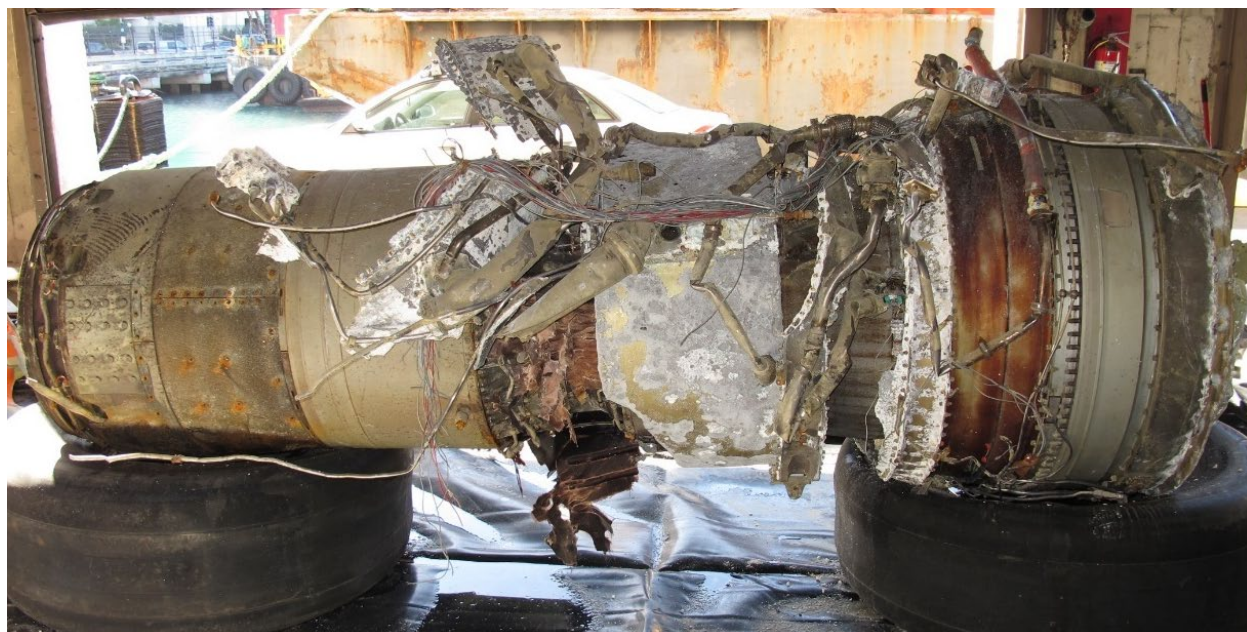
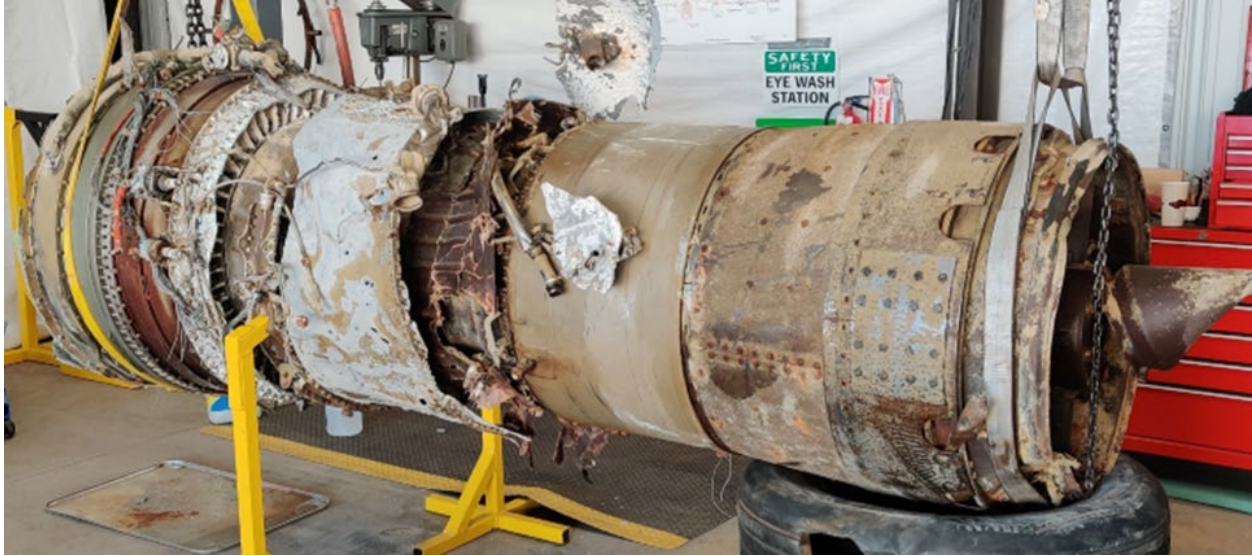
Only remnants of the fan discharge front compressor outer duct and the fan discharge duct remained. The fan discharge outer rear duct was present although the aluminum showed a gray color consistent with corrosion and appeared to be disintegrating. The MGB and MGB-mounted accessories⁹ were missing.¹⁰ The pressure ratio bleed control remained installed. All cases were present and there were no indications of fire, uncontainment or case rupture. See Figures 8 and 9.

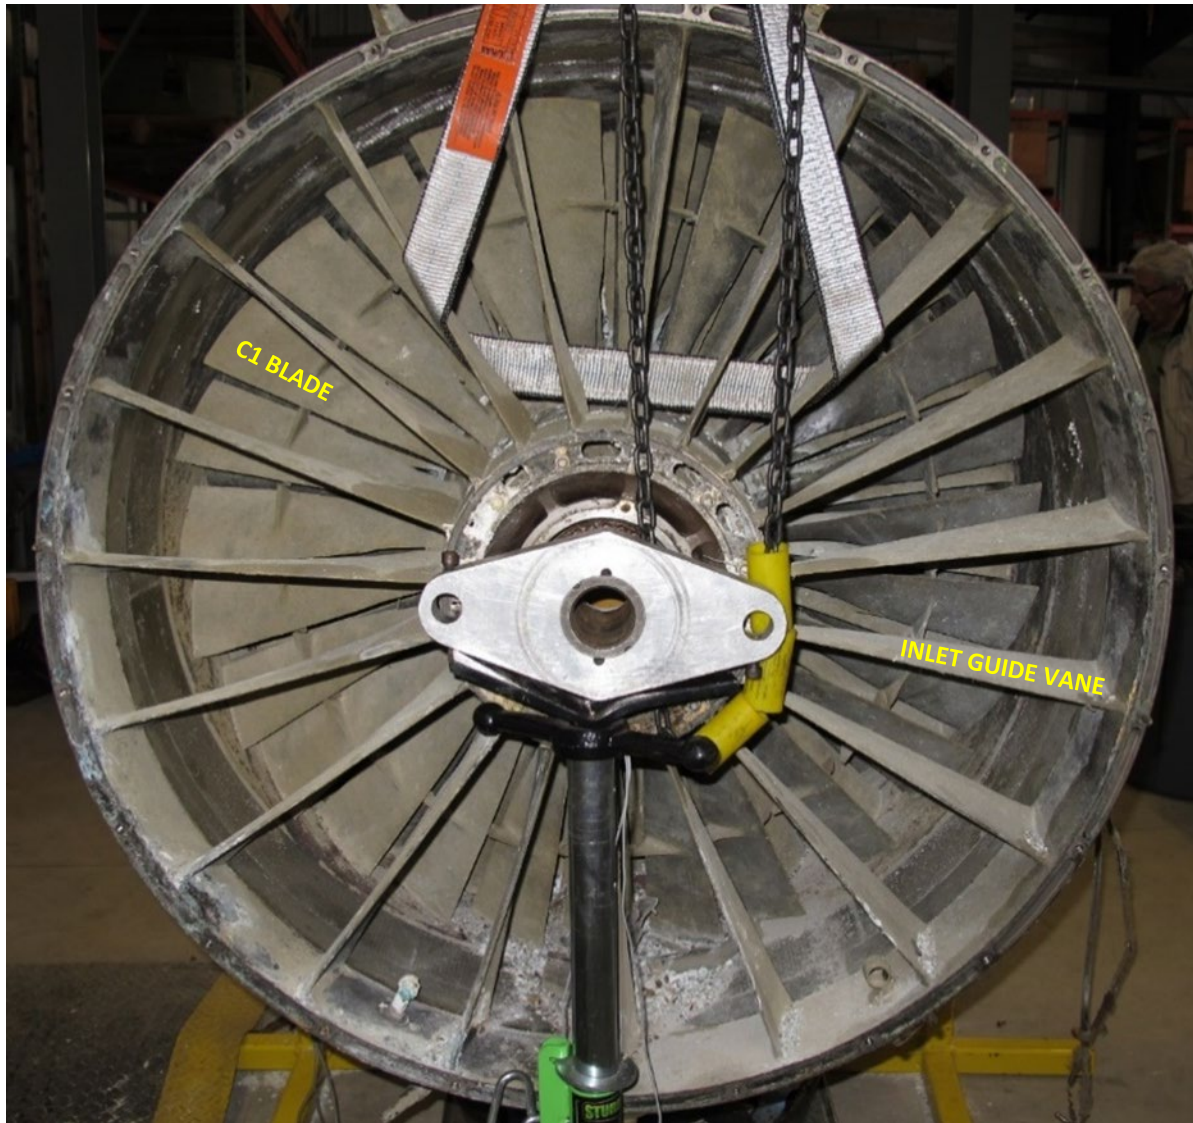
Figure 10 No. 1 engine, inlet view showing IGVs and C1

Material consistent with nose cowl sheet aluminum structure was compressed across the No. 1 engine inlet guide vane (IGV) leading edges (LEs) from 2 to 7 o'clock. The nose bullet assembly was missing.

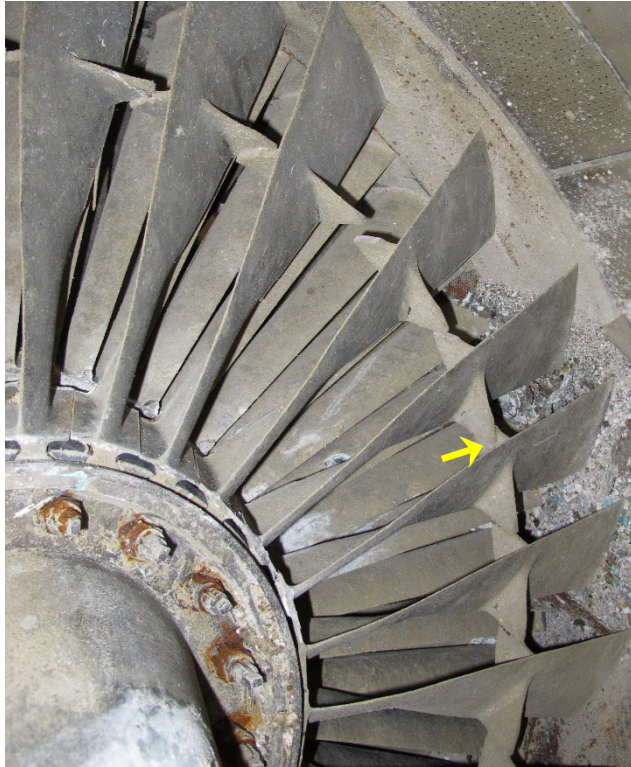
Adjacent C1 blade midspan shrouds were overlapped (shingled) at two locations. See Figure 11. There were small LE cusps on several adjacent C1 blades just outboard of the midspan shrouds. Clashing damage was observed on the inboard five inches of C1 blade TEs. See Figure 12.

Figure 11 No. 1 engine showing shingled C1 shrouds

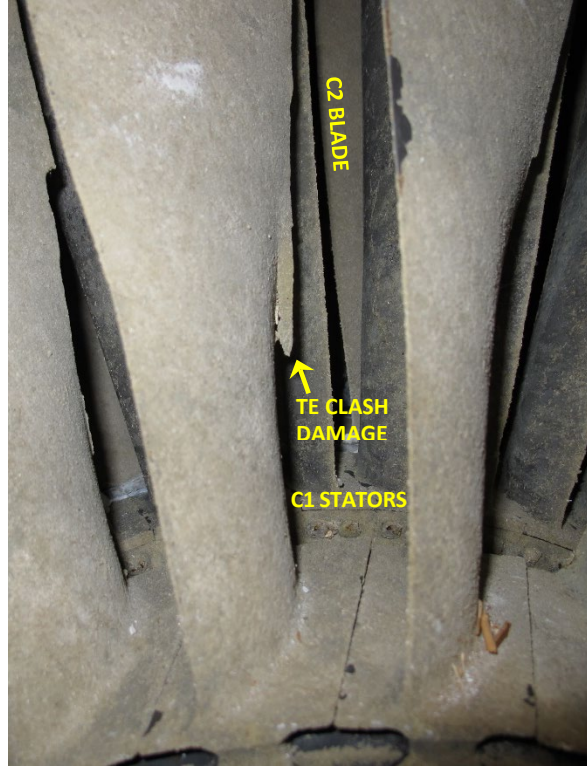
Figure 12 Example of C1 TE clash damage

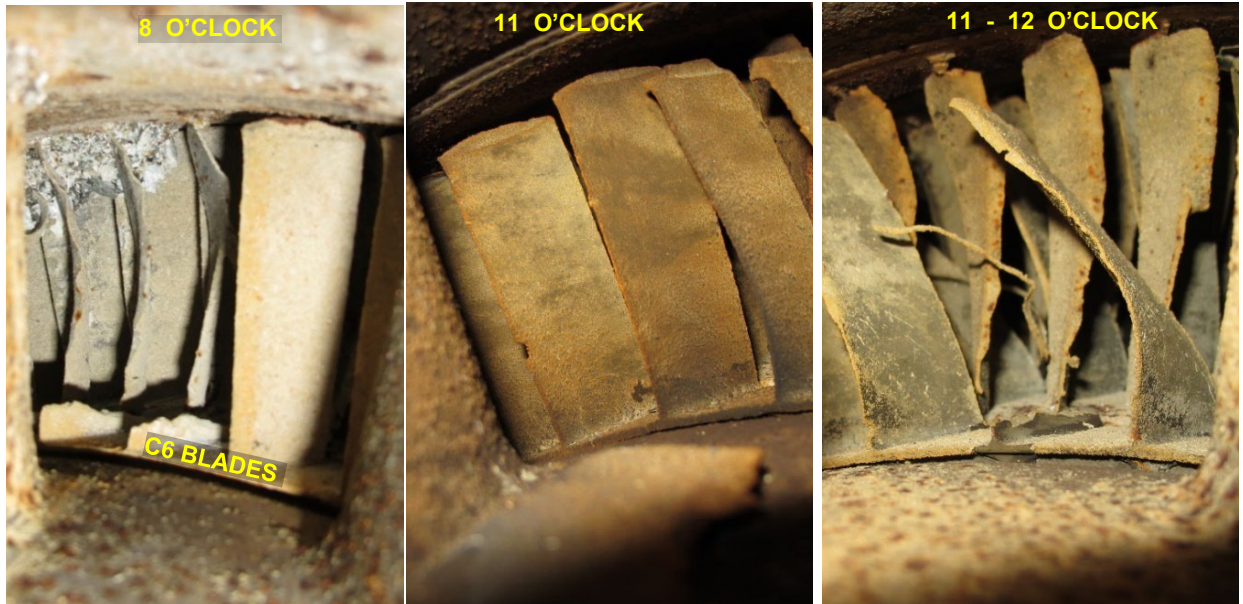
The C5 and C6 were documented as viewed through the back of the low compressor. The C6 blades were full length and straight between 8 and 11 o'clock, full length and bent opposite the direction of rotation between 11 and 12 o'clock and fractured at the platform between 12 and 8 o'clock.¹² See Figure 13.

Figure 13 Three views through the aft end of the low compressor showing the last in the arc of fractured C6 blades at 8 o'clock, the last of the straight, intact C6 blades at 11 o'clock and the full-length but reverse-bent C6 blades between 11 and 12 o'clock.

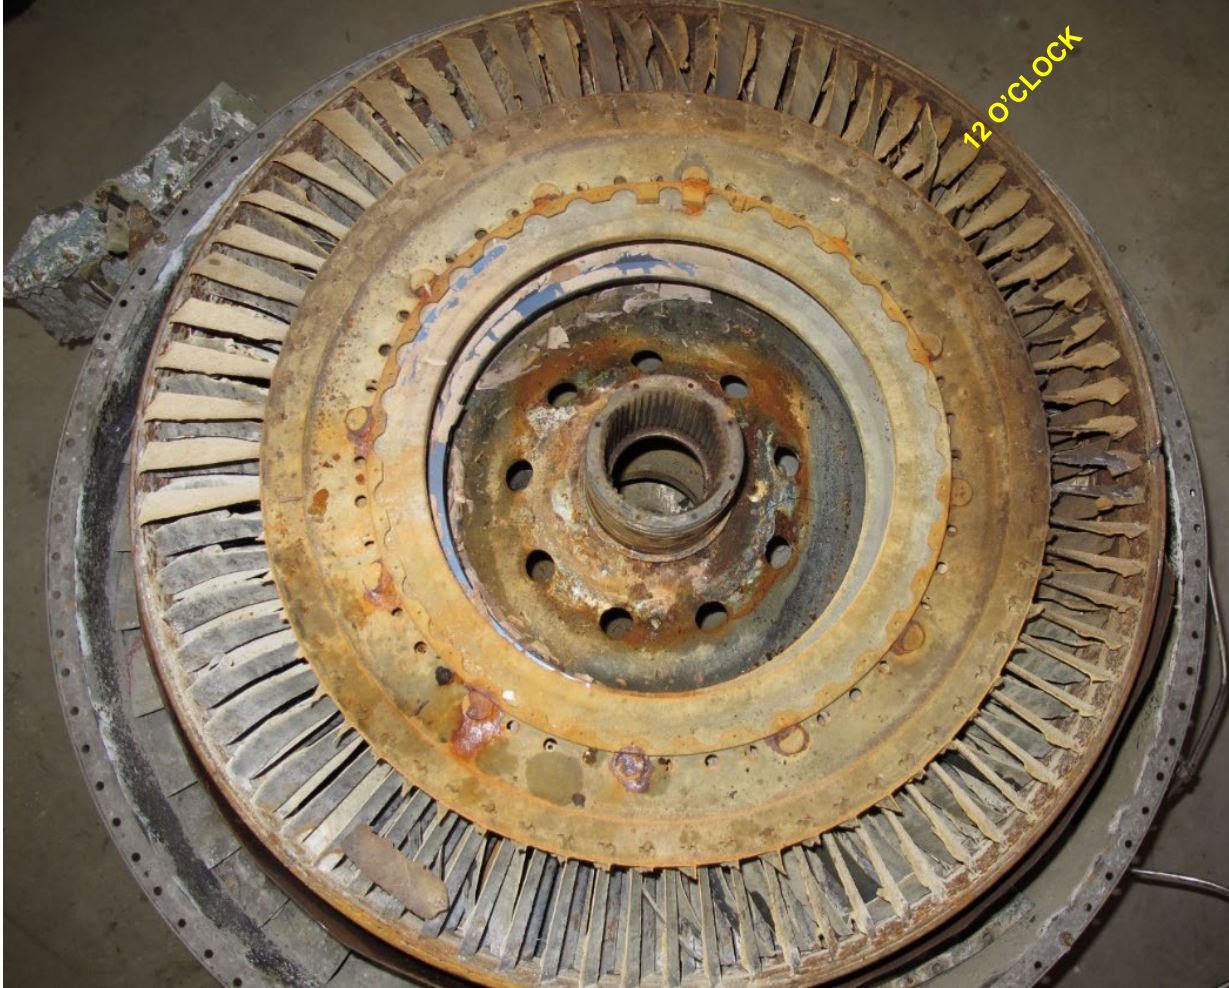
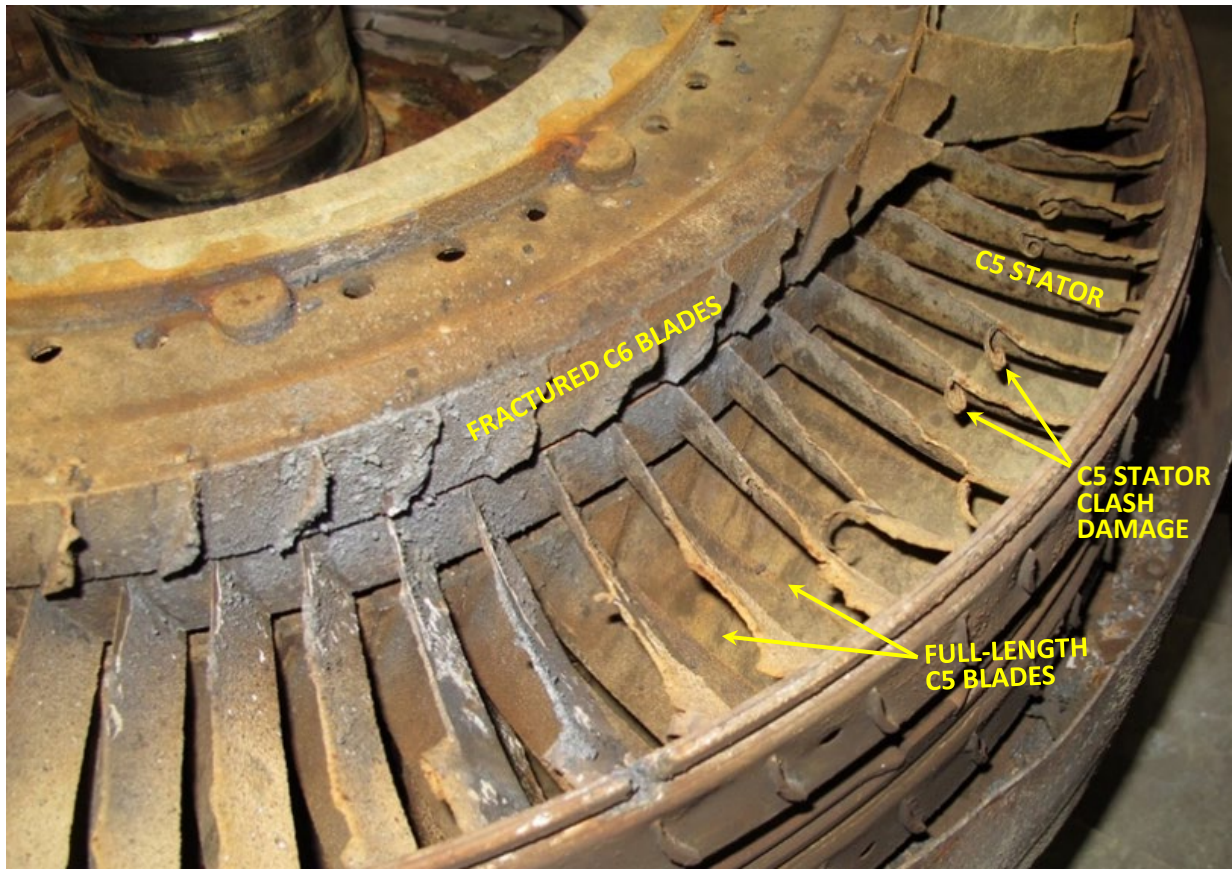
The C5 blades were full length except two that were fractured off at 6 o'clock. The full-length blades were straight between 7 and 11 o'clock and bent opposite the direction of rotation between 11 and 7 o'clock. See Figures 14 and 15.

Figure 14 Low compressor viewed from the rear. The clock reference indicates the arrested rotor position

Figure 15 Detail of Figure 14 showing No. 1 engine low compressor C6/C5 damage

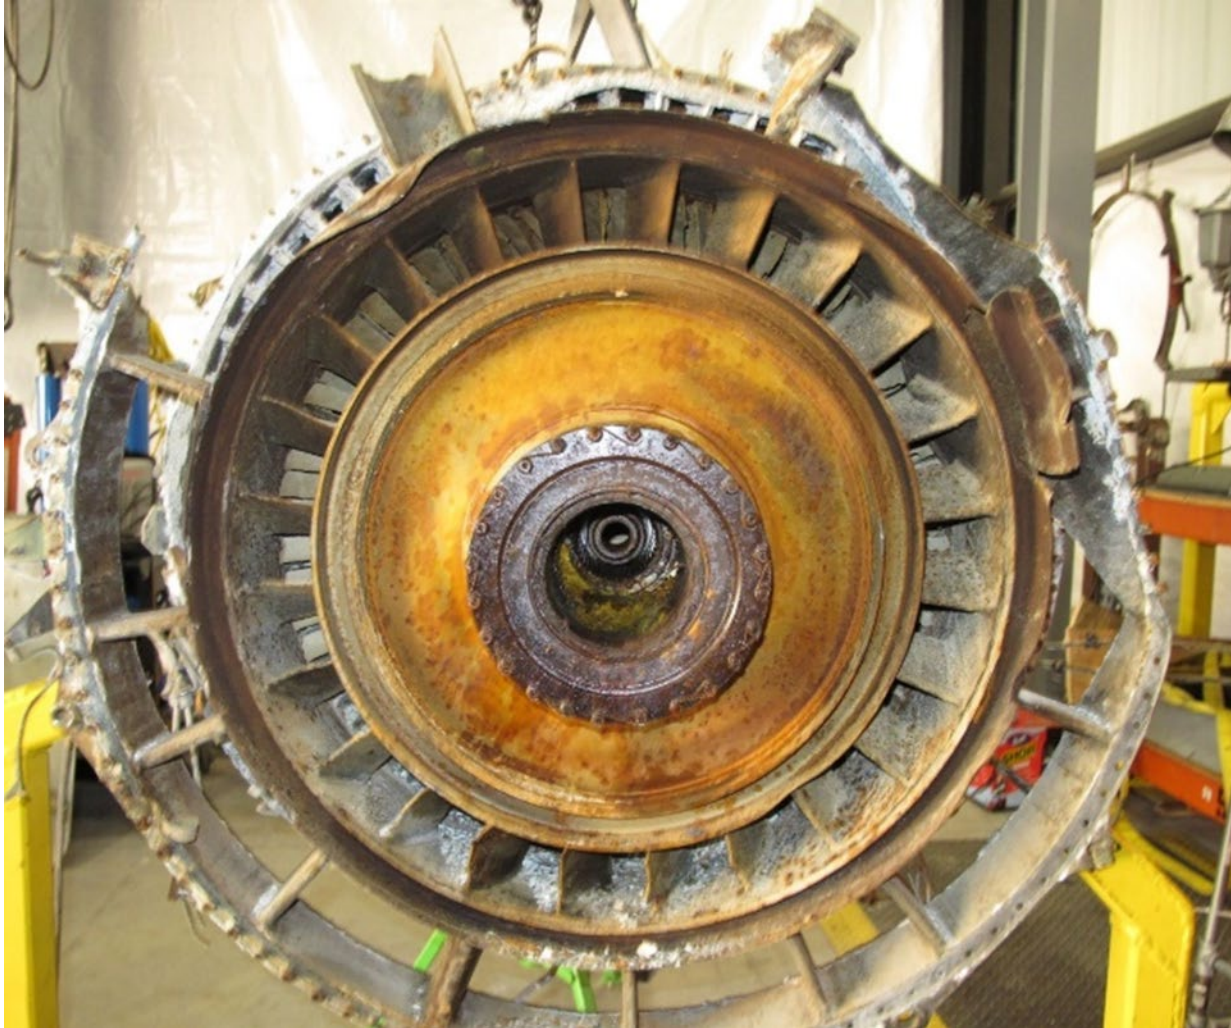
The intermediate case (IMC) front mount rail was fractured and a segment between 10 and 12 o'clock was missing. The 12 o'clock IMC strut TE was deformed in the clockwise direction. The front mount rail and the strut were rolled forward from 12 to 3 o'clock and the rear skirt was torn forward. See Figure 16.

Figure 16 No. 1 engine low compressor aft view showing missing/displaced IMC rail section

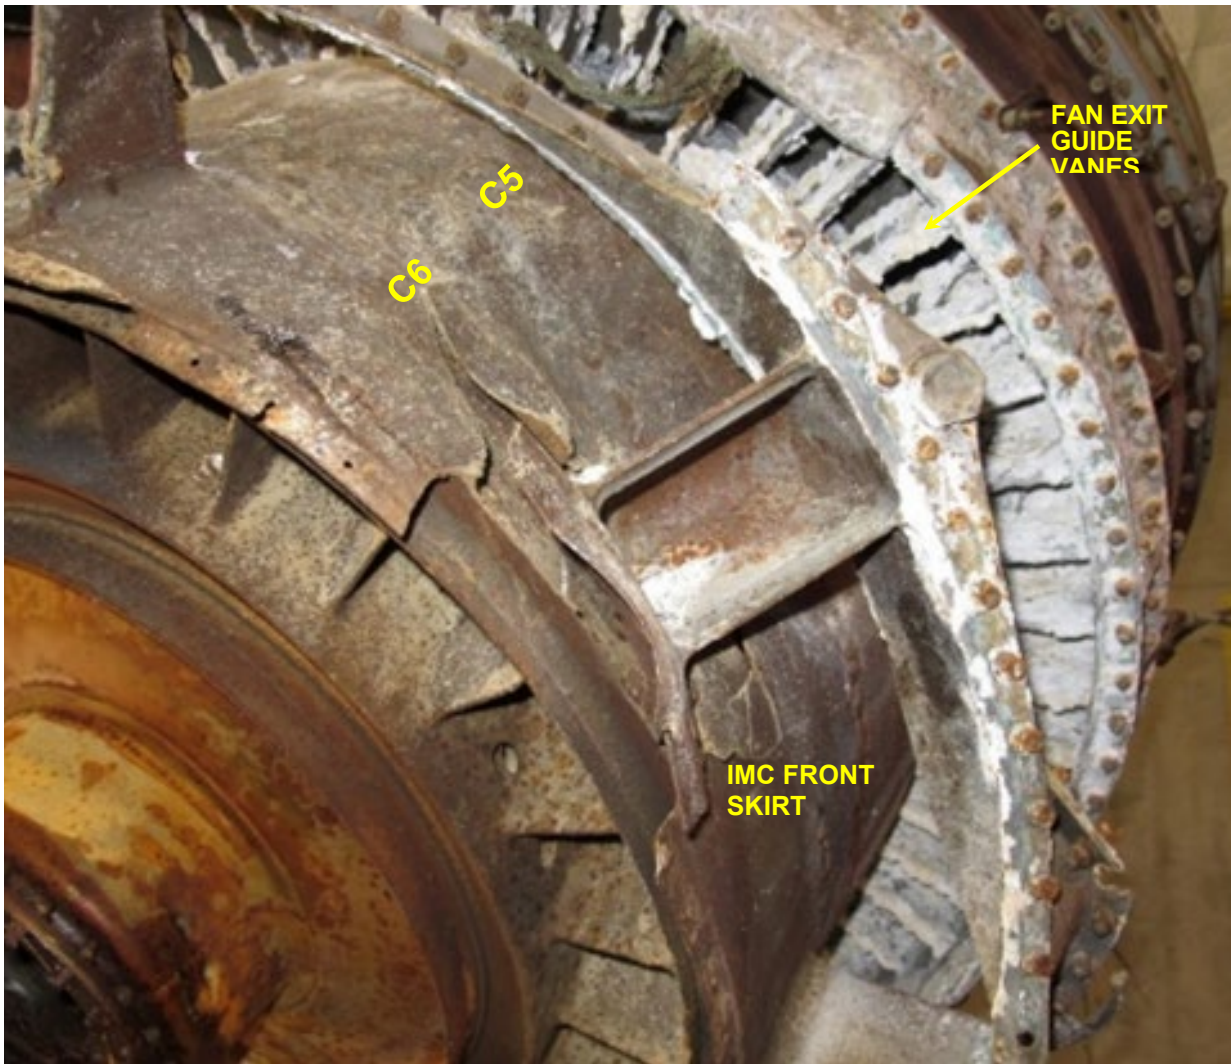
Consistent with the IMC front mount rail damage, there was a deep inward dent and case deformity in the IMC front skirt over the aft low compressor stages (C5 and C6). The dent was centered on the strut below the right mount cone bolt, between 1 and 2 o'clock. See Figure 17.

Figure 17 No. 1 engine showing front skirt deformation from 1 to 2 o'clock

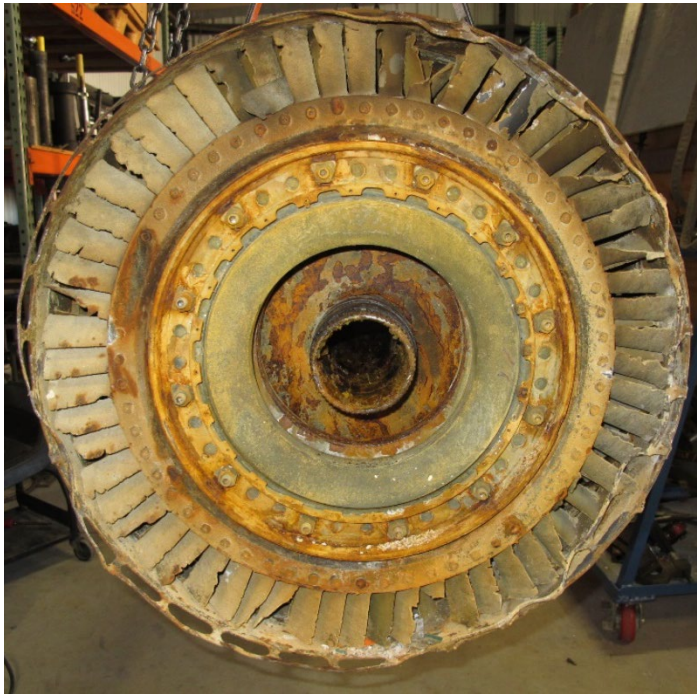
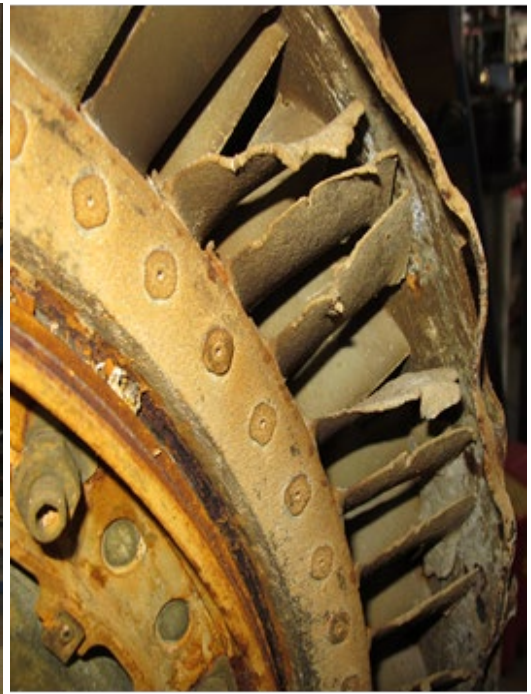
The high compressor was not disassembled. The high rotor was seized. The C7 was inspected through the high compressor front end. All C7 blades were present, with most exhibiting LE tearing, random bending, and deformation in the direction opposite of rotation. Four random C7 blades were fractured with fracture surfaces deformed opposite the direction of rotation. The C7 stators exhibited TE clashing damage that was deformed in the direction of rotation. See Figure 18. C8 blades viewable past C7 were full length. See Figure 19.

Figure 18 No. 1 engine high compressor front view showing C7 damage

Figure 19 Detail of Figure 18 showing C7 blade LE damage and full-length C8 blades

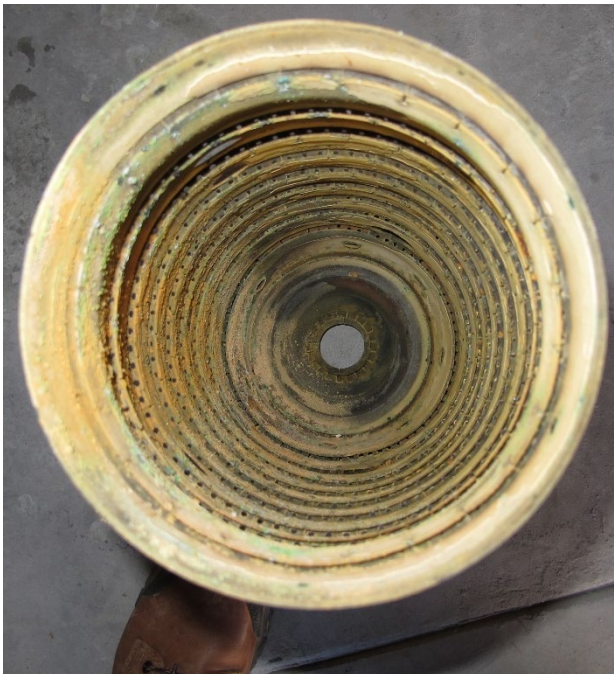
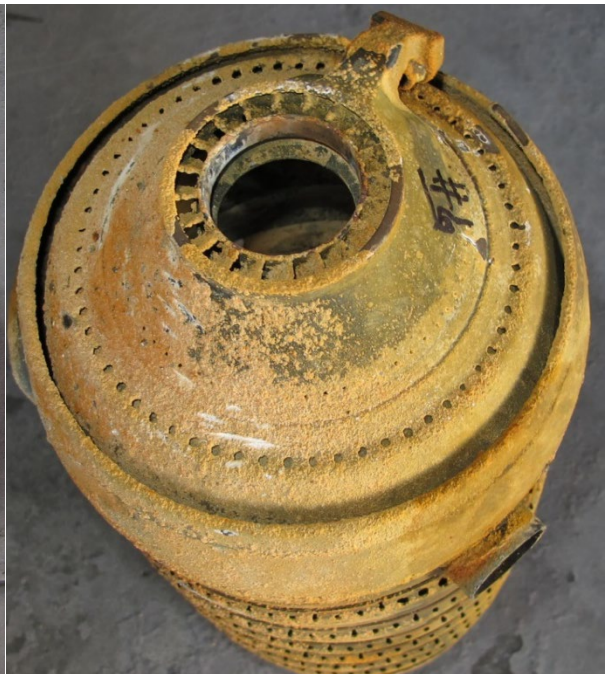
The nine combustion chambers were intact and appeared in good condition, with no evidence of thermal distress. No metallization was observed on the chamber domes in areas free of coral deposits. See Figures 20 and 21.

Figure 20 No. 1 engine exemplar combustion chamber showing no thermal distress

Figure 21 Visible combustor dome surface showing absence of metallization

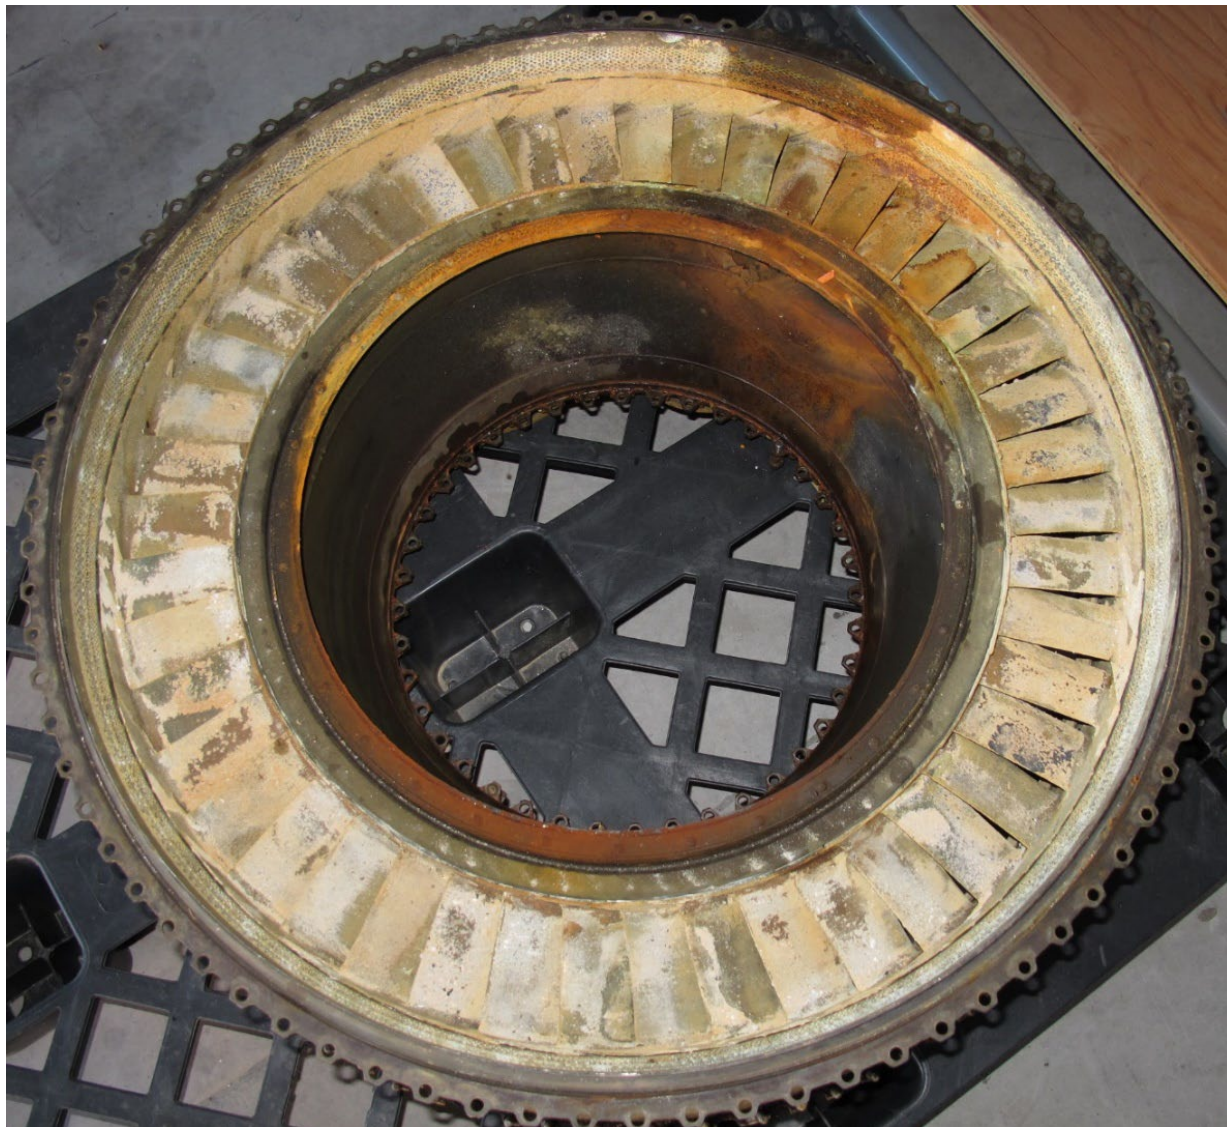
Two of the T1 NGVs were bowed; one of these was cracked mid-span. Eight vanes displayed TE cracks near the root. There were no burn-throughs or missing material. A smooth, blue-gray coloration was observed beneath the coral encrustation on several of the vanes. See Figure 22.

Figure 22 No. 1 engine T1 nozzle aft face, showing typical in-service T1 vane condition

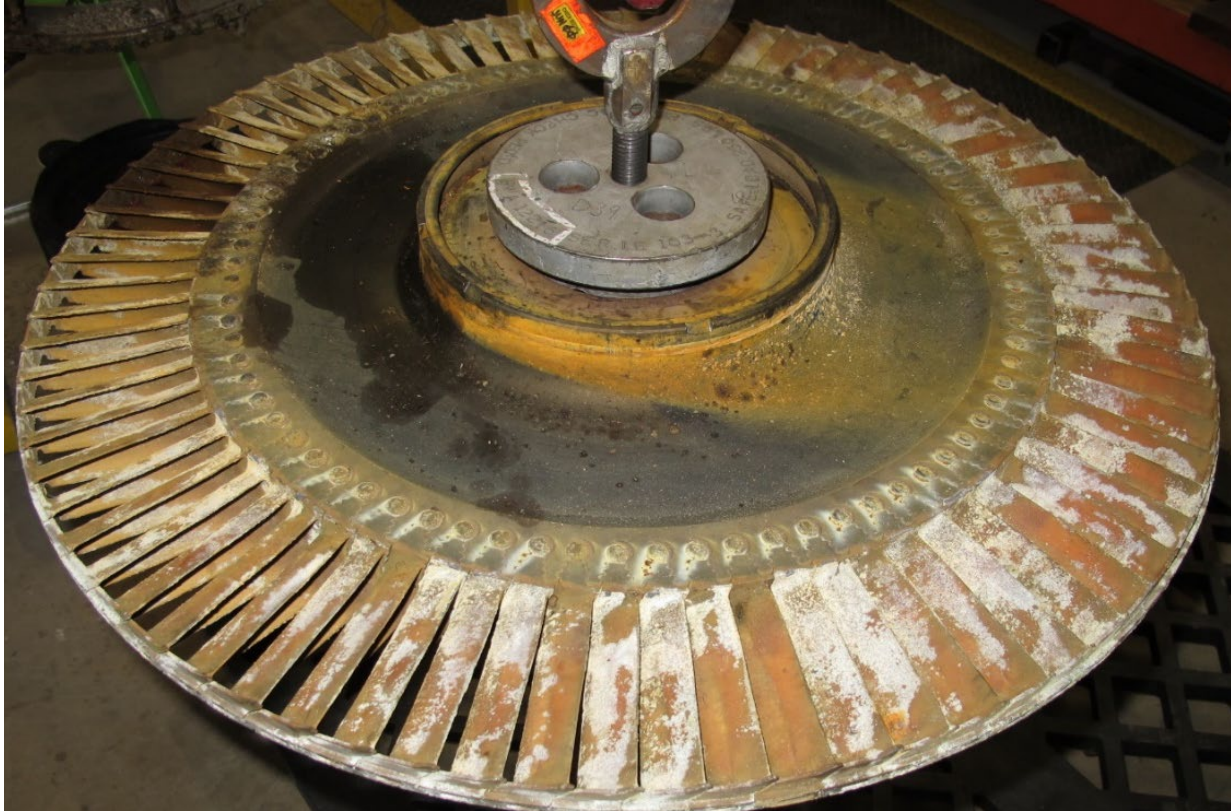
The T1 blades were intact with no obvious damage. The tip shrouds showed no abnormal wear. See Figure 23.

Figure 23 Aft face of the No. 1 engine T1 disk assembly showing intact airfoils and tip shrouds

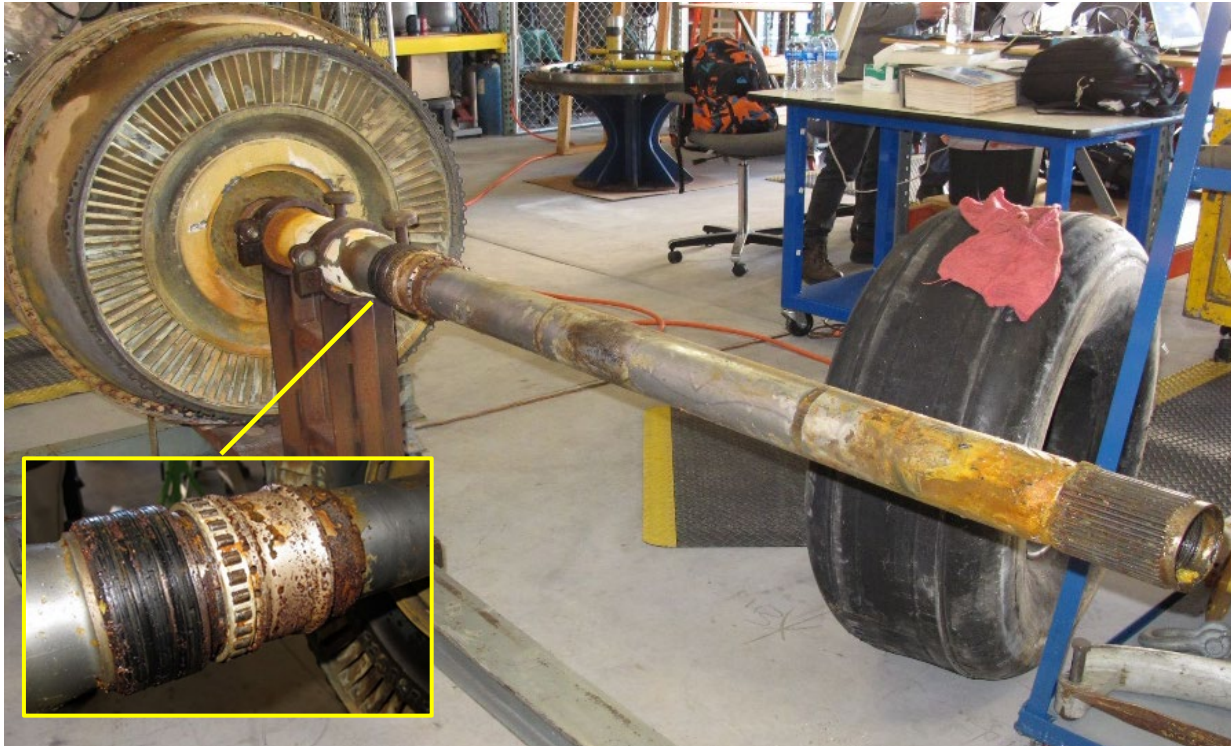
The low turbine shaft was bent but intact. Areas of circumferential rub were noted at three axial locations. The turbine intershaft (No. 4 ½) bearing turned smoothly by hand. The roller elements appeared evenly spaced and full diameter. The silver plate showed no discoloration or blistering. There was no acrid oil odor. The carbon seals appeared intact. See Figure 24.

Figure 24 No. 1 engine low turbine and shaft and closeup view of No. 4 ½ interstage bearing roller elements and rotating seal components

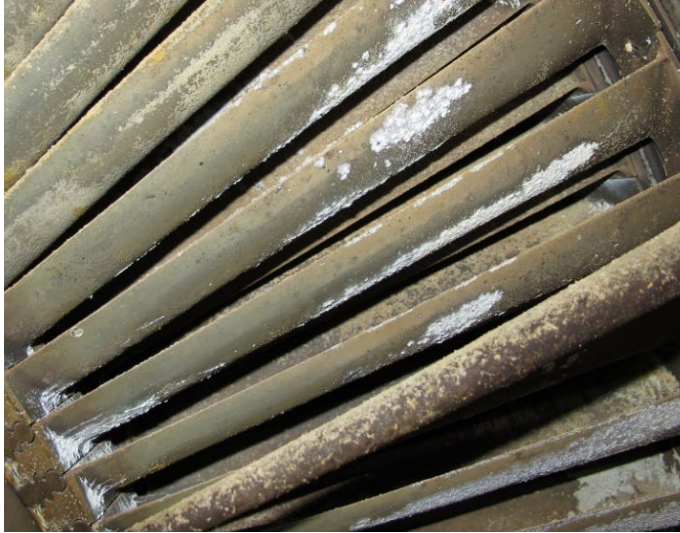
Figure 25 Detail view, T4 blades

The T4 was inspected through the TEC. The T4 vanes were in place with no damage noted. The T4 blades and their tip shrouds were intact and in good condition. See Figure 25.
