NATIONAL TRANSPORTATION SAFETY BOARD

Group Chairman's Factual Report

POWERPLANTS

DCA21FA174

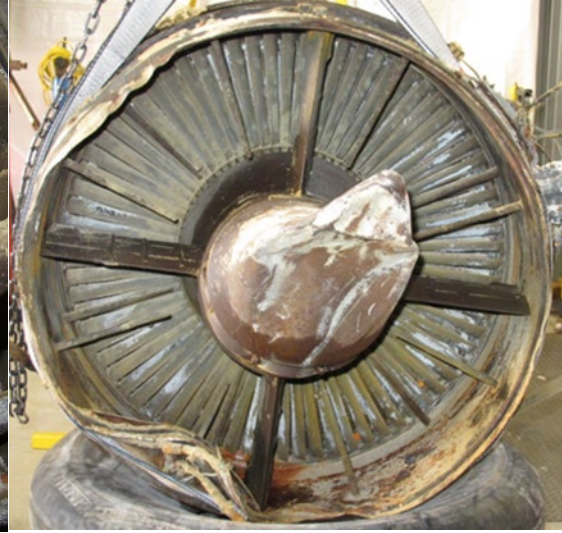
The aft end of the TEC was dented radially inward, and the turbine exhaust cone was flattened and partially separated from its flange. The TEC struts were straight. No tactile check of the case was performed based on the intact condition of the turbine blades. All exhaust gas temperature (EGT) Tt7 and the engine pressure ratio system (Pt7) probes were full length. See Figure 26.

Figure 26 Aft view of No. 1 engine showing T4, and Tt7 and Pt7 probes

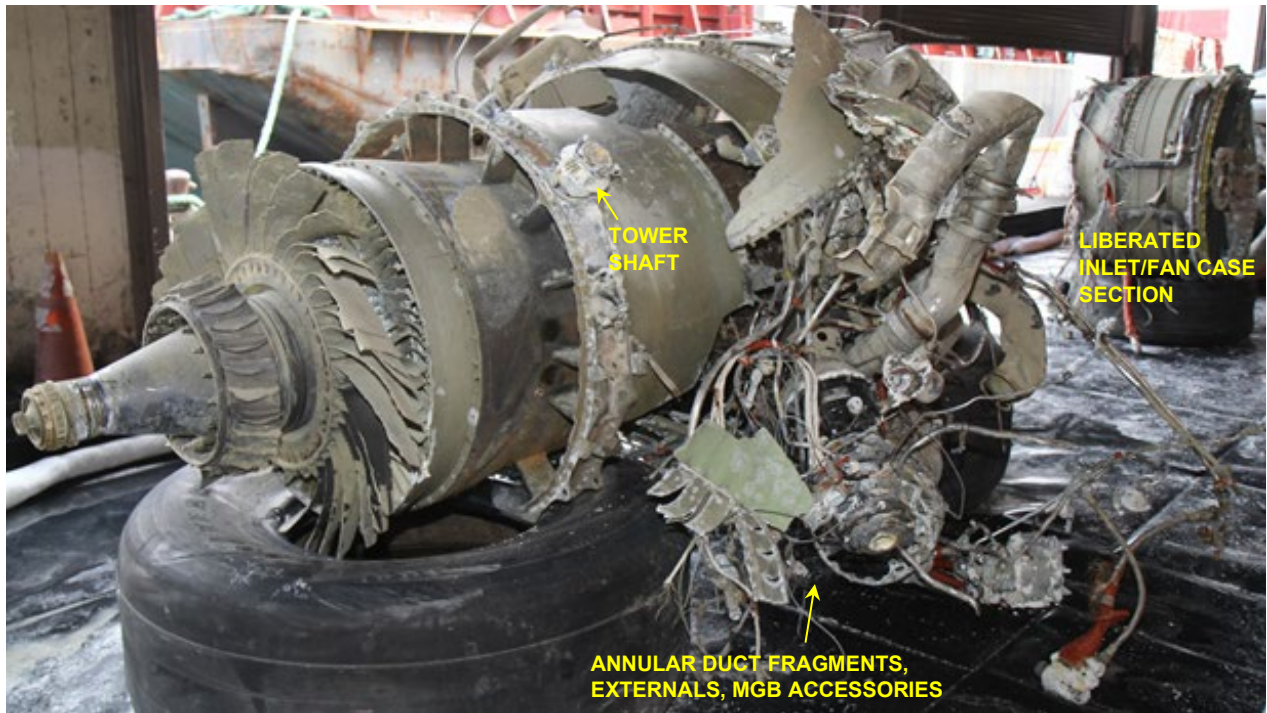
The engine inlet/fan case section was liberated from the No. 2 engine and was recovered separately. See Figure 27.

Figure 27 No. 2 engine and liberated inlet/fan section at Honolulu recovery location

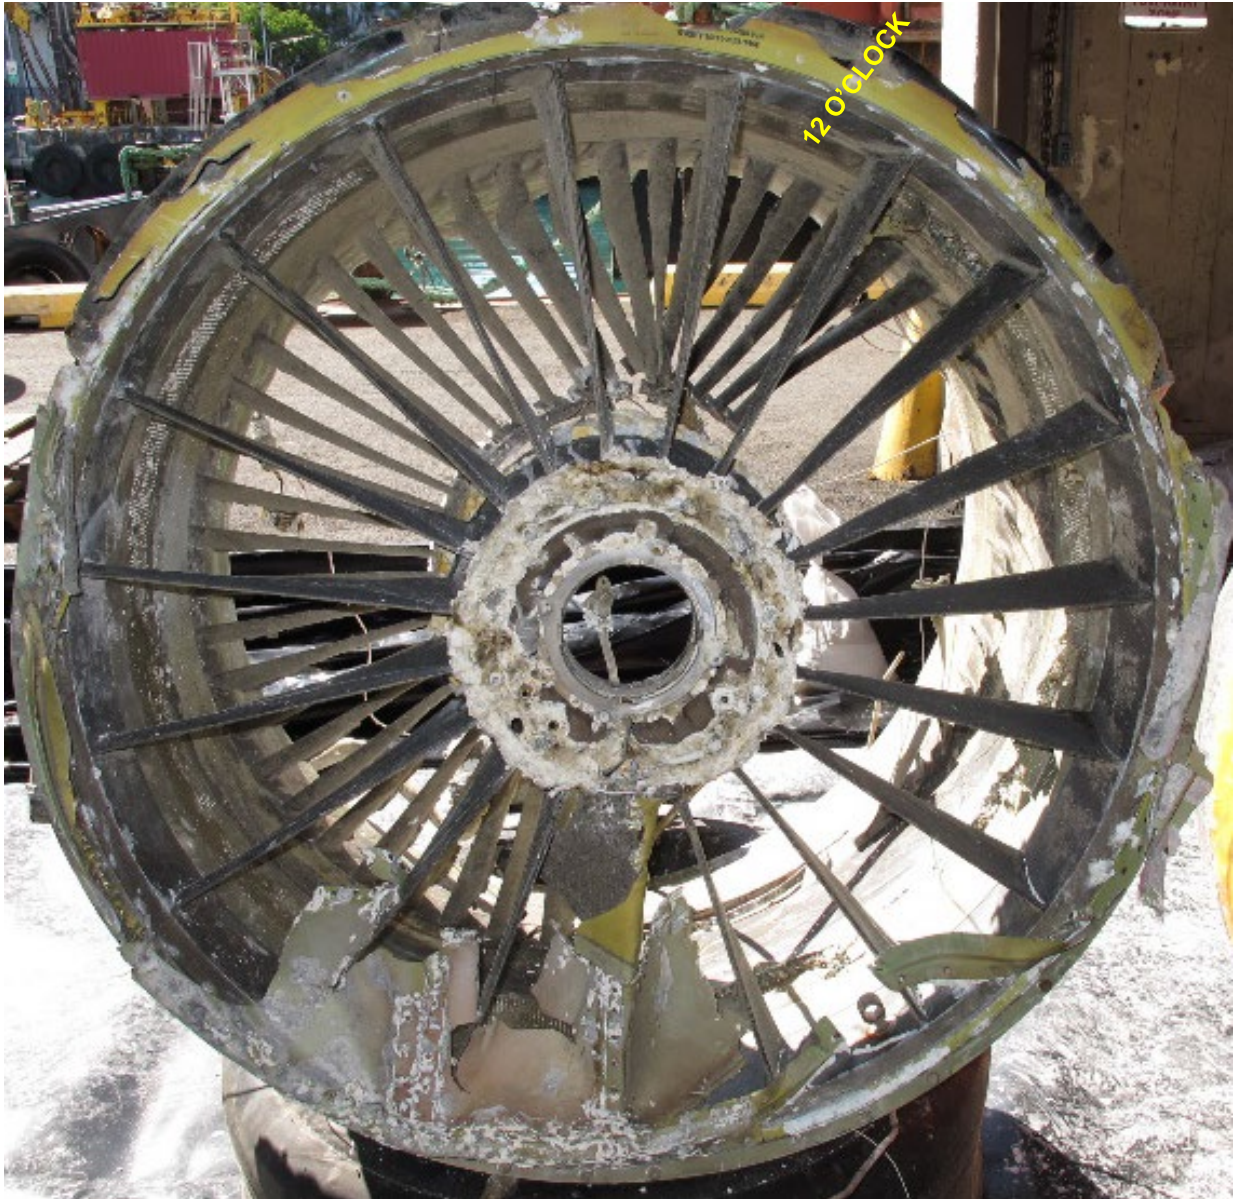
Figure 28 No. 2 engine inlet/fan case section, forward view

The IGVs were intact and straight. Material consistent with nose cowl aluminum sheet metal was wrapped around the IGV LEs from 5 to 7 o'clock. The nose bullet assembly was not recovered. See Figure 28.

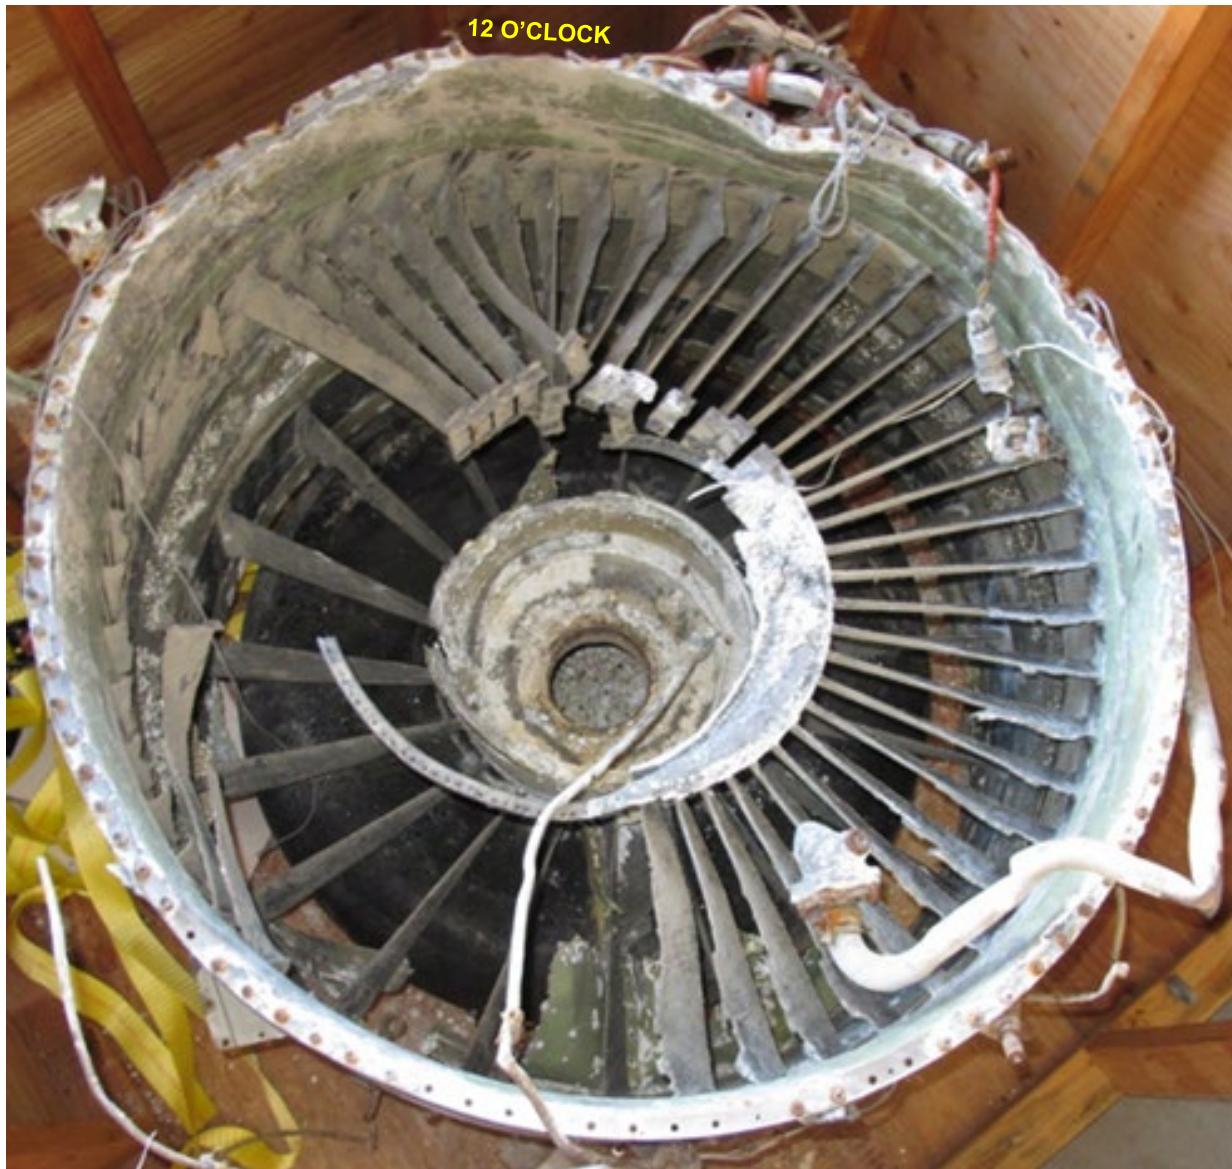
Figure 29 No. 2 engine inlet/fan case section, rear view

The C1 stators were missing between 6 and 10 o'clock except for two that were bent/folded in the direction of rotation. The C1 stators between 10 and 6 o'clock were full length and were deformed in the direction of rotation. See Figure 29.

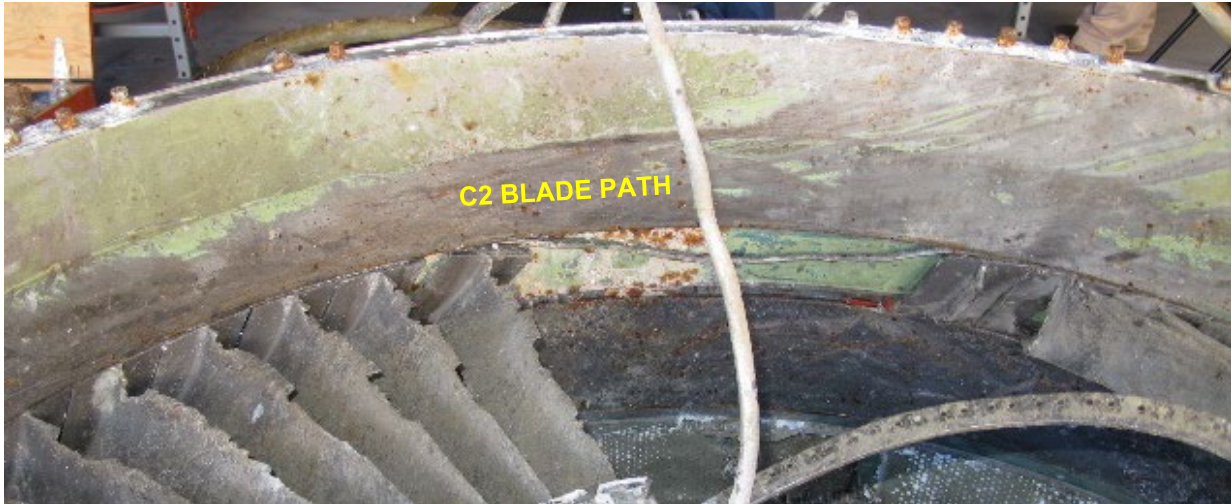
The C1 stator TEs exhibited clashing damage. The C2 blade path was circumferentially scored from 3 to 7 o'clock, tracking out of plane from 6 to 7 o'clock. See Figure 30.

Figure 30 No. 2 engine C1 stator TE clash and C2 blade path scoring

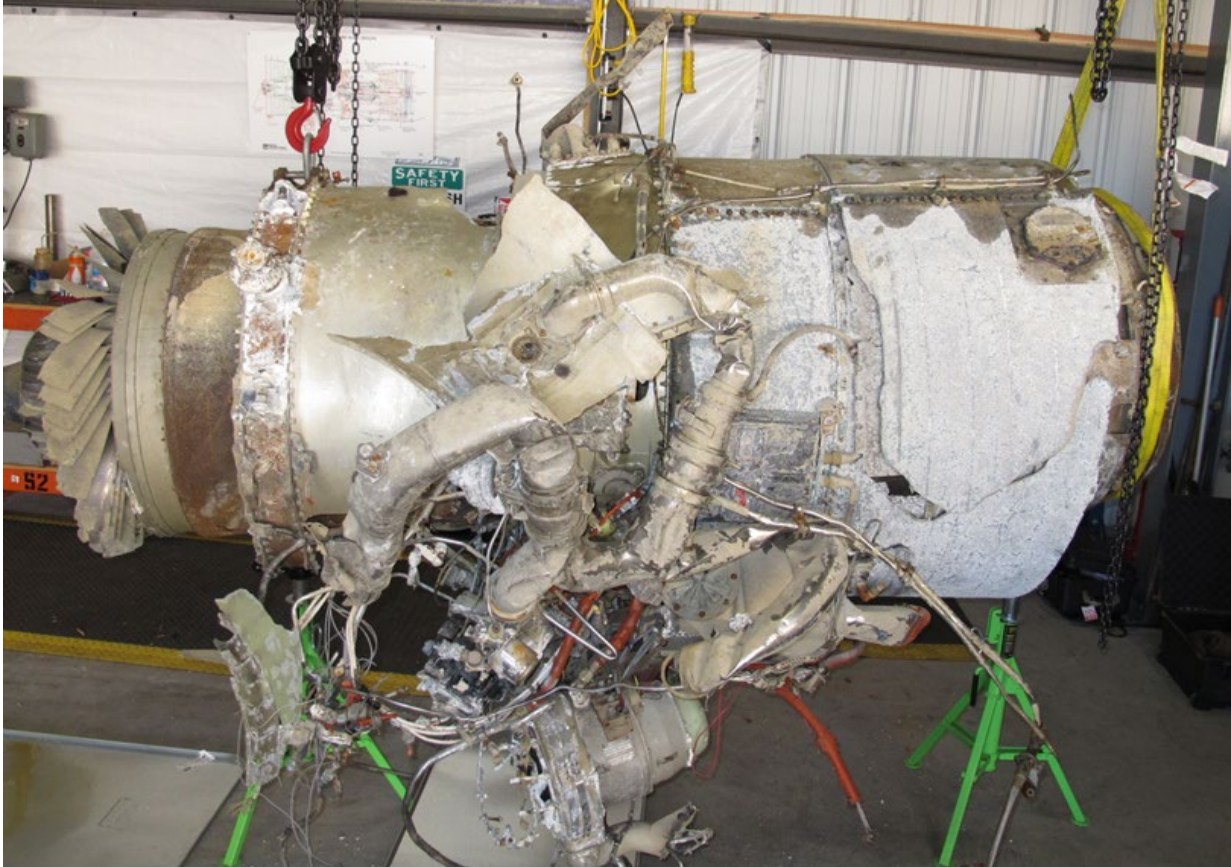
Coral encrustation coated the external and gas path surfaces. Rust was observed on the steel components. See Figure 31.

Figure 31 No. 2 engine bottom view, showing missing annular duct pieces and inlet/fan case section. The MGB cases has disintegrated, and MGB-mounted accessories are attached by tubing and electrical harness

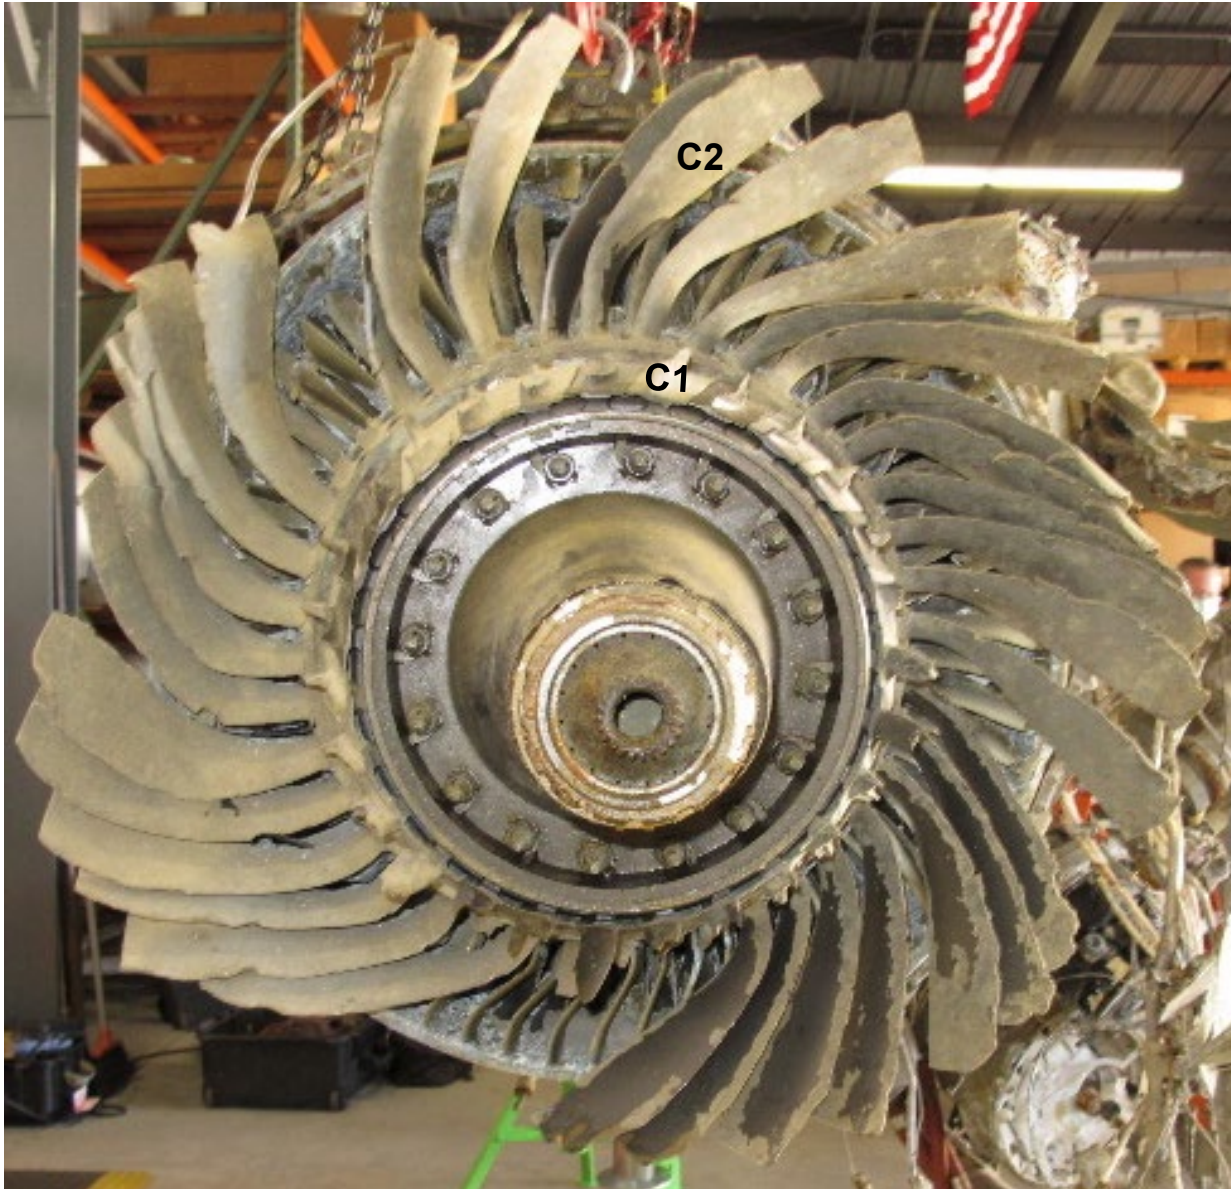
Figure 32 No. 2 engine as received, front view

All C1 blades were fractured close to the platform. The C2 blades were full length and bent opposite the direction of rotation except for seven that were fractured within two inches of the platform. See Figure 32.

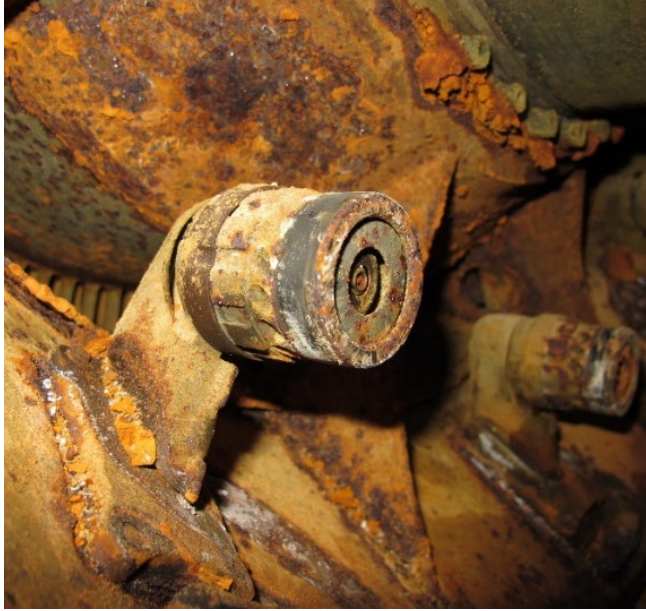
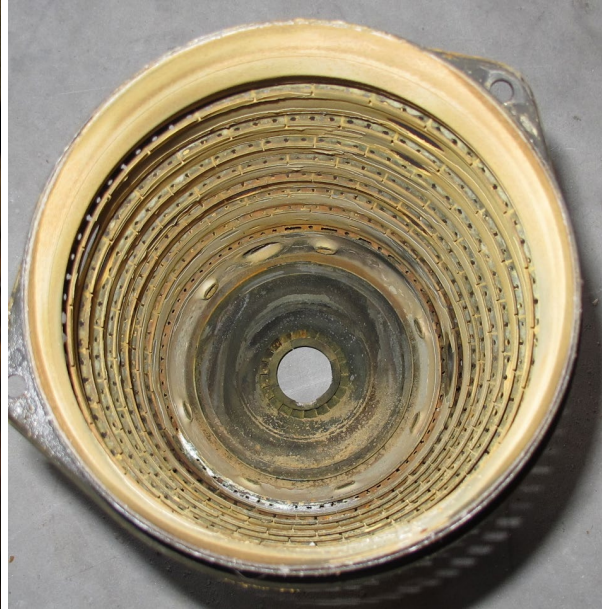
The diffuser case struts exhibited advanced corrosion. The fuel nozzles were unremarkable other than heavy rust and coral encrustation. See Figure 33. Inspection of the nine combustion chambers found no evidence of metallization on the dome surfaces unobscured by deposits. All chambers were intact with no burn-through or other thermal damage. See Figure 34.

Figure 33 No. 2 engine diffuser case and fuel nozzle

Figure 34 Exemplar combustion chamber inside surfaces, showing no thermal distress

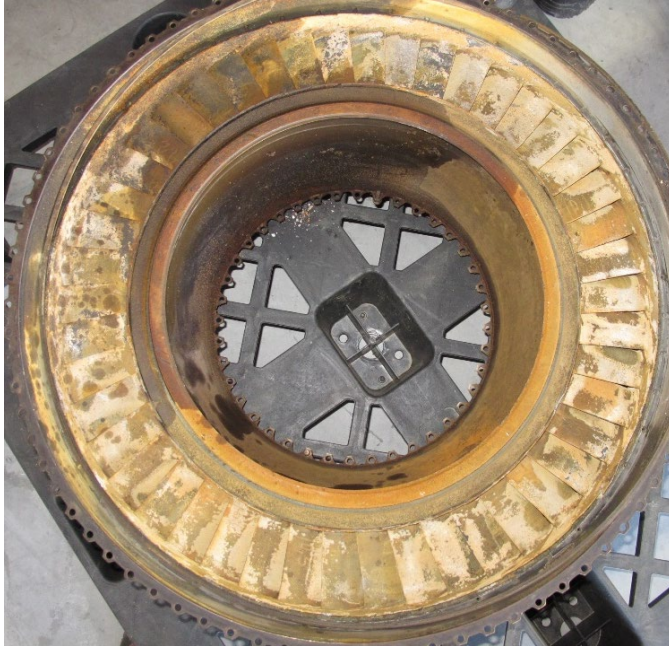
The T1 nozzle vanes were in place and exhibited no leading or TE damage. See Figure 35. Where coral encrustation was absent, the vane surfaces were smooth and uniformly steel blue-gray in color. One vane at 7 o'clock was cracked; the crack was open mid chord and wrapped around the airfoil LE. See Figure 36.

Figure 35 No. 2 engine NGV in good condition

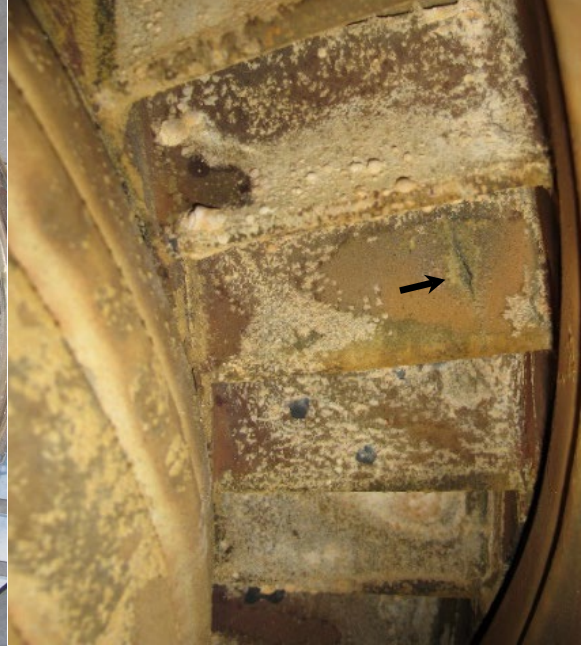
Figure 36 Chordwise vane crack

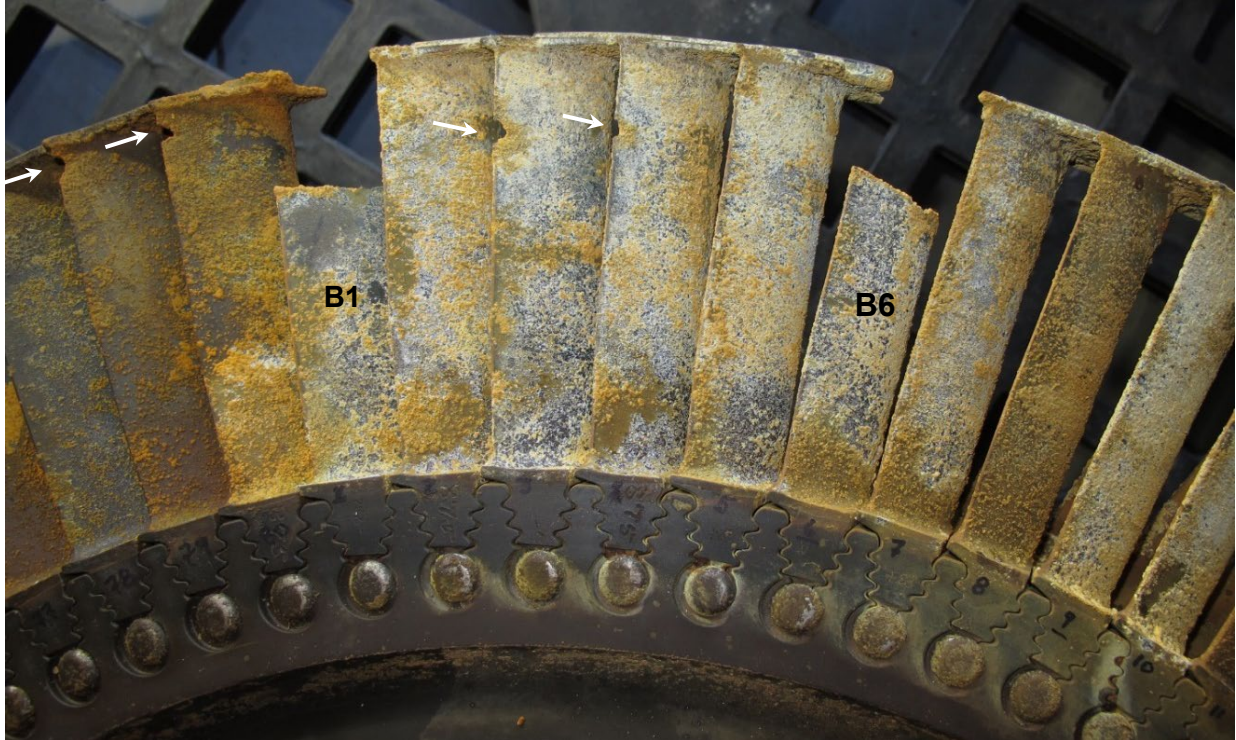
The blades were numbered clockwise from 1 to 80, with the trailing fractured blade designated blade 1. Blade 1 was fractured transversely approximately 2.4 inches above the platform TE. Blade 6 was fractured transversely approximately 2.7 inches above the platform TE. Blades 79, 80, 3 and 4 exhibited TE outer diameter impact damage toward the outer span. There was random TE damage to other blades with missing material up to 0.04 inch radially. See Figure 37.

Figure 37 No. 2 engine T1 showing the two fractured blades. TE impact damage is indicated by arrows

Metallurgical and fractographic examination of blade 1 and blade 6 found that regions of the chordwise fracture surfaces not covered with ocean deposits were predominantly rough textured (intergranular) except for regions around the two internal spanwise weight reduction holes, which were mostly flat.

Metallographic examination of blade 6 determined that the flat textured regions were in oxidation /corrosion scale and not sound base metal. Extensive oxidation /corrosion through the blade cross-section and secondary intergranular cracks were observed around the internal hole profile and near the plane of the fracture. Gross plastic deformation was not evident visually.

It was determined that the most probable failure mode was internal oxidation/corrosion that led to the loss of load-bearing cross section, resulting in stress rupture fracture. It was inconclusive which of the two blades failed first.

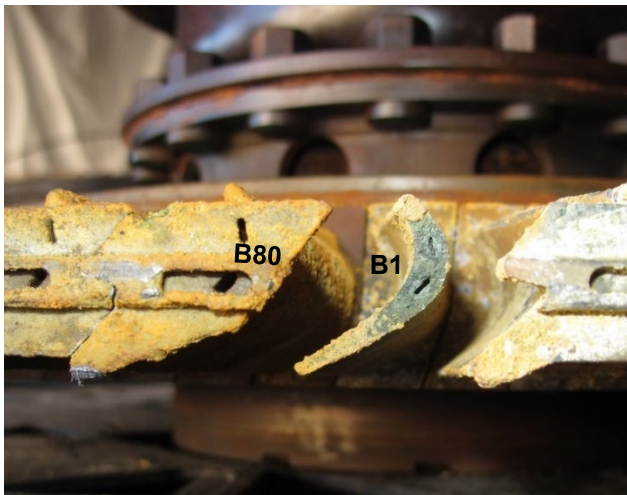
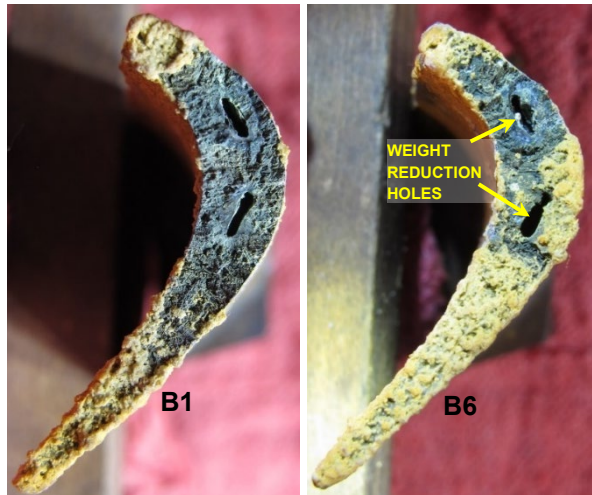
There was no T1 blade LE impact damage. The intact tip shrouds appeared full height and exhibited no evidence of rub. The tip shroud of the blade following blade 6 (blade 5) had a normal appearance. The tip shroud of the blade following blade 1 (blade 80) was missing material on the convex side and had an eroded appearance. See Figure 38. The blade fracture surfaces were heavily coated with deposits. See Figure 39.

Figure 38 T1 showing B1 and B80 shroud

Figure 39 Fractured T1 blades B1 and B6

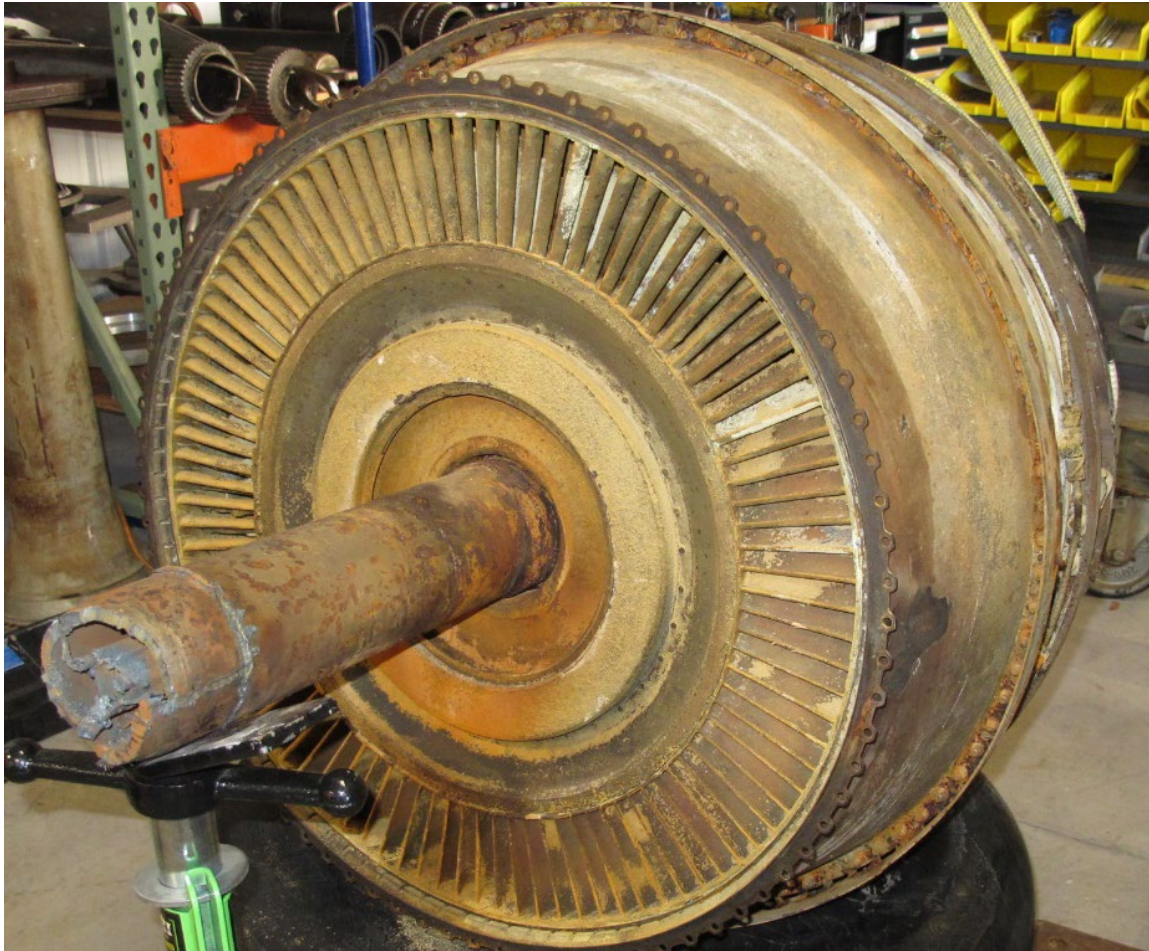
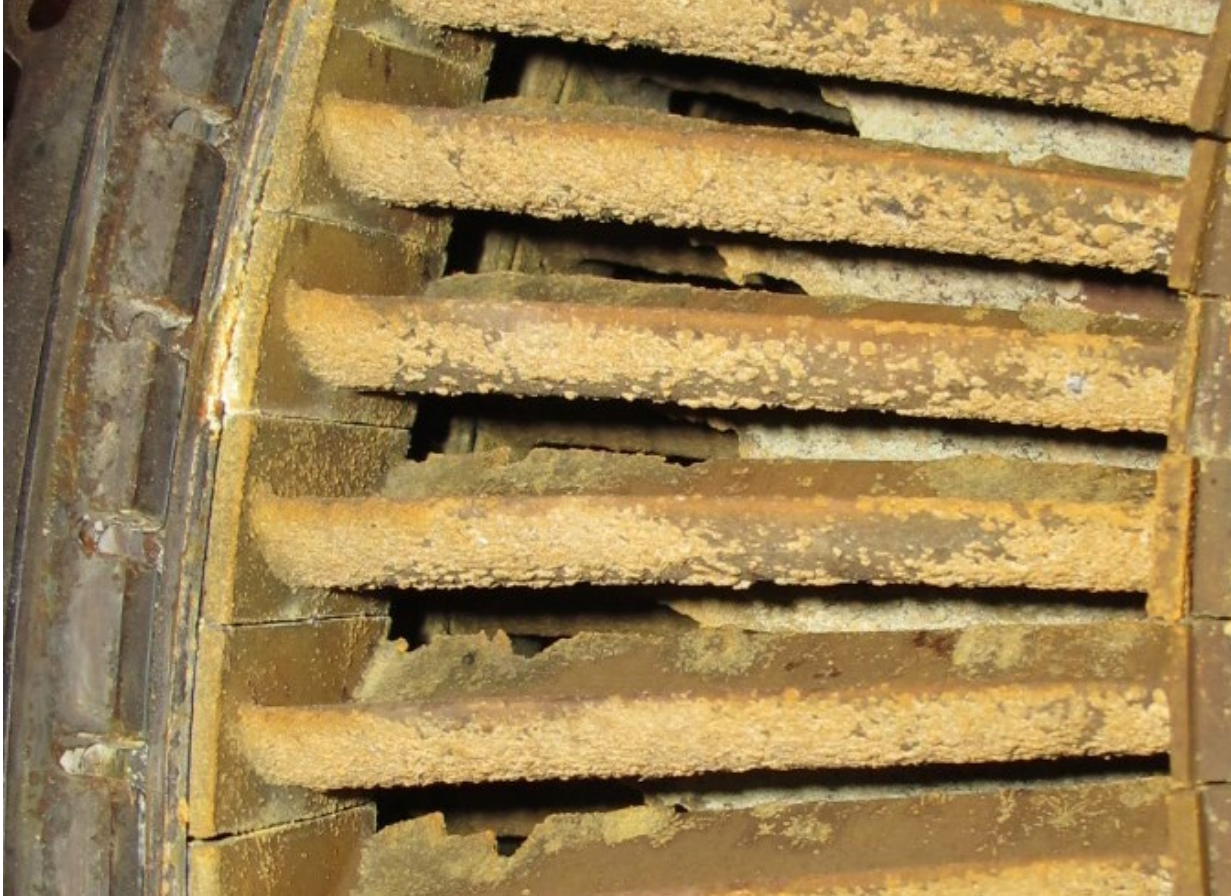
The low turbine module was not disassembled. A tactile inspection of the low turbine case found no bulging or other deformity. The T2 was inspected through the front. Three T2 vanes at 5 o'clock exhibited LE damage. All T2 vanes exhibited TE breakout damage. All T2 blades exhibited outer span fractures. See Figures 40 and 41.

Figure 40 Front view of No. 2 engine low turbine. The shaft was cut to aid disassembly

Figure 41 Detail view of No. 2 engine T2 blade outer span damage

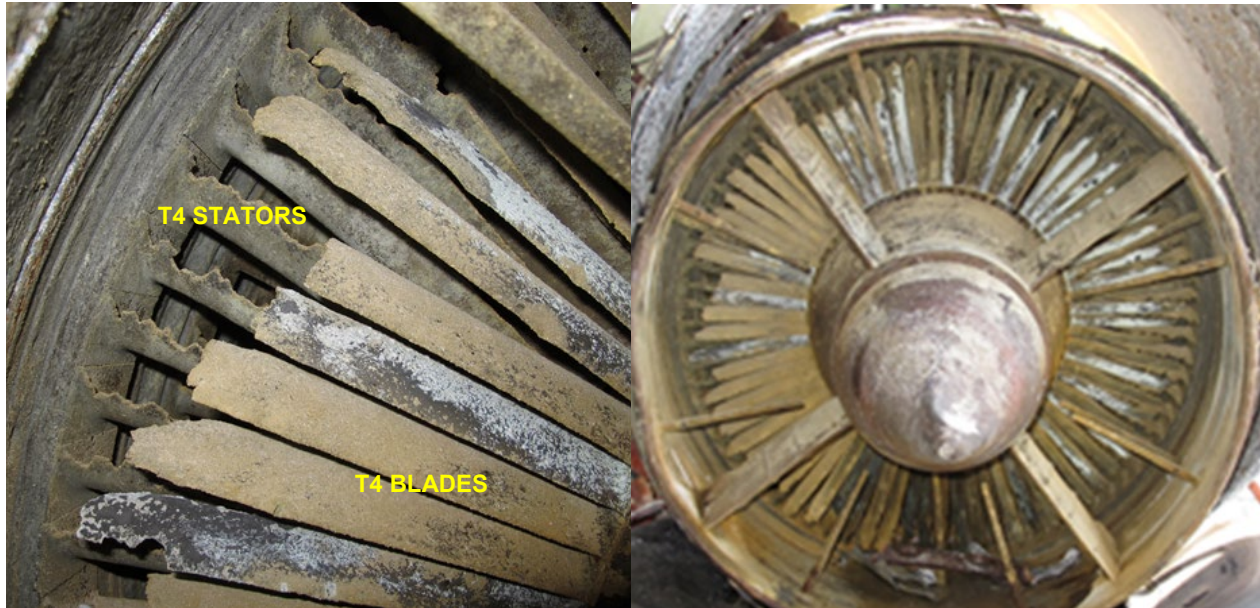
The T3 and T4 were inspected through the back of the TEC. The T3 exhibited outer span blade fractures and TE stator breakout damage similar to the T2 damage. Up to three inches of outer span material was missing from all T4 blades. The T4 vane airfoil breakout damage was most pronounced over the outer 50% span. See Figure 42.

Figure 42 View through the No. 2 engine TEC showing T4 vane TE breakout damage and T4 blade outer span fractures
