National Transportation Safety Board

DCA21FA174

STRUCTURES

Group Chair's Factual Report

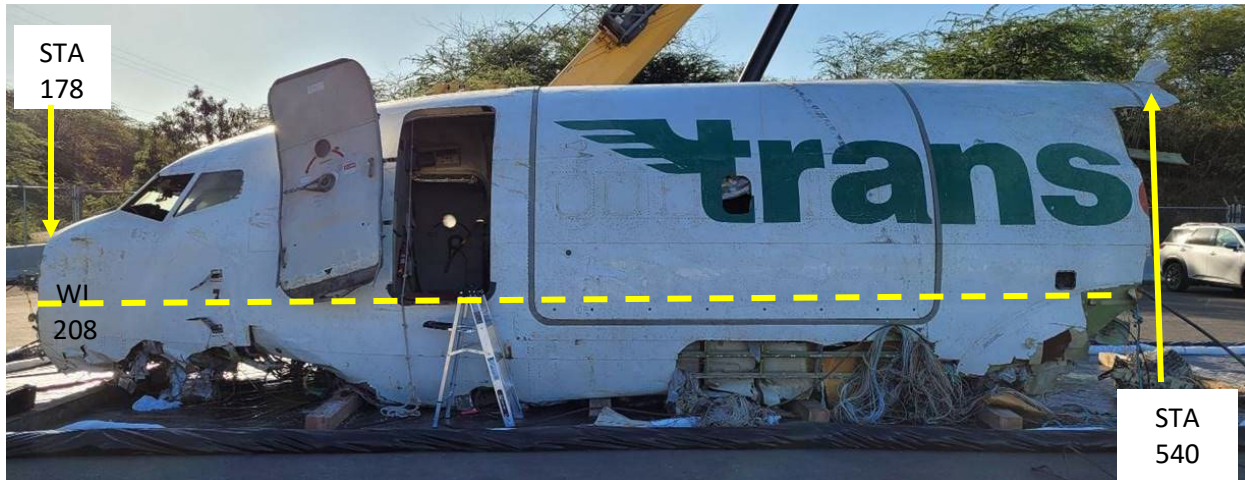
Figure 4 shows the left side of the recovered forward fuselage section. The section was mostly intact from STA 178 to STA 540 where it separated from the aft fuselage. Most of the structure below the floor at water line (WL) 208 was crushed, torn, and separated.

Figure 4. Left side of recovered forward fuselage section (Boeing photo)

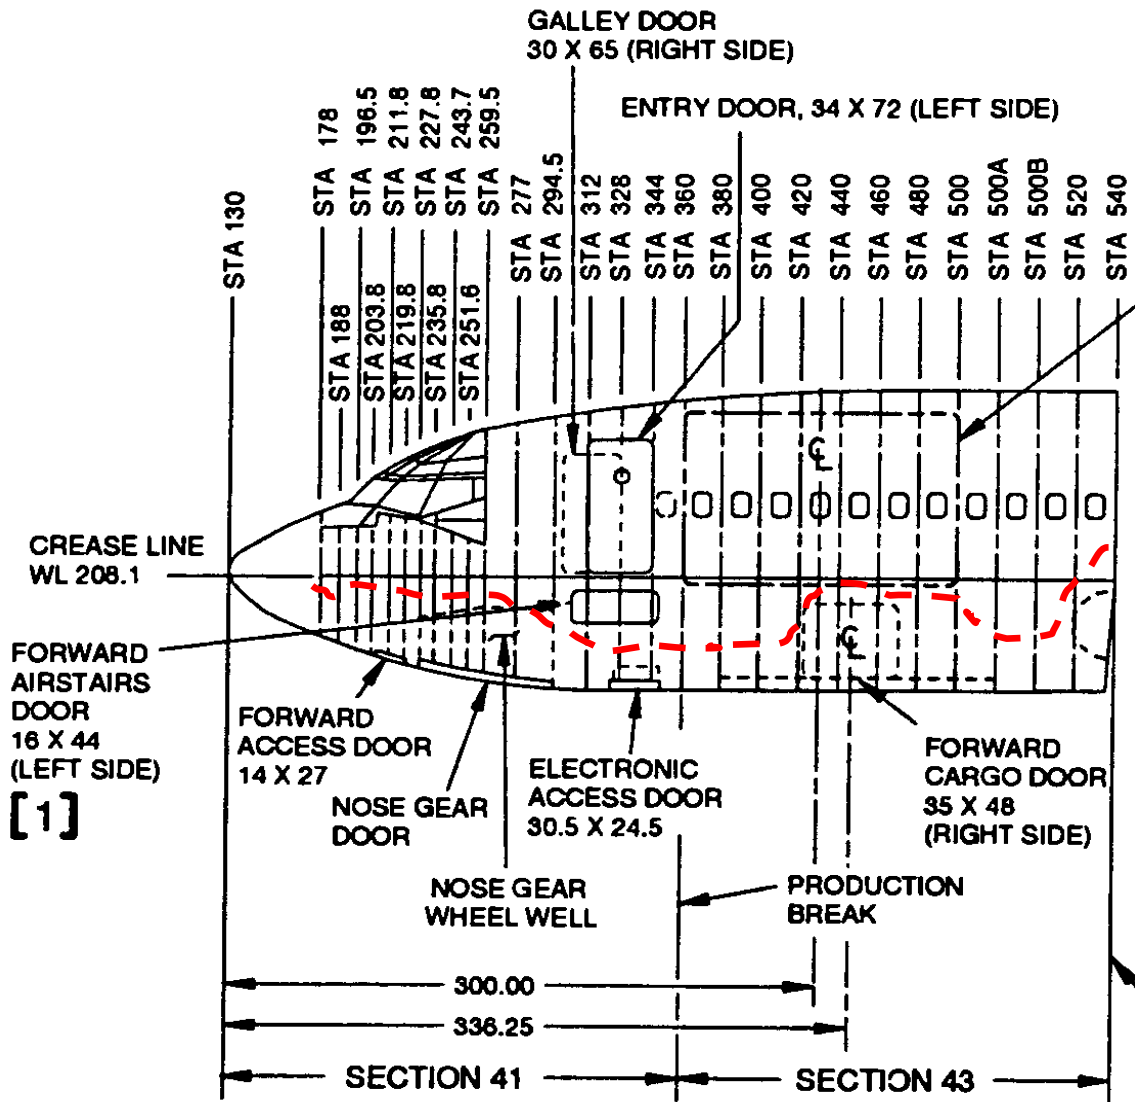
Figure 5 shows a body station diagram of the forward portion of the airplane with the approximate boundary of the lower lobe damage on the left side indicated.

Figure 5. Left side approximate damage boundary (provided by Boeing)

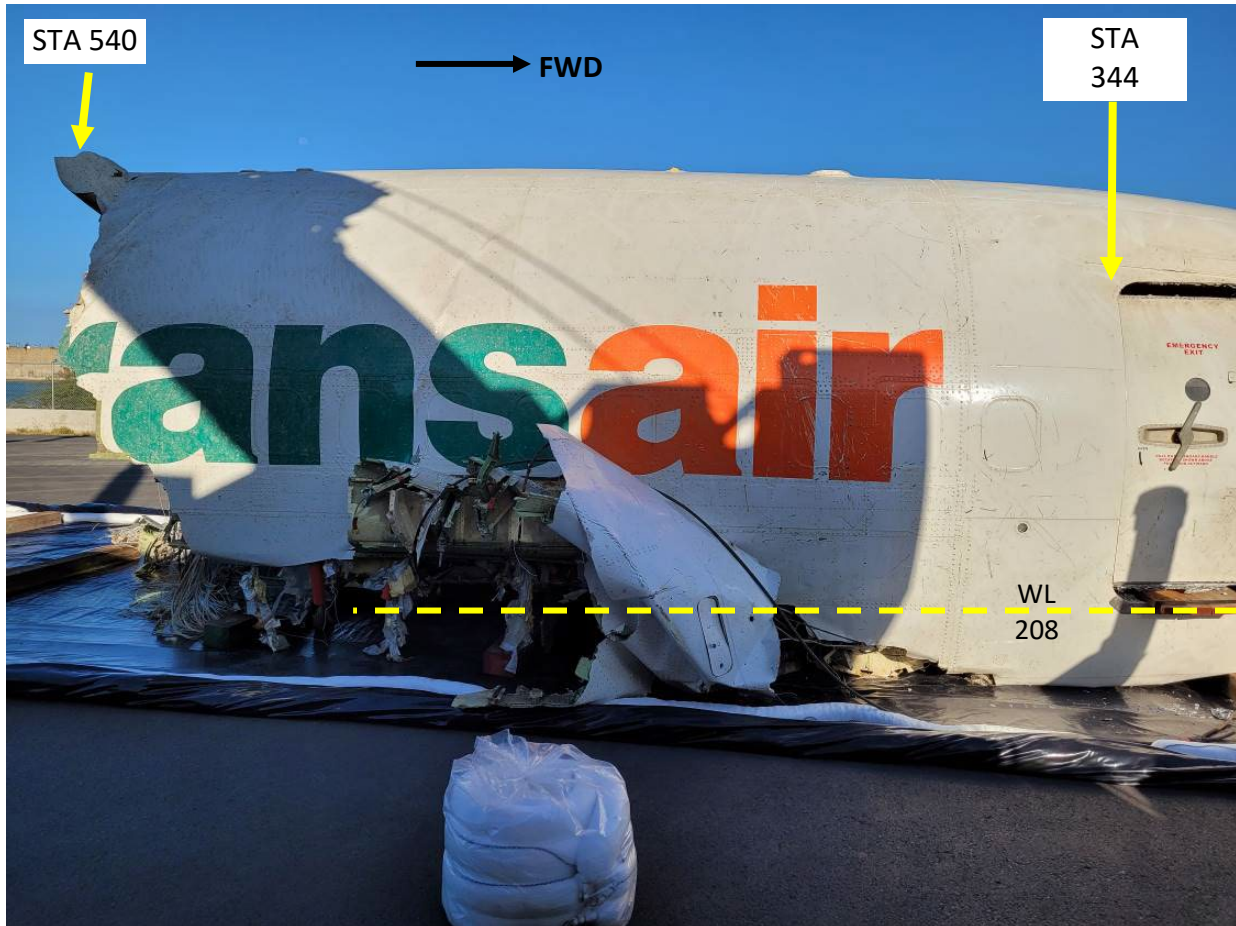
Figures 6 and 7 show the right side of the recovered forward fuselage section. The section was mostly intact from STA 178 to STA 540 where it separated from the aft fuselage. Most of the structure below the floor at water line (WL) 208 was crushed, torn, and separated.

Figure 6. Right side aft view of forward fuselage section (Boeing photo)

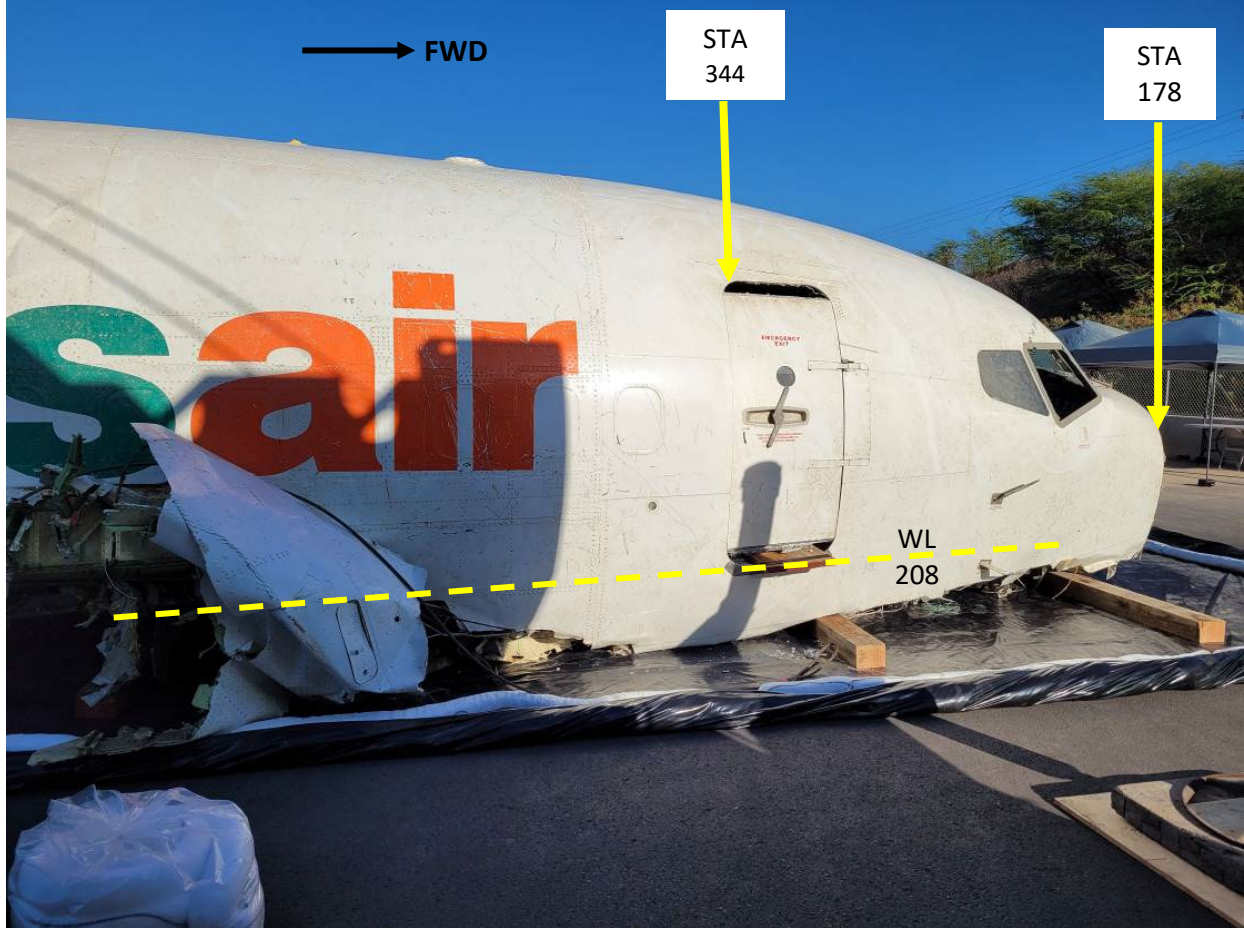
Figure 7. Right side forward view of forward fuselage section (Boeing photo)

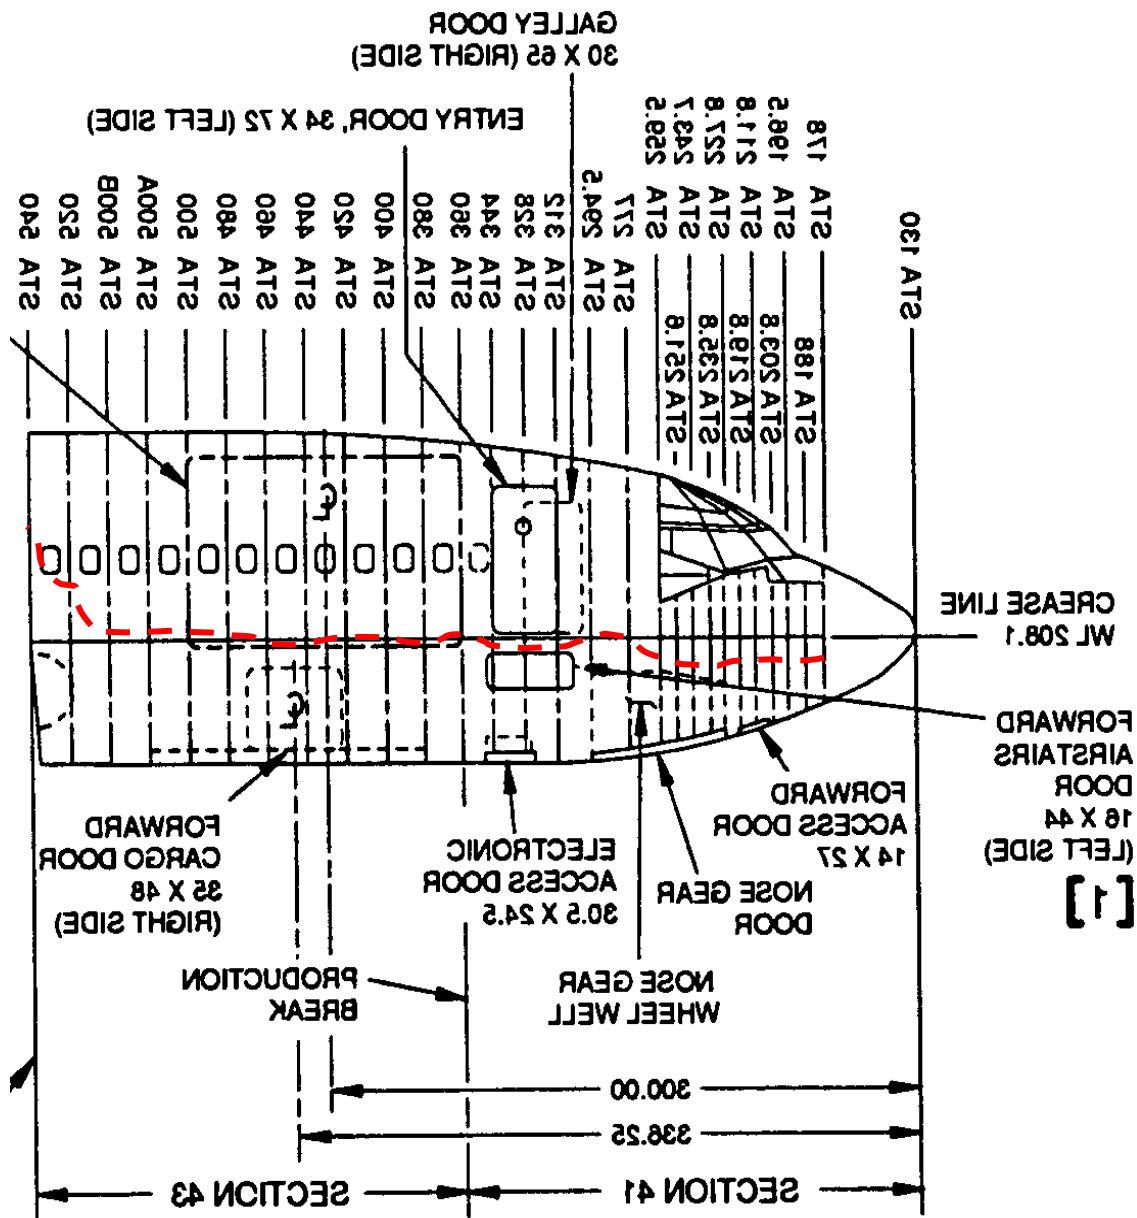
Figure 8 shows a body station diagram of the forward portion of the airplane with the approximate boundary of lower lobe damage on the right side indicated.

Figure 8. Right side approximate damage boundary (provided by Boeing)

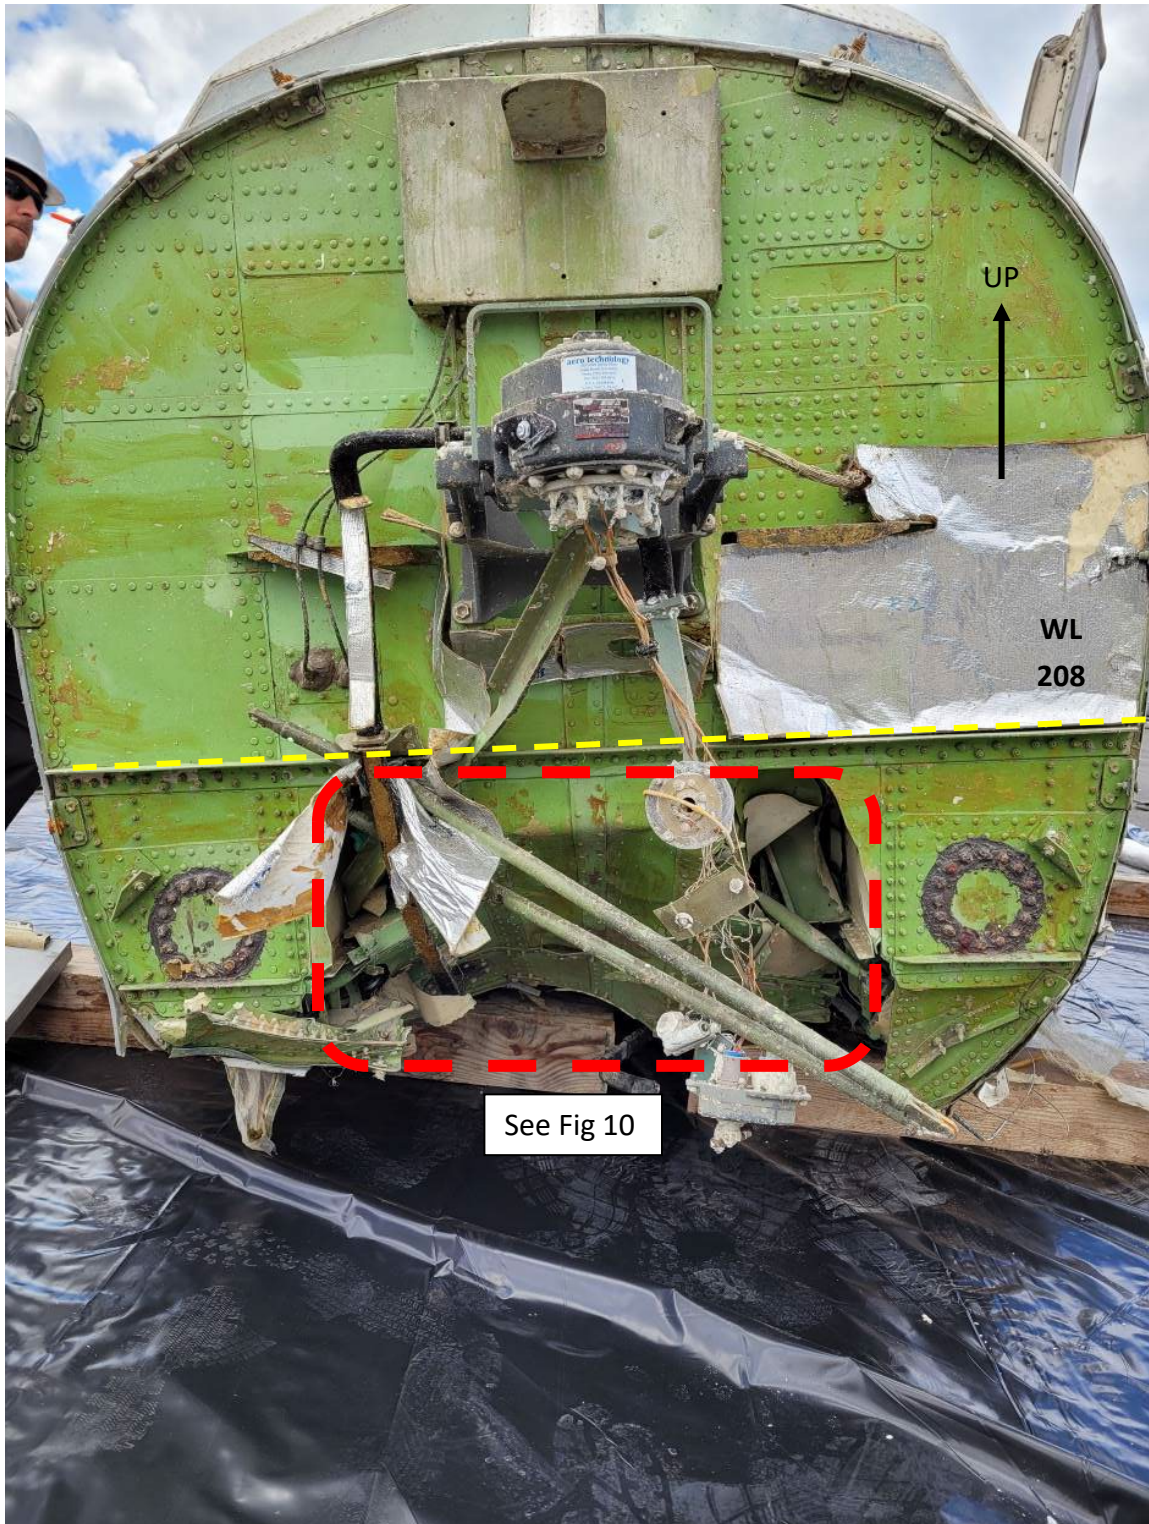
Figure 9 shows the STA 178 Forward Pressure Bulkhead (FPB) with the upper portion mostly intact and the lower portion below WL 208 damaged.

Figure 9. STA 178 FPB with lower region damaged, looking aft (Boeing photo)

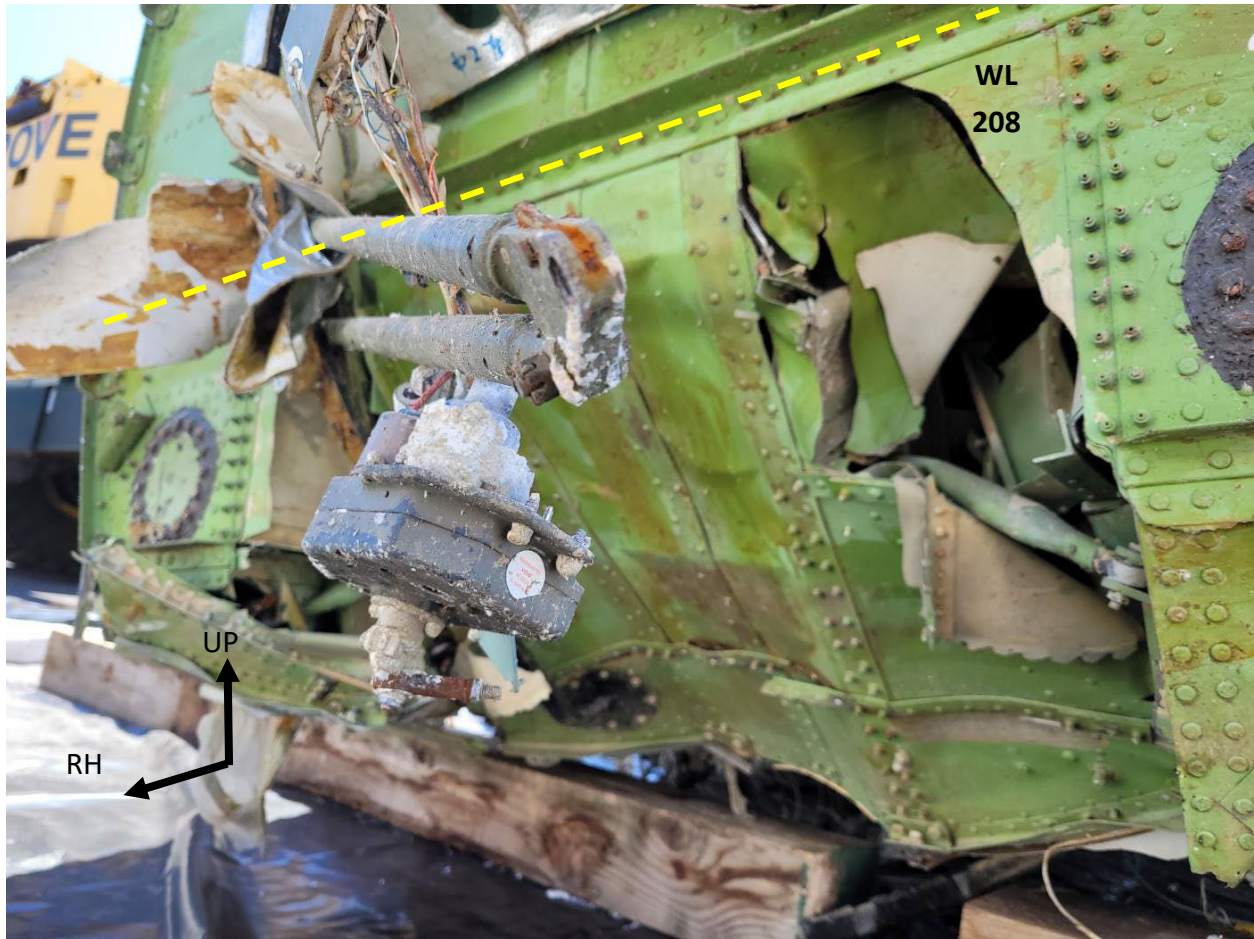
Figure 10 shows a close-up of the lower damaged region of the FPB with fractures and aftward deformation.

Figure 10. STA 178 FPB lower region damage close-up, looking aft/right (Boeing photo)

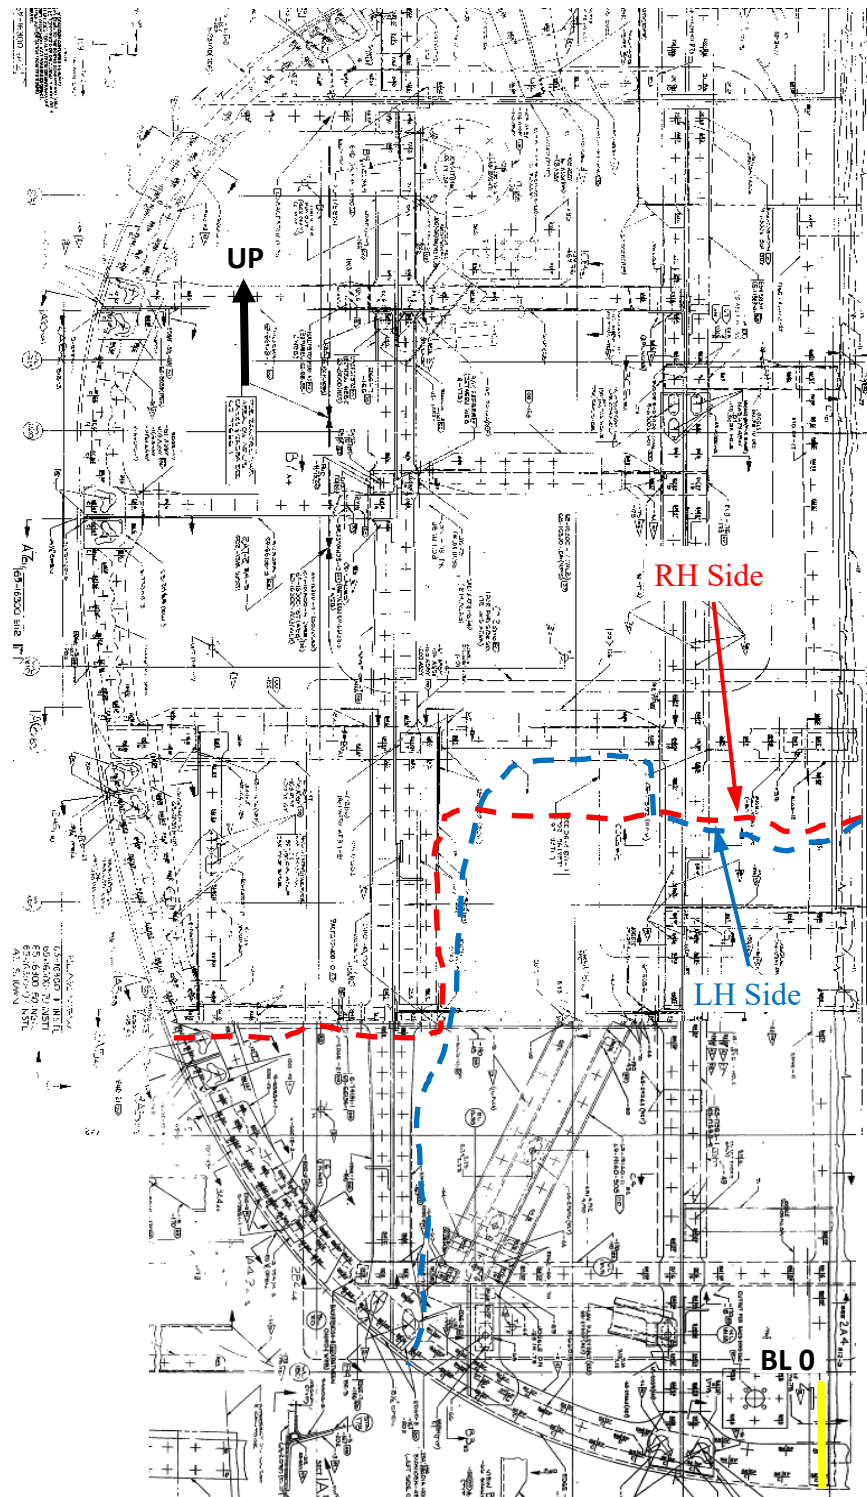
Figure 11 shows the STA 178 FPB drawing with the left (blue) and right (red) fractures indicated.

Figure 11. FPB left and right fractures (provided by Boeing)

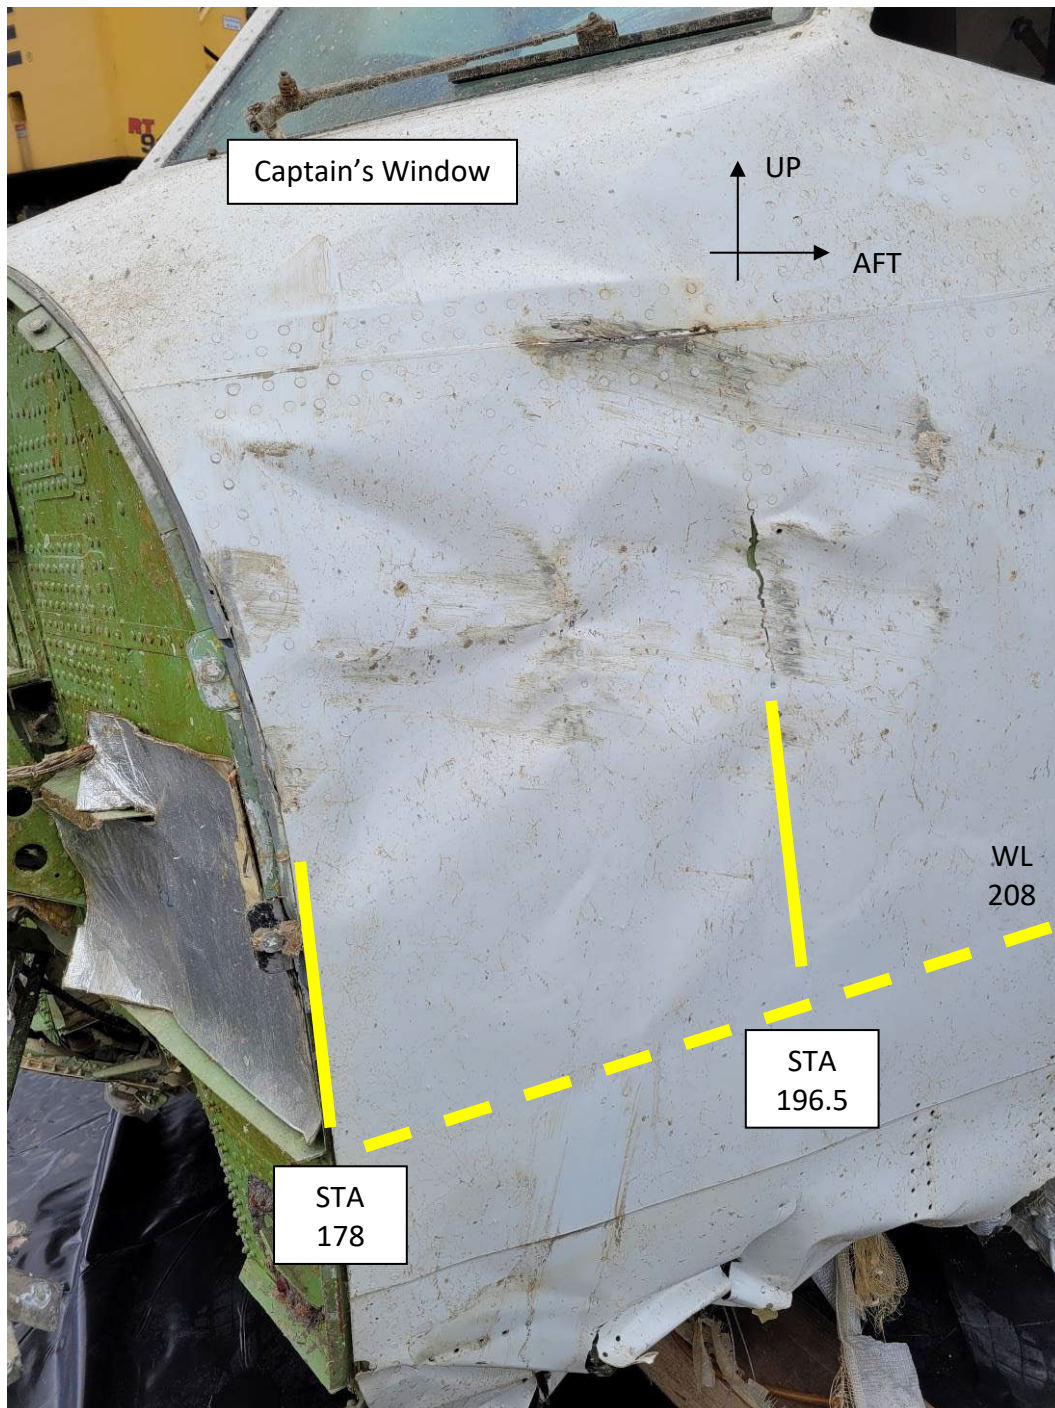
Figure 12 shows a vertical crack about 8.5 inches long in the left fuselage skin at the STA 196.5 frame common to a dent. There were multiple dents in the left fuselage skin between the STA 178 FPB and STA 211 frame.

Figure 12. Left forward fuselage damage (Boeing photo)

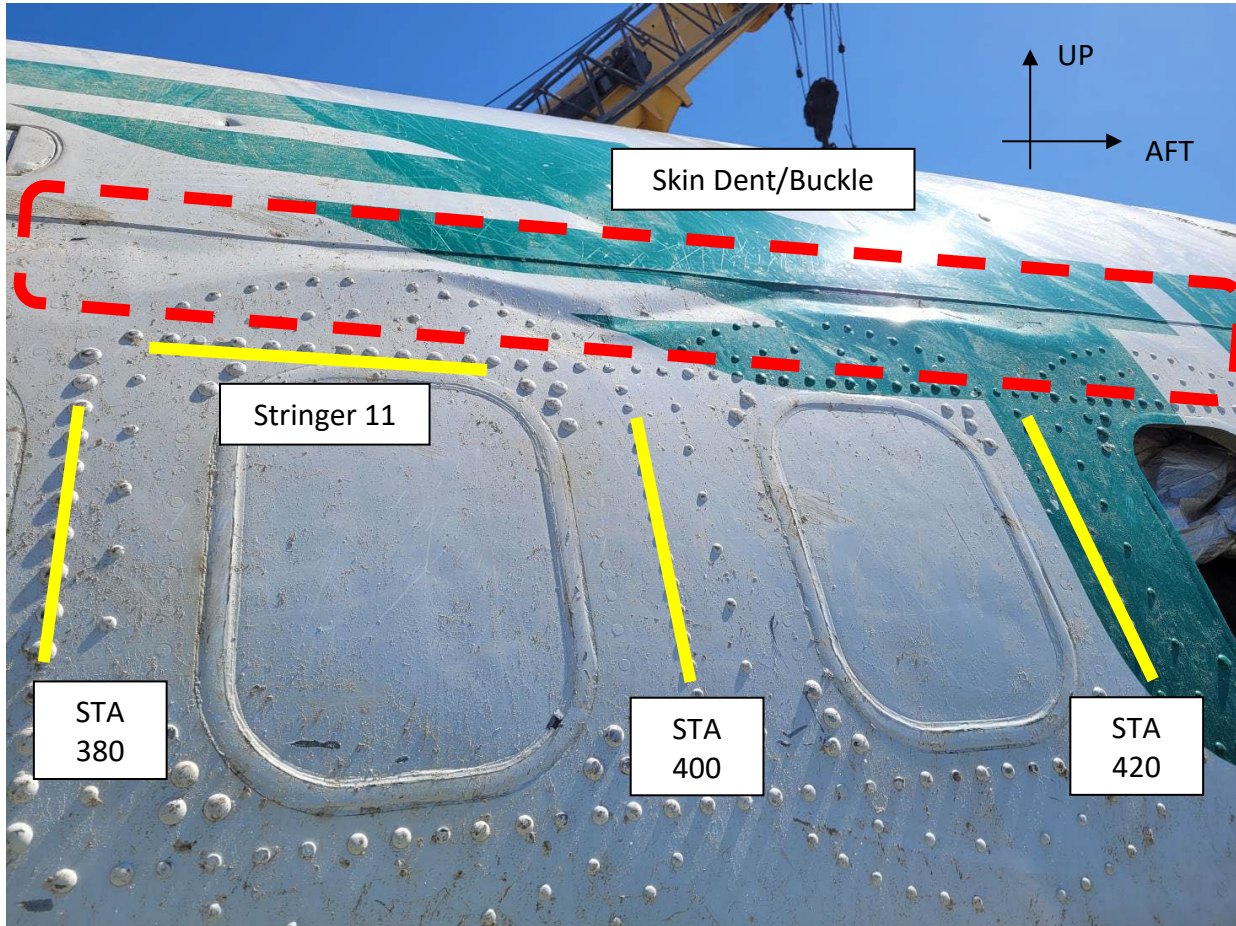
Figure 13 shows a STA 380-420 external skin dent/buckle in the Main Deck Side Cargo Door (MDSCD) above the window belt. The missing window plug aft of STA 420 frame is also shown.

Figure 13. Main Deck Side Cargo Door external skin (Boeing photo)

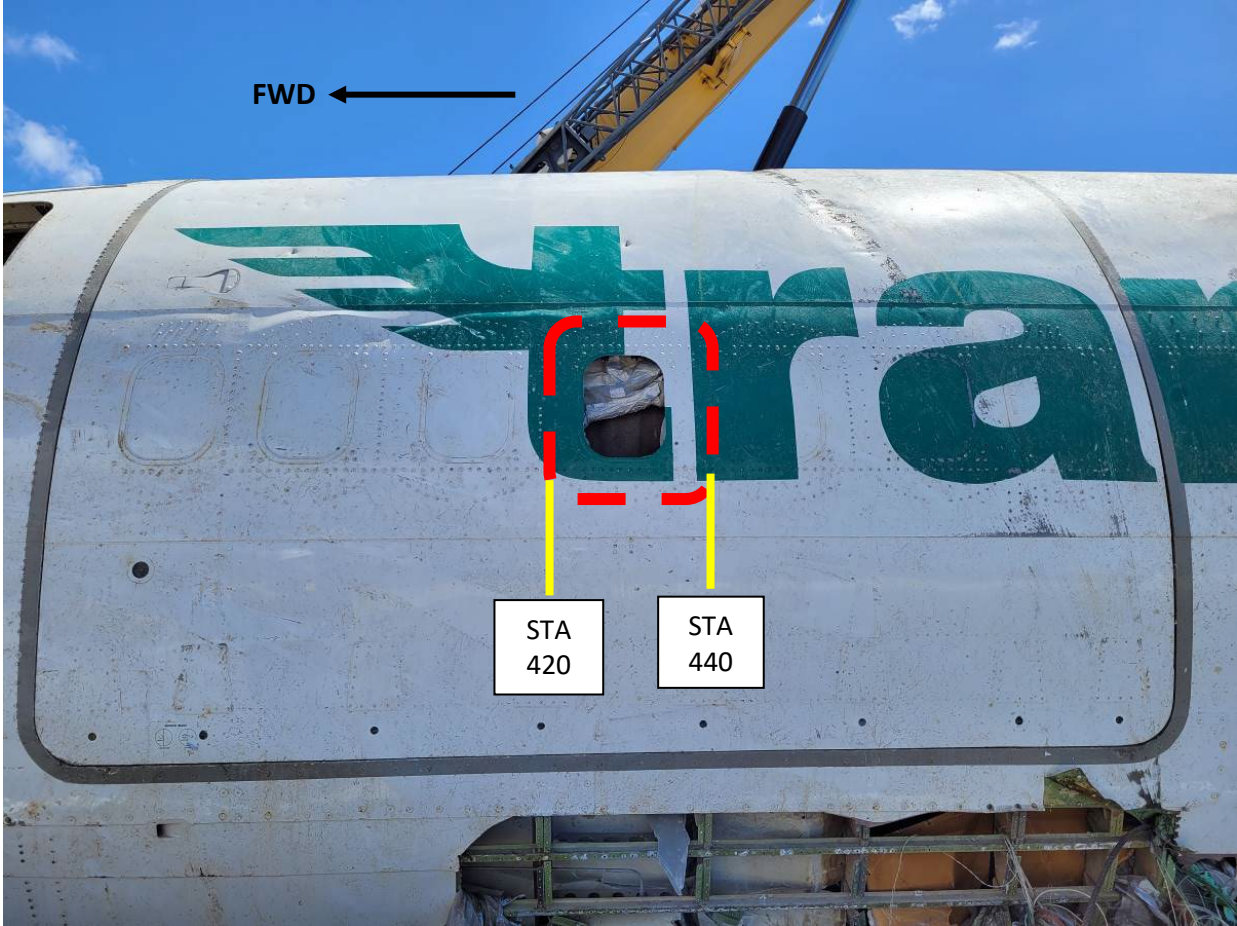
Figure 14 shows the missing window plug in the left forward fuselage between STA 420 and STA 440 frames.

Figure 14. Missing window plug on left fuselage between STA 420 and STA 440 frames (Boeing photo)

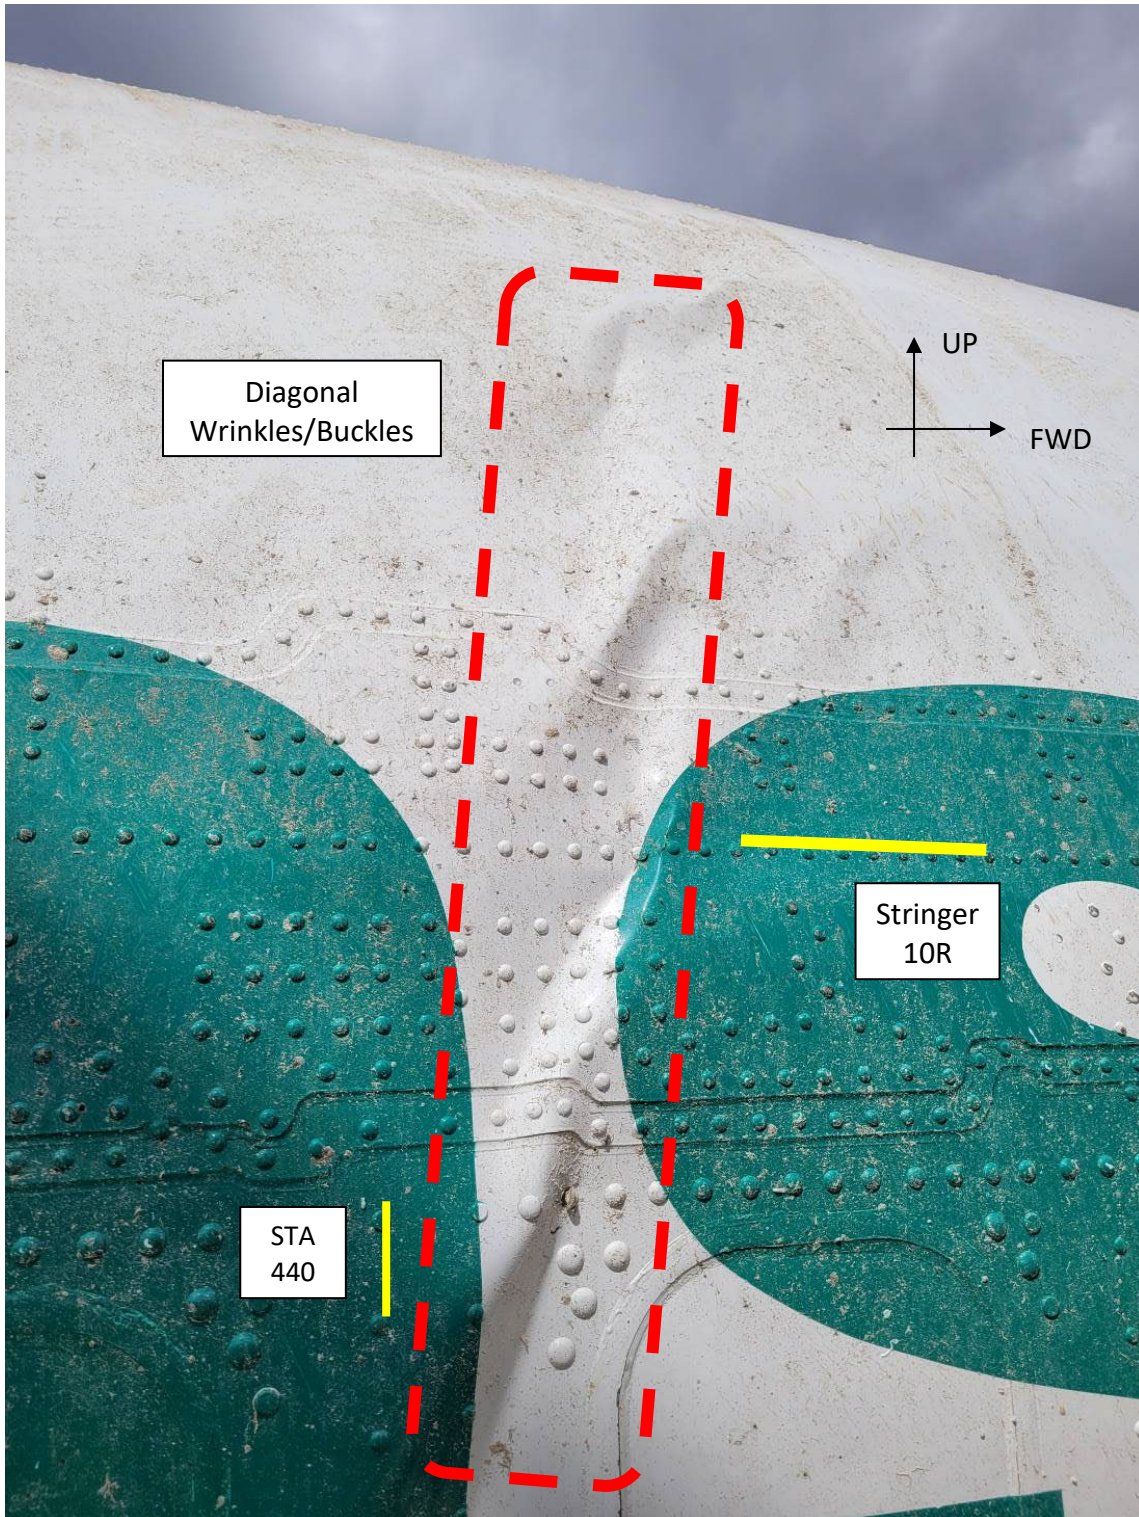
Figure 15 shows diagonal skin wrinkles/buckles in the right forward fuselage skin near STA 435.

Figure 15. Right forward fuselage skin diagonal wrinkles near STA 435 (Boeing photo)

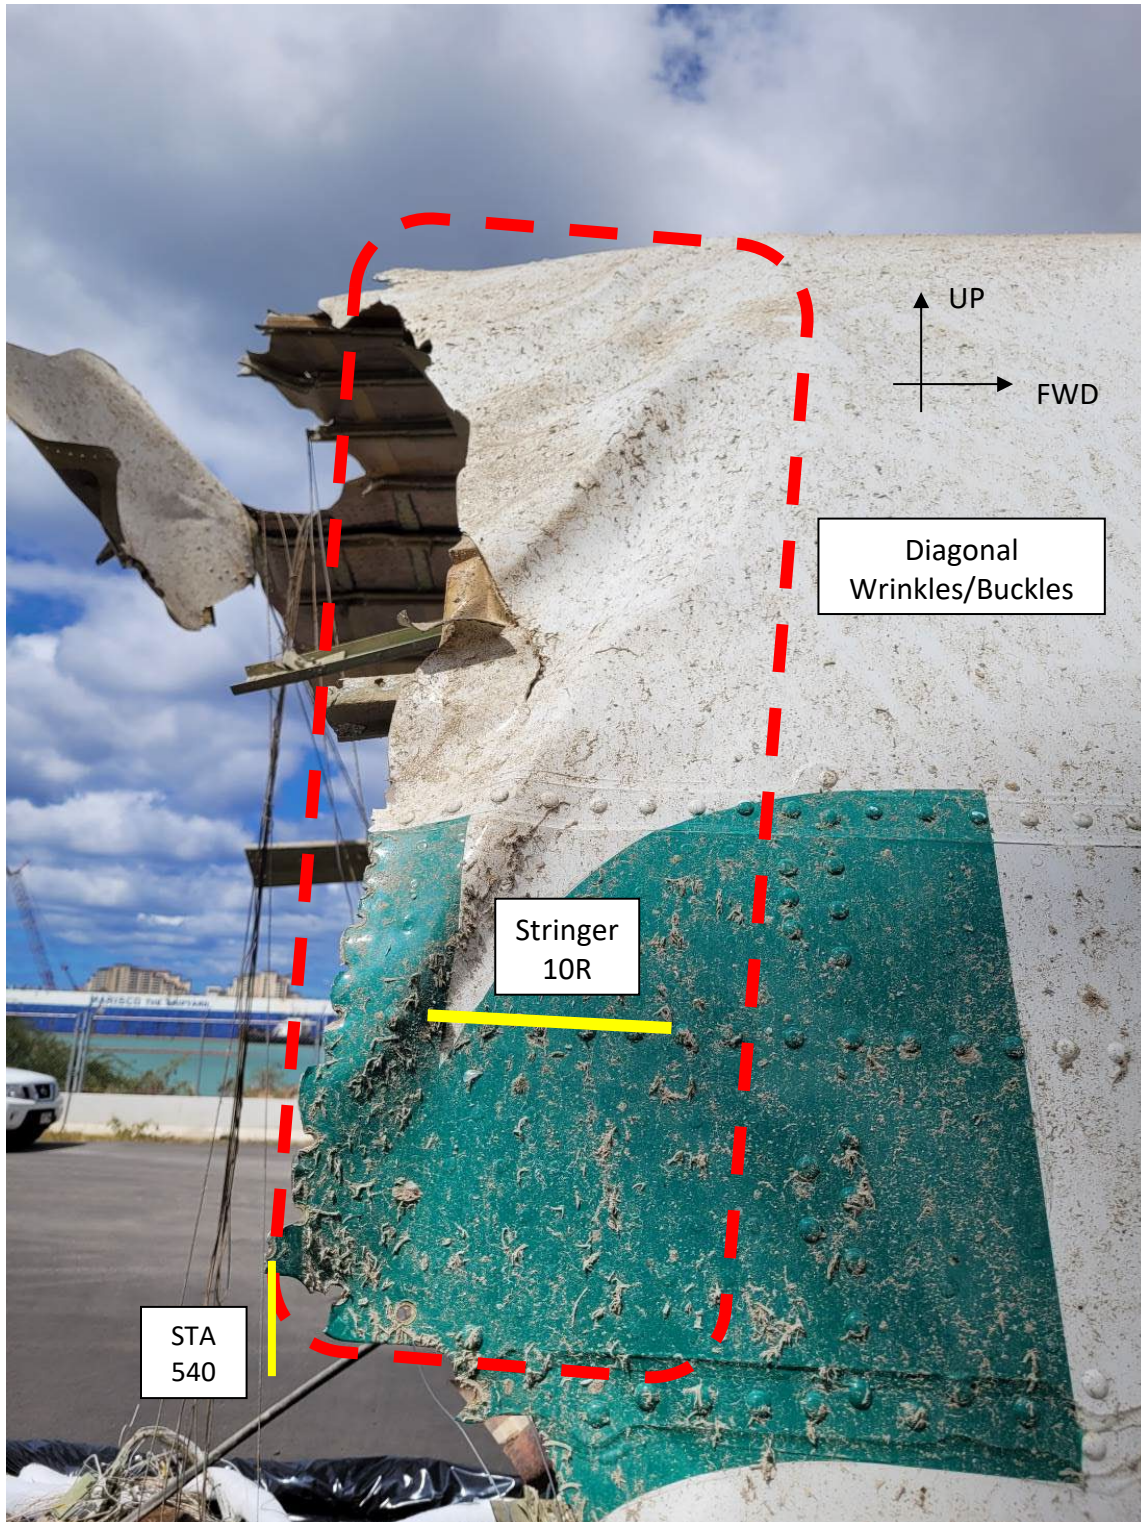
Figure 16 shows diagonal skin wrinkles in the right fuselage forward of the STA 540 separation location.

Figure 16. Right forward fuselage skin diagonal wrinkles forward of separation (Boeing photo)

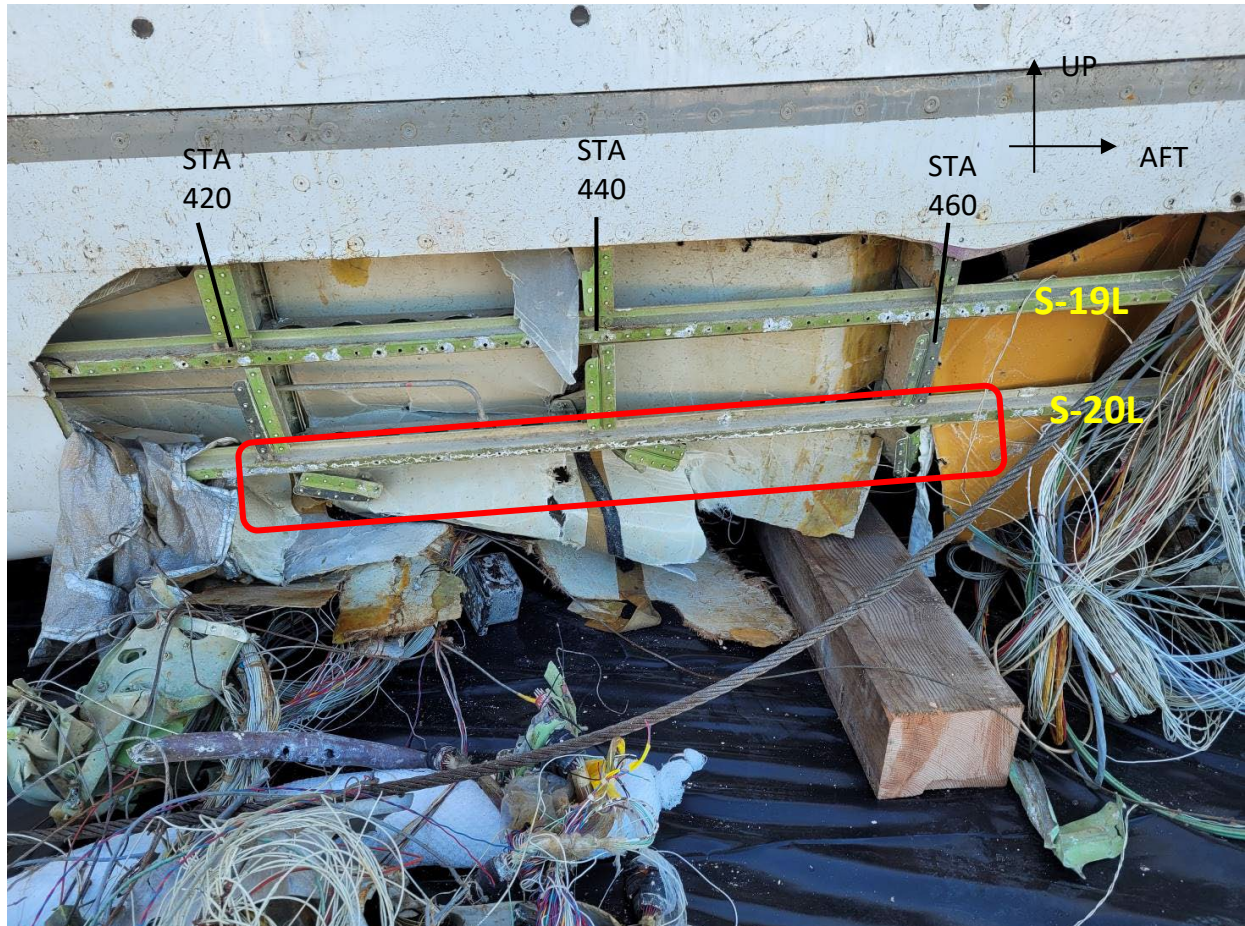
Figure 17 shows the left fuselage damage between STA 400 and STA 480 below the WL 208 floor structure. Multiple rivets were pulled-through and there was aftward deformation of the STA 420, 440 and 460 frames between S-20L and S-21L, outlined in red.

Figure 17. Left fuselage damage below floor location (Boeing photo)

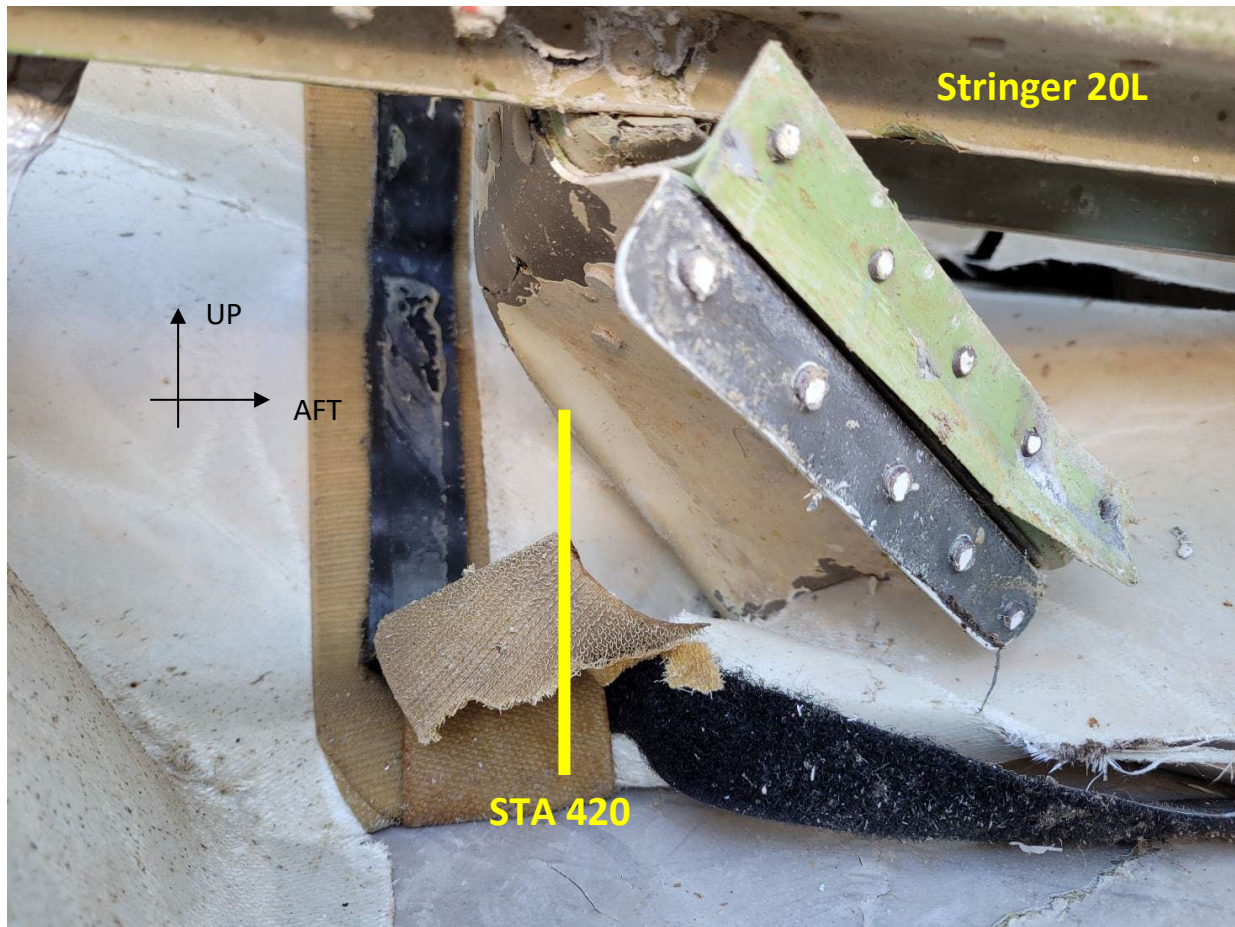
Figure 18 shows a close-up of the aftward deformation of the STA 420 frame between stringer S-20L and S-21L. STA 440 and 460 frame damage between stringers S-20L and S-21L was similar.

Figure 18. Left fuselage STA 420 frame damage detail (Boeing photo)

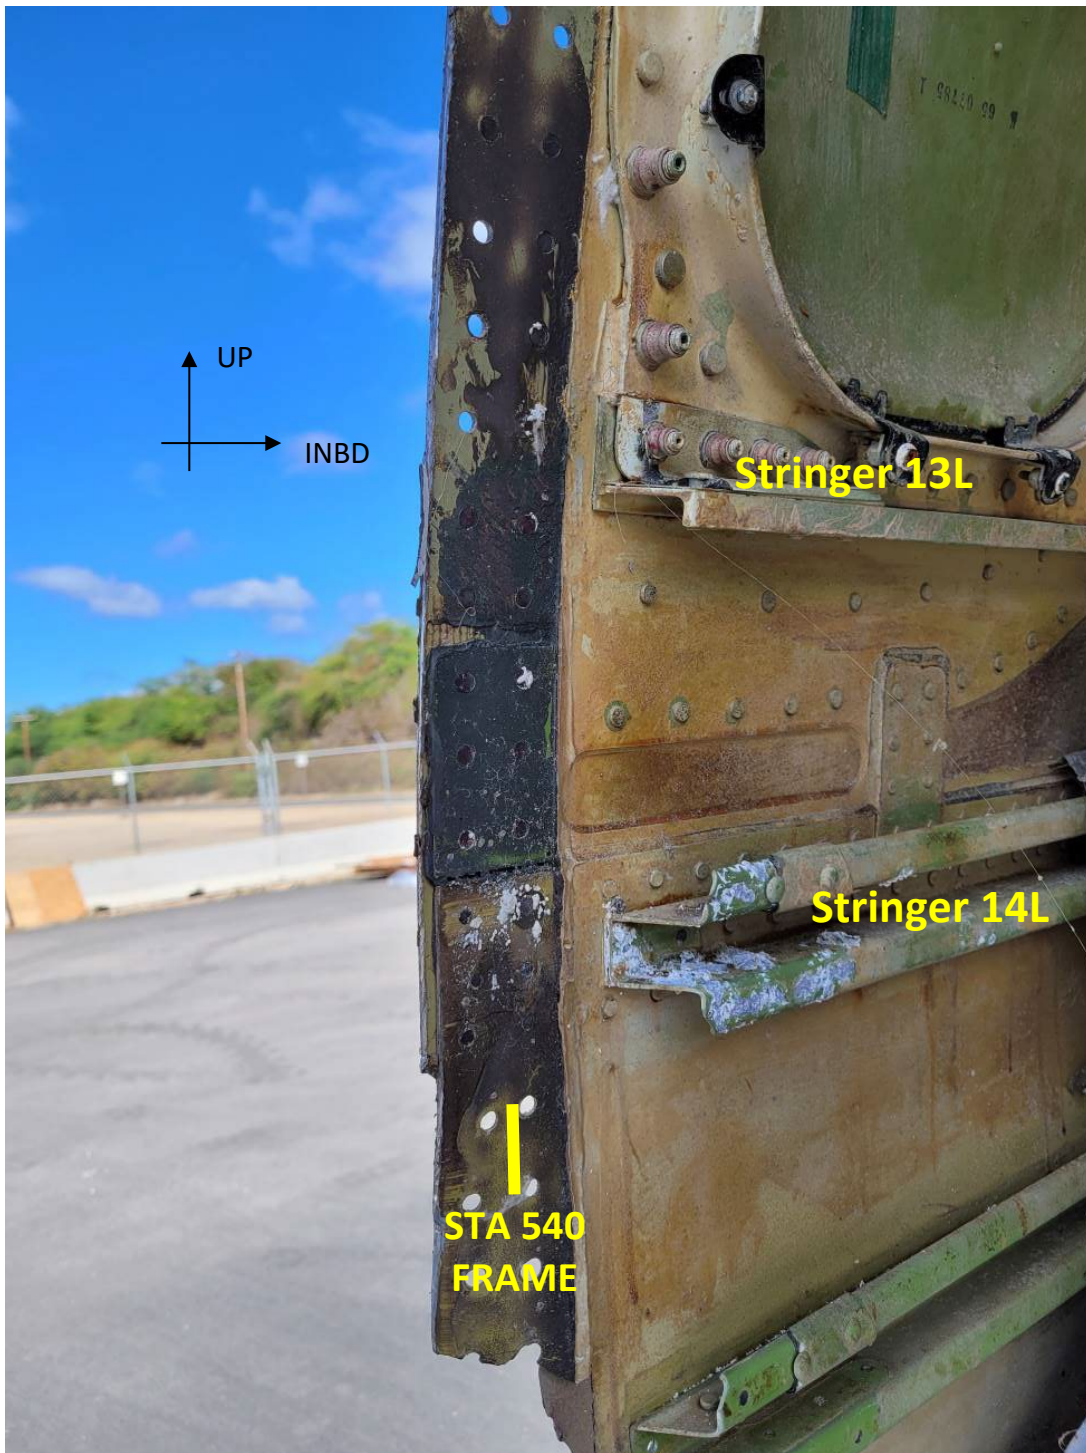
Figure 21 shows the forward fuselage section left side separation region near STA 540. The STA 540 frame is also the wing attachment location (pickle fork attachment to center section front spar).

Figure 21. Left STA 540 separation location side view (Boeing photo)

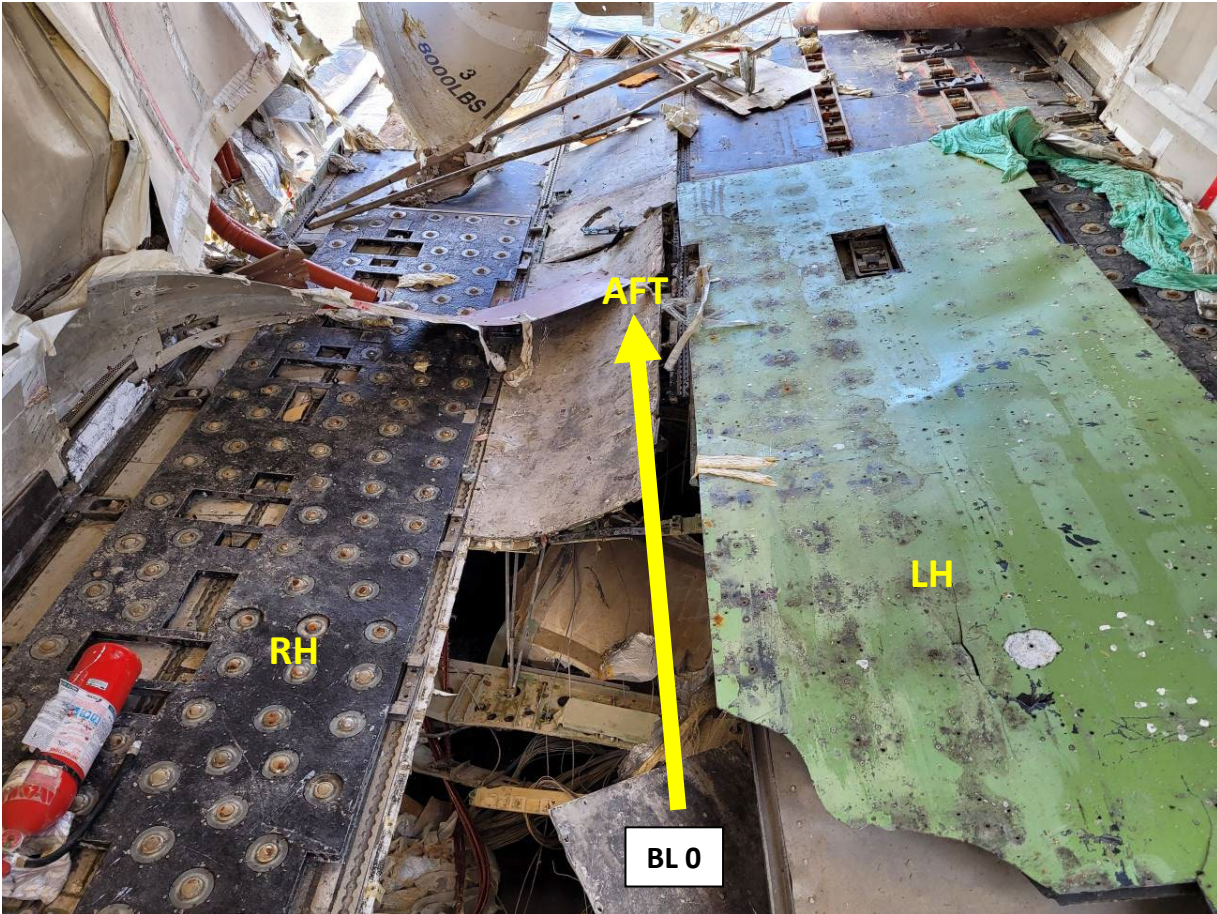
Figure 22 shows the forward fuselage section Main Deck Floor structure damage. A portion of the RH floor structure was missing just right of the centerline. The ball mats remained installed along the right side of the fuselage. The LH floor substructure, although damaged, was mostly intact and in-place.

Figure 22. Main Deck Floor structure damage, looking aft (Boeing photo)
