National Transportation Safety Board

DCA21FA174

STRUCTURES

Group Chair's Factual Report

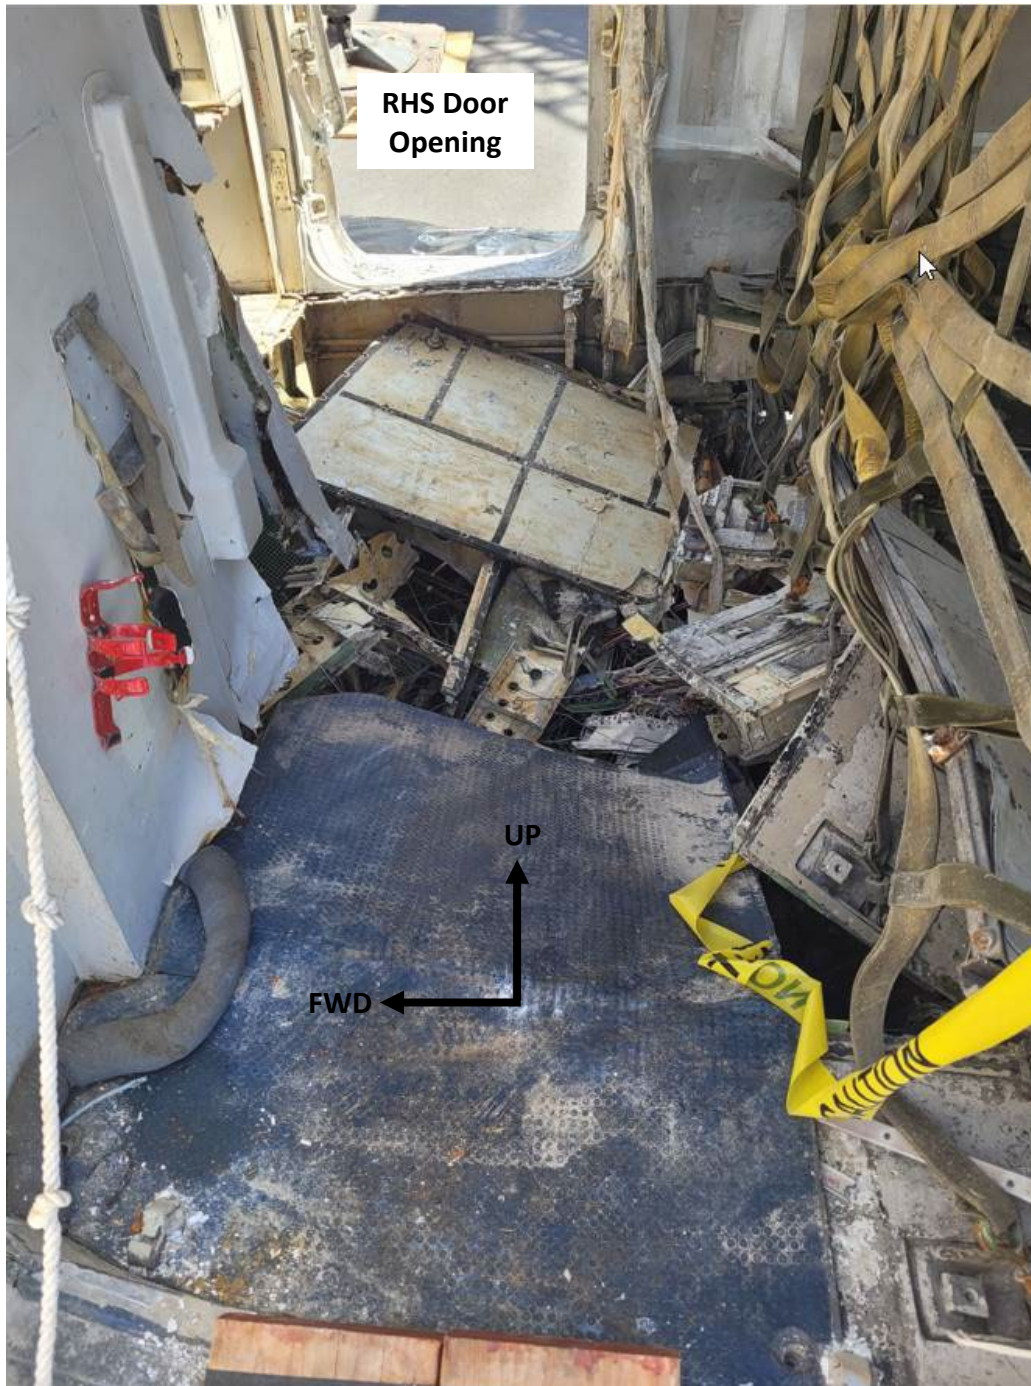
Figure 23 shows the damage to the floor structure behind the cockpit. View is looking into the cabin from the LH Forward Entry Door opening. The right floor structure was more damaged than the left.

Figure 23. Floor structure damage behind the cockpit (Boeing photo)

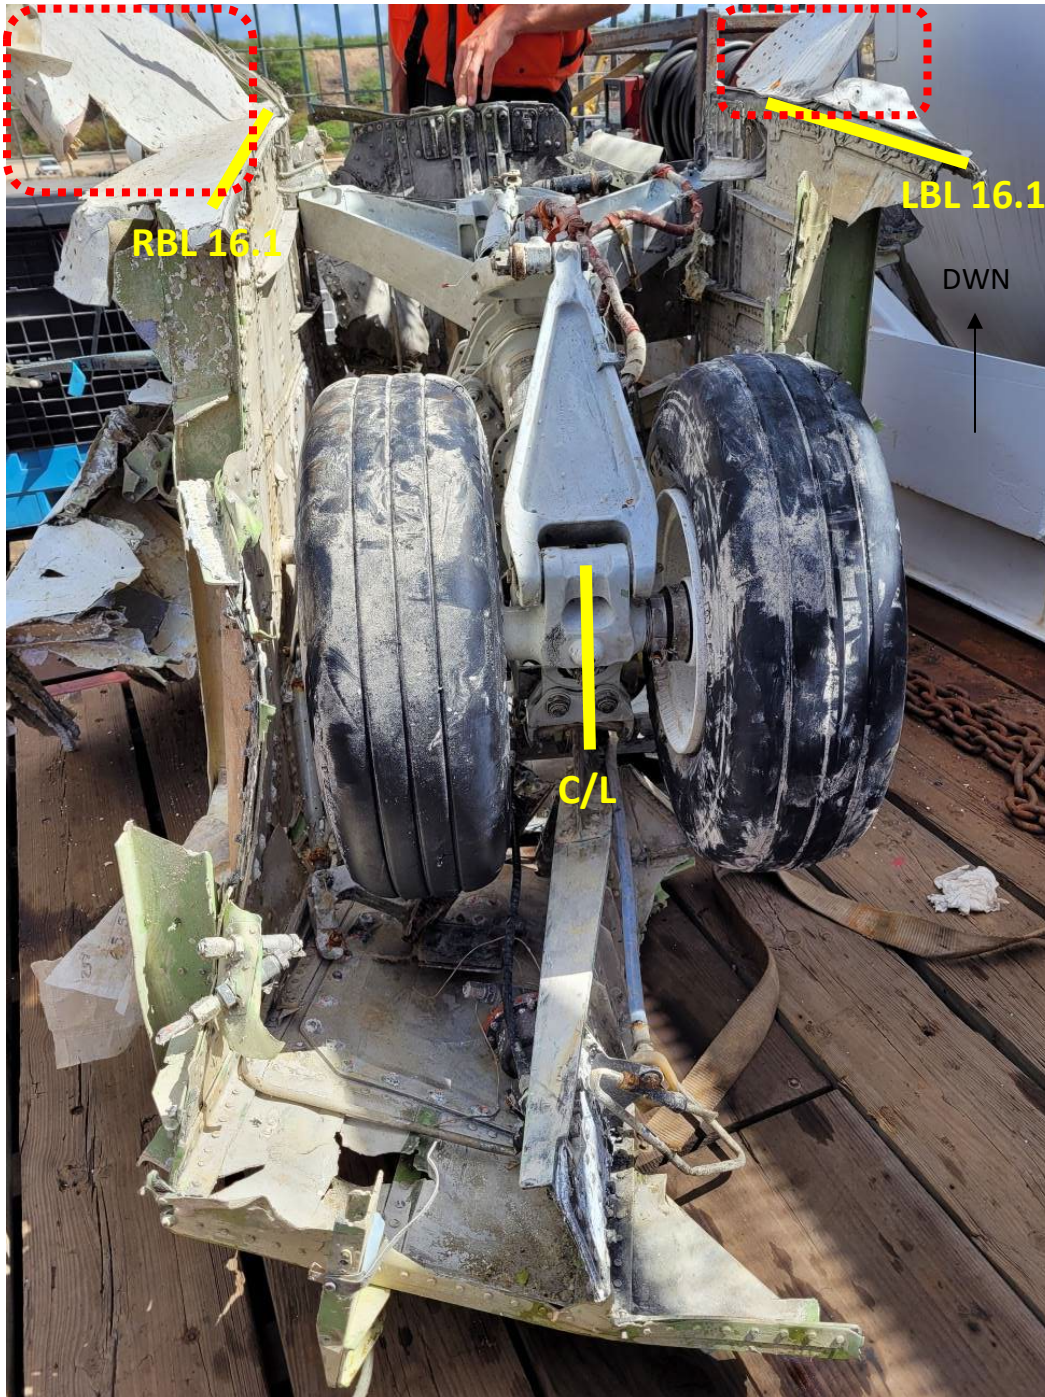
Figure 25 shows an aft side view (looking forward) of the NLG and wheel well structure which separated from the forward fuselage section. The aft wall of the wheel well was missing from the recovered assembly. A portion of the attaching fuselage skin panels adjacent to the wheel well were attached and flared away from the landing gear assembly as outlined in red.

Figure 25. Aft side view of NLG and wheel well structure, looking forward (Boeing photo)

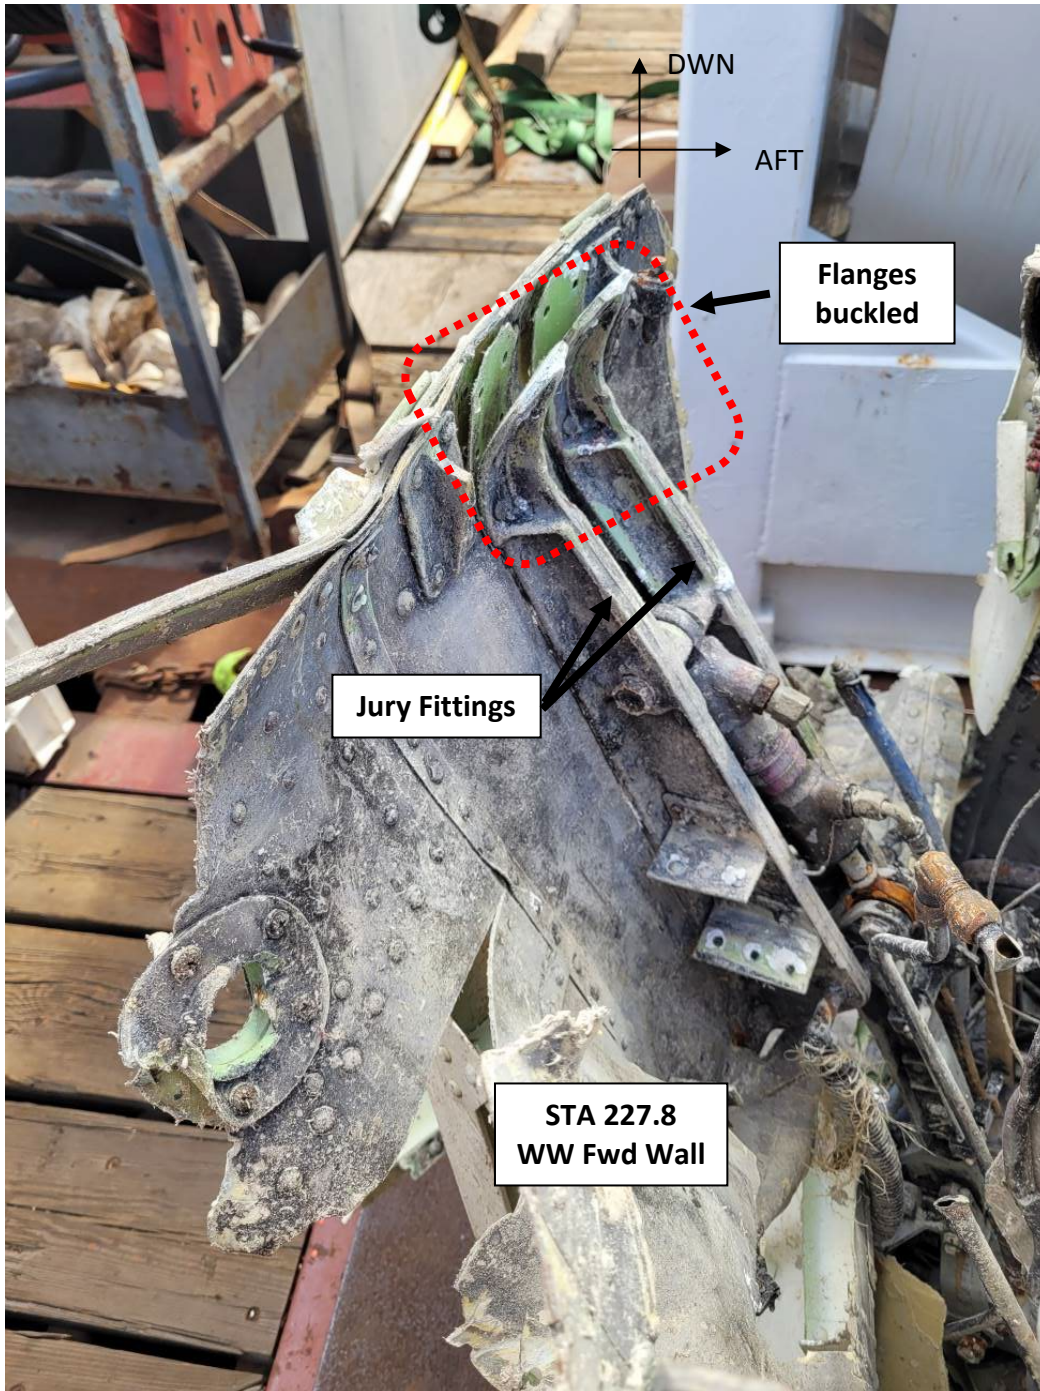
Figure 28 shows the inside of the lower portion of the forward wall of the wheel well structure which separated from the forward fuselage section. The lower portions of the Jury Fittings are bent aft. Damage included buckled upstanding fitting flanges on both fittings.

Figure 28. NLG and wheel well structure Jury Fitting damage (Boeing photo)

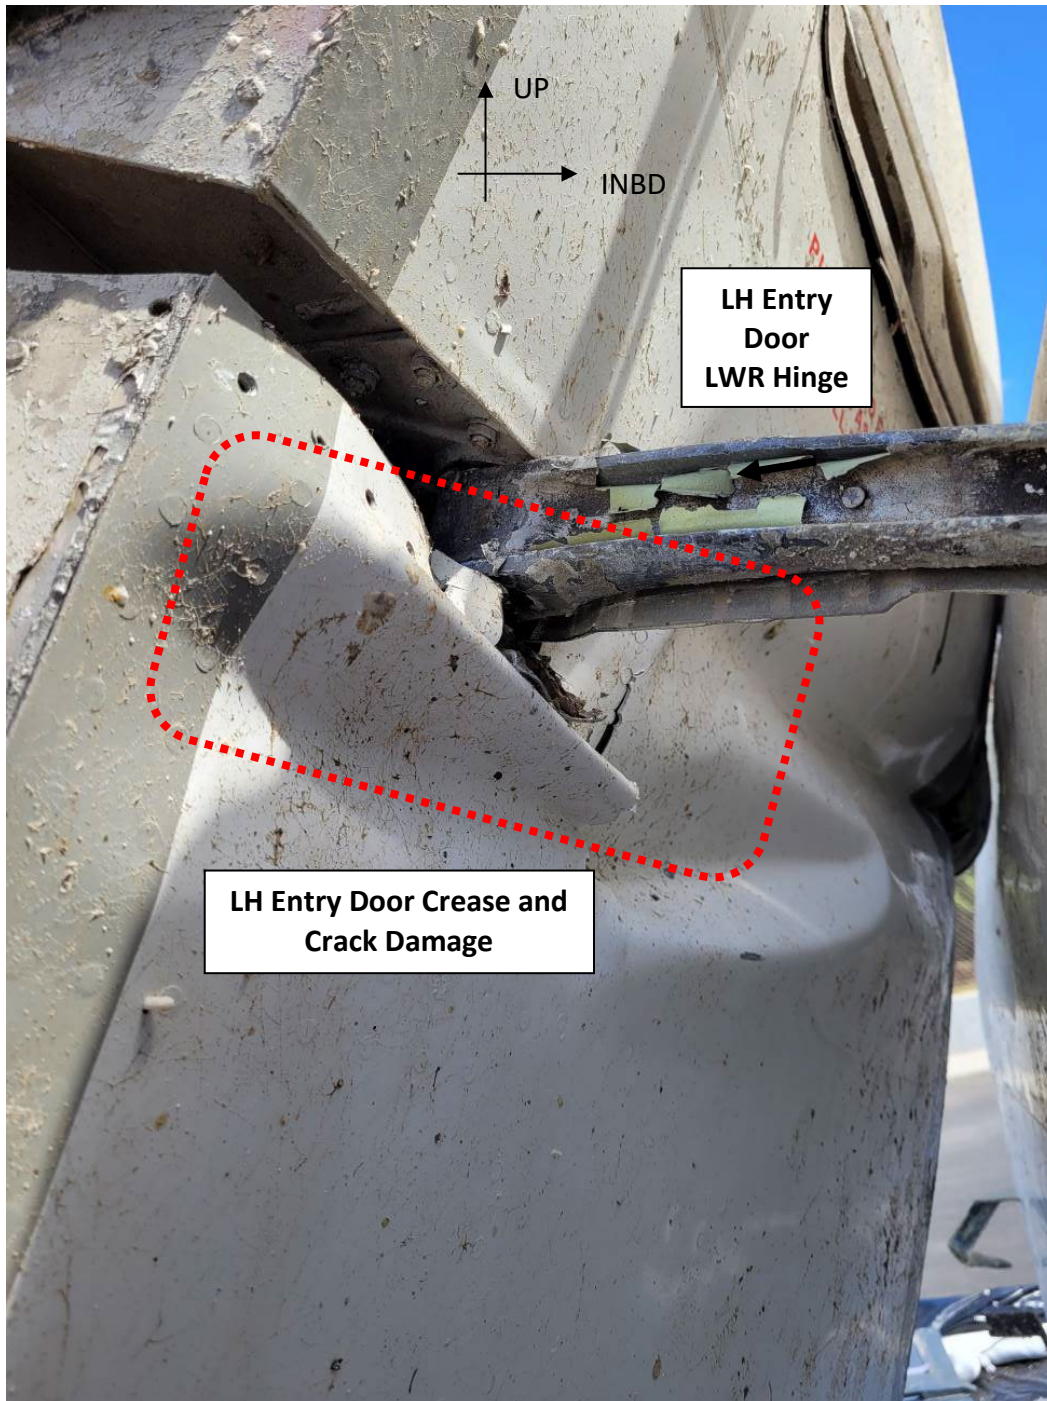
The LH forward entry door was ajar during the initial survey. The RH forward entry door and LH aft entry door were closed. The LH aft entry door was deactivated. The overwing exits were closed. The LH forward, RH forward, and RH aft doors were opened during the recovery and examination. Figure 29 shows the LH Forward Entry Door crease and crack damage below the lower hinge.

Figure 29. Left Forward Entry Door crease and crack damage (Boeing photo)

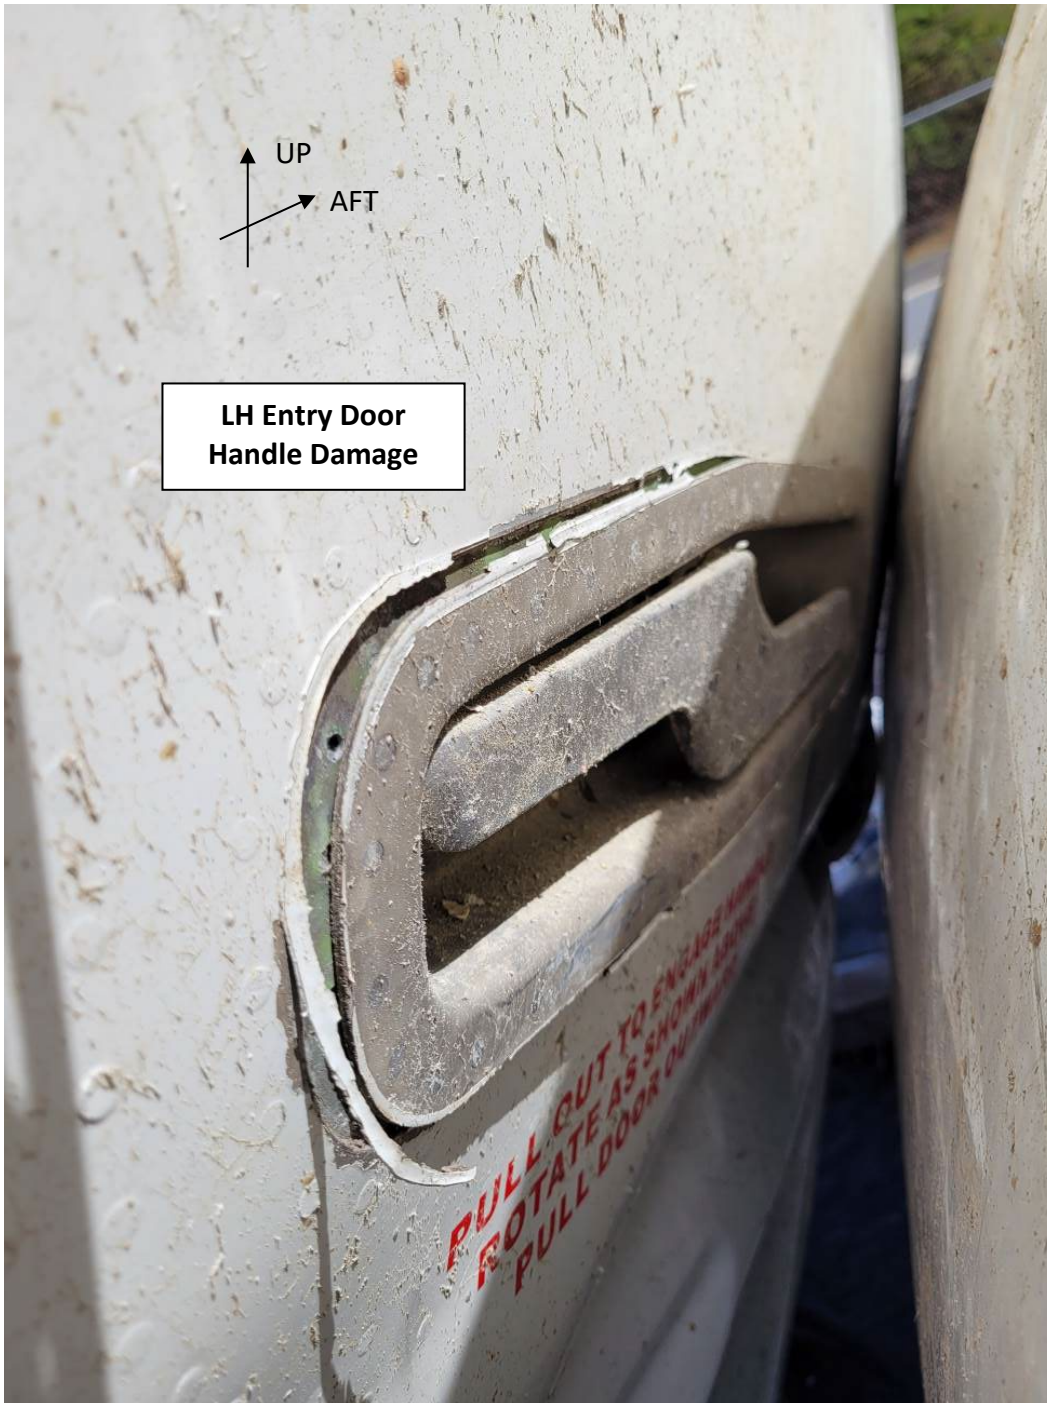
Figure 30 shows the LH Forward Entry Door exterior handle damage.

Figure 30. Left Forward Entry Door exterior handle damage (Boeing photo)

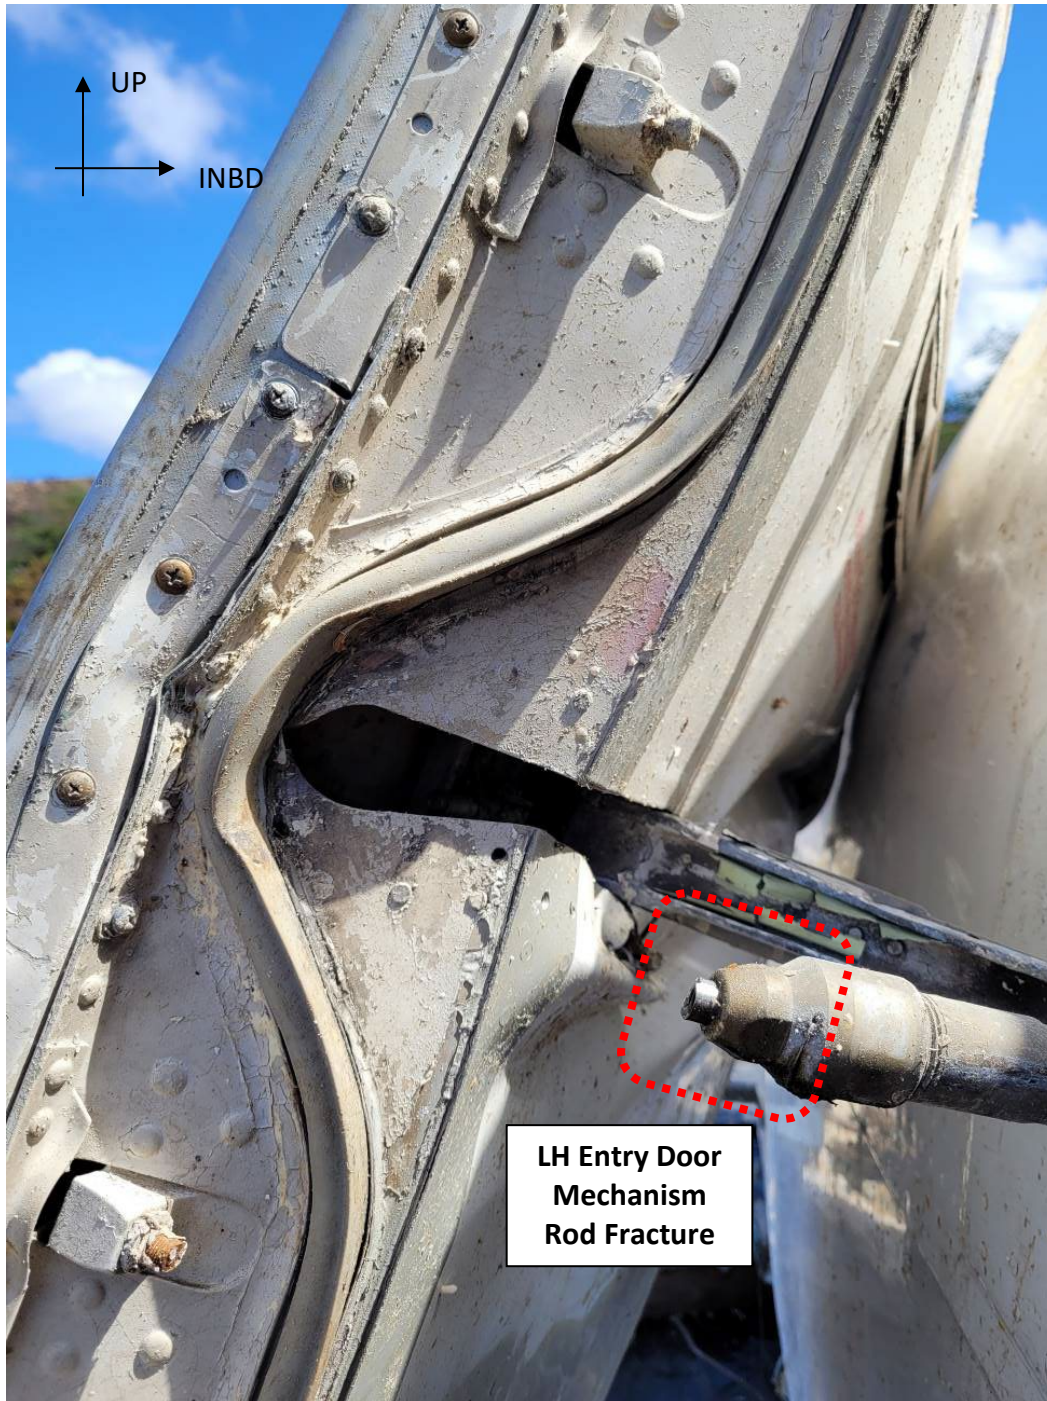
Figure 31 shows LH Forward Entry Door lower hinge mechanism rod fracture.

Figure 31. Left Forward Entry Door lower hinge mechanism rod damage (Boeing photo)

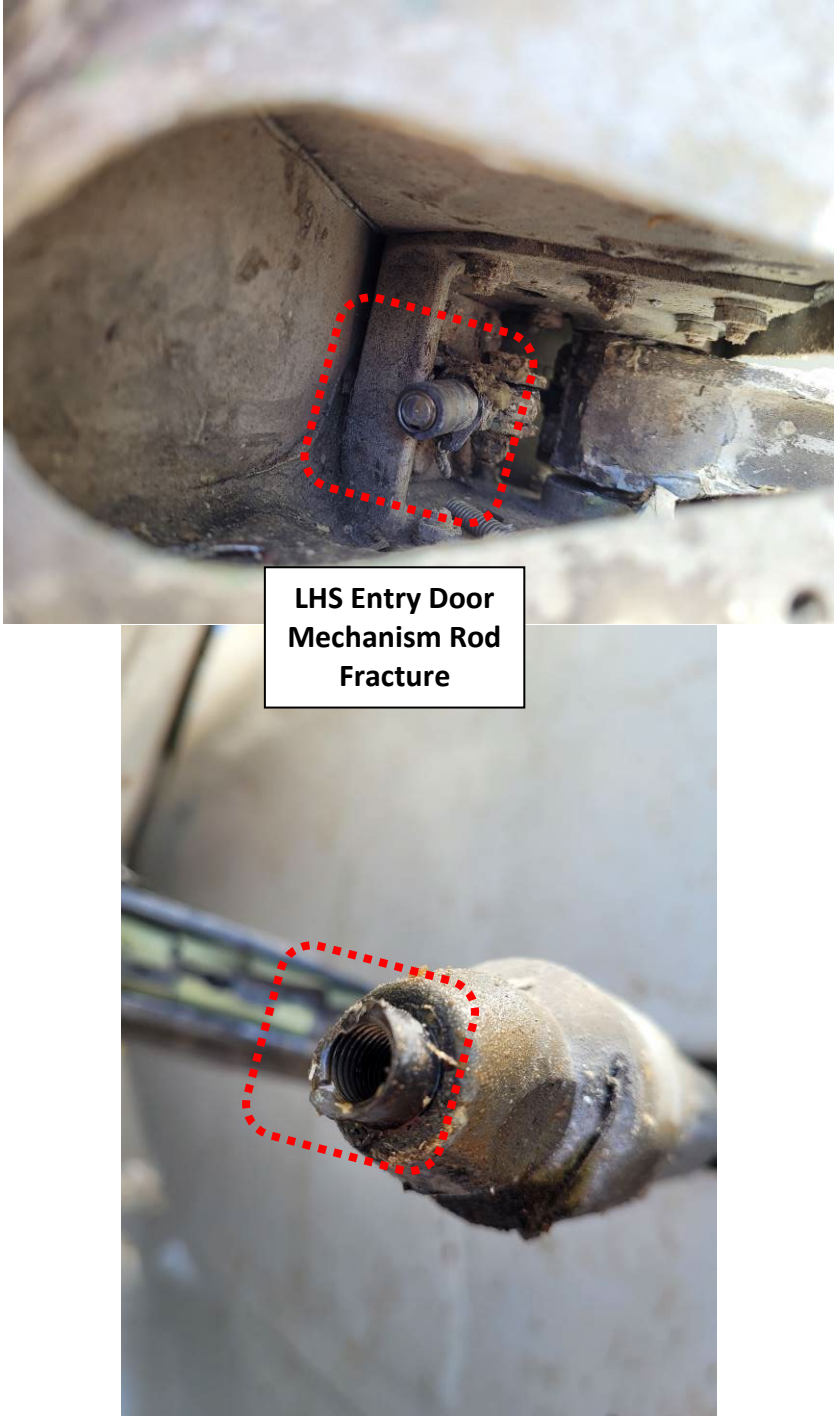
Figure 32 shows close-ups of the LH Forward Entry Door lower hinge mechanism rod fracture within the door and outside the door.

Figure 32. Left Forward Entry Door lower hinge mechanism rod fracture (Boeing photo)

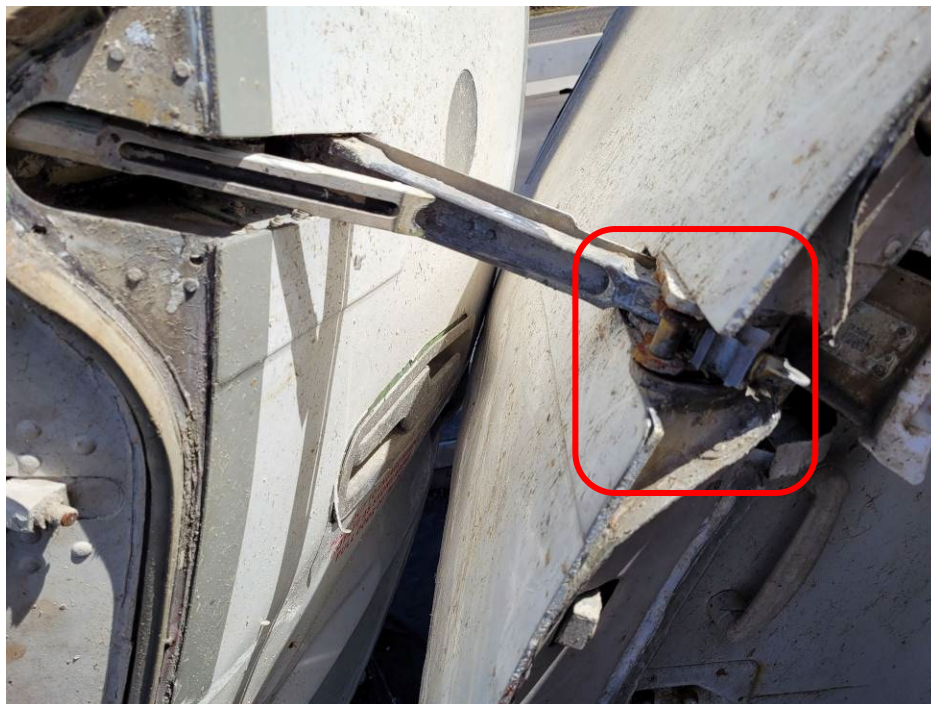
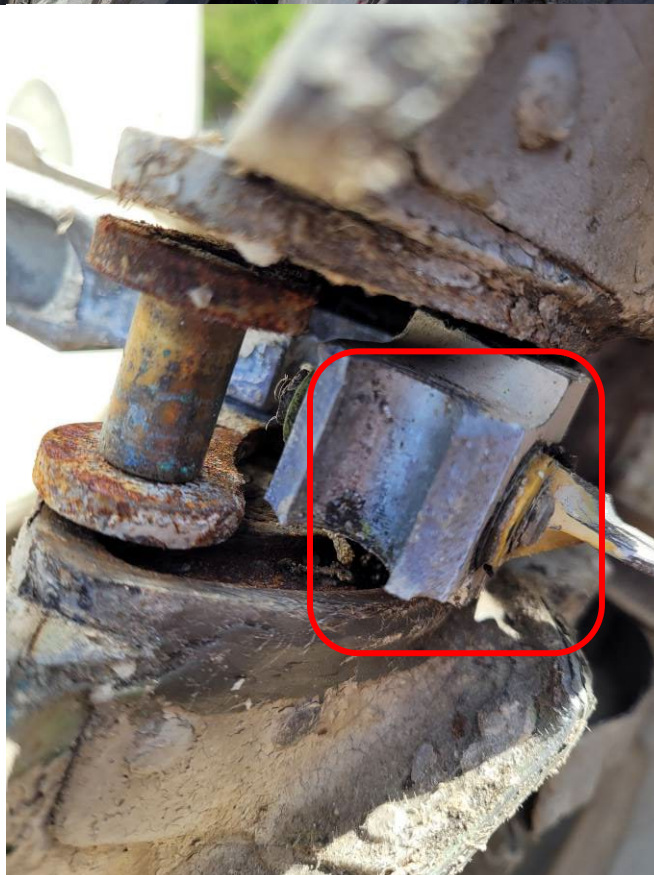
Figure 33 shows close-ups of the LH Forward Entry Door upper hinge mechanism fracture at the attachment to the fuselage structure.

Figure 33. Left Forward Entry Door upper hinge mechanism fracture (Boeing photo)

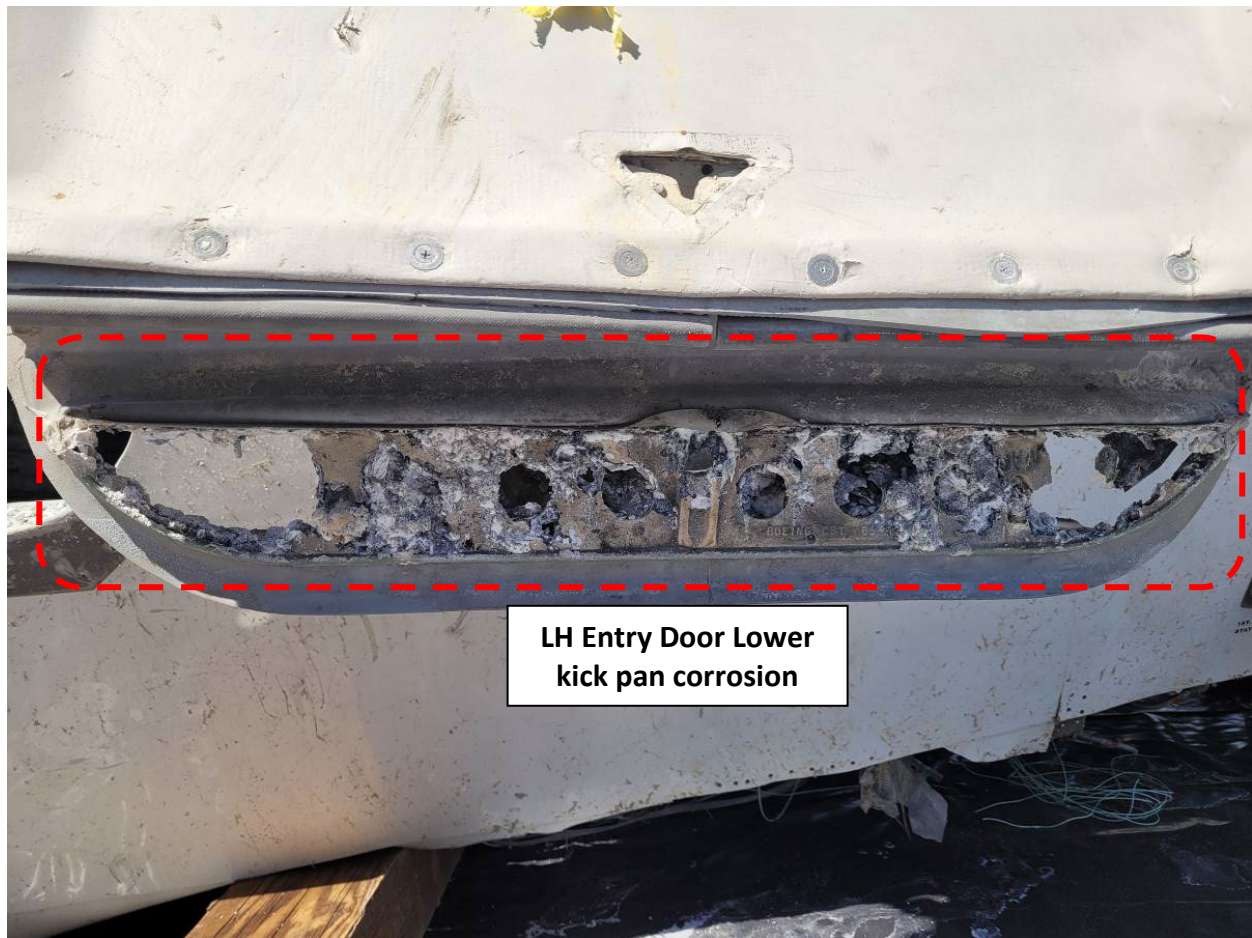
Figure 35 shows the LH Entry Door lower magnesium kick pan corrosion damage. All other magnesium door parts (upper & lower, LH and RH) were similarly corroded.

Figure 35. Left Forward Entry Door lower kick pan corrosion (Boeing photo)

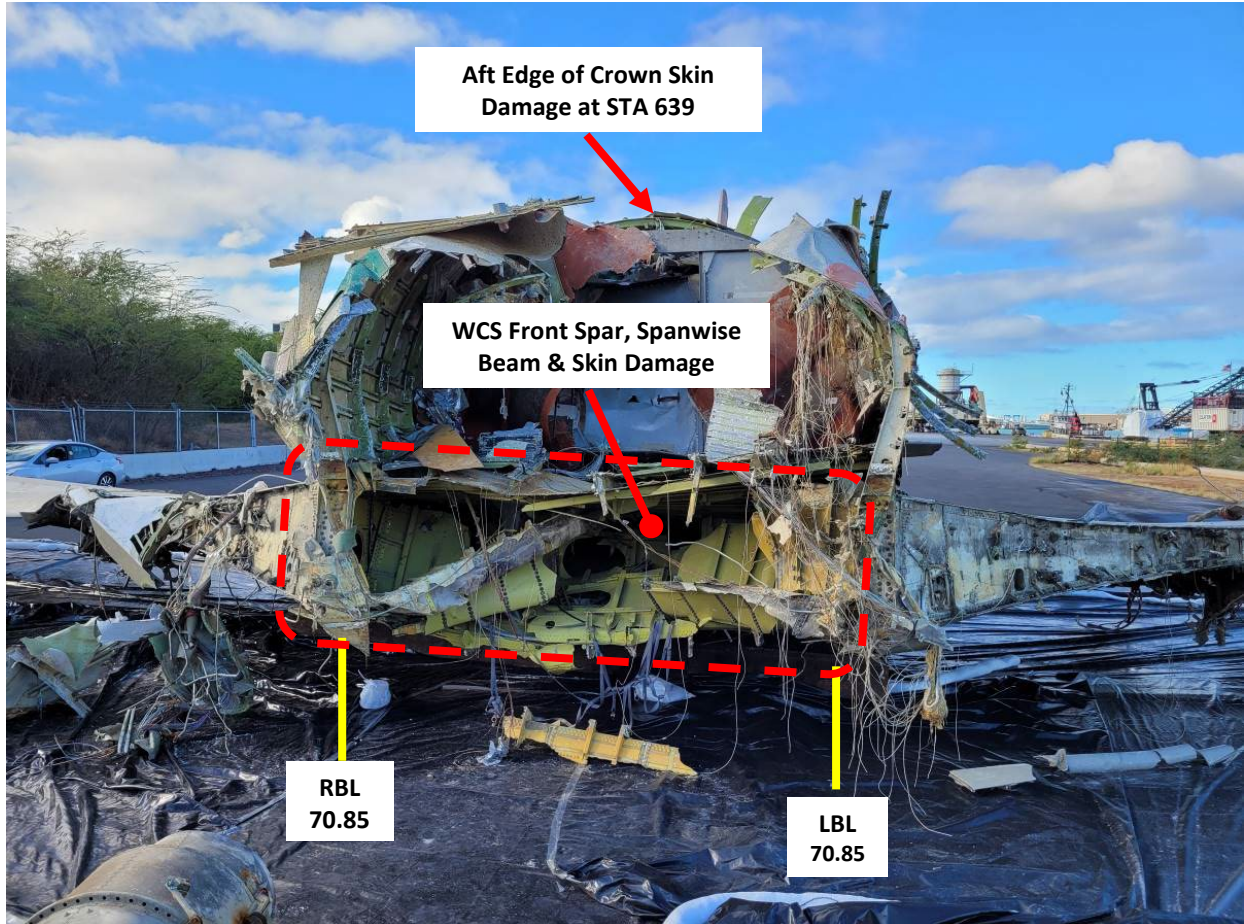
Figure 40 shows a view of the forward side of the recovered aft fuselage at the STA 540 separation. Figure 40 also shows the crown skin damage between the STA 540 separation and STA 639 as well as the WCS Front Spar, Spanwise Beam and upper/lower wing skin damage.

Figure 40. Forward view of aft fuselage section STA 540 separation (Boeing photo)

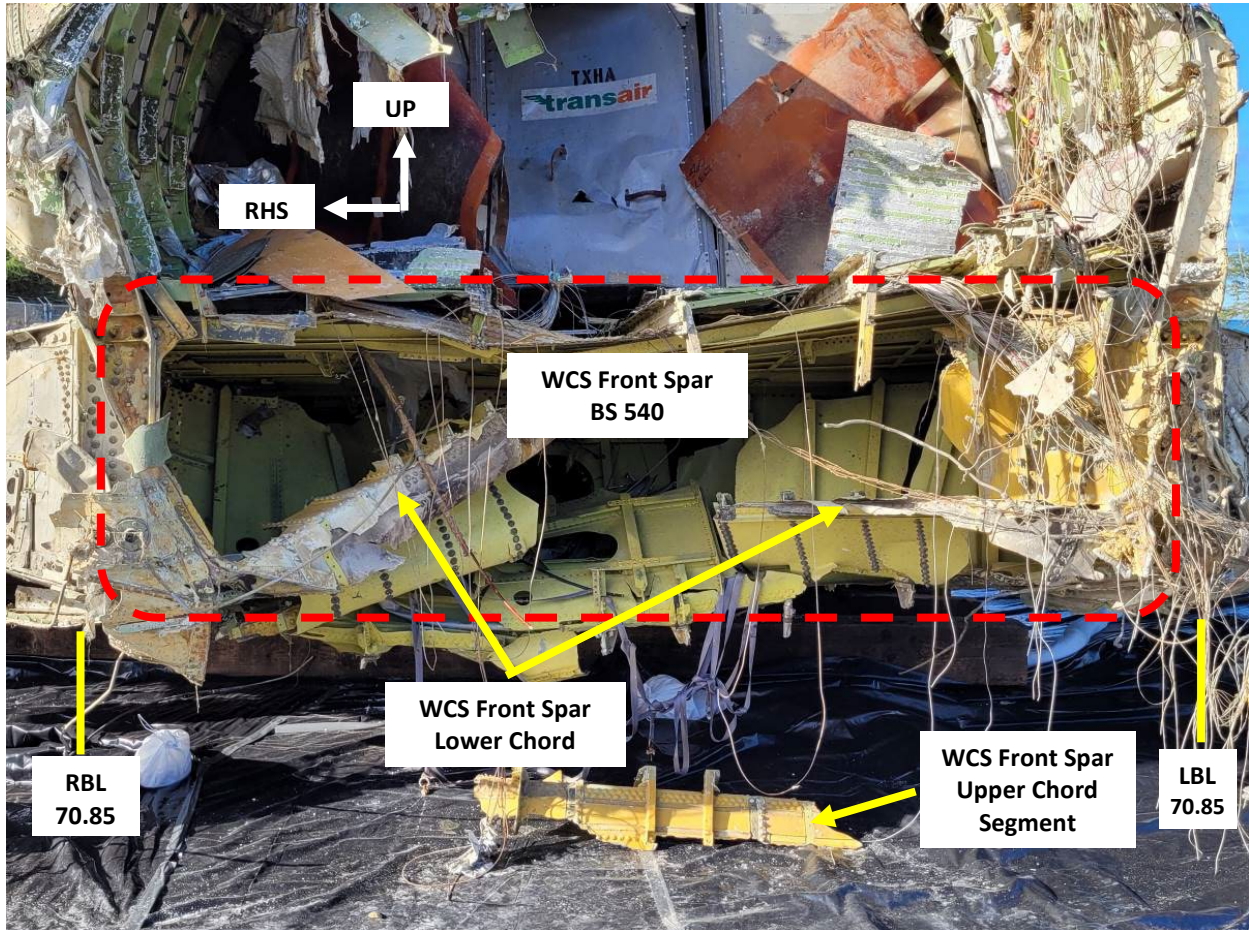
Figure 45 shows the WCS front spar damage at the STA 540 separation location. Portions of the Front Spar Lower Chord remained attached but were deformed up while much of the front spar web was missing or deformed aftward into the WCS fuel tank. The center portion of the Front Spar Upper Chord was found separated from the airplane and is also shown.

Figure 45. WCS Front Spar damage at STA 540 separation location, looking aft (Boeing photo)

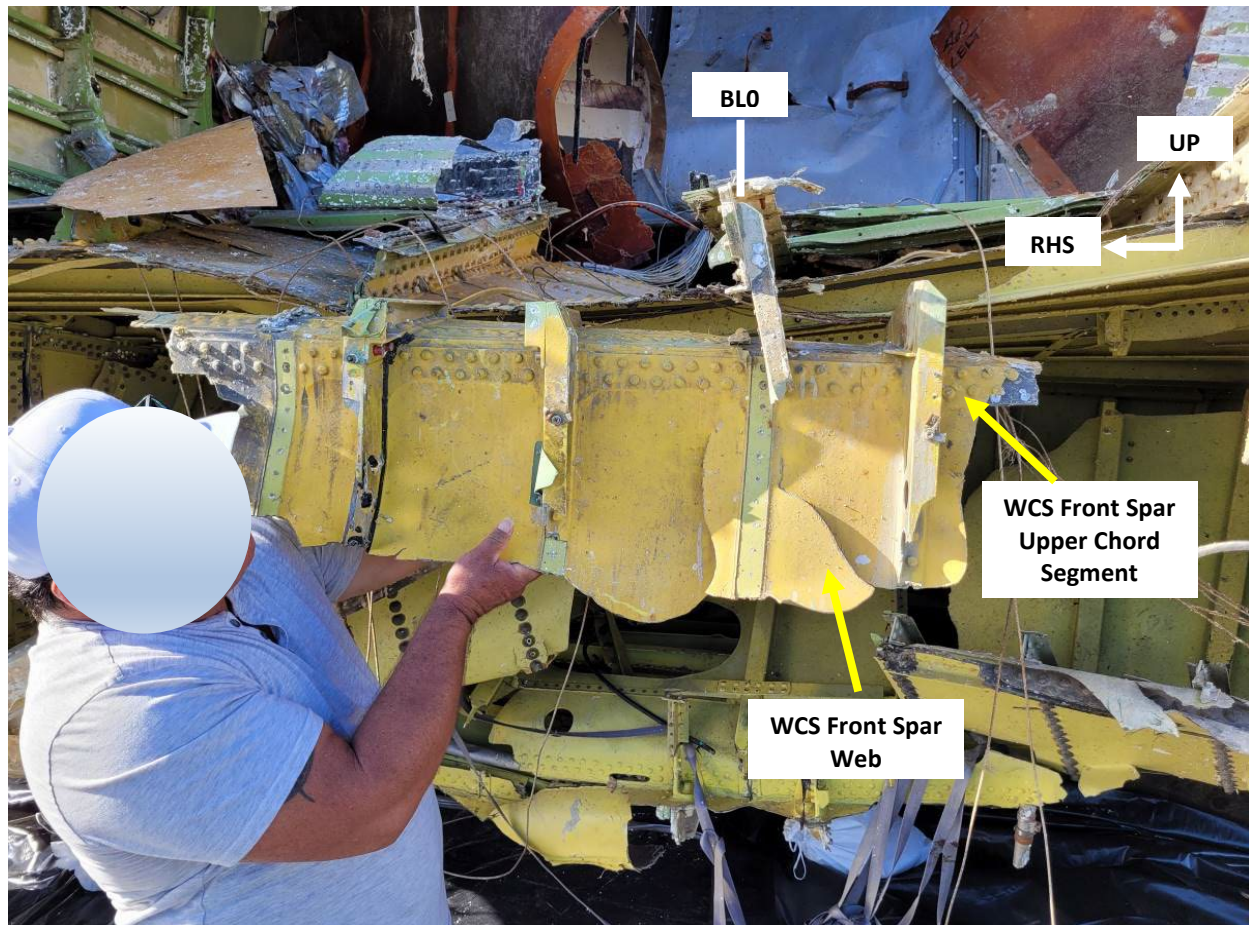
Figure 46 shows the WCS Front Spar Upper Chord center portion that was found separated from the airplane held in its production location.

Figure 46. WCS Front Spar Upper Chord segment (Boeing photo)

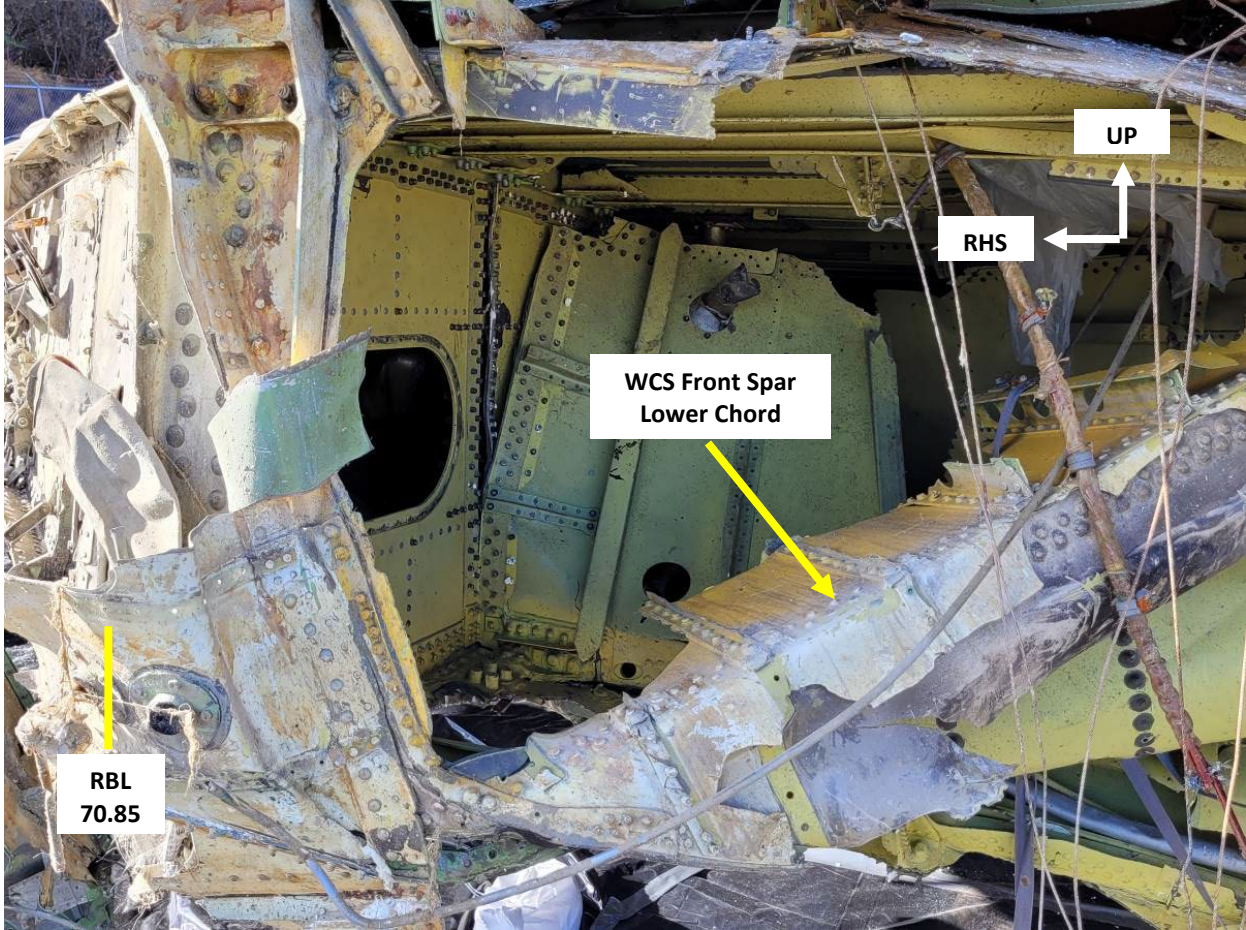
Figure 47. Right WCS Front Spar Lower Chord damage (Boeing photo)

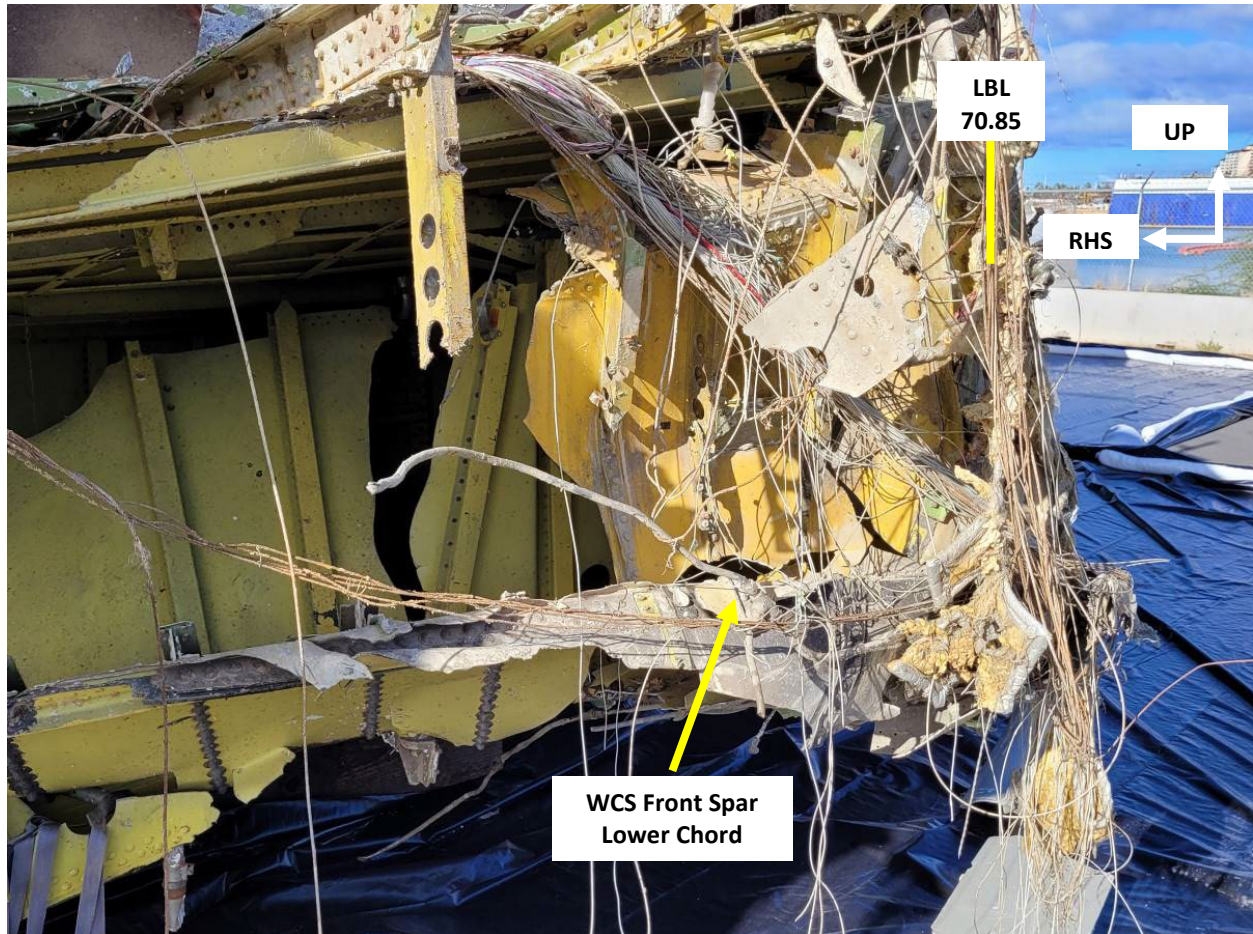
Figure 48. Left WCS Front Spar Lower Chord damage (Boeing photo)

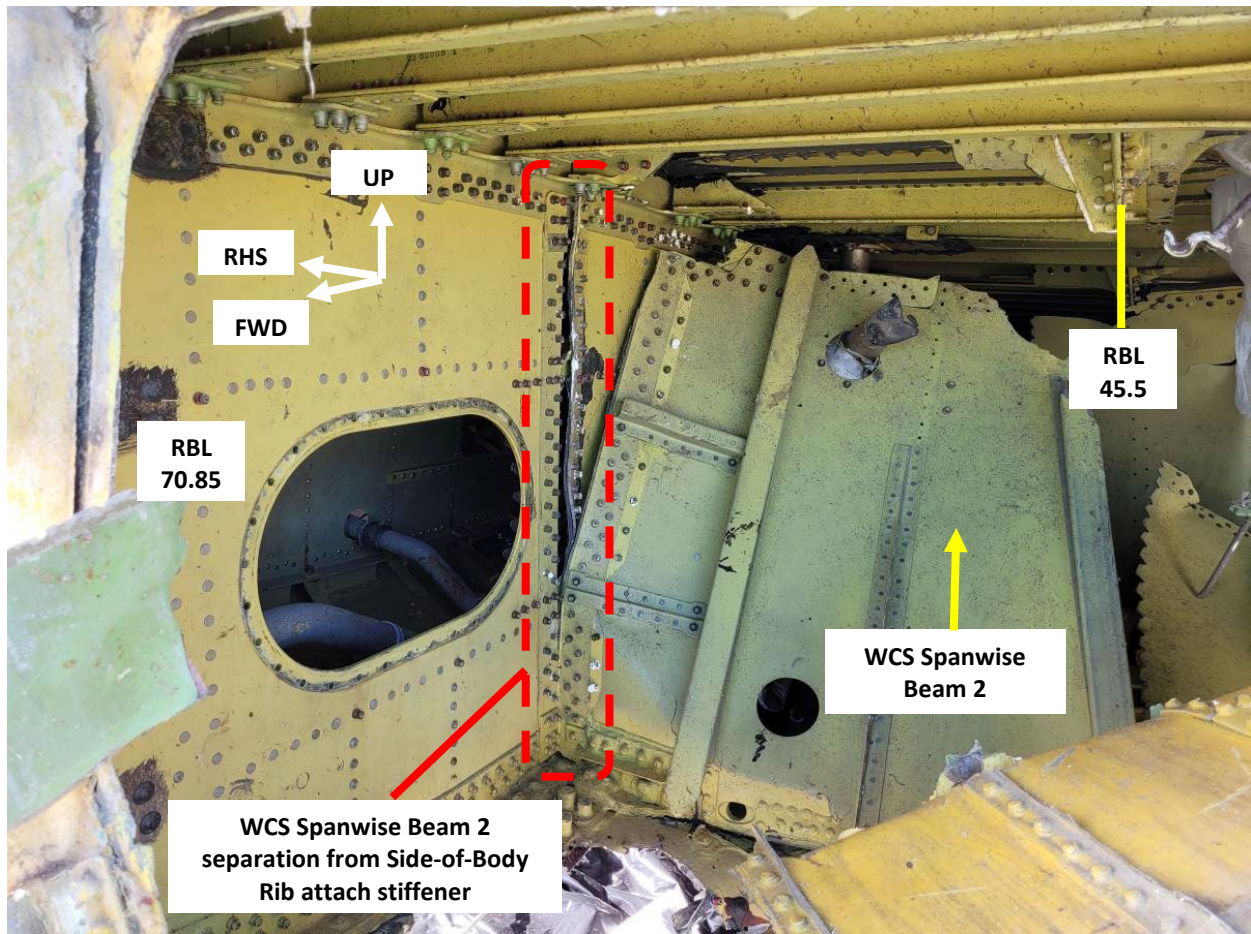
Figure 49. Damage to the right side WCS Spanwise Beam 2-to-SOB Rib attach stiffener (Boeing photo)

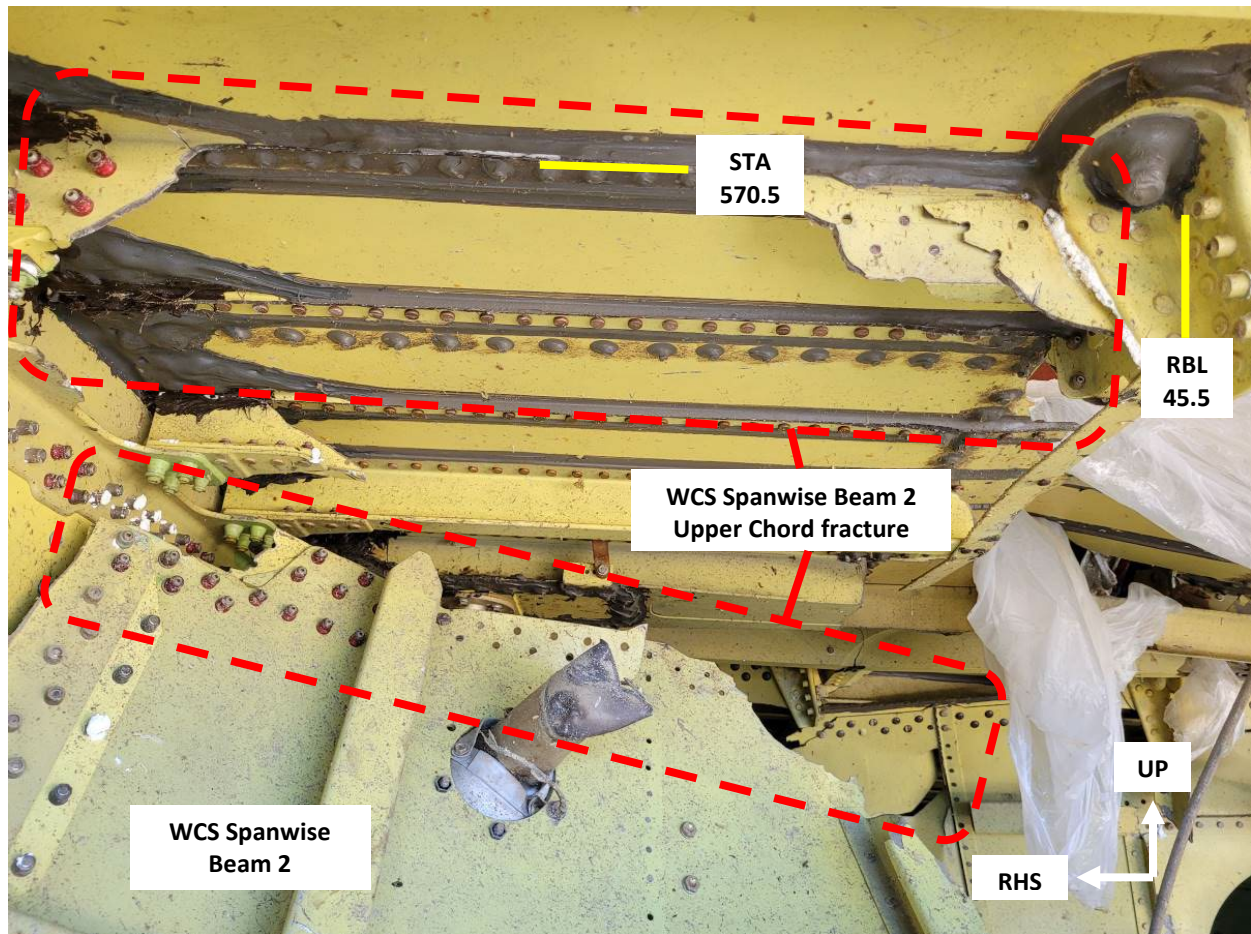
Figure 50 shows the right side of the Spanwise Beam 2 Upper Chord and Web fracture due to the aftward deformation of the spanwise beam web. The left side of the Spanwise Beam 2 Upper Chord was found to be fractured similarly.

Figure 50. Damage to right WCS Spanwise Beam 2 Upper Chord (Boeing photo)

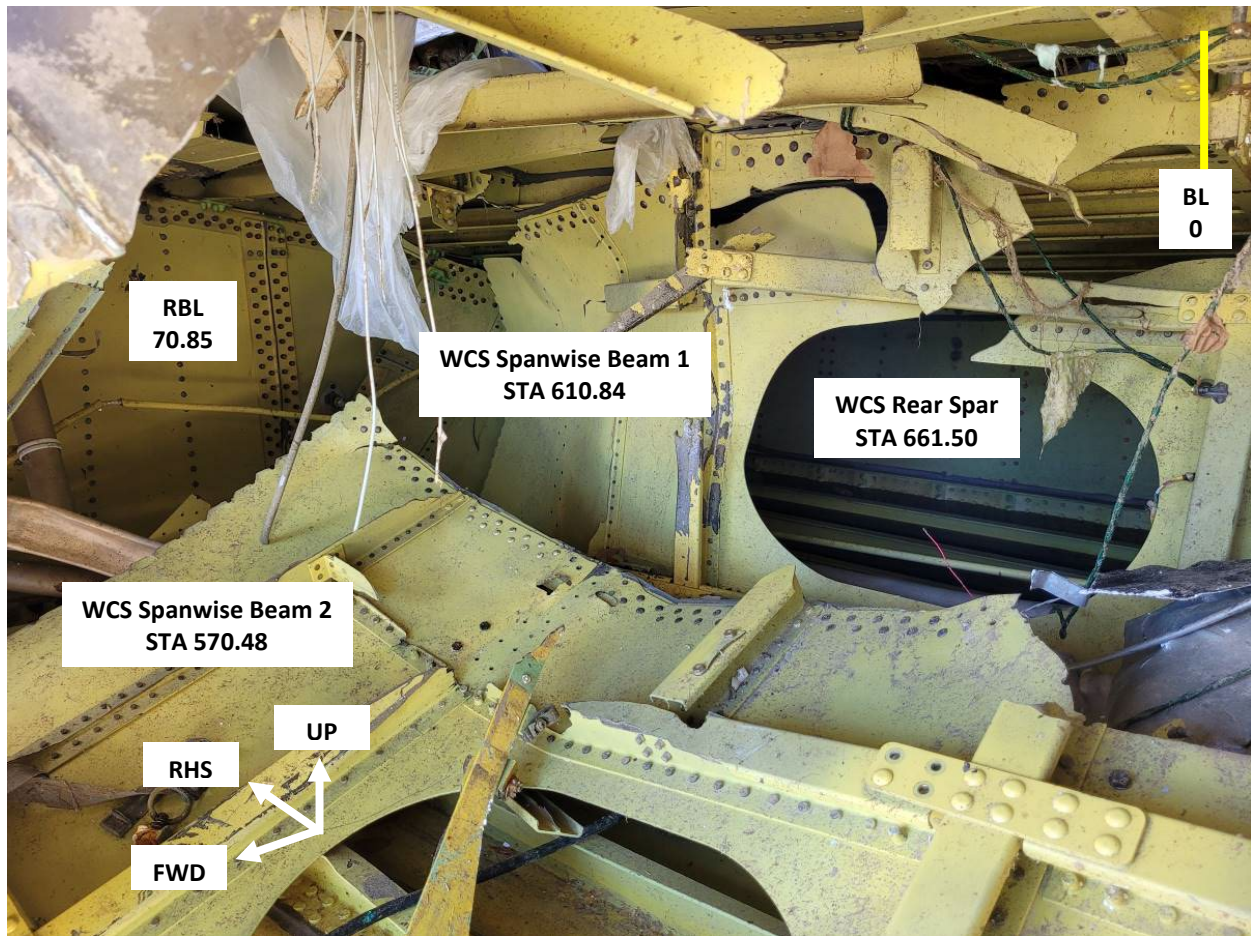
Figure 51 shows both WCS spanwise beams rotated and deformed aftward. There was less damage to the further aft Spanwise Beam 1 relative to the more forward Spanwise Beam 2.

Figure 51. Damage to WCS Spanwise Beams 1 & 2 (Boeing photo)
