National Transportation Safety Board

DCA21FA174

STRUCTURES

Group Chair's Factual Report

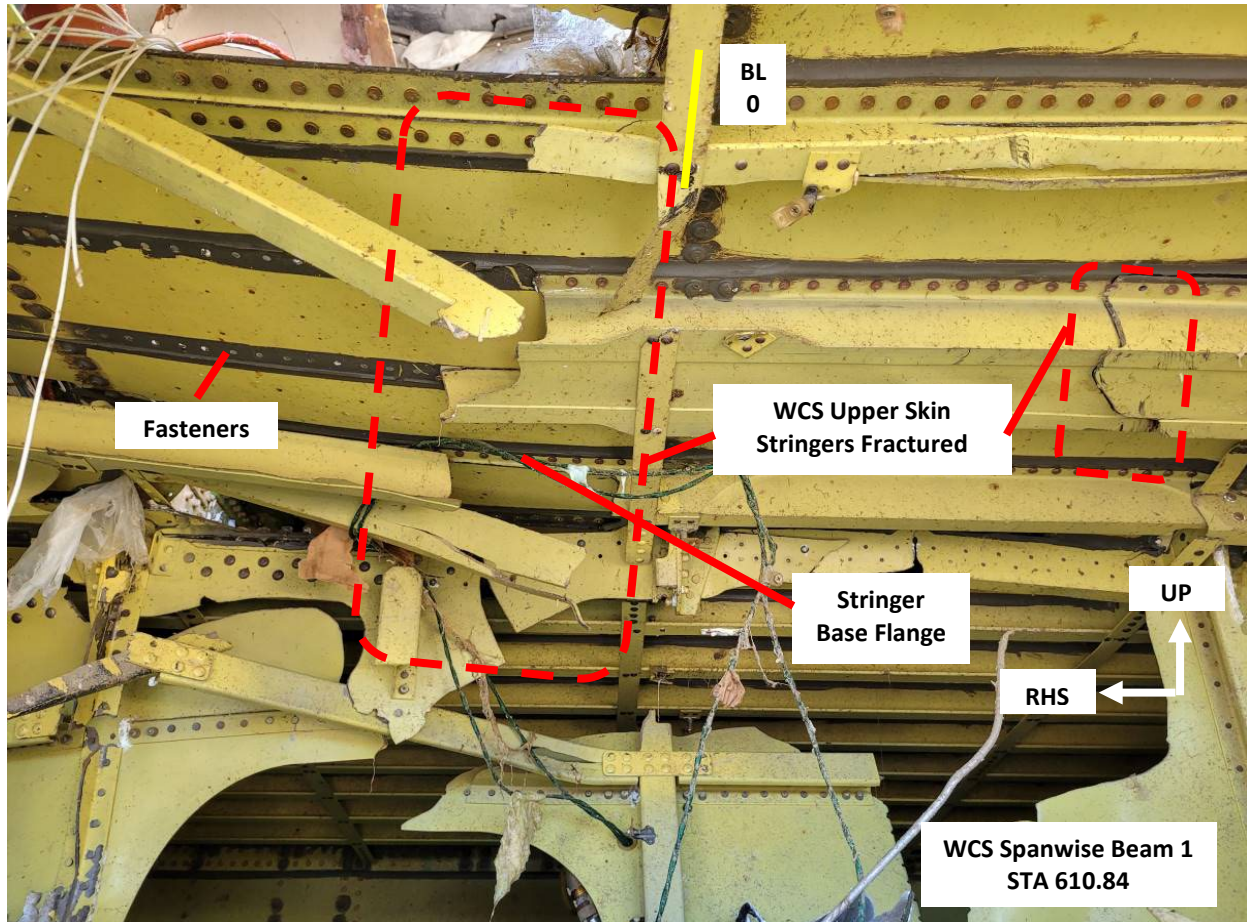
Figure 53 shows multiple WCS upper skin panel stringers fractured near the BL 0 floor beam attachment. Some of the stringers were separated at the fasteners attaching to the upper skin while others were failed through the base flange of the stringer.

Figure 53. Upward aft view of WCS Upper Skin Panel and fractured stringers (Boeing photo)

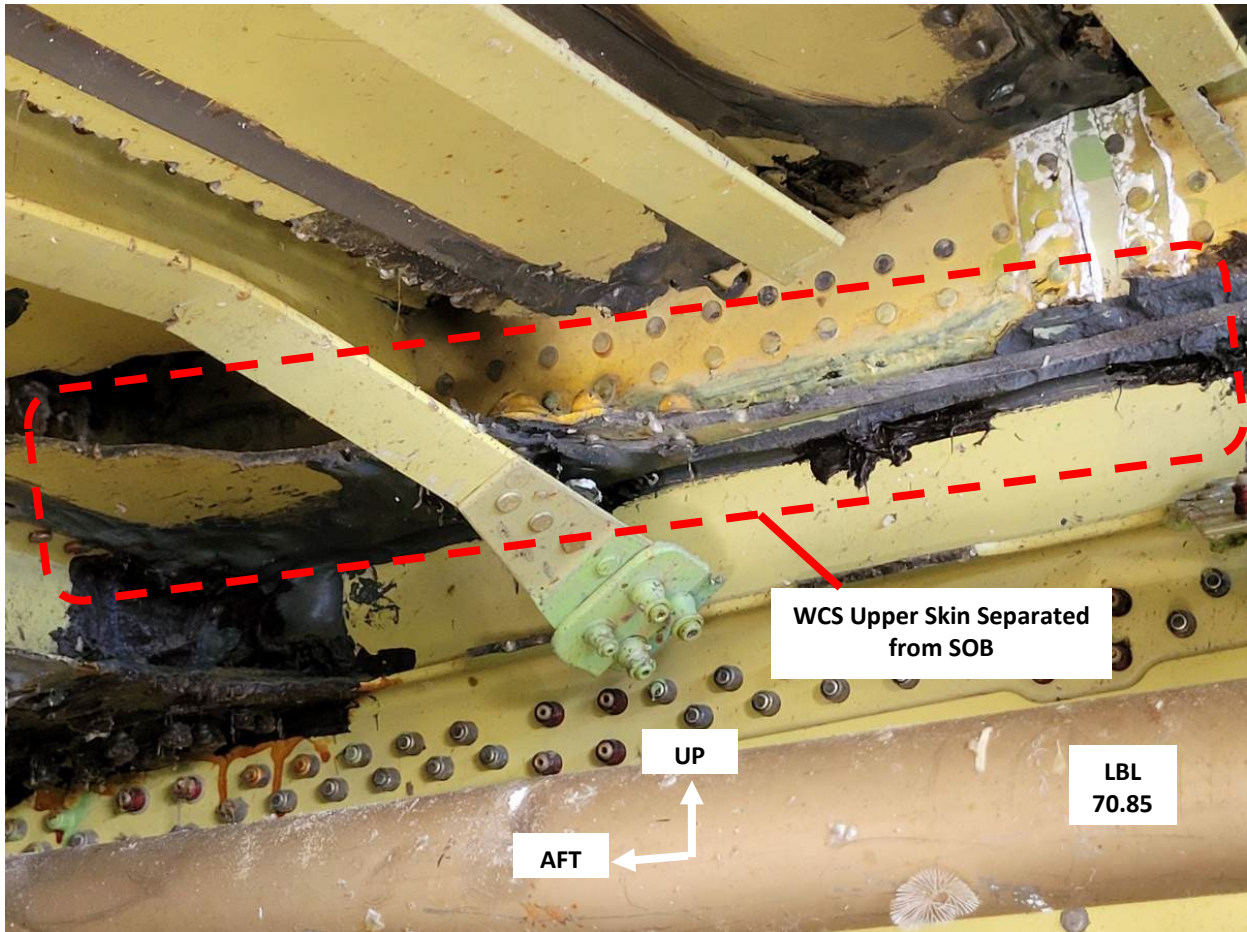
Figure 54. Upward close-up view of left side WCS Upper Skin separation at Side-of-Body (Boeing photo)

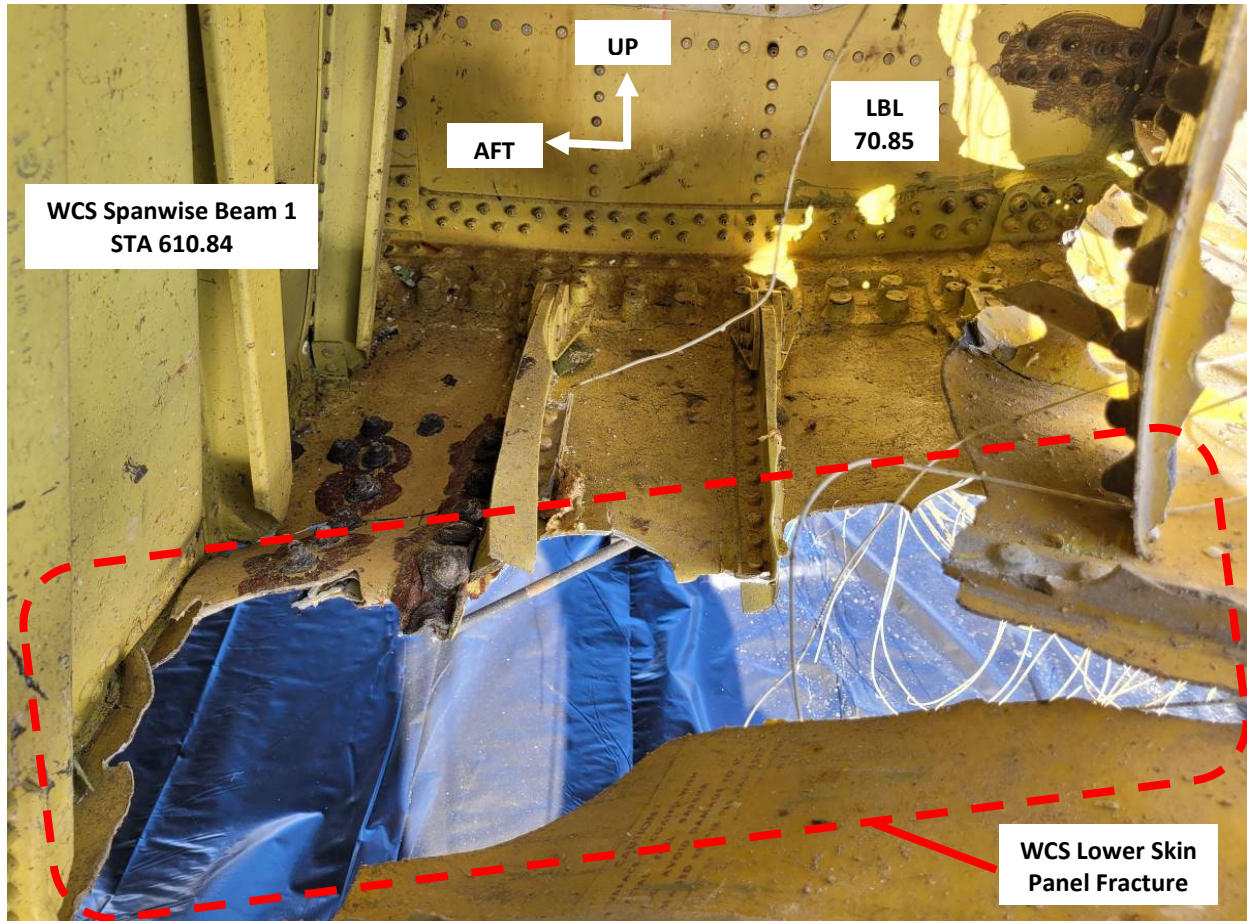
Figure 55 shows the left side view of the WCS lower skin panel fracture between Spanwise Beams 1 and 2.

Figure 55. Left side WCS Lower Skin fracture between Spanwise Beam 1 and 2 (Boeing photo)

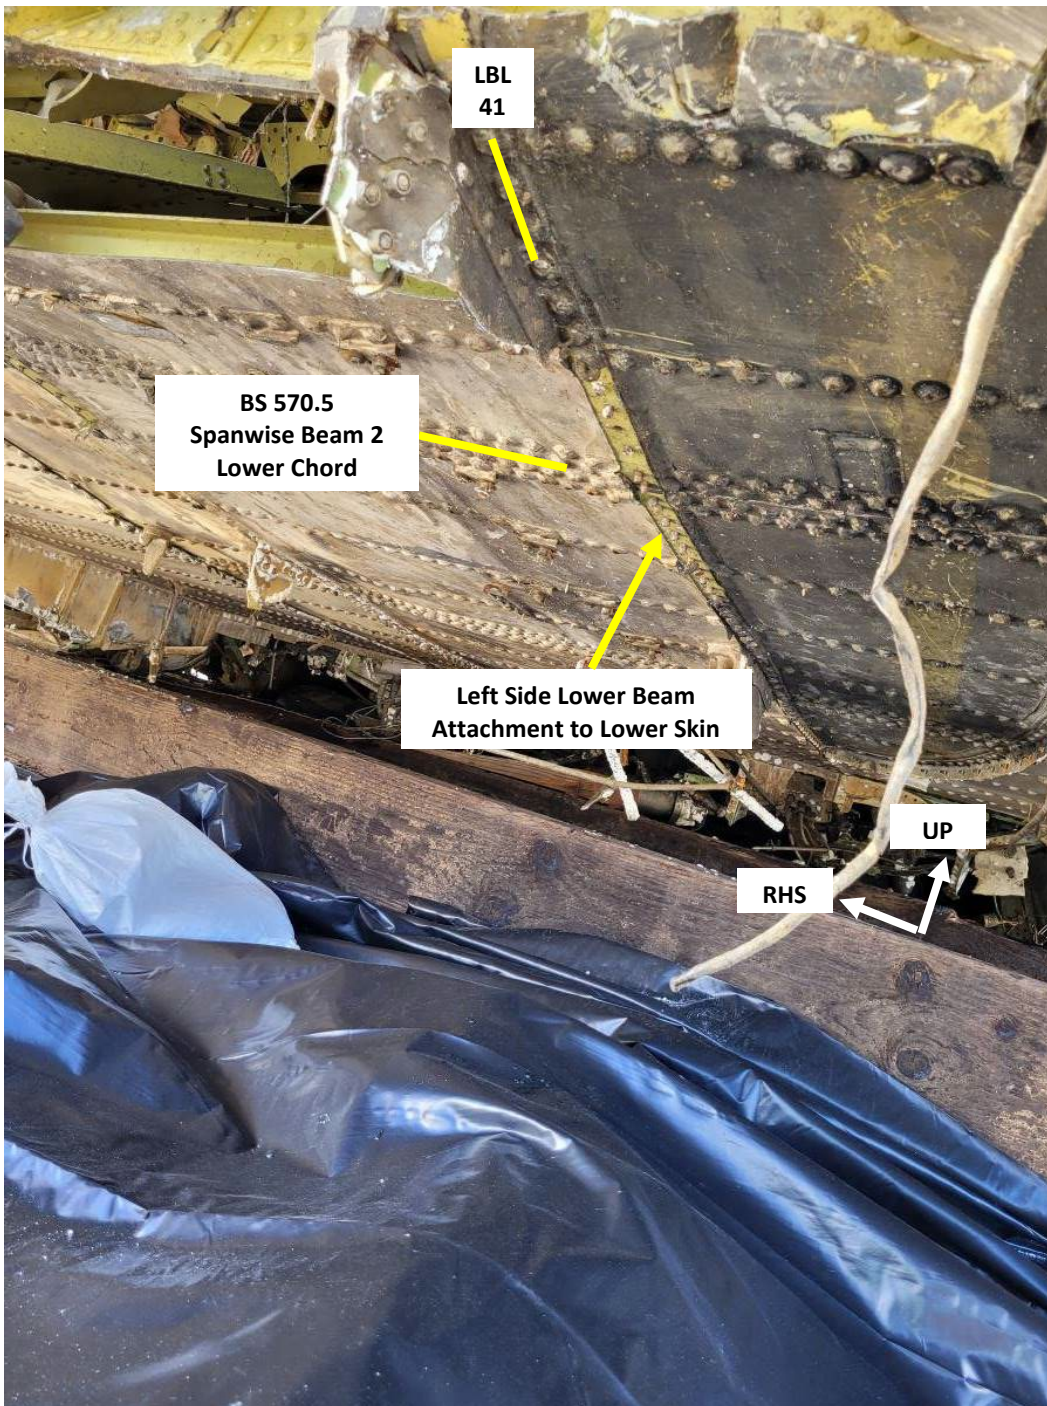
Figure 56. WCS Lower Skin left Lower External Beam attach point damage (Boeing photo)

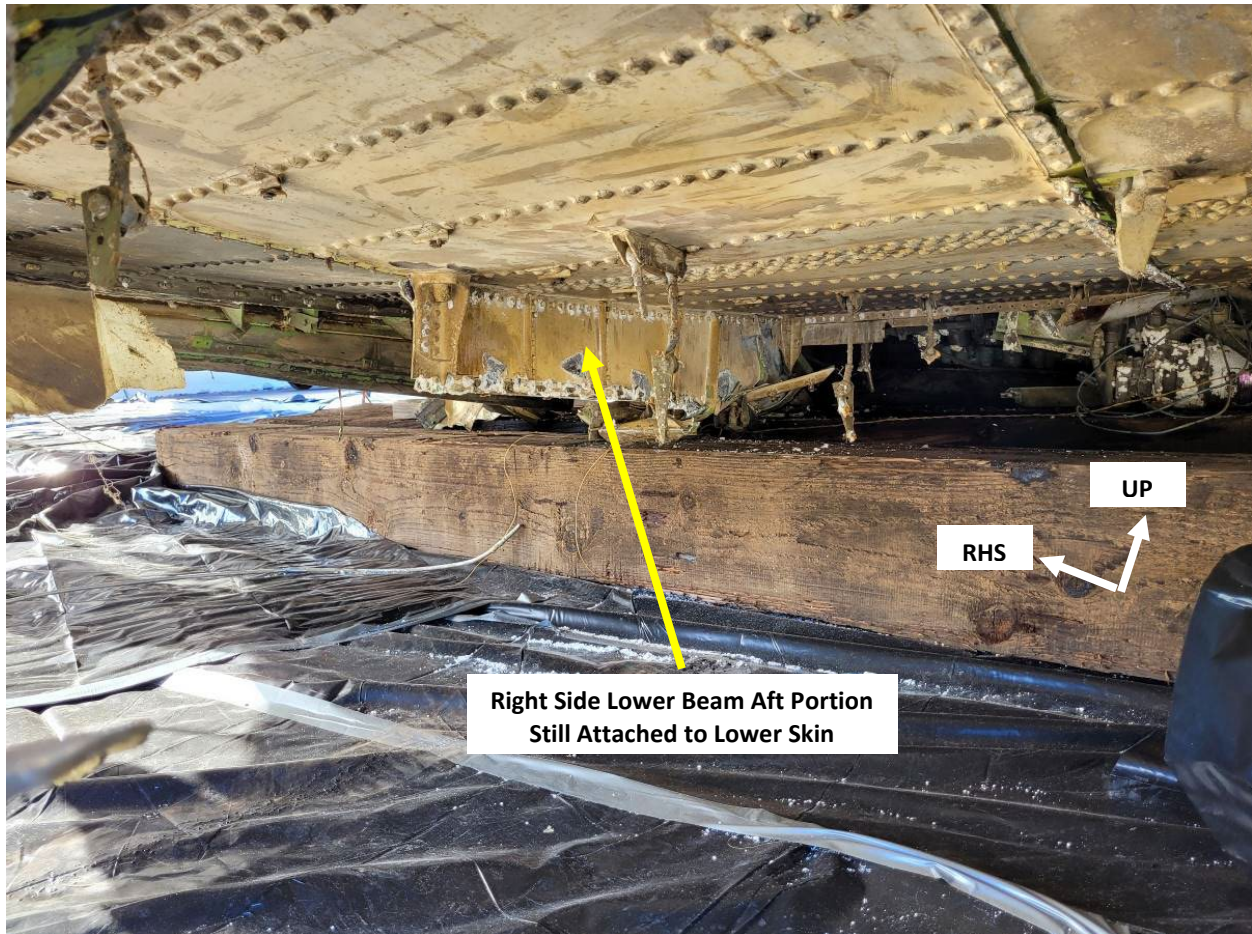
Figure 57. WCS Lower Skin right Lower External Beam attach point damage (Boeing photo)

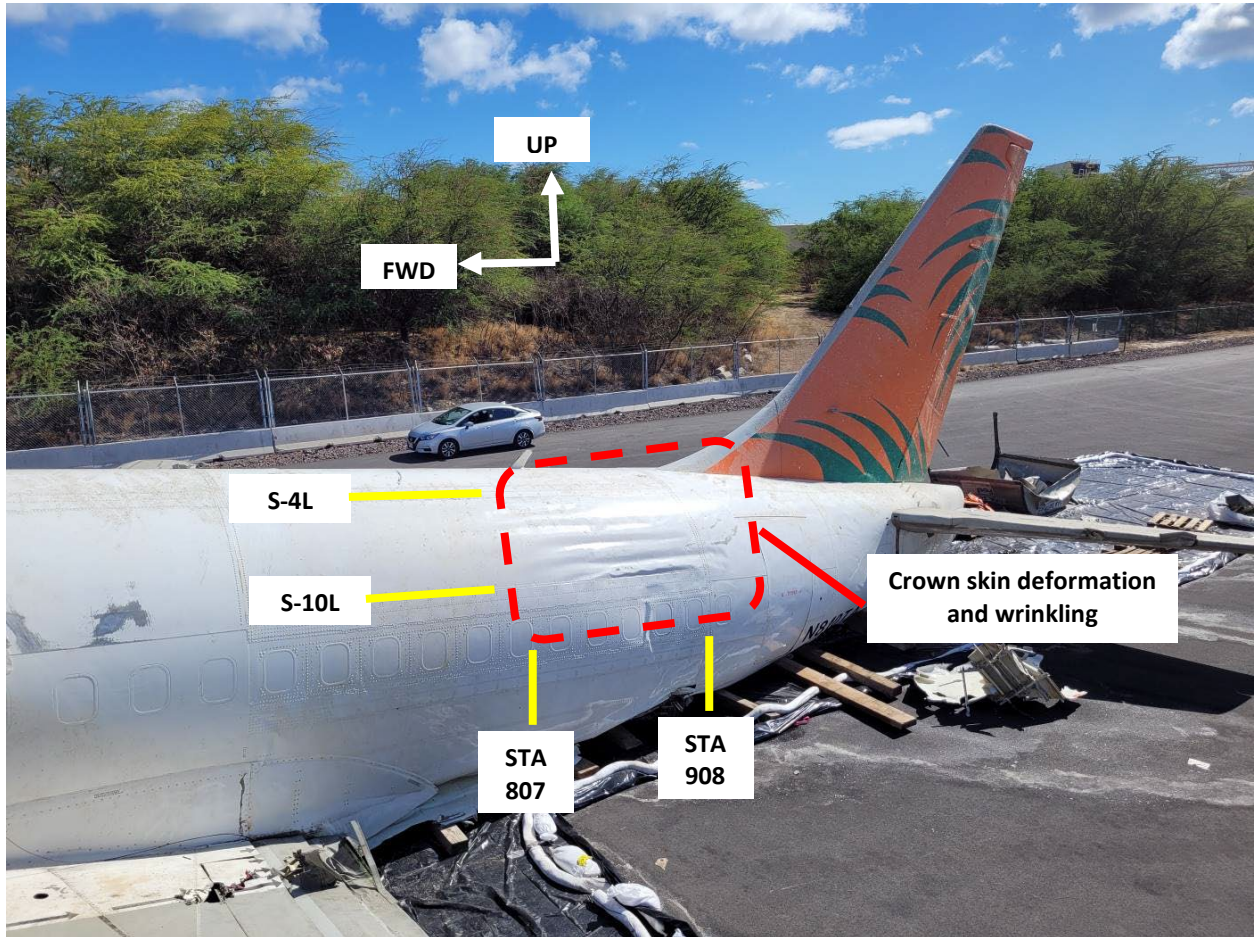
Figures 58 and 59 show the aft fuselage upper skin deformation and wrinkling between STA 807 and STA 908 and S-4 and S-10 on the left and right sides, respectively. The aft lift straps were placed in this area during the recovery of the aft fuselage. There was also buckling of the skins and stringers noted between frames 727A and 727B that spanned from S-11R to S-1.

Figure 58. Left aft fuselage upper skin deformation and wrinkling (Boeing photo)

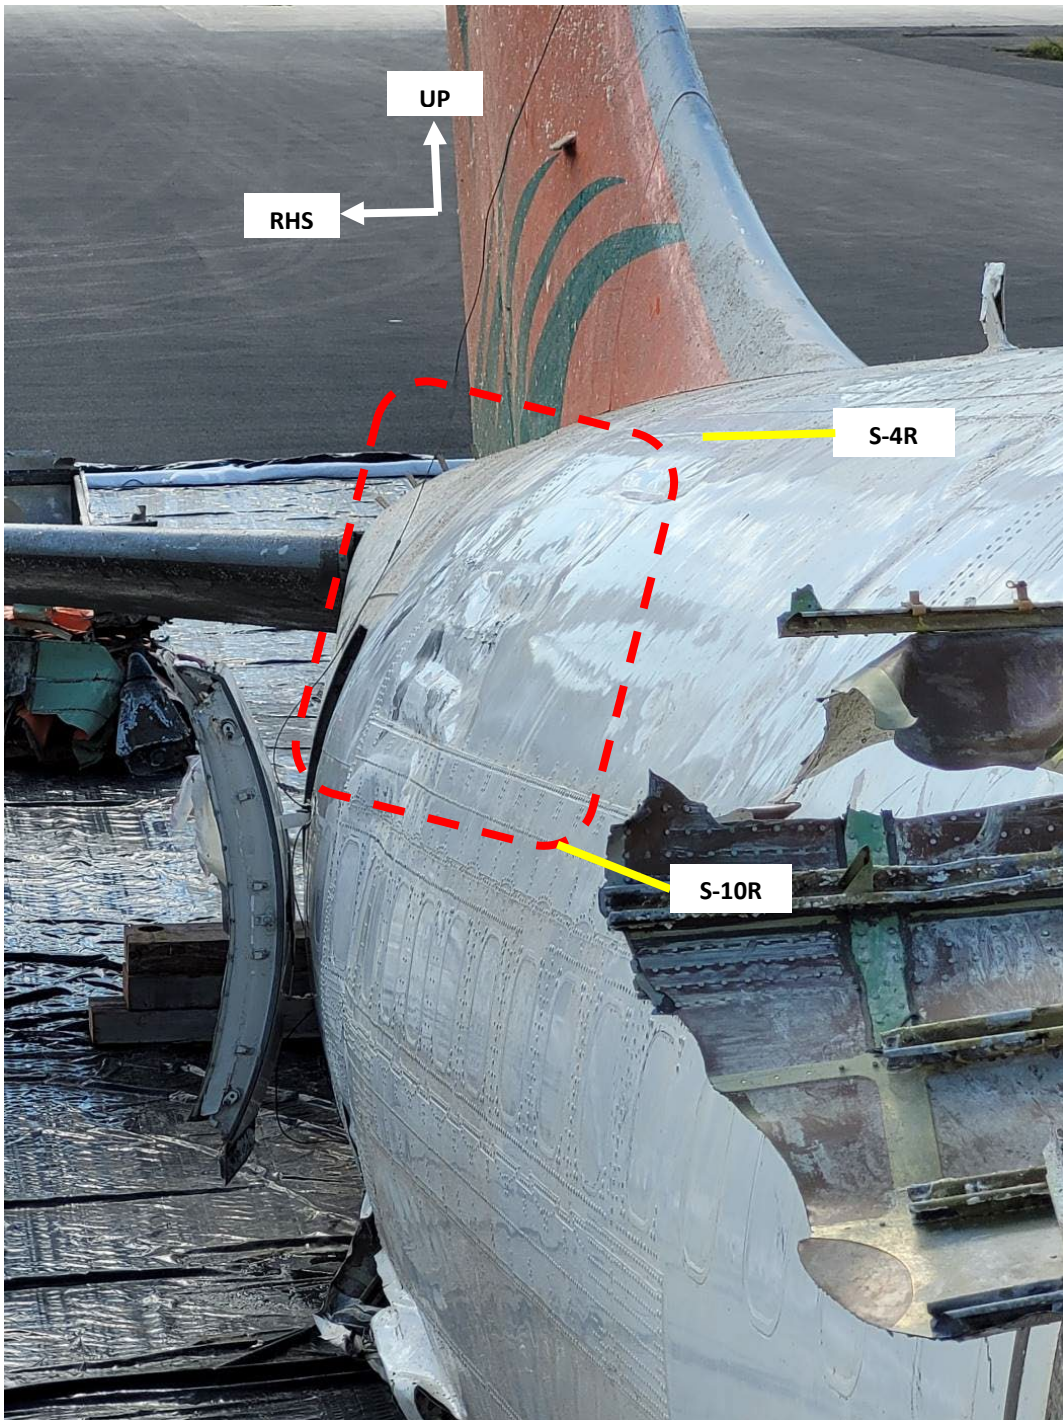
Figure 59. Right aft fuselage upper skin deformation and wrinkling (Boeing photo)

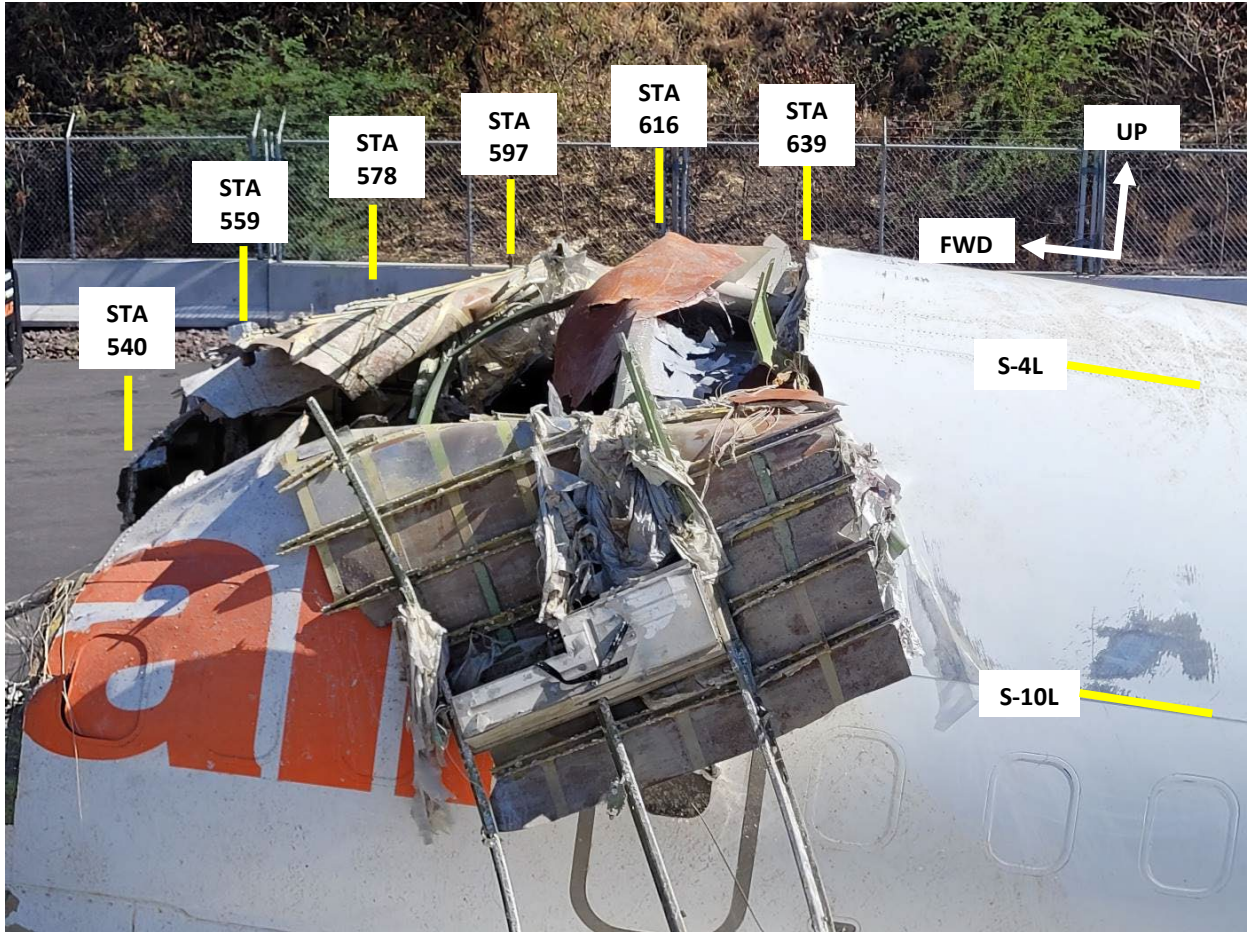
Figure 60 shows the damage to the upper crown skins aft of the fuselage separation near STA 540.

Figure 60. Fuselage crown skin damage aft of STA 540 separation (Boeing photo)

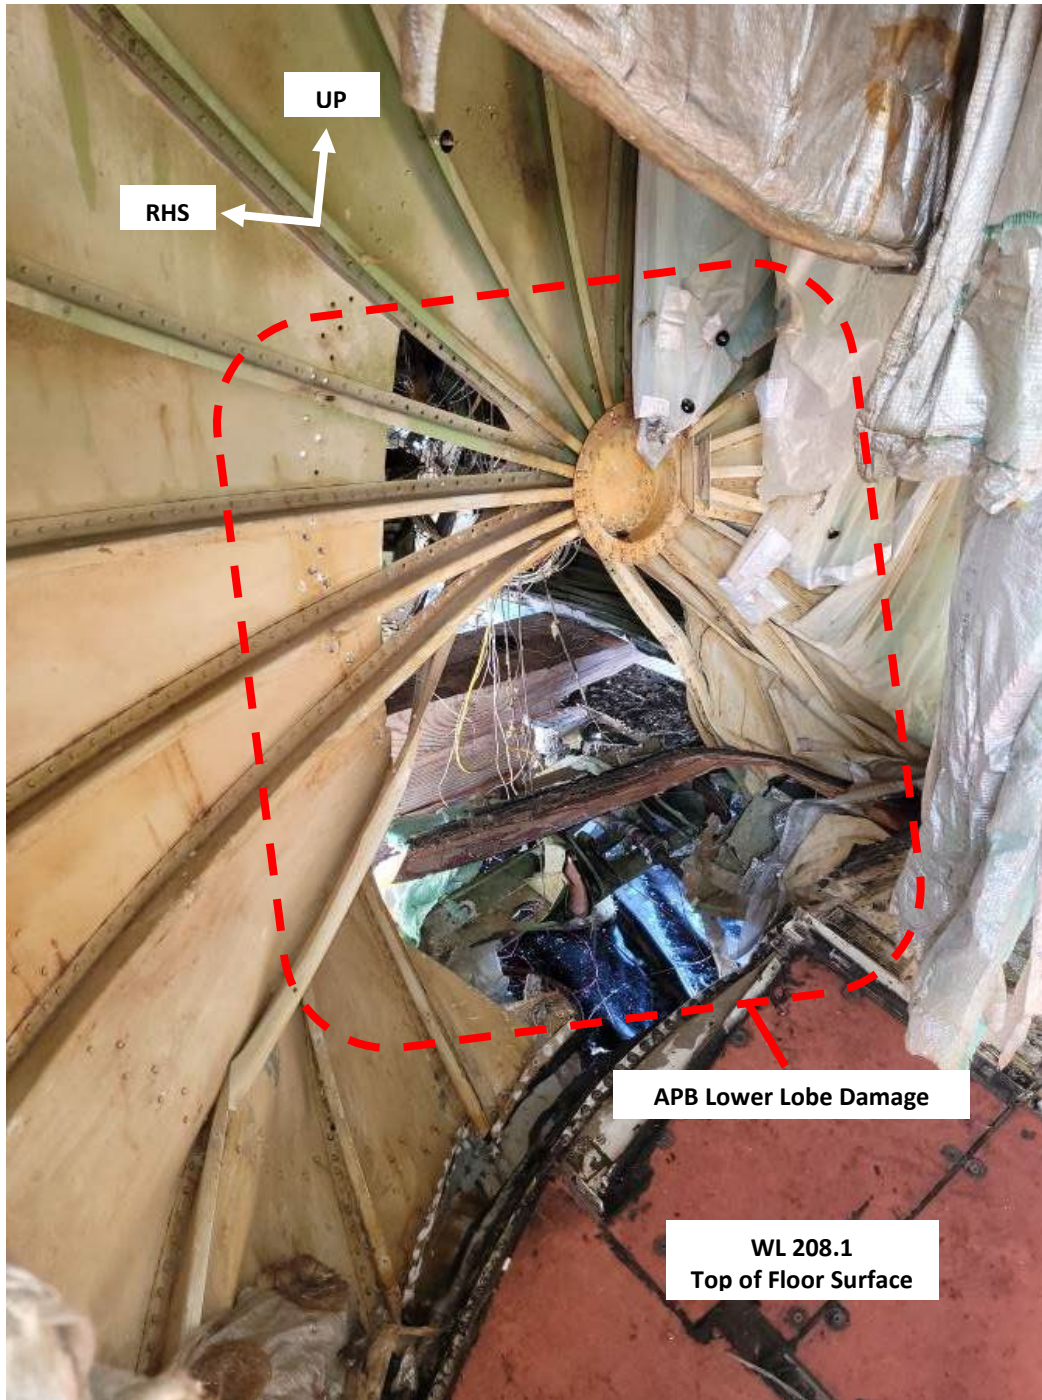
Figure 61 shows the Aft Pressure Bulkhead (APB) Pressure Web and Pressure Chord damage along the lower lobe of the fuselage. The pressure chord was deformed aftward along the BL 0 belly skin and the pressure web was fractured aftward with the chord. A portion of the pressure web and chord was missing.

Figure 61. Aft Pressure Bulkhead damage, looking aft/down (Boeing photo)

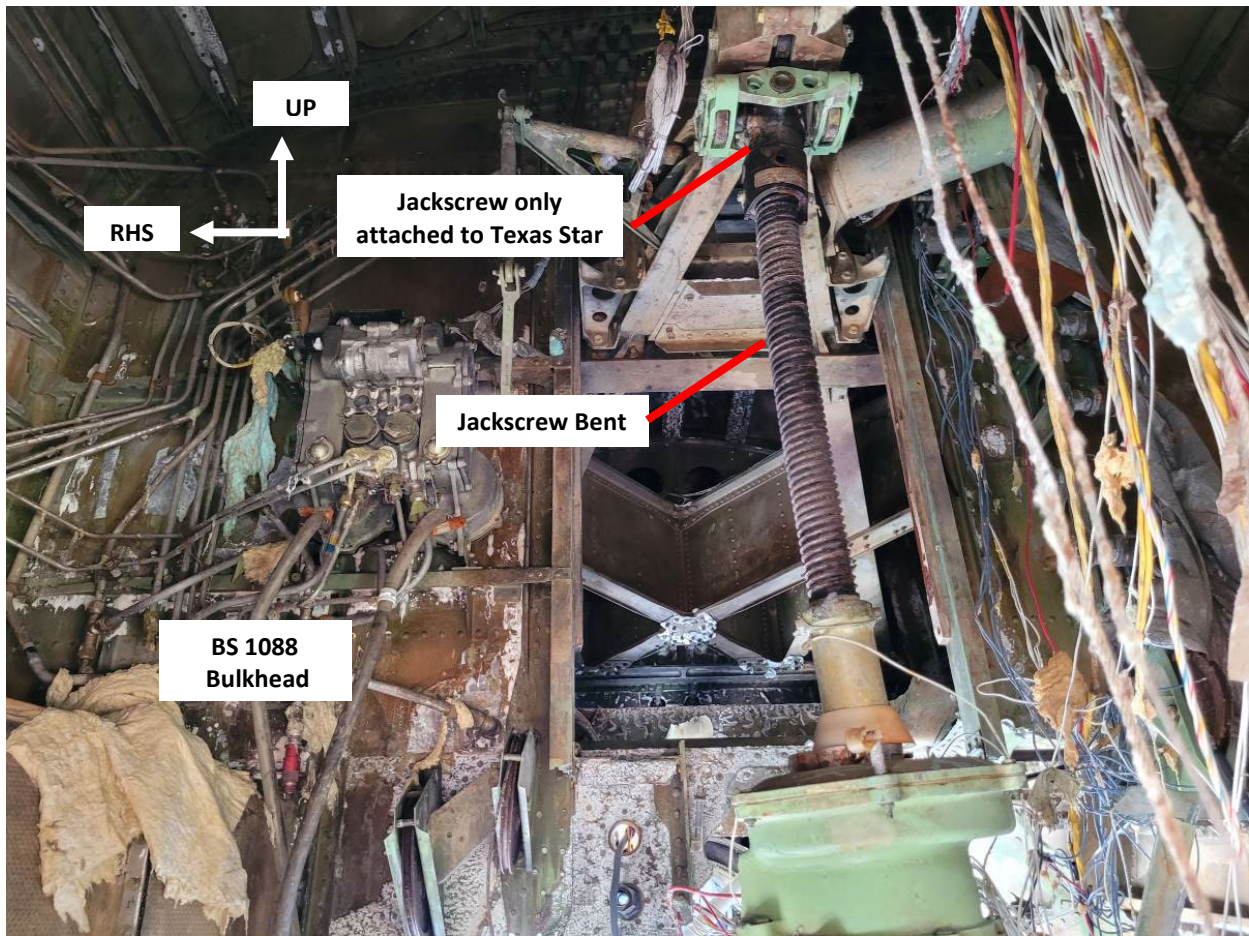
Figure 62 shows the Horizontal Stabilizer Trim Jackscrew still attached to the Texas Star at the upper ballnut. There was a slight bend in the jackscrew. The lower end of the jackscrew mechanism was fractured from the bulkhead.

Figure 62. Horizontal Stabilizer Trim Jackscrew damage (Boeing photo)

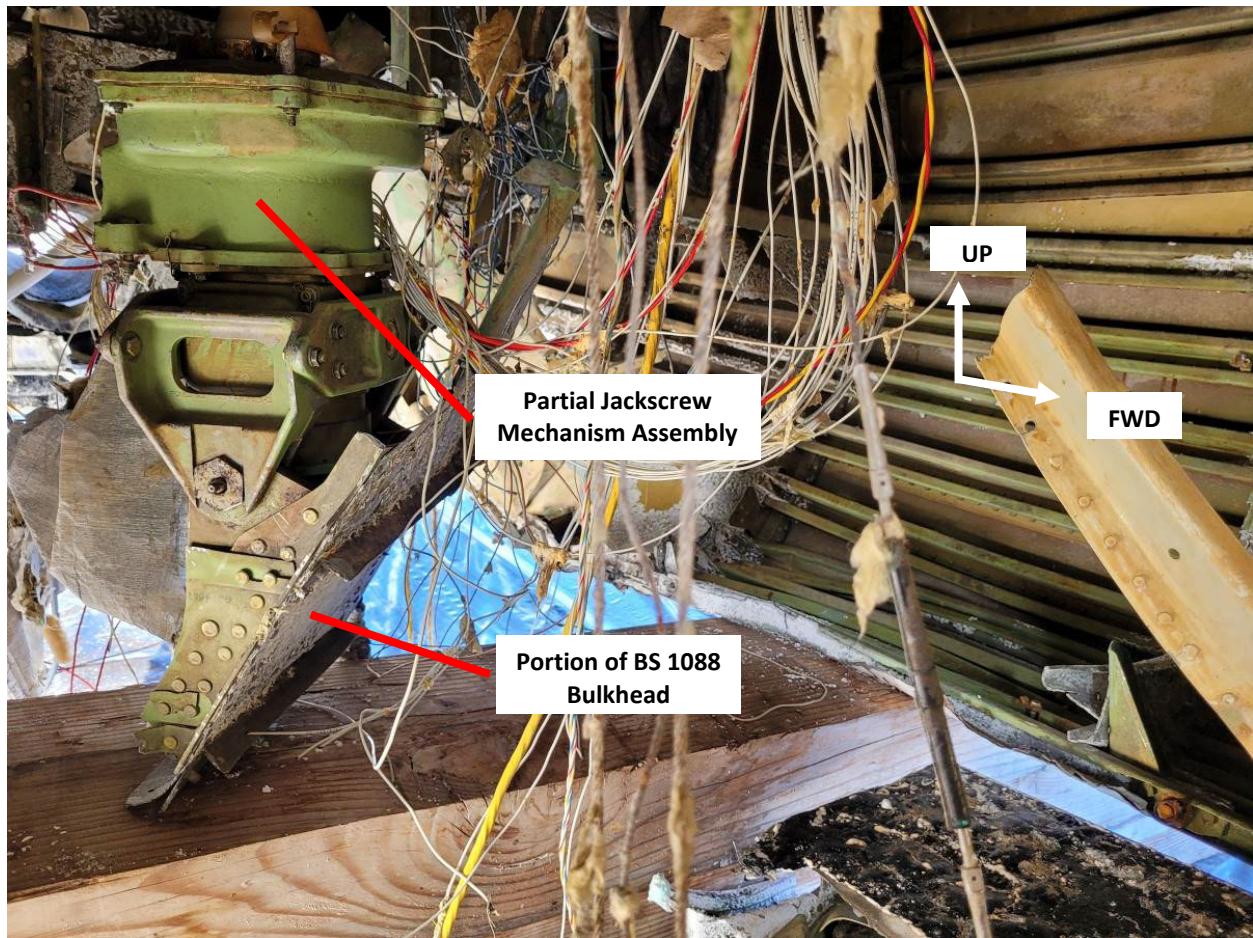
Figure 63 shows the Horizontal Stabilizer Trim Jackscrew lower mechanism. A portion of the mechanism was fractured away and a portion of the BS 1088 bulkhead was still attached to the jackscrew mechanism assembly.

Figure 63. Horizontal Stabilizer Trim Jackscrew lower mechanism (Boeing photo)

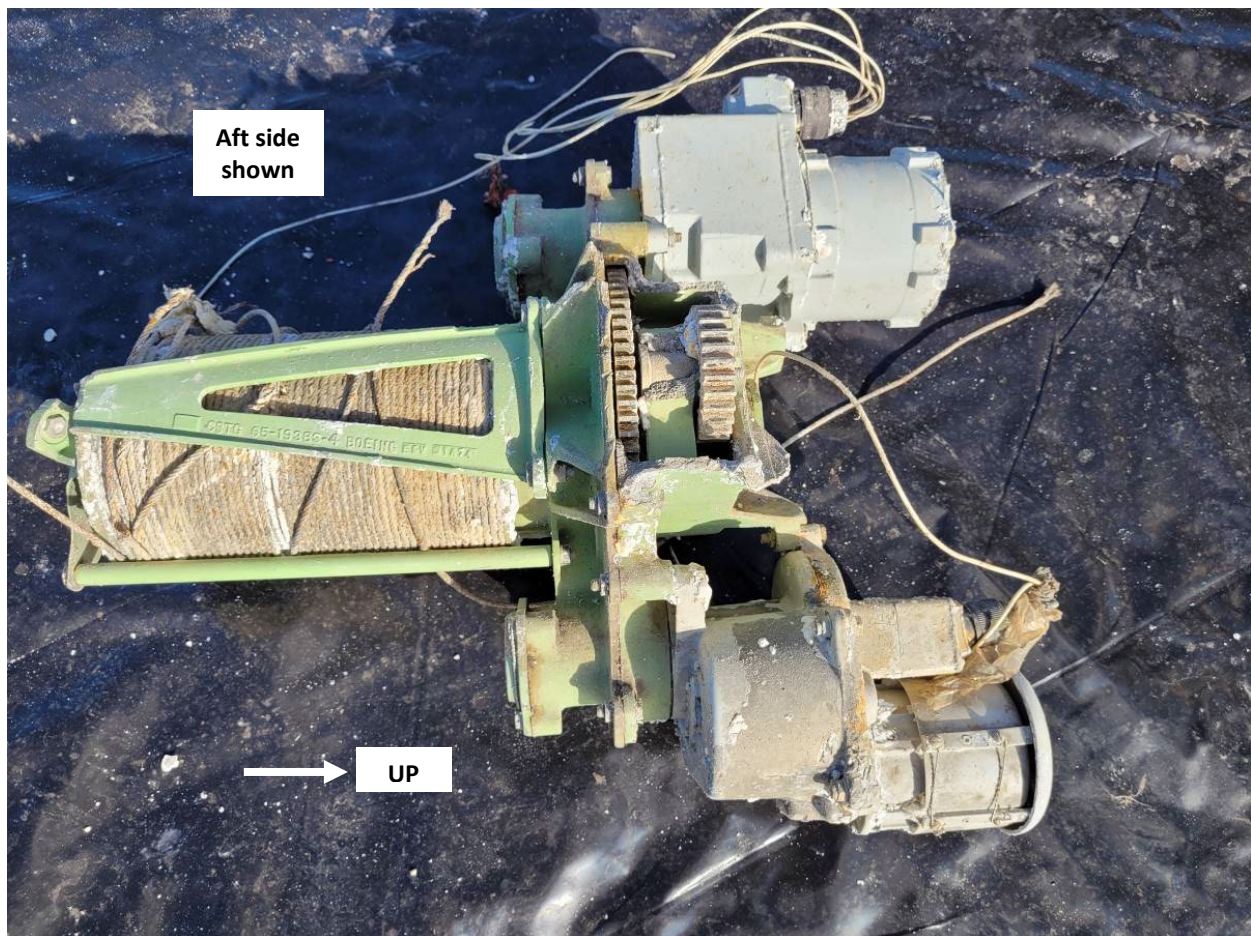
Figure 64. Separated Horizontal Stabilizer Trim Jackscrew gearbox, cable drum, and actuators (Boeing photo)

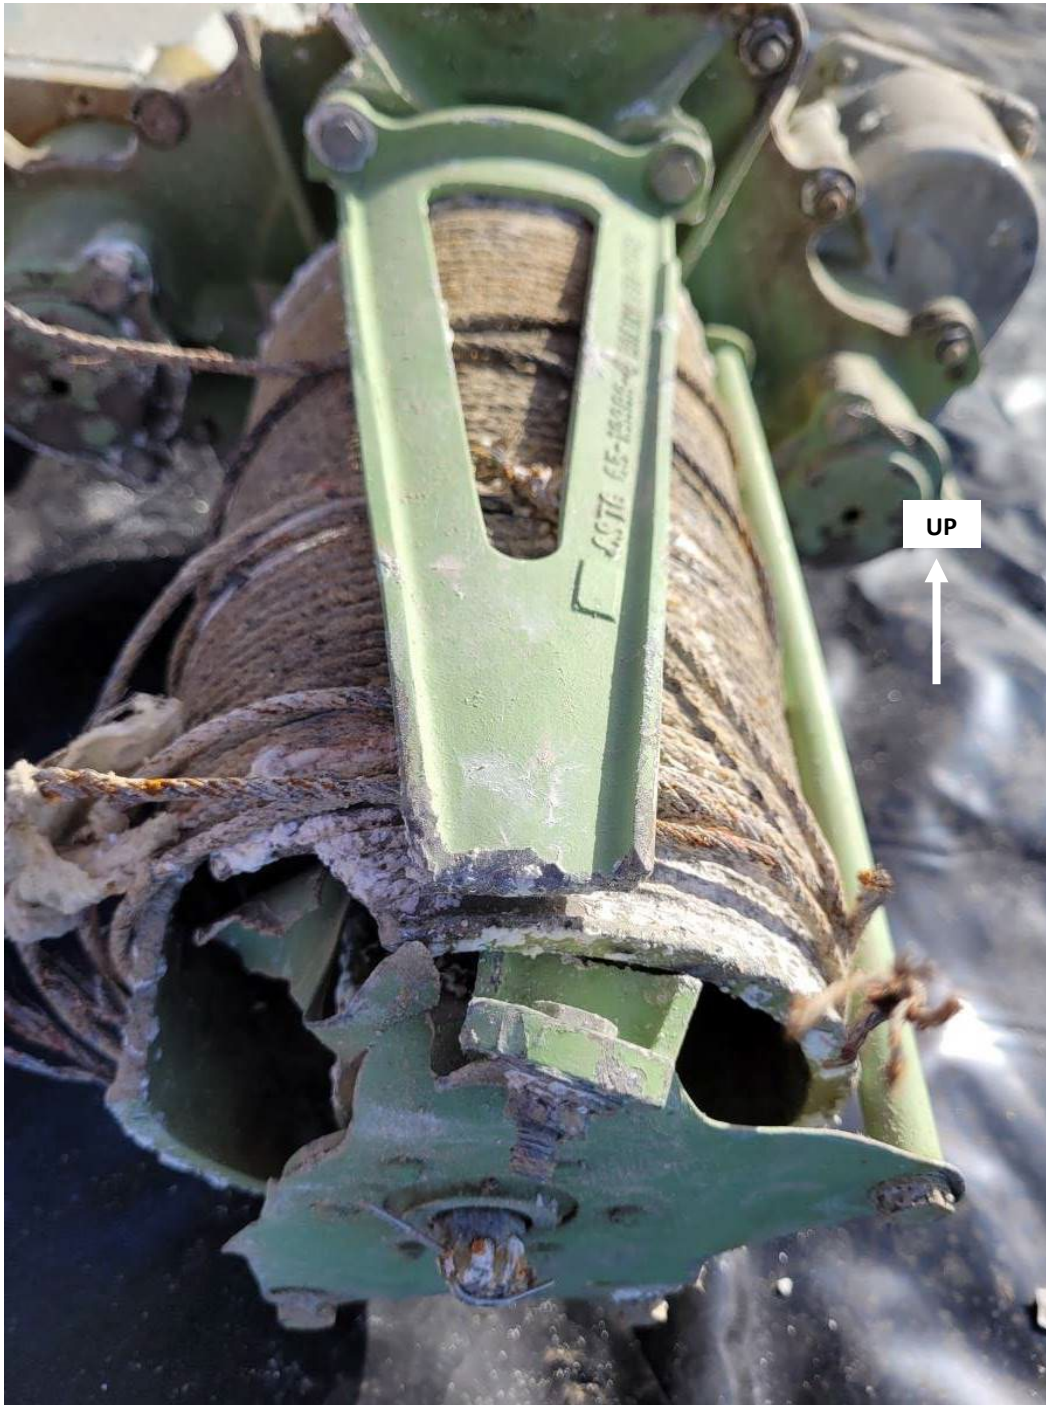
Figure 65 shows a close-up of the fracture at the lower end of the cable drum.

Figure 65. Close-up view of jackscrew cable drum damage (Boeing photo)

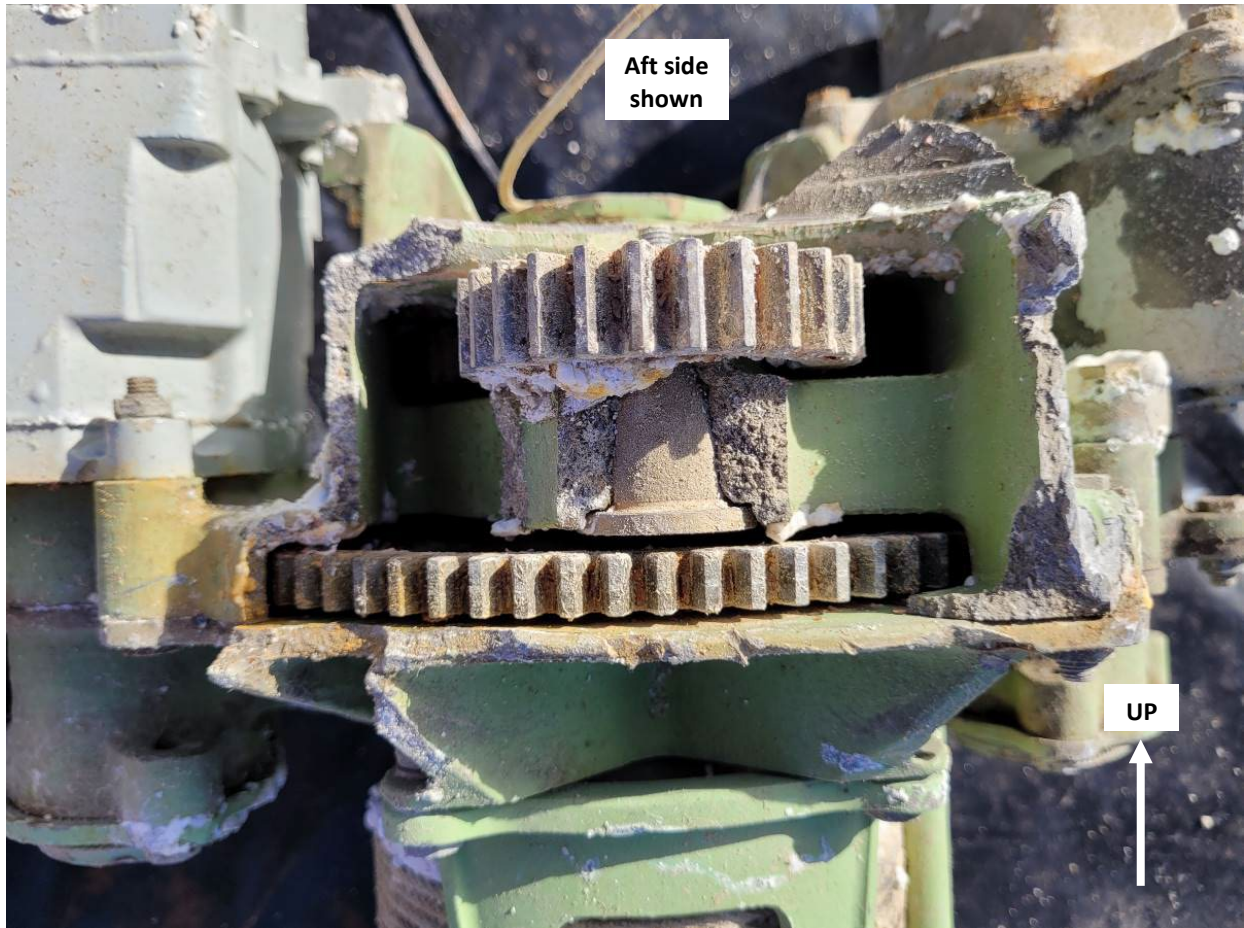
Figure 66 shows the fracture of the gearbox housing where it separated from the Jackscrew assembly.

Figure 66. Close-up of jackscrew gearbox fracture (Boeing photo)

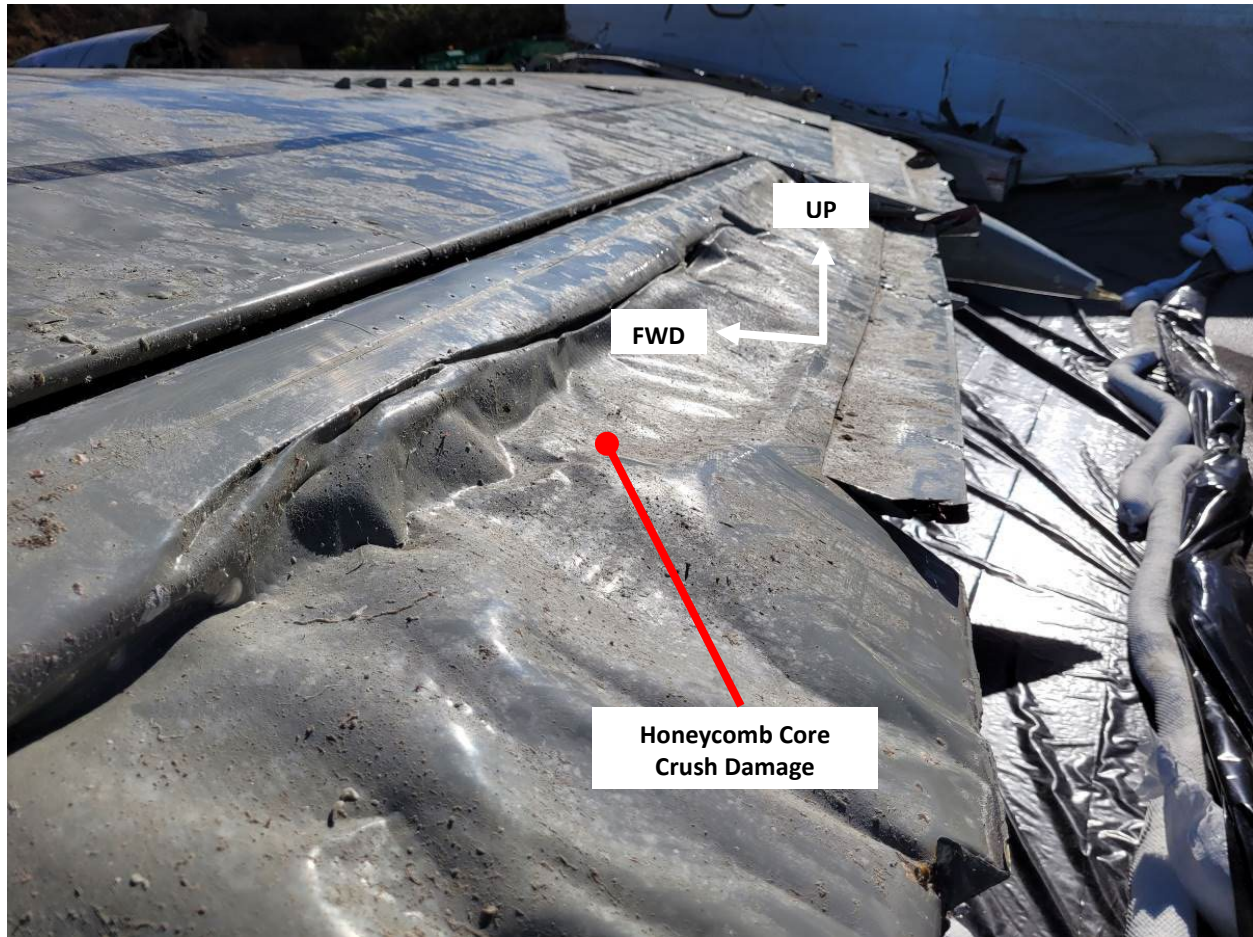
Figure 67 shows the left outboard aft flap honeycomb core crush damage. This damage was evident on a majority of honeycomb core assembly parts on the aircraft.

Figure 67. Left outboard aft flap honeycomb core crush damage (Boeing photo)

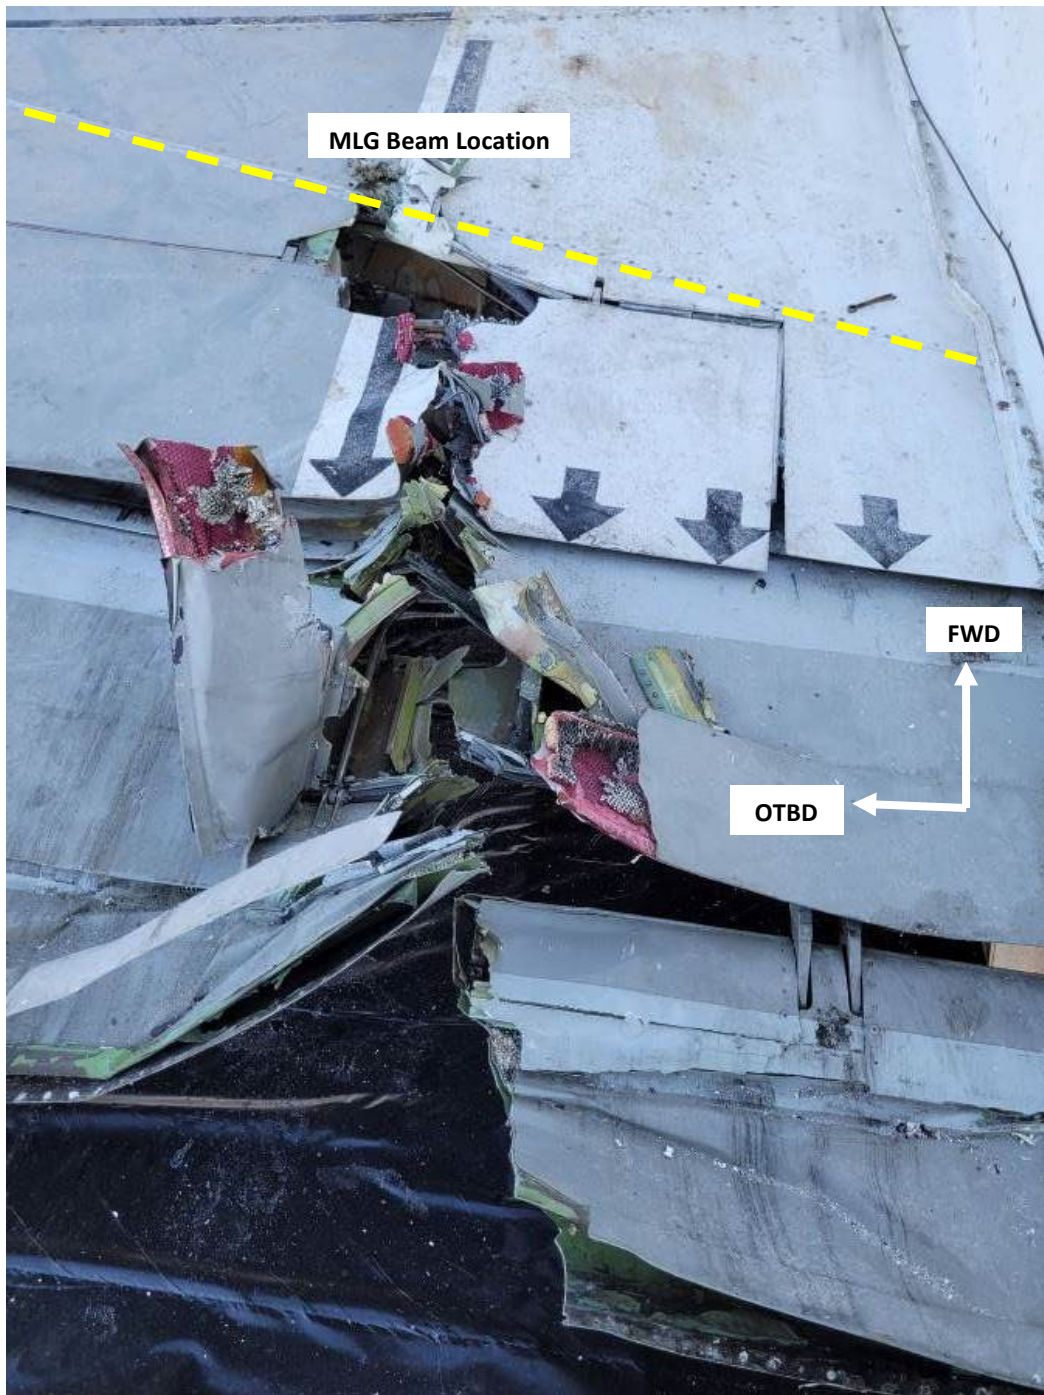
Figures 70 and 71 show the tearing damage to the left inboard flap, spoiler, and trailing edge panels from the trailing edge forward to the MLG Beam where the lift cables were situated during recovery. The right wing had similar damage.

Figure 70. Left wing trailing edge damage, looking down/forward (Boeing photo)

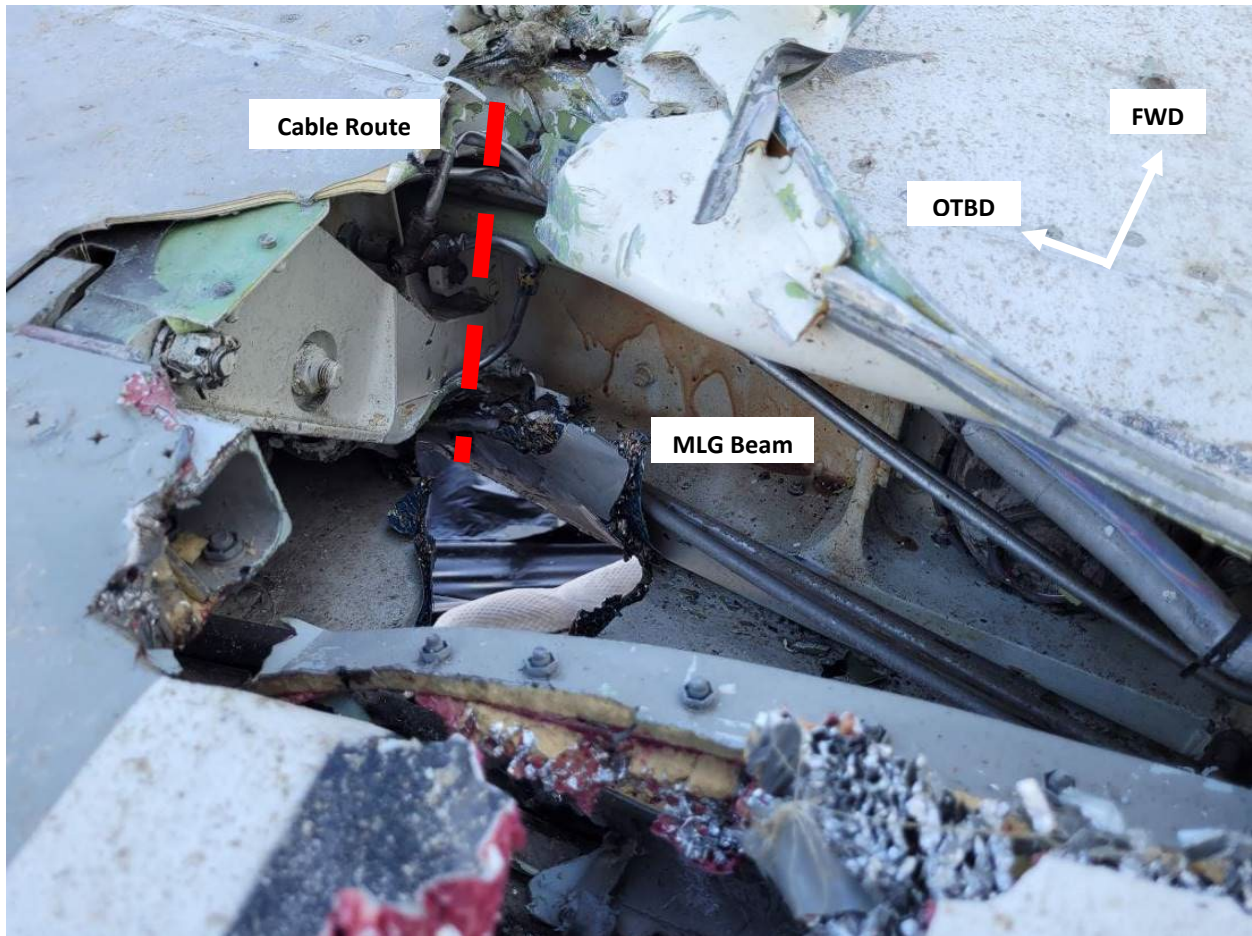
Figure 71. Left wing trailing edge damage close-up of MLG Beam (Boeing photo)
