## National Transportation Safety Board

### Interview Summary – DCA21FM014

**Interview of:** Carlos Chauvin – captain of the towing vessel *Robert Cenac*  
**Date/Time:** March 31, 2021 1510 to 1600 CDT  
**Location:** Telephonic/conference call  
**Interviewed by:** Lt. [REDACTED] – USCG and Adam Tucker – NTSB  
**Attendees:** Michael Held – Phelps Dunbar, LLC (attorney for Al Cenac Towing)  
**Accident:** January 13, 2021 Contact of barge *H238*, pushed by towing vessel *Robert Cenac*, with CSX Rigolets railway swing bridge (NTSB No. DCA21FM014). Rigolets Pass, Louisiana.

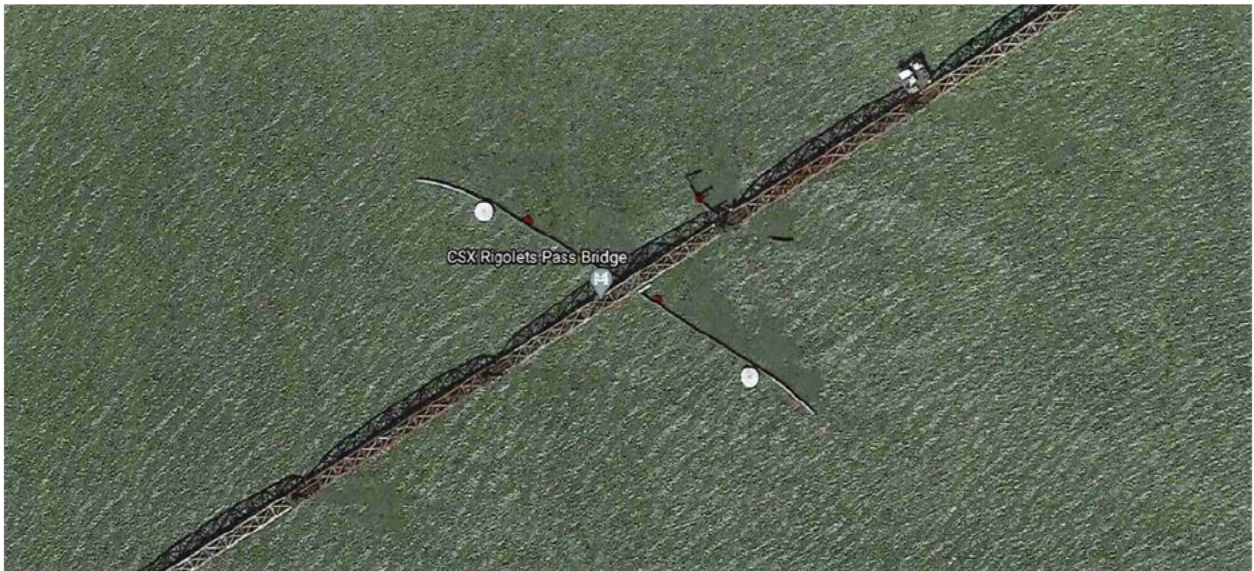
- When asked about the lighting at the bridge, Mr. Chauvin said that when approaching the bridge, there is only one red light on the south side of the west bridge fender works which is not marking the end. It is mid-way up which is the same for the light on the north side. For the fender works on the east side, there is only one light which is in about the middle of the fender works. There are no lights on the bridge itself and it is dark. There are no range lights (refer to diagram submitted by Mr. Chauvin).

- The bridge swings south, meaning clockwise, and when it is fully open, it is entirely behind the fender works.
- When asked if there were any reflectors on the fender works, Mr. Chauvin said there were not.
- When asked to describe how he noticed that the bridge was not fully open, Mr. Chauvin said he was expecting the fender wall. His attention was to look for the fender wall with the spotlight to make sure the tow was inside the fender works. When he noticed the
