National Transportation Safety Board

Interview Summary – DCA21FM028

Interview of: Steven Engermann – President of Hermann Sand & Gravel Inc
Missouri River Towing LLC
Date/Time: February 4, 2022 – 1005 to 1100 CDT
Location: Conference call
Interviewed by: Adam Tucker – NTSB and Bart Barnum - NTSB
Attendees: None
Accident: May 18, 2021, engine room fire aboard the towing vessel *Mary Lynn* at mile 176 upper Mississippi River, St. Louis, Missouri.

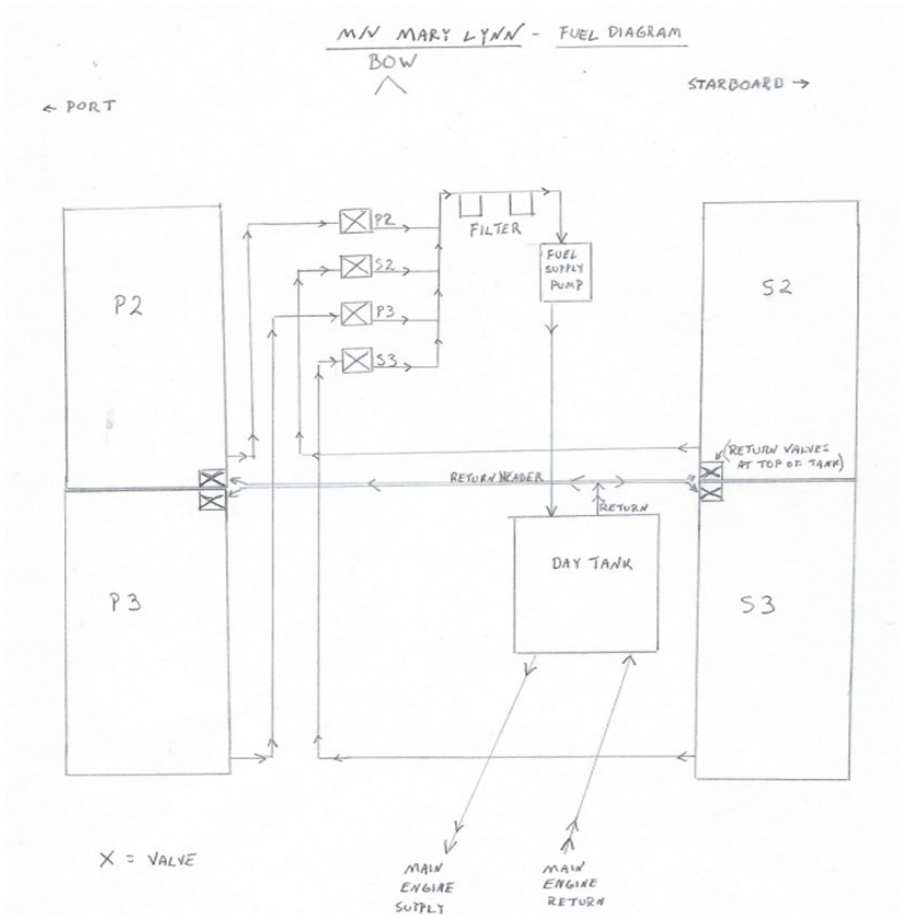
Mary Lynn fuel oil system diagram provided by Mr. Steven Engermann on February 4, 2022.

- When asked of the suction filters on the pump, Mr. Engermann said there were three filters, not the two that were on the fuel oil system diagram.
- When asked to confirm if there were two fuel supply pumps, Mr. Engermann confirmed there were two. He confirmed the discharge of the supply pumps go to the day tank. From the day tank, there was a suction line to the consumers. Mr. Engermann said there was an engine driven fuel pump on each engine as well as on the suction line before the two main engines, there were two more fuel filters. Asked to confirm that the spin on filters on the front of the engines were the ones with the glass bulbs, Mr. Engermann confirmed that was correct.

- When asked, based on the submitted fuel oil system diagram, about the pump discharge going into the return header line to whatever tank is open, and if it also goes to the day tank, Mr. Engermann confirmed it goes to the same header line. When asked of the overflow line having a check valve in it, or manual valve to prevent backflow into that tank, Mr. Engermann said they did not run the fuel supply pumps and the water filtration system pump at the same time.

- When asked with respect to the fuel system schematic diagram provided, what the no. 4 tanks were used for, Mr. Engermann said the no. 4 tanks were part of the original system of the boat, but they were only using them for dirty oil or slop.
