National Transportation Safety Board

DCA22FA082

VIDEO STUDY

Location: Jolon, CA
Date: February 16, 2022
Time: 09:58 pacific standard time (PST)
UAS: Joby Aero Inc. JAS4-2, N542AJ

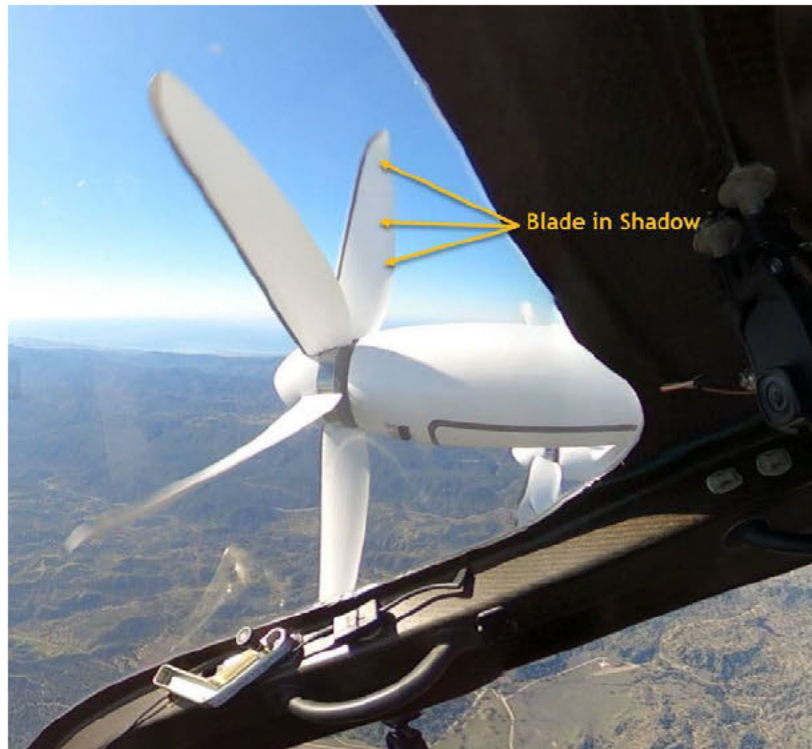
The first examined image provided in figure 3 was captured at 09:58:11.373 PST. This figure shows the blades at a nominal position for the given conditions. Note the position of the outboard upper blade in relation to a shadow cast on the blade itself. The shadow is cast on the entire blade. The shadow is annotated in figure 3.

Figure 3. Time 09:58:11.373 PST. Blade shown at a nominal blade angle for the given conditions.

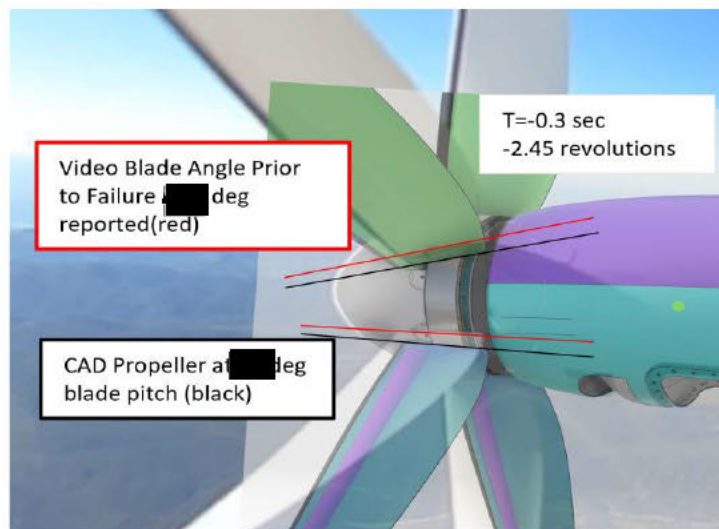
Figure 4 is a screen capture containing the CAD model overlay that was created by Joby. The CAD model shows correlation between the model and the data reported from the HRR for station 3 commanded pitch angles at the annotated time (same time as figure 3). For information on the data reported from the HRR, see the Electronic Devices Specialist's Factual Report, which can be found in the public docket for this accident.

Figure 4. Time 09:58:11.373 PST. A CAD model overlay provided by Joby for the referenced time, showing nominal conditions.

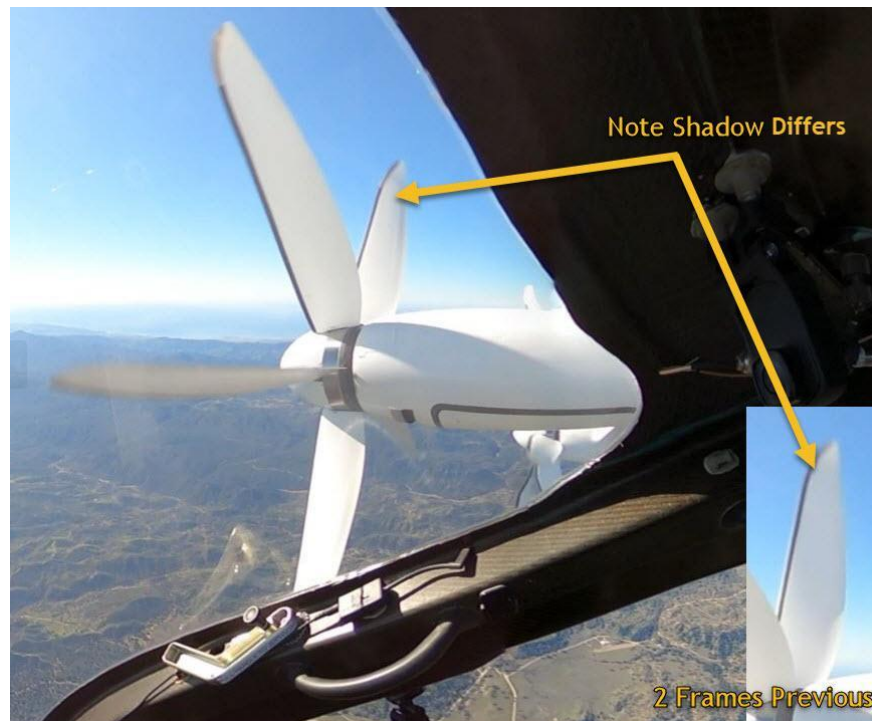
The next screen capture provided in figure 5 was captured at 09:58:11.373 PST. The arrow points to an area of the upper outboard blade, which is no longer in shadow, showing that the blade had reached a steeper angle. For comparison, the upper outboard blade from the previous figure is inset to better illustrate the difference.

Figure 5. Time 09:58:11.373 PST. Blade shadow differences are illustrated.

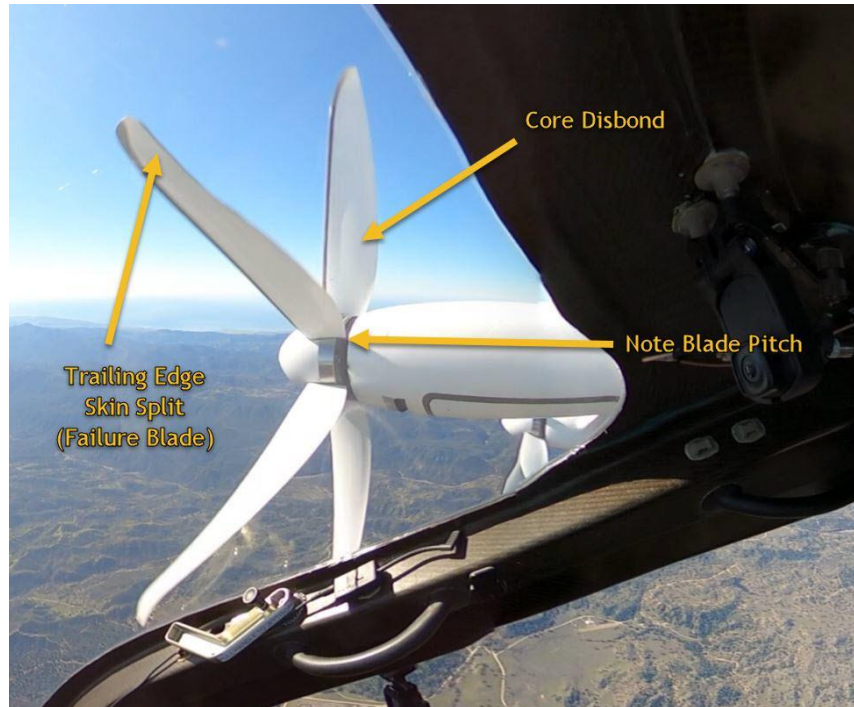
The next screen capture provided in figure 6 was captured at 09:58:11.406 PST. A blade later identified to be the first to depart (herein referred to as the failure blade) shows a possible trailing edge split on the blade that would be first to depart station 3. A blade, later identified to be the second blade to depart station 3 exhibits a possible core disbond. Note the blade pitch angle at this time is flatter than the previous imagery.

Figure 6. Time 09:58:11.406 PST. The image shows a core disbond, a possible trailing edge skin split and increased pitch angle of the ascending blade.

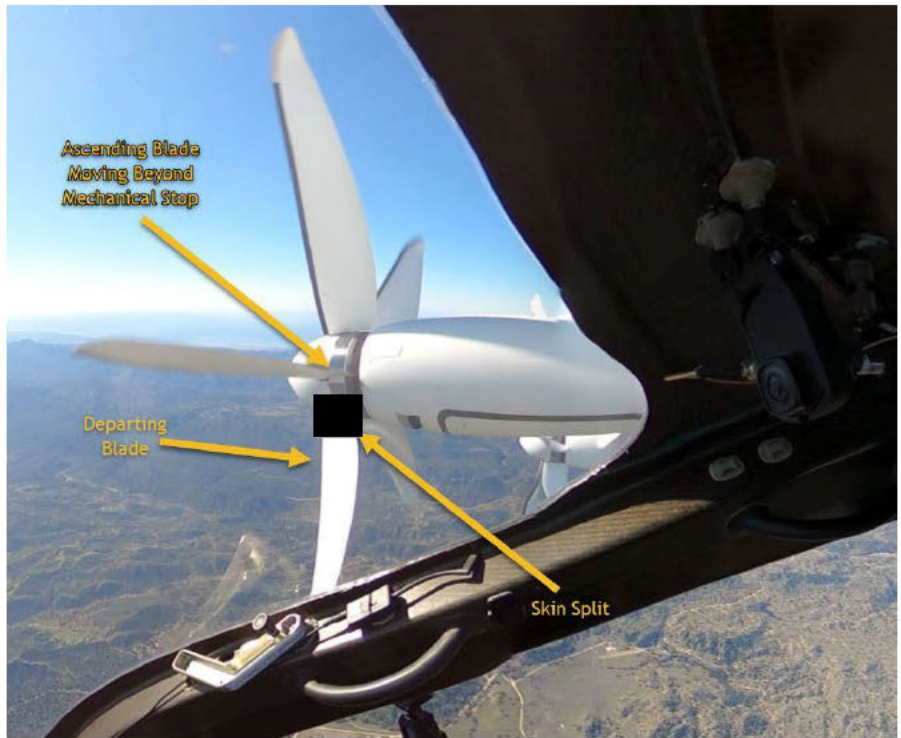
The next screen capture provided in figure 7 was captured at 09:58:11.440 PST. This image captures the moment the failure blade began to depart from station 3. Joby engineers identified a skin split¹ at this time, annotated in the figure. The blade appeared to become displaced radially from the hub. The blade also begins to trail its nominal position. Using the CAD model comparison method, the blade angle for the inboard ascending blade appears above the mechanical stop.

¹ Skin split – In this context, the skin of the propeller blade delaminates from the core structure. It appeared as separate of the two propeller blade skins at the trailing edge.

Figure 7. Time 09:58:11.440 PST. The frame shows the failure blade departing from station 3. The inboard ascending blade has pitched beyond its mechanical stop.

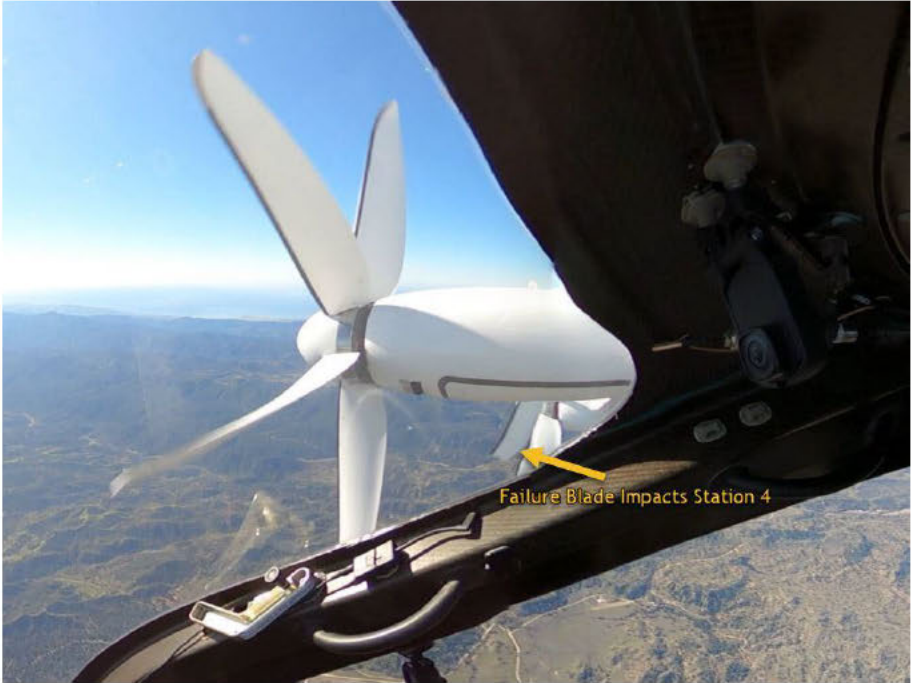
Figure 8 was captured at 09:58:11.473 PST. This image shows the failure blade impacting station 4.

Figure 8. Time 09:58:11.473 PST. The frame shows the failure blade contacting station 4.

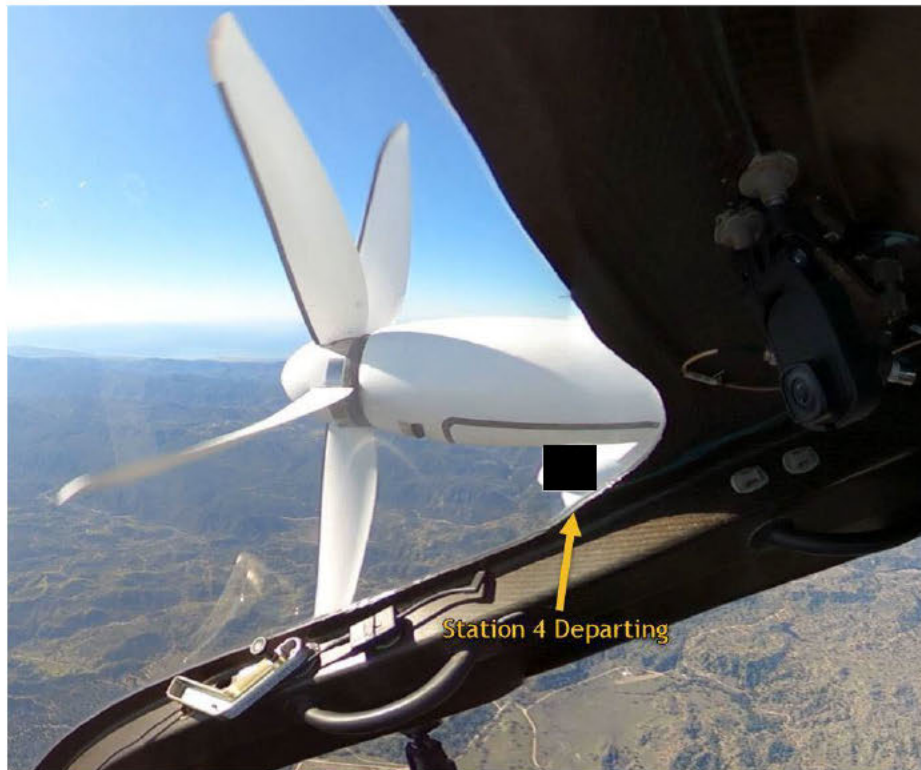
Figure 9 was captured at 09:58:11.704 PST. This frame shows station 4 rotating downward and departing from its nominal position.

Figure 9. Time 09:58:11.704 PST. The frame shows station 4 departing from its nominal position.

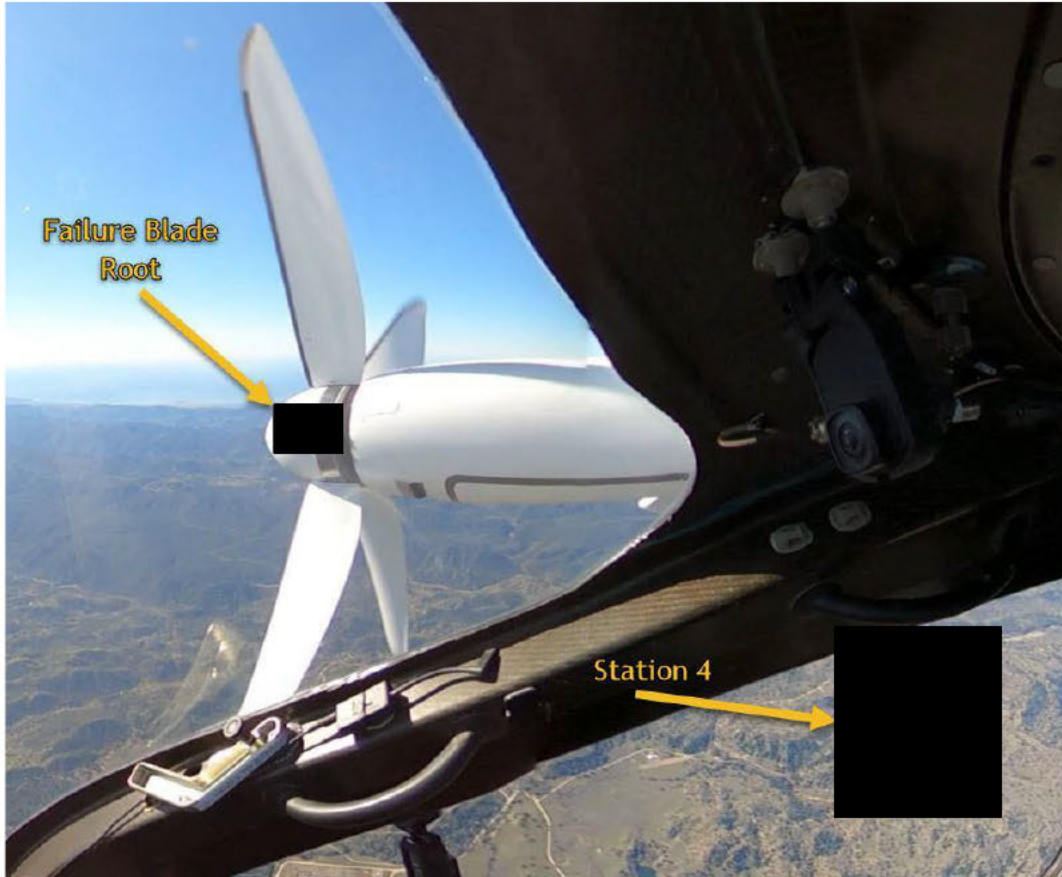
Figure 10 was captured at 09:58:12.01 PST. This frame shows station 4 free from the UAS. An annotation shows the root area where the failure blade was once attached to station 3.

Figure 10. Time 09:58:12.001 PST. The frame shows station 4 moving from its nominal position. An annotation shows where the failure blade was once attached to station 3.

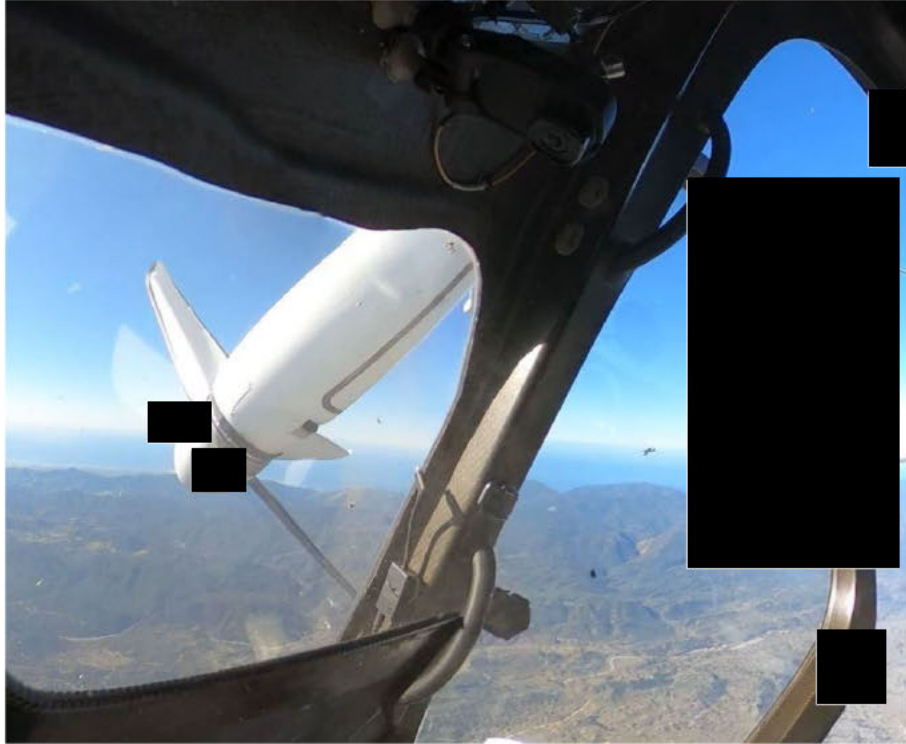
Figure 11 was captured at 09:58:12.793 PST. it shows the vehicle had pitched forward. Station 3 is missing numerous blades and station 4 was missing from the vehicle entirely. The glareshield detached and began to enter the cockpit area.

Figure 11. Time 09:58:12.793 PST. Shows the vehicle pitching forward, the missing blades from station 3, missing station 4. The glareshield had begun to detach.
