National Transportation Safety Board

DCA22FA132

SYSTEMS AND STRUCTURES - FACTUAL REPORT

Location: Miami, FL
Date: June 21, 2022
Time: 1738 EDT
Airplane: McDonnell Douglas MD-82

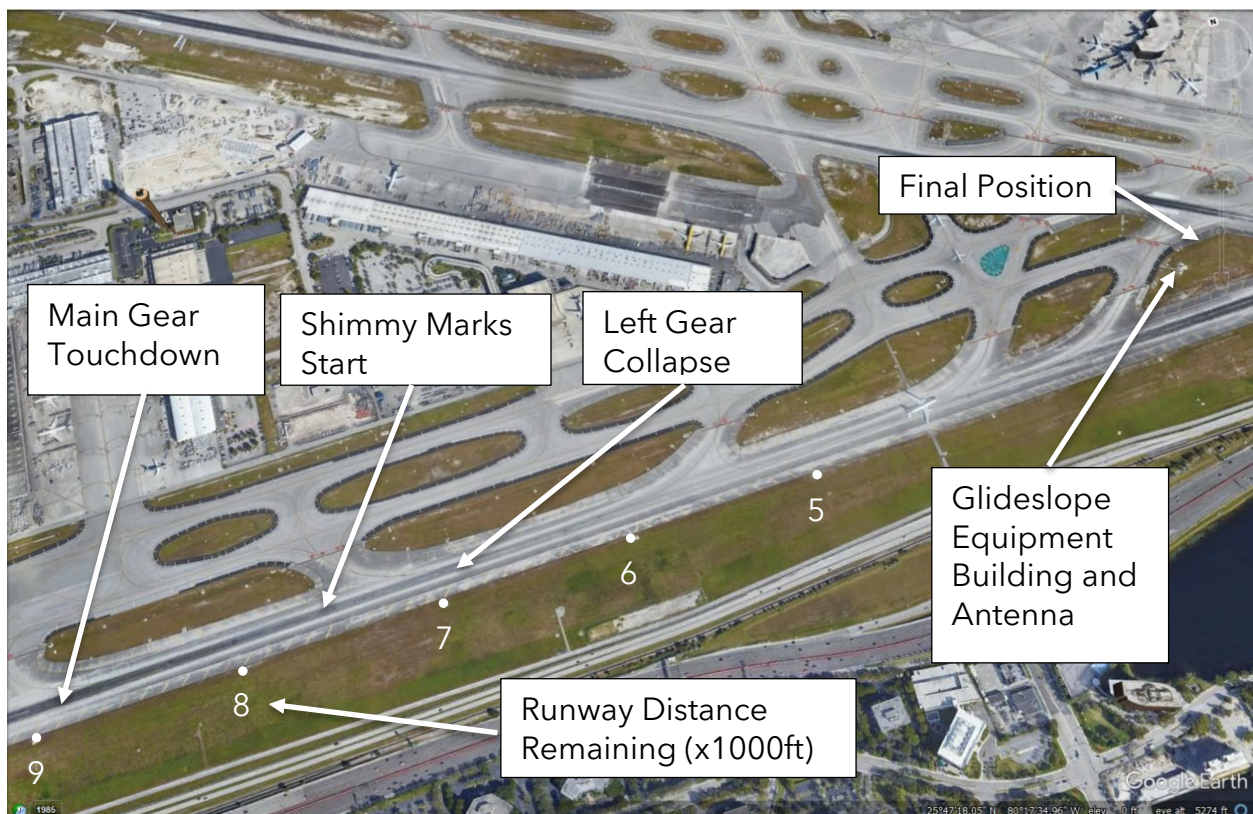
From video evidence, the airplane touched down on runway 9 with approximately 8900 feet remaining. Tire deposits on the runway, which started about 1300 ft later, showed evidence of left main gear shimmy. The amplitude of the shimmy steadily increased until the left main landing gear collapsed under the airplane about 675 feet later. The airplane continued down the runway skidding on the left wing. The airplane veered left and impacted an FAA glideslope equipment building and antenna (Figure 2). Both the nose gear and right main gear then collapsed, and the airplane came to a stop.

Figure 1 Runway 9 overview

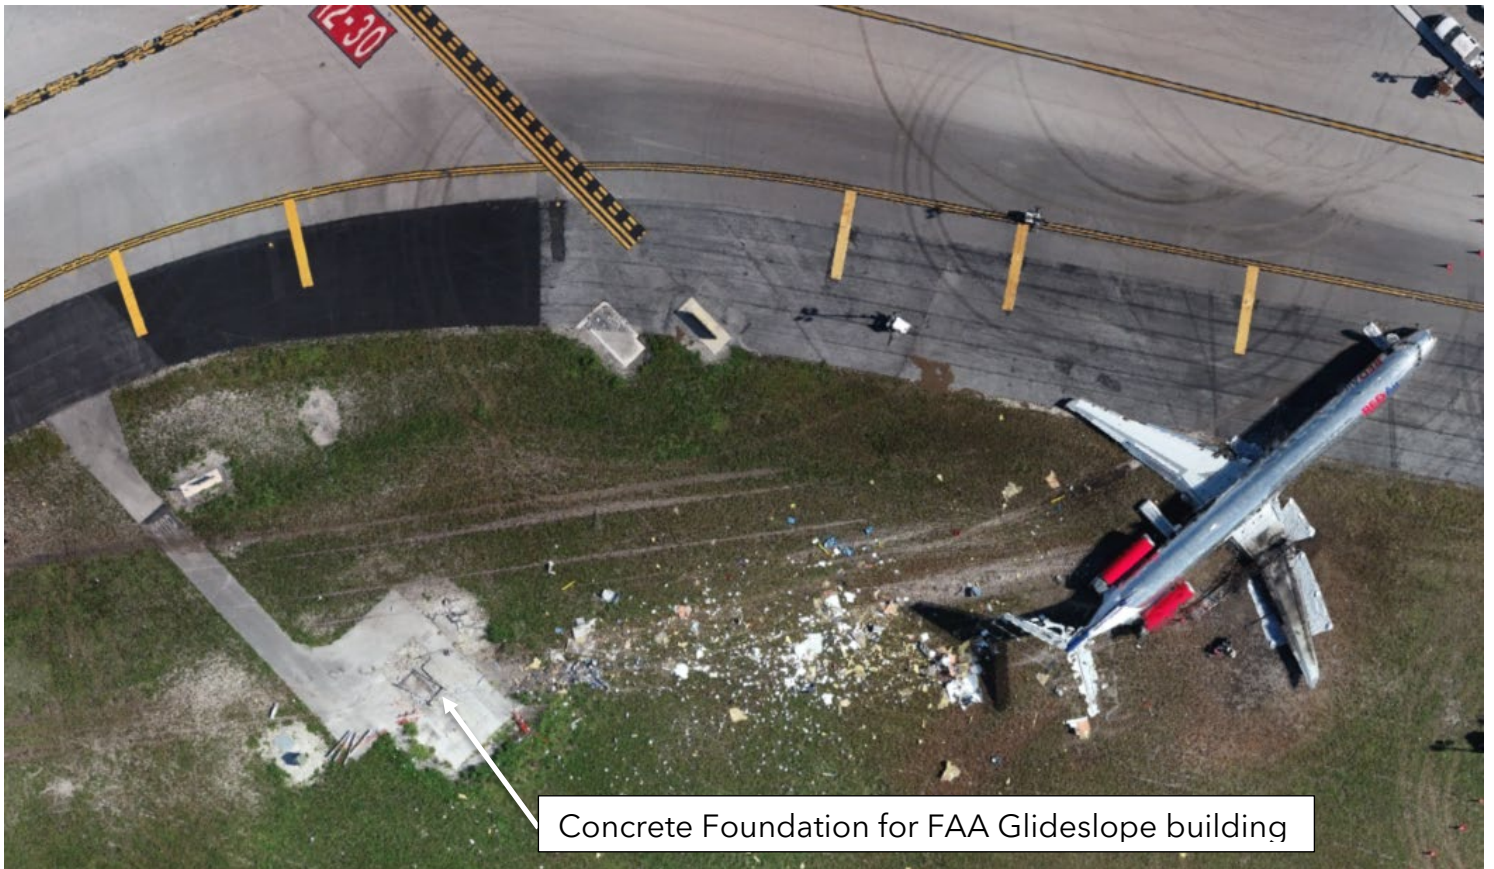
Figure 2 Final position of airplane

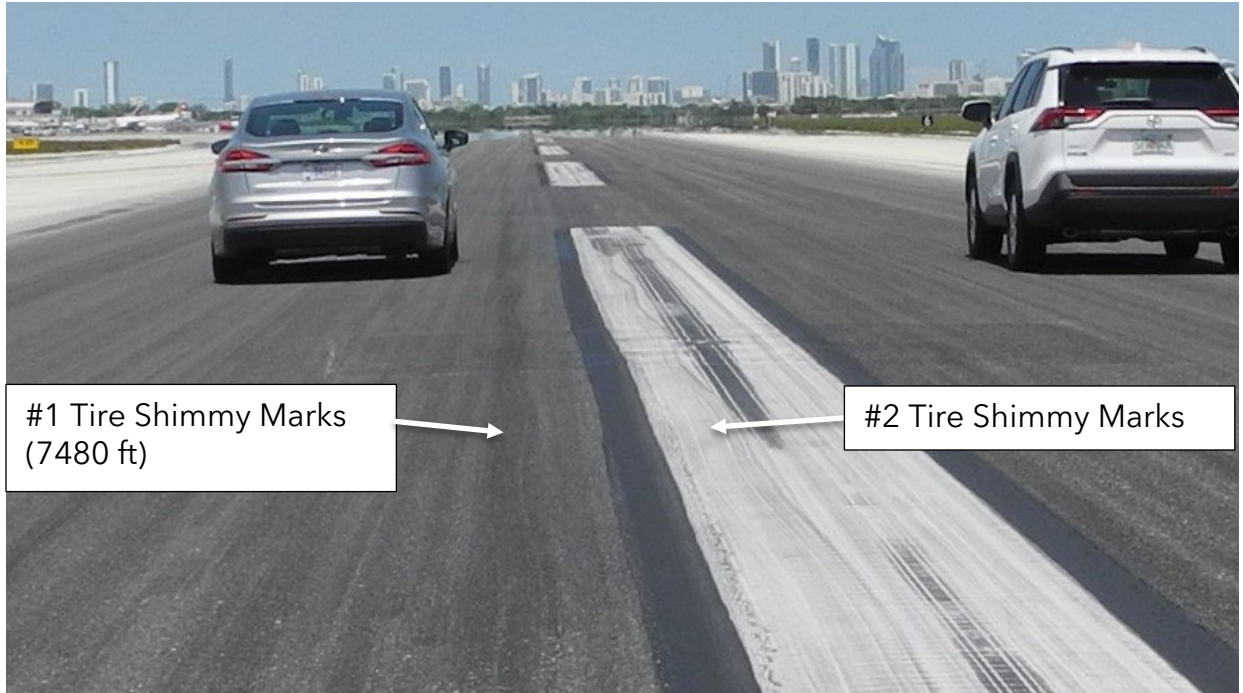
Figures 3 - 7 show how the rubber deposits on the runway for the left main gear tires started with a small oscillation and grew in amplitude (increasing shimmy). The labels with distance indicate approximate distance of runway 9 remaining. The tire marks changed in appearance. The initial markings were continuous and consistent with side-to-side oscillations (Figures 3 through 6). Figure 6 shows the location of the first debris found on the runway (approximately 7060 ft of runway remaining). The debris was a small piece of rubber, later determined to be from the outboard side of the #2 tire. The markings then were more arched and non-continuous, consistent with the axle/wheels turning about the vertical axis (Figure 7). The markings then changed from a two-tire pattern to a single tire pattern, and to the opposite side of the runway centerline, consistent with the tire sidewall contacting the runway after the left main landing gear collapse (Figure 8).

Figure 3 Start of left main gear shimmy marks

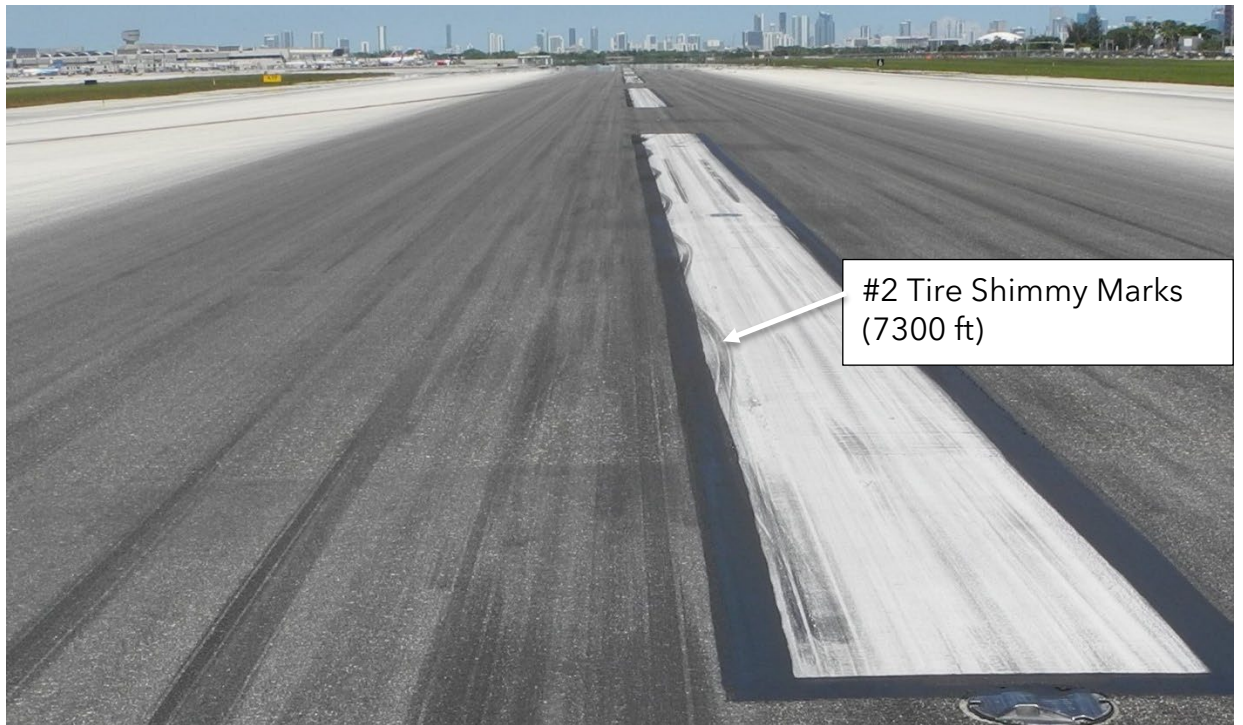
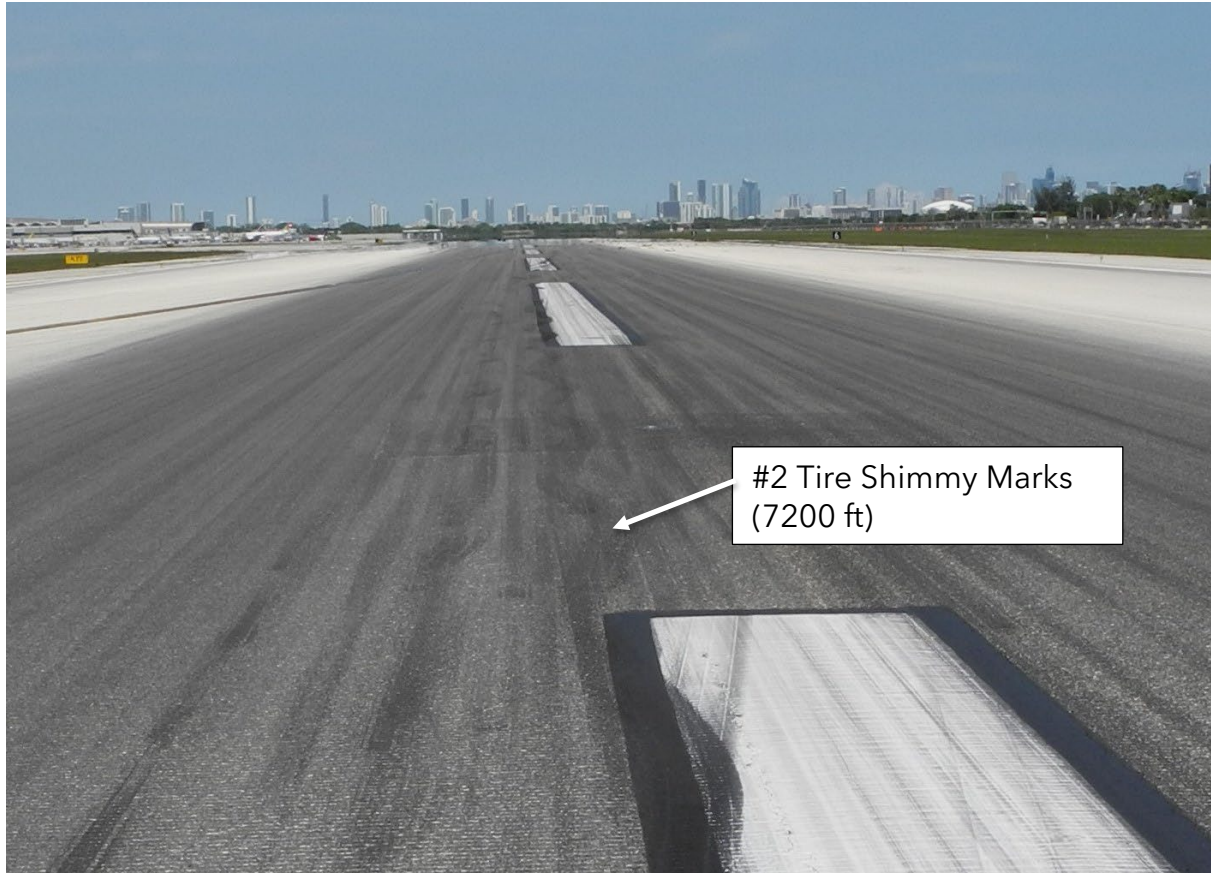
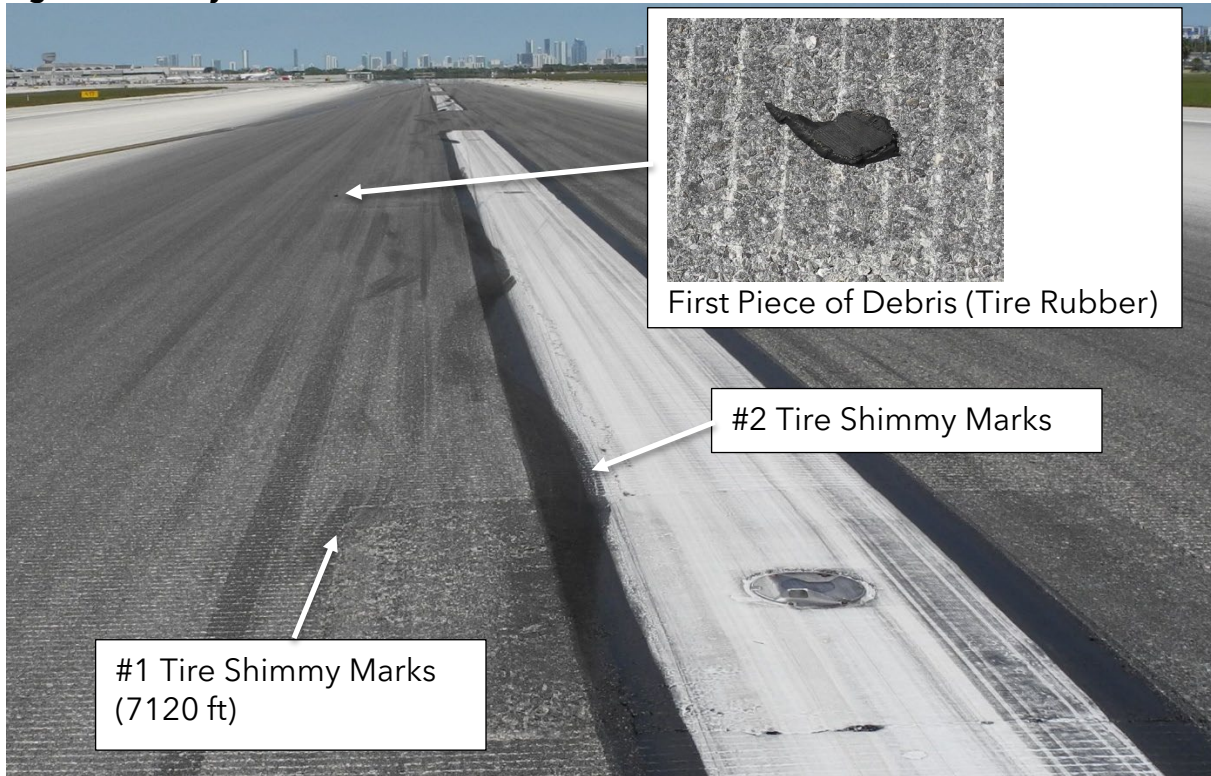
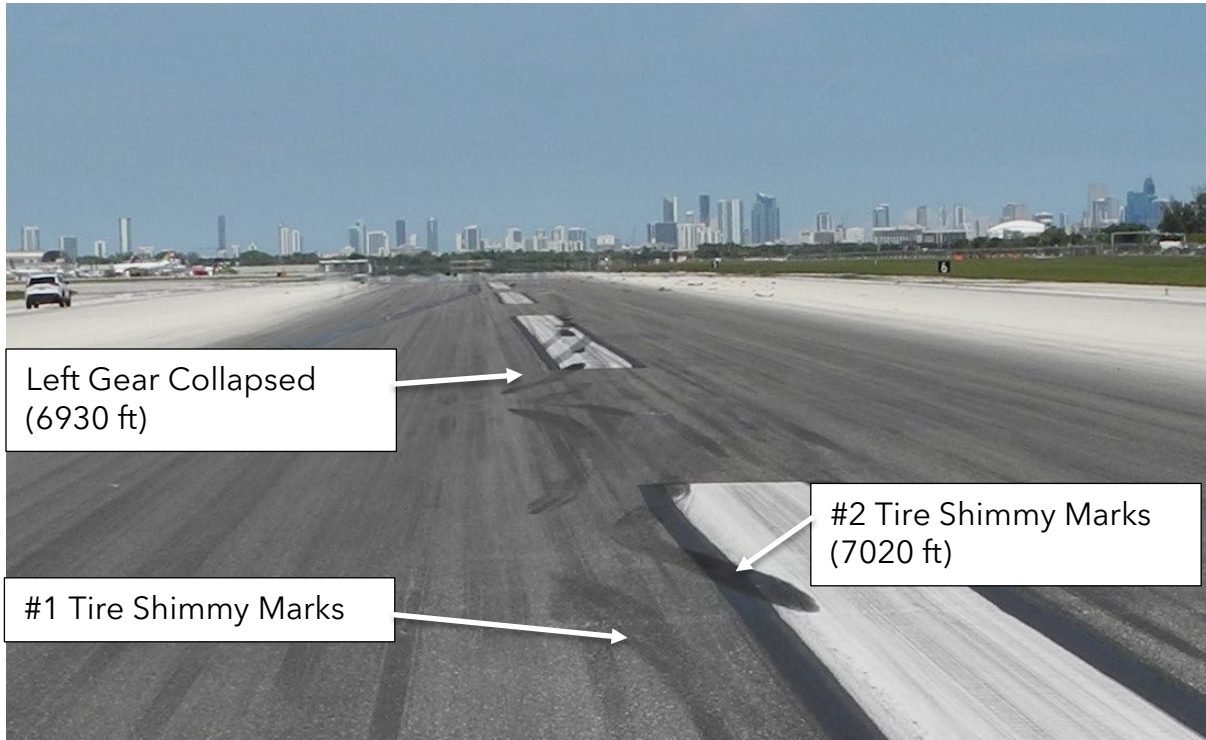
Figure 4 Shimmy marks continue

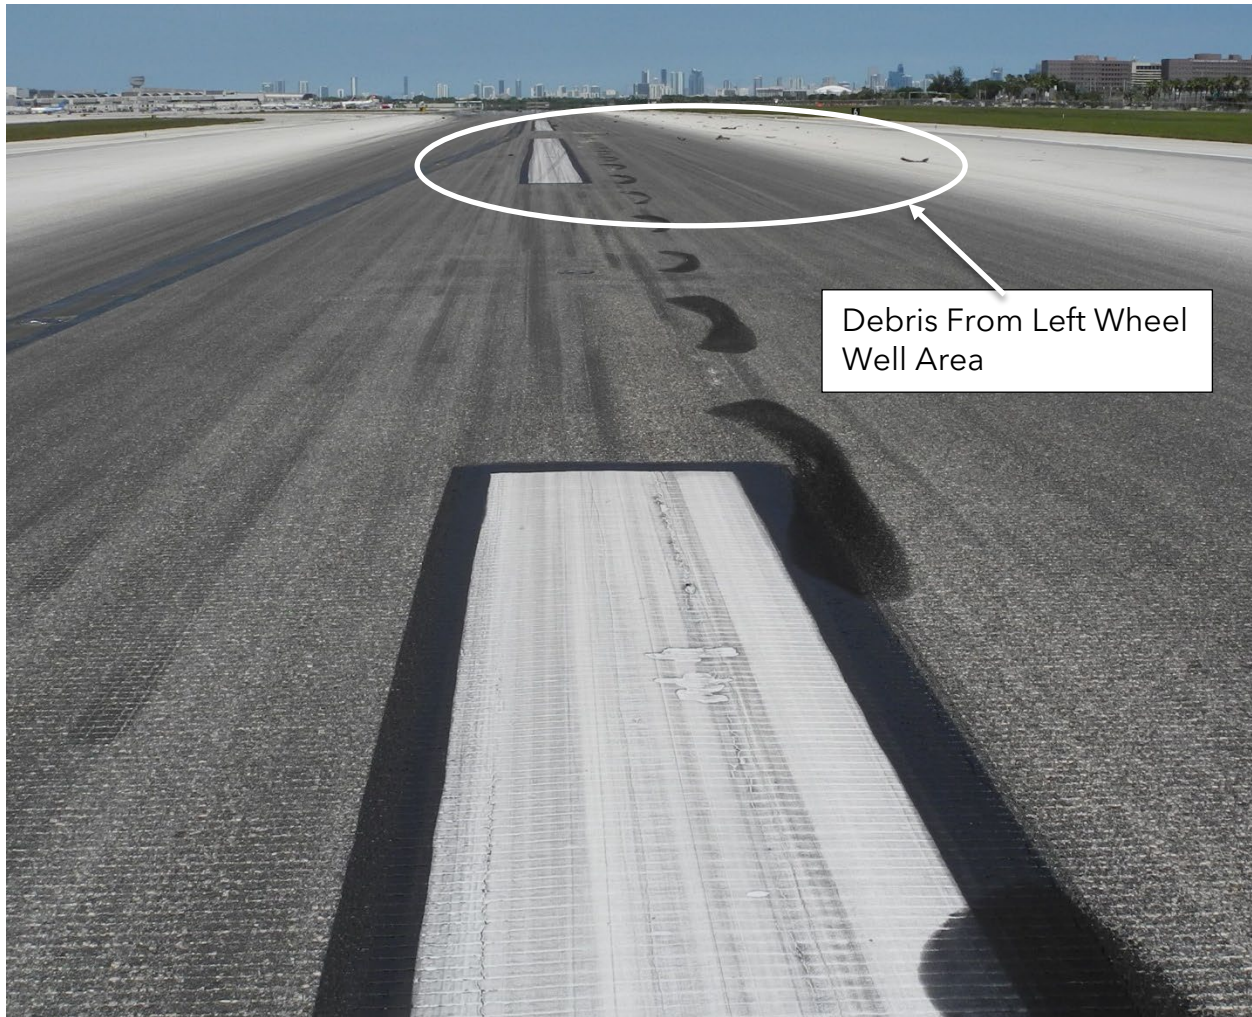
Figure 8 Tire marks after gear collapse

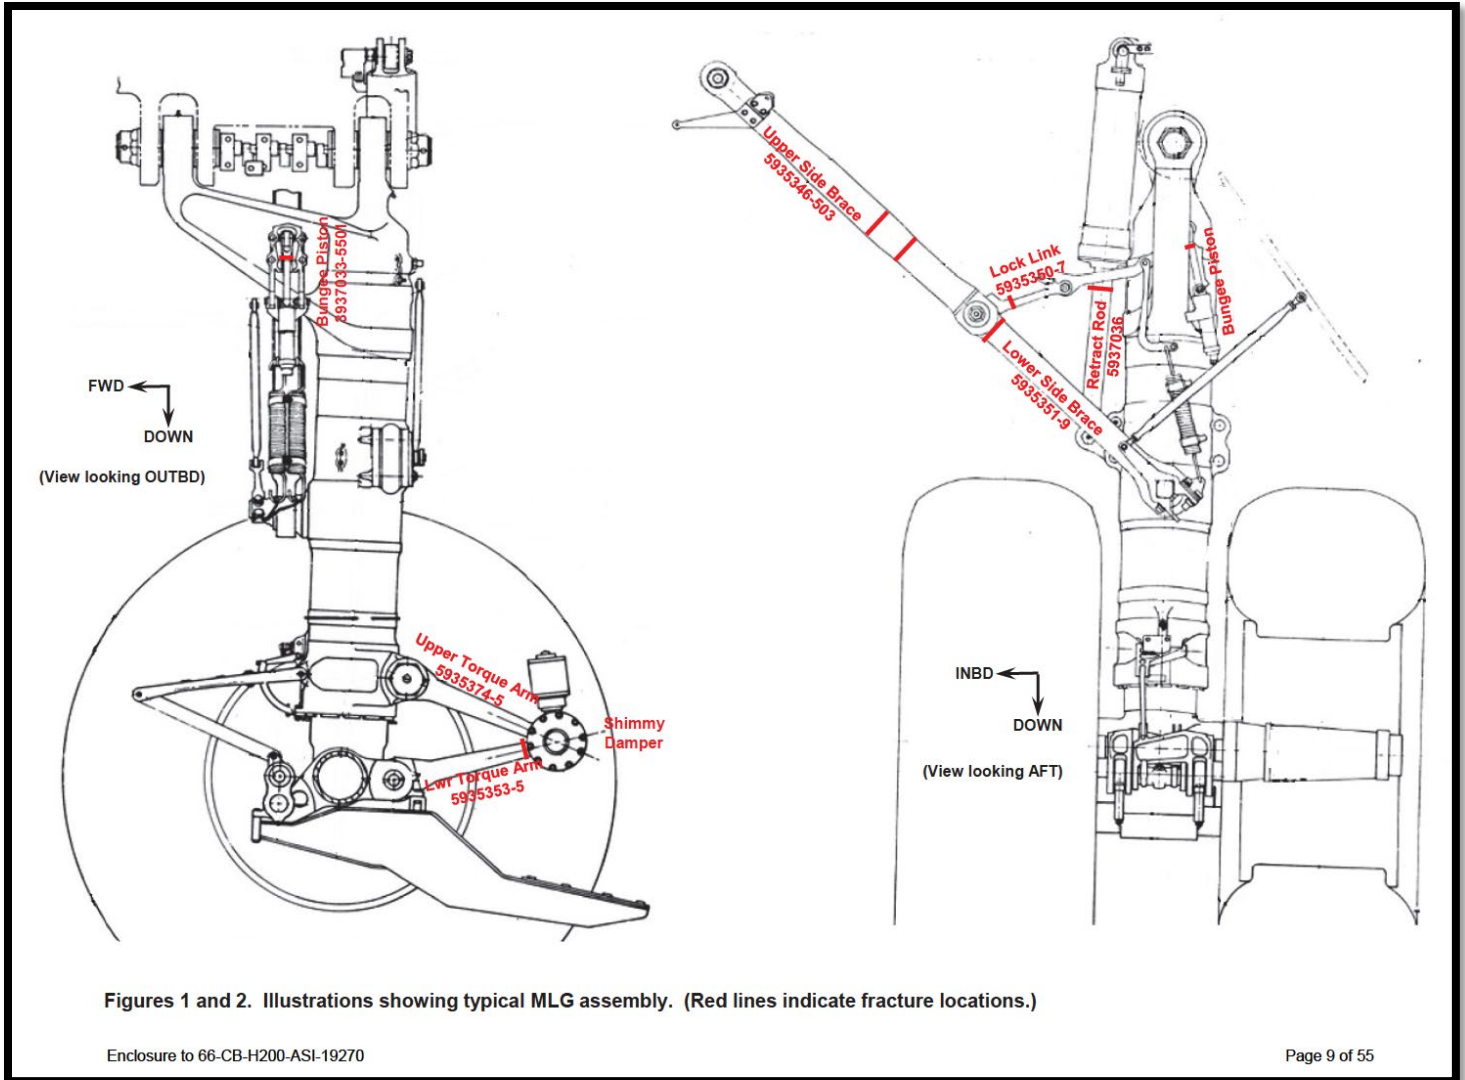
The landing gear components with the location of fractures are shown in Figure 9. Landing gear torque links and shimmy damper installation are shown in Figure 10. When the airplane was lifted during recovery, the gear extended, and the axle was found to be rotated outboard 90 degrees (#2 tire forward, Figure 11). The gear part number was 5935355-501, serial number CPT0718.

Figure 9 Landing gear components with fractures identified. Image copyright © Boeing. Reproduced with Permission.

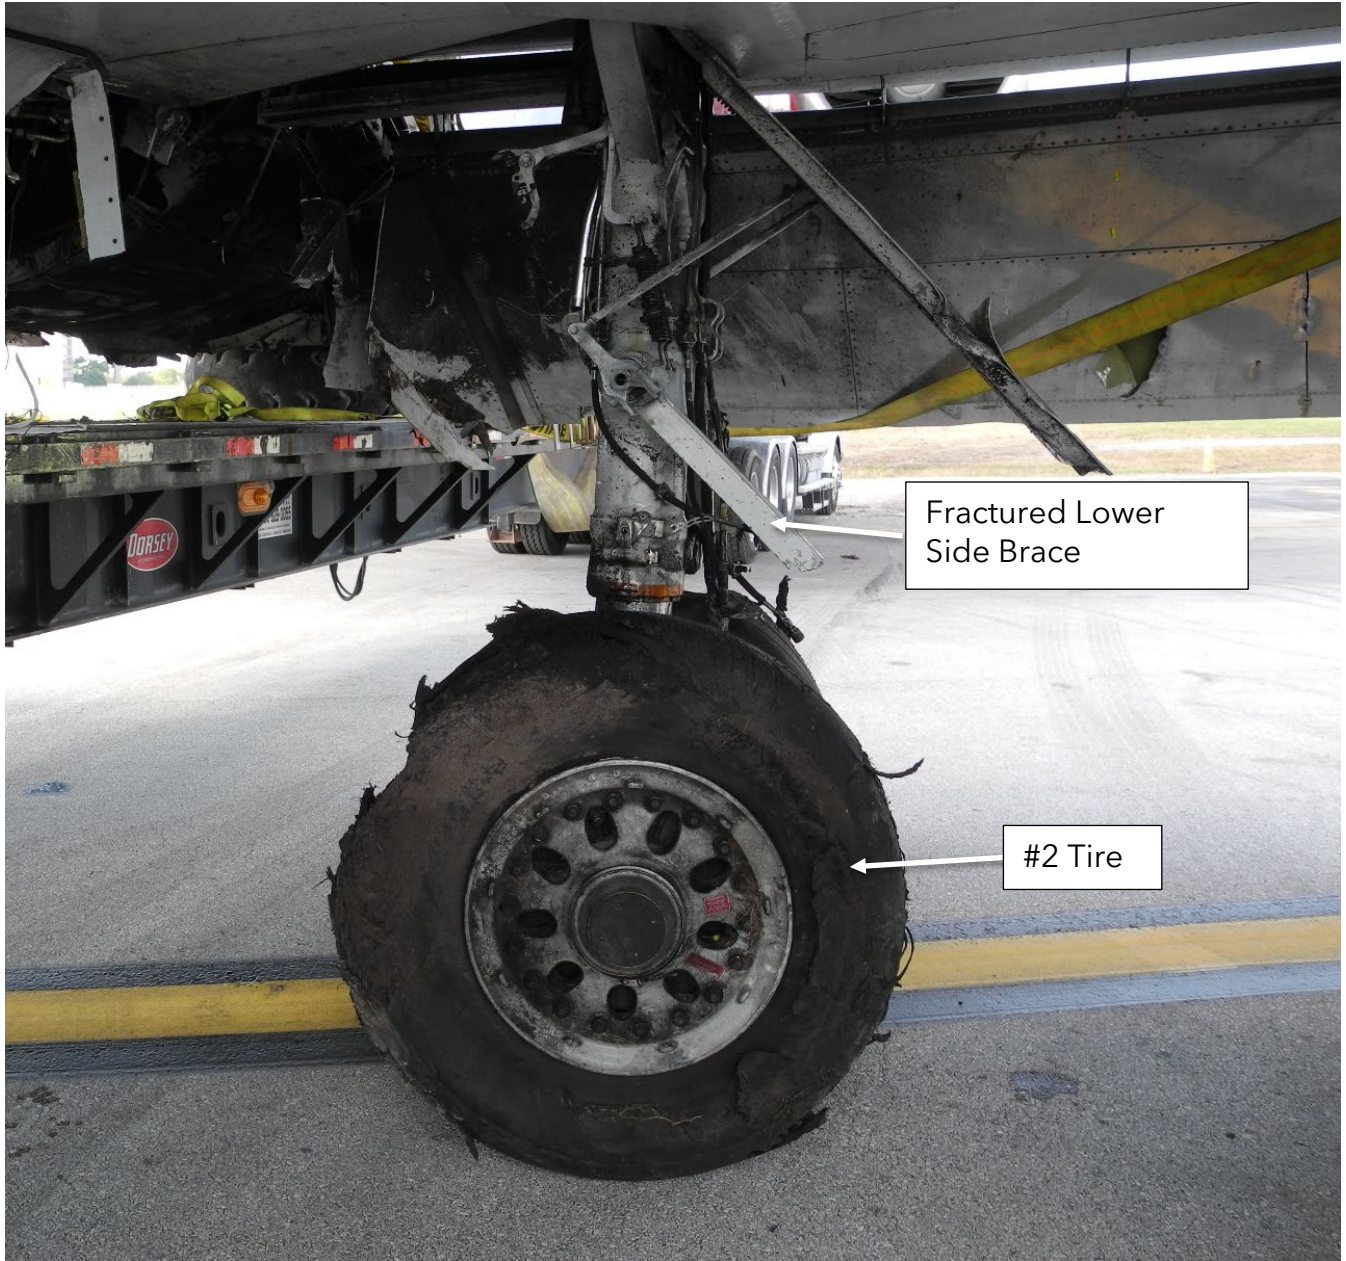
The lower side brace fractured just below the joint of the upper and lower braces, Figure 11. The lower end of the lower side brace remained attached to the outer cylinder.

Figure 11 Left main landing gear (looking aft)

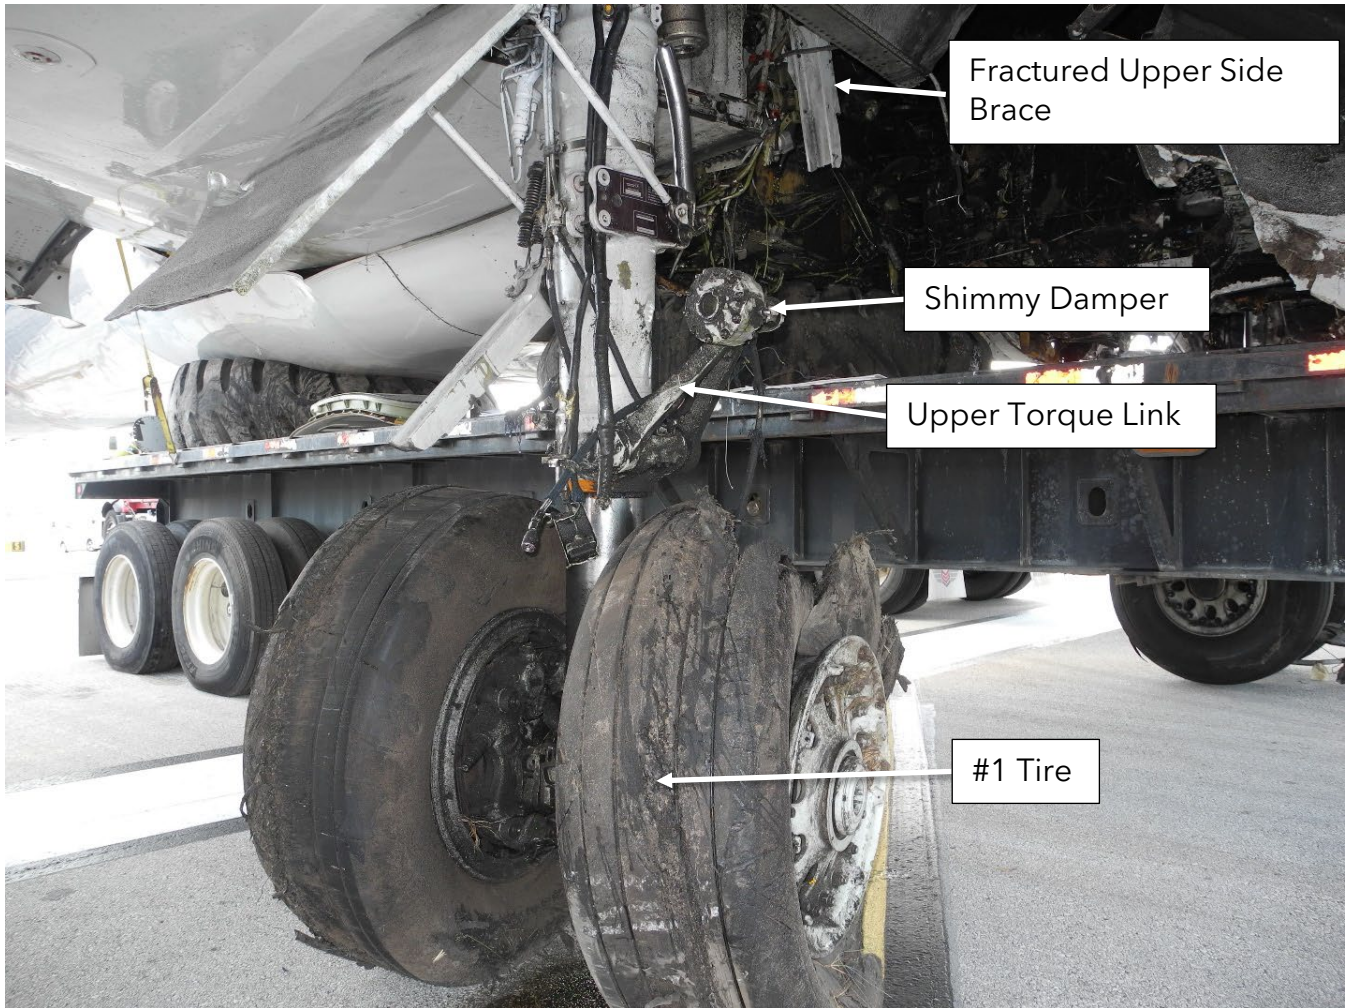
The upper side brace fractured into three pieces (to be referred to as the upper, middle, and lower). The largest piece (upper) remained attached to the airplane, Figure 12-13. The two smaller pieces, middle and lower, were recovered in the debris field just past the FAA glideslope building base, Figure 14. The middle piece had evidence of impact damage on its forward face. The damage measured approximately ½ inch in width. The lower piece included the joint and a portion of the lower side brace. A small piece of black rubber, consistent with tire material, was wedged in the joint.

The upper torque link was intact, Figure 12. The lower torque link remained attached to the inner cylinder, but the upper end fractured fully at the lug, Figure 15.

Figure 12 Left main gear looking inboard and slightly forward

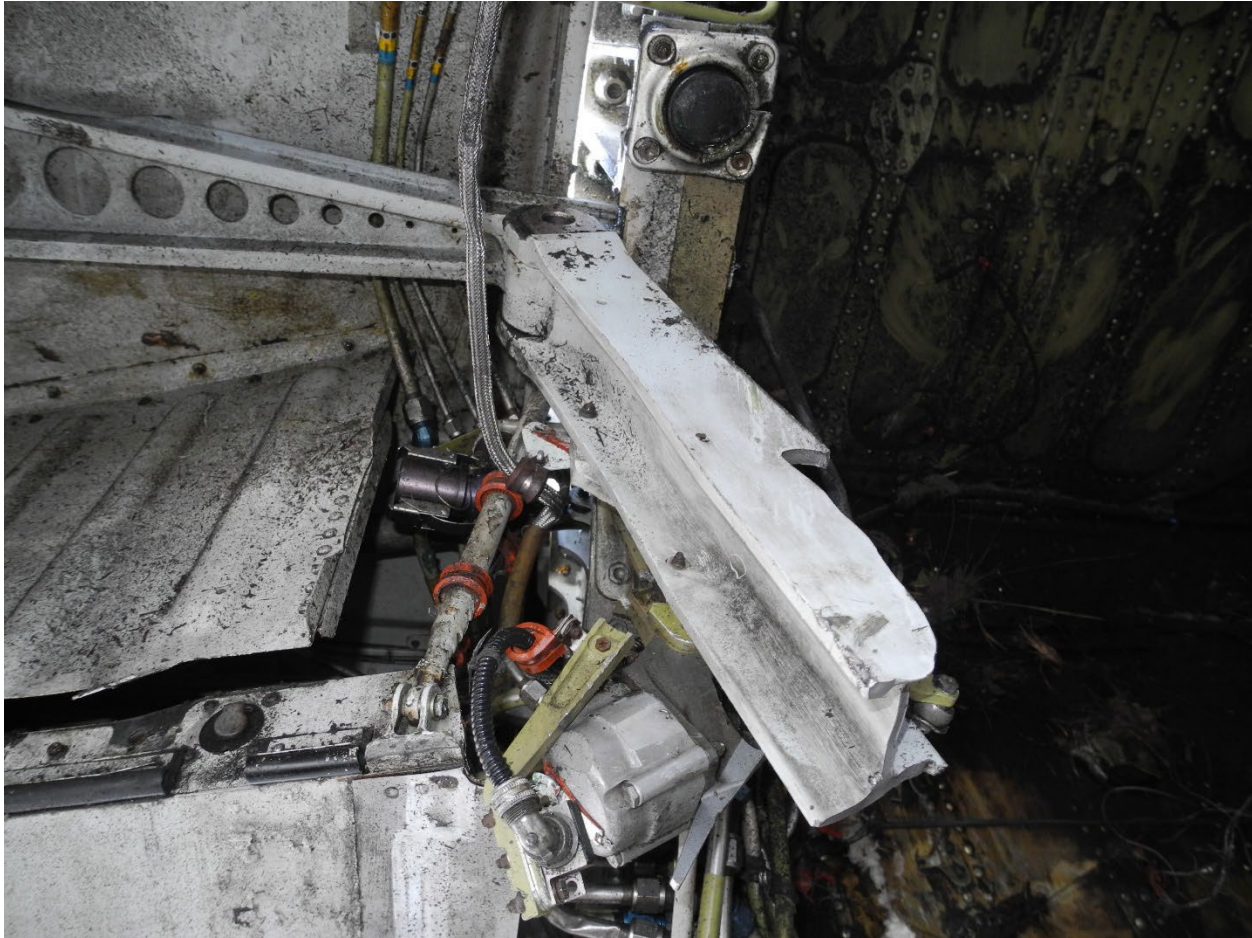
Figure 13 Upper portion of upper side brace

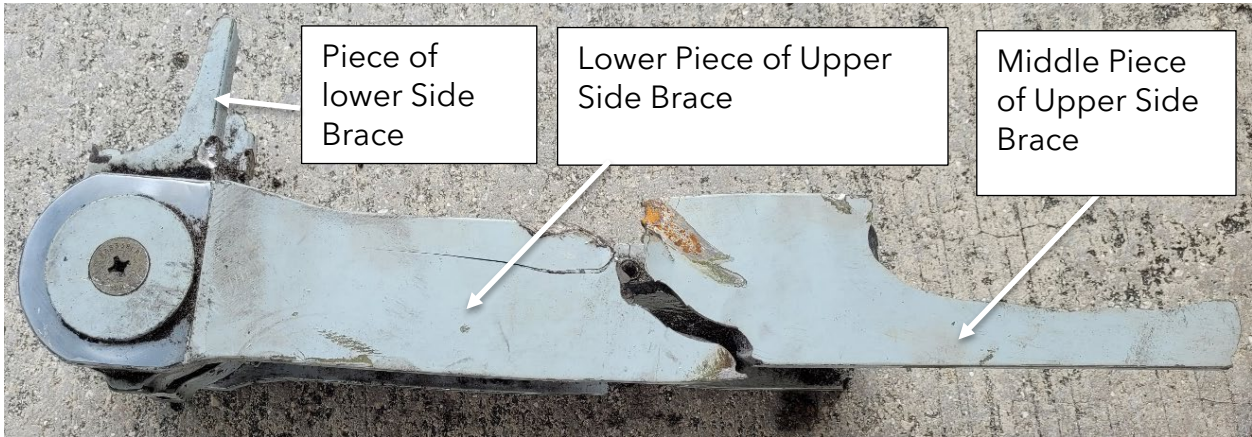
Figure 14 Left main gear upper and lower side brace pieces found after the glideslope installation

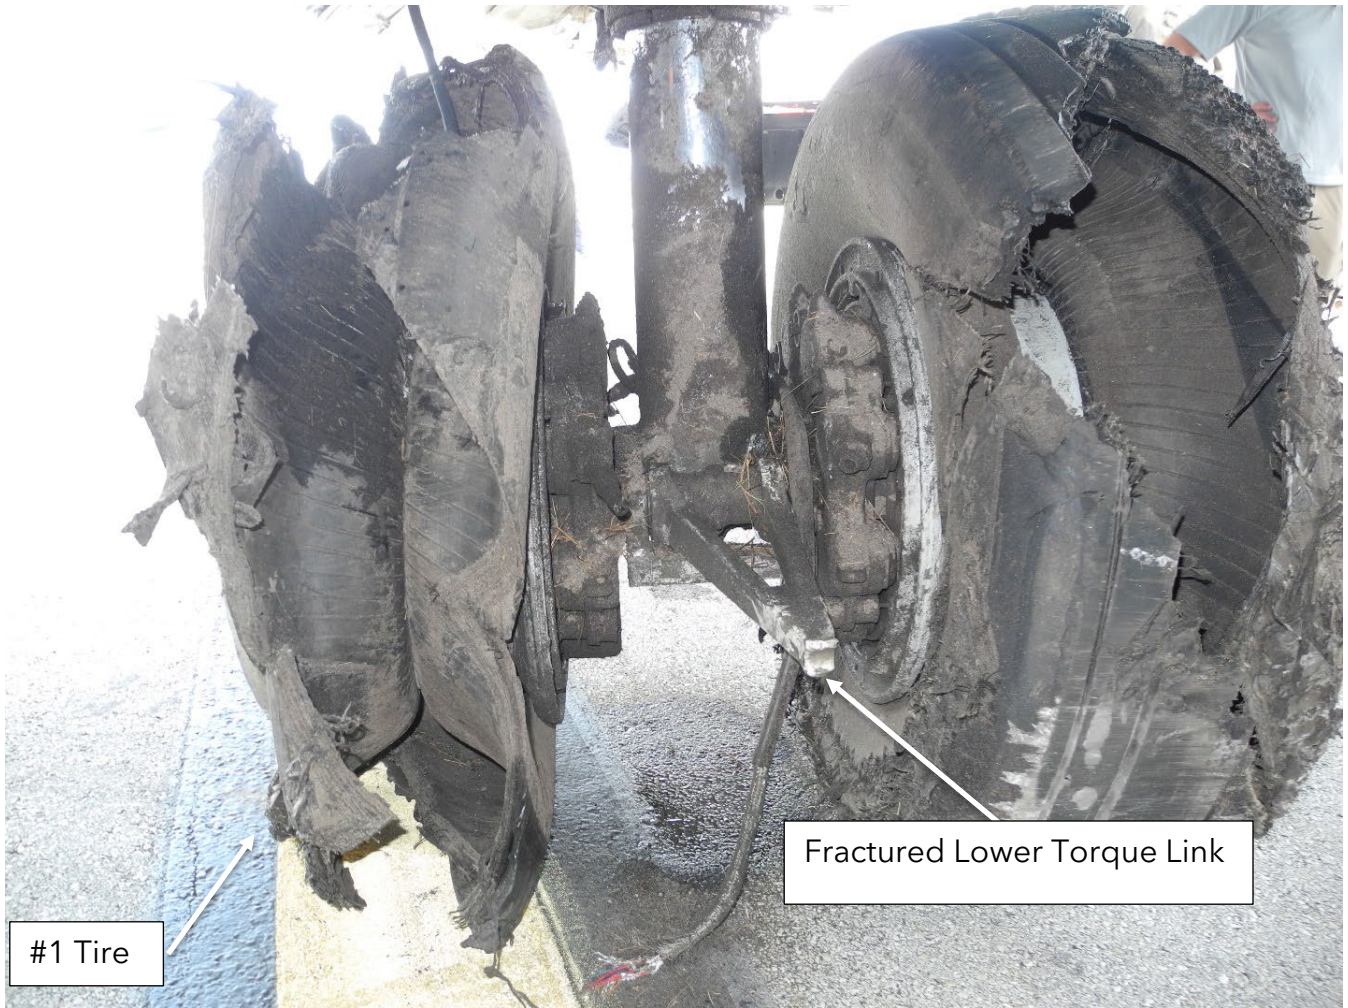
Figure 15 Left main gear looking outboard

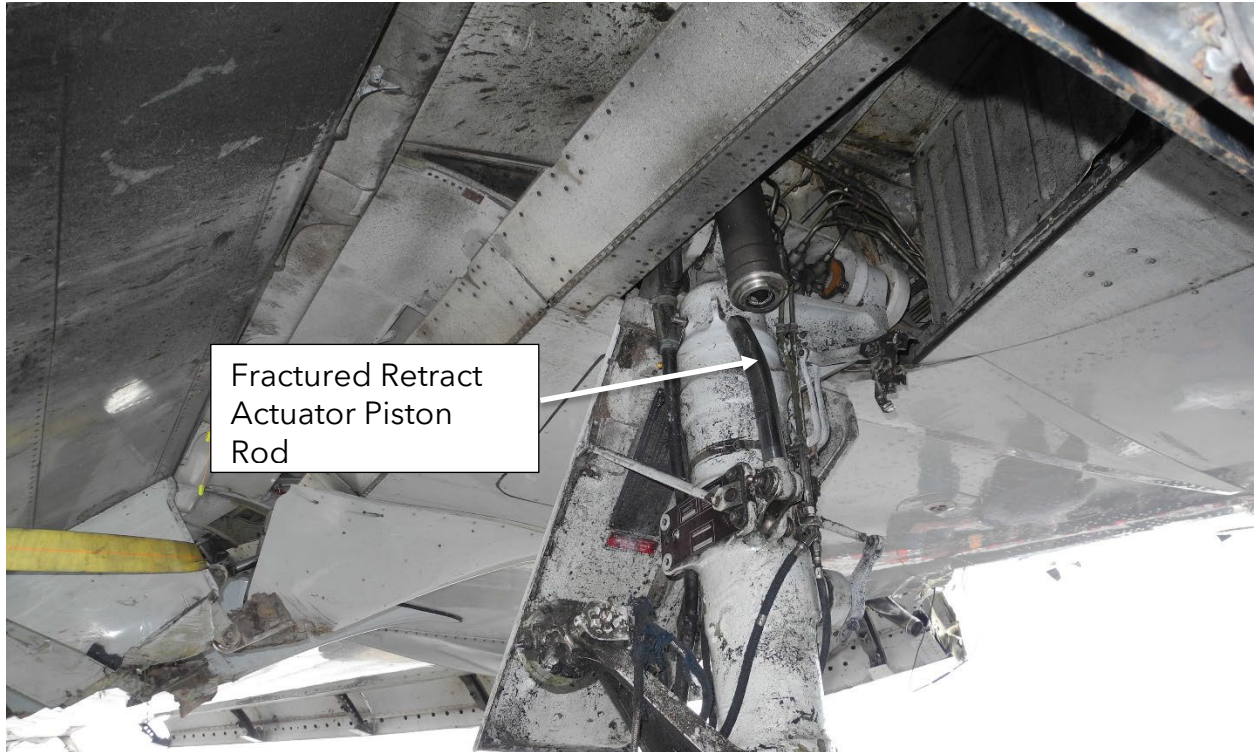
The main landing gear retract actuator piston was fractured and bent near the fully extended position, Figure 16. The down lock actuator and upper lock link springs exhibited no damage and appeared normal. The lower lock fractured just inboard of its attachment to the upper side brace and remained attached to the side brace.

Figure 16 Left main gear retract actuator

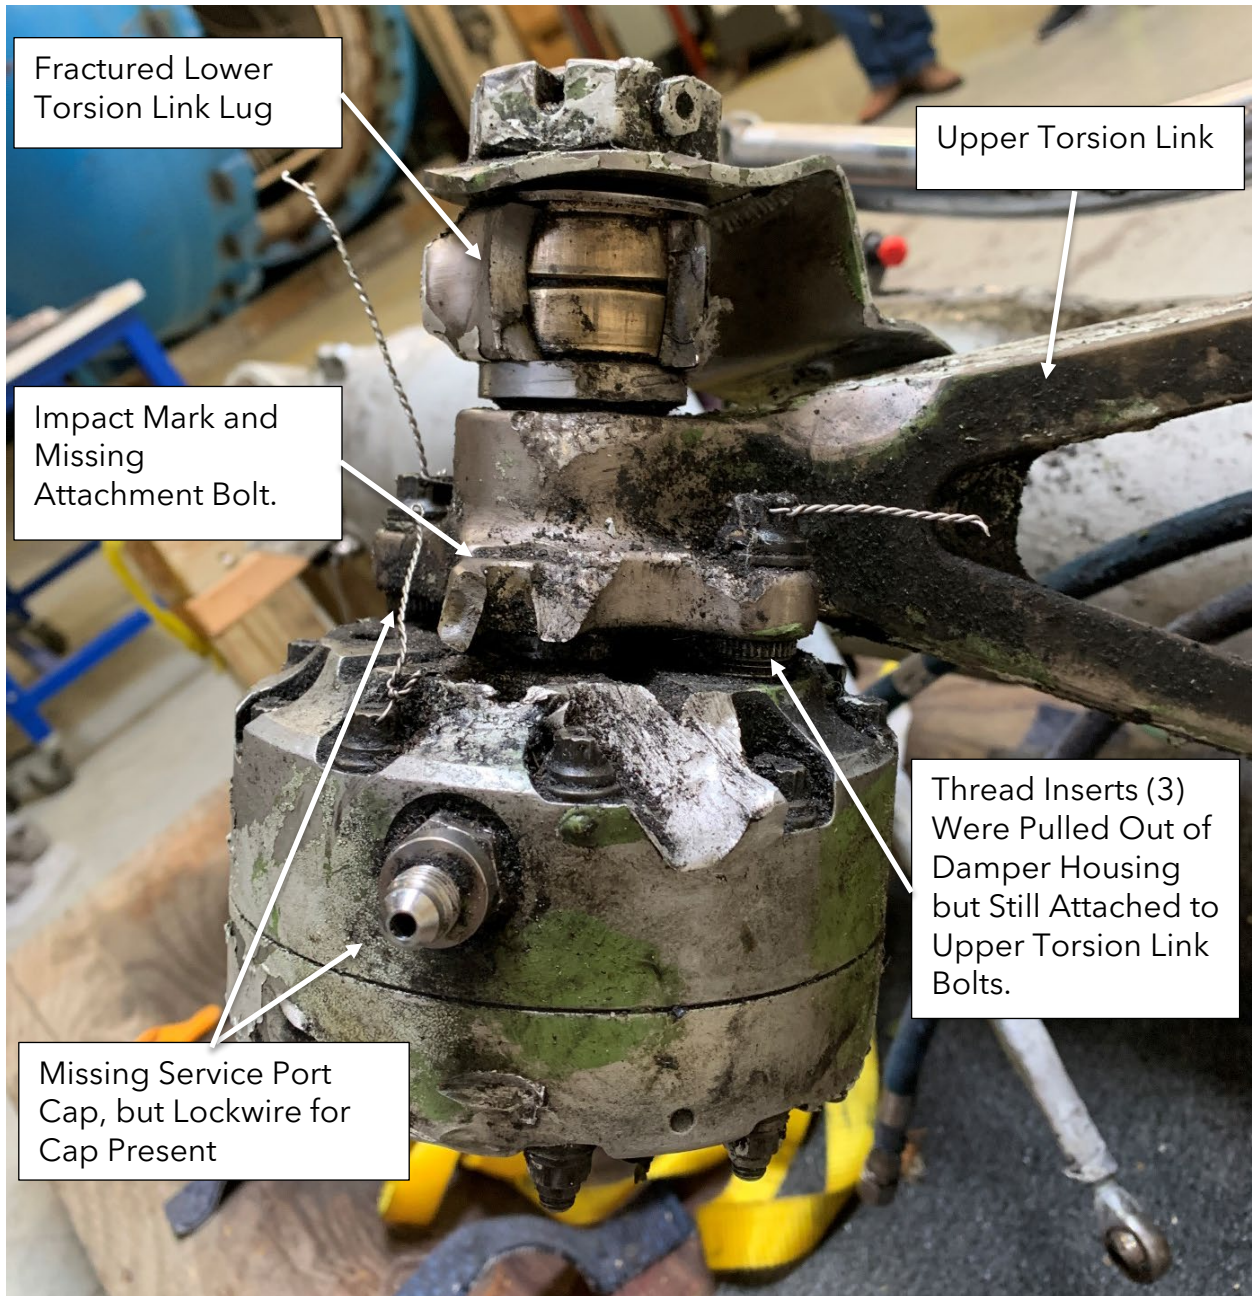
On June 24th, after the airplane was lifted and placed on a trailer, it was observed that the shimmy damper was missing its service port cap and hydraulic reservoir (Figures 18-19). During a search of the runway area on June 25th, the reservoir pieces, Figure 20, were found in the recently mowed grass about 200 ft north of runway 9 centerline and 6340 feet remaining on the runway. The reservoir was in many pieces and appeared to have damage consistent with impact from mower blades. The area where the reservoir is threaded into the damper housing had a large impact mark which deformed the area, and the threads were stripped.

Figure 18 Left gear shimmy damper

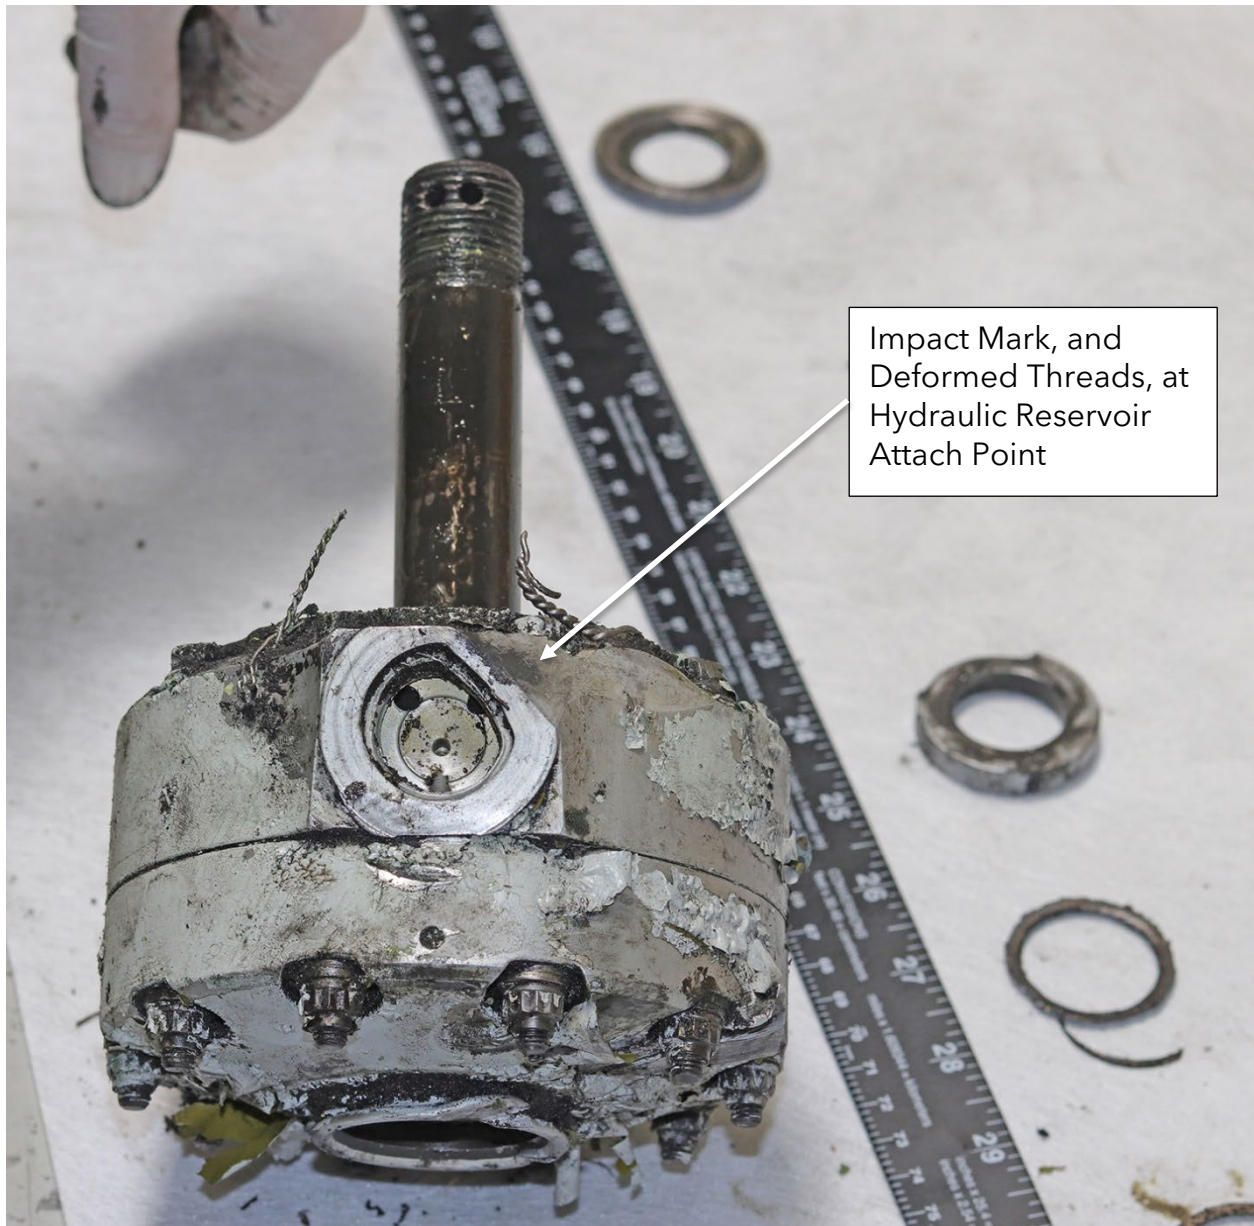
Figure 19 Shimmy damper reservoir attach point

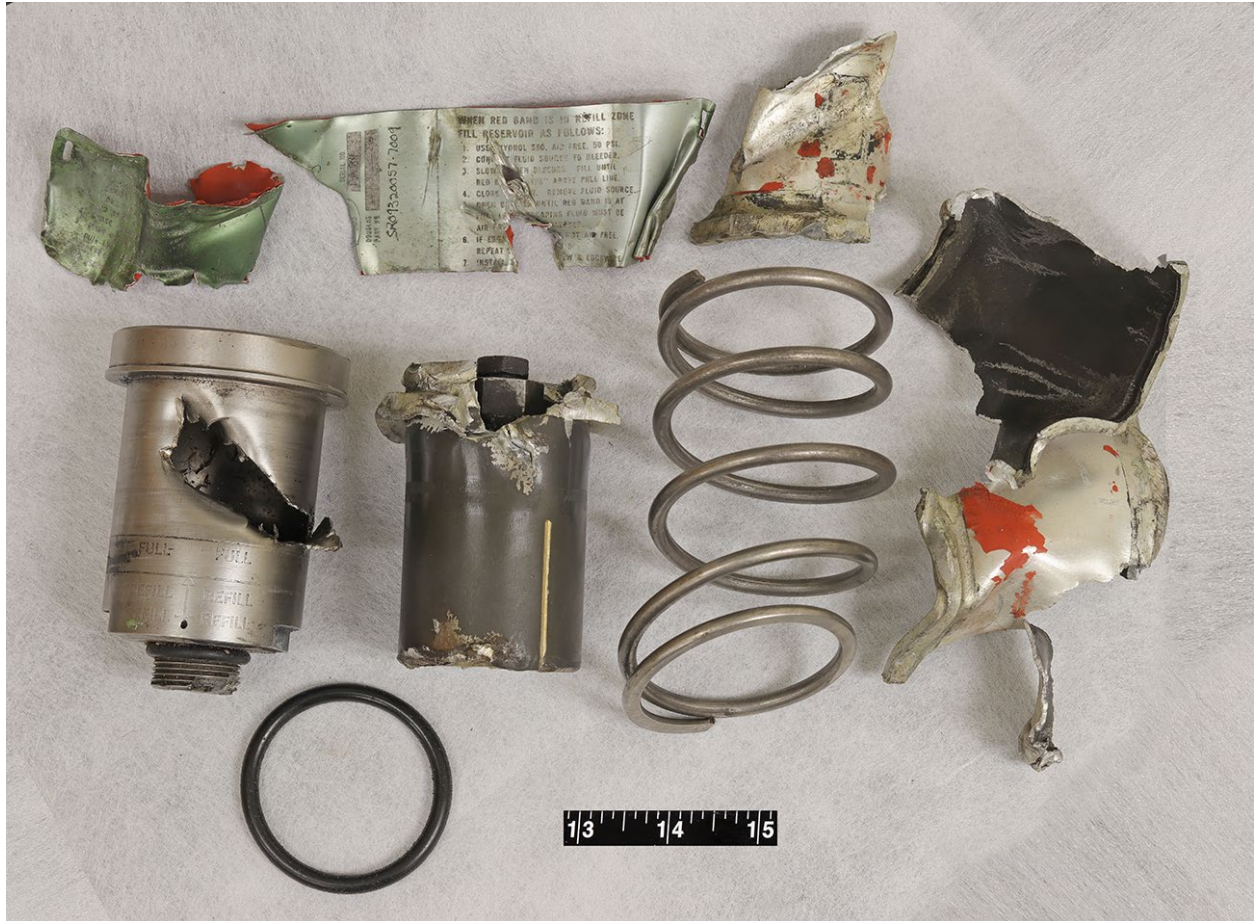
Figure 20 Shimmy damper hydraulic reservoir pieces
