National Transportation Safety Board

DCA22FA132

SYSTEMS AND STRUCTURES - FACTUAL REPORT

Location: Miami, FL
Date: June 21, 2022
Time: 1738 EDT
Airplane: McDonnell Douglas MD-82

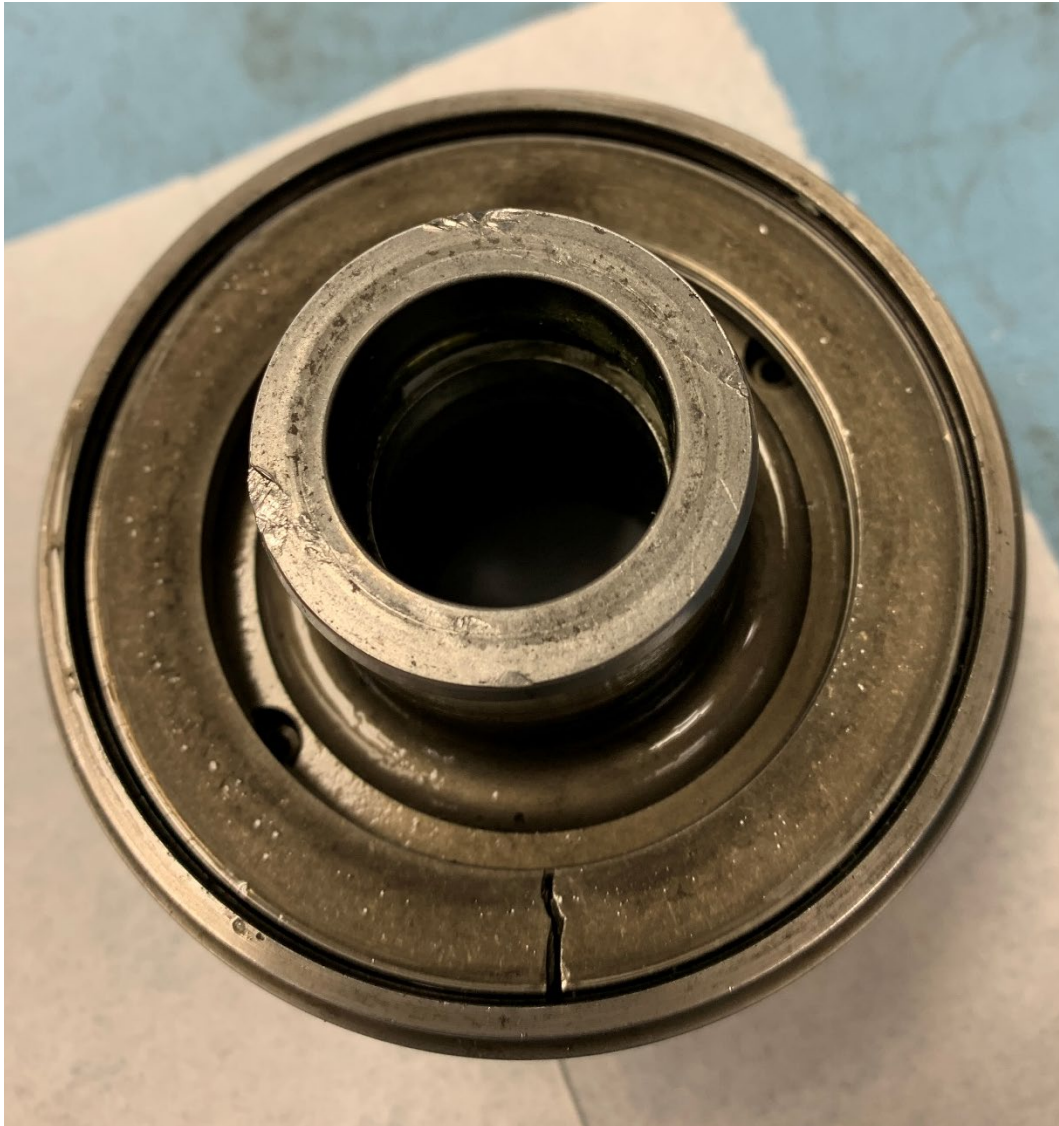
The cap was removed, revealing the internal components. The components on the cap side of the piston were removed and all parts were installed correctly with no apparent damage. The apex bolt had to be cut and pressed out to access the internal components on the housing side of the piston. When these were removed, all parts were found to be installed correctly with no apparent damage. The only discrepancy found was that one of the five Belleville washers was found to be fractured (the one second from the piston face), Figure 21. The fracture in the washer was examined and determined to be ductile separation.

Figure 21 Shimmy damper piston and fractured Belleville washer

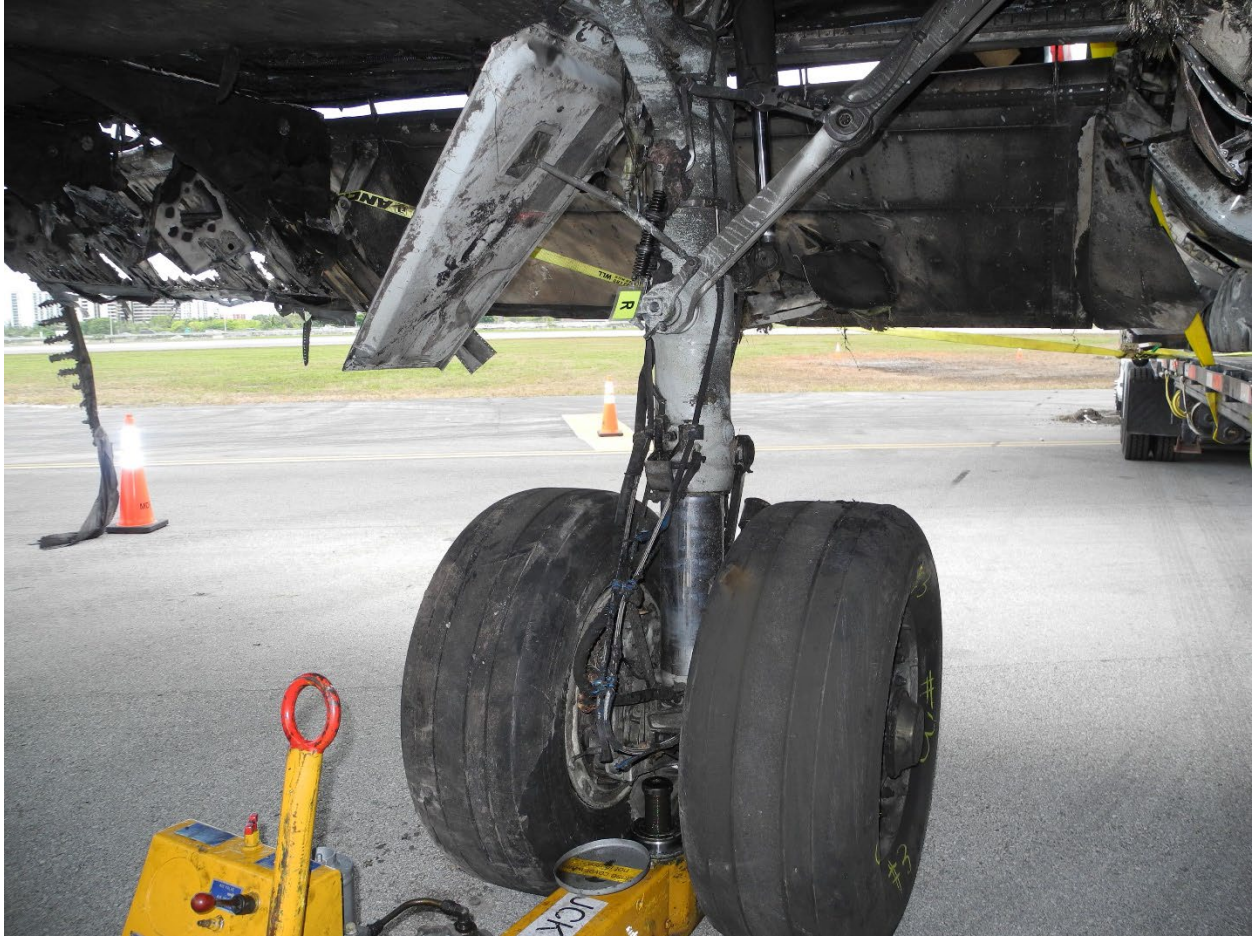
The right gear collapsed and was up in the wheel well when the airplane came to rest. After the airplane was lifted, the gear dropped down to almost the down and locked position, but not quite, Figure 22. All components were intact and undamaged except for the bungee cylinder upper hydraulic tube was fractured, and the lock links position was slightly short of center. The gear part number was 5935355-501, serial number CPT1232.

Figure 22 Right main landing gear

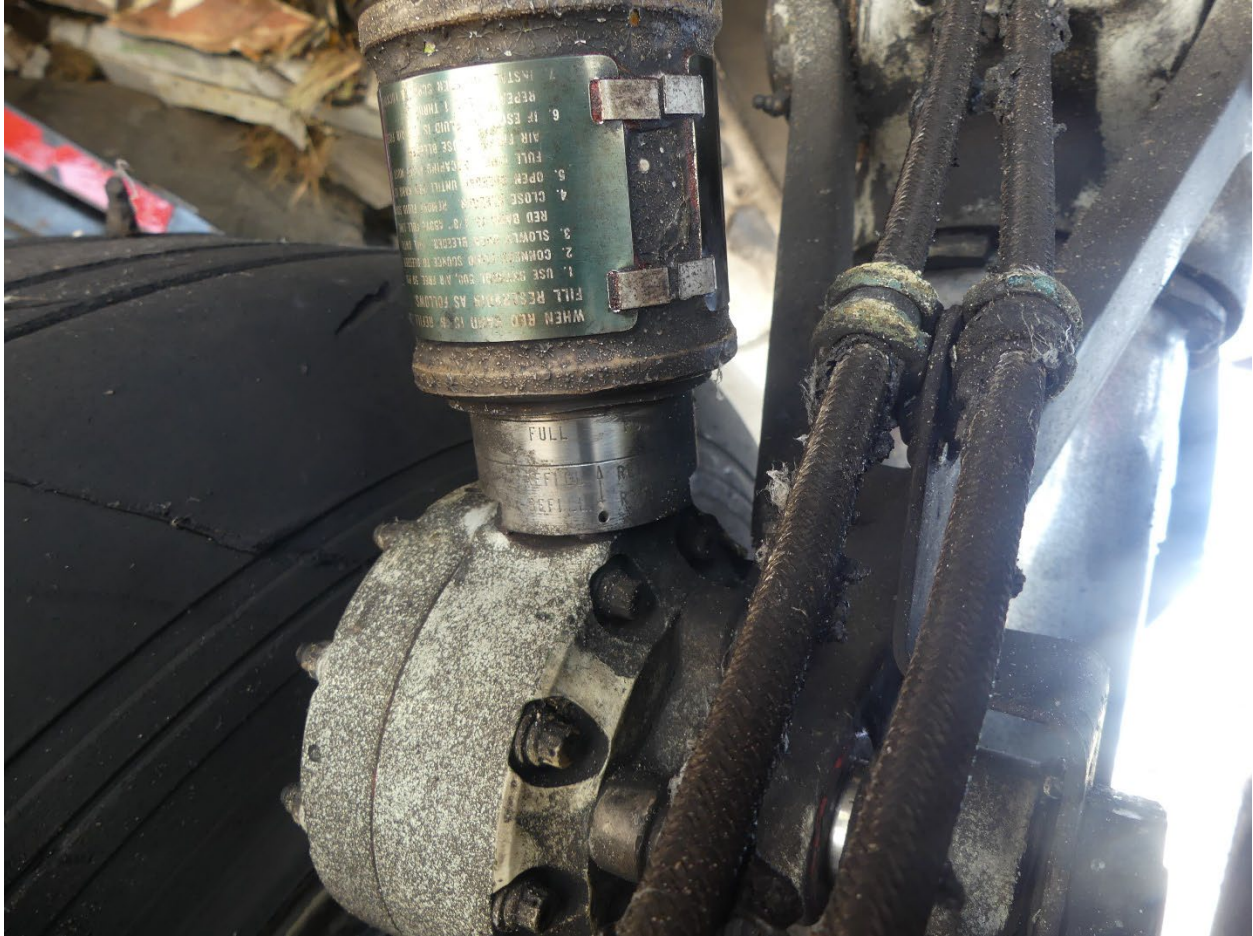
The shimmy damper was intact and properly serviced with servicing port cap installed and properly lock wired, Figures 23-24.

Figure 23 Right gear shimmy damper with hydraulic reservoir intact

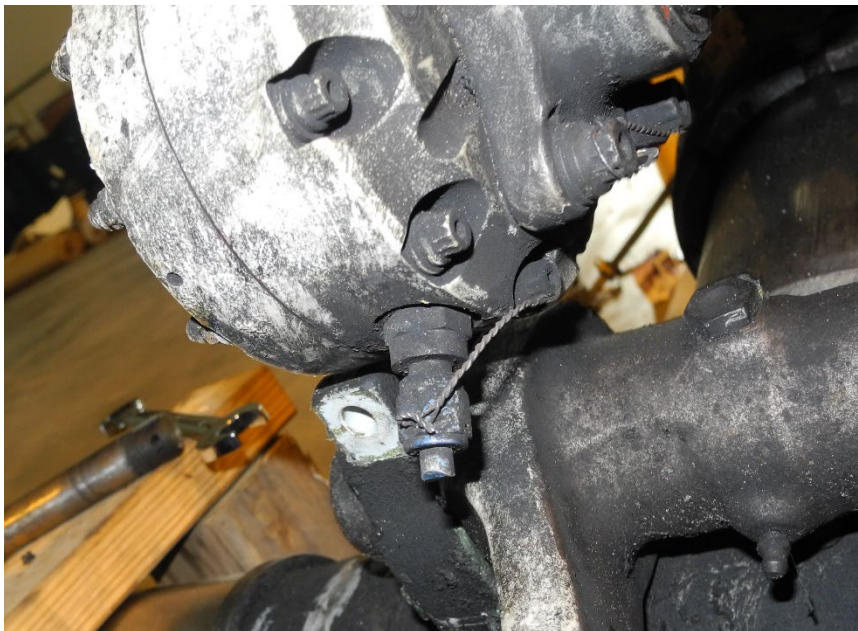
Figure 24 Right gear shimmy damper service port

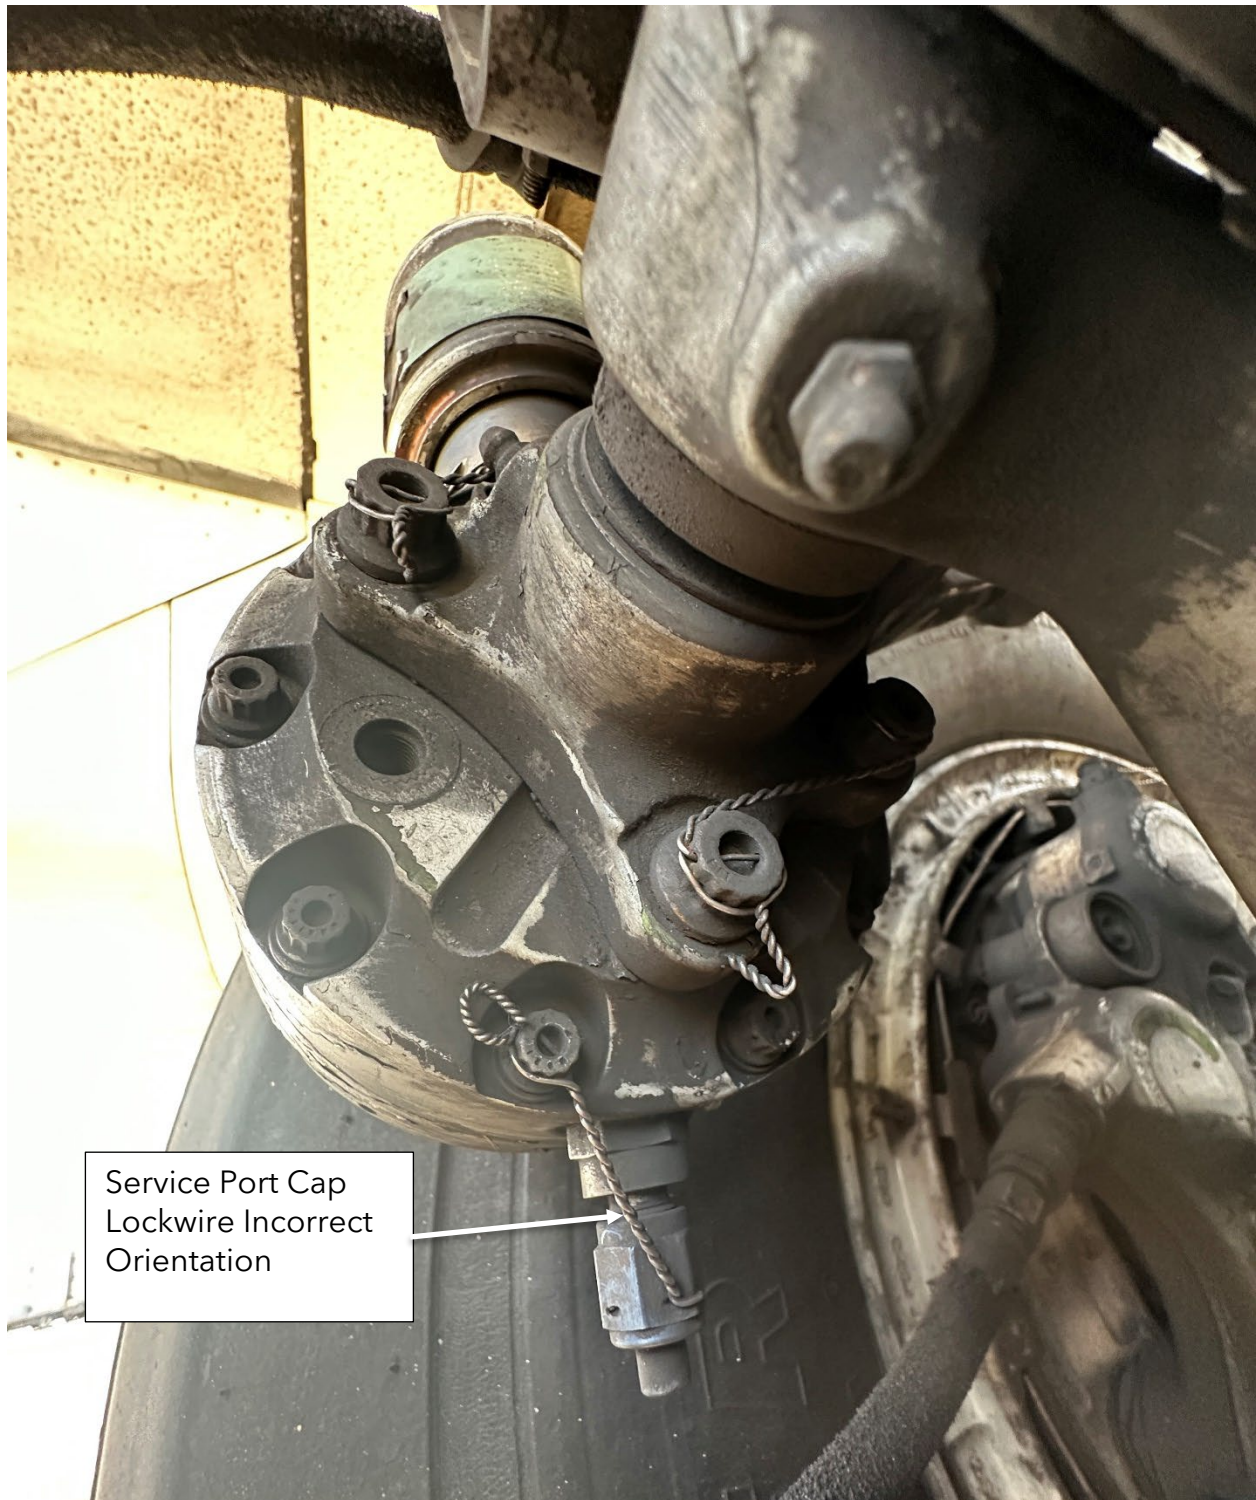
In November 2022, the NTSB observed the condition of Red Air airplanes shimmy dampers at Miami International Airport. Airplane HI1066 had both left and right shimmy dampers properly serviced, with service port caps installed, but both service port cap lockwires were installed incorrectly (wrong orientation), Figure 25. Airplane HI1069 both left and right shimmy dampers properly serviced, with service port caps installed, and lockwire installed correctly.

Service Port Cap
Lockwire Incorrect
Orientation

Figure 25 Red Air airplane HI1066 right main gear shimmy damper

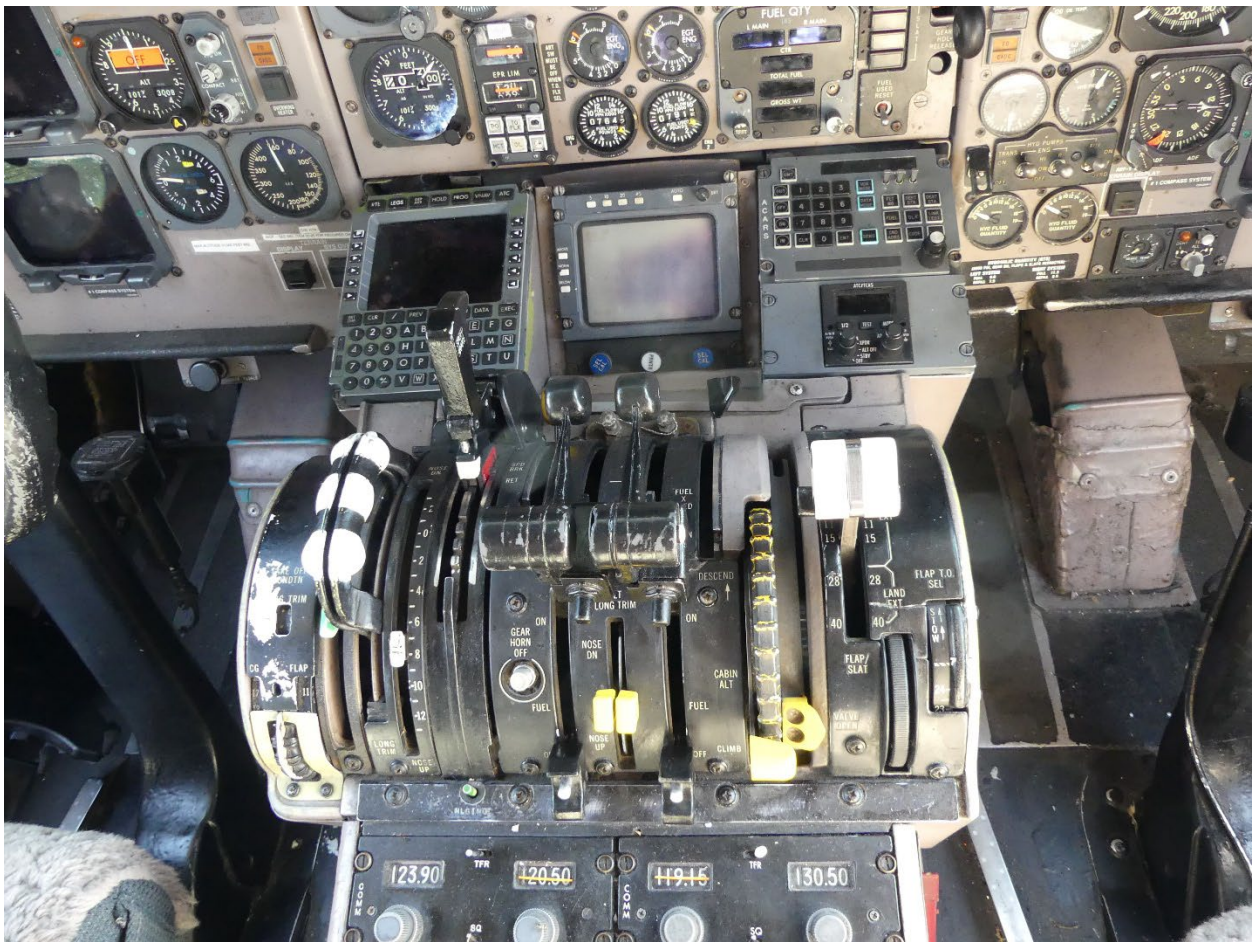
- Stabilizer Trim - 8 units
- Spoiler Handle - Stowed
- Throttles - Aft stop
- Flaps Handle - Approximately 15 units

Fuel Shutoff - Both off
Auto Brake - Off and Disarm
Rudder Trim - 1 unit nose right
Aileron Trim - 1 unit left wing down

Figure 26 Control stand

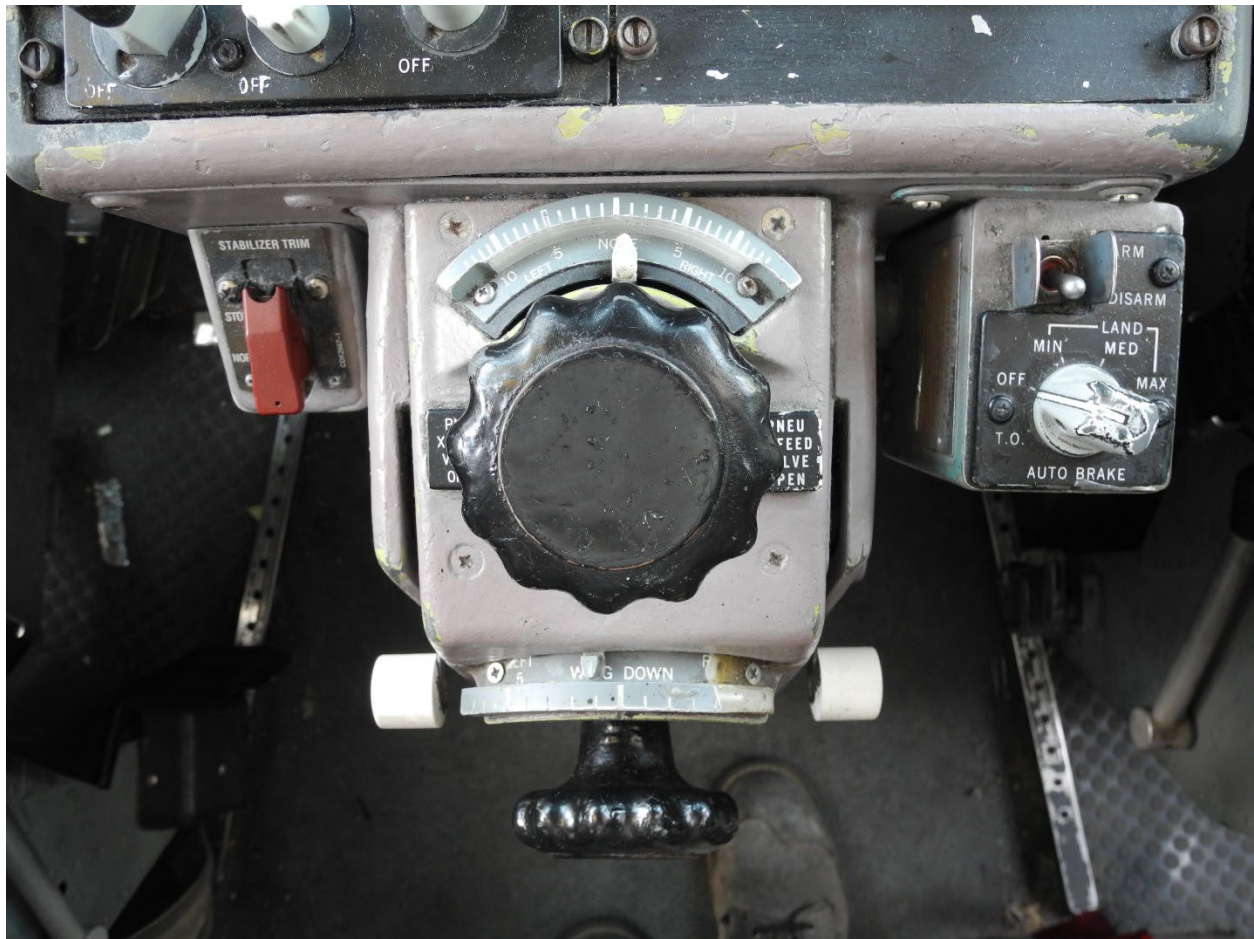
Figure 27 Aft control stand
