NATIONAL TRANSPORTATION SAFETY BOARD

OPERATIONAL FACTORS

DCA22LA069

On January 22, 2022, JetBlue 1748, an Airbus A320-232, registration N760JB, incurred a tail strike on takeoff from runway 10 at Yampa Valley Airport (HDN) in Hayden, Colorado. A Beechcraft B300 King Air, registration N350J, reported on the Common Traffic Advisory Frequency (CTAF)¹ that they were conducting a visual approach to runway 28 at HDN prior to JetBlue 1748 departing runway 10.² After departure, JetBlue 1748 diverted to Denver International Airport (DEN) in Denver, Colorado. Post-accident inspections determined that airplane suffered substantial damage from the tail strike.³ JetBlue 1748 was a scheduled flight from HDN to Fort

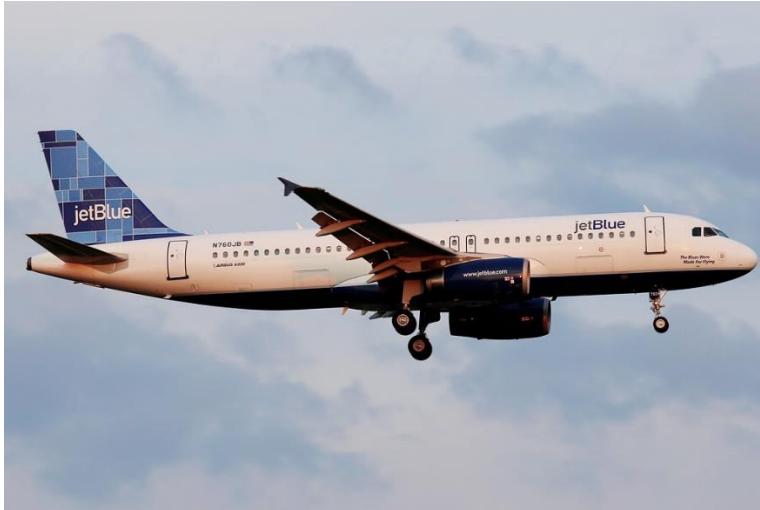
Photo 1: Photo of accident airplane N760JB.¹⁵

The accident airplane was an Airbus A-320-232, registration N760JB (serial number 3659) and was manufactured in 2008. Its airworthiness certification was issued October 27, 2008. It was powered by two IAE V2527-A5 engines. According to FAA records, it was registered to JetBlue Airways Corp. on Long Island City, New York.

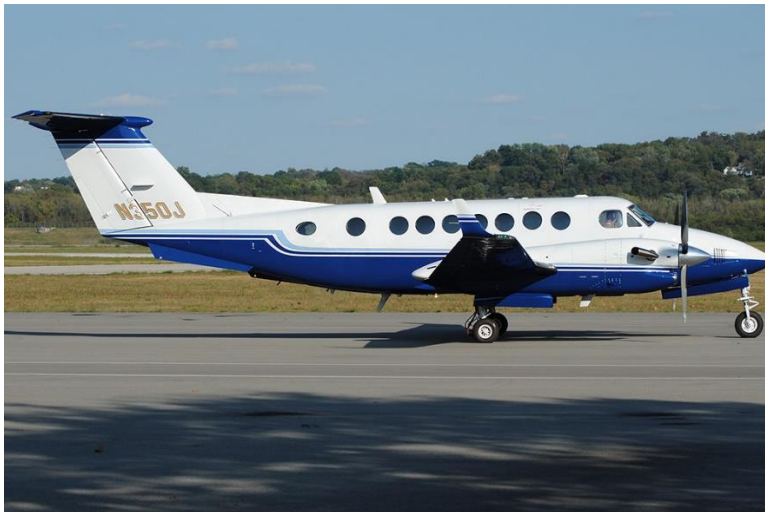
Photo 2: Photo of N350J.¹⁶

The airplane on a visual approach to runway 28 at HDN when JetBlue 1748 suffered its tail strike on departure was a Beechcraft B300 King Air, registration N350J (serial number FL80) and was
