NATIONAL TRANSPORTATION SAFETY BOARD

Airworthiness Group Factual Report - Addendum 1
Elevator Dampers Examination

DCA22MA009

Location: Brookshire, Texas
Date: October 19, 2021
Time: 1000 central daylight time (CDT)
Aircraft: McDonnell Douglas DC-9-87, Registration N987AK

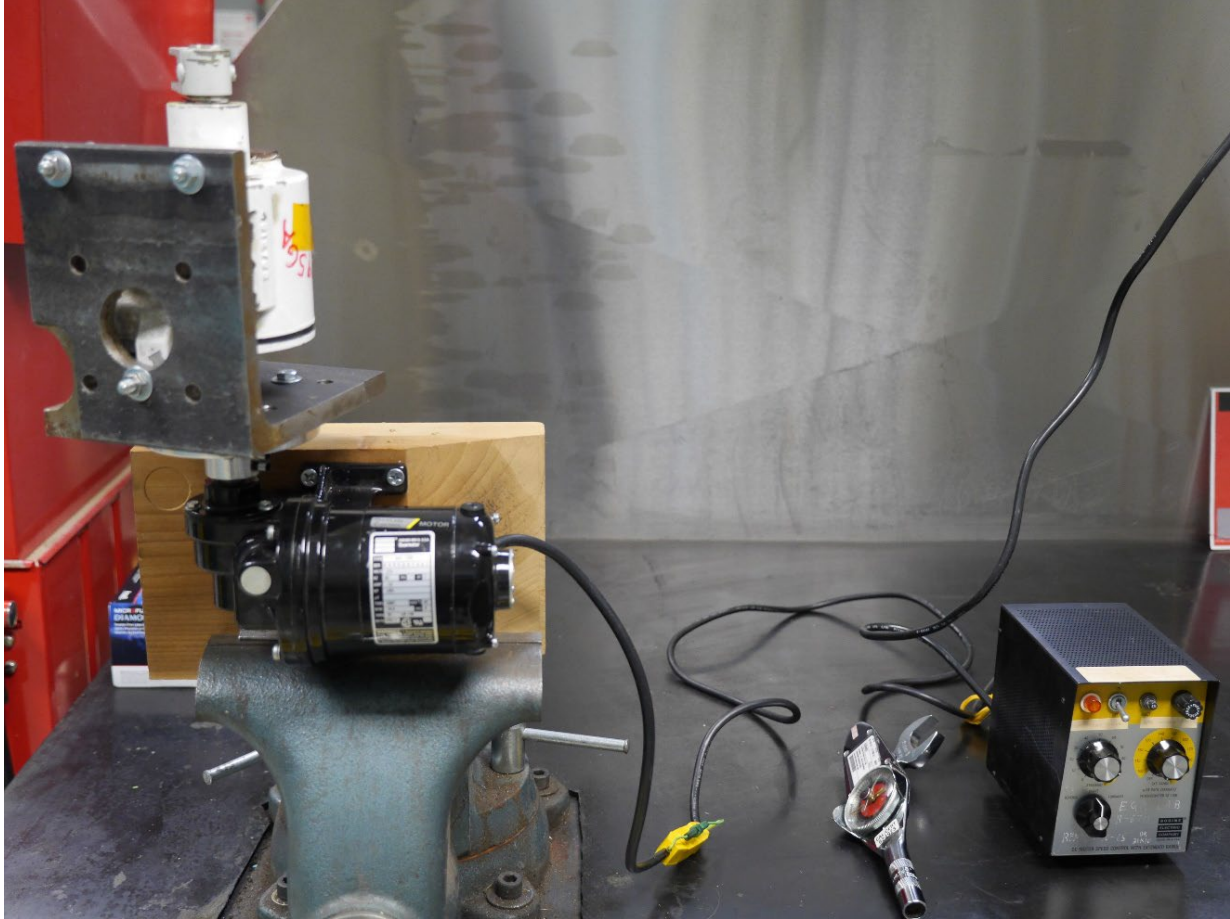
Figure 1. The Elevator Damper Test Rig, with exemplar damper attached.

The torque measured 53 inch-pounds (in-lb) in both directions, within the acceptable limits of the test procedure. The group considered the test successful, and the test rig verified.

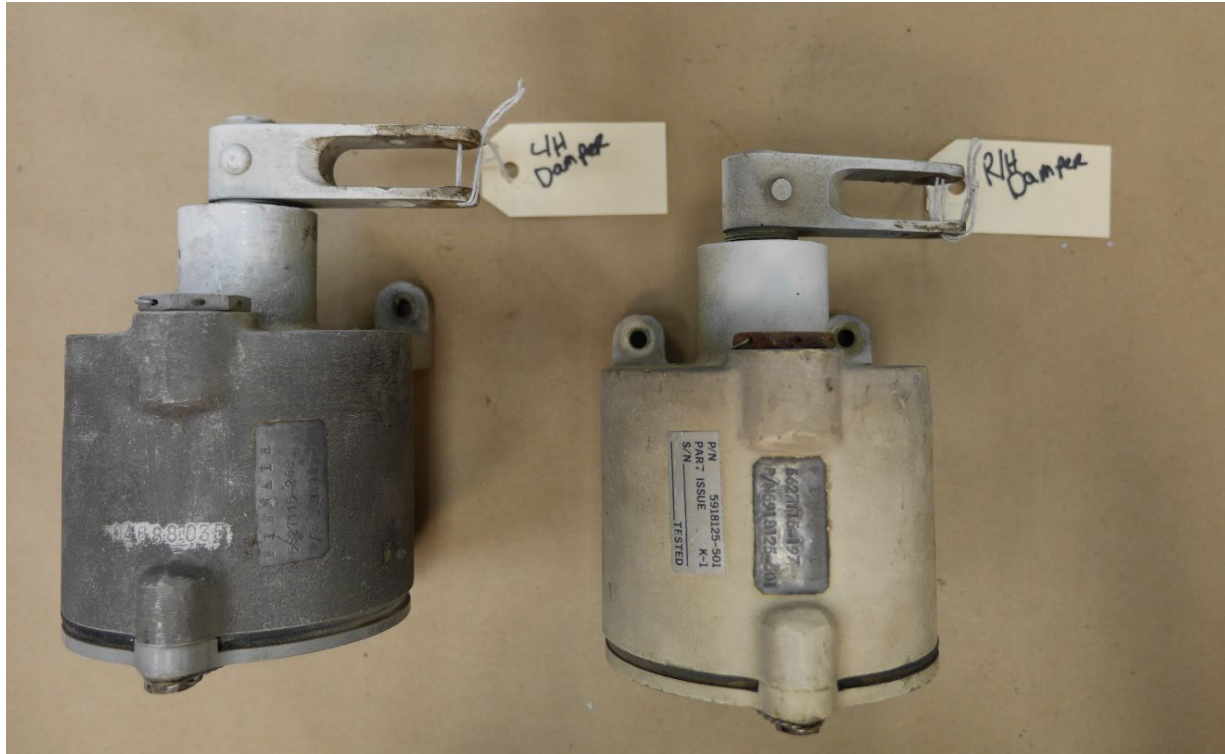
Figure 2. The Accident Elevator Dampers at EQA Lab, with linkage arms removed.

Both units were visually examined. No visible defects or fluid leakage were noted on either unit. All safety wire and cotter pins were intact.

The elevator damper part and serial numbers were noted. The left-hand Elevator Damper was missing an identification plate; therefore, the serial number was unknown.

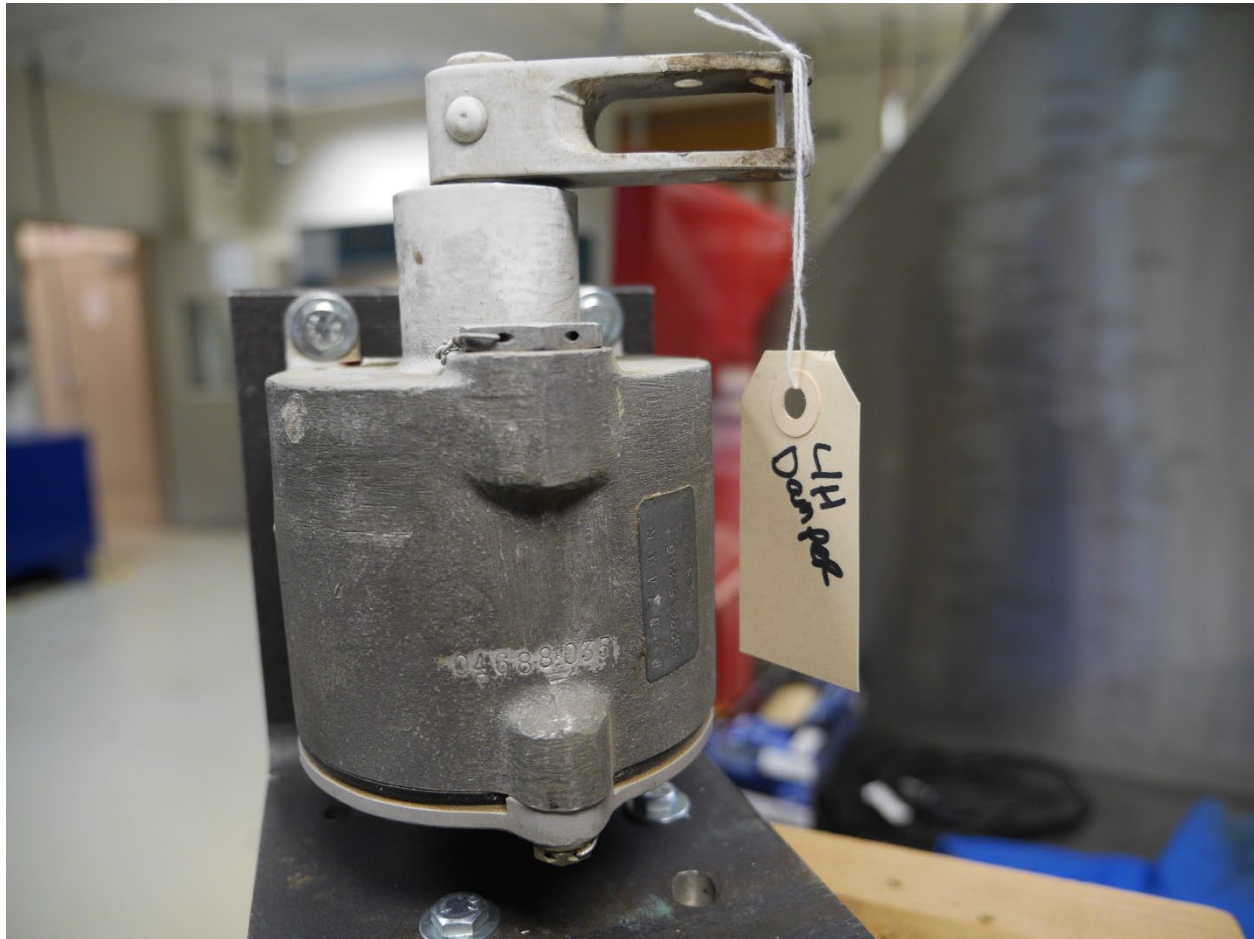
Figure 3. The Left-Hand Elevator Damper, attached to the test rig.

Unit	Torque (in-lb)	
	Direction	
	CW	CCW
Right-Hand Elevator Damper	55 (initial), 48 (running)	48 (initial), 46 (running)
Left-Hand Elevator Damper	51 (initial), 46 (running)	68 (initial), 46-68 (running range)

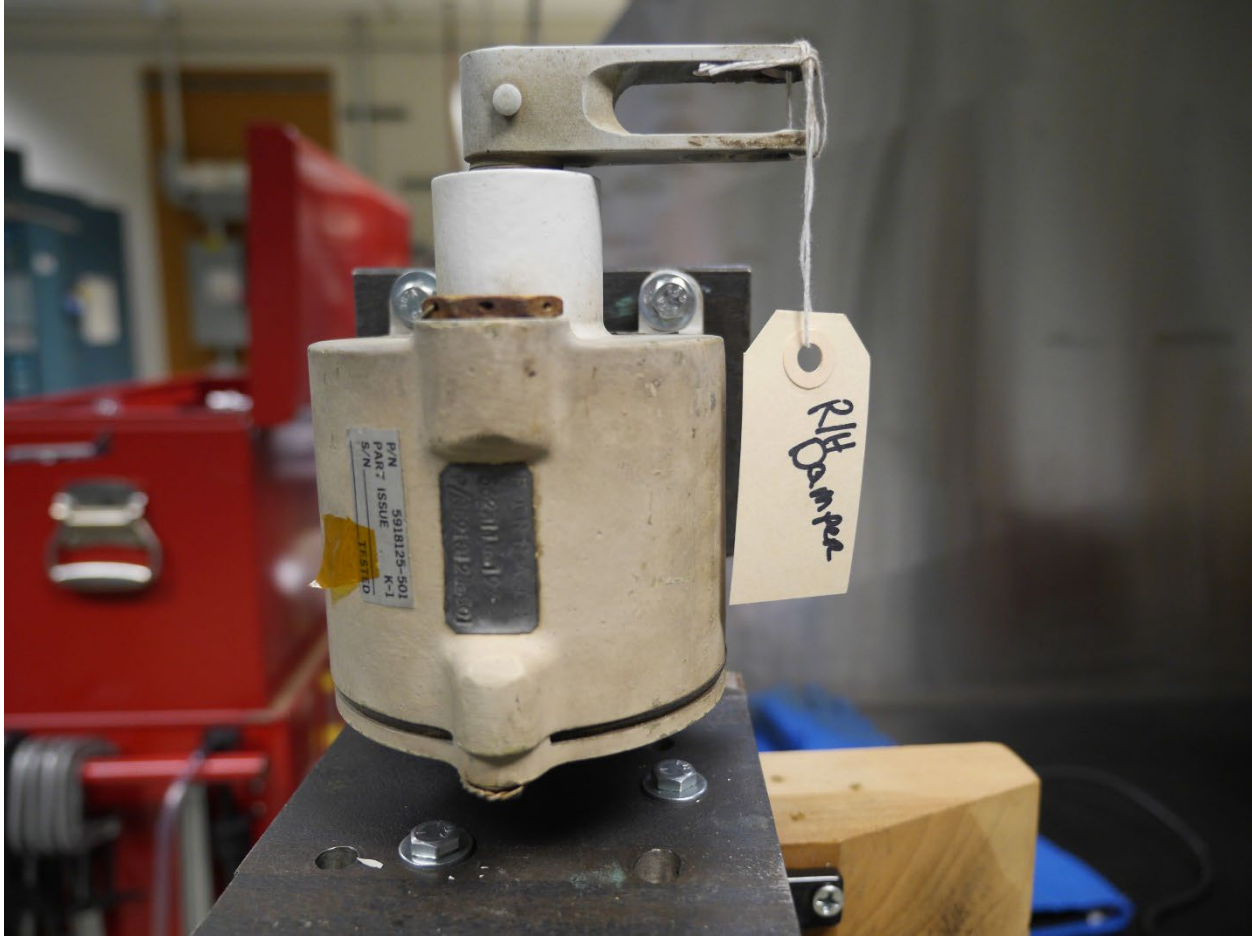
Figure 4. The Right-Hand Elevator Damper, attached to the test rig.

During testing, the right-hand elevator damper output shaft rotation was smooth.

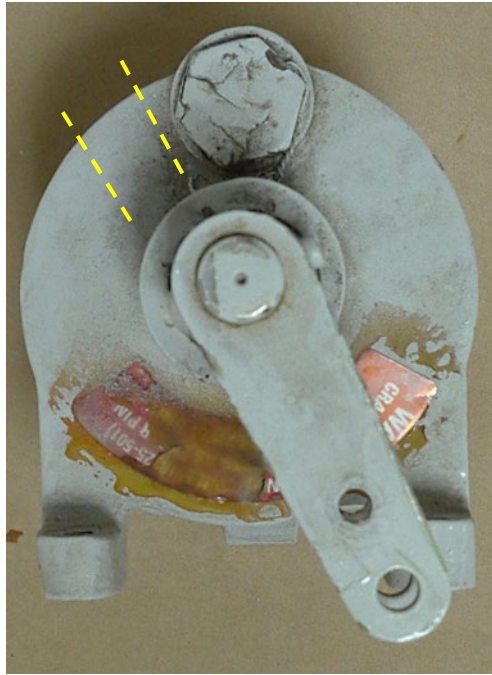
During testing, the left-hand elevator damper output shaft had more friction felt at approximately the 11:00 to 12:00 o'clock position; see Figure 5.

Figure 5. The area of increased friction on the Left Elevator Damper, indicated by yellow dashed lines. Damper shown is an exemplar, not an accident unit.
