National Transportation Safety Board

DCA22MA009

AIRWORTHINESS GROUP

Location: Brookshire, Texas
Date: October 19, 2021
Time: 1000 central daylight time (CDT)
Aircraft: McDonnell Douglas DC-9-87, Registration N987AK

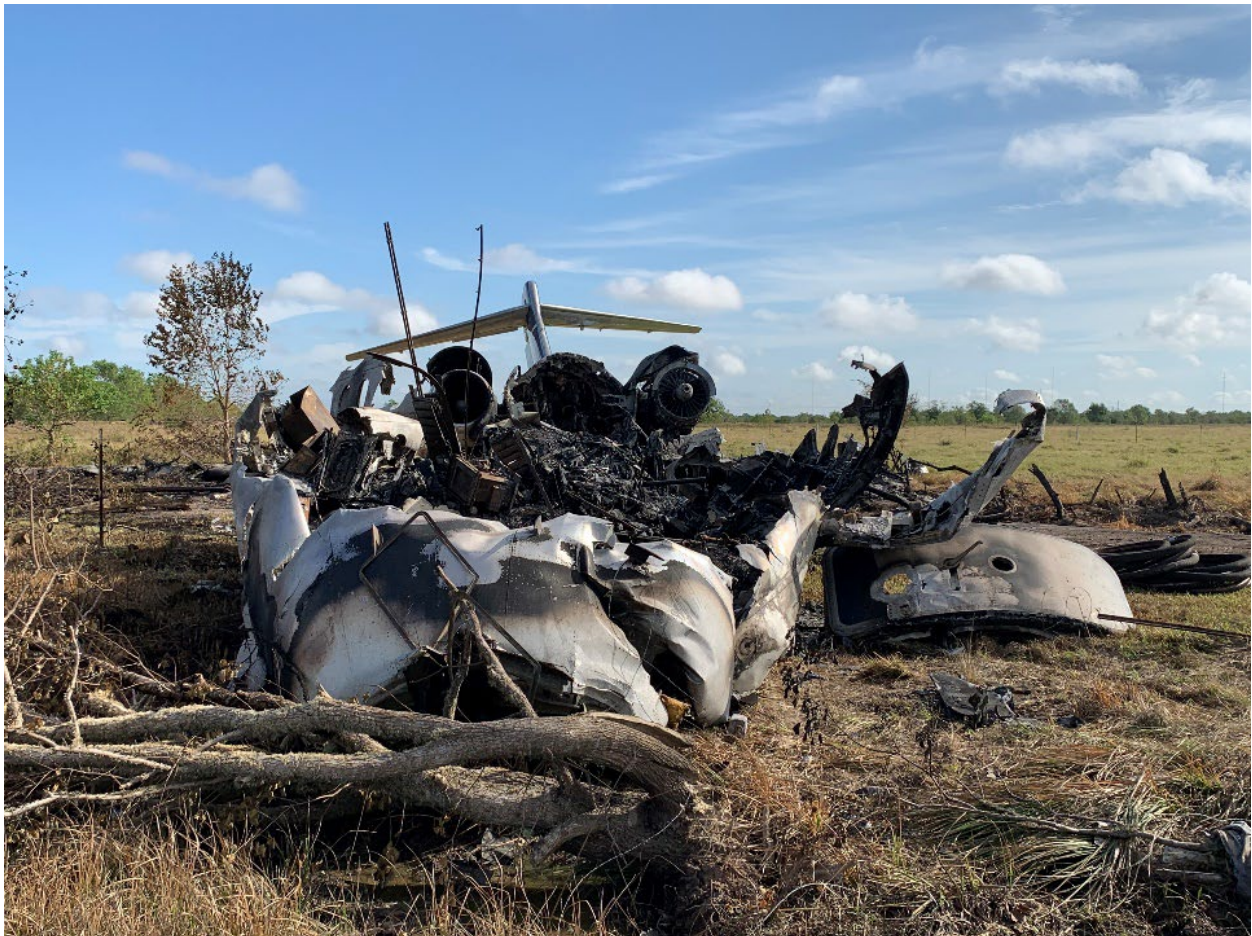
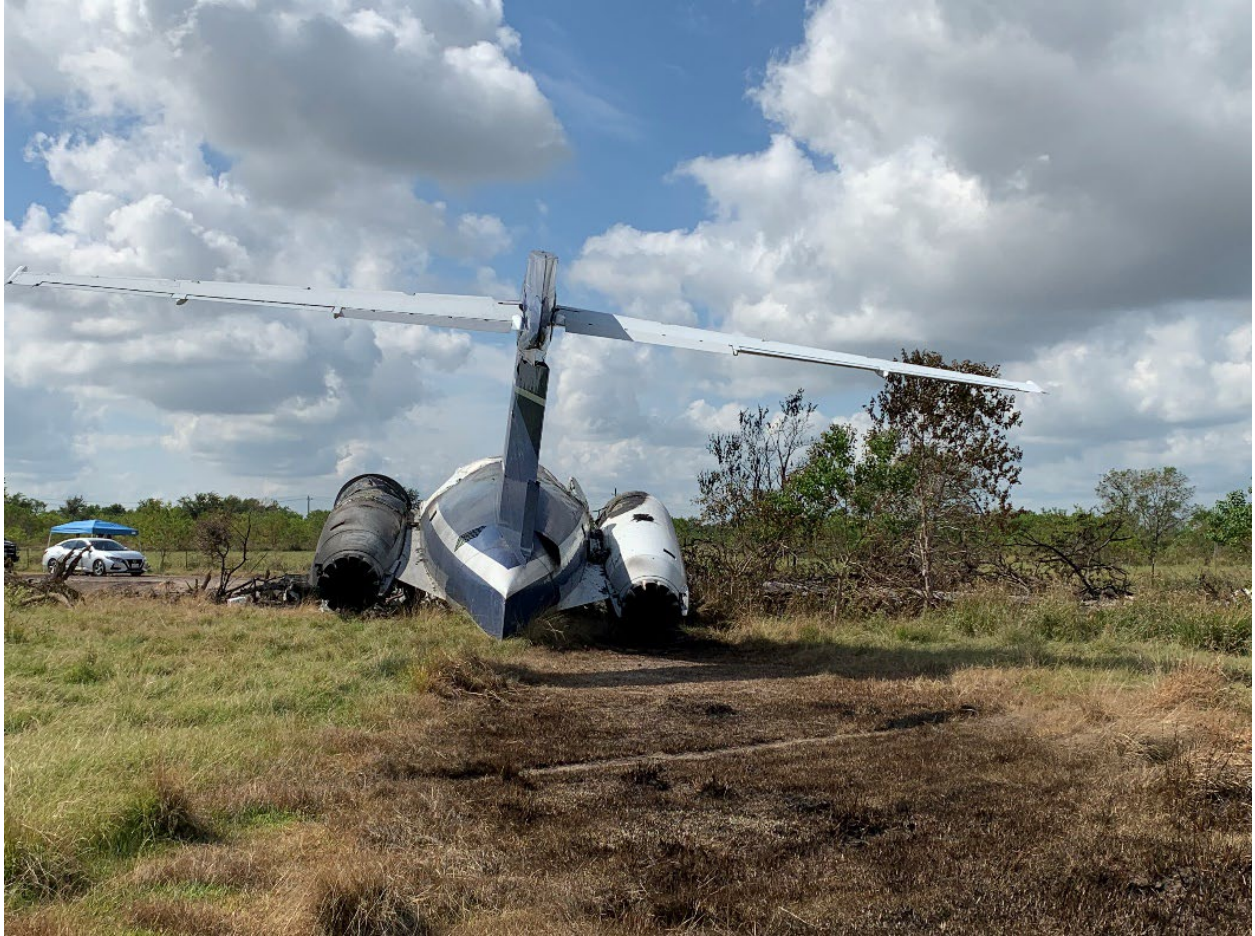
Much of the airplane's structure was consumed by a post-crash fire. The empennage of the airplane was partially intact; the upper vertical stabilizer and horizontal stabilizer were not damaged by fire. See Figures 1 and 2.

Figure 1. View of airplane fuselage wreckage, from the airplane nose and looking aft.

Figure 2. View of the airplane fuselage wreckage, from behind the airplane, looking forward.

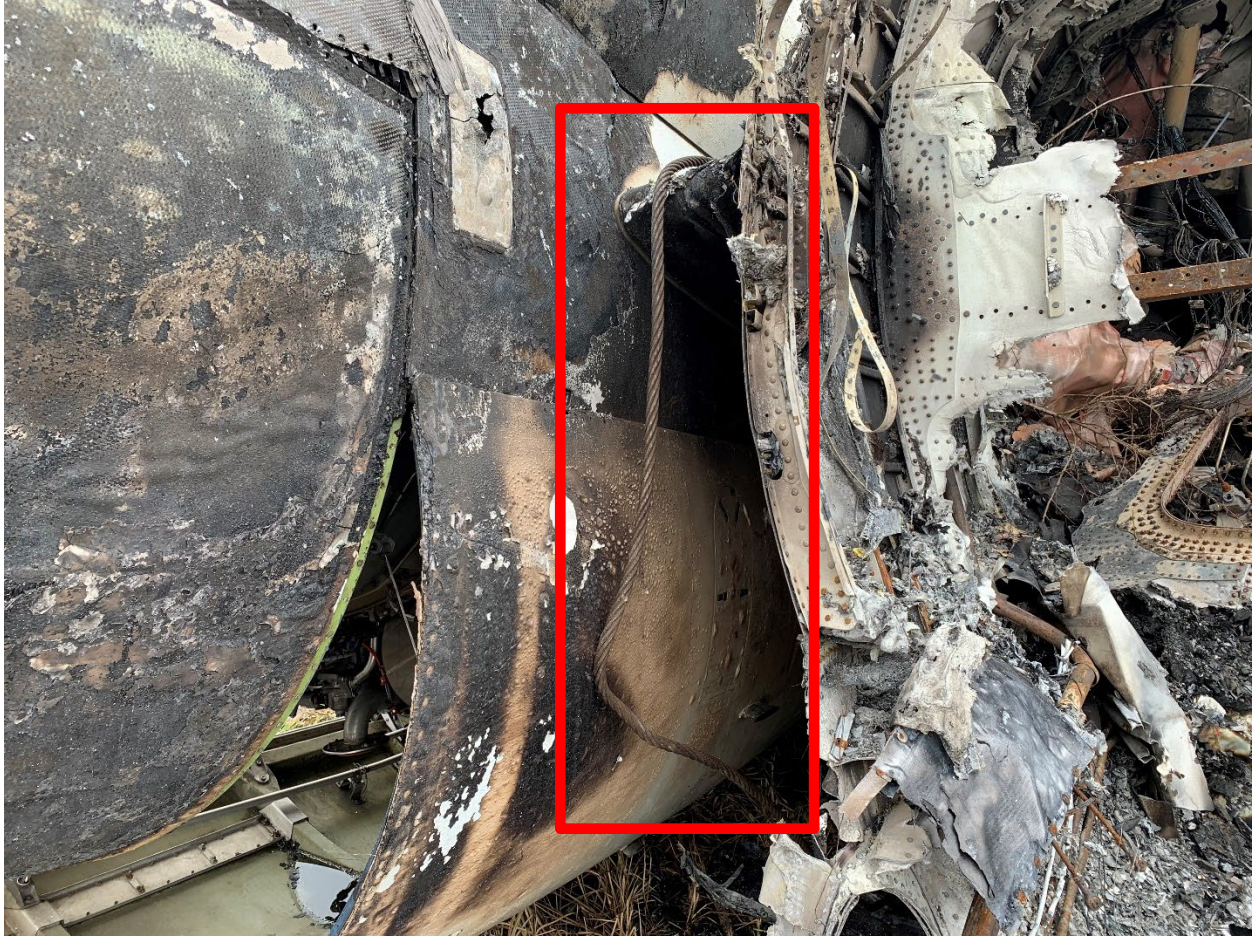
After the airplane left airport property, it crossed Morton Road and struck electrical distribution lines that paralleled the road. Pieces of the electrical lines were found on the airplane. See Figure 3.

Figure 3. Piece of electrical distribution line, highlighted in red box, found on Number 1 Engine pylon.

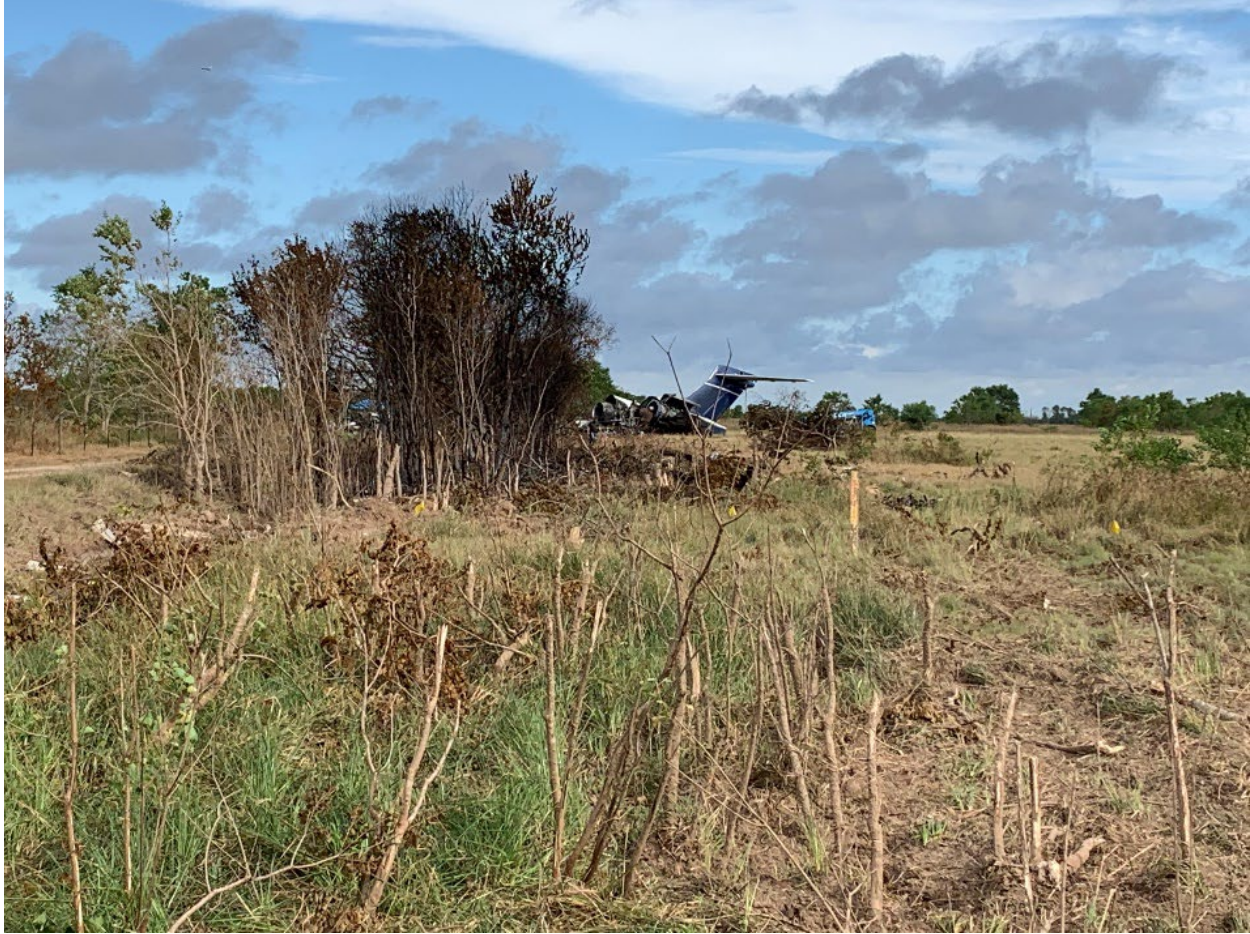
The airplane was damaged by impact with trees as it moved across the field. See Figure 4.

Figure 4. View of the airplane's path through field. Airplane wreckage is in background. Some of the trees on the left side of photograph are scorched or burnt.

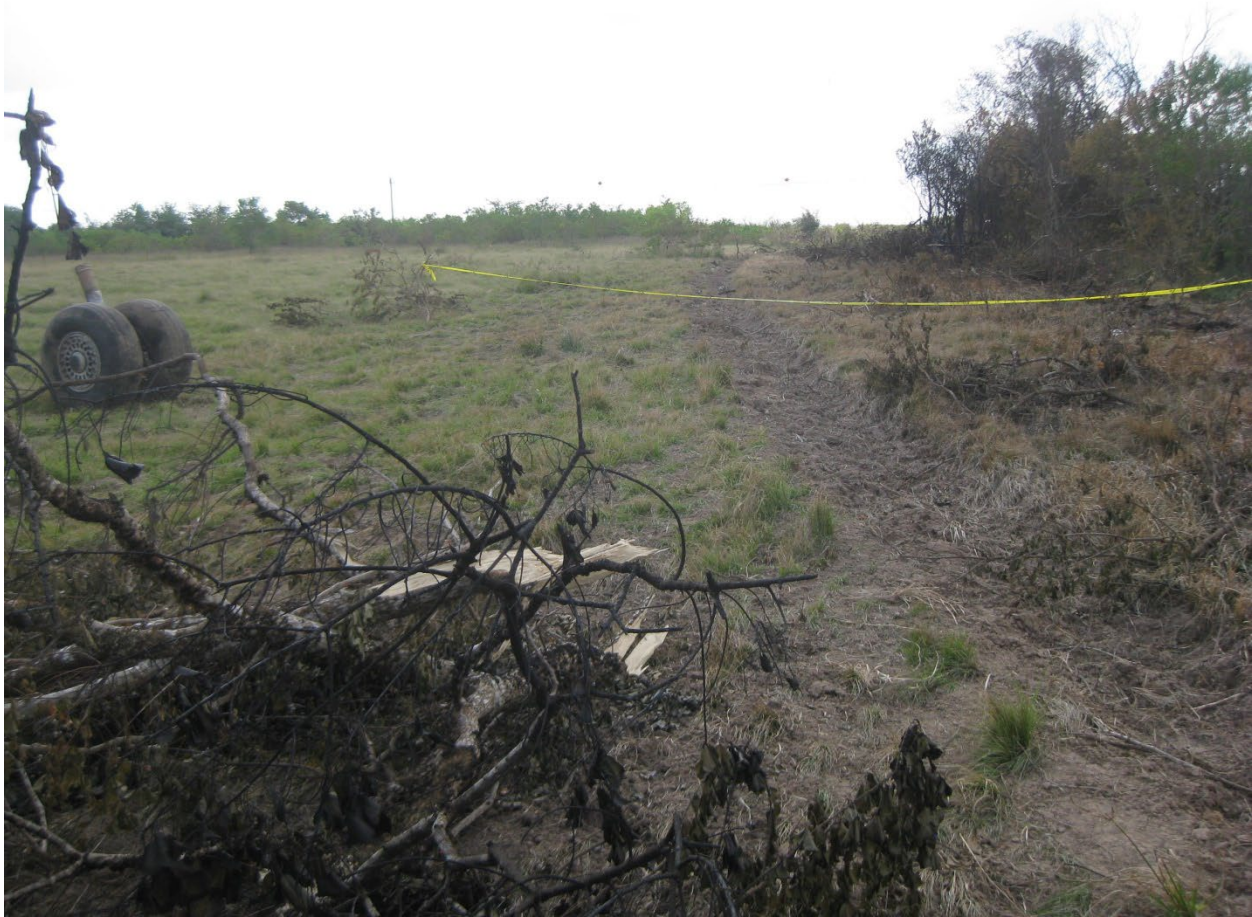
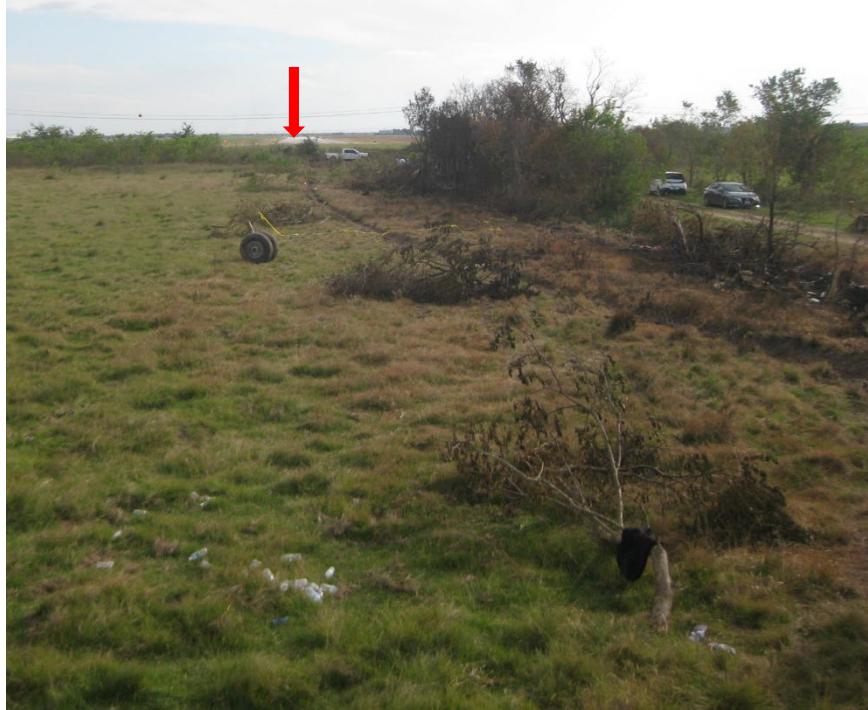
Pieces of the airplane's wings and landing gear were found in the field, along the wreckage path, before the airplane's final resting location. See Figures 5 and 6.

Figure 5. View from near final airplane location, looking back up the impact path to the airport. The left main landing gear is on the left side of photograph.

Figure 6. Photograph taken from a scissors lift, stationed (above ground) at airplane tail, showing wreckage path from airplane back to airport. The red arrow points to the airport runway surface. The white pick-up truck is parked on Morton Road.

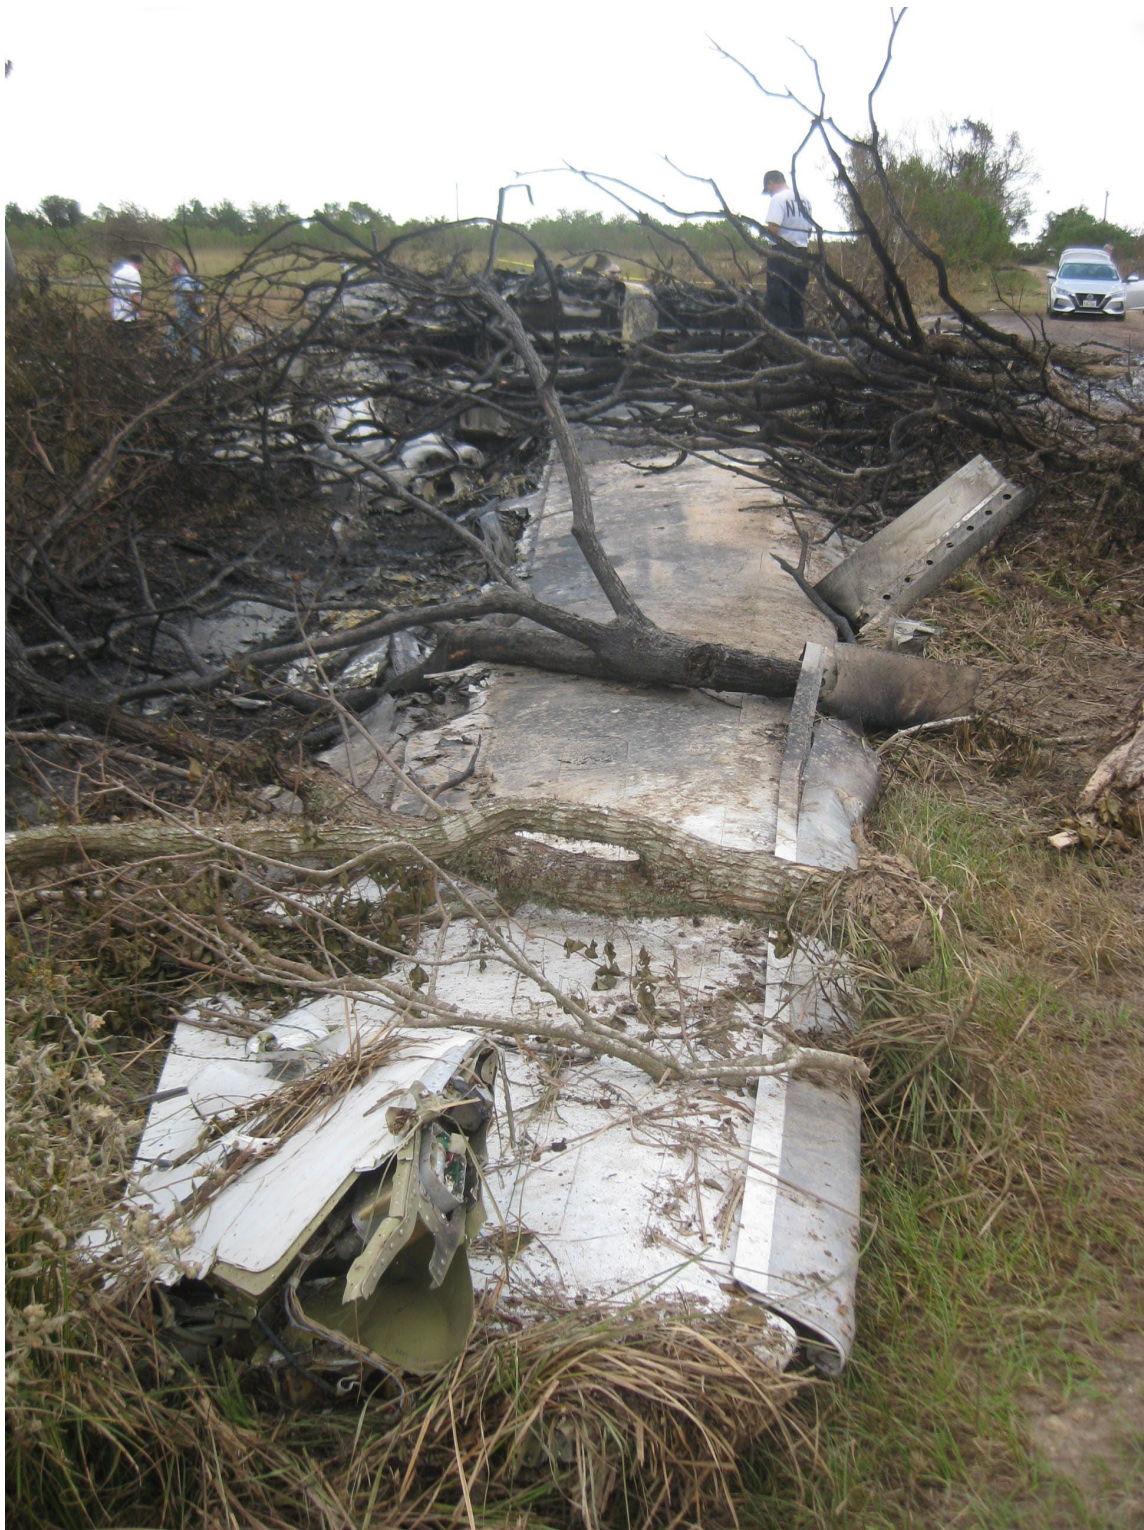
The airplane also dragged tree branches and debris before it came to a stop. See Figure 7.

Figure 7. View of right wing, looking inboard from the right wingtip. The wing's leading edge is on the right side of the picture.

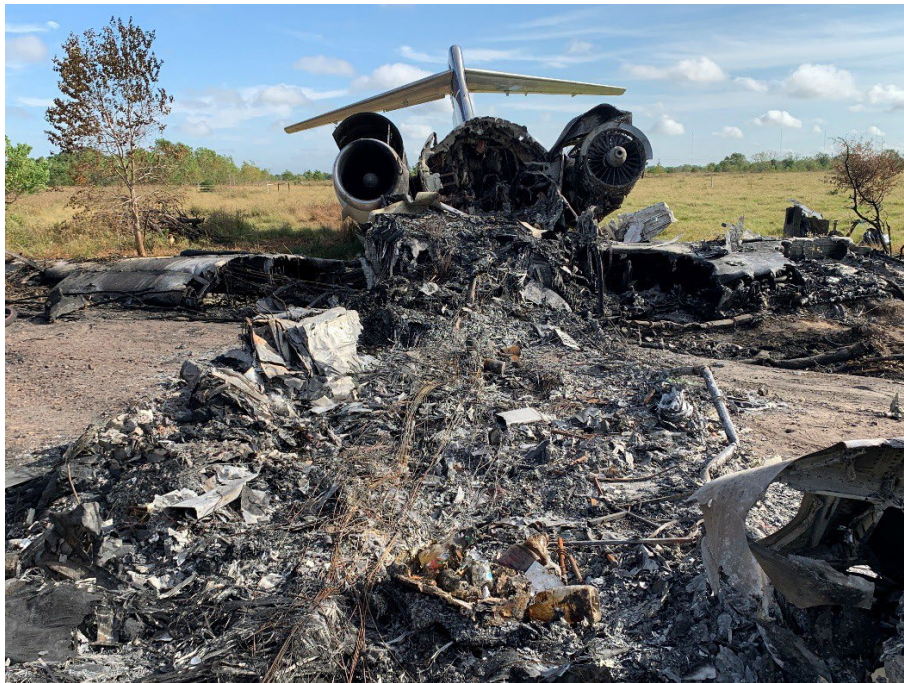
The airplane structure was heavily damaged due to the fire that ensued after the airplane came to rest during the accident sequence. See Figure 8.

Figure 8. View of fuselage wreckage, from the flight deck area.

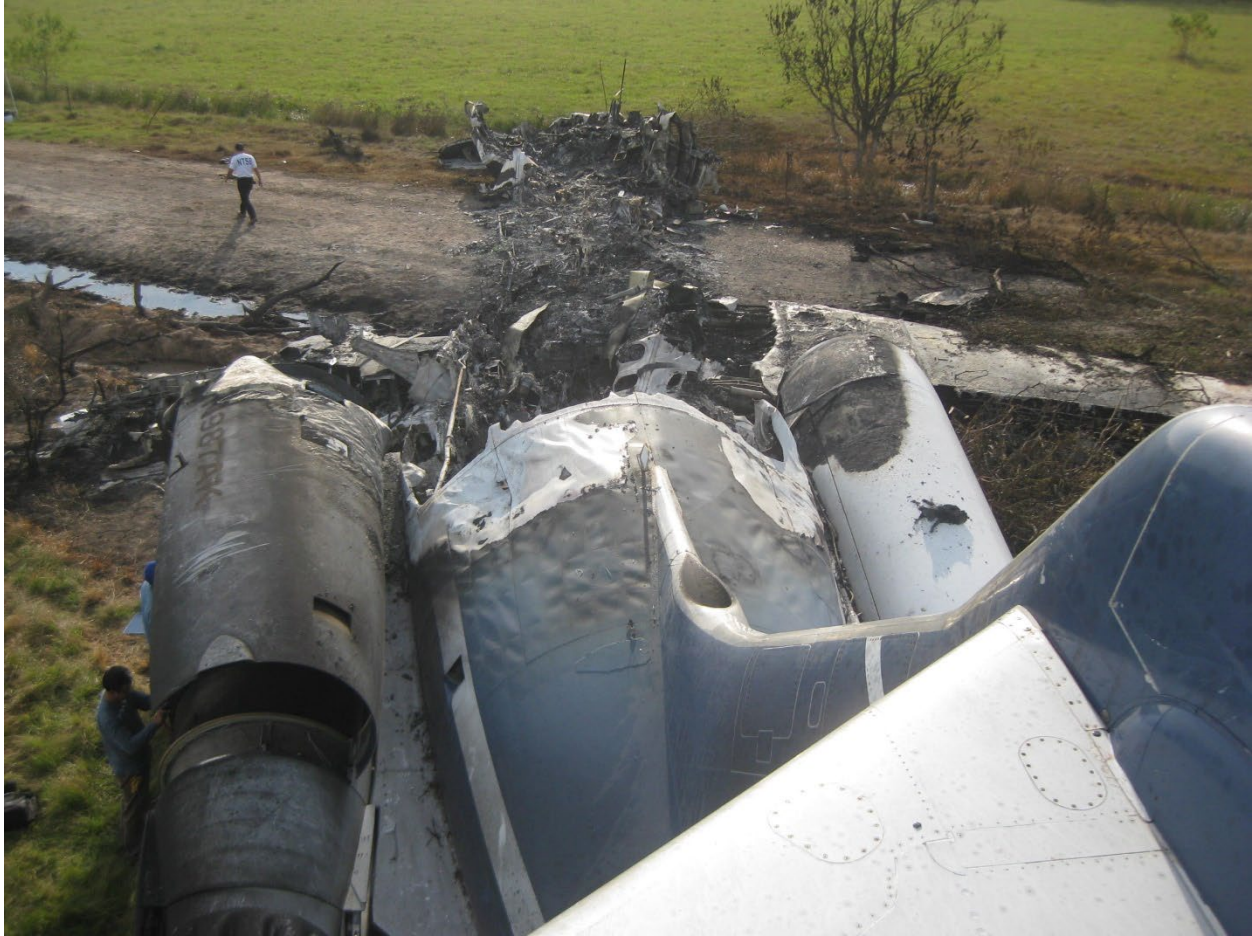
Fire consumed more than two thirds of the structure. All upper fuselage structure (except for a small section of the upper nose structure) was consumed by fire. See Figure 9.

Figure 9. Photograph from top of the horizontal stabilizer, looking forward, of the forward fuselage and damage from post-crash fire.

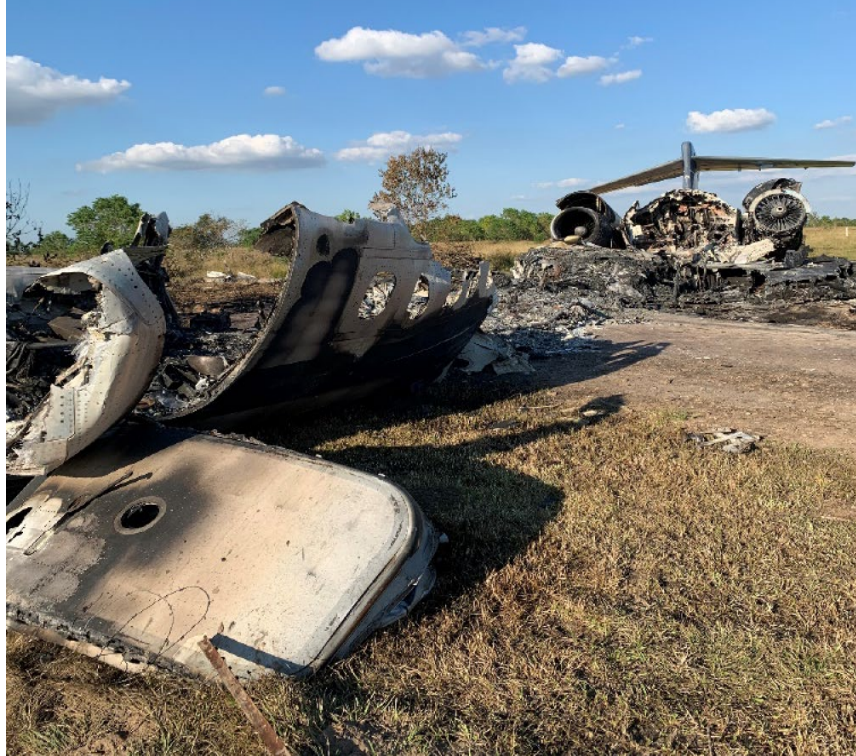
On the left side of the airplane, damaged structure (from approximately Station (STA) 41 to approximately STA 351), was visible. The damage in this area encompassed a partial left hand main entry door (L1) opening structure causing the forward entry plug-type door to sag and lay on the ground. Sooting and fire damage were found on some of the panels below the window cutouts. See Figure 10.

Figure 10. View of the fuselage wreckage, looking aft from the front, left corner of the airplane.

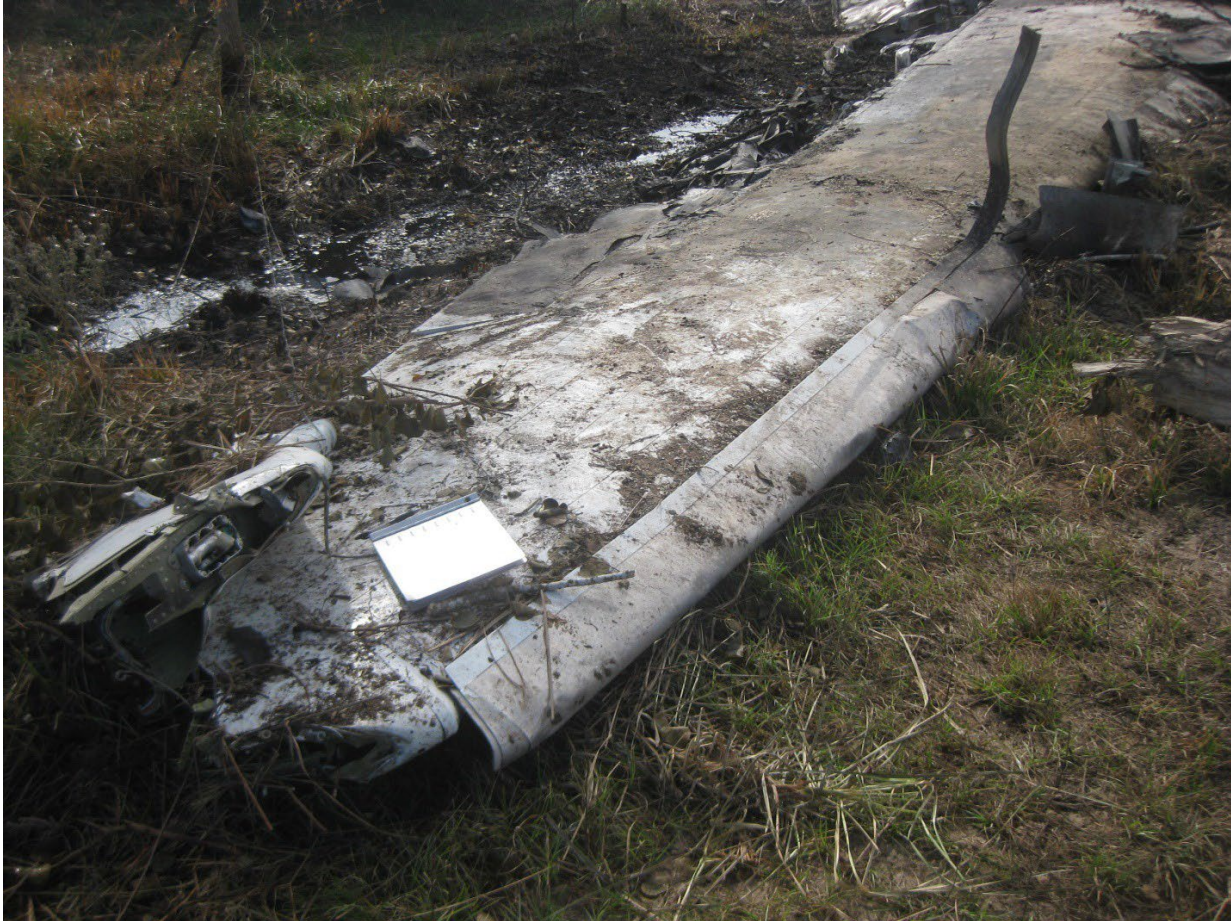
Most of the right wing was still partially attached to the wing root but sustained heavy fire damage in the wing root. The wing skin upper surface showed signs of fire damage in the same area. The right-wing tip was still attached but was damaged due to ground impact. See Figure 11.

Figure 11. View of right wing after debris was removed from top of the wing, looking from wingtip inboard.

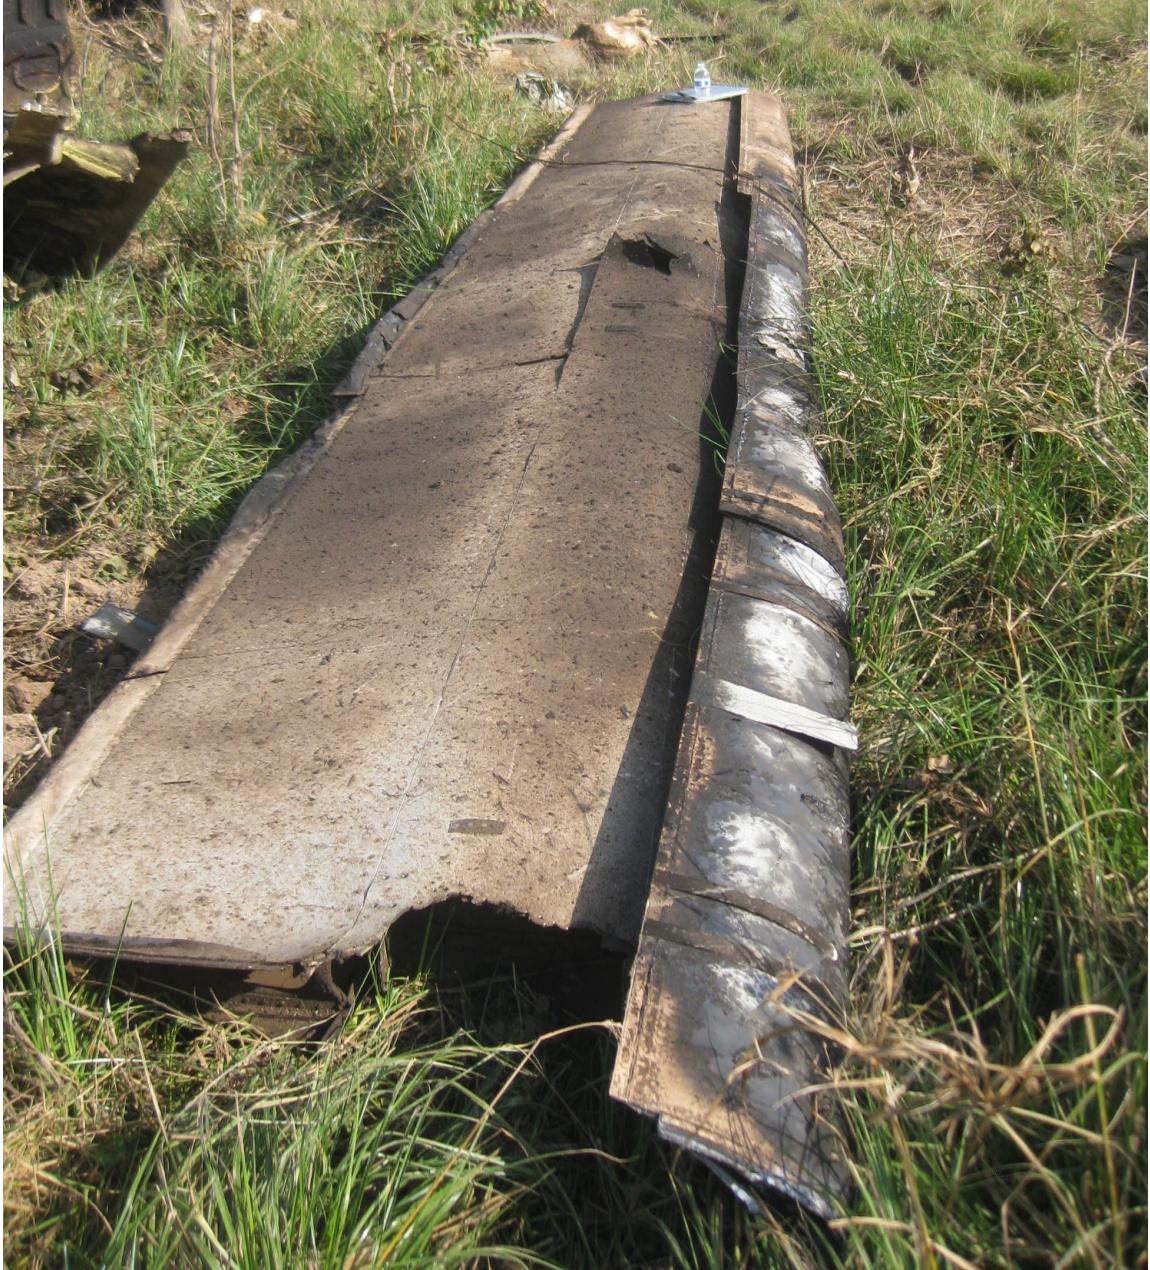
During the accident sequence an outboard portion of the left wing was separated due to contact with several trees and impact with the ground. See Figure 12.

Figure 12. A section of the outboard left wing, located in the wreckage path. The wing's leading edge is on the right side of the photograph.

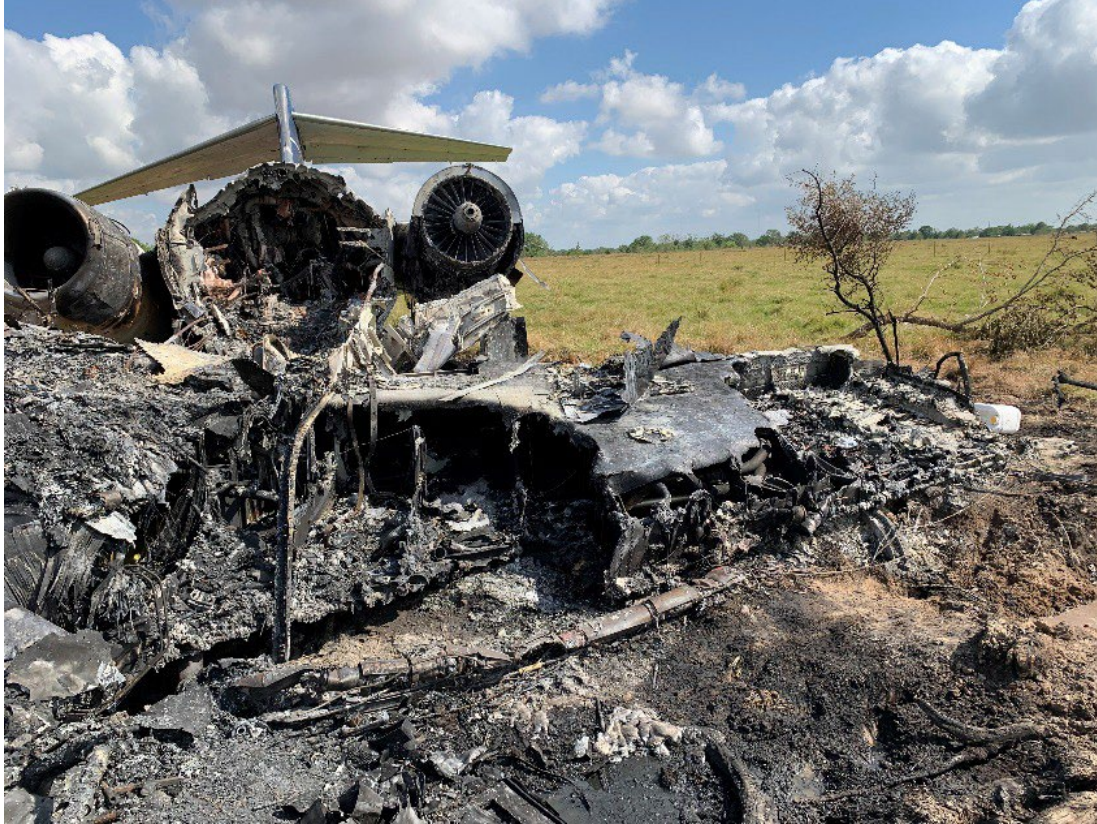
There was approximately 15 feet of the left wing still attached to the fuselage. The left wing was heavily damaged due to the fire. See Figure 13.

Figure 13. Section of left wing, still attached to the fuselage.

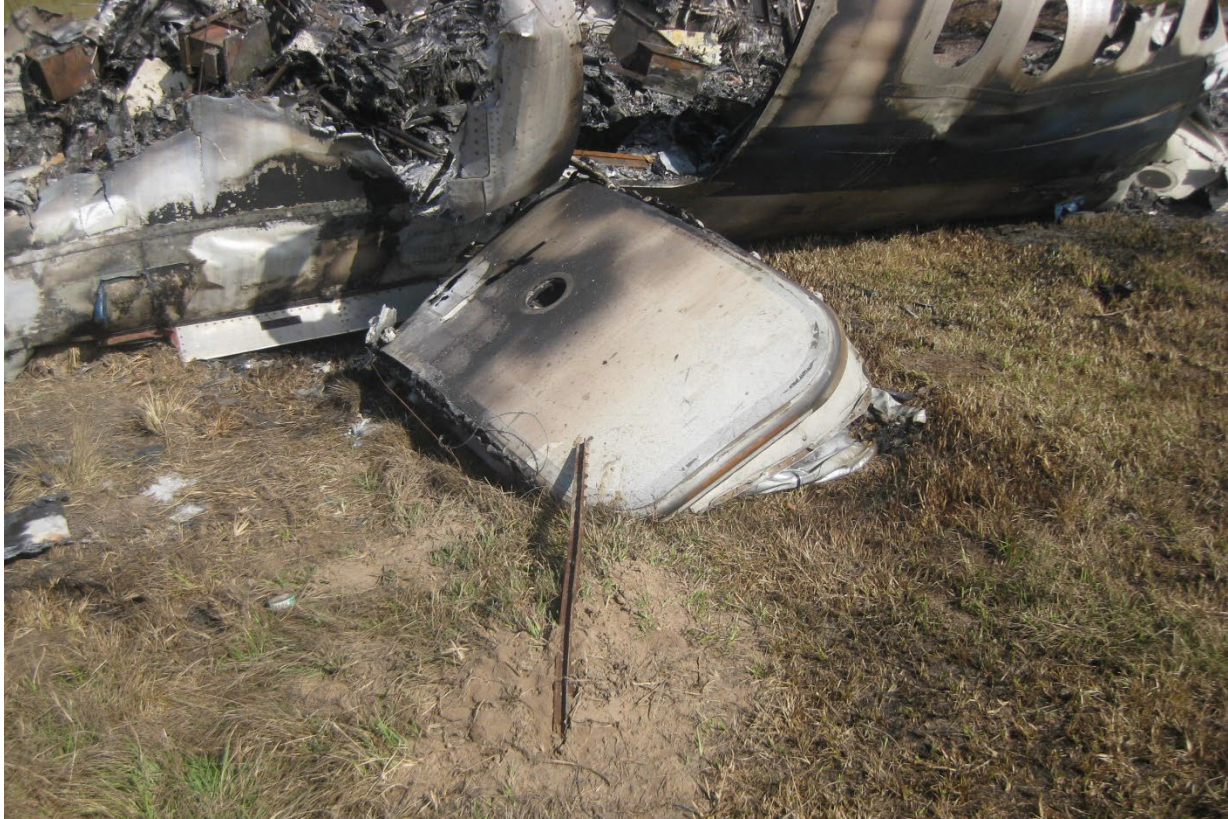
The forward (left) entry door (L1) remained partially attached to the airplane but was heavily damaged due to the fire. See Figure 14.

Figure 14. The forward left entry door, with fuselage wreckage.

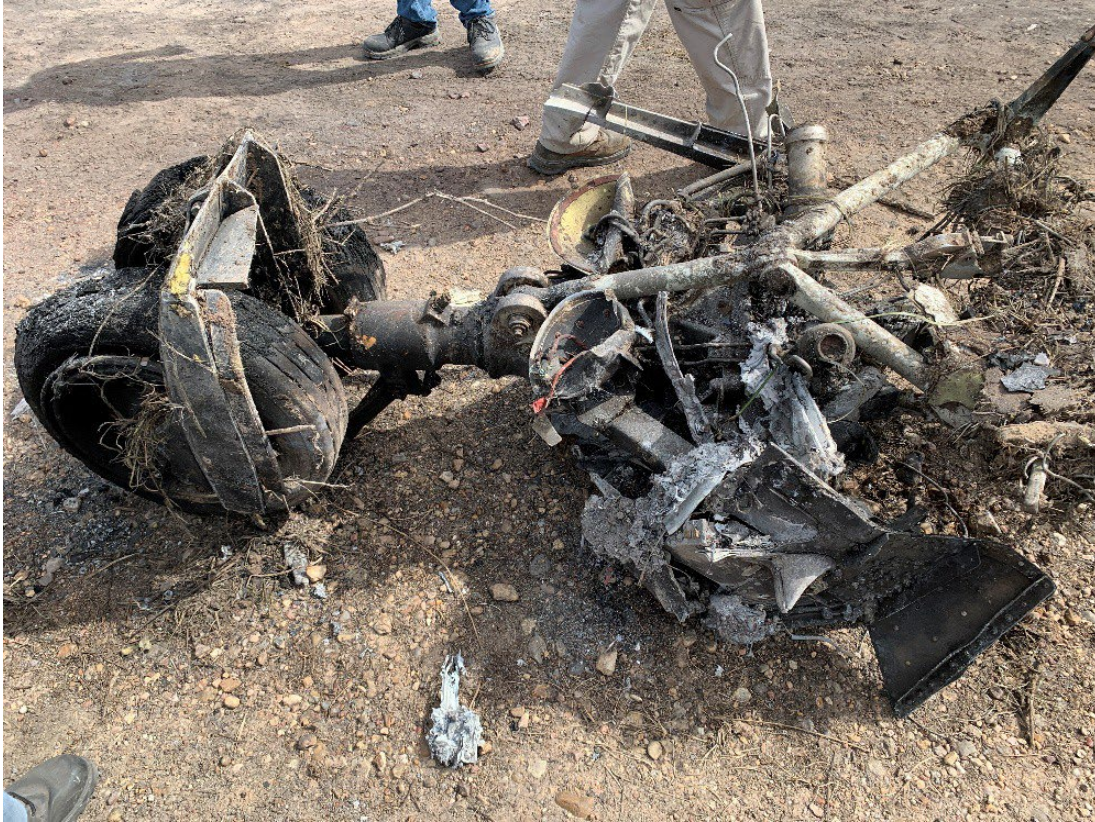
The nose gear was identified in the main wreckage. The gear was found folded aft in the electrical and equipment compartment. The nose landing gear's supporting structure failed with a portion of the structure still attached to the nose gear. See Figure 16.

Figure 16. The nose landing gear after removal from underneath the airplane fuselage.

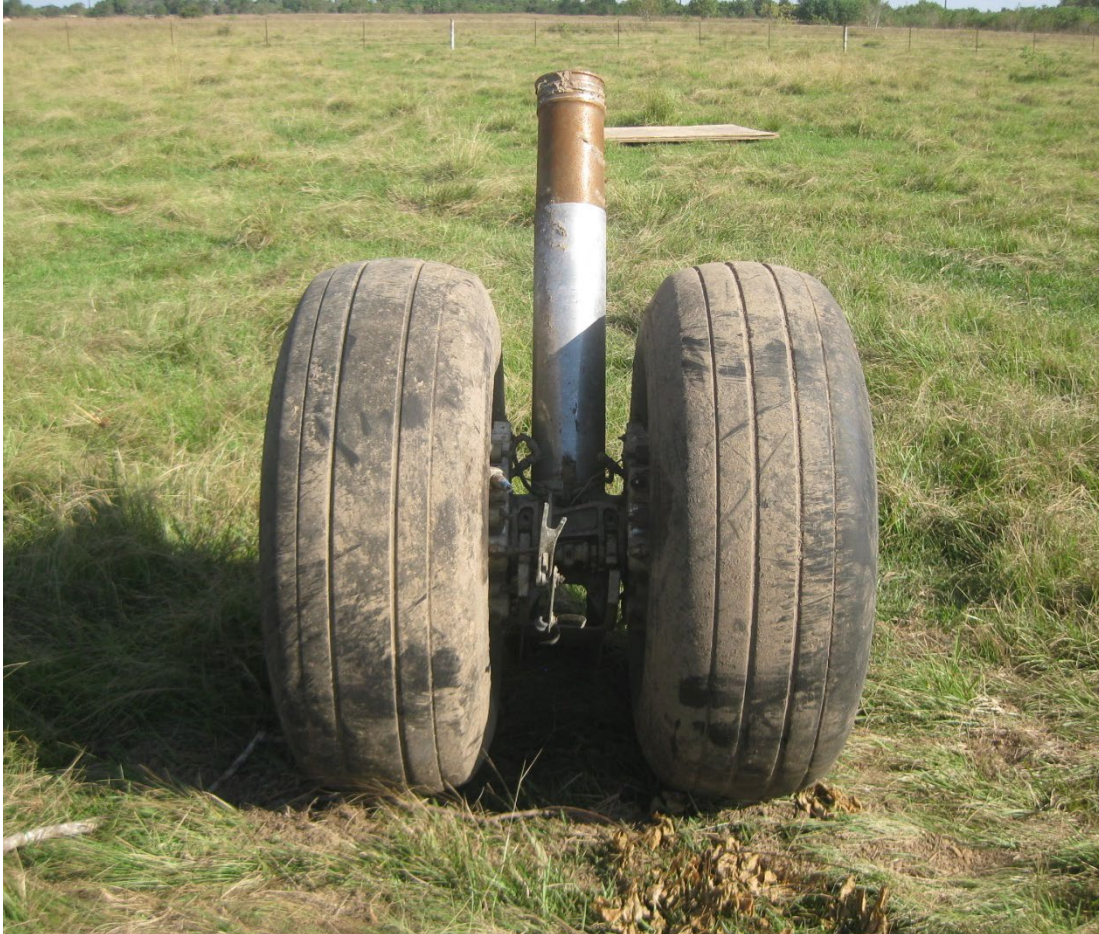
The lower section of the left main landing gear, including the truck, wheels, and inner cylinder (separated from the outer cylinder) was found in the wreckage field, separated from the airplane. The gear departed the aircraft during the aircraft accident sequence and was found approximately 150 feet from the main wreckage. See Figure 17.

Figure 17. Lower section of left main landing gear, as found in wreckage path.

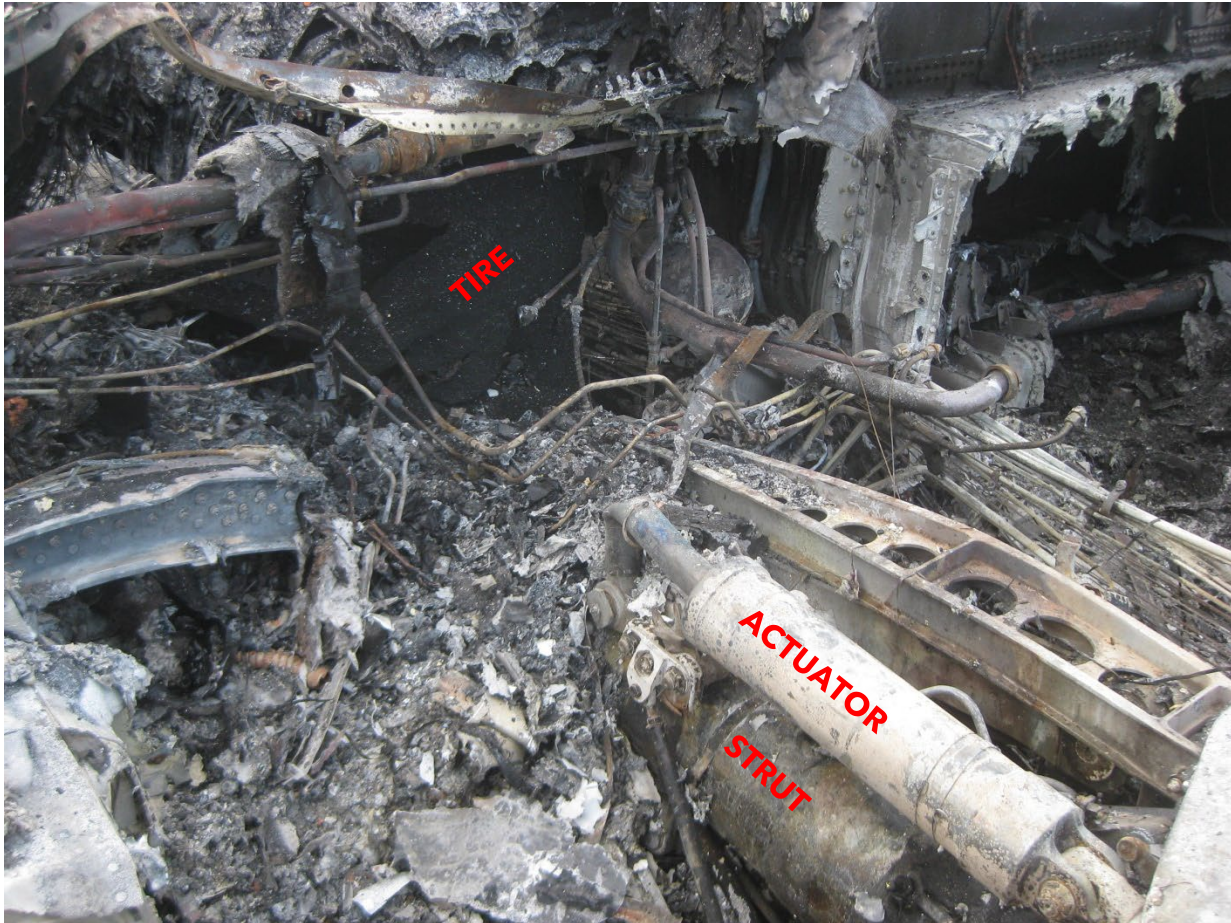
The right main landing gear was found in the right main gear wheel well. The actuating cylinder piston was bent approximately 90 degrees. See Figure 18.

Figure 18. The right main landing gear, as found in the main wreckage. The gear strut, strut actuator, and one of the tires have been annotated.

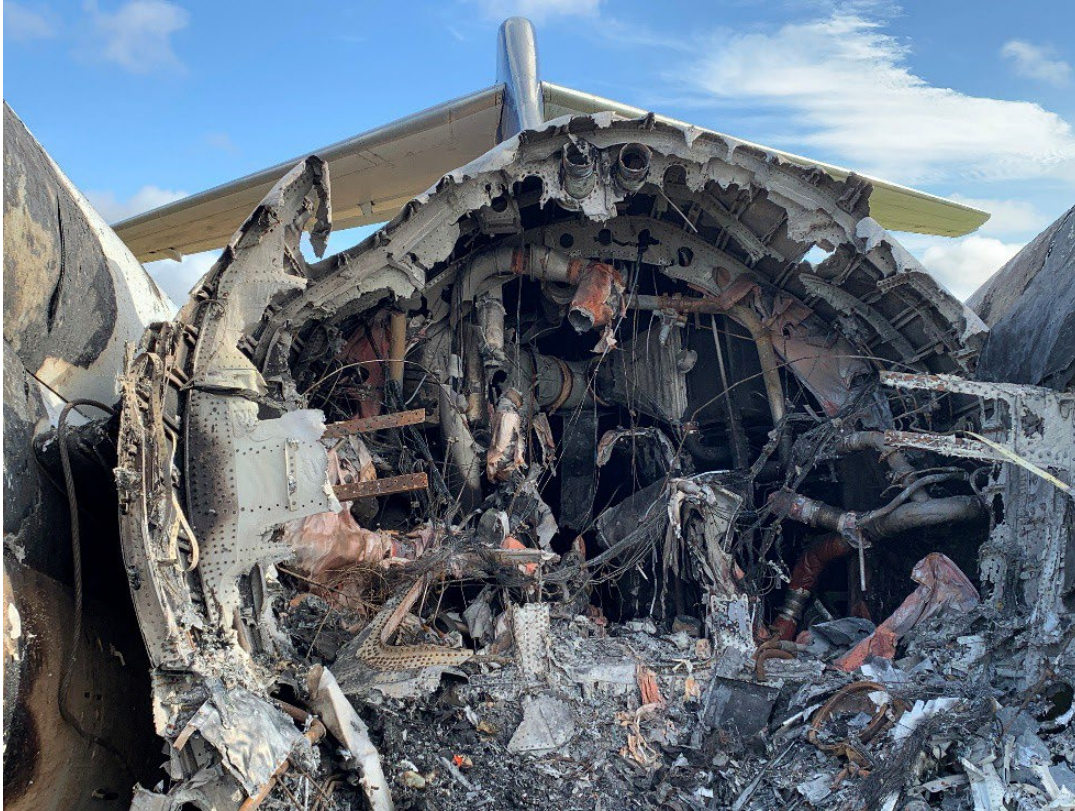
Much of the aft pressure bulkhead structure at approximately STA 1152 was consumed by the fire damage during the accident. See Figure 19.

Figure 19. Area of the aft pressure bulkhead, showing the area consumed by post-crash fire.

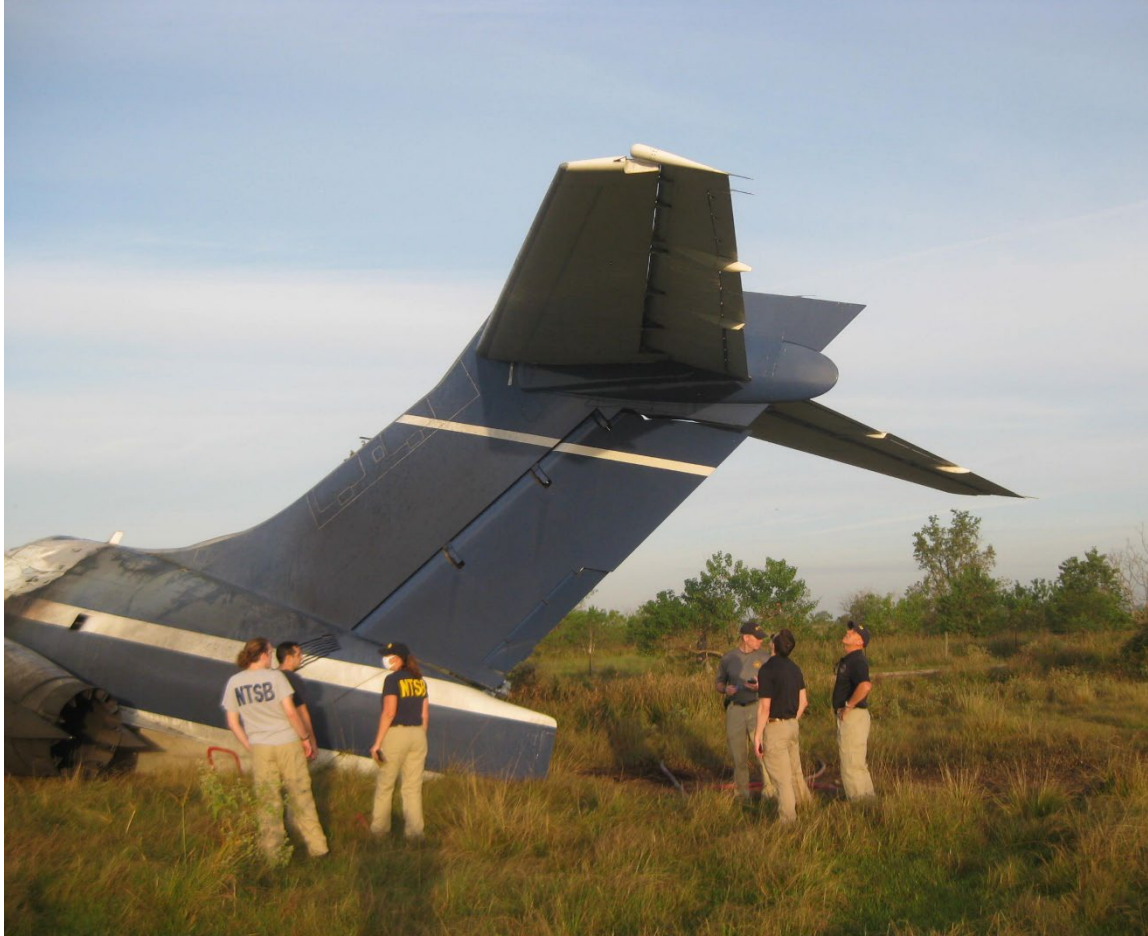
Figure 21. The left side of the vertical stabilizer and rudder. Note that the elevators are in a trailing edge down position.

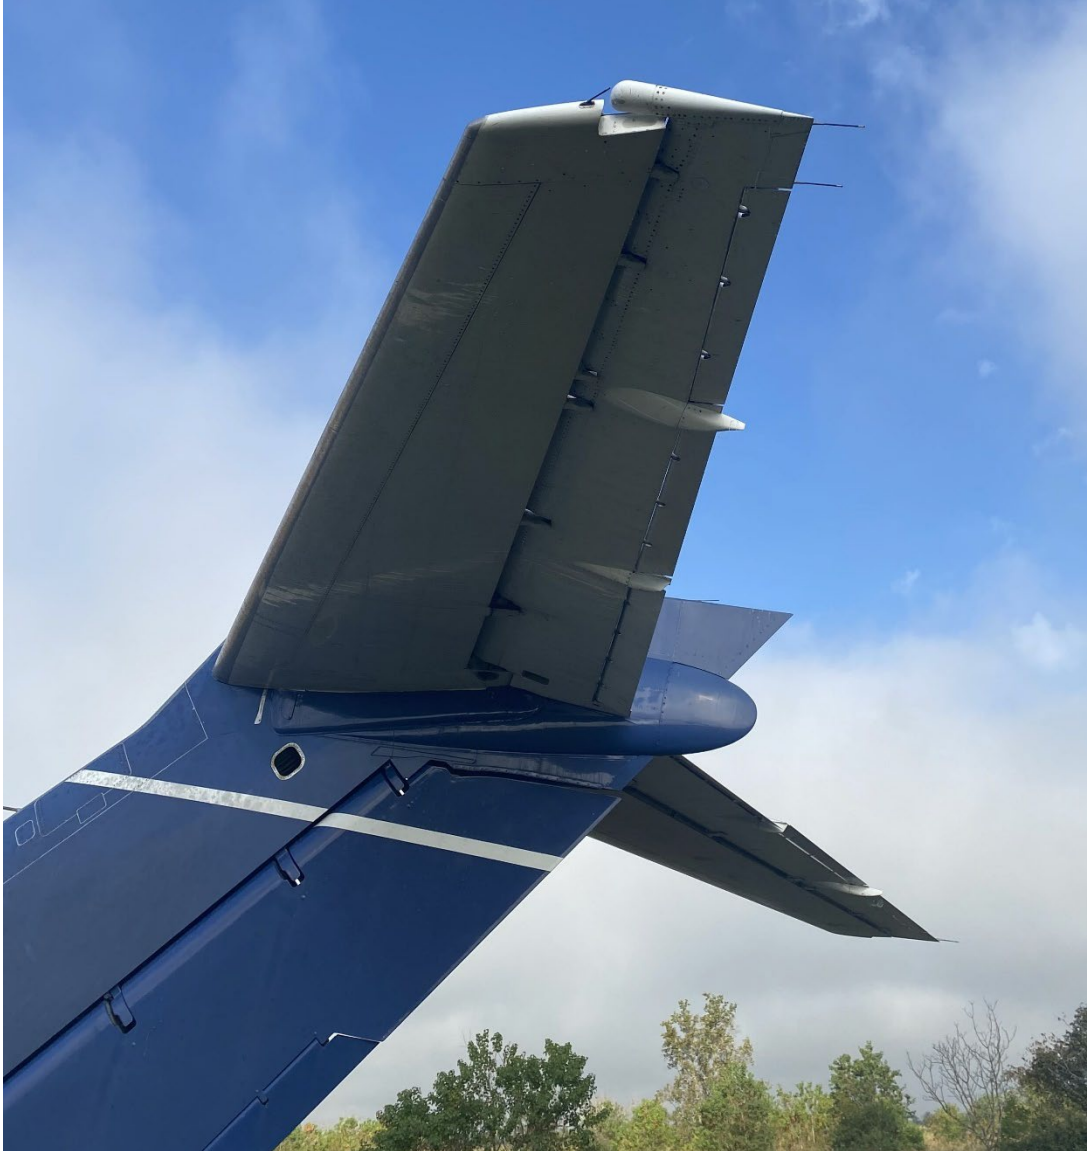
From the ground, when viewed from behind, both the left and right elevators were in a trailing edge down position. The forward portion of the outboard balance weight "horns" on both the left and right elevator surfaces were shown to be above the top surface of the horizontal stabilizer. See Figure 24.

Figure 24. Elevators in the as-found trailing edge down position.
