National Transportation Safety Board

DCA22MA009

AIRWORTHINESS GROUP

Location: Brookshire, Texas
Date: October 19, 2021
Time: 1000 central daylight time (CDT)
Aircraft: McDonnell Douglas DC-9-87, Registration N987AK

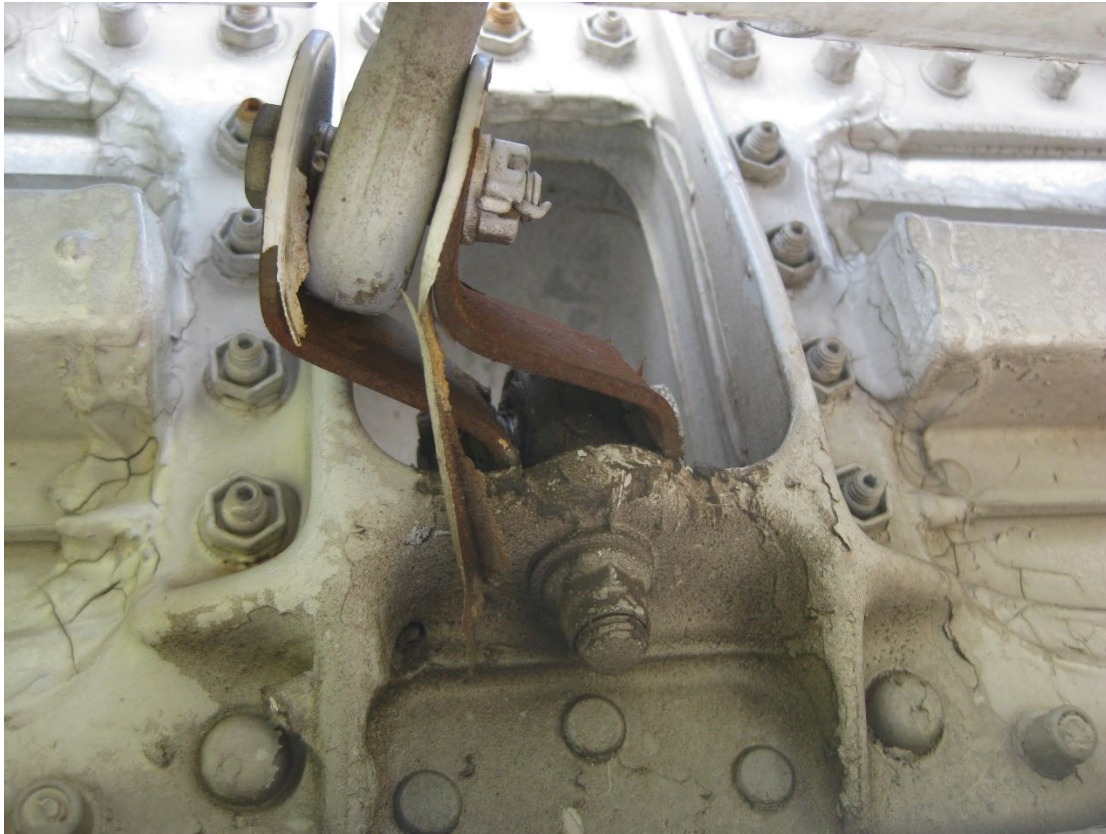
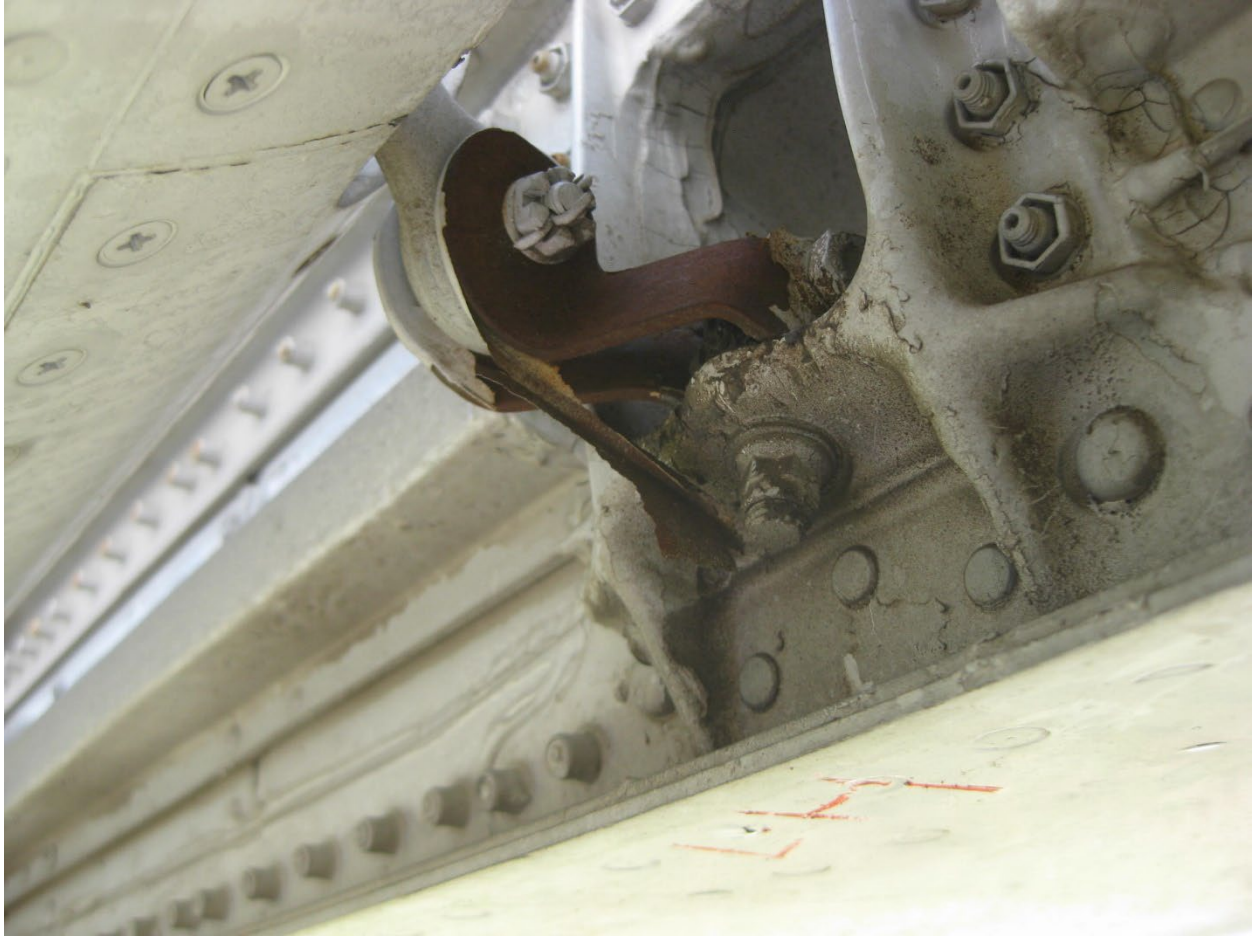
Left Elevator:

The group used a scissors lift to inspect the elevators. From an elevated position behind the elevators, the group confirmed that both the left and right elevators were in a trailing edge down position. Further, a visual examination of the tab hinges and control linkages found that both inboard geared tab links and actuating crank were damaged and in an over-centered position; the linkage to the horizontal stabilizer at the inboard end of the geared tab was damaged and out of its normal position, displaced aft and bent to the outboard side (of its normal position). See Figures 25 and 26 for the left elevator and see Figures 27 and 28 for the right elevator.

Figure 25. Left-hand elevator and inboard geared tab attachment linkage, looking forward into the horizontal stabilizer, viewed from underneath the left elevator.

Figure 26. Left-hand elevator inboard geared tab attachment linkage, looking forward (into the horizontal stabilizer) and outboard, viewed from underneath the left elevator.

When the group attempted to move the elevators by hand they could not be moved from their trailing edge down position.

The damaged links were disconnected, and the associated attachment hardware were removed for further examination³. After the items were removed, both elevators were free to move, by hand, to nearly the limit of the elevator stops; when the elevators were actuated trailing edge up, the movement near the end of the throw was restricted. The geared tabs were still jammed, even with the hardware removed. The input cables to the sectors near the top of the vertical stabilizers were removed, and the elevators then achieved full travel in both directions.

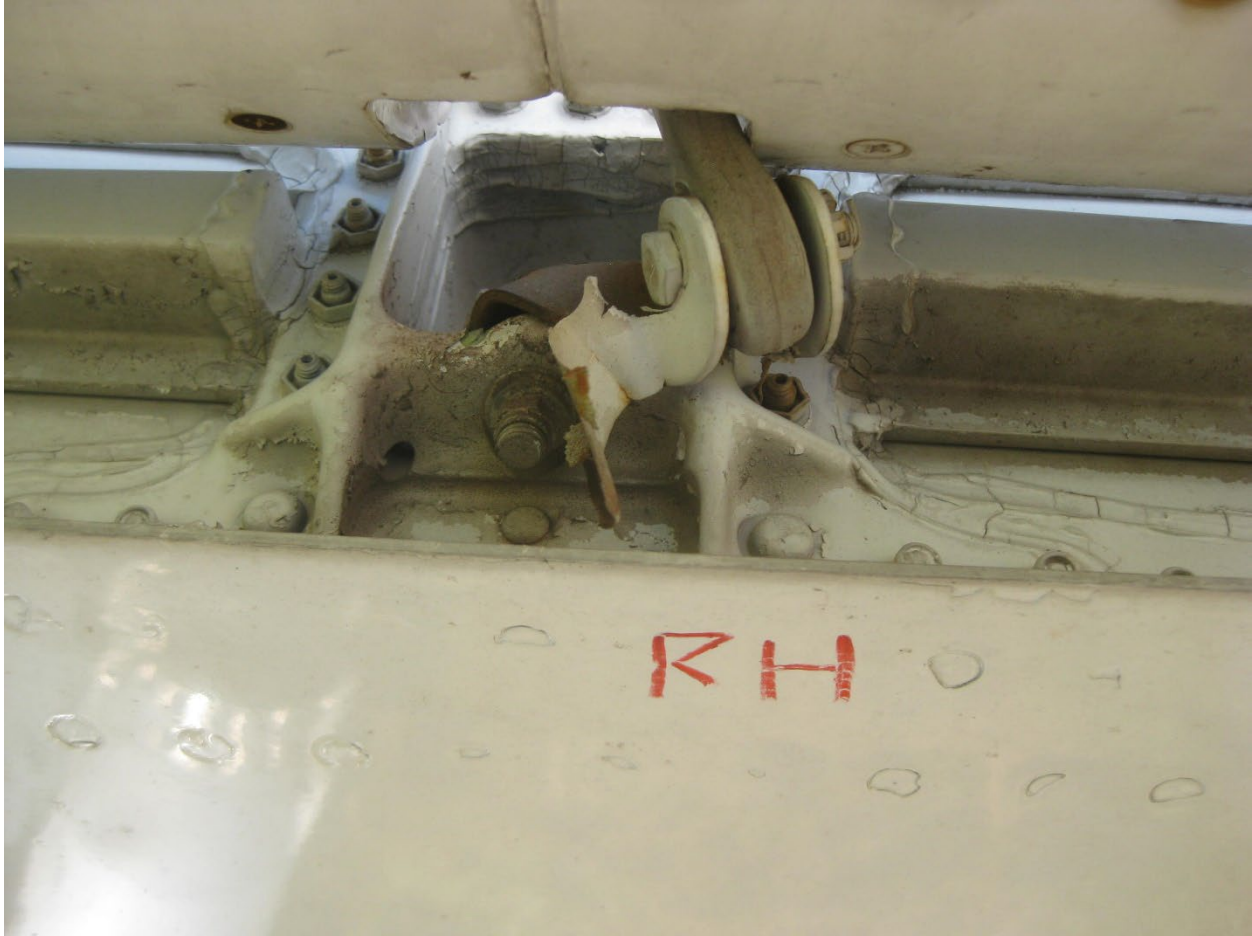
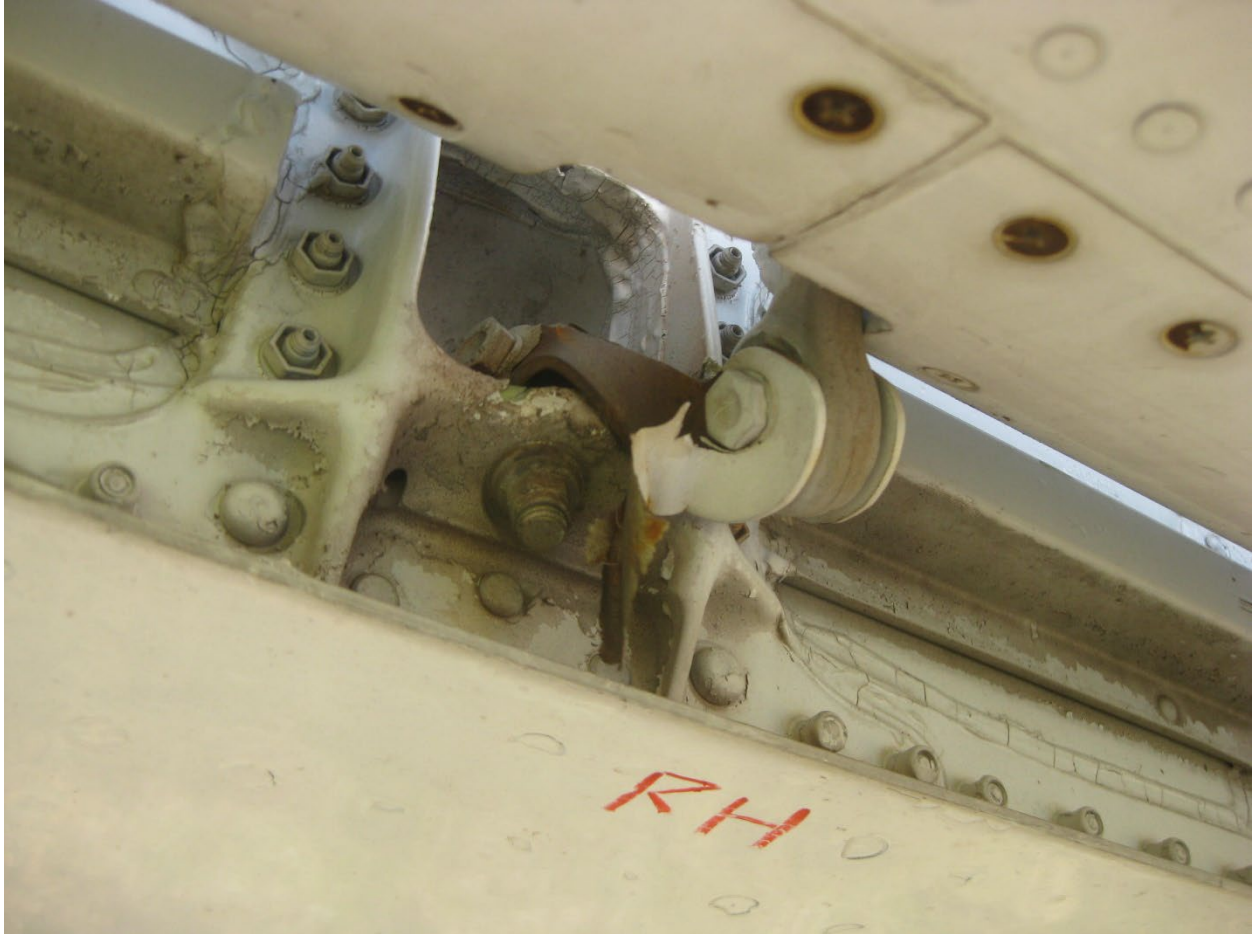
Right Elevator:

Figure 27. Right-hand elevator inboard geared tab attachment linkage, looking forward into the horizontal stabilizer, viewed from underneath the right elevator.

Figure 28. Right elevator inboard geared tab attachment linkage, looking forward (into the horizontal stabilizer) and outboard, viewed from underneath the right elevator.

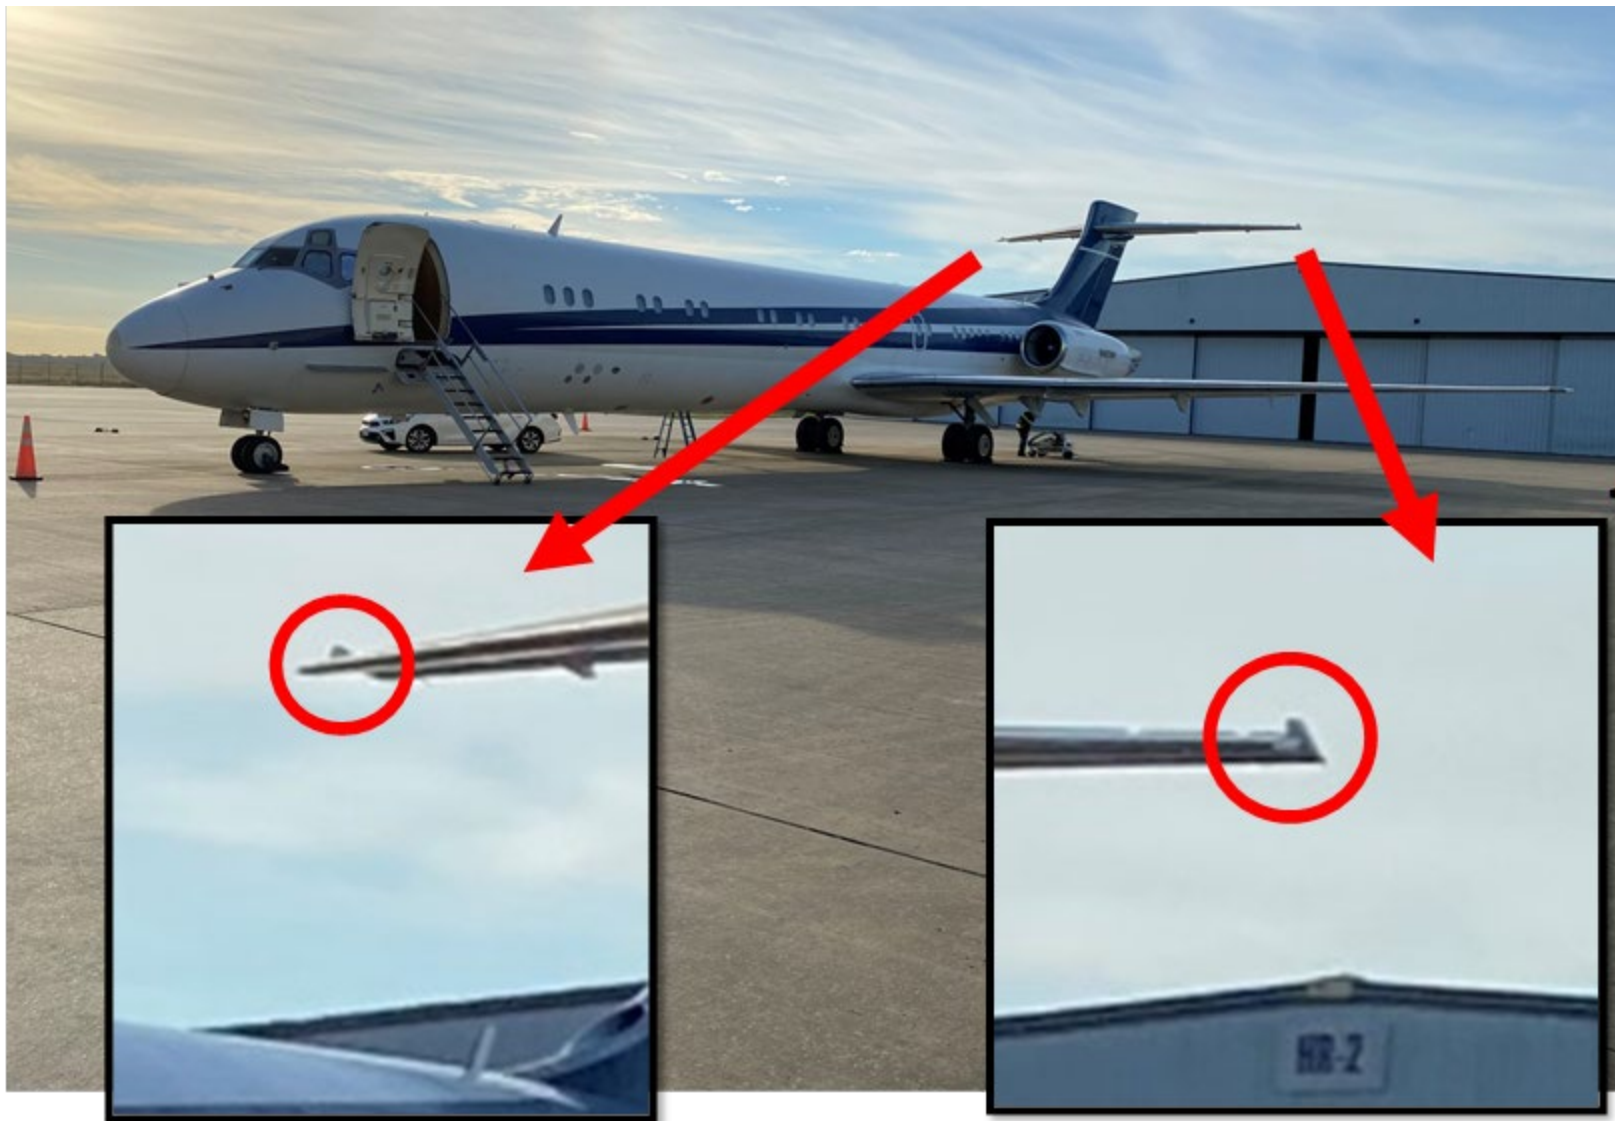
Figure 32. Photograph of the accident airplane the morning of the accident. Inset photos show the trailing edge down position of the left and right elevator based on the elevator "horn" position.

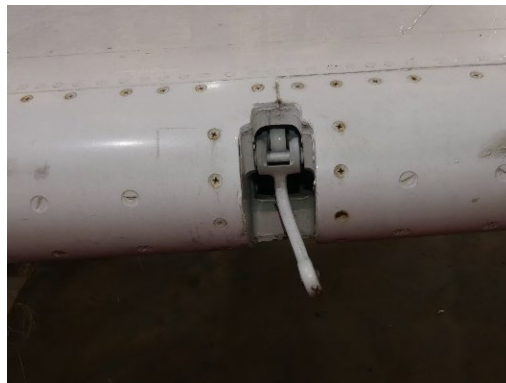
The group met at the accident site from October 20-27, 2021 to examine the airworthiness aspects of the airplane. At the accident site, the inboard linkages of the elevator's geared tab for both elevators were found bent outward and over-center such that the elevators were jammed in a trailing edge down condition.

The actuating crank and pushrod from the geared tab were removed and examined. The inboard crank for the left and right geared tab were bent and deformed, both outboard. The pushrods had no visible anomalies. The outboard cranks had no visible anomalies. See Figures 45 and 46.

Figure 43. The left geared tab inboard input crank (looking aft). Note that the crank is bent outboard.

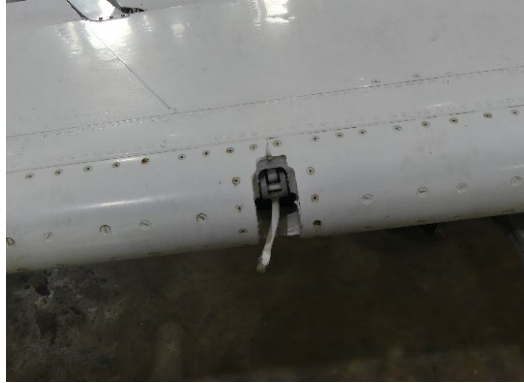
Figure 44. The right geared tab inboard input crank (looking aft). Note that the crank is bent outboard.
