National Transportation Safety Board

DCA22MA009

OPERATIONAL FACTORS/HUMAN PERFORMANCE

Group Chair's Factual Report

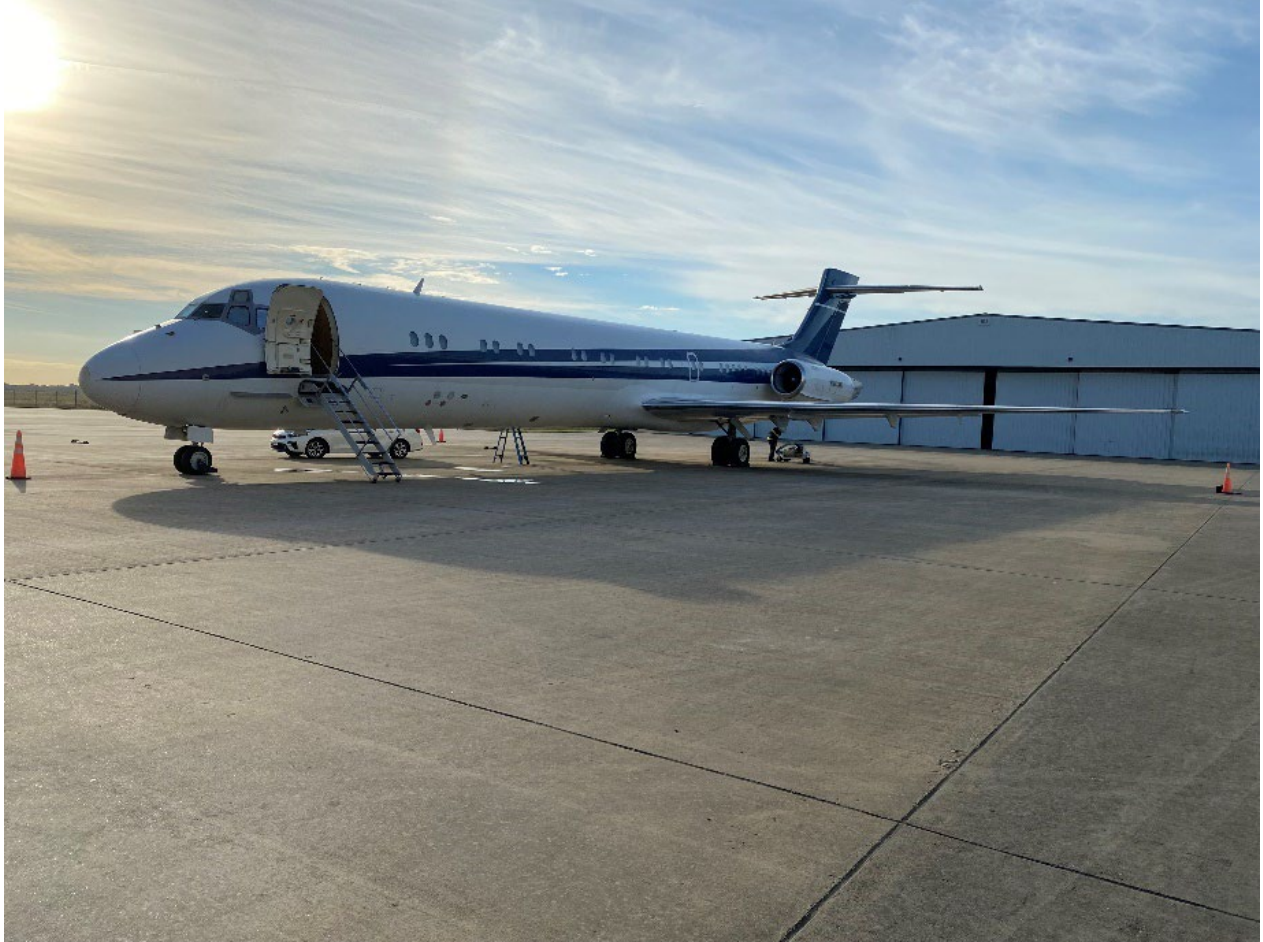
Photo 1: Accident airplane the morning of the accident
(Source: first officer)
