NATIONAL TRANSPORTATION SAFETY BOARD

SURVIVAL FACTORS

Group Chairman's Factual Report

I. ACCIDENT DCA22MA009

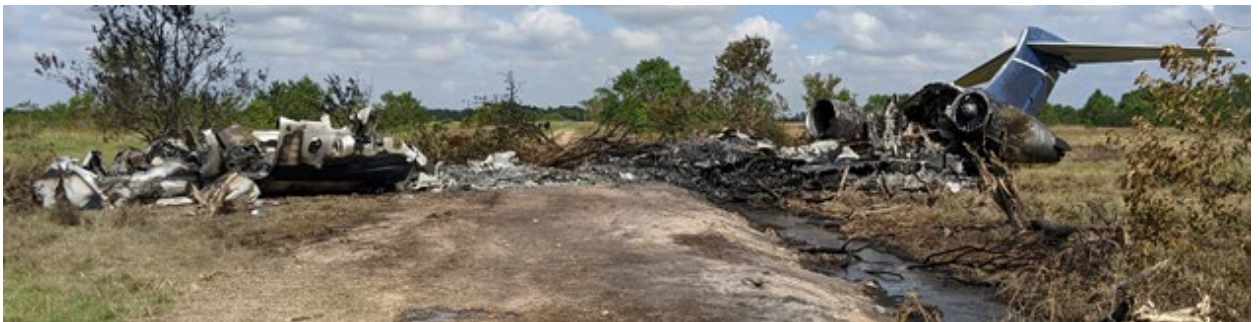
The survival factors group documented the wreckage site on October 20, 2021. The airplane was mostly consumed by post-crash fire (see photograph 5).

Photograph 5. N987AK after the post-crash fire was extinguished.

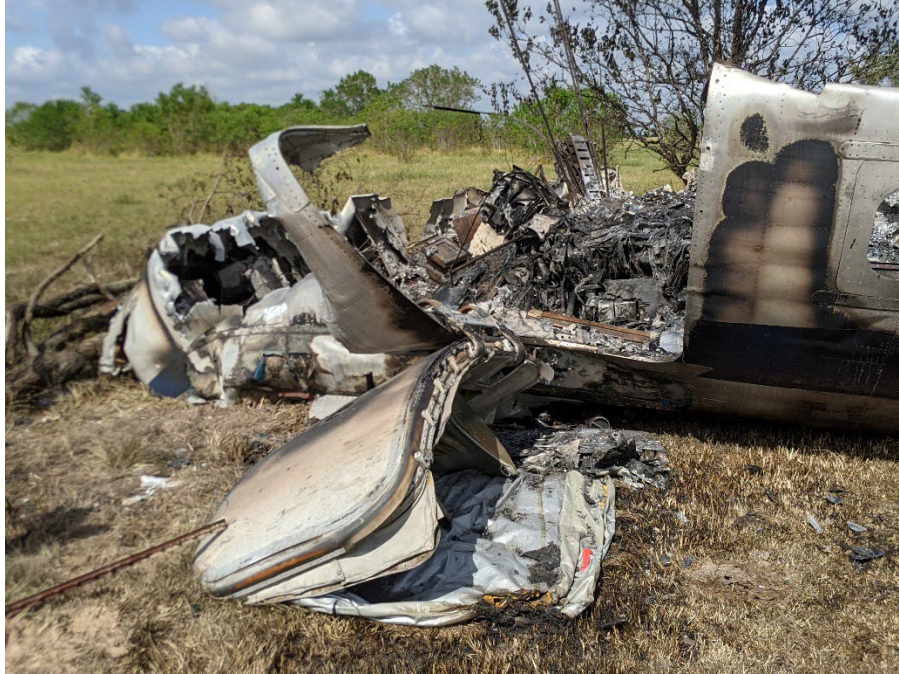
Door 1L was damaged by fire. The door was on the ground with the door hinge attached to the deformed door frame. The door and associated door handle were in the open position. A portion of evacuation slide was found under the exit door (see photograph 6). The slide material was under the door and the slide aspirator and pressure cylinder were found under the deformed doorsill.

Photograph 6. N987AK door 1L and evacuation slide.

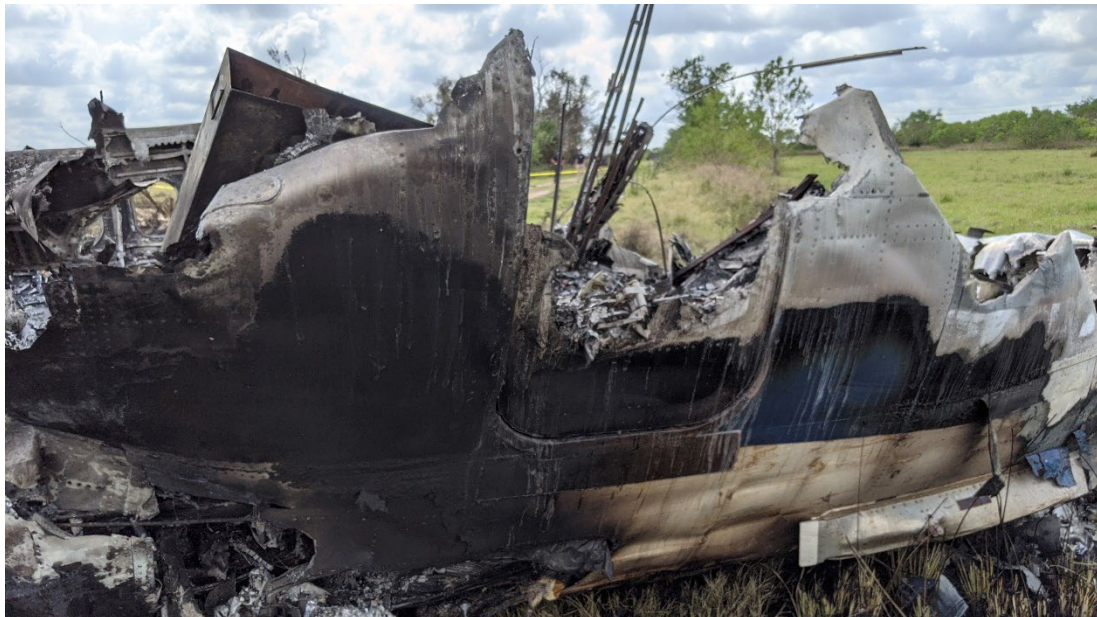
Door 1R and the surrounding fuselage structure was damaged by fire. The lower portion of the door and door frame indicated the door was in the closed position. The door 1R evacuation slide was destroyed by fire (see photograph 7).

Photograph 7. N987AK door 1R.

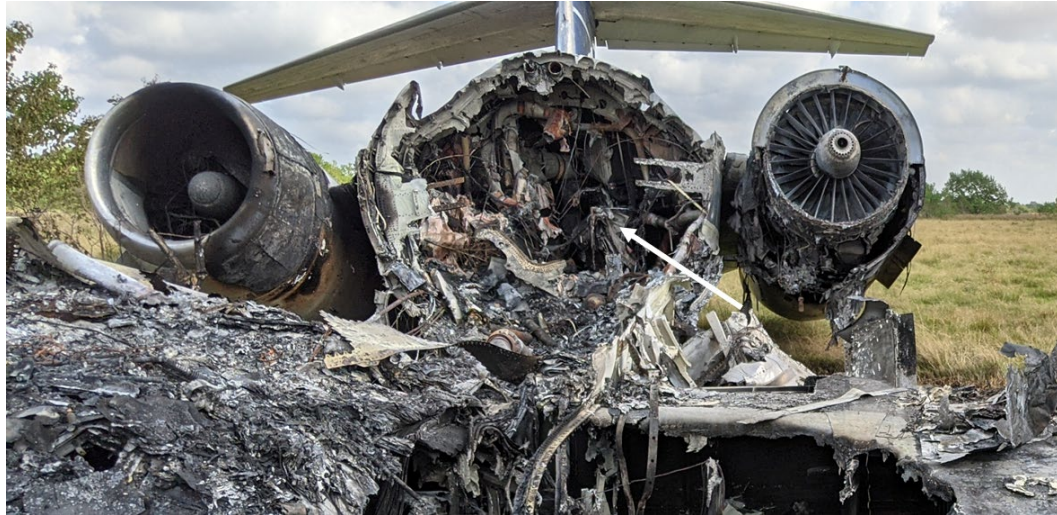
The tailcone exit and the passageway leading to the tailcone exit were destroyed by fire. The tailcone slide appeared intact and undamaged but was not accessed due to on-site safety concerns (see photograph 8 and 9).

Photograph 8. N987AK tailcone exit.

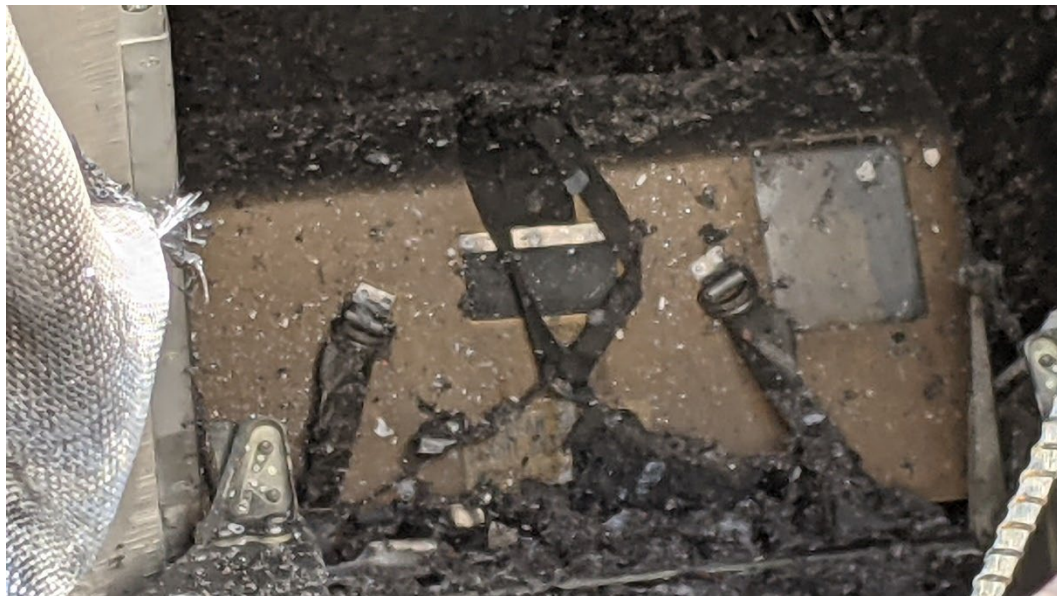
Photograph 9. N987AK tailcone slide still in packaging.

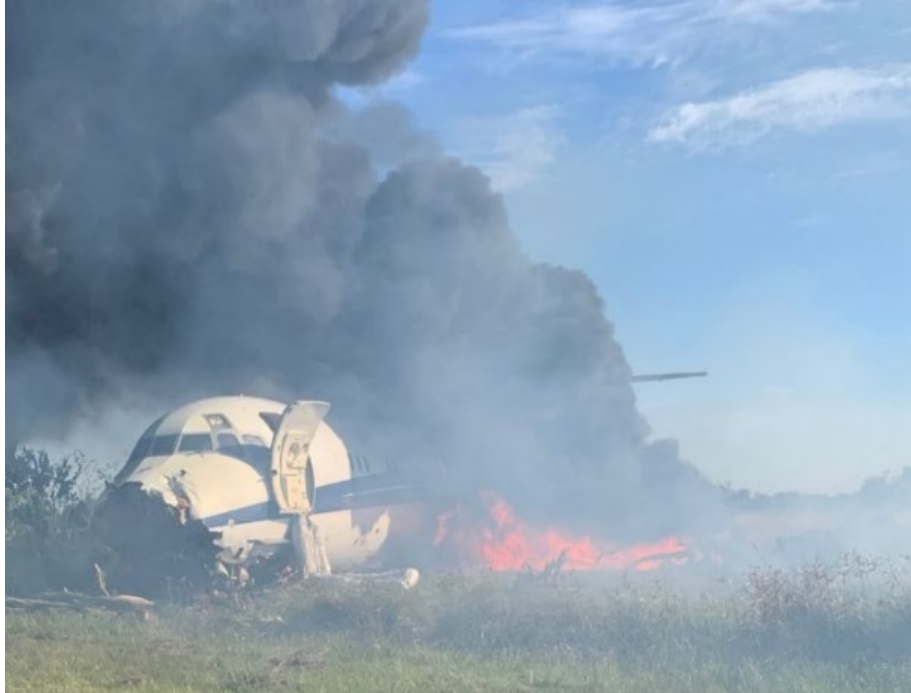
The evacuation slide at door 1L was described as fully inflated at the beginning of the evacuation; however, later passengers described it as being less inflated (see photograph 10). After evacuating, passengers walked toward a road. Passenger 7 was unable to walk due to back pain and several passengers helped to move him away from the airplane. Emergency responders met passengers and put passenger 7 on a backboard and several passengers helped carry him to where emergency vehicles were located.

Photograph 10. Passenger photograph of N987AK showing door 1L and slide at 1001 CDT⁷, after evacuation.
