National Transportation Safety Board
Office of Research and Engineering
Washington, D.C. 20594

Airplane Performance Study

Specialist Report
Timothy Burtch

Location: Brookshire, Texas
Date: October 19, 2021
Time: 1500 GMT (1000 CDT)
Airplane: McDonnell Douglas DC-9-87, N987AK
NTSB Number: DCA22MA009

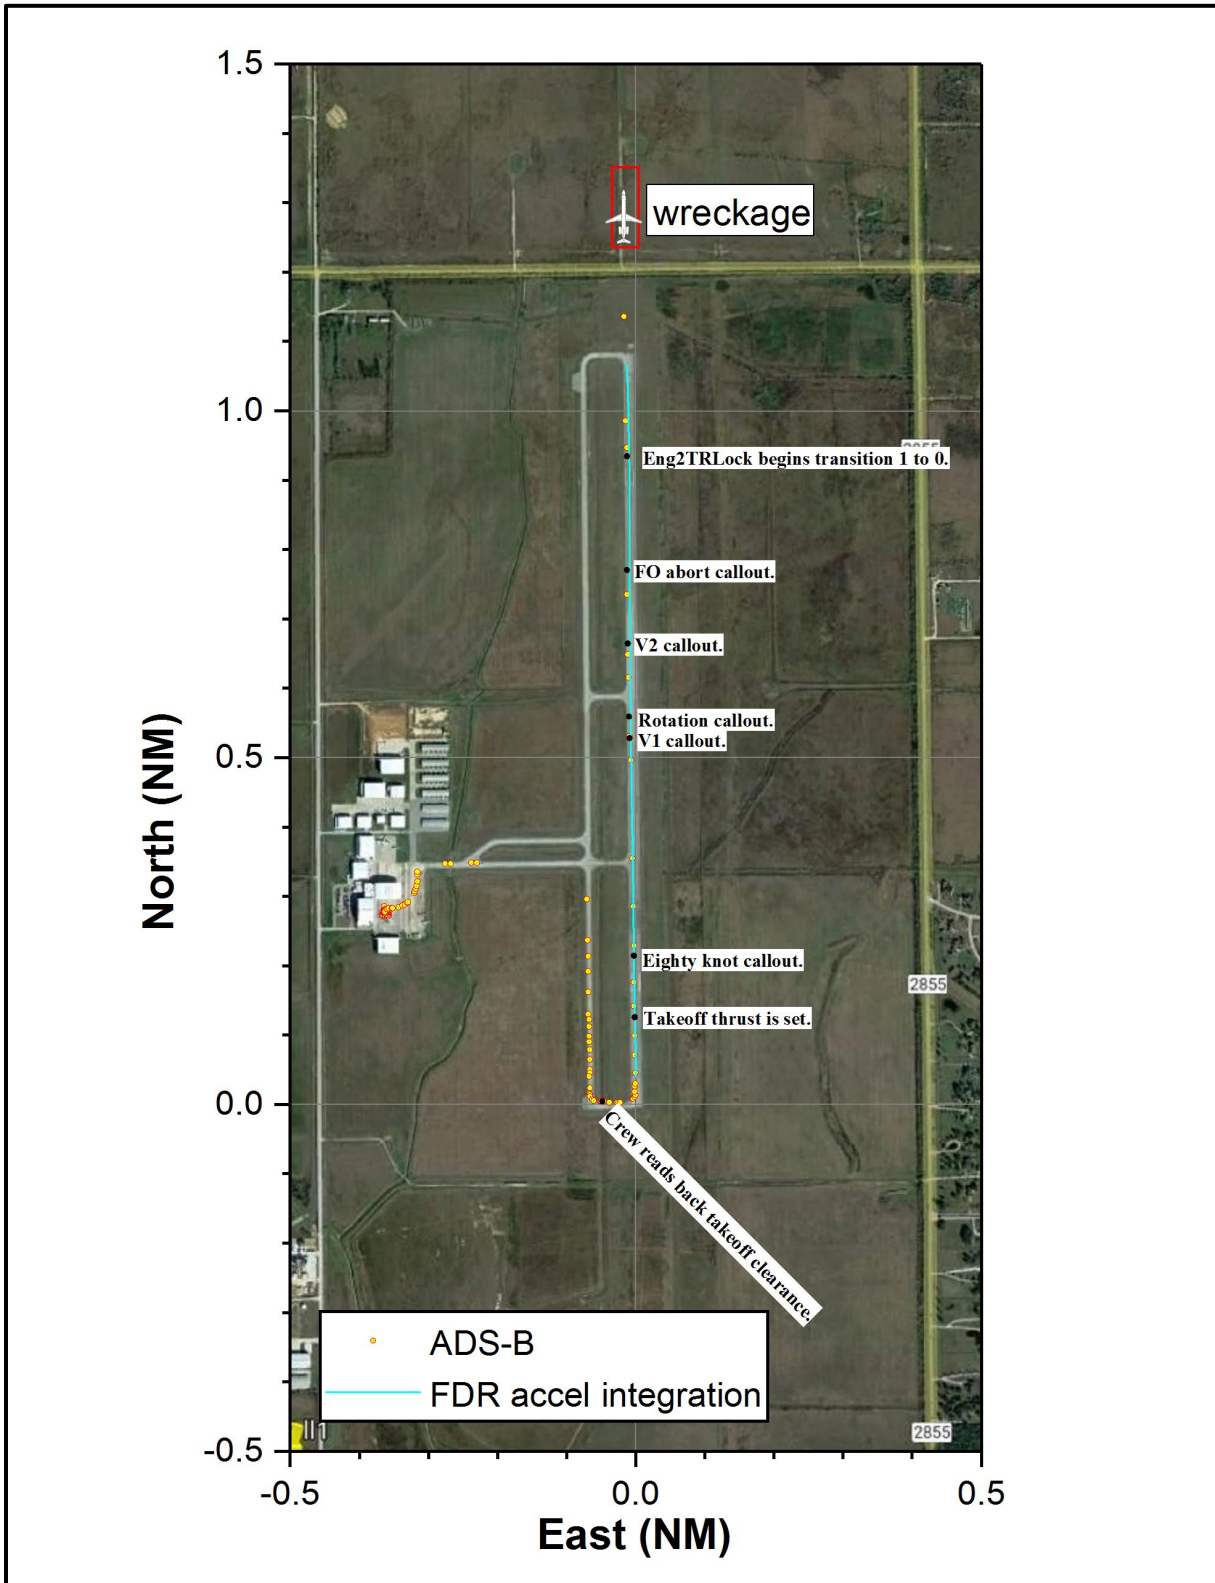
On October 19, 2021, at about 1000 central daylight time (CDT), a McDonnell Douglas DC-9-87, N987AK, owned by 987 Investments, LLC, overran runway 36 during takeoff and came to rest about a 1/4 mile off the departure end of the runway 36 at Houston Executive Airport (TME), Brookshire, Texas. (See Figure 1.) Of the 23 passengers and crew on board, two passengers received serious injuries, and one passenger received minor injuries. There was a post-crash fire, and the airplane was destroyed. The flight was operating under 14 Code of Federal Regulations Part 91 from TME to Laurence G. Hanscom Field Airport (BED), Bedford, Massachusetts.

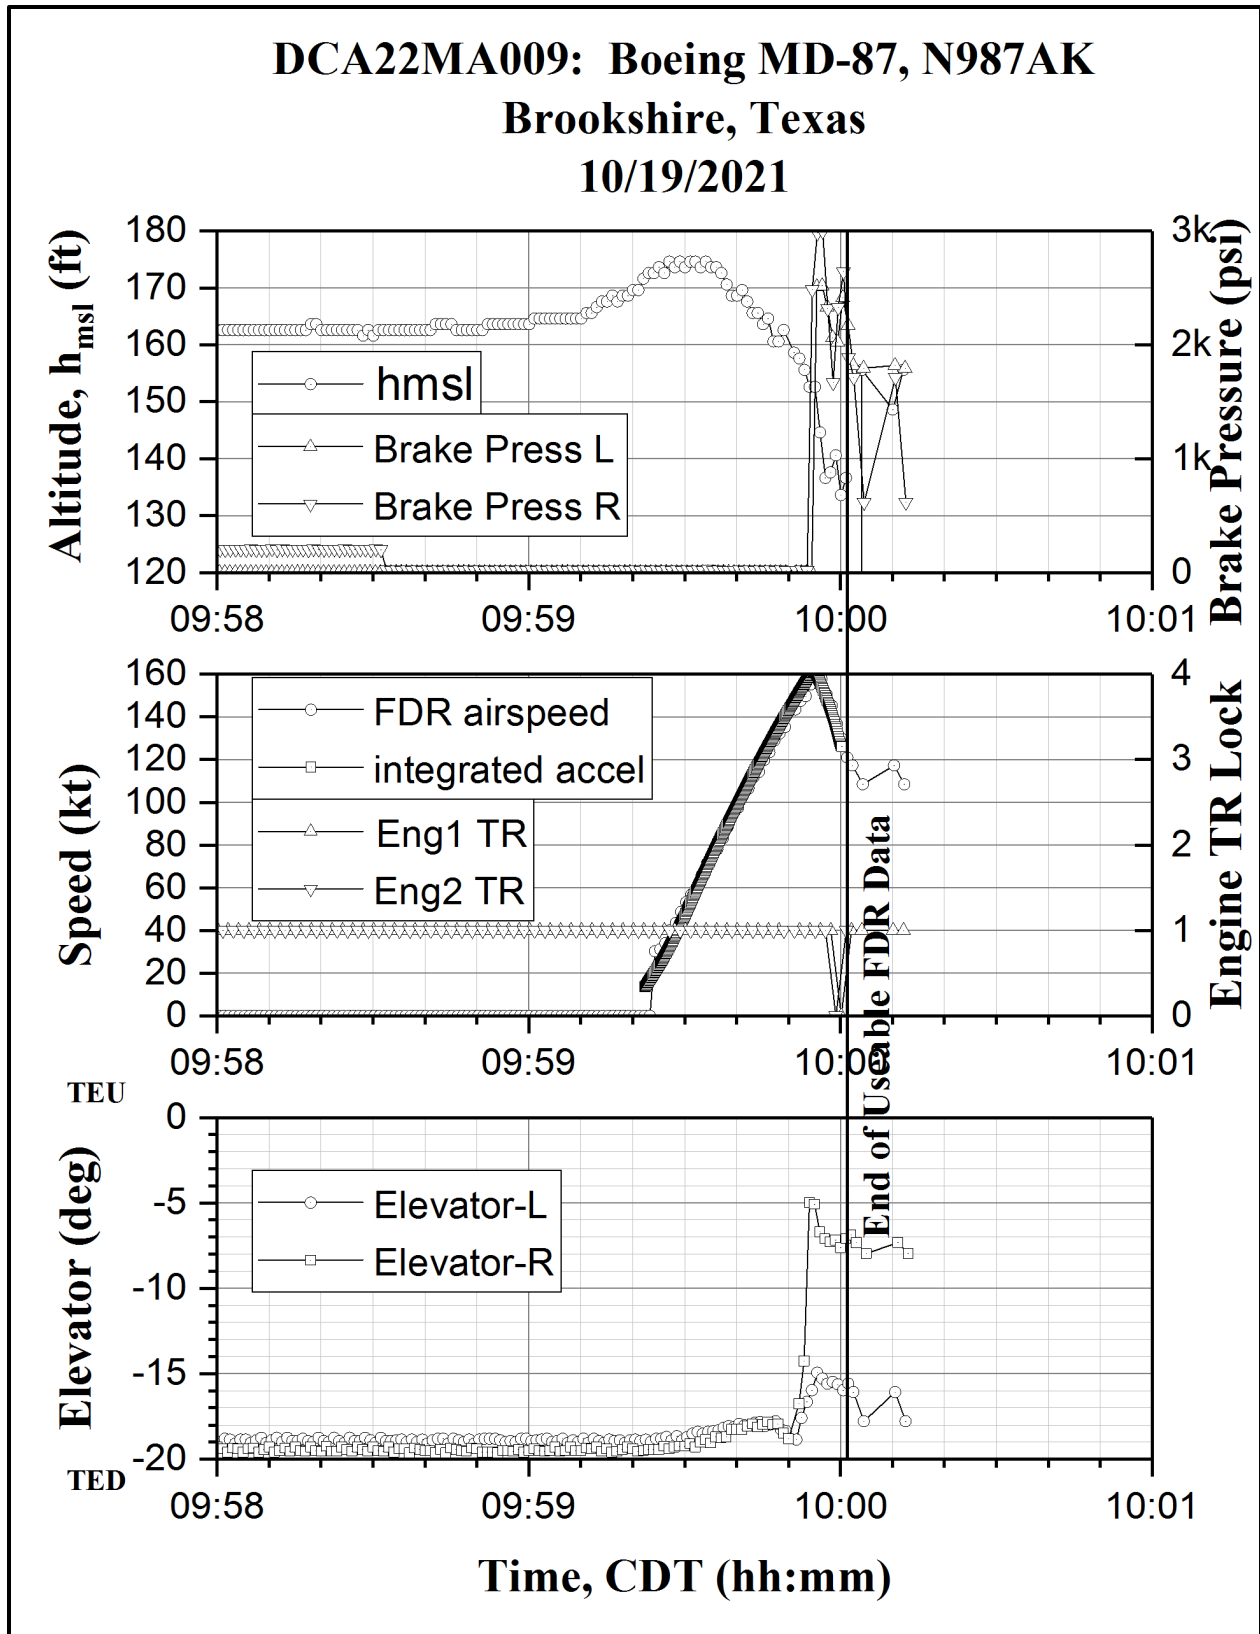
Figure 3: FDR Altitude and Airspeed during the Accident Take-off Attempt

The take-off began with the flaps, slats, and horizontal stabilizer set correctly. Figure 3 shows the FDR altitude, speed, and elevator positions during N987AK’s take-off attempt. Figure 3 includes both the recorded indicated airspeed and the groundspeed calculated from integrating the recorded longitudinal acceleration; these two speeds were very similar during the accident sequence, so reference to speed in this study indicates both the indicated airspeed and the groundspeed. The recorded elevator positions indicate that the flight crew attempted to rotate that airplane at about 0959:50 and 130 kt. However, the airplane’s pitch attitude never

increased; both the left and right elevators remained negative in the nearly full trailing-edge-down (TED) position, never reaching an airplane-nose-up or trailing-edge-up (TEU) position³.

The recovered FDR data indicate that both the left and right elevators never reached an airplane-nose-up position as would be required for rotation and take-off. The FDR recorded a maximum airspeed of 158 kt at 0959:55, well above the 132 kt rotation speed.

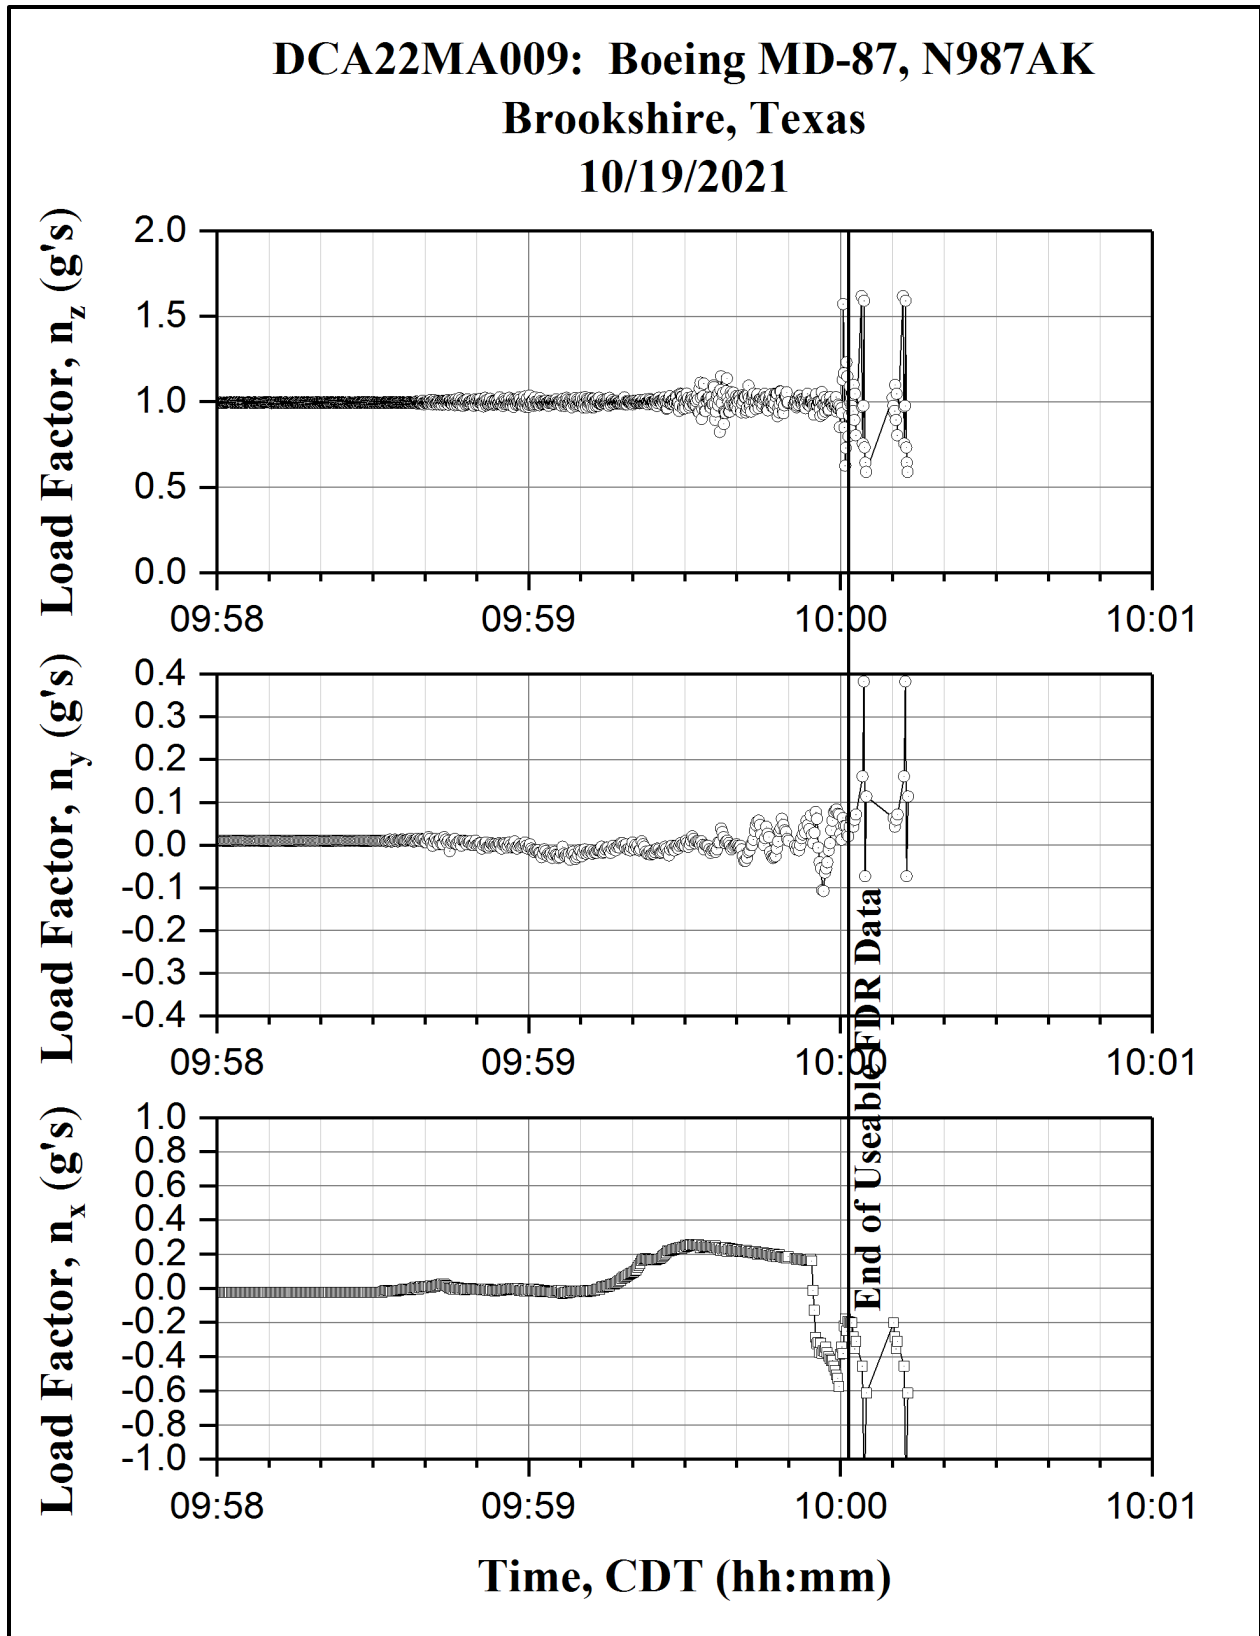
Figure 5: FDR Accelerations during the Accident Take-off Attempt

Figure 6 indicates the FDR recorded a 1.5g vertical load factor when the airplane went off the runway. The figure also shows a 0.6g deceleration and a 0.1g acceleration to the left about six seconds before the airplane departed the hard surface or about the same time the first officer called for a rejected take-off.

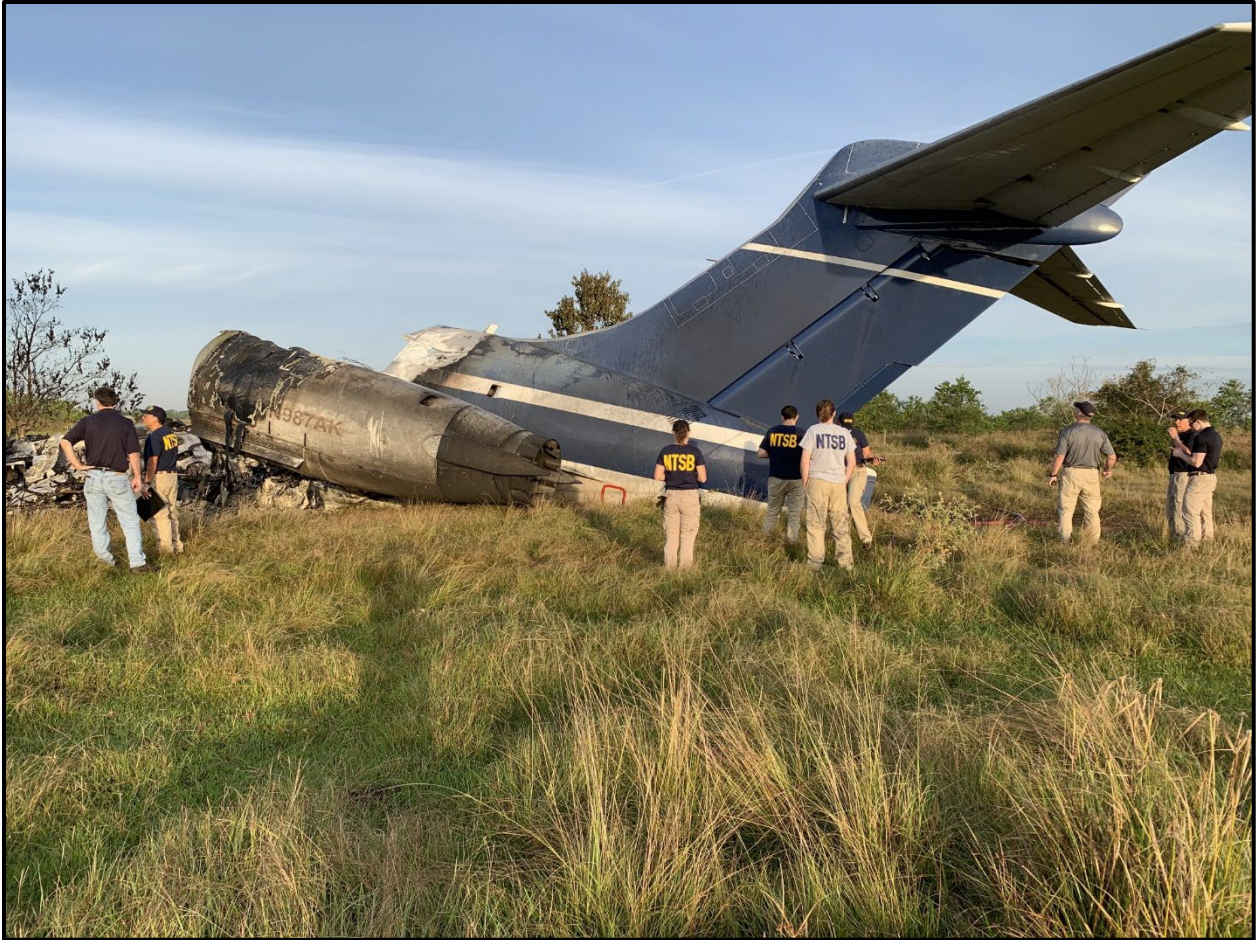
Figure 6: Photo of Tail Section

The wreckage was found scattered beyond the airport perimeter fence which is located about 600 ft beyond the end of the runway. The tail section shown in Figure 6 was one of the pieces that was furthest out, and it was located approximately 1,450 ft beyond the runway end.
