National Transportation Safety Board

DCA22MA193

AIRWORTHINESS

Group Chair's Factual Report

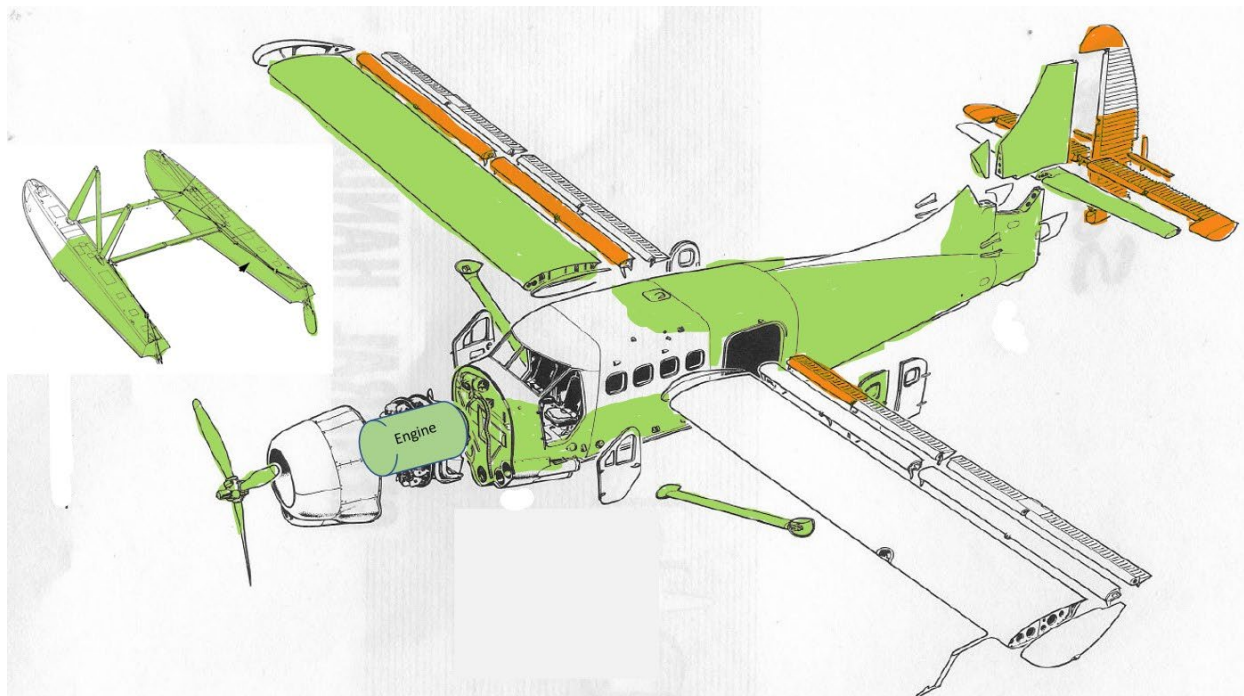
The airplane wreckage was examined at the AvTech facility after it was recovered. The airplane was highly fragmented and suffered significant damage. Most of the fuselage and floats were connected together by various flight control cables, float struts, and flying wires when recovered. These were cut during recovery to facilitate transport of the wreckage. The recovered wreckage was laid out on the floor and examined. The main items recovered included the main nose fuel tank, engine mount and engine, propeller hub and blades, forward fuselage (FS 0 to FS 204), center fuselage (FS 170 to FS 308), tail section (FS 323 to FS 467), right wing, floats, some sections of flaps, and the left and right elevators. The left wing was identified on the seafloor separated from the fuselage and the right horizontal stabilizer was identified partially attached to the empennage using underwater photography prior to recovery but they were not recovered. Major portions of 11 seats were recovered. Figure 5 highlights the parts of the airplane recovered and conclusively identified.

Figure 5. DHC-3 Otter recovered wreckage (green) and flight controls (orange) (provided by Viking, annotated by NTSB)

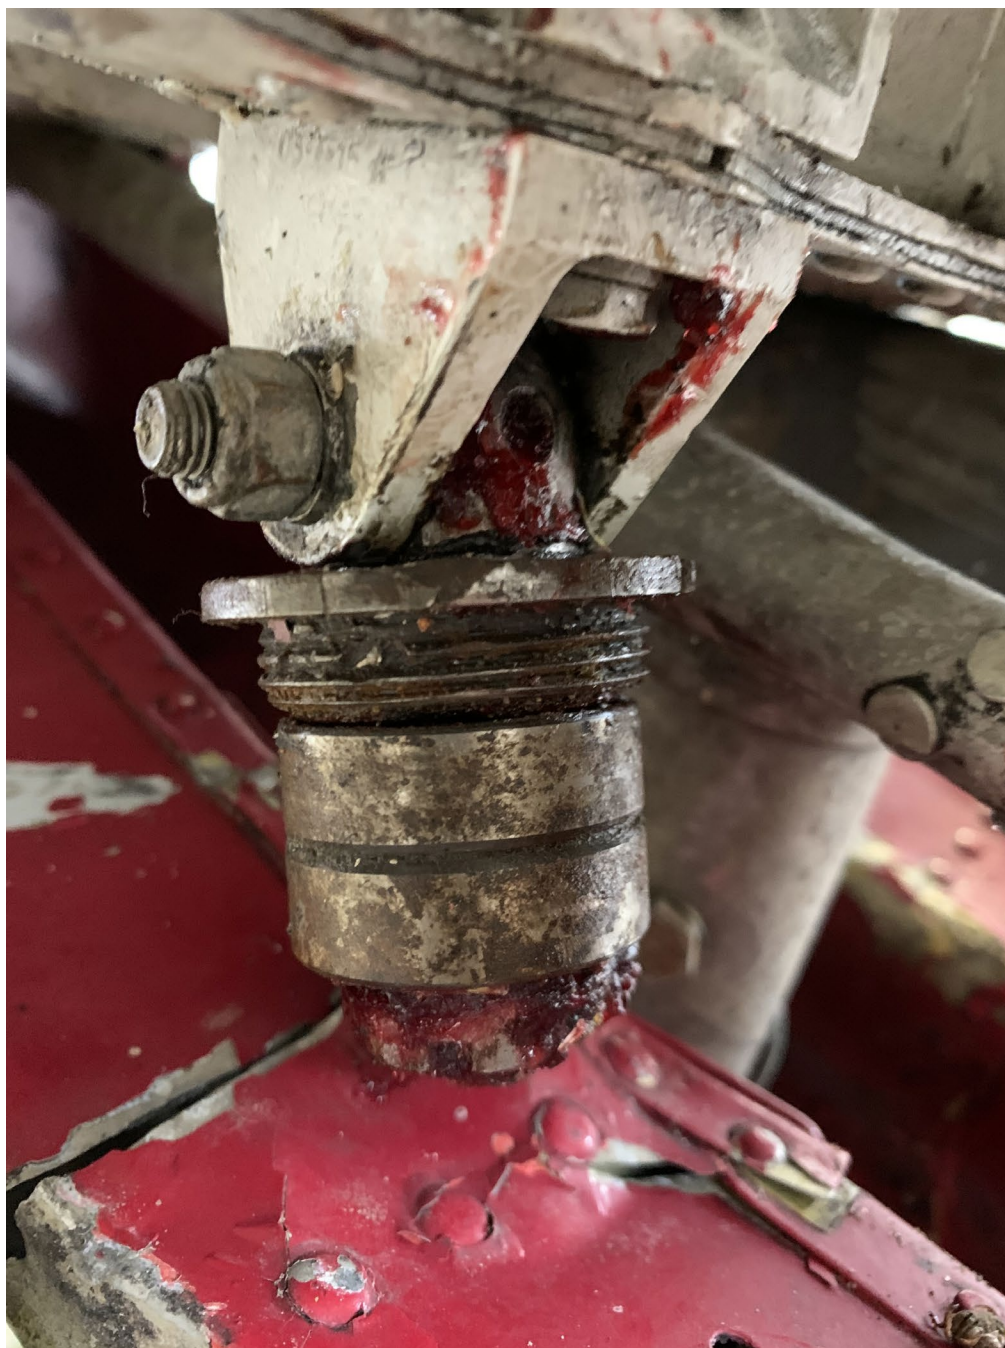
The top eye end and bearing assembly clamp nut was found unscrewed from the horizontal stabilizer trim actuator upper housing with no obvious damage to the threads. The top eye end and bearing assembly remained connected to the horizontal stabilizer mounting bracket by the upper actuator attachment bolt and could pivot freely about this bolt (Figure 6). The clamp nut could spin freely about the top eye end and bearing assembly eye bolt. The bolt attaching the lower end of the horizontal stabilizer trim actuator to the airplane was intact and installed. The lower horizontal stabilizer actuator mounting block did not exhibit looseness. The lower actuator housing could rotate freely fore-aft about the lower attachment bolt. When

the assembly was rotated full forward about the lower attachment bolt, the actuator upper assembly contacted structure. The structure was bent inwards and downwards in this location. Directly above the actuator when it was in this full forward position, the lower center skin of the horizontal stabilizer was punched through at a 90° angle. The punch through was in a rounded shape and left a circular grease imprint on the contact surface that was consistent with the top of the actuator upper housing assembly without the top eye end and bearing assembly present (Figure 7). The lock ring was not present in the lock ring groove of the upper housing assembly. The through hole in the lock ring groove was mostly clean and light could be seen through it. The area below the actuator, as well as inside the horizontal stabilizer in the area of the punch through, was searched visually and with a magnet for the lock ring but the lock ring was not found. The control cables were no longer uniformly wrapped around the drum. The actuator extension measured about 2.75 inches from the lower eye attachment bolt to the base of the actuator housing which equates to an incidence of about -2° (takeoff/neutral position) according to Viking if the clamp nut was fully seated in the top of the actuator. During removal of the actuator, the lower attachment bolt fell into the fuselage and was not recovered.

Figure 6. Horizontal stabilizer trim actuator top eye end and bearing assembly as found attached to the horizontal stabilizer mounting bracket (NTSB photo)

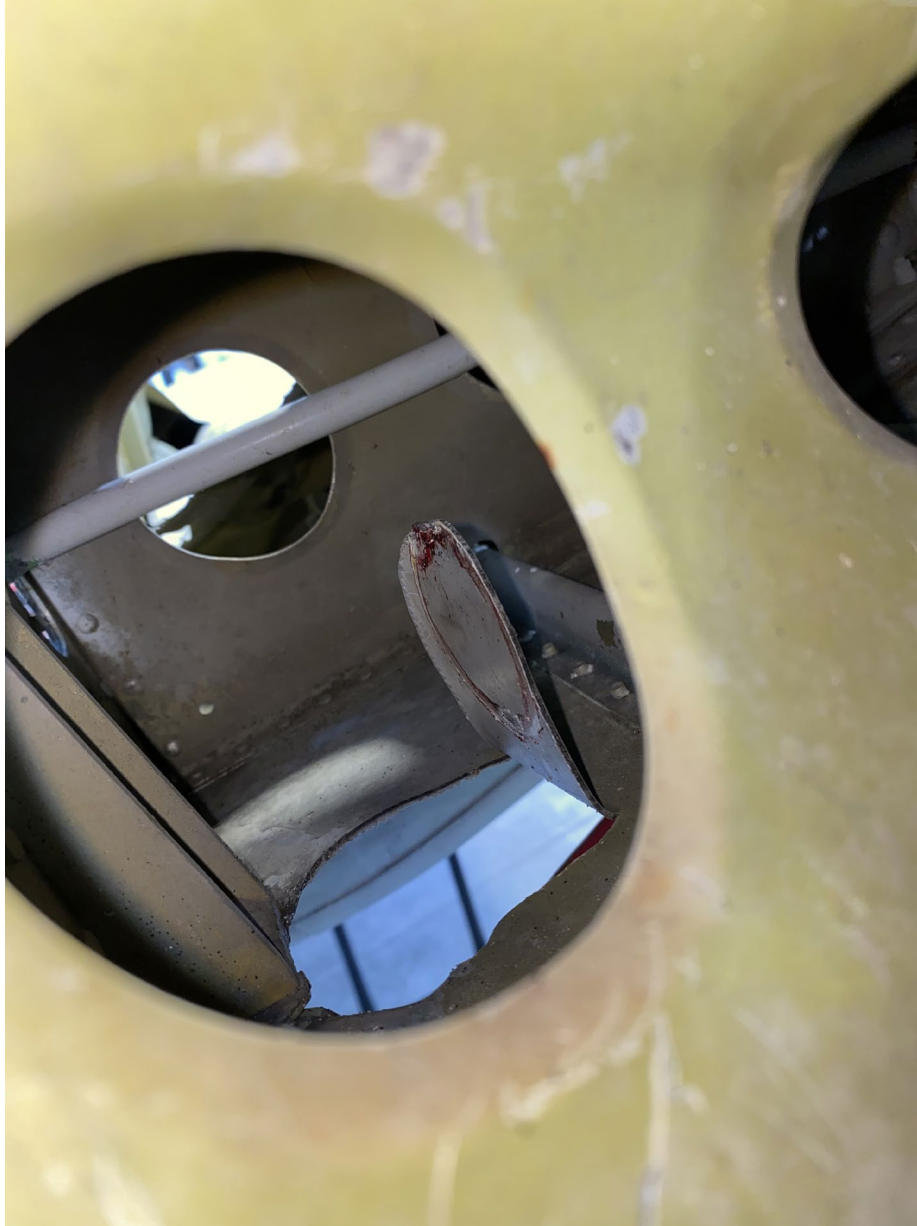
Figure 7. Lower stabilizer skin punch through and grease imprint (NTSB photo)

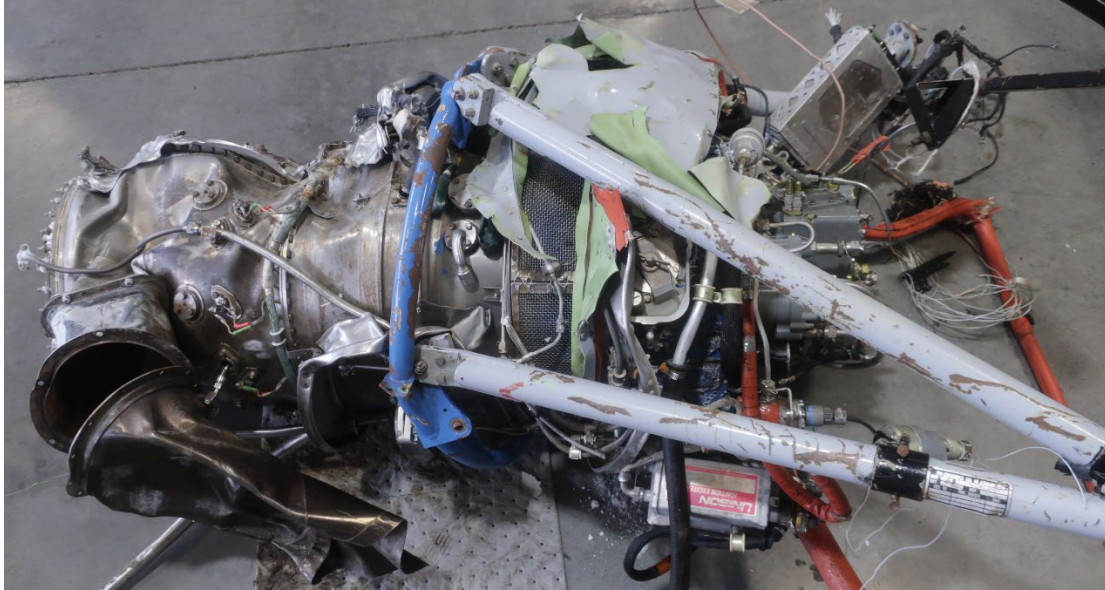
The engine was mostly intact, and the propeller assembly was separated from the front of the engine (Figure 9). The engine exhaust duct liner exhibited a counterclockwise twist as viewed from the rear. The upper engine mount connections were connected to the engine mount ring structure. The upper engine mount left and right arms were separated intact from the main fuel tank and fire wall. The engine mount "feet" had fragments of fire wall material still attached. The three engine mount points on the engine were connected to the engine mount ring.

Figure 9. Recovered engine with engine mount attached (NTSB photo)

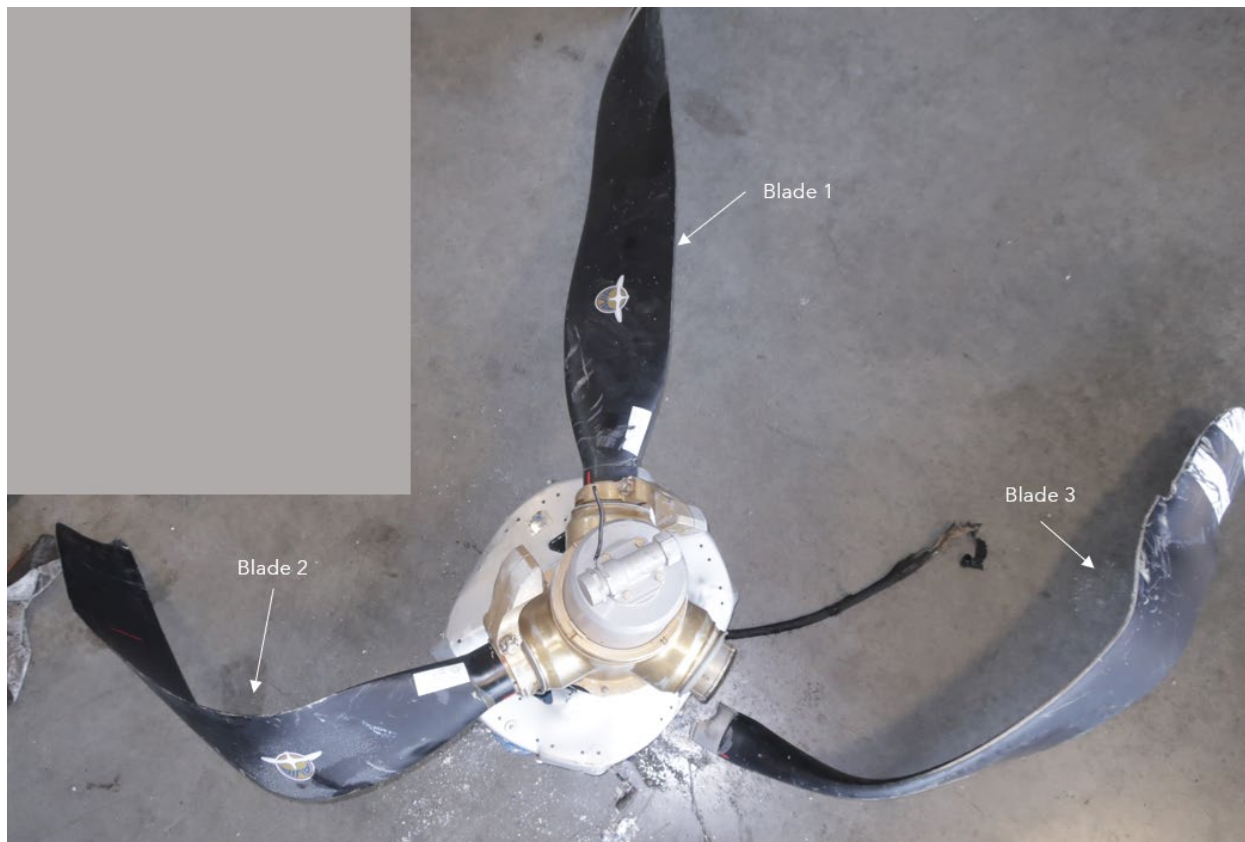
The propeller installed on the accident engine was an Avia V508H 3-bladed aluminum, single acting, feathering, and reversible constant speed propeller with a maximum allowed rotational speed of 2200 rpm; a feathering pump was not required. The propeller hub was recovered with two blades attached (Figure 10). The separated propeller blade was also recovered.

Figure 10. Recovered propeller hub and all three blades (NTSB photo)

The blade was in place in the hub and exhibited a slight torsional twist with slight trailing edge s-bending

The blade was in place in the hub and was bent aft about 80° with the leading edge facing aft. Hard body leading edge damage was evident on the blade tip.

The blade was broken out of the hub and the blade butt exhibited heavy saltwater corrosion. The blade was twisted along its length, bent aft about 50°, and the leading edge had s-bending at the tip. There was leading edge damage with ½ inch semicircular gouge located about 8 inches from the tip.

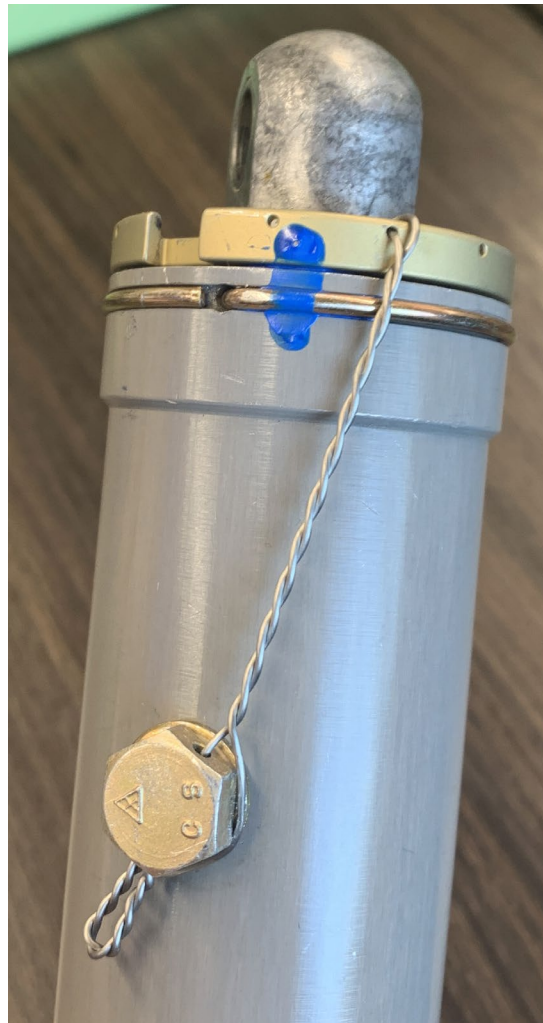
About 25 years ago Kenmore developed an umbrella for the top of the horizontal stabilizer actuator to prevent moisture from entering the internal mechanism of the actuator. The rubber umbrella is installed on the horizontal stabilizer between the lower skin and the actuator mount on all their airplanes as a minor alteration. After the accident and based on the preliminary information published, Kenmore began development of a secondary lock feature for the horizontal stabilizer actuator clamp nut. STC SA02761SE was issued by the FAA on January 31, 2023. The STC modification provides a new clamp nut with a raised flange on the upper edge where safety wire can be attached. A new drilled head screw block bolt, washers, and castellated nut are provided to allow for the installation of safety wire between the clamp nut and bolt and a new lock ring is

provided for the clamp nut (Figure 11). The STC instructions state that only one hole is allowed in the clamp nut.

Figure 11. STC modification to horizontal stabilizer actuator clamp nut (NTSB photo)
