National Transportation Safety Board

DCA22MA193

OPERATIONAL FACTORS

Group Chair's Factual Report

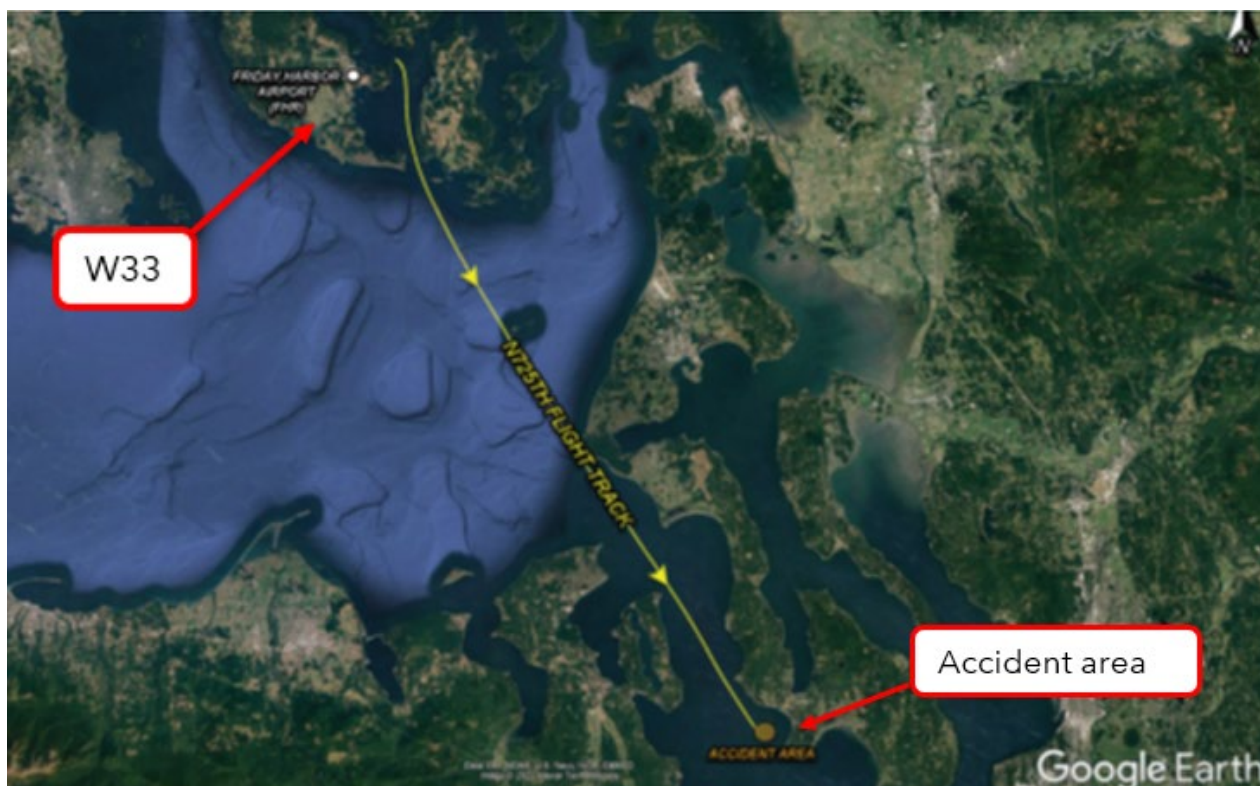
Figure 2. ADS-B track of accident flight on Google Earth overlay

FAA tracking data showed that after the accident flight departed W33, it initially flew on an approximate ground track of south and then turned to an approximate ground track of south-southeast, (see Figure 2).

The accident flight lasted about 18 minutes with the airplane cruising at altitudes mostly between 600 and 700 ft mean seal level (msl) and at groundspeeds between 115 and 125 knots. During the final minutes of the flight, the airplane began a climb, reaching a maximum altitude of about 1,000 ft msl before entering a rapid descent, and the data ended about 1509.

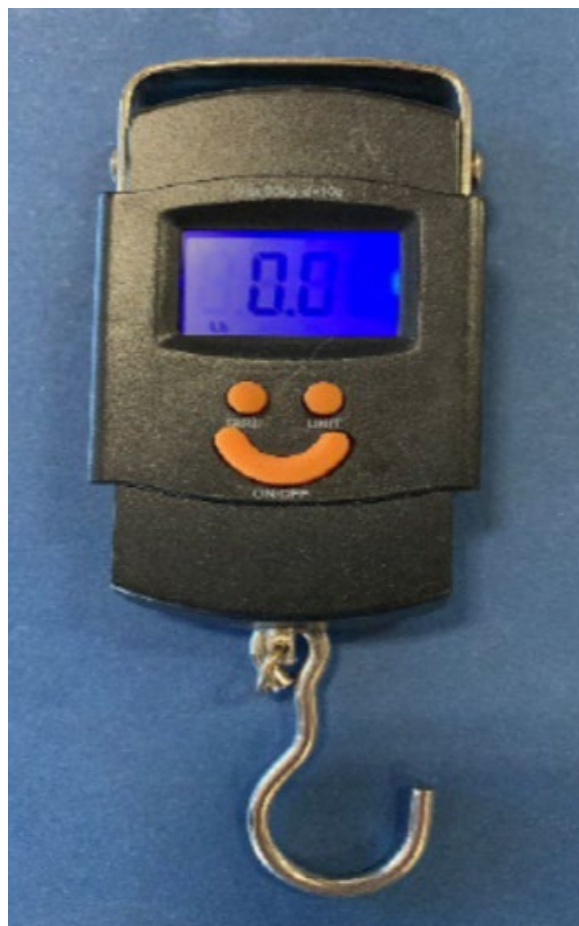
Figure 4. Sample baggage scale used to weigh bags at docks.

The airplane was equipped with a hand-held baggage scale that a pilot would use to get the bag weights for any passenger bag that was being loaded. The photo below in Figure 5 was of a similar bag scale that would have been on the accident airplane, according to the chief pilot.
