National Transportation Safety Board

DCA22MA193

AIRPLANE PERFORMANCE STUDY

Location: Mutiny Bay, Whidbey Island, Washington
Date: September 4, 2022
Time: 1509 PDT
2209 GMT
Airplane: De Havilland DHC-3 Turbine Otter Seaplane, N725TH

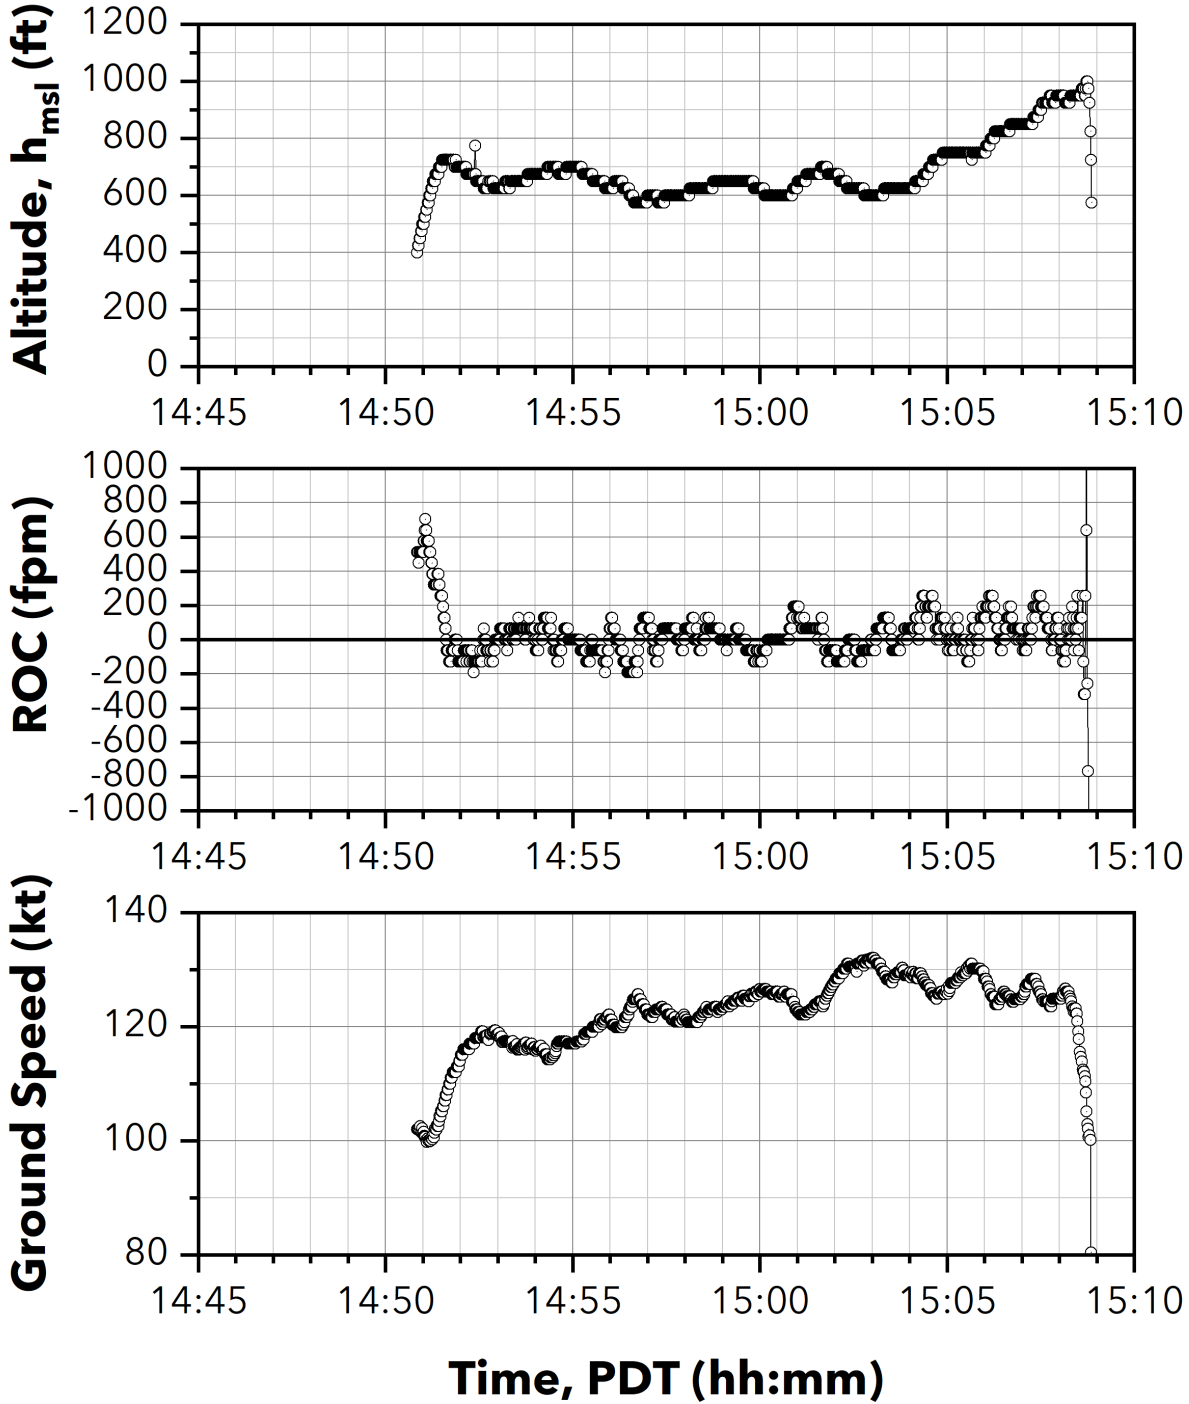
Figure 3 shows the ADS-B altitude, rate of climb, and ground speed for the approximately 18-minute flight. A sounding for the area at the time of the accident indicated that a headwind of approximately 5 kt existed at 1,000 ft msl. Figure 4 highlights the final two minutes of the flight.

Figure 3: ADS-B Altitude, ROC, and Ground Speed for Accident Flight

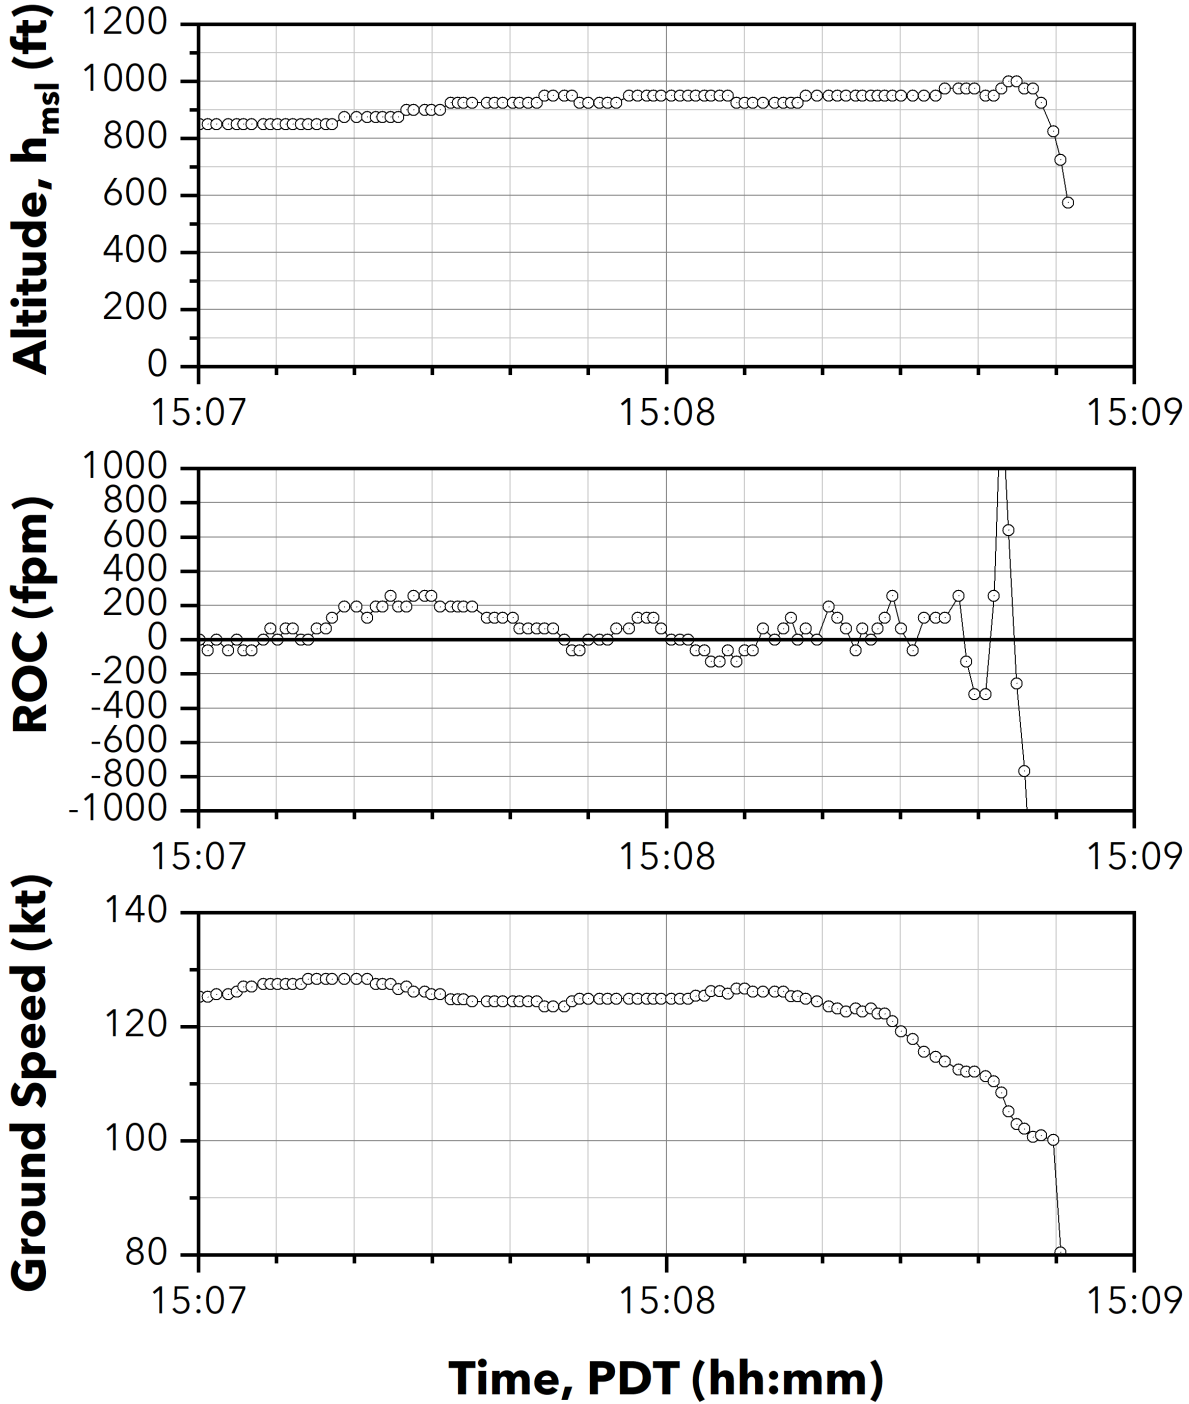
Figure 4: ADS-B Altitude, ROC, and Ground Speed for Final Two Minutes

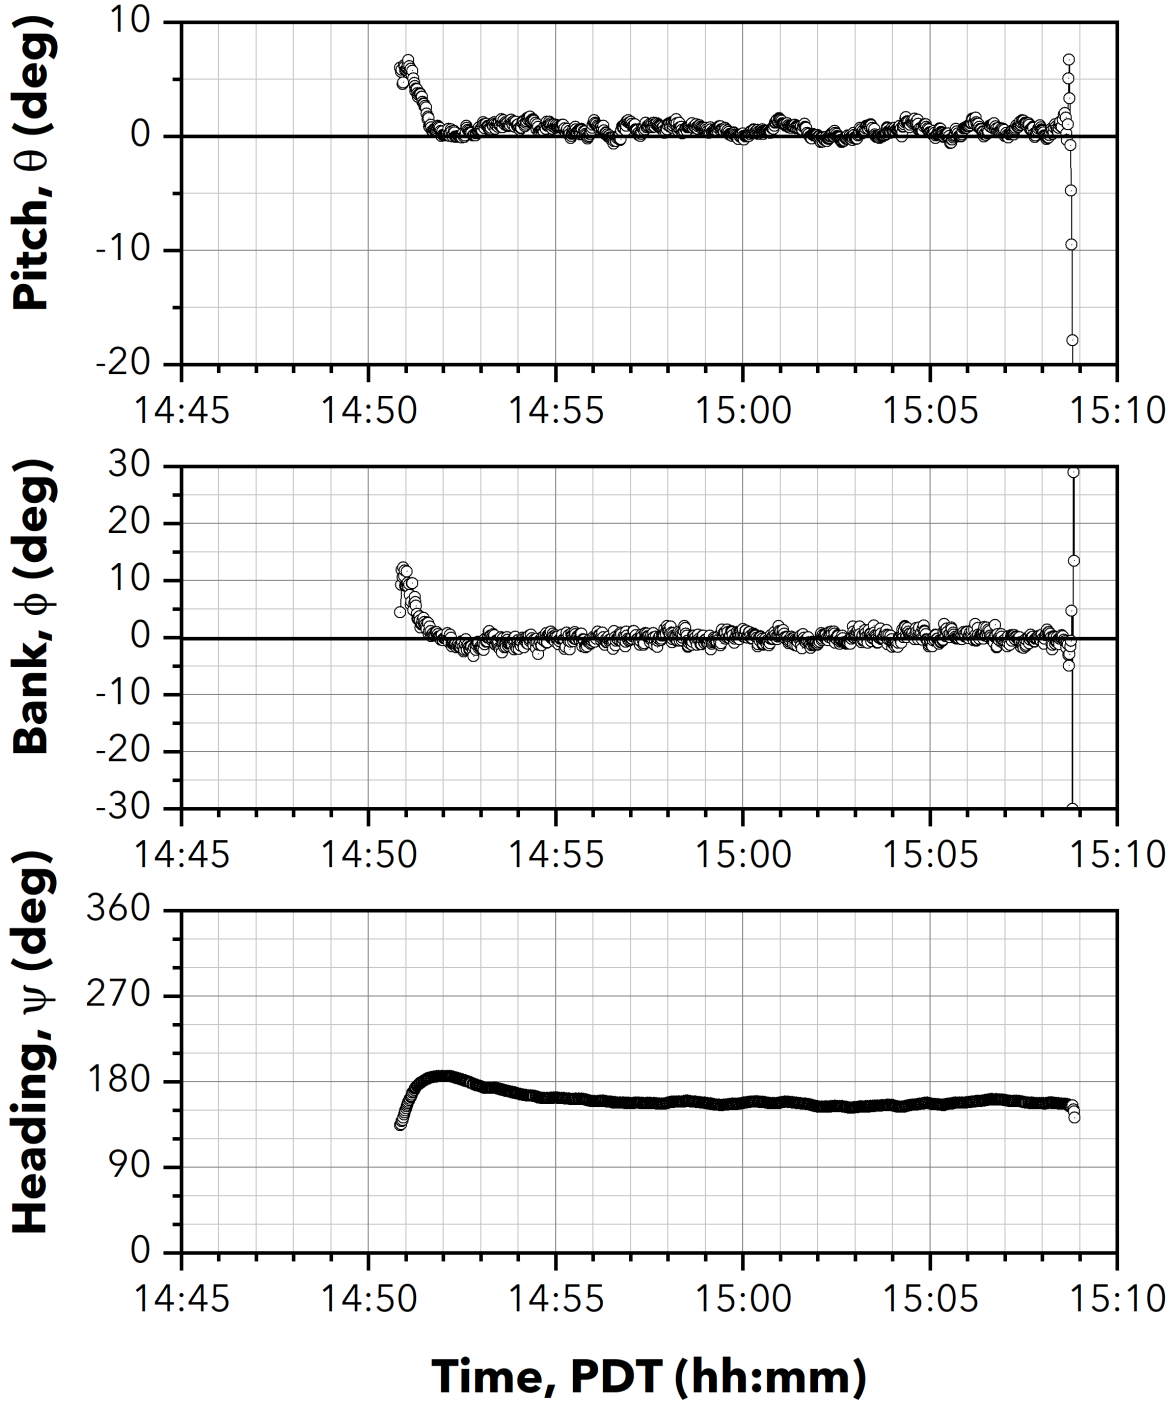
The airplane attitude information for the flight estimated from ADS-B data is shown in Figure 5 and is unremarkable until the end of the flight at about 1508:43. At this time, the airplane pitched up to approximately 8° and then abruptly pitched down to 58° when the ADS-B data ended. Figure 6 highlights the airplane attitude in the final two minutes of the flight.

Figure 5: Estimated Pitch, Bank, and Heading Angles for Accident Flight

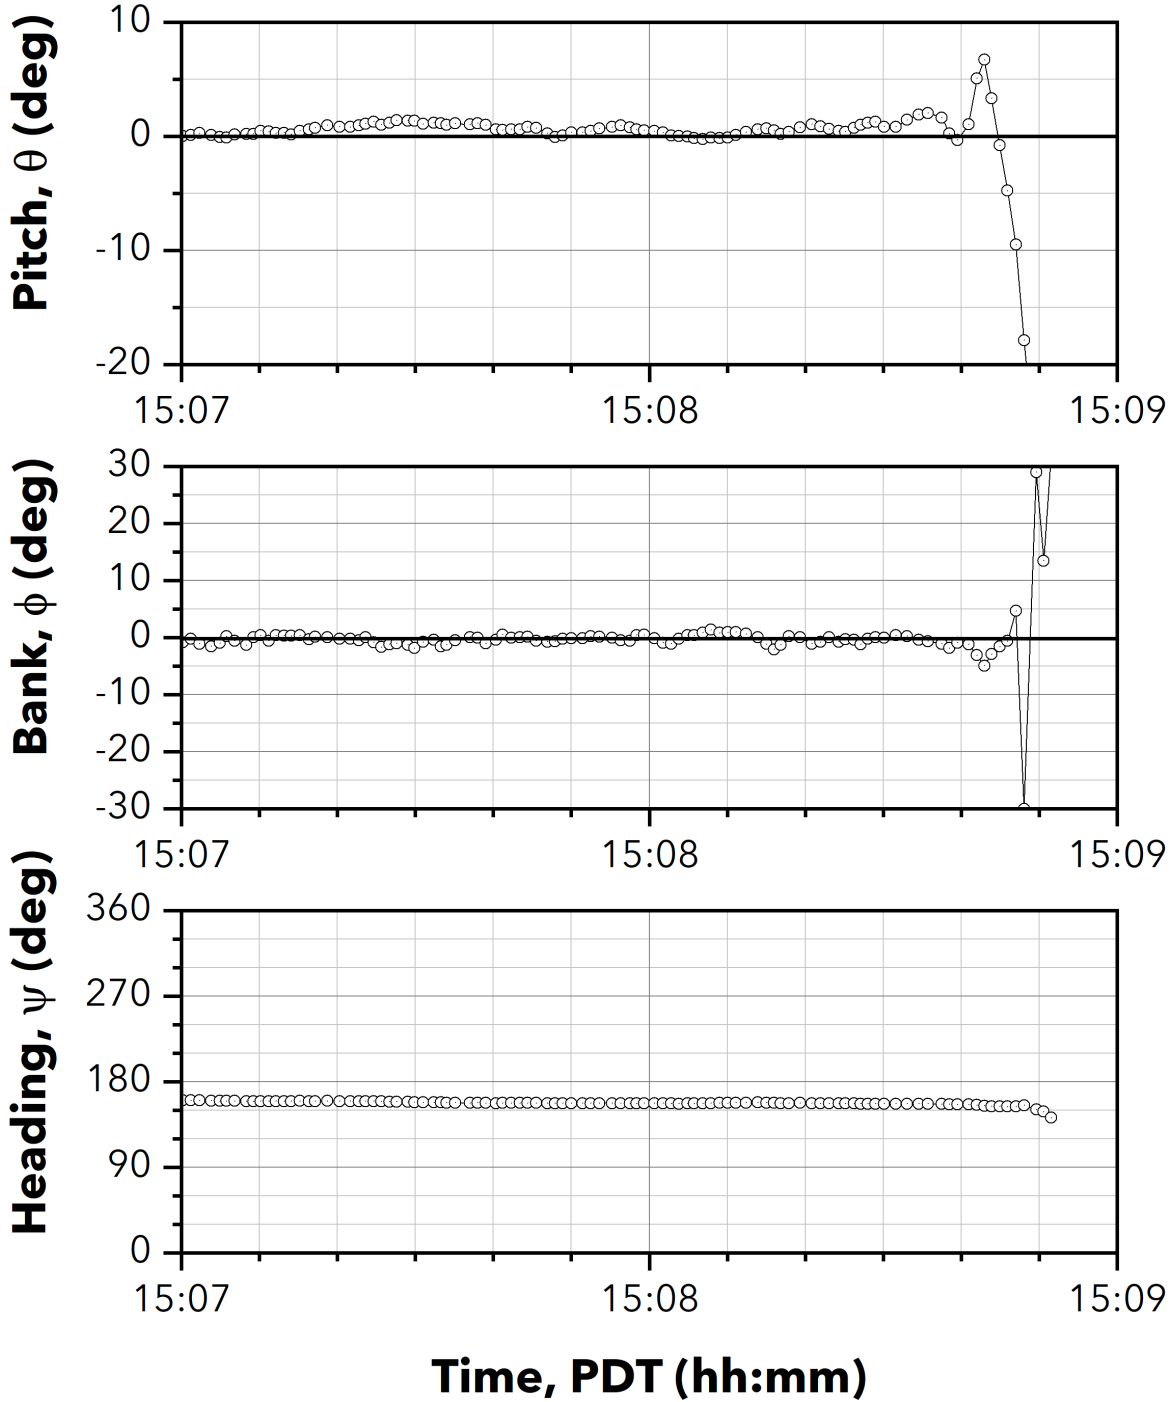
Figure 6: Estimated Pitch, Bank, and Heading Angles for Final Two Minutes

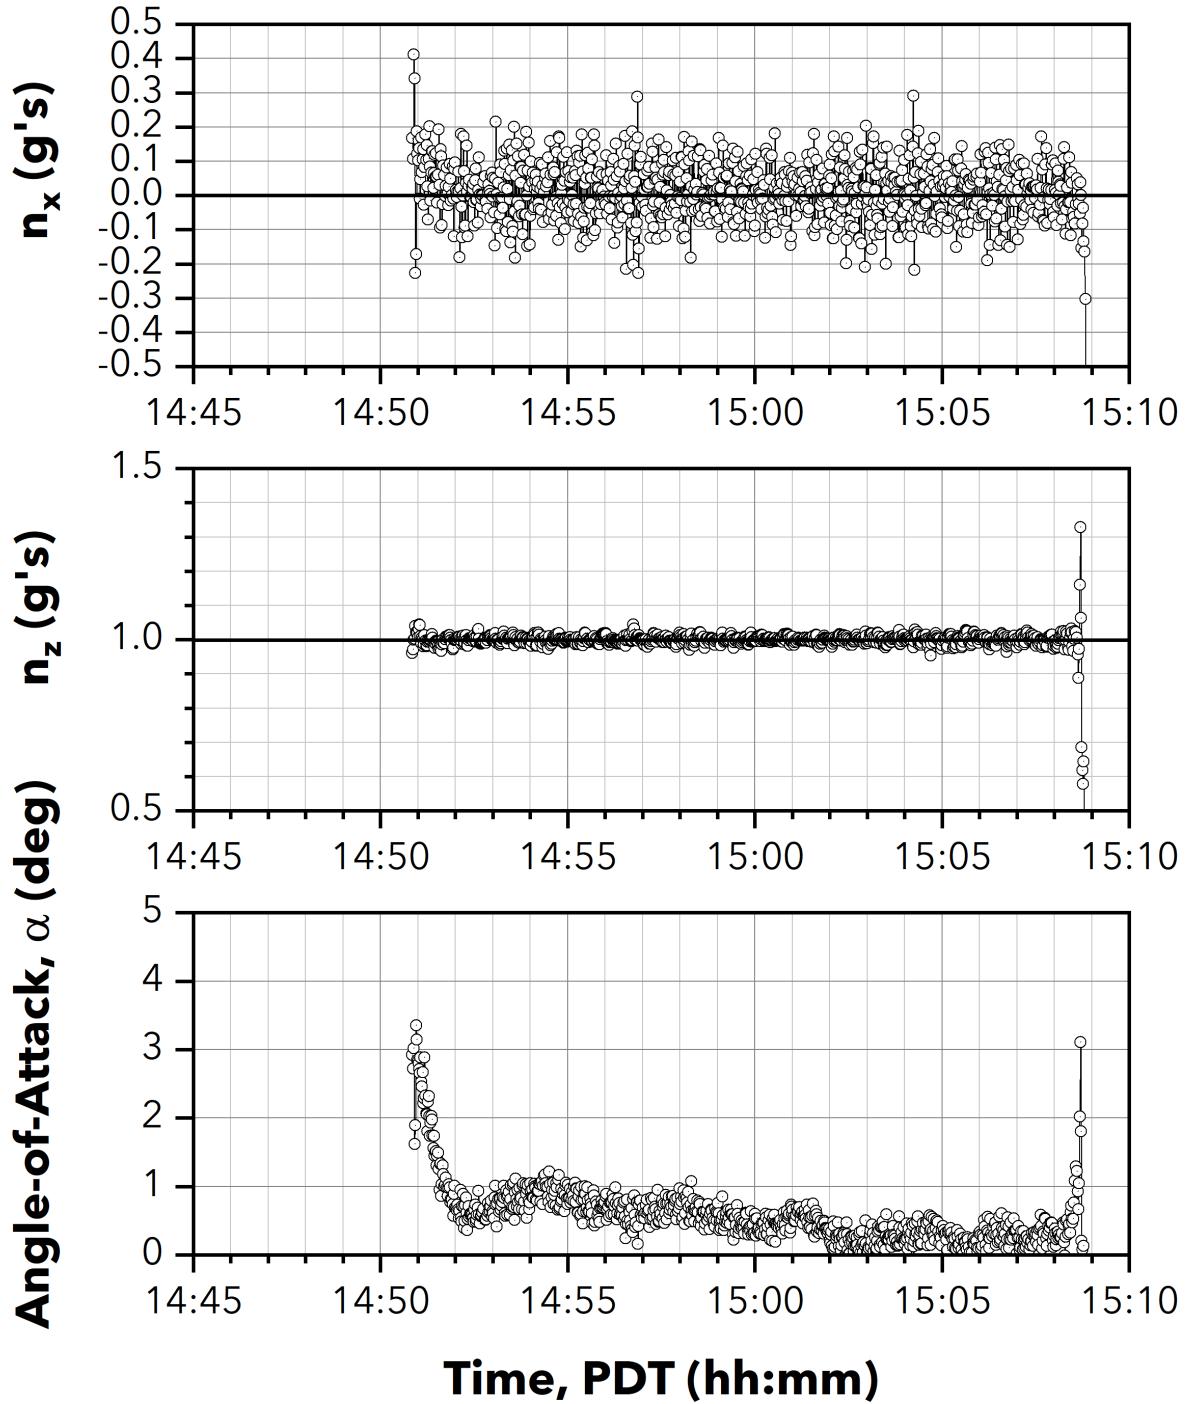
Figure 7 includes the estimated angle-of-attack, as well as longitudinal and normal load factors. Like the airplane attitude data, these data appear normal until the last eight seconds when the airplane pitched up to reach a normal load factor of 1.3g's and then pitched down to a normal load factor of less than 0.5g's before the data ended. Figure 8 highlights the final two minutes of the flight.

Figure 7: Estimated Longitudinal / Normal Load Factors and Angle-of-Attack for Accident Flight

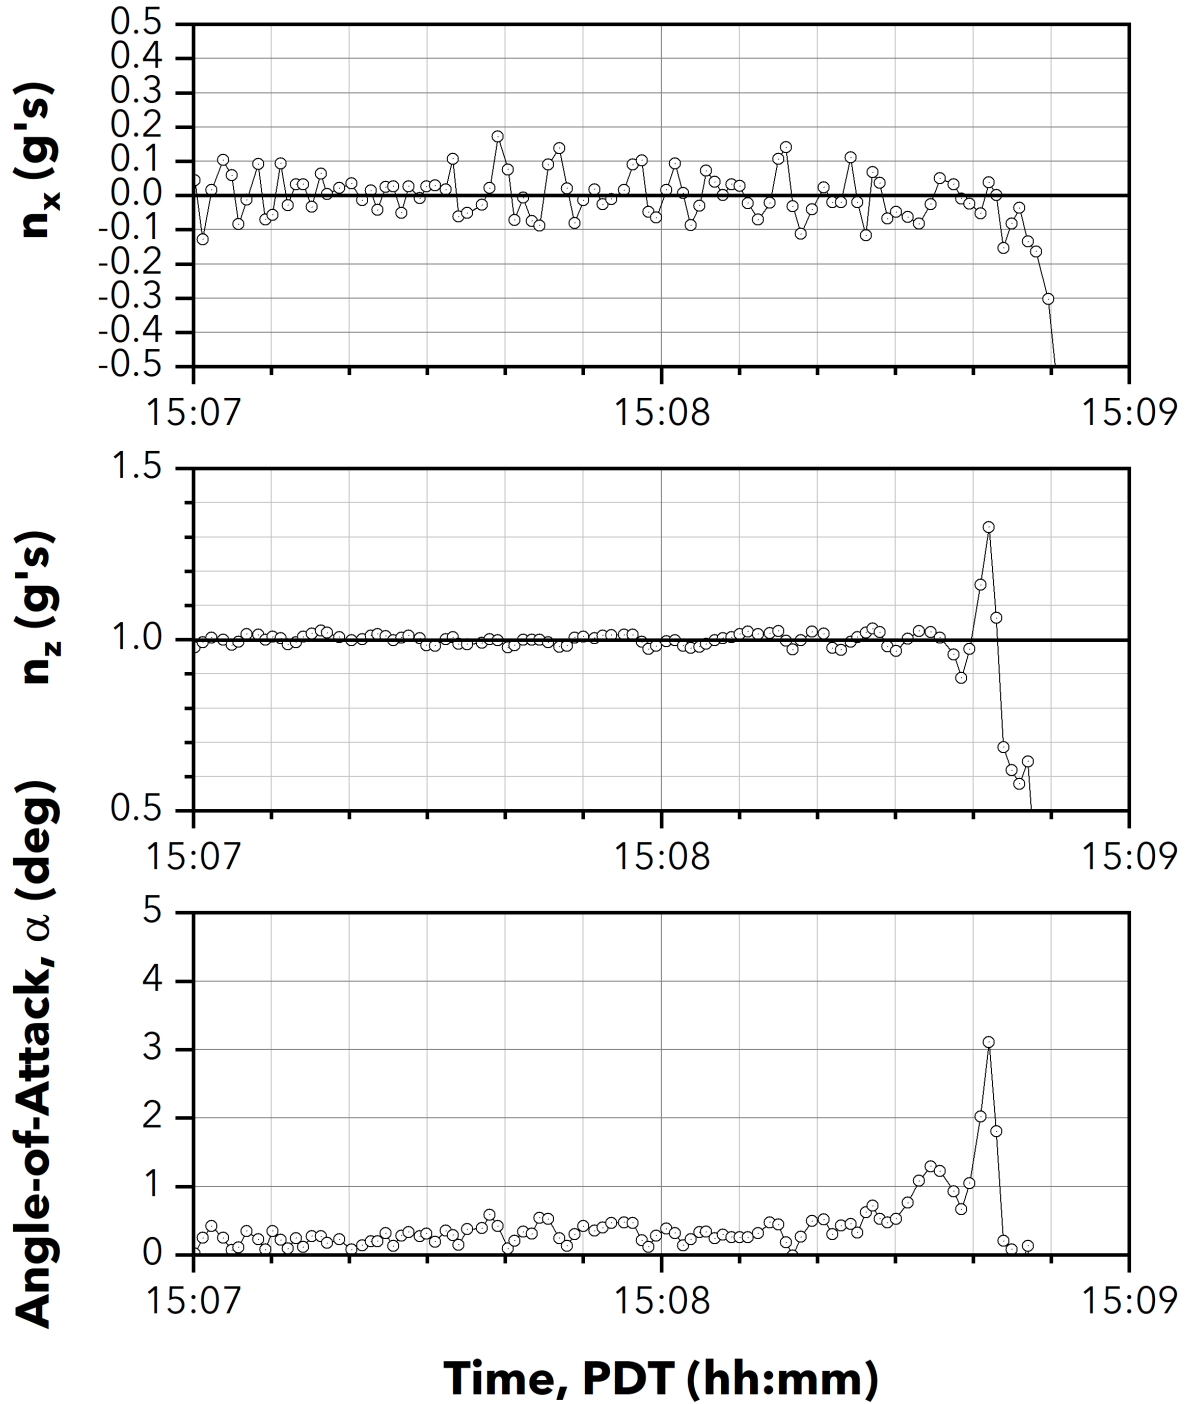
Figure 8: Estimated Longitudinal / Normal Load Factors and Angle-of-Attack for Final Two Minutes
