National Transportation Safety Board

DCA23FA149

AIR TRAFFIC CONTROL

Group Chair's Factual Report

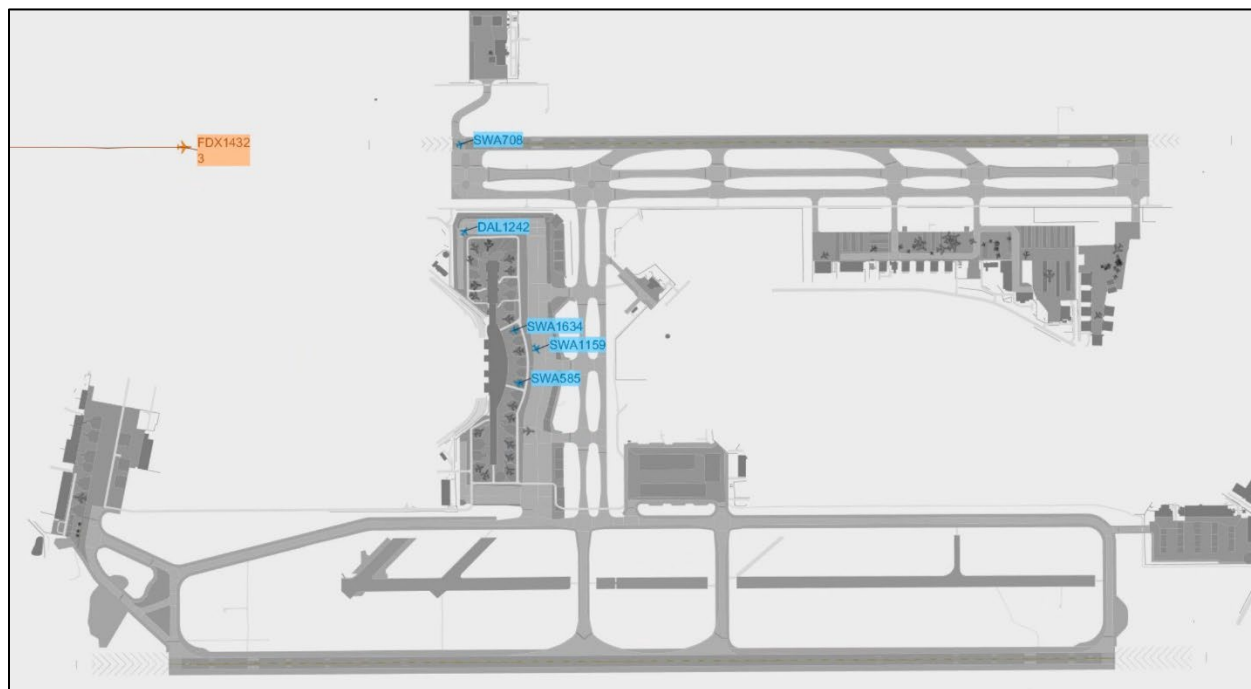
The flight track information used in the RE Performance Study, and playback provided with this report¹⁰ was provided by Saab, Inc. and is a recording from Saab's Aerobahn Global Flight Manager tool. Aerobahn Global Flight Manager is a commercial product typically used by airport operators and airlines to improve the efficiency of their operation. At the time of the incident, Aerobahn was being evaluated by commercial users and was not being utilized by air traffic control. A screen capture of this replay is provided below in figure 1.

Figure 1: Screen capture of the SAAB Aerobahn Collaborative Decision Making (CDM) and Efficiencies platform playback as viewed through a beta desktop application display.

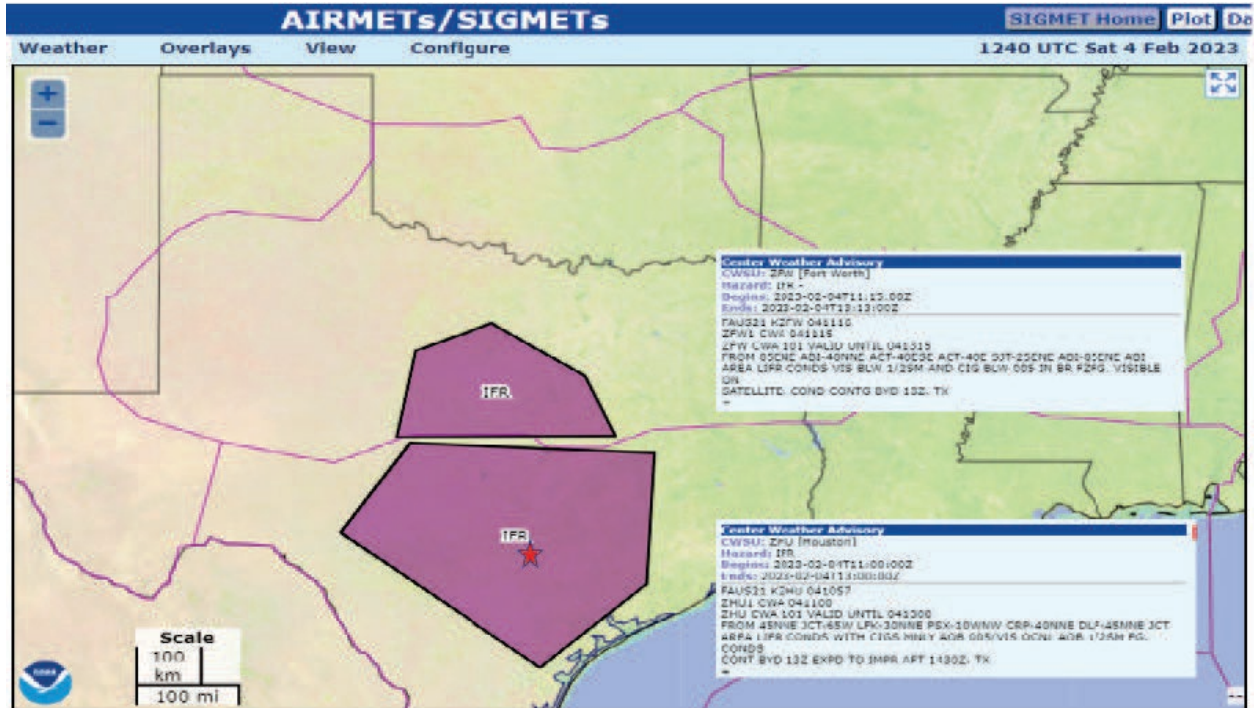
The NWS Houston CWSU issued a CWA #101 at 0457 CST, which was valid through 0700 CST for LIFR conditions over the region with ceilings below 500 feet agl, and visibilities at or below 1/2 mile in fog. The CWA advisories that were current are depicted in figure 2.

Figure 2. Center Weather Advisory (CWA) current for LIFR conditions over the area. The approximate incursion location is marked by the red star.

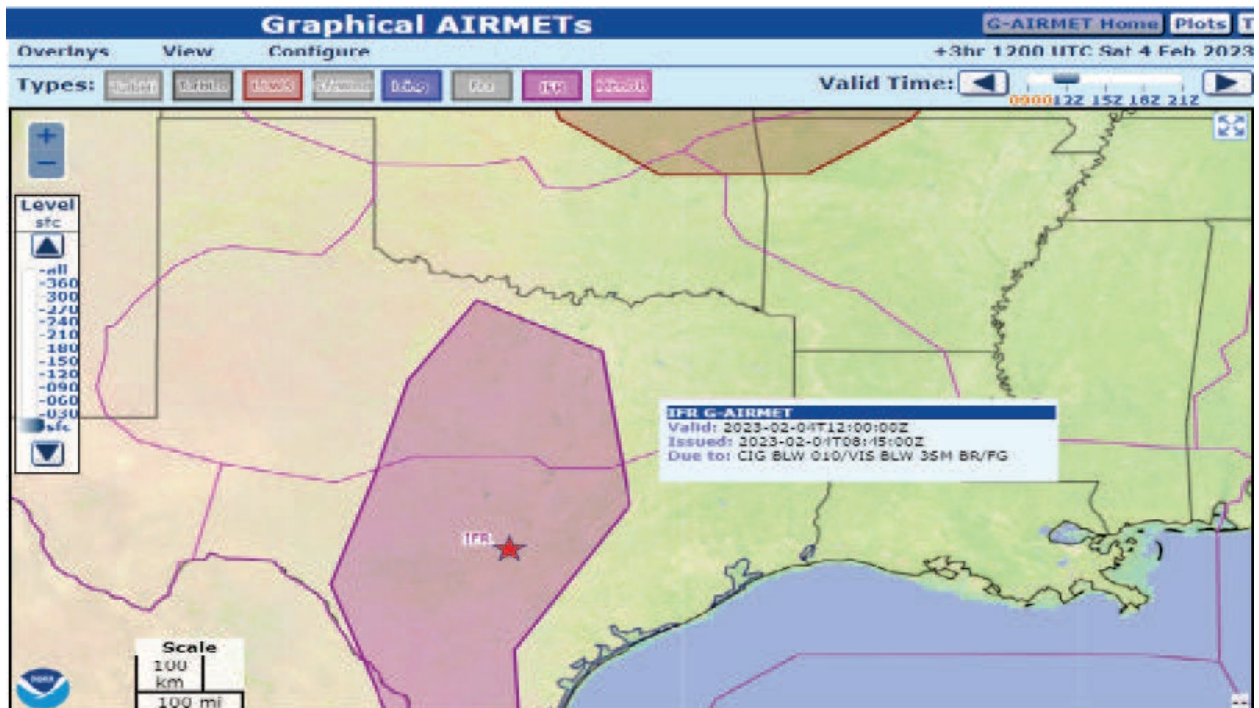
The NWS issued a G-AIRMET at 0245 CST that was valid through 0700 CST for a large area of IFR conditions over Texas which included the incident location. The applicable G-AIRMET is depicted in figure 3.

Figure 3: Depiction of Graphical-AIRMETS for 0640 CST and valid at the time of the incident.

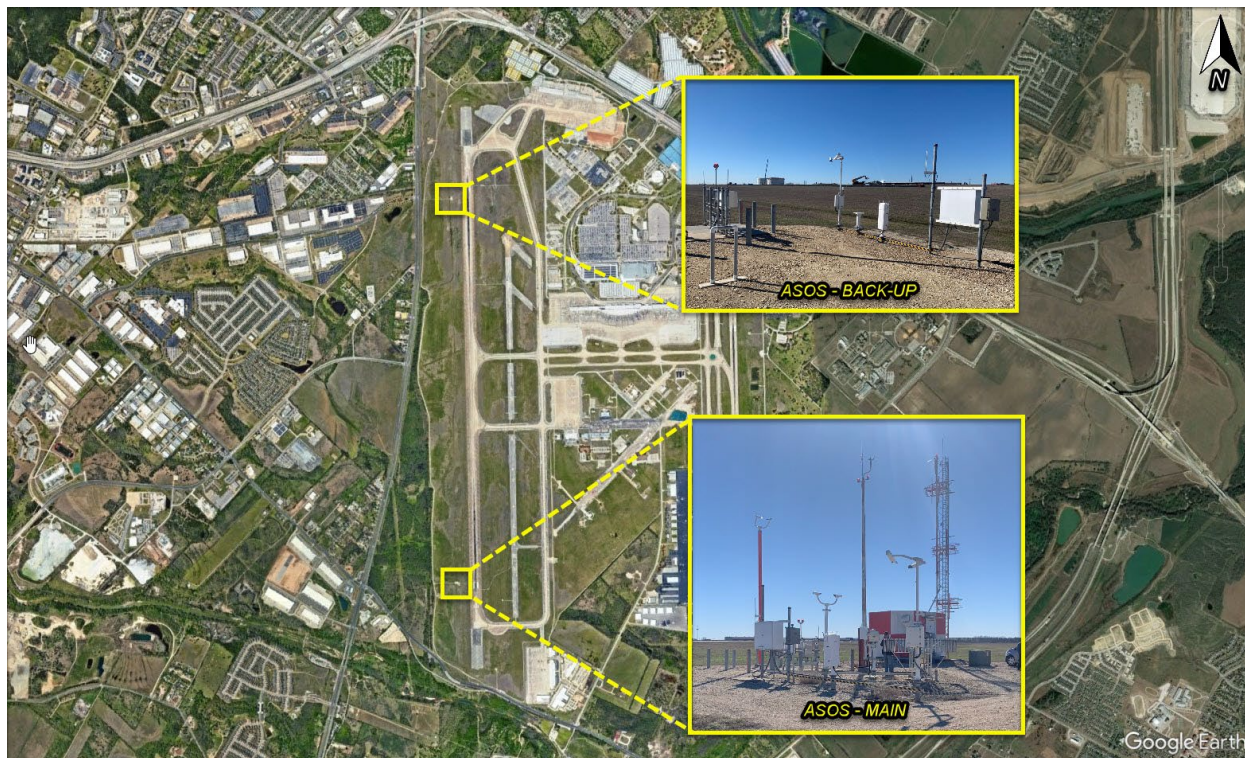
There was an ASOS installed at the facility, and more detailed information is available in the Meteorology factual report. The technical operations person that maintained this equipment was not available while we were on-site at AUS. Figure 4 below shows the location of the installed sensors, with photos of the main and back-up arrays inset. According to the interview conducted with the CWO Supervisor, there had been long-term accuracy concerns regarding the reported temperatures from their installed ASOS. According to the CWO Supervisor, it was believed to be linked to its physical location on the airfield. The location was such, that it sat low in sort of a “bowl”, and allowed the cold air to sink, and provided temperature readings that could be significantly lower than that on the airport operating area. Locally based airlines had significant concern with regards to its effect on their deicing requirements. The CWO was able to verify this disparity, and therefore began

augmenting the METARs when the disparity was noted but was then instructed by the FAA to stop, and they no longer augmented the temperature values.

Figure 4. Location of ASOS Main and Backup weather sensor arrays.

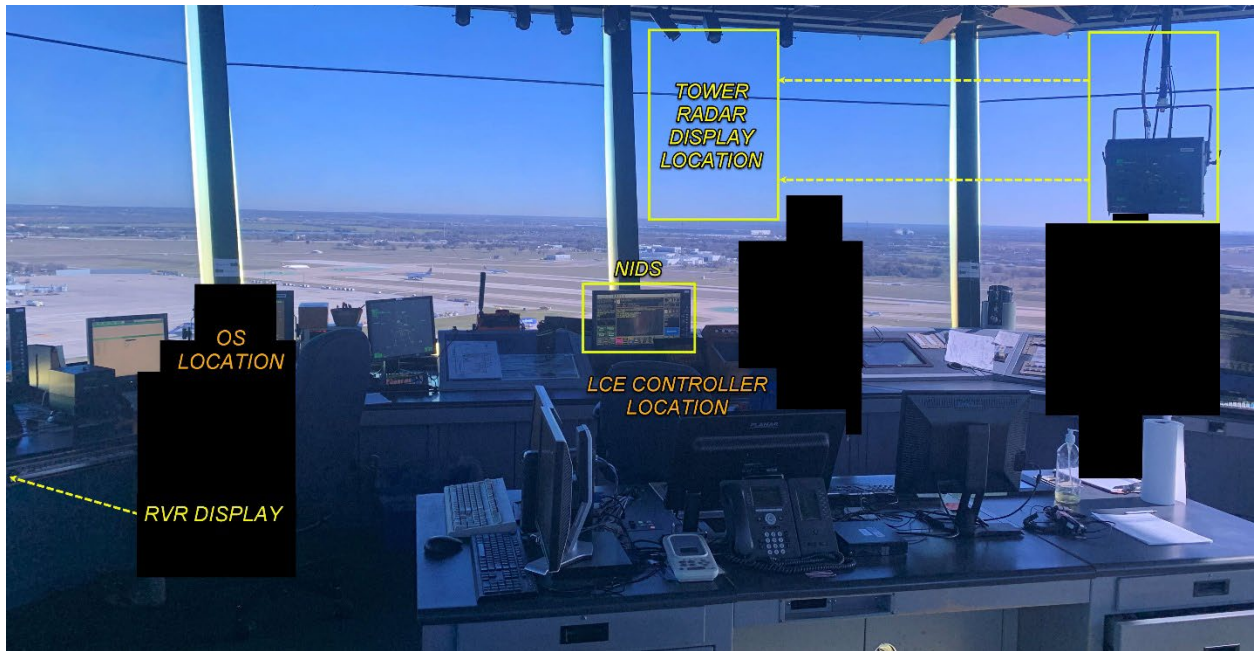
Figure 5. Tower cab shows applicable control positions and pertinent equipment locations (individuals redacted for privacy).

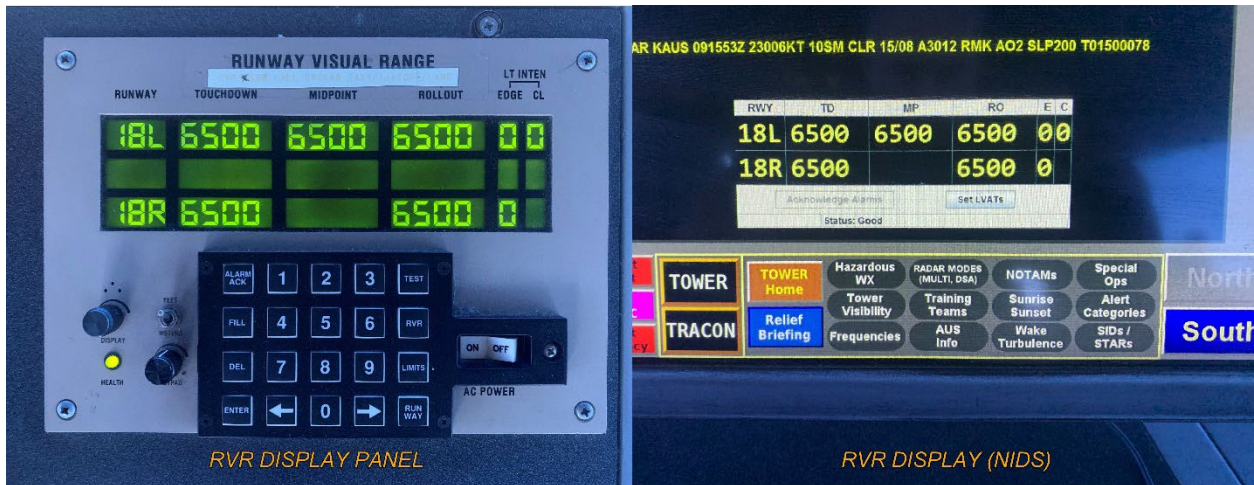
Figure 6. Photographs of RVR Display Panel (left) and the RVR Display on NIDS (right) - (NOT the values from the time of the incident).

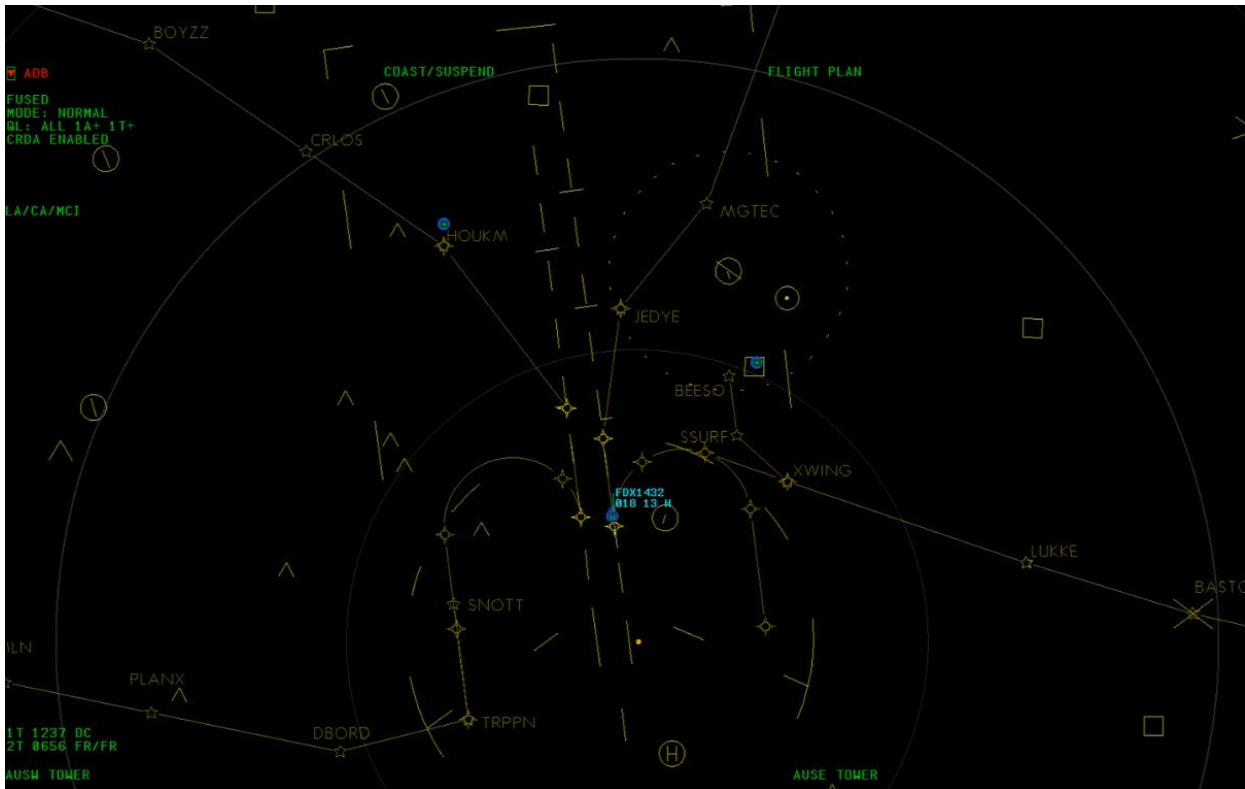
Figure 7. Close up photograph of tower radar display as it was set up on the morning of the incident. FD1432 can be seen near the center of the display.
