National Transportation Safety Board

Interview Summary - DCA23FM008

Interview of: Don T Le - Captain of fishing vessel Captain Alex
Date/Time: November 28, 2022, 1145 to 1235 CST
Location: US Coast Guard Marine Safety Unit Texas City conference room
Interviewed by: CWO [REDACTED] - USCG, Adam Tucker (by phone) - NTSB, [REDACTED]
- USCG, Lt. [REDACTED] - USCG
Attendees: Jenny Nguyen - interpreter for Mr. Le (former owner of the Captain Alex and owner of the dock where Captain Alex departed from), Thanh L'han - Owner of Captain Alex, Thu T Deo - crew member of the Captain Alex, Man V Nguyen - crew member of the Captain Alex, Hoi Van Nguyen - crew member of the Captain Alex
Accident: November 25, 2022, flooding and subsequent sinking of the fishing vessel Captain Alex, about 11 miles south of Jamacia Beach, Texas (NTSB No. DCA23FM008).

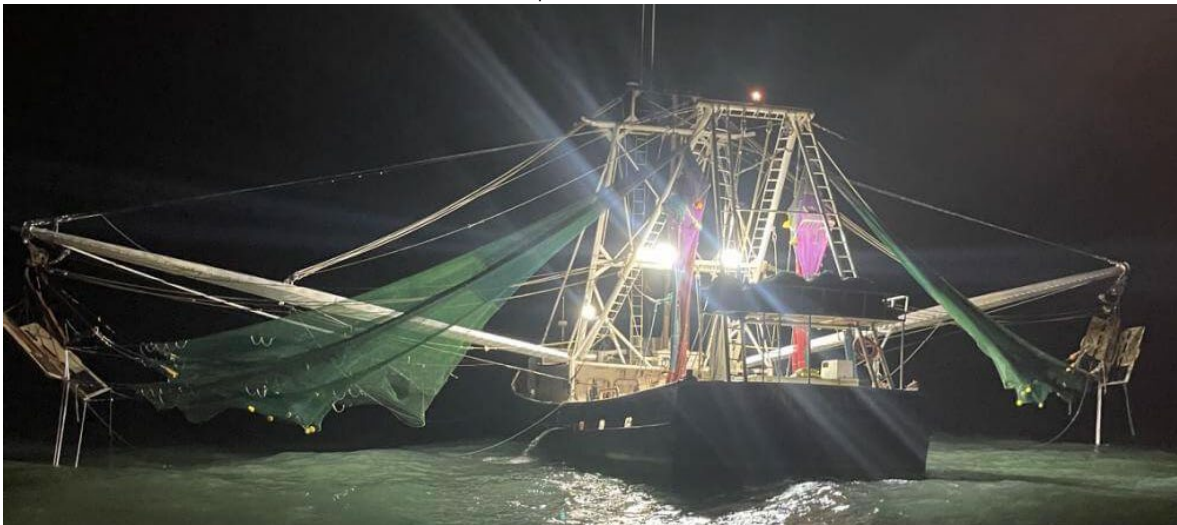
- When asked what engines and generators were running at the time of the accident, Mr. Le said they were all online.
- When asked about a picture taken from on scene from the Coast Guard Boat, referencing the one showing the stern of the Captain Alex with water coming out from the port side main deck of the boat, the Mr. L'han stated the water was from the bilge pump. When asked if the picture was taken while the crew were still on the Captain Alex or on the Coast Guard boat, Mr. Le said they were on the Coast Guard boat when that picture was taken.

- When asked of the Captain Alex, Mr. L'han said it was 12.5 to 13 feet but could be more depending on the catch. In the picture taken of the Captain Alex stern, Mr. L'han said it looked "pretty normal", maybe 14 feet.

- When asked to confirm, based on the picture taken of the Captain Alex stern, if the outriggers were extended, Mr. L'han said they were extended. At the time of the discovery of water in the engine room, they had recovered their catch and the crew were in process of separating the by catch fish from the shrimp. There were no nets in the water at the time.
