National Transportation Safety Board

Interview Summary – DCA23FM024

Interview of: Rajendrakumar Nikhil Mahajan– Chief Officer of Sirocco
Date/Time: March 29, 2023
Location: On board the Sirocco – ships meeting room – 1138 to 1255 central daylight time
Interviewed by: CWO [REDACTED] – USCG, Adam Tucker – NTSB
Attendees: John Musser – Murphy, Rogers, Sloss, Gambel and Tompkins (representing Sirocco owners), Gareth Fernandes – Newship, Inc. (representing Sirocco interests), Jorge Leon – V. Ships (representing Sirocco operator interests)
Accident: March 27, 2023, Breakaway of the bulk carrier Sirocco and subsequent contact with barge MEM 5087 moored at the Mosaic Uncle Sam dock in Covert, Louisiana (NTSB No. DCA23FM024).

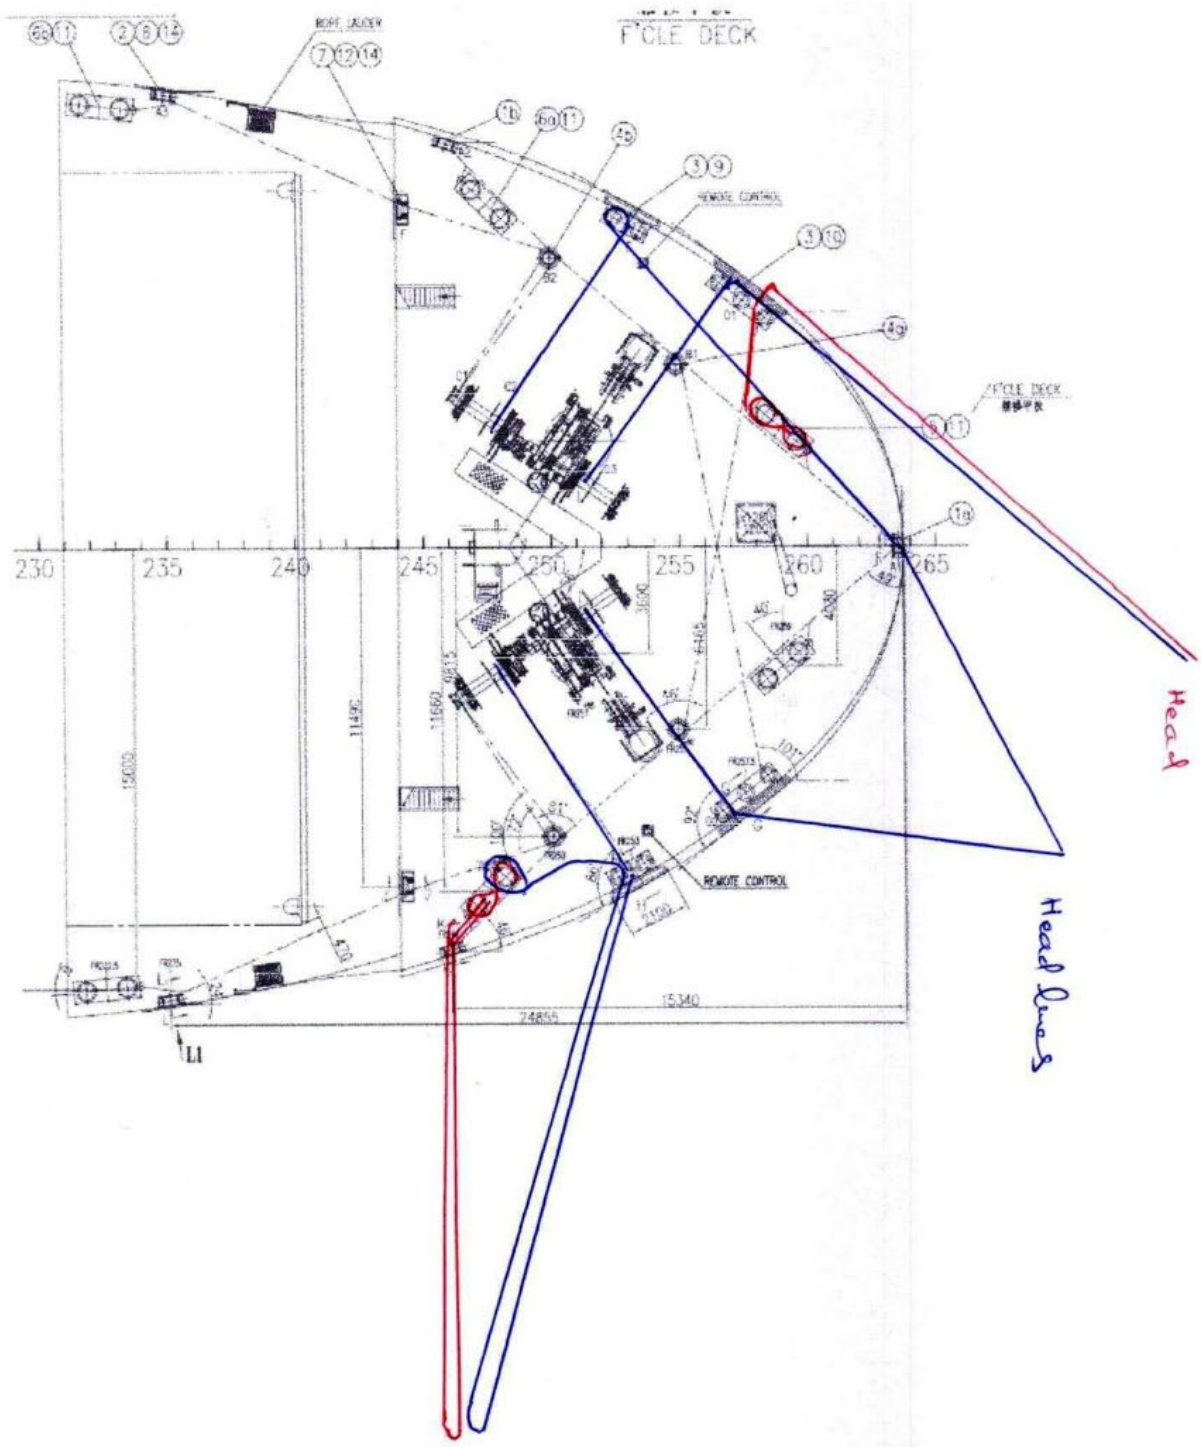
Figure 1: Forward mooring arrangement.

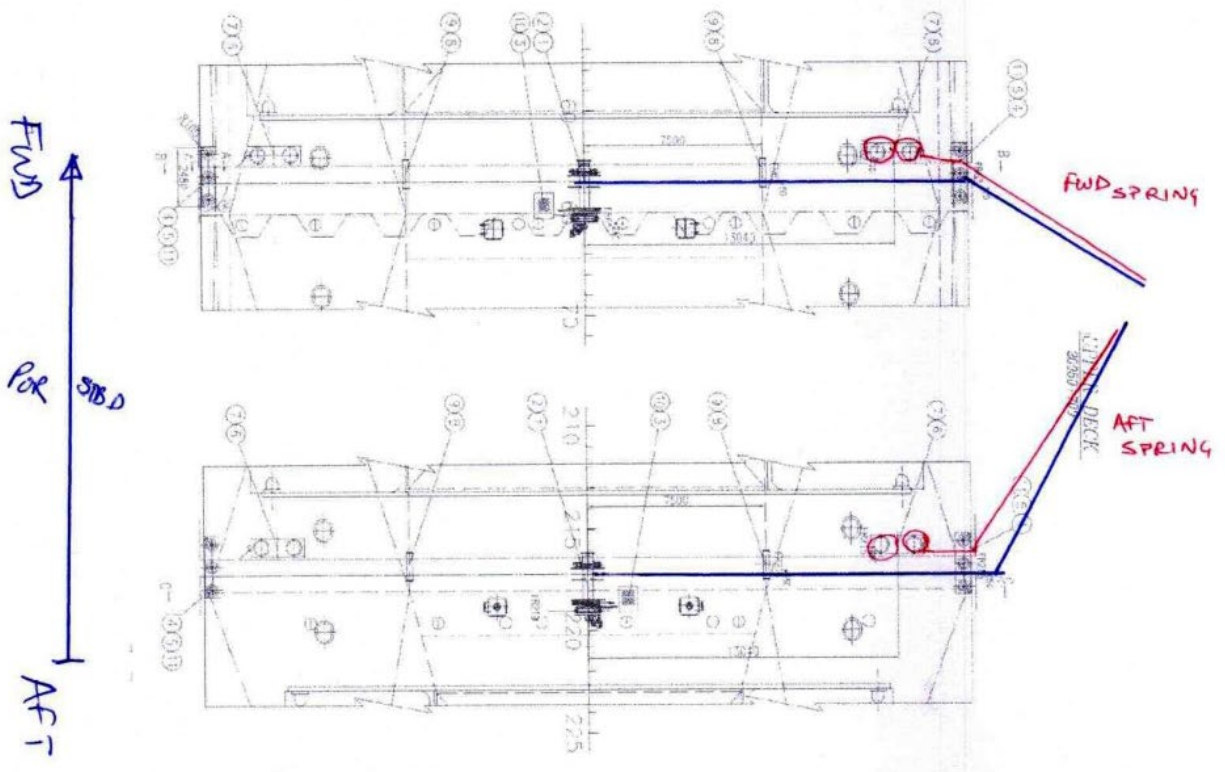
Figure 2: Main deck mooring arrangement.
