National Transportation Safety Board

DCA23LA125

AIRPORTS

Specialist's Factual Report

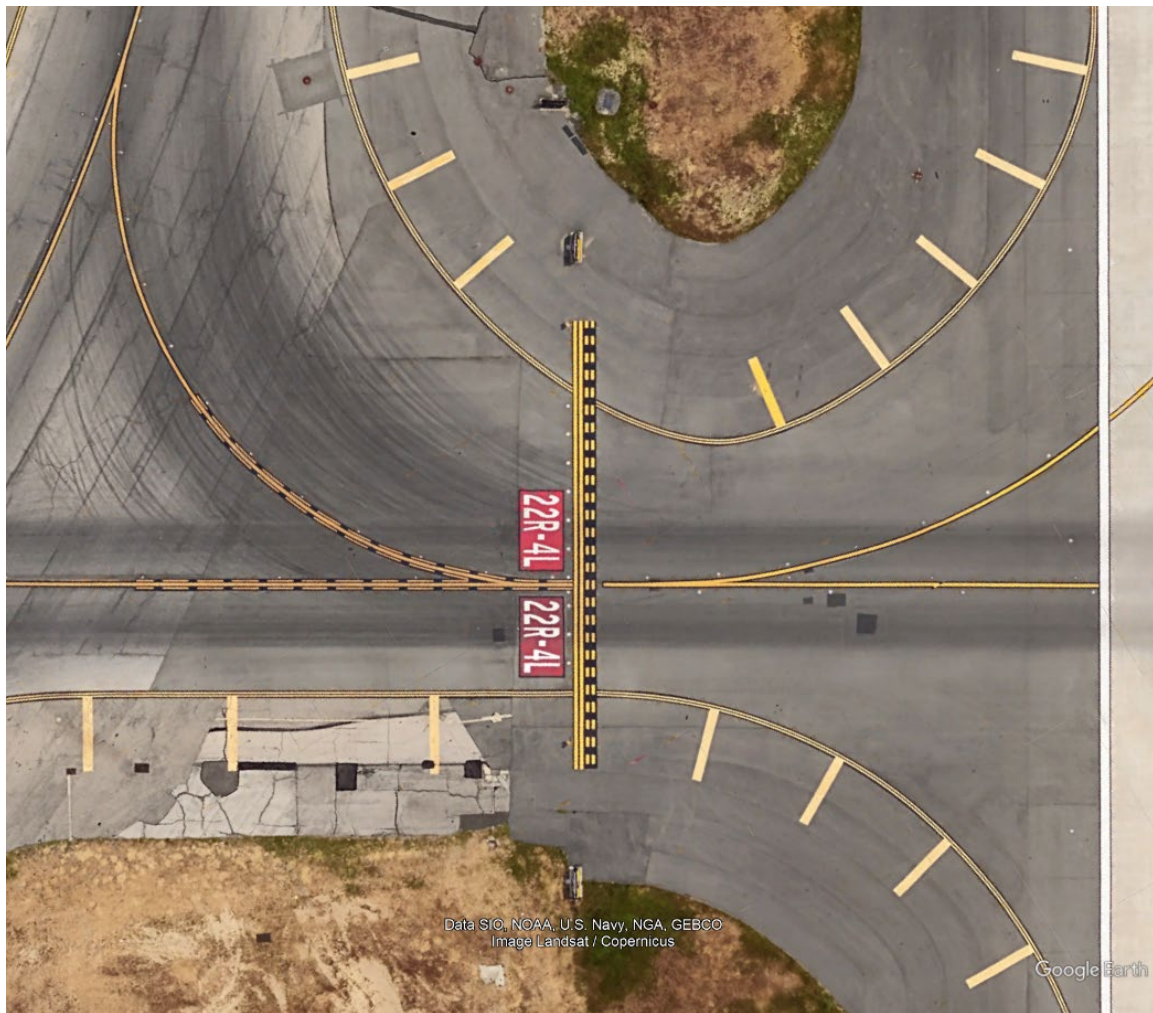
The taxiway J/runway 04L/22R intersection was lighted and marked with taxiway edge lights, taxiway edge markings, an enhanced taxiway centerline, both elevated and in-pavement runway guard lights, hold short markings, and two surface painted holding position markings. See figure 3. The Port Authority provided the FAA-approved signage and marking plan from JFK's Airport Certification Manual (ACM). See figures 4 and 5.

Figure 3. Google Earth image of taxiway J/runway 04L intersection.

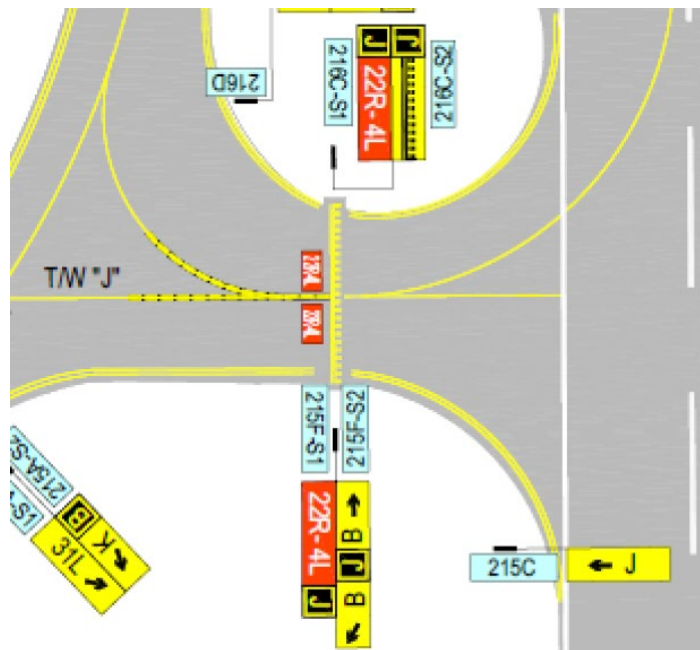
Figure 5. An enhanced view of the taxiway J/runway 04L/22R intersection from JFK's signage and marking plan showing the presence of the two vertical taxiway location signs collocated with runway holding position signs on either side of taxiway J. [Source: Port Authority of NY and NJ.]

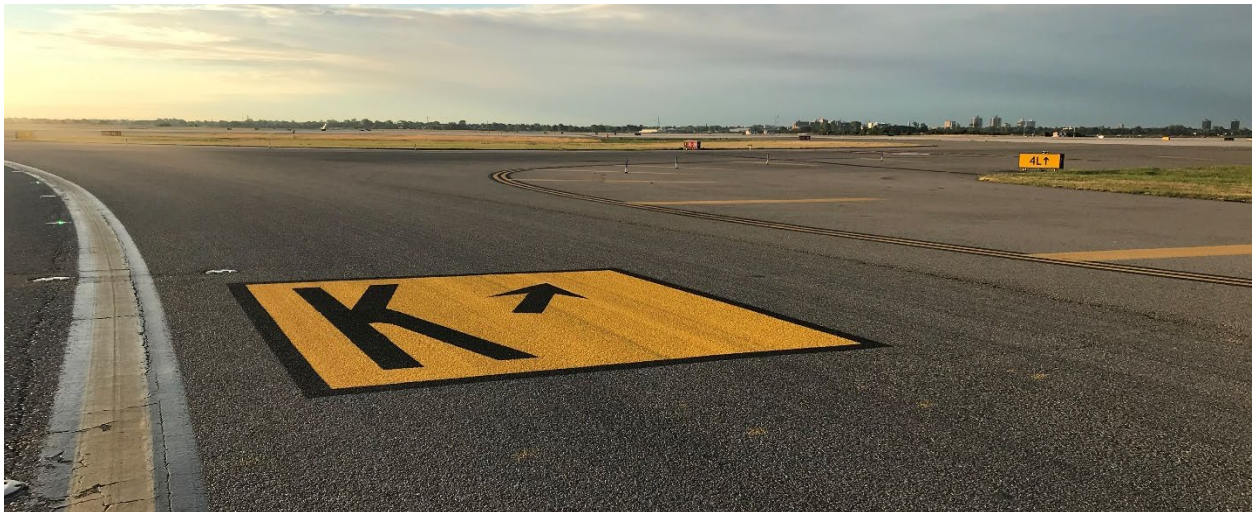
Additionally, the Port Authority reported that a surface painted direction sign for taxiway K had been painted on taxiway B in the area of taxiway K on July 26, 2022. The Port Authority provided a photo of the sign as well as a dated invoice for the painting work. See figure 6. Also provided was an email sent the following day from the Port Authority to the FAA Air Traffic Organization (ATO) that included the photo. The Port Authority created a revised signage and marking plan for their ACM and submitted it to the FAA for approval on January 21, 2023. The new plan showed the presence and location of new surface painted direction sign for taxiway K. An enhanced view of the taxiway B/K/J area from JFK's revised signage and marking plan is shown as figure 7.

Figure 6. The surface painted direction sign for taxiway K painted on July 26, 2022. [Source: Port Authority of NY and NJ.]

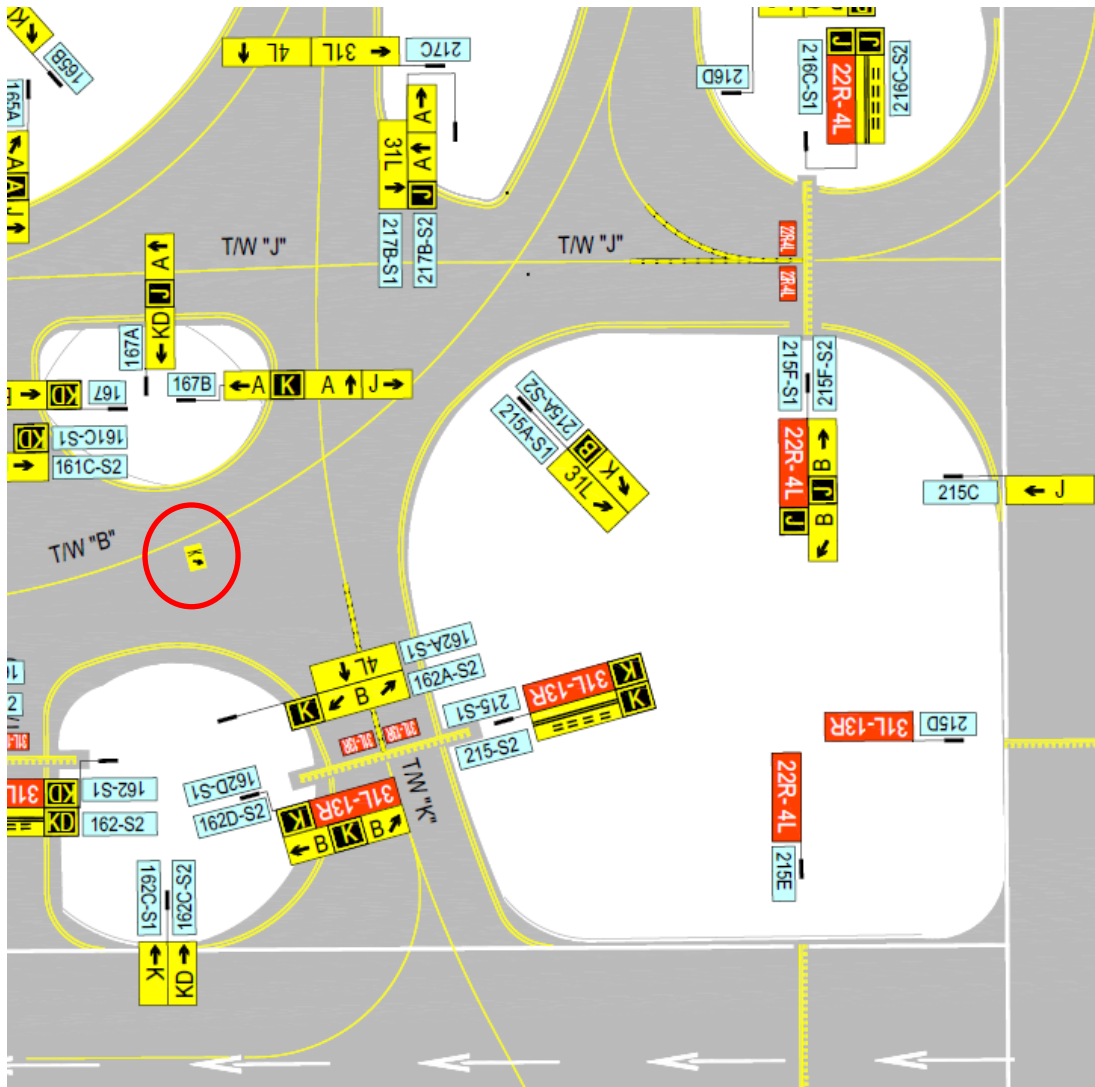
Figure 7. An enhanced view of the taxiway B/K/J area from JFK's new signage and marking plan showing the location of the new surface painted direction sign for taxiway K painted on July 26, 2022. (A red circle has been added for conspicuity in this NTSB report.) [Source: Port Authority of NY and NJ.]

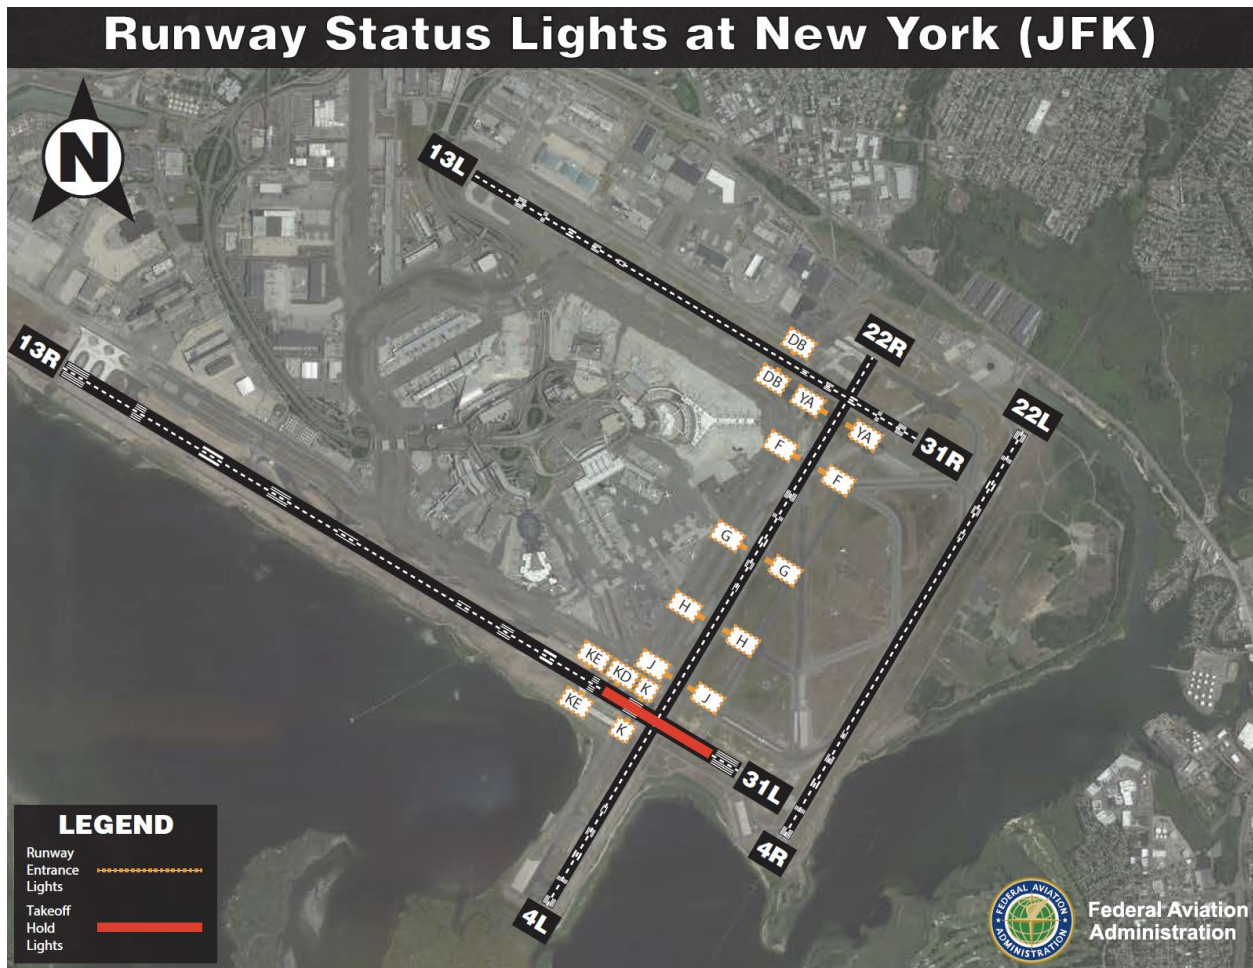
The RWSL were installed in 2015 during JFK's 04L/22R reconstruction project. However, Port Authority personnel could not confirm "if the lights were commissioned when the runway reopened or if they were operationalized at a later date." According to the Port Authority, "the conceptualization, planning, installation, and maintenance of the RWSL system is the purview of the FAA [Tech Ops]." If Port Authority airport operations personnel noticed an issue with the RWSL system during routine patrols, FAA Tech Ops would be notified. The RWSL installation at JFK included THL on runway 31L and REL primarily at the intersection near runway 31L/04L and continuing down runway 04L to the intersection with runway 31R/13L. See figure 12.

Figure 13. RWSL locations at JFK. REL locations are shown in outlined boxes with the taxiway designation. [Source: FAA]

The NTSB requested that the FAA research the installation at JFK and attempt to determine why those particular locations were chosen for THL and REL. The FAA responded that “extensive research conducted found no record of specific discussions regarding the JFK RWSL array locations... the normal process used by the FAA when it comes to determining RWSL locations is to coordinate with local Air Traffic and Airport Authority to come up with the number and location of light arrays based on several factors:

local FAA Air Traffic and Port Authority Personnel in 2009. This request did not include any request for THL arrays on Runway 4L-22R... the only request removed was the requested REL arrays on Runway 31L-13R and Runway 31R-13L where they intersected/crossed Runway 4L-22R. REL arrays cannot be installed on a runway-to-runway intersection for technical and safety reasons.”

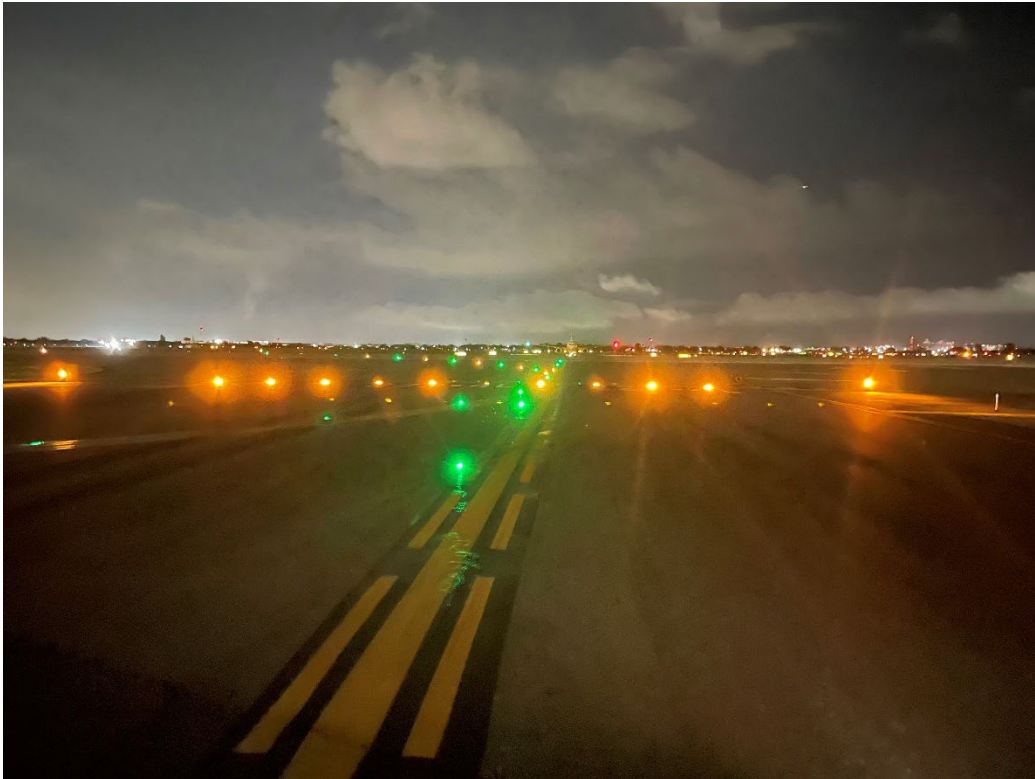
Figure 14. Nighttime photo taken just prior to the hold short marking at the taxiway J/runway 4L intersection. The taxiway centerline lights are green while the runway guard lights appear yellow/orange. [Source: Port Authority of NY and NJ.]

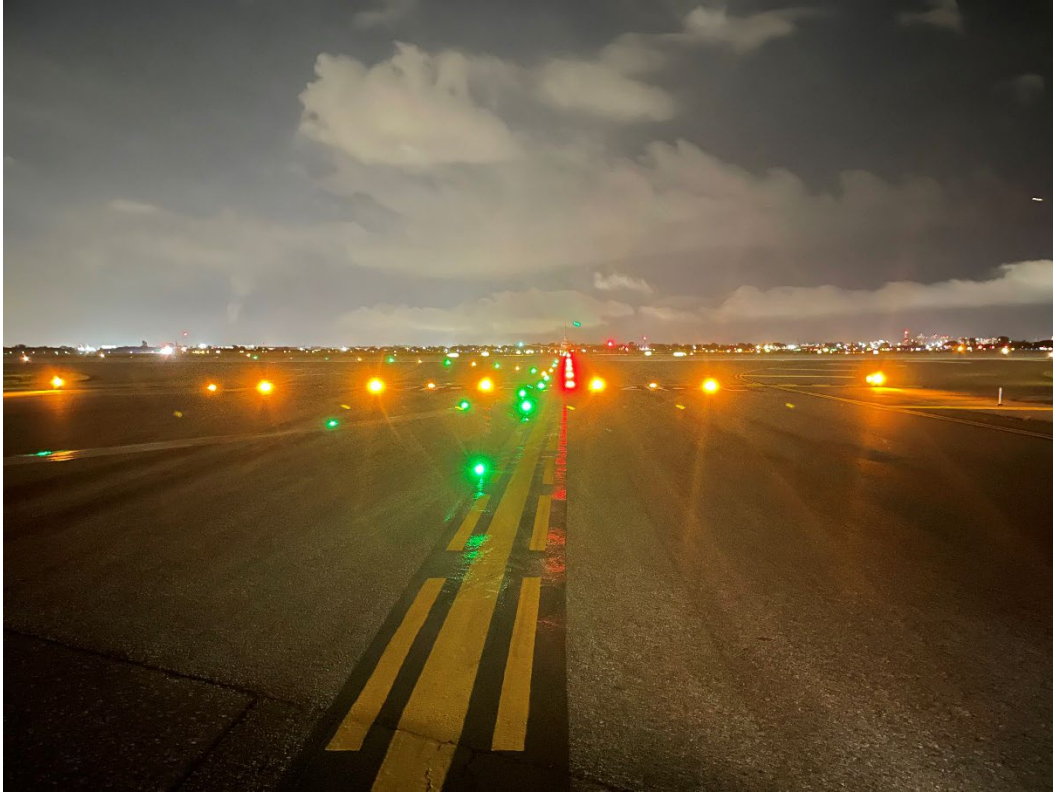
Figure 15. Nighttime photo just prior to the hold short marking at the taxiway J/runway 4L intersection with the runway entrance lights illuminated in red. [Source: Port Authority of NY and NJ.]

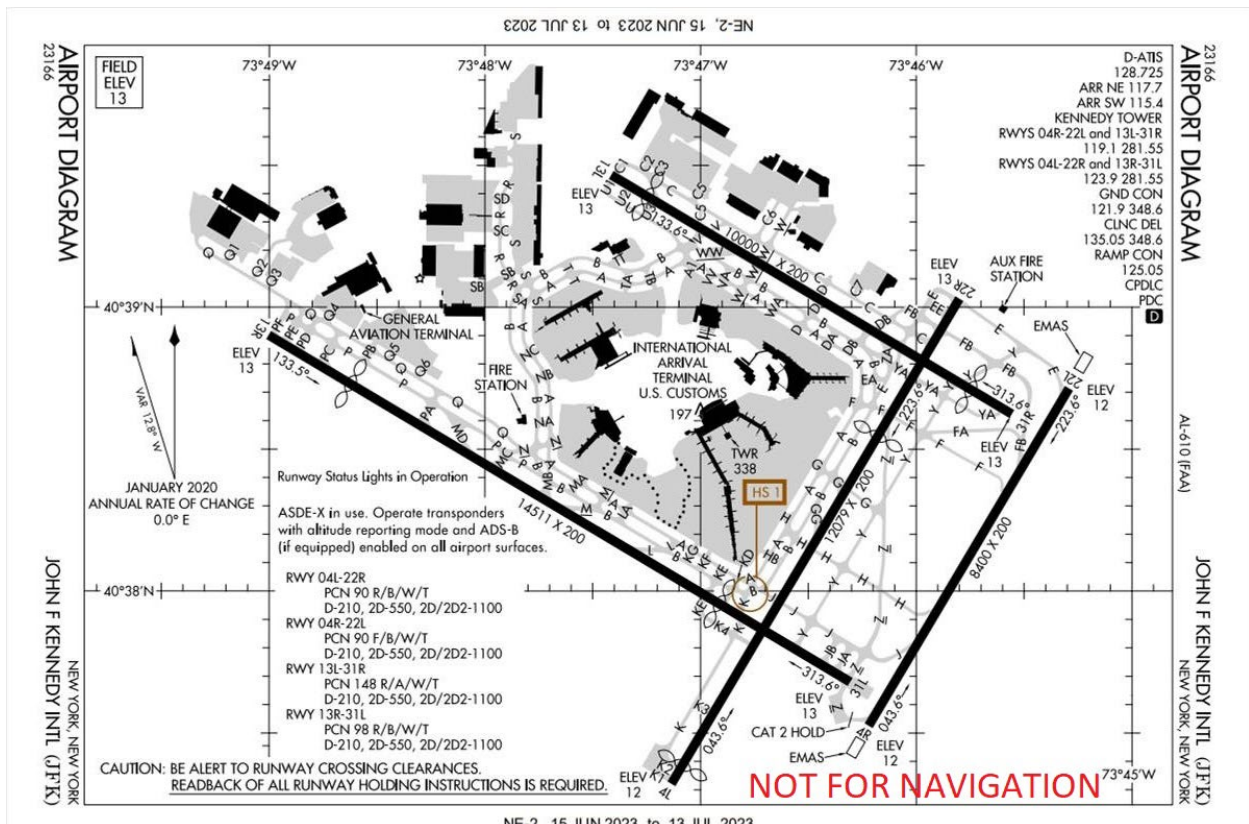
Figure 17. JFK’s published June 15, 2023, Jeppesen chart showing a new hot spot at the intersection where the January 13, 2023, incident took place.

After the January 13, 2023, runway incursion, the JFK ATCT performed a system safety review (SSR). The SSR team discussed the possibility of creating a taxiway hotspot in the taxiway K and taxiway J area for future charting cycles and referred the event to the Local Safety Council (LSC). It was thought that a hot spot could draw flight crew attention to that intersection and avoid an incorrect turn. The Corrective Action Plan (CAP) created by the LSC stated that "a collaborative effort resulted in a hot spot created for the June 15, 2023 [Jeppesen] map update... aimed at mitigating confusion in the area..." See figure 14. The JFK ATCT issued a letter to airmen on May 22, 2023, notifying them about the hot spot near the intersection of taxiways B, K, and J that would become effective on June 15, 2023. It advised flight crews to "maintain additional attention to the intersection while JFK is departing [runway] 4L. The taxi route for [runway] 4L departures is via [taxiway] K. The turn from [taxiway] B onto [taxiway] K is more than 90 degrees and is in close proximity to [taxiway] J. If flight crews mistakenly turn on [taxiway] J when JFK is departing [runway] 4L it will result in a runway incursion."
