National Transportation Safety Board

DCA23LA125

OPERATIONAL FACTORS/HUMAN PERFORMANCE

Group Chair's Factual Report

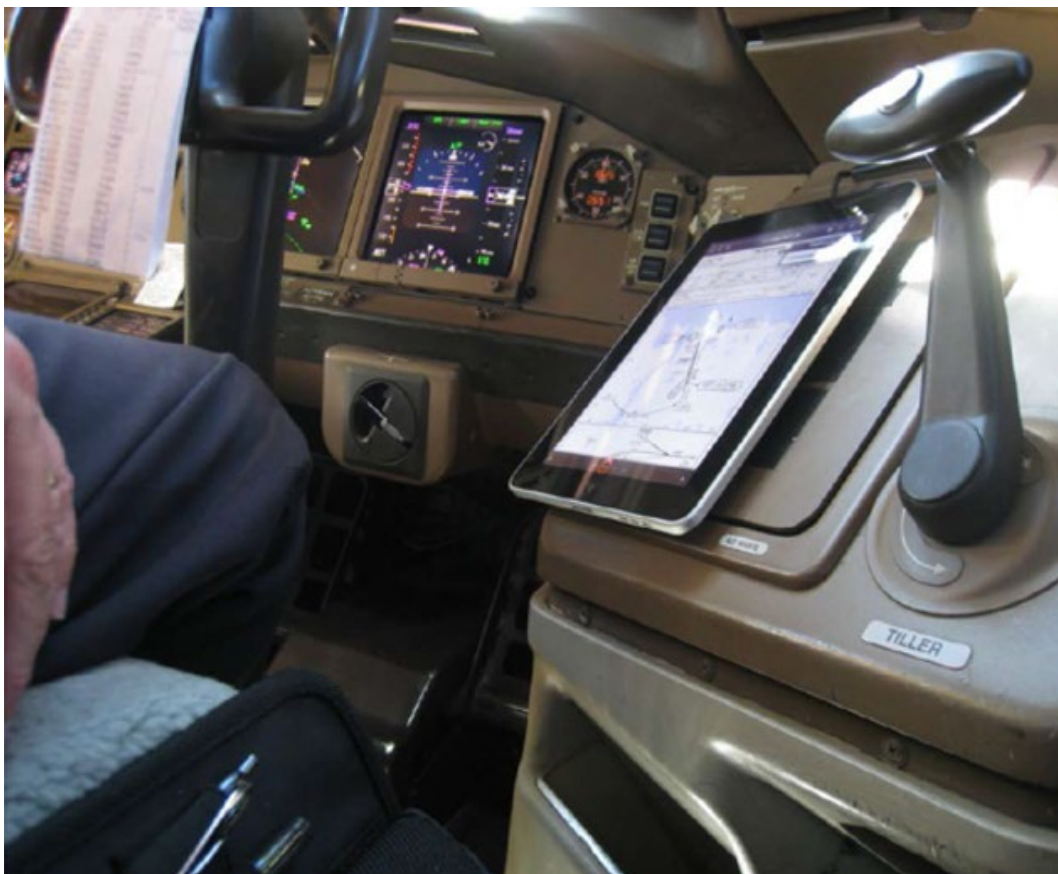
The incident airplane had Velcro pads on the side panels inside the cockpit to which the pilots attached their iPads for easy viewing. According to American Airlines, airplanes in its B777 fleet, including N754AN, were not equipped with an electronic runway situation awareness tool capable of providing aural annunciations about runways the airplane was approaching.⁴⁹

Figure 2. The first officer's iPad mount in the cockpit of an American Airlines B777.

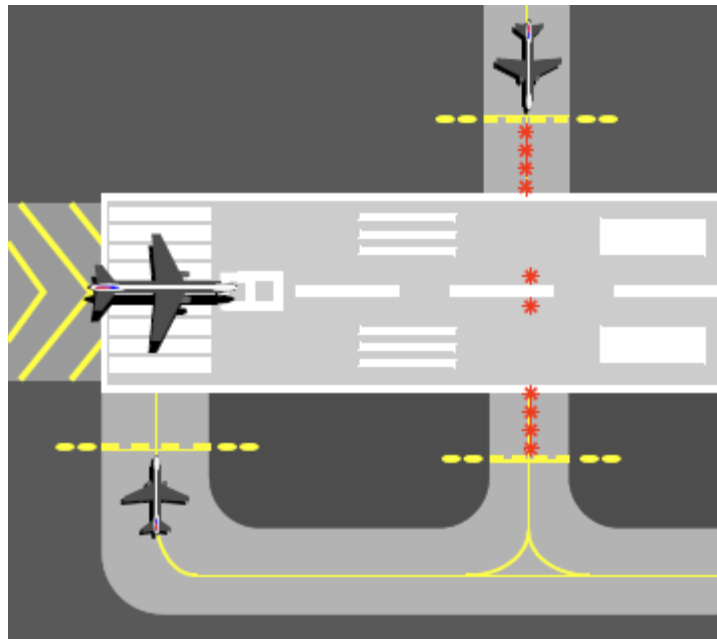
When activated, the red lights indicate there is either high speed traffic on the runway or an aircraft on final approach within the activation area.

Figure 3. Diagram of runway entrance lights from the American Airlines Flight Operations Manual.

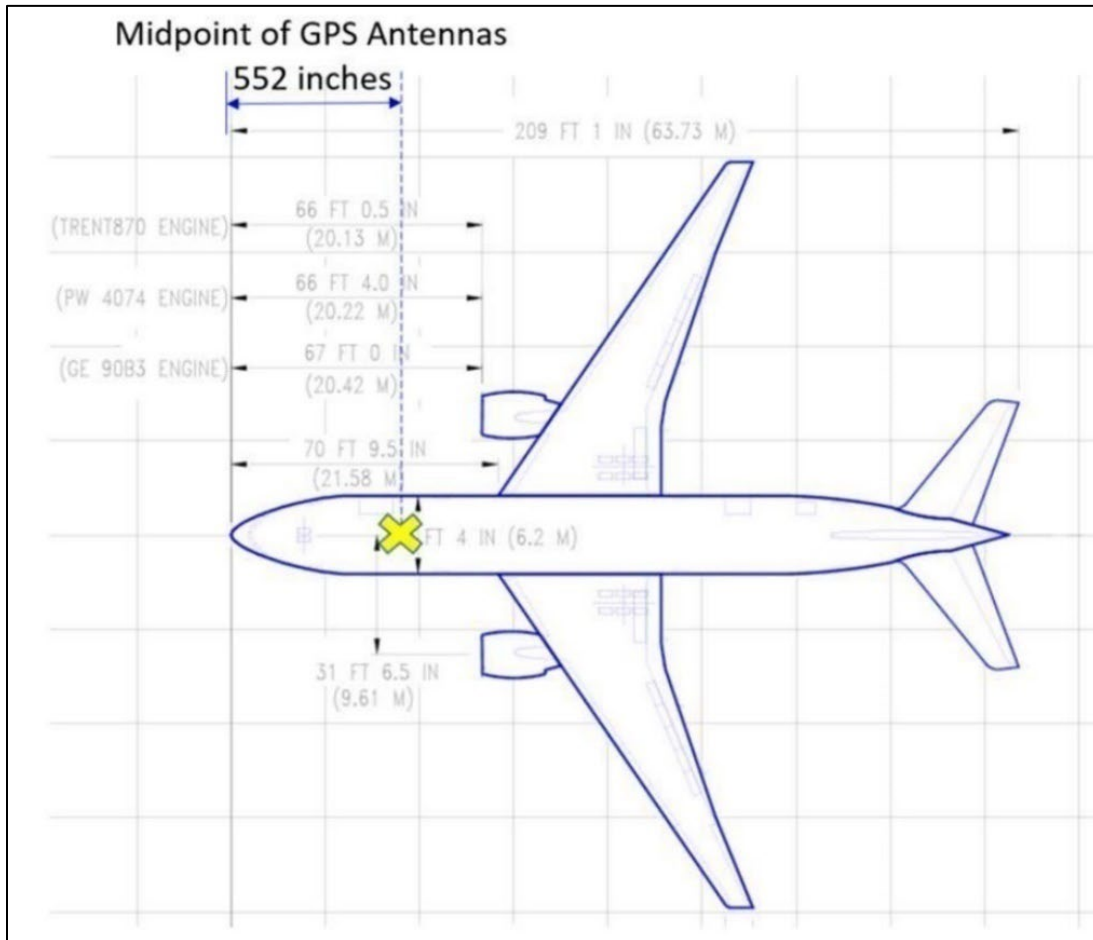
inches (11 feet 11 inches) (figure 4). In addition, it indicated that the horizontal distance between the nose gear and the nose of the airplane was 232 inches (19 feet 4 inches) (figure 5). These dimensions indicate that the horizontal distance between the closest point on the ground in front of the airplane that was visible to the pilots and the transmitted GPS location was 1,045 inches (87 feet, 1 inch).

Figure 4. Location of the broadcast GPS position on the fuselage of the B777-200 ER.⁶³

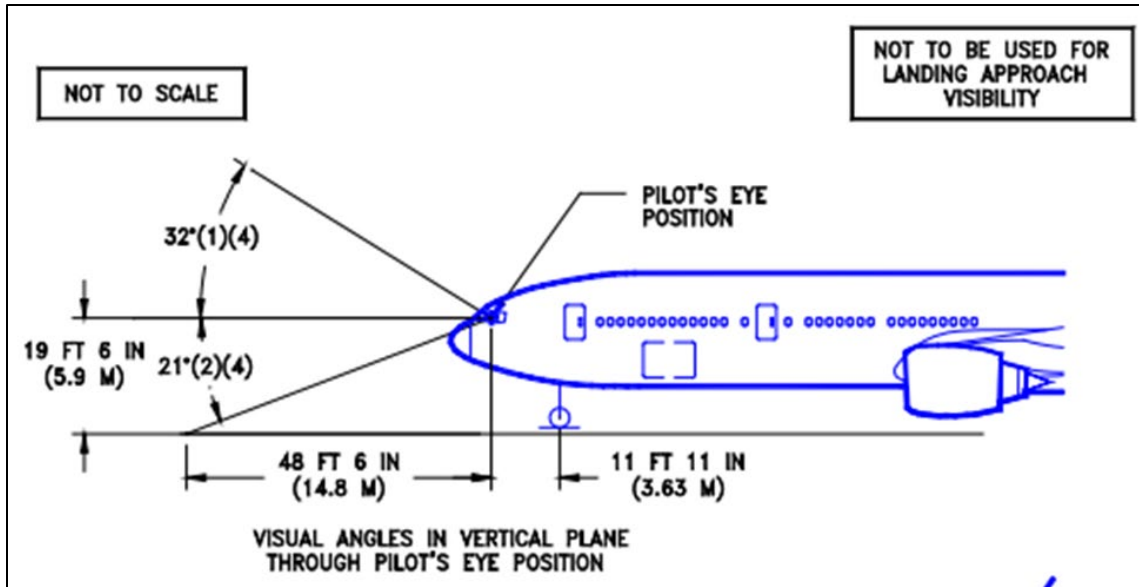
Figure 5. Sightline from the pilot's eye position to the ground for the Boeing 777-200.⁶⁴

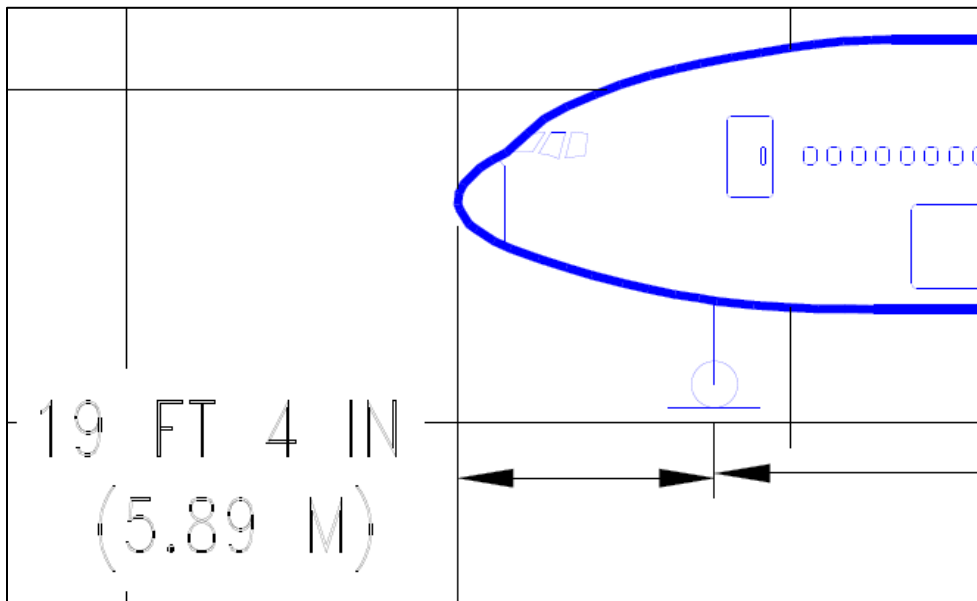
Figure 6. Horizontal distance between the nose and the nose gear of the Boeing 777-200.⁶⁵
