# National Transportation Safety Board

DCA23LA125

## **FDR AND ADS-B STUDY**

Aircraft Performance Study

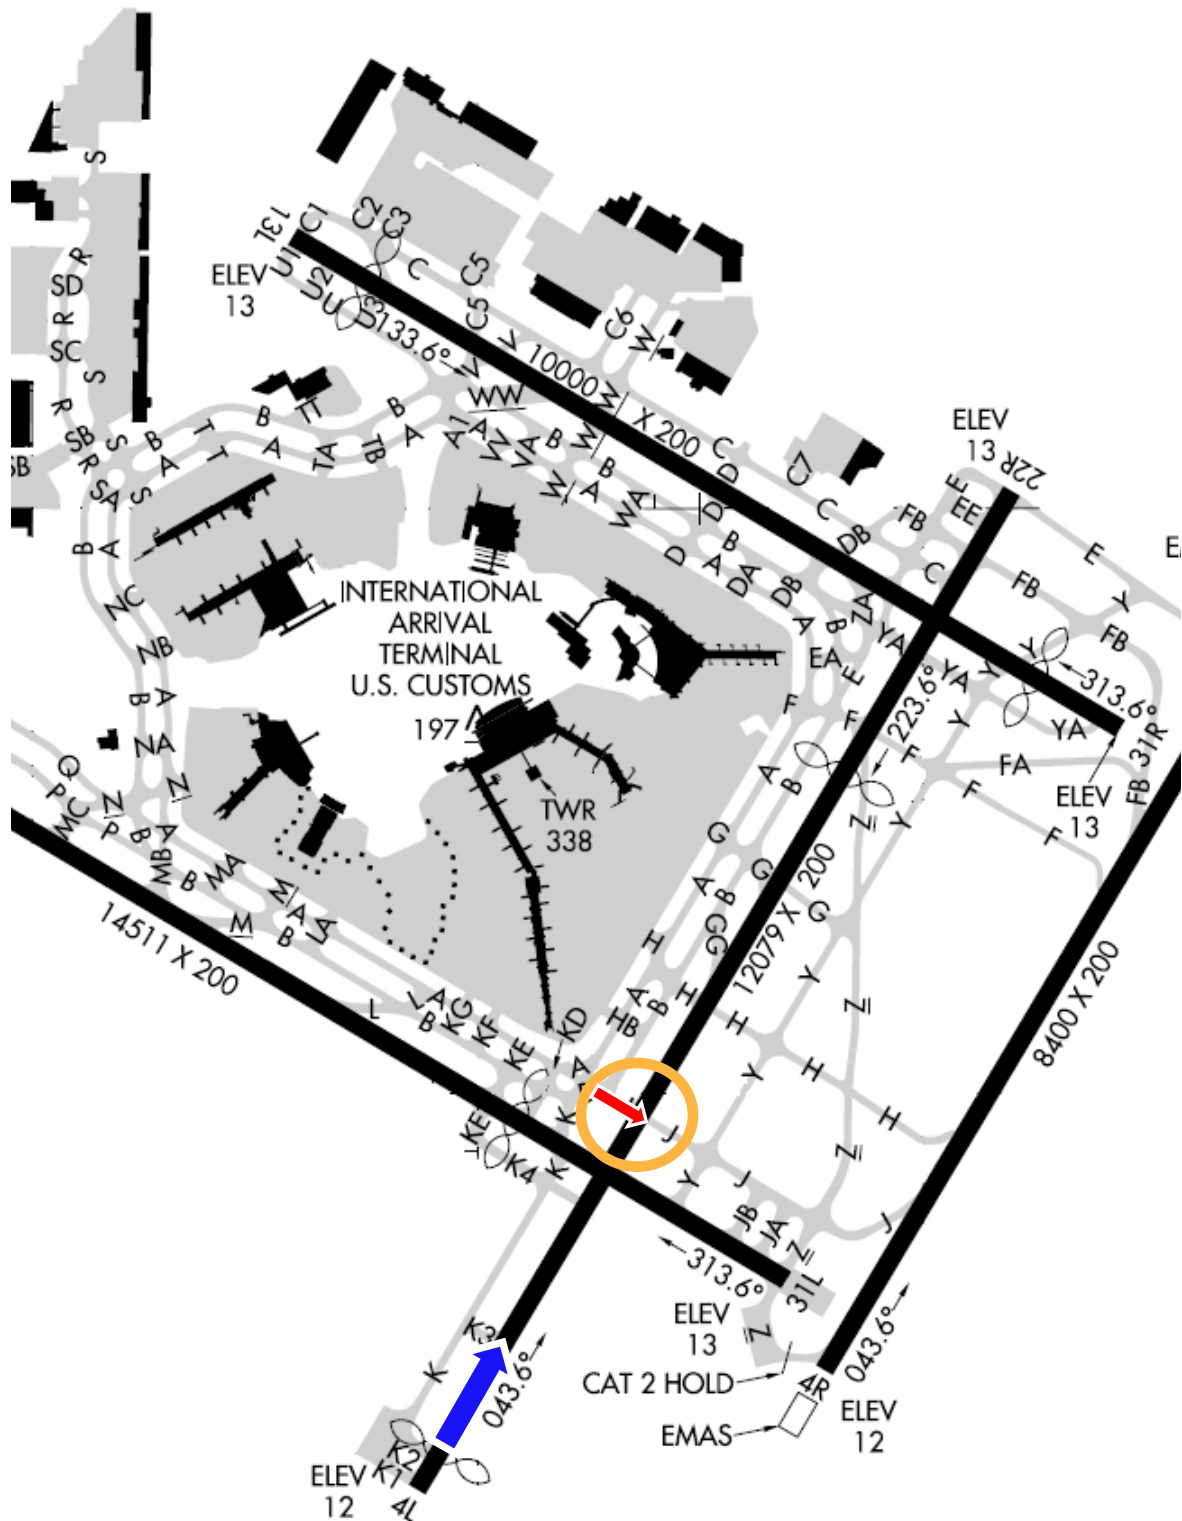
The event occurred where taxiway J crosses runway 4L at JFK. Figure 3 shows a portion of the airport diagram with the runway crossing circled in orange. DAL1943 (blue arrow) was taking off from runway 4L when AA106 (red arrow) crossed from west to east on taxiway J. Figure 4 shows a satellite image of runway 31L, runway 4L, and taxiways B, K, and J.

**Figure 3.** JFK airport diagram. The intersection of interest is circled in orange. AA106's direction is highlighted with a red arrow and DAL1943's direction with a blue arrow.

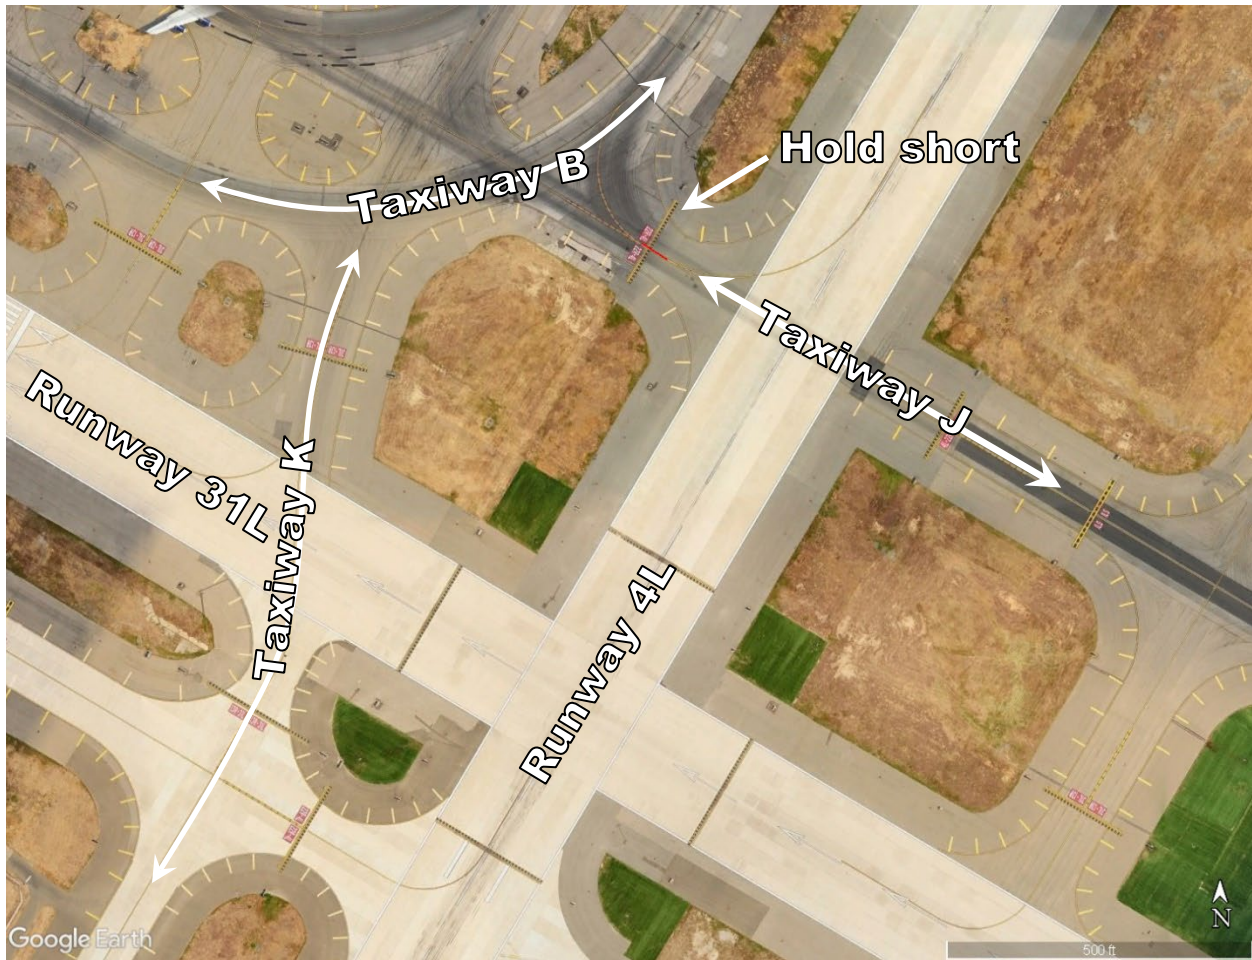
Runway 4L is 12,079 ft long and 200 ft wide from edge marking to edge marking. Taxiway J is 4,500 ft from the threshold of 4L. The hold short line on taxiway J for runway 4L is 175 ft from the edge of runway 4L.

**Figure 4.** Satellite image of the area of interest. Taxiways B, K, and J and Runways 4L and 31L are labeled as is the hold short line on taxiway J before runway 4L.

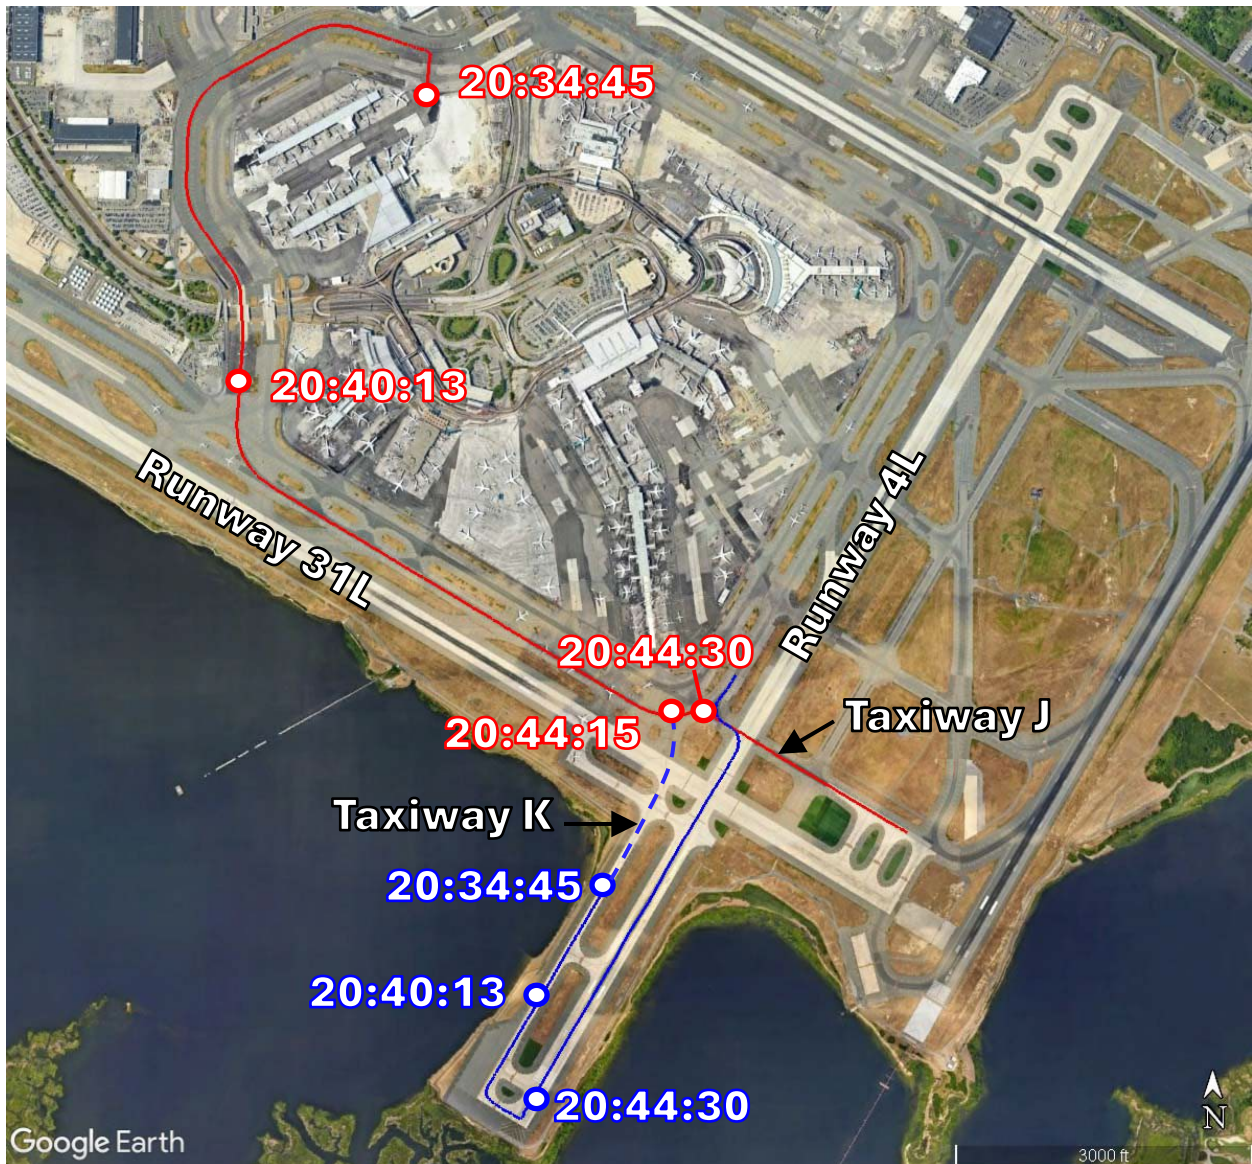
AA106 left the ramp area and entered taxiway TA (Figure 3) at 20:34:45 (Figure 5). At this time, DAL1943 was in line on taxiway K for departure on runway 4L. AA106 turned left on taxiway B and followed it for several minutes. At 20:40:13, ATC contacted AA106 and said "American 106 heavy, cross 31Left at Kilo". The crew responded, "Cross 31Left at Kilo for American 106 heavy."

**Figure 5.** B-777 taxi in red and B-737 in blue with selected times annotated.

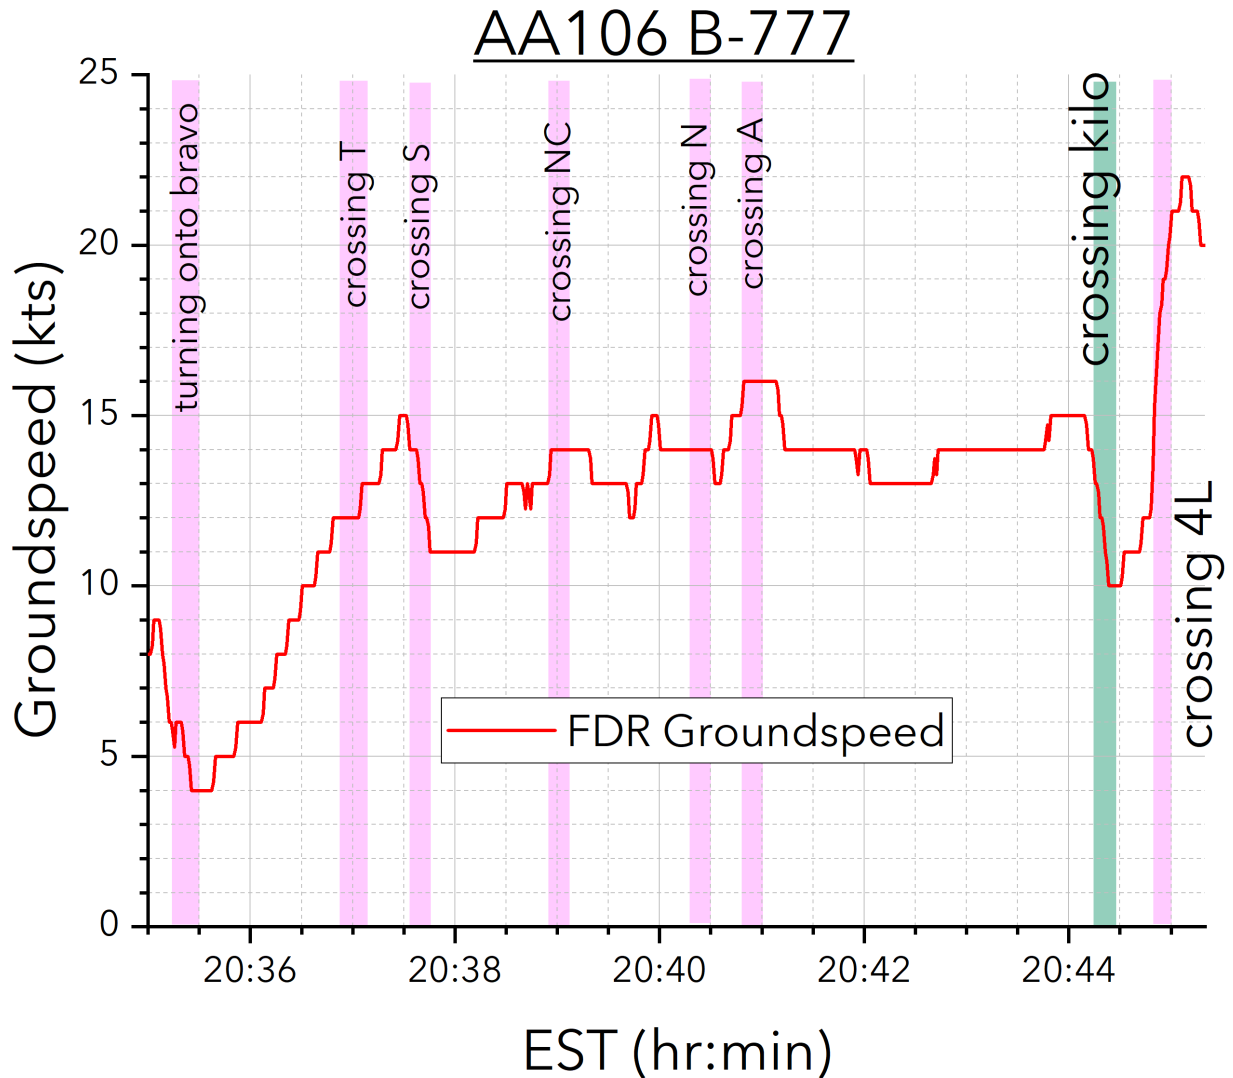
AA106 slowed from 15 kts groundspeed to 10 kts as it approached and passed taxiway K (Figure 6). At 20:44:30, AA106 turned onto taxiway J as DAL1943 began its

**Figure 6.** B-777 FDR recorded groundspeed during taxi.

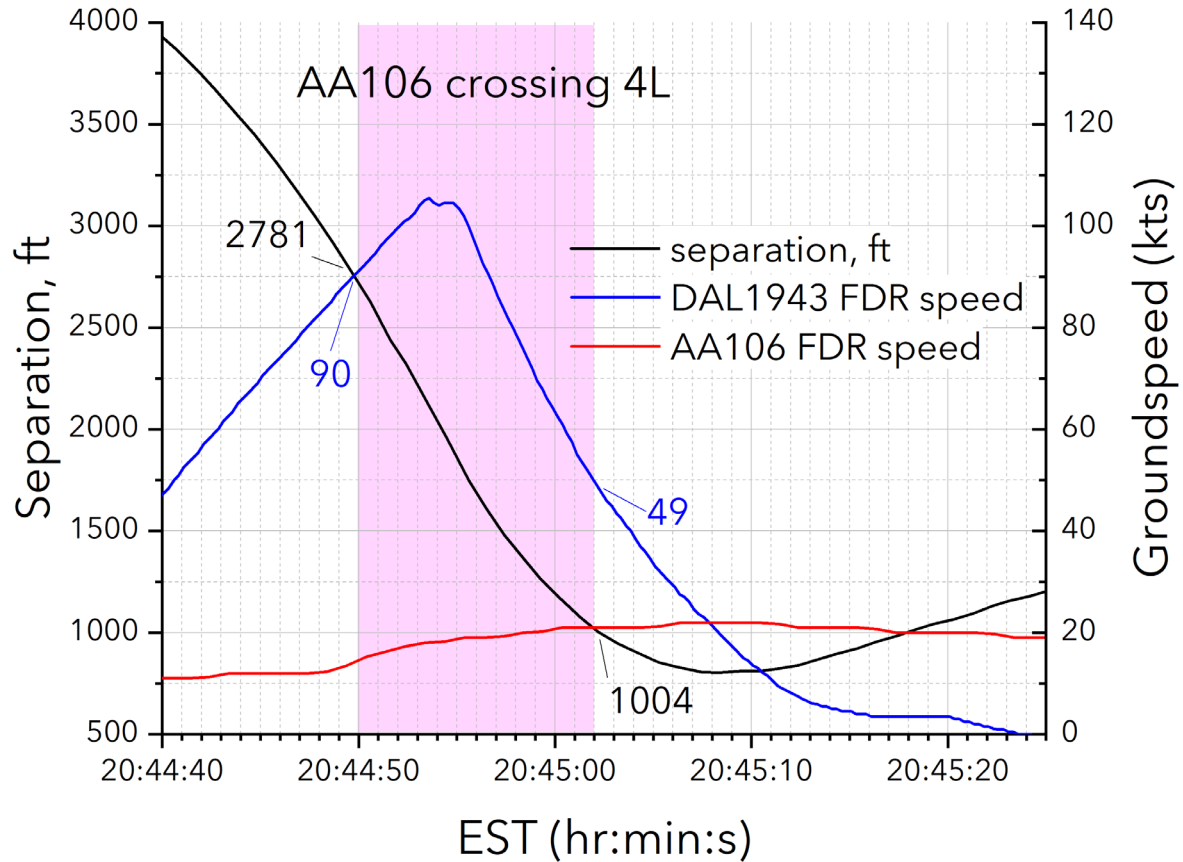
**Figure 7.** Airplane separation and FDR groundspeeds.

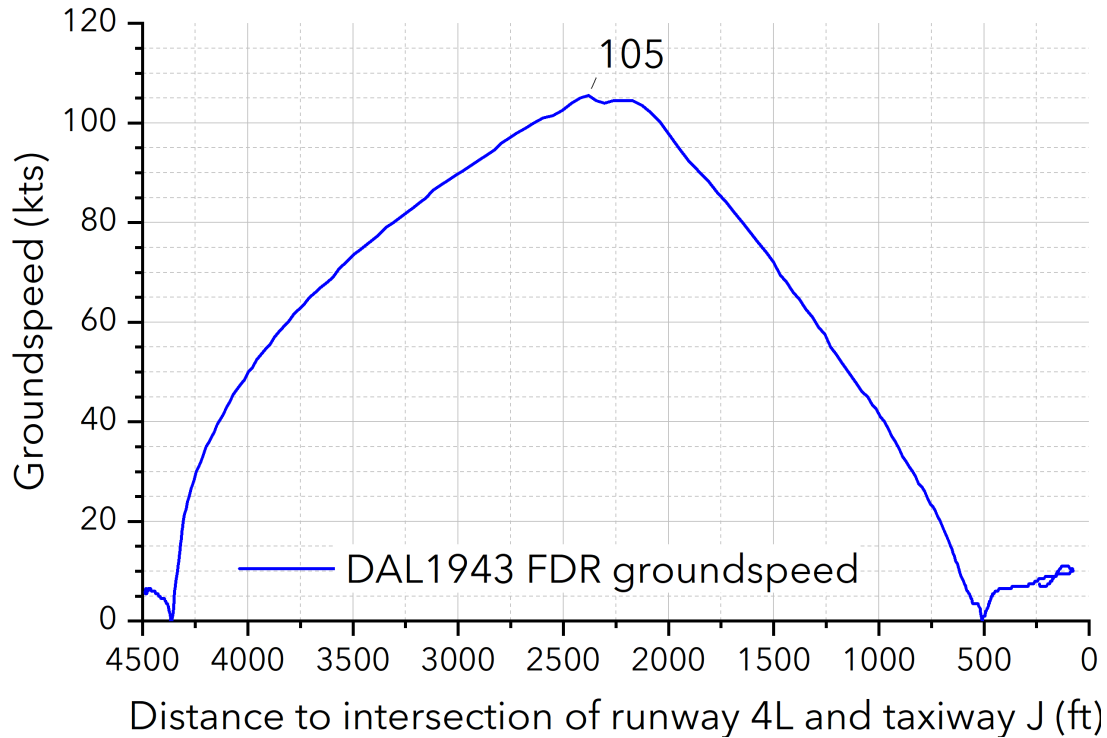
By 20:44:40, AA106's nose was passing the hold short line for runway 4L at a groundspeed of about 11 kts. DAL1943 was 3,900 ft from the intersection of 4L and taxiway J at 47 kts groundspeed and accelerating (Figure 8).

**Figure 8.** DAL1943 FDR groundspeed versus distance to intersection of runway 4L and taxiway J.

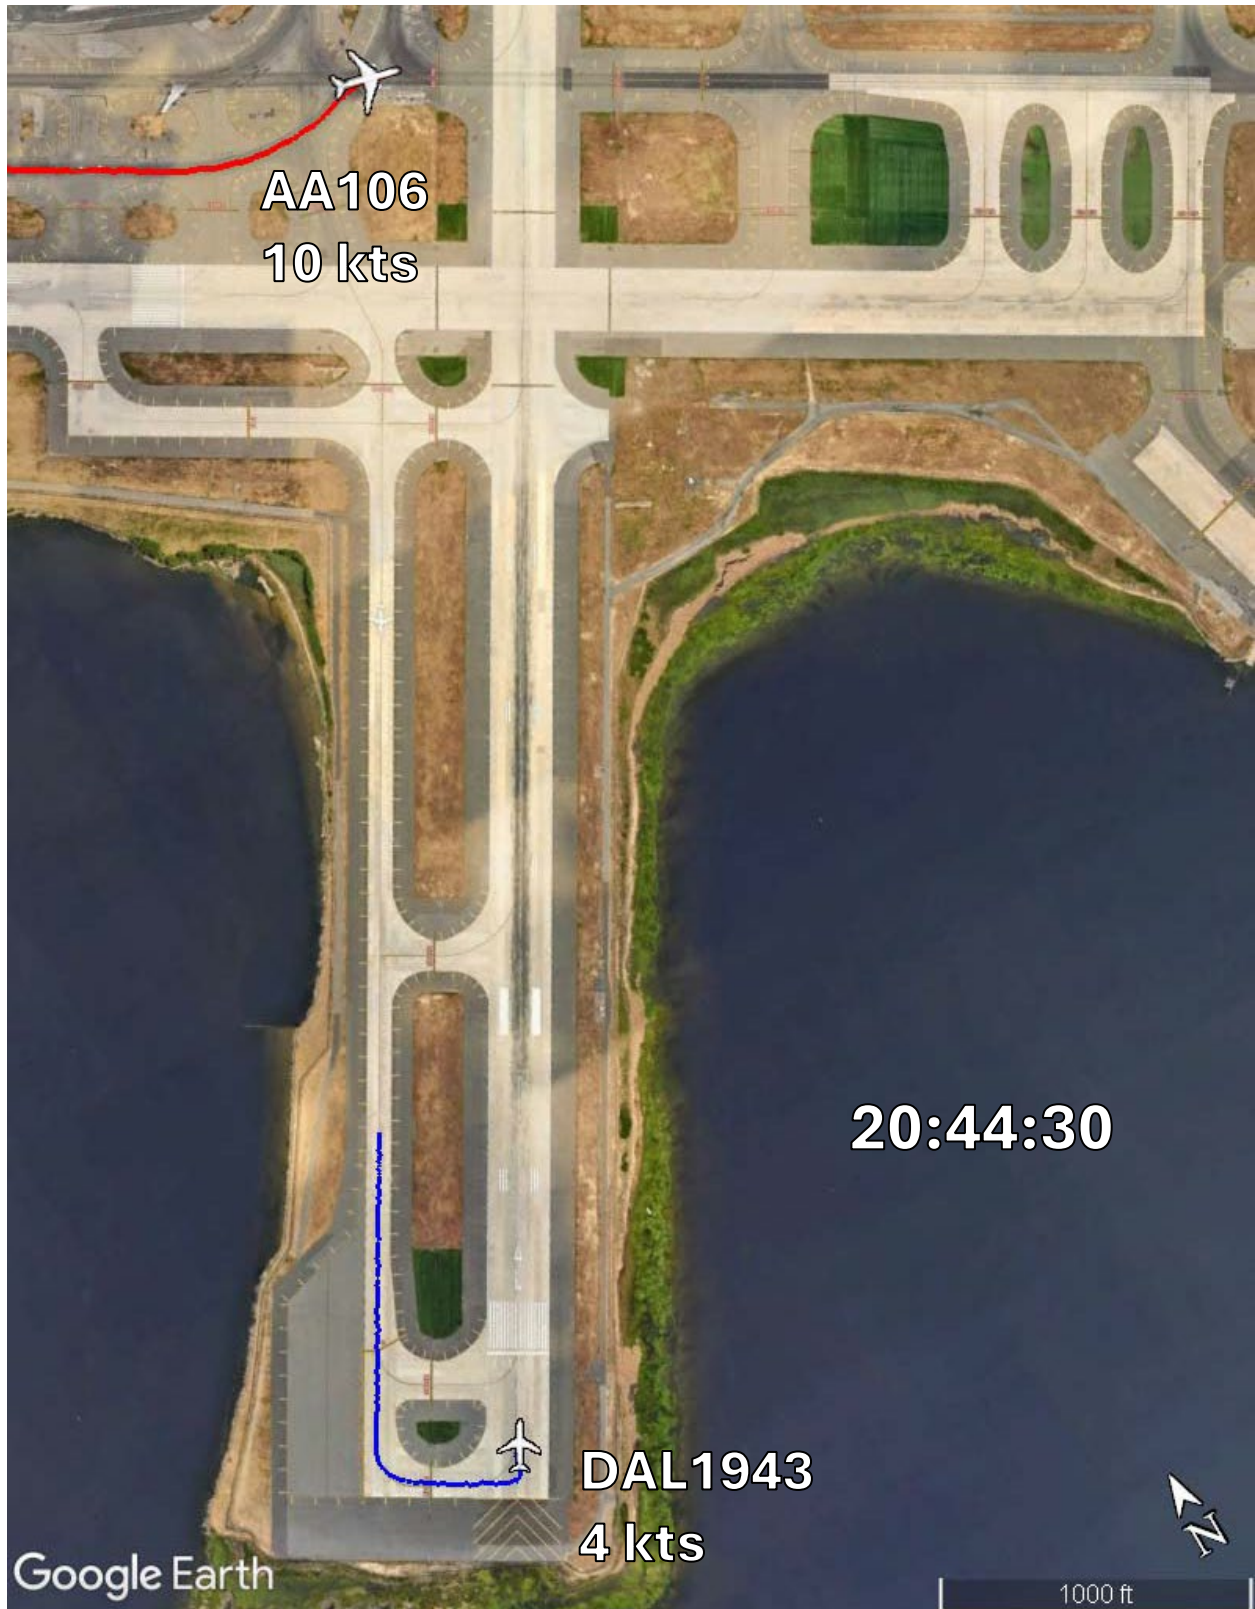
**Figure 9.** Locations and groundspeeds of both airplanes when AA106 turned onto taxiway J at 20:44:30.

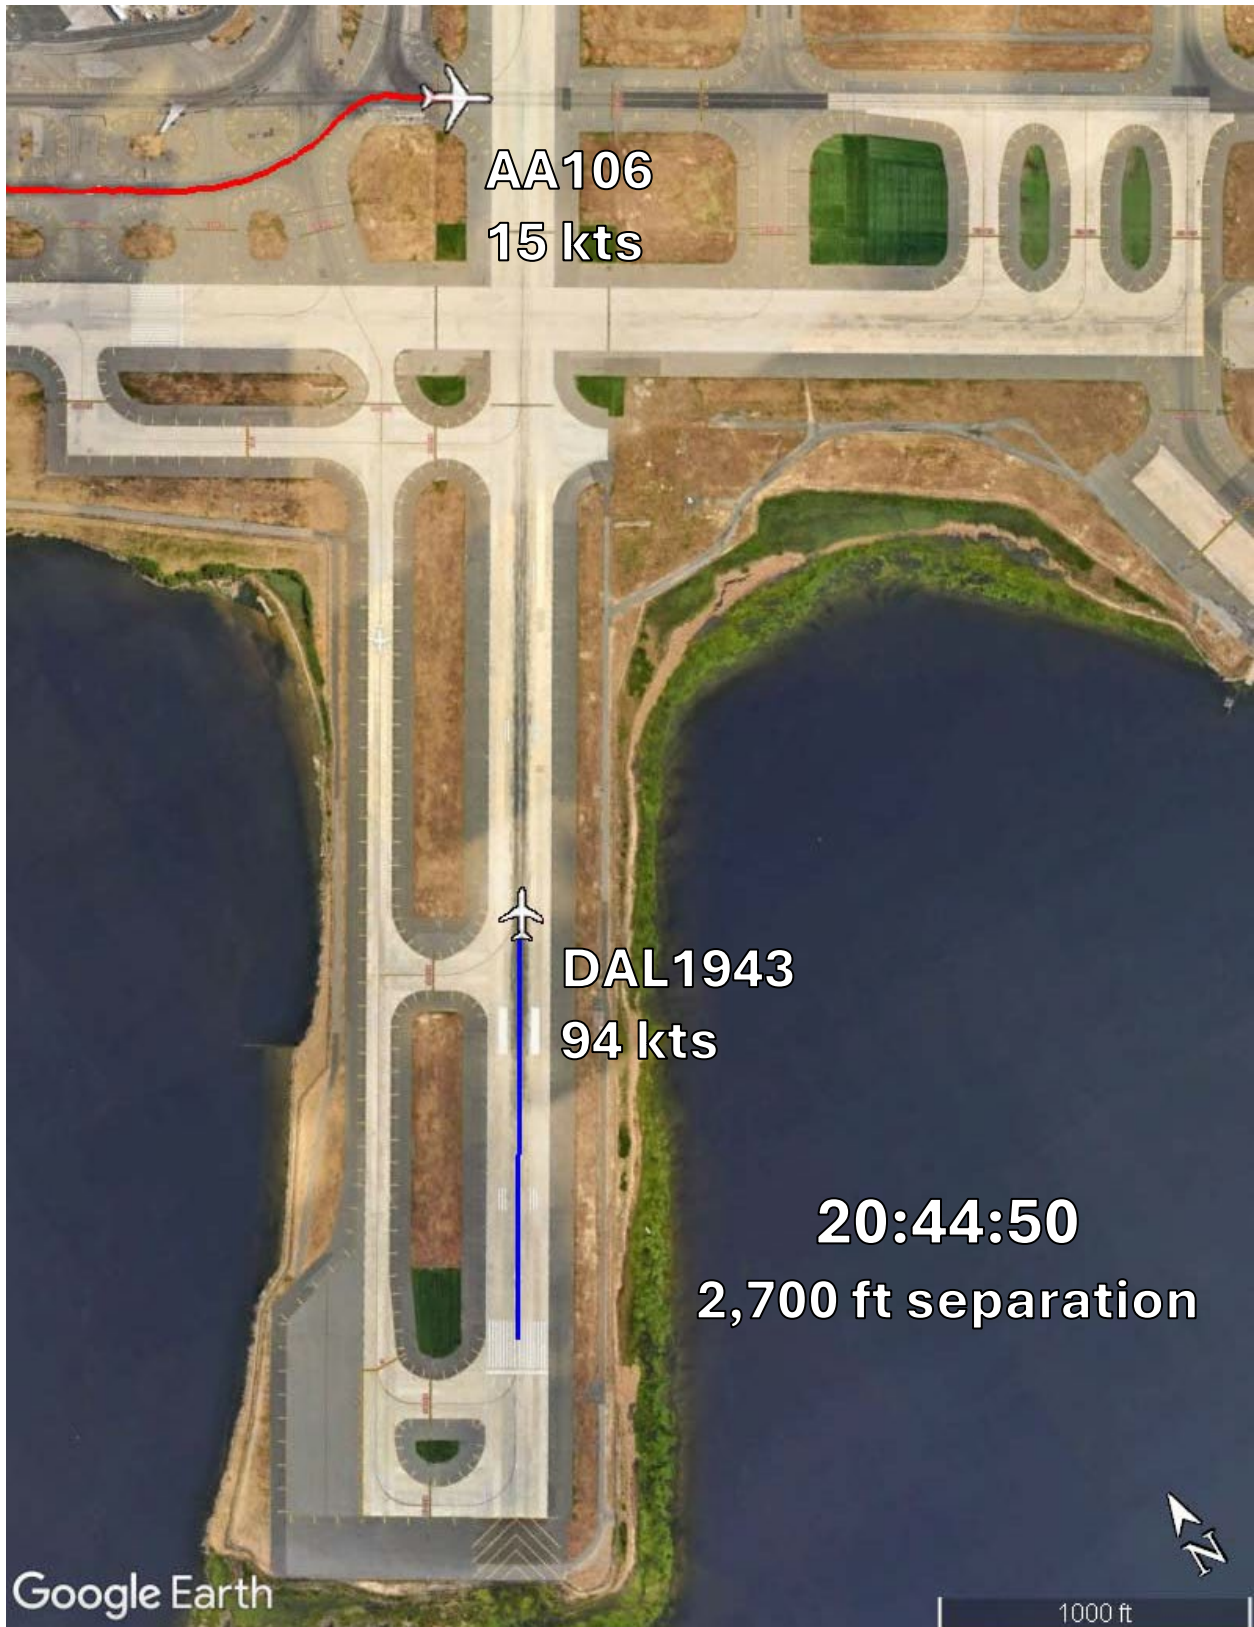
At 20:44:50 (Figure 10), the nose of AA106 entered onto runway 4L at a groundspeed of about 15 kts. DAL1943 was 2,700 ft from the intersection of 4L and taxiway J at 94 kts groundspeed and accelerating.

**Figure 10.** Locations and groundspeeds of both airplanes when AA106 entered runway 4L at 20:44:50.

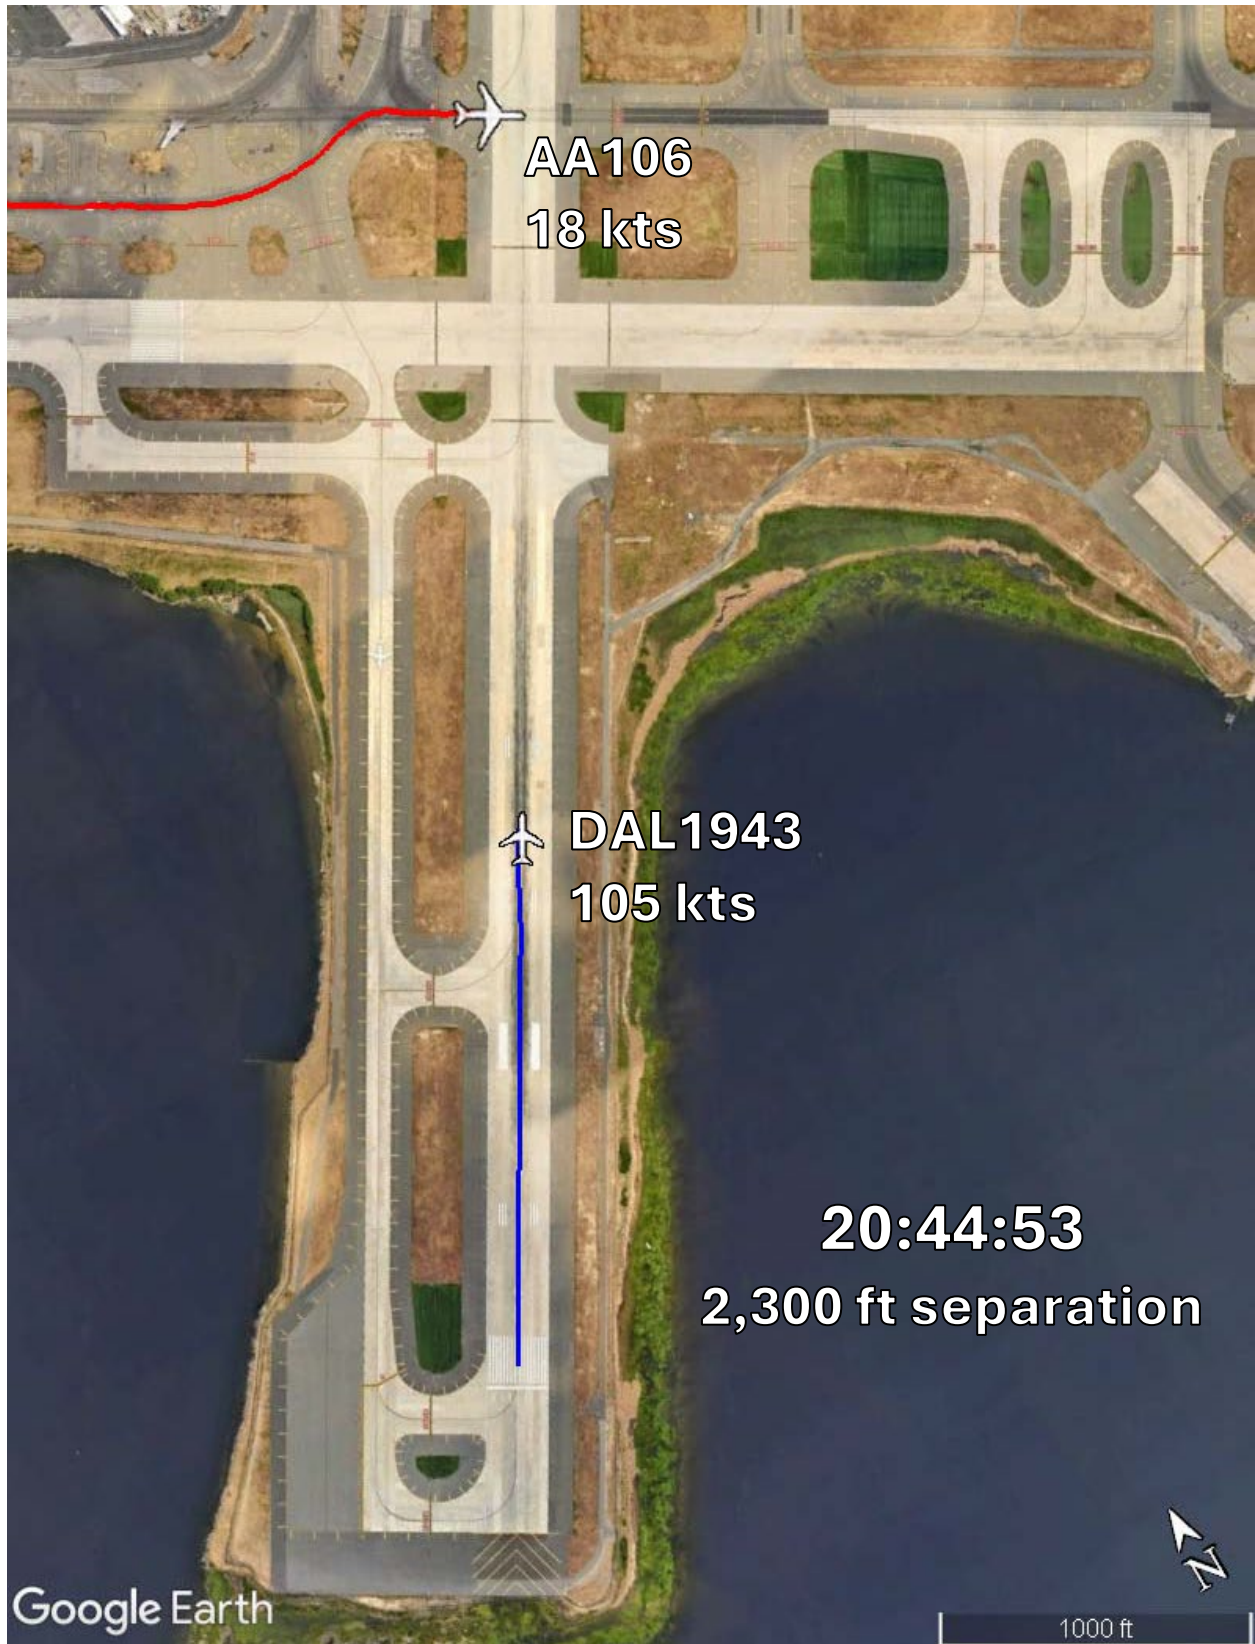
At 20:44:48, the local controller told DAL1943 their take-off clearance was canceled [4]. On DAL1943, the throttle moved to idle and autobrakes were triggered at 20:44:51. Speedbrakes were deployed at 20:44:52 and thrust reversers at 20:44:55. DAL1943 reached a maximum groundspeed of 105 kts at 20:44:53 (Figure 11), when it was 2,300 ft from the intersection of 4L and taxiway J. The nose of AA106 was just passing over the centerline of runway 4L at a groundspeed of 18 kts.

**Figure 11.** Locations and groundspeeds of both airplanes when DAL1943 was at its maximum speed at 20:44:53.

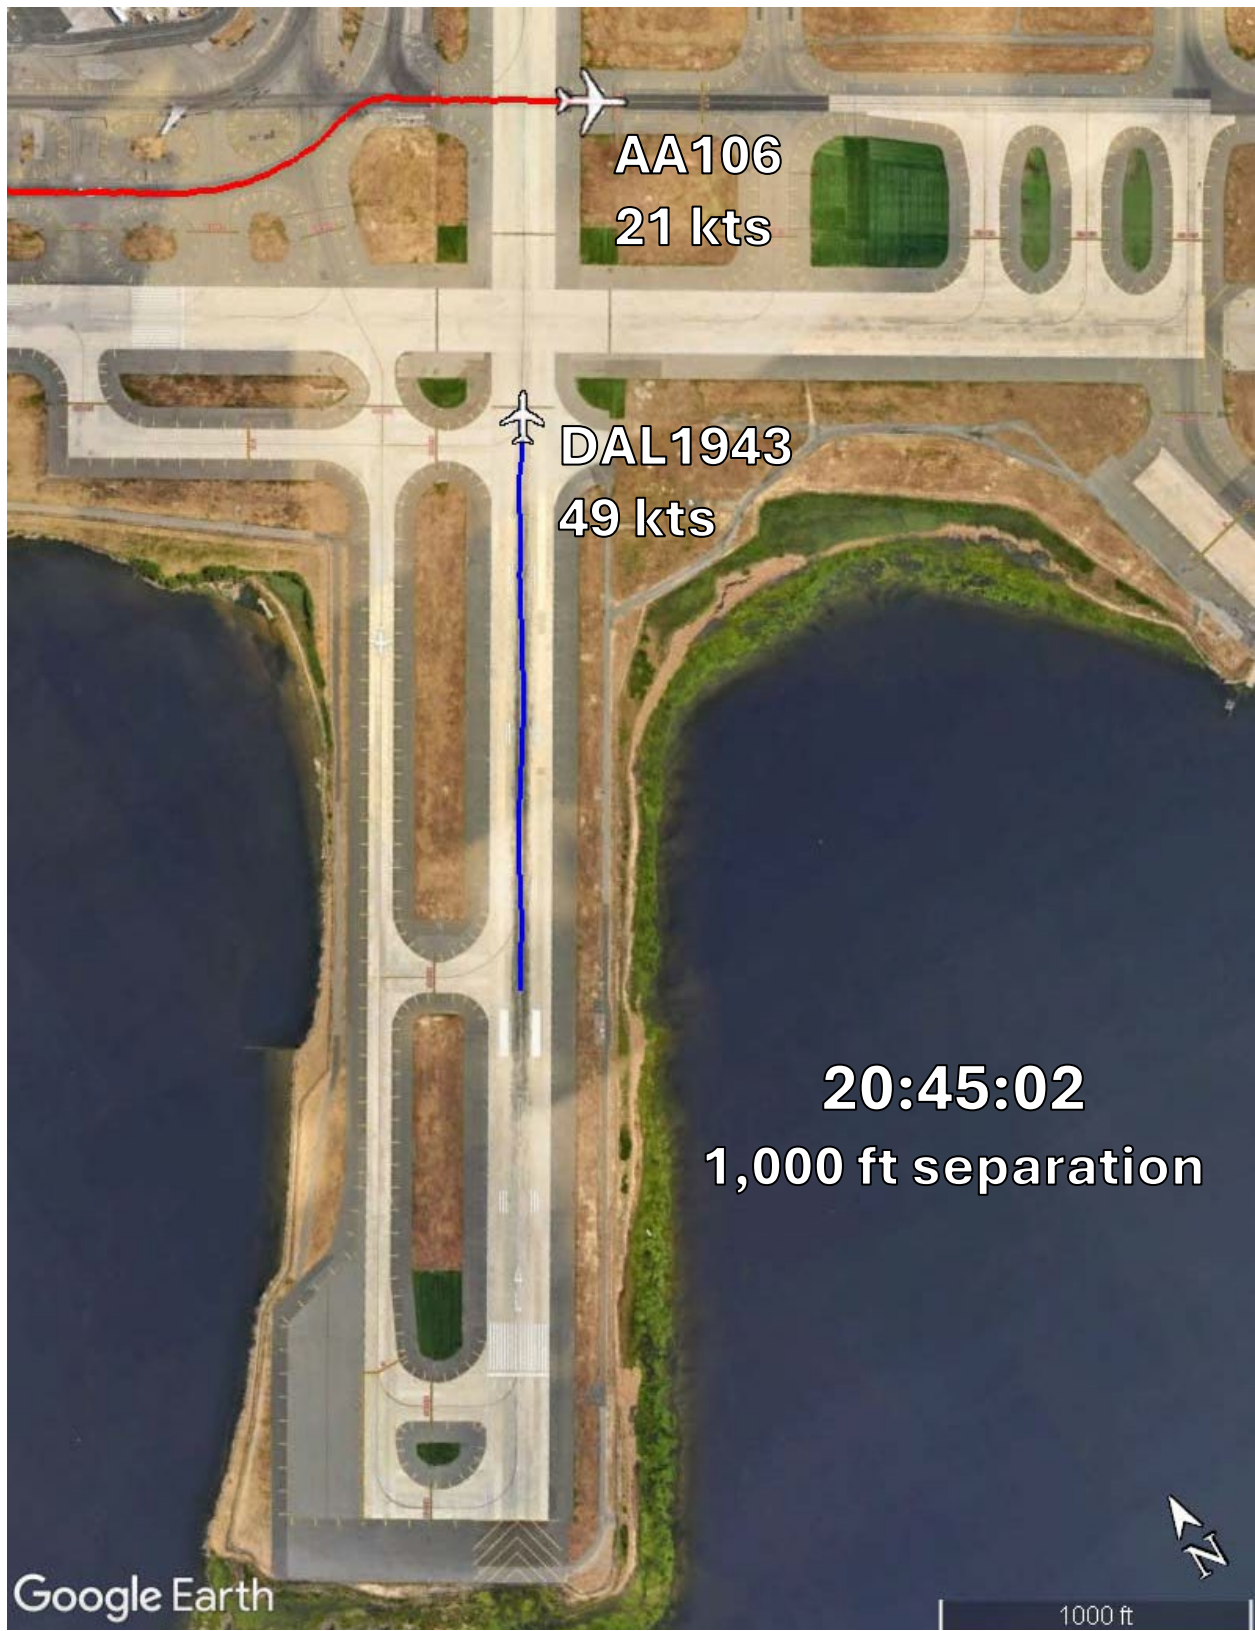
By 20:45:02 (Figure 12), AA106 was clear of runway 4L and traveling at a groundspeed of 21 kts. DAL1943 had decelerated to 49 kts and was 1,000 ft from AA106.

**Figure 12.** Locations and groundspeeds of both airplanes when AA106 clears runway 4L at 20:45:02.

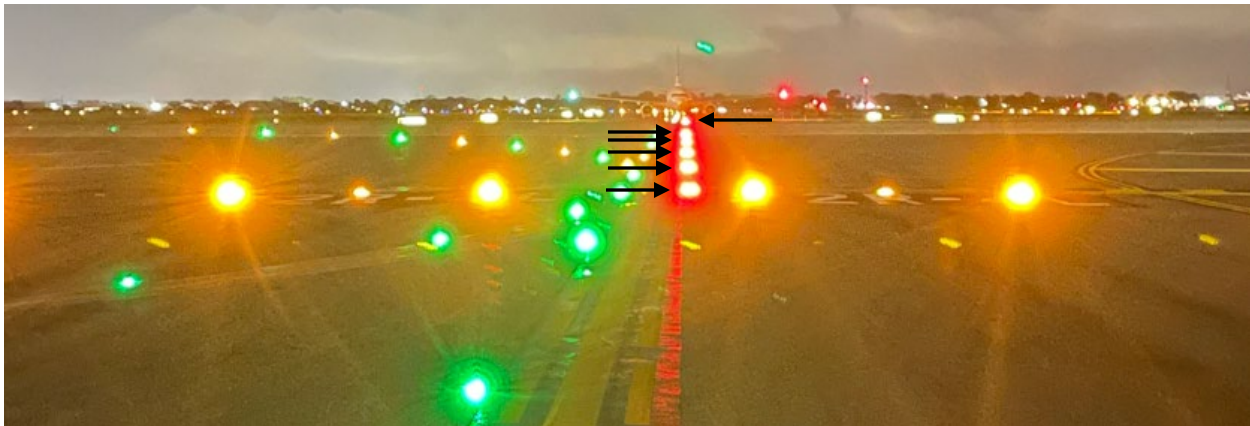
Six RELs were installed at the taxiway J/runway 4L intersection. Figure 13 shows a photograph of these lights when activated. The first five lights are approximately equidistant apart while the 6<sup>th</sup> light is farther away. The first light is just beyond the runway designation at the hold short line and the 5<sup>th</sup> appears even with the edge of the runway.

**Figure 13.** Photograph of activated REL lights from taxiway J crossing runway 22R-4L at night. [Source: Port Authority of NY & NJ]

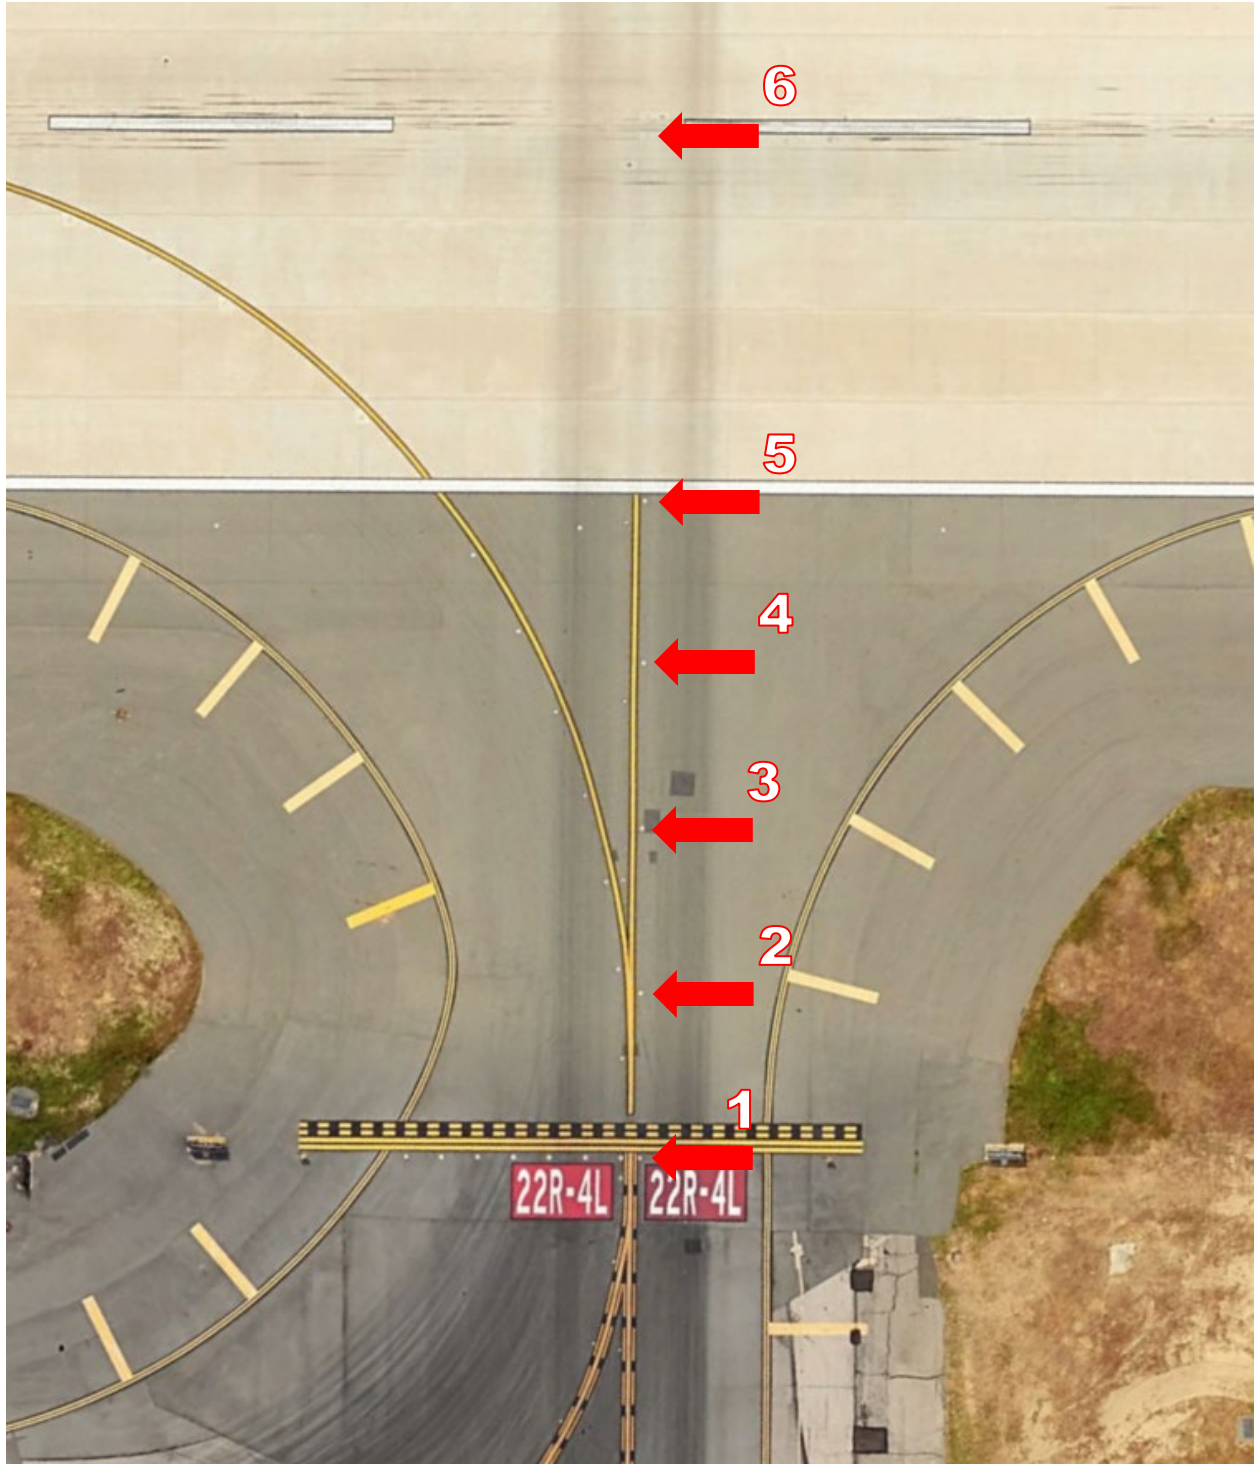
Figure 14 shows the location of the RELs on a Google Earth image of taxiway J and runway 4L. The lights are visible in the pavement as white marks, more easily seen on the dark taxiway than the lighter surfaced runway.

**Figure 14.** Location of RELs on taxiway J and Runway 4L.

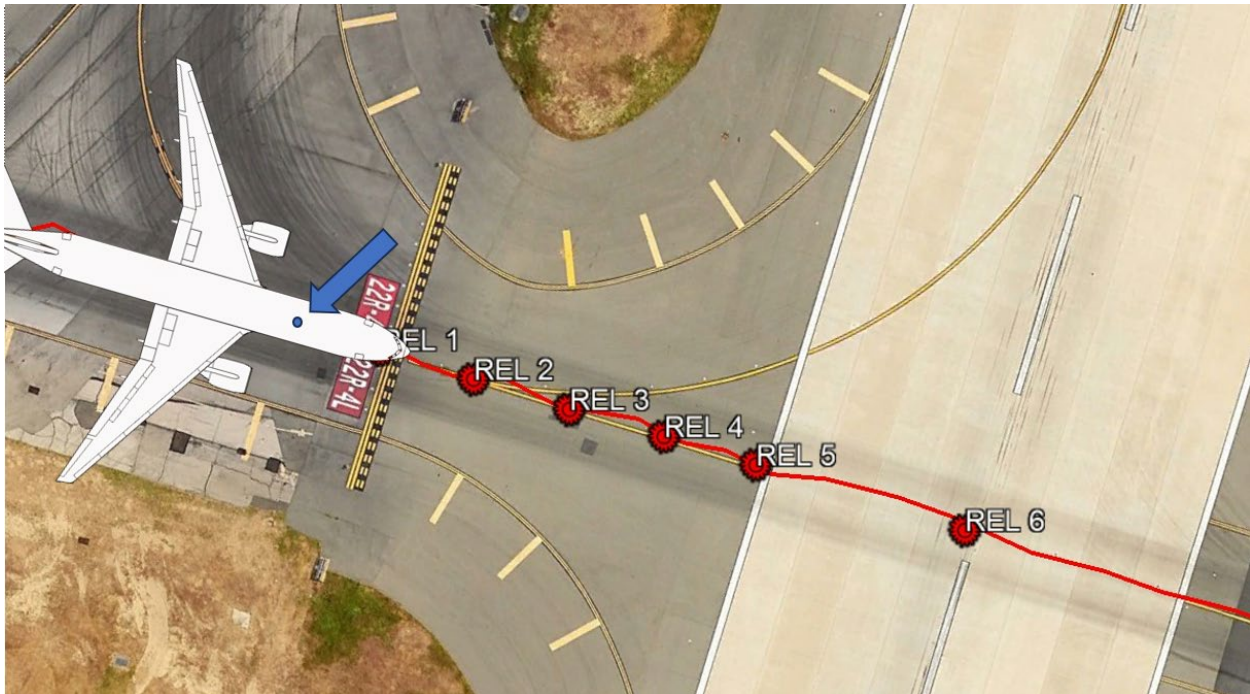
According to the ASDE-X replay, the RELs illuminated at 20:44:40 coincident with DAL1943 accelerating from 47 kts through 49 kts groundspeed. Figure 15 shows a scaled drawing of AA106 with the GPS antenna location positioned at the ADS-B GPS position point. At 20:44:40, the nose of AA106 was just crossing the hold short line and REL 1 was beneath the airplane.

**Figure 15.** Google Earth image showing the illumination of the RELs at 20:44:40 and the location of AA106. Note, the plane icon displayed with the GPS antenna position.

By 20:44:39, the hold short line and REL 1 would have been out of view of the crew. At 20:44:40, REL 2 was 100 ft forward of the point location of AA106. Therefore, when the RELs illuminated, REL 2 may have been within view of the crew of AA106 while REL 3, 4, 5, and 6 were within view. As AA106 continued forward, subsequent
