# National Transportation Safety Board

DCA23LA384

## **OPERATIONAL FACTORS**

Group Chair's Factual Report

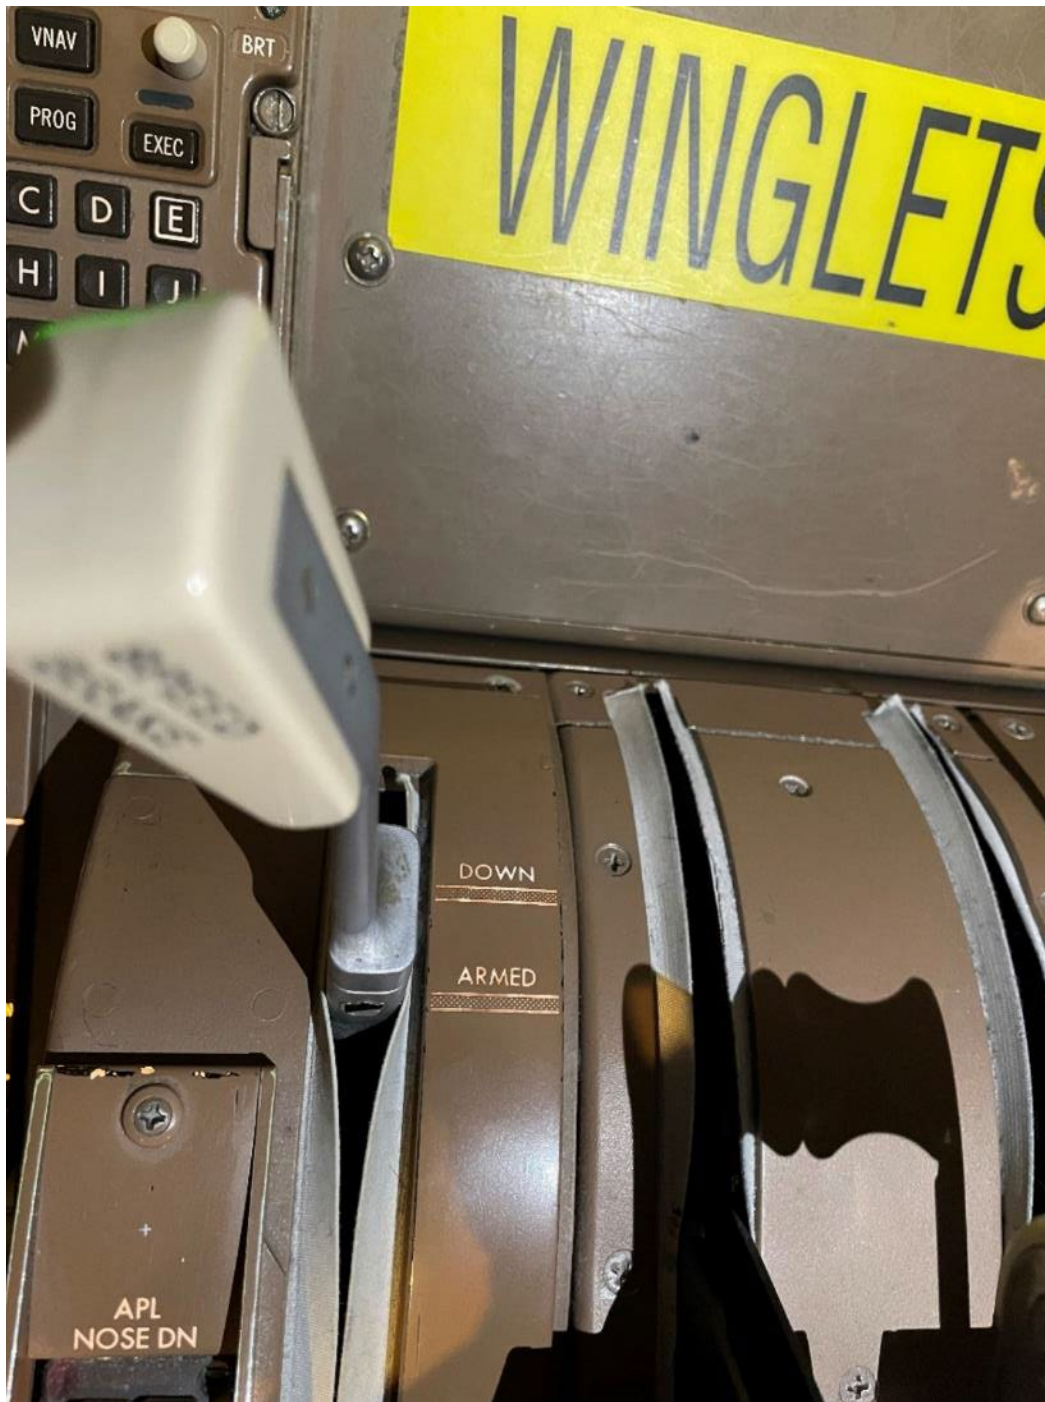
A review of the FDR data indicated that the speed brake lever was not in the "ARMED" position prior to landing. For further information about the simulator evaluation please reference "Operational Factors - Attachment 12 - Simulator Evaluation" located in the docket for this investigation.

**Figure 7:** View of Speed Brake Lever in "Armed" Position from Aft of the Center Pedestal. (Source: NTSB)

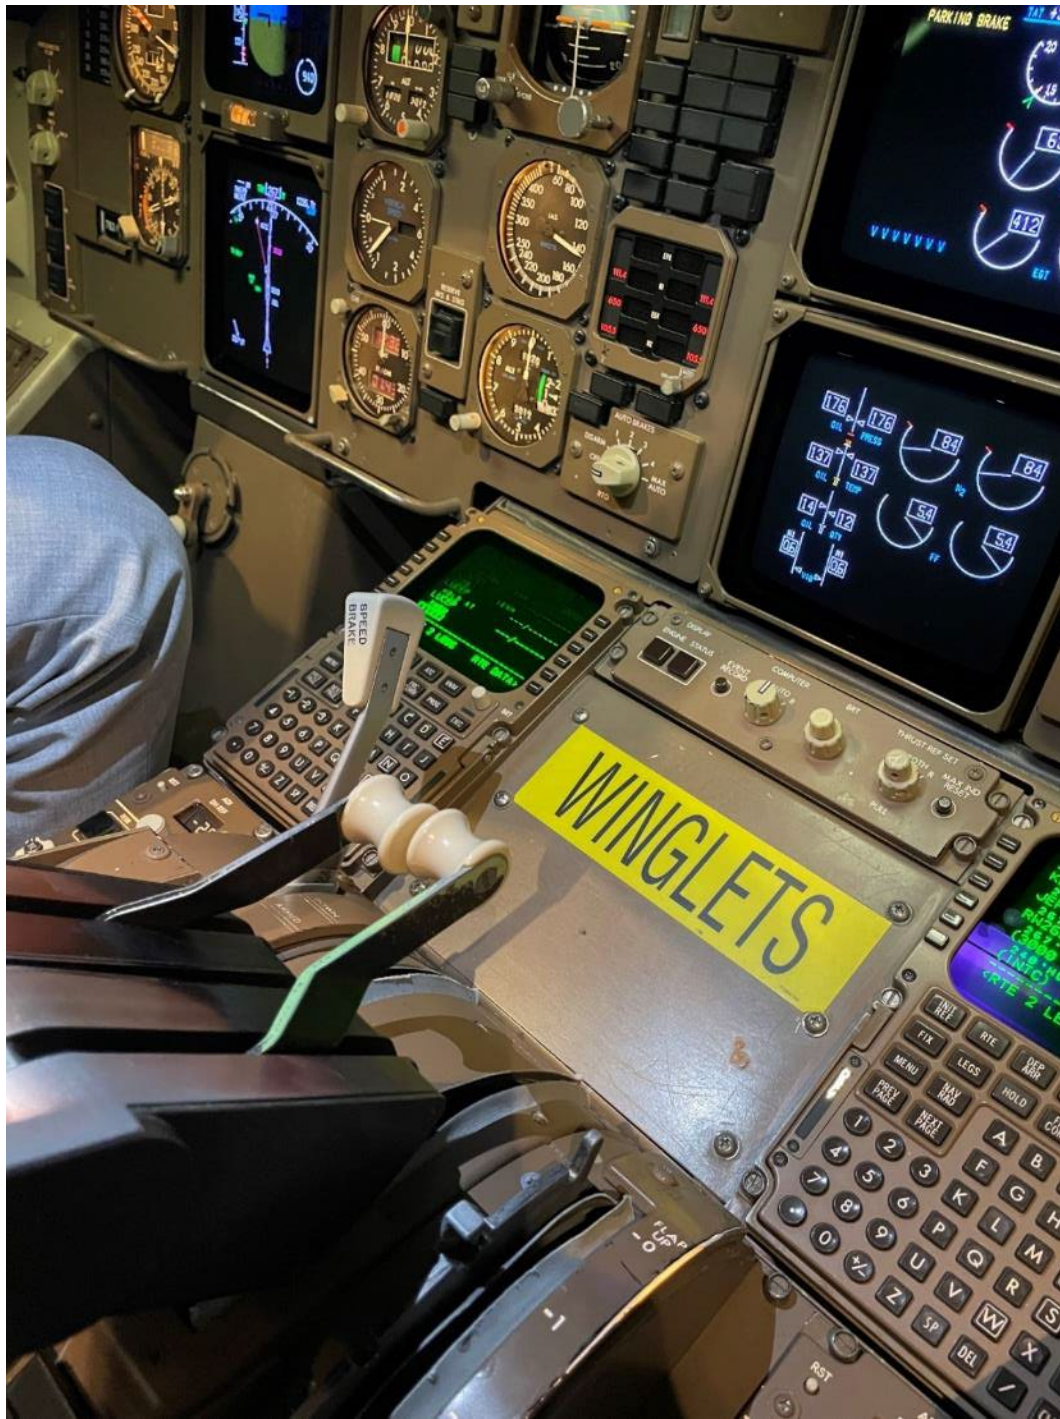
**Figure 8:** View from First Officer's Seat with Speed Brake Lever in "DOWN" Position. (Source: NTSB)

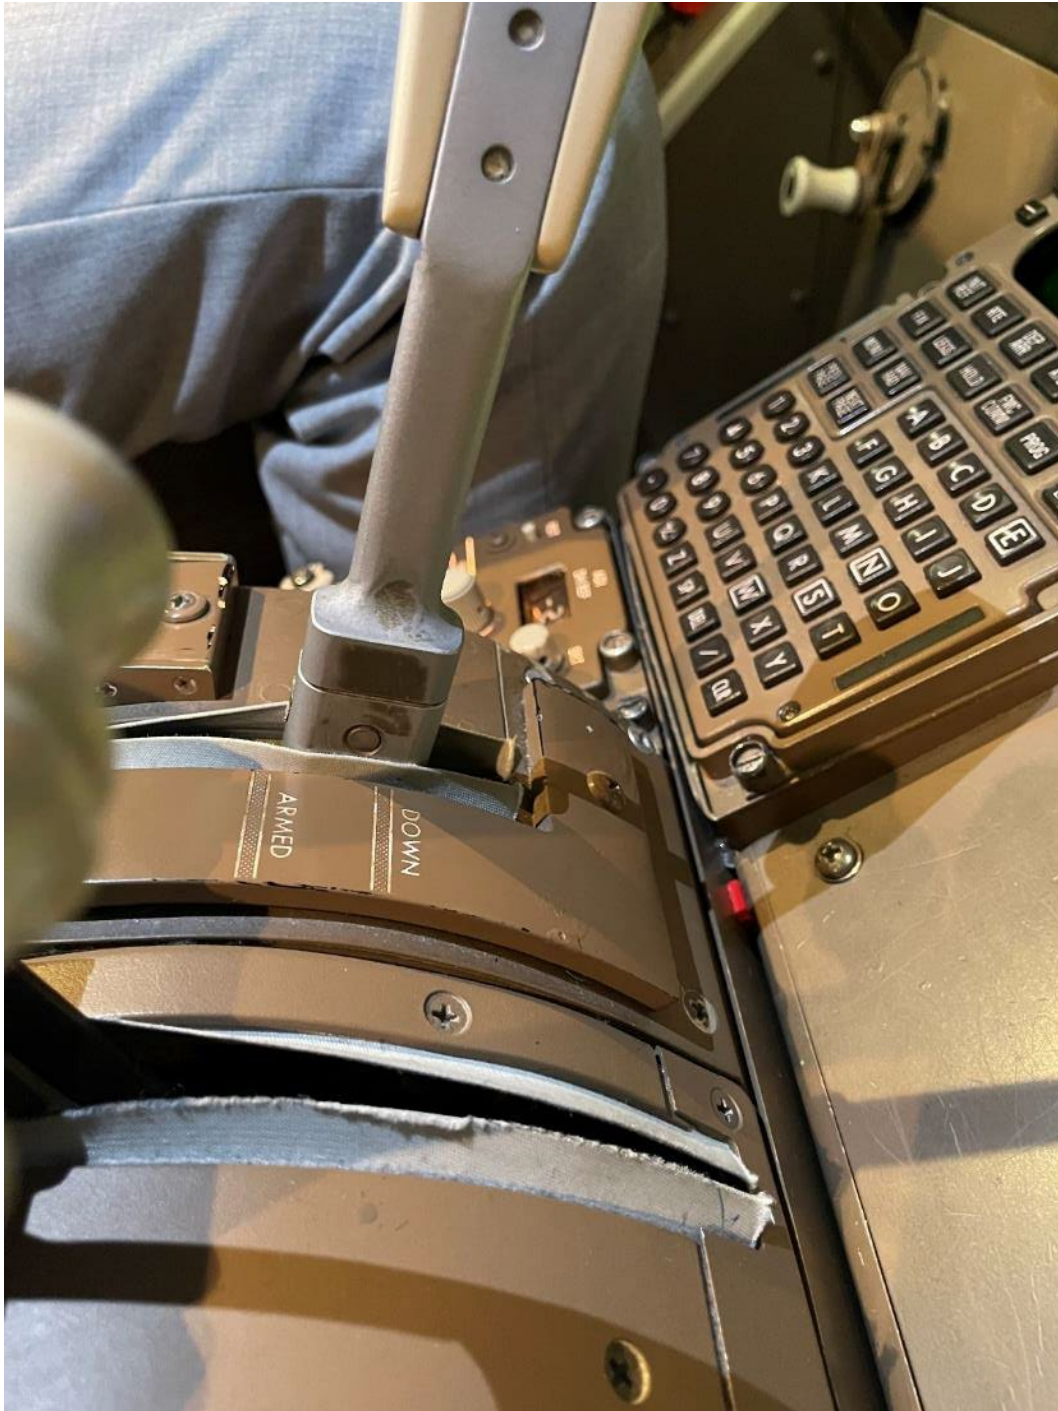
**Figure 9:** Speed Brake Lever in the "ARMED" Position as viewed from the First Officer's Seat and Lean Forward to look around the thrust reversers. (Source: NTSB)
