Alaska Airlines Flight 1282

Left Mid Exit Door Plug Separation in Portland, OR

Docket No.	SA-543
EXHIBIT	
12

**Cockpit Voice Recorder
Specialist's Factual Report**
(6 Pages)

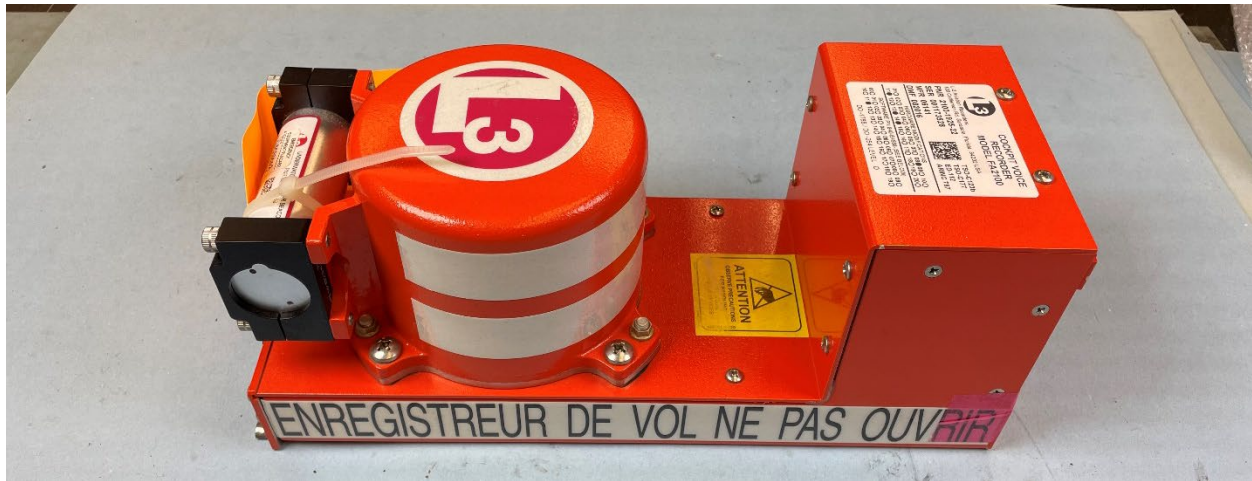
Figure 1. L3Harris FA2100 CVR, as received.

Upon arrival at the laboratory, it was evident that the CVR had not sustained any heat or structural damage (see Figure 1) and the audio information was extracted from the recorder normally, without difficulty.
