NATIONAL TRANSPORTATION SAFETY BOARD

Alaska Airlines Flight 1282

Left Mid Exit Door Plug Separation in Portland, OR

Group Chair's Factual Report

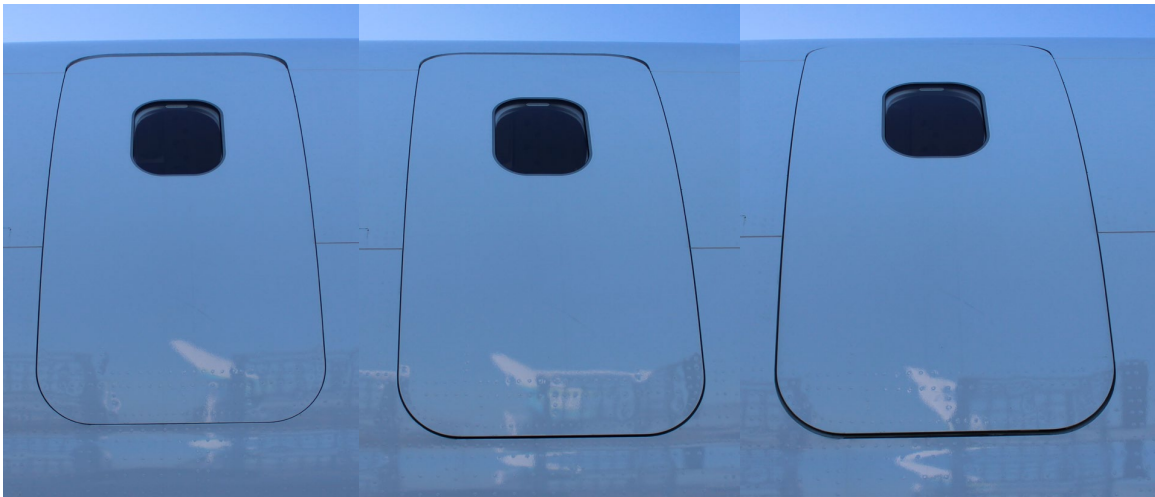
The exterior gap between the lower edge of the right MED plug and the fuselage opening was examined at 3 different plug vertical positions. With the right MED plug in the fully down position, the distance between the lower sill and the lower edge of stop beam 6 was measured to be 4-5/16" at the forward and aft hinge locations. The lower gap on the exterior measured 0.079" (Position A (left), Figure 5). With the plug in the middle position, the distance between the lower sill and the lower edge of stop beam 6 was measured to be 4-17/32" at the forward hinge and 4-9/16" at the aft hinge. The lower gap on the exterior measured 0.315" (Position B (center), Figure 5). With the plug in the upper position (stop pin to pad instability point), the distance between the lower sill and stop beam 6 was measured to be 4-7/8" at the forward and aft hinge locations. The lower gap on the exterior measured 0.630" (Position C (right), Figure 5).

Figure 5. Right MED plug exterior at position A (left), position B (center), and position C (right) [NTSB photos].

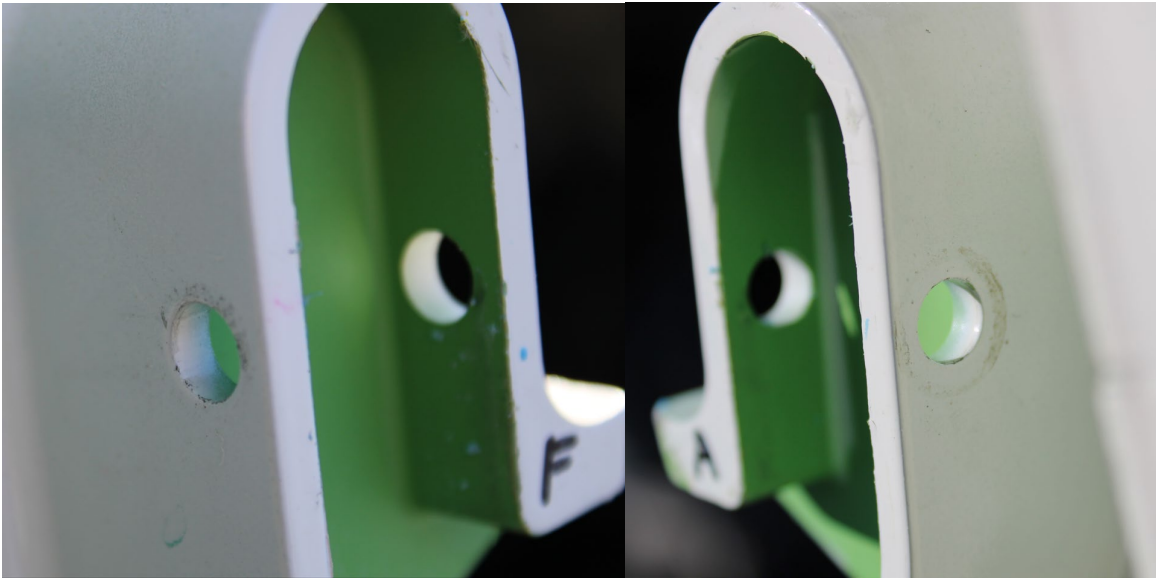
There was a dirt witness mark along the upper edge of the plug on the inboard surface where it mated with the upper seal that appeared to align with the bulb feature of the seal. A sample of the material was retained for further analysis as detailed in the Materials Laboratory Factual Report 24-007. The forward and aft upper guide track fittings had disturbed paint on the inboard and outboard surfaces consistent with a washer being installed (Figure 6). The hole bores and outer hole corners had disturbed and missing paint. The forward and aft lower hinge guide fittings had disturbed paint on the inboard surfaces consistent with a washer being installed (Figure 7). The hole bores and outer corners of the holes had disturbed and missing paint.

Figure 6. Right MED plug forward (left) and aft (right) upper guide track fitting outboard holes after removal of the upper guide track bolts (NTSB Photos).

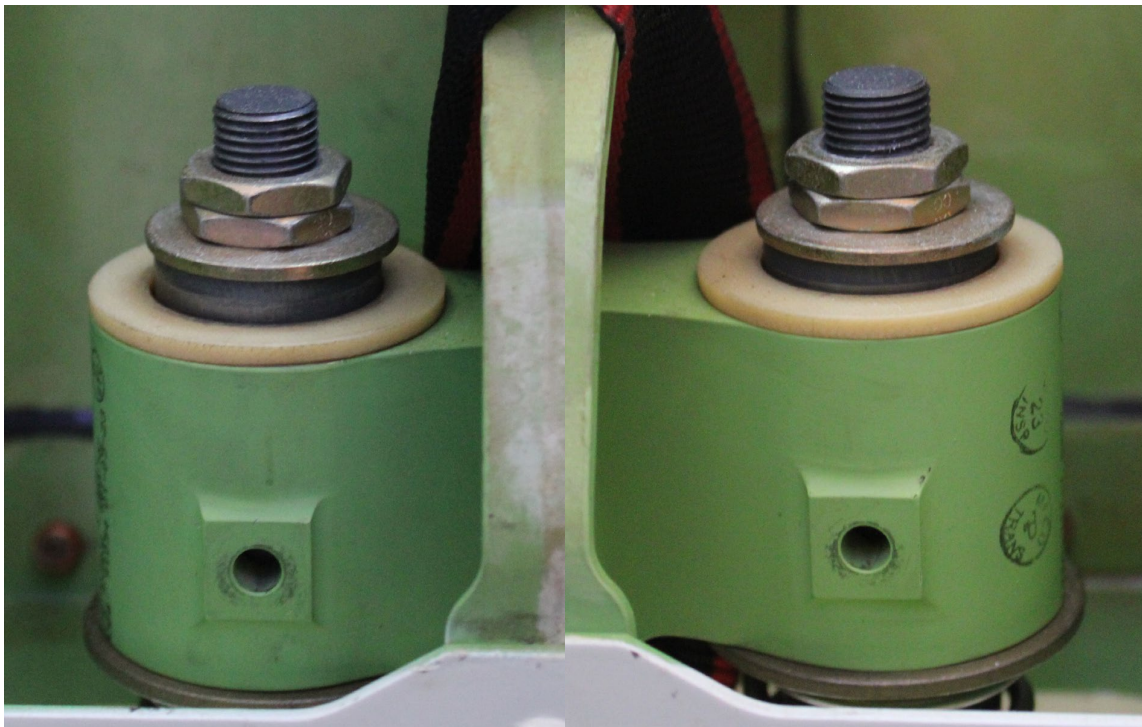
Figure 7. Right MED plug forward (left) and aft (right) lower hinge guide fitting inboard holes after removal of the vertical movement arrestor bolts (NTSB Photos).
