NATIONAL TRANSPORTATION SAFETY BOARD
Investigative Hearing

Alaska Airlines Flight 1282

Left Mid Exit Door Plug Separation in Portland, OR

**Survival Factors Group Chair's
Factual Report**
(56 Pages)

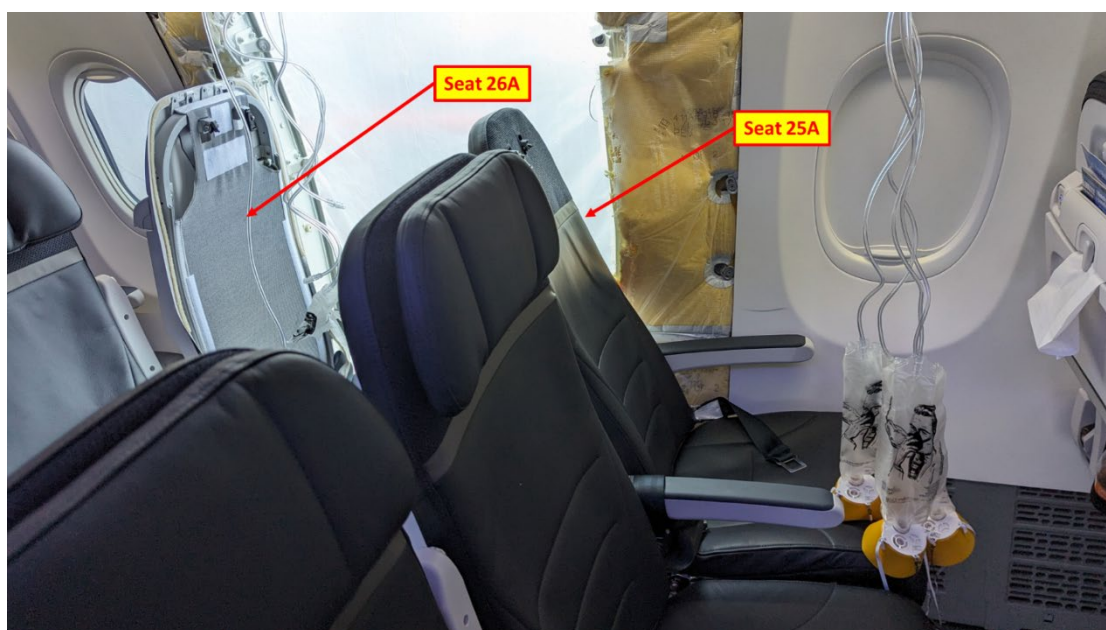
Damage to the interior cabin was primarily in the area of the door plug that departed the airplane - rows 25ABC and 26ABC. Seat unit 25ABC was manufactured by Recaro Aircraft (Type 3530A; P/N 3530AY80-31-331; S/N 949969; EASA# 210.1005 4881b; DOM 10JUL2023). The seat unit frame was structurally intact and undamaged. It was connected firmly to the floor with spacers in place between row 24 and 25. Seat 25A was rotated outboard and aft approximately 10-20 degrees toward the fuselage opening. The seat cushion was pulled up approximately 1½ in. The headrest unit was missing. There was a horizontal scrape mark on the sidewall just above the outboard armrest. There was no damage to any of the seat belts. Seat 25B's seat cushion was not clipped in its secure position. No damage or anomalies were noted to seat 25C. There was exposed insulation on either side of the opening where the MED plug had been.

Figure 9. Seats 25A and 26A.

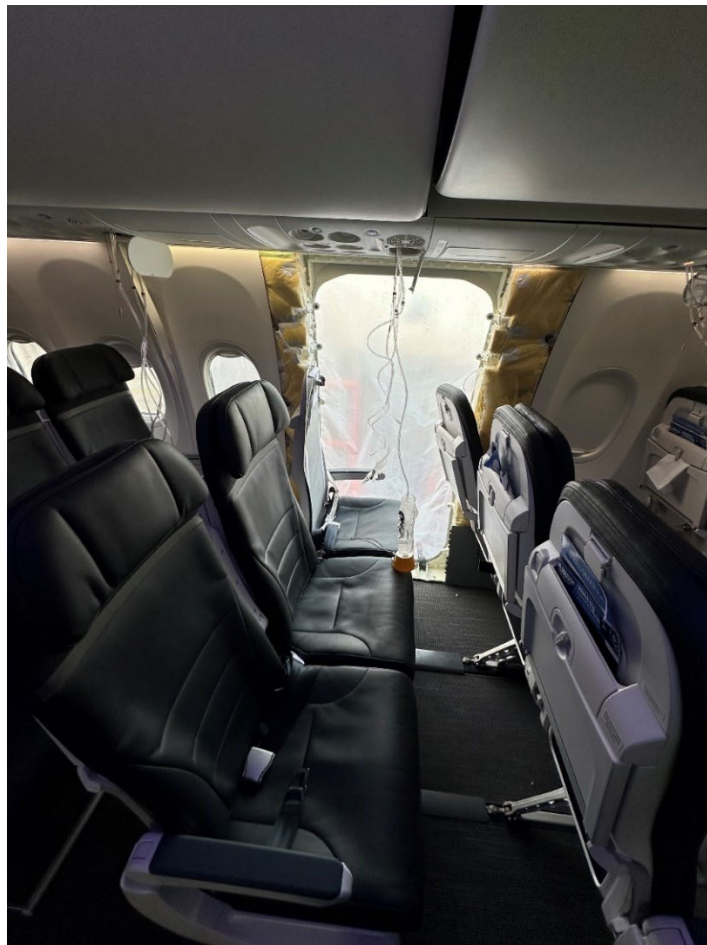
unit frame was structurally intact and undamaged. It was connected firmly to the floor with spacers in place between row 25 and 26. Seat 26A's seatback cushion and covering was missing but the seat bottom cushion was present and clipped in place. The seatback was rotated forward and outboard. The forward support tube under the seat bottom cushion had orange oil/grease droplets present. The outboard armrest was deformed outboard approximately 15 degrees. The armrest had an abrasion on the upper surface, mid-armrest. There was no other wear, tears or abrasions on the other armrests of the seat unit. The tray table of seat 26A (for use by the passenger in 27A) was missing. The lower supports of the tray table had been fractured approximately ¼-inch aft of their connection with seat 26A. The tray table (with support legs) was later located during the ground search for the MED door plug. See figure 11. Seats 26B and 26C were undamaged with both the seatback and seat bottom cushions clipped in place. There was no damage to any of the seat belts.

Figure 10. Row 26ABC.

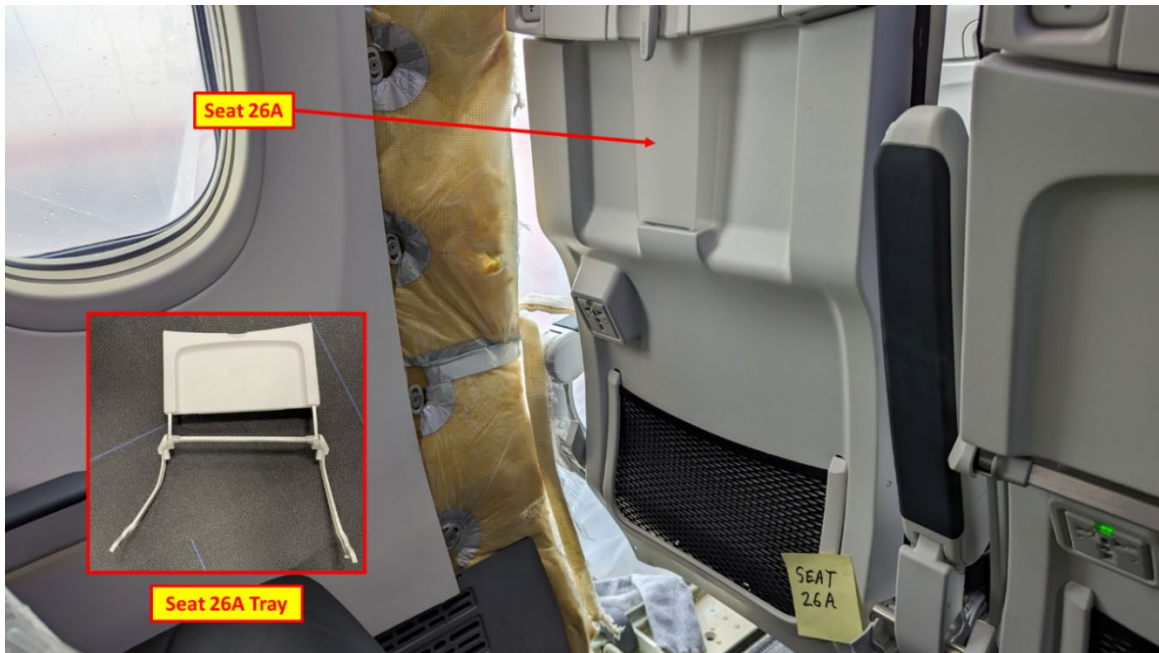
Figure 11. The back of seat 26A and the tray table that was located during the ground search for the MED door plug.

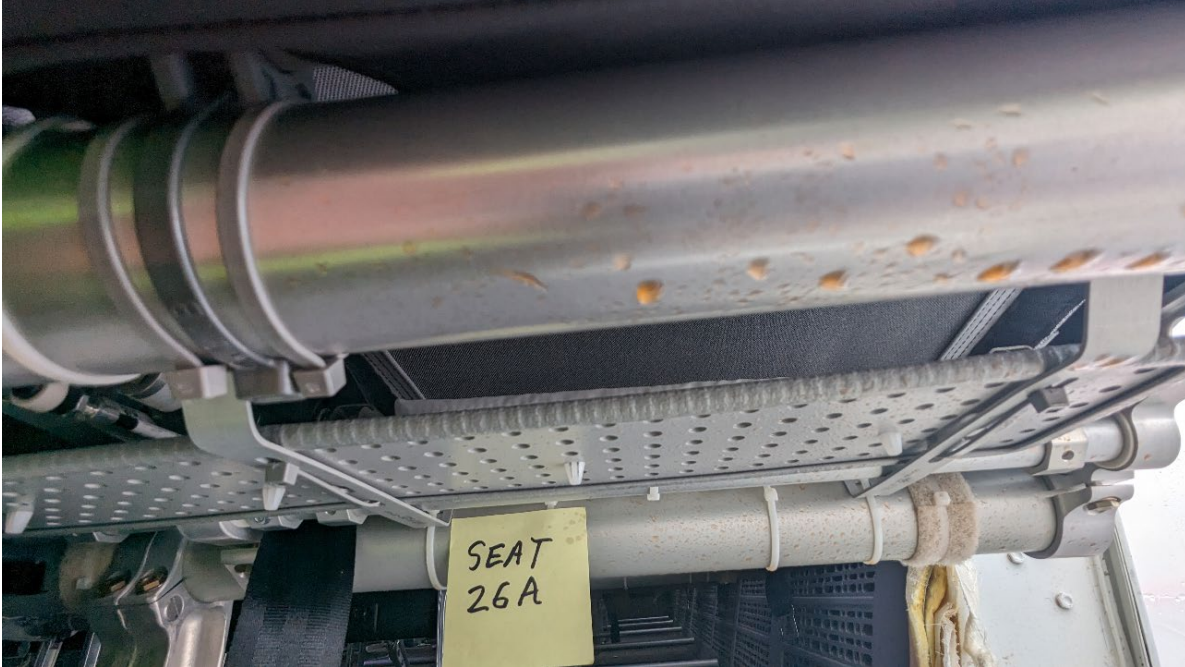
Figure 13. Forward seat tube of seat 26A with orange oil/grease droplets present.

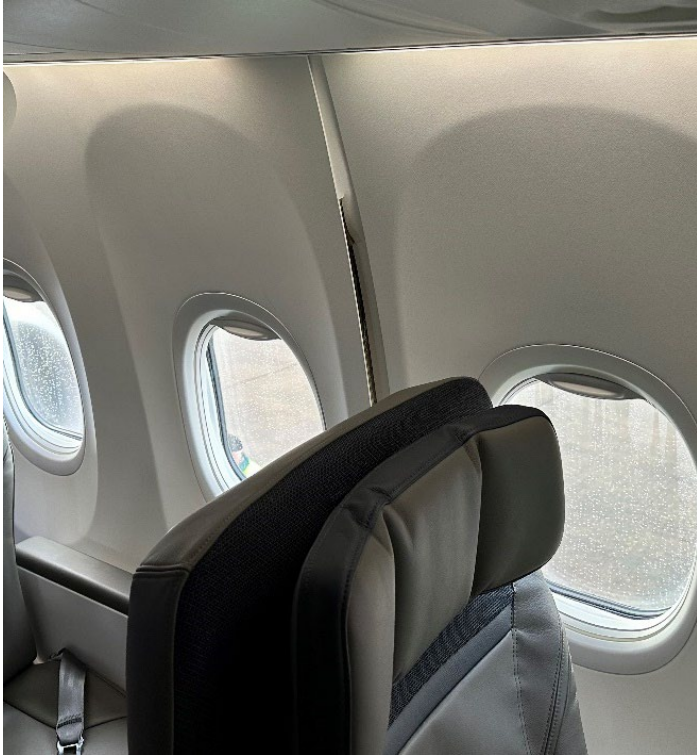
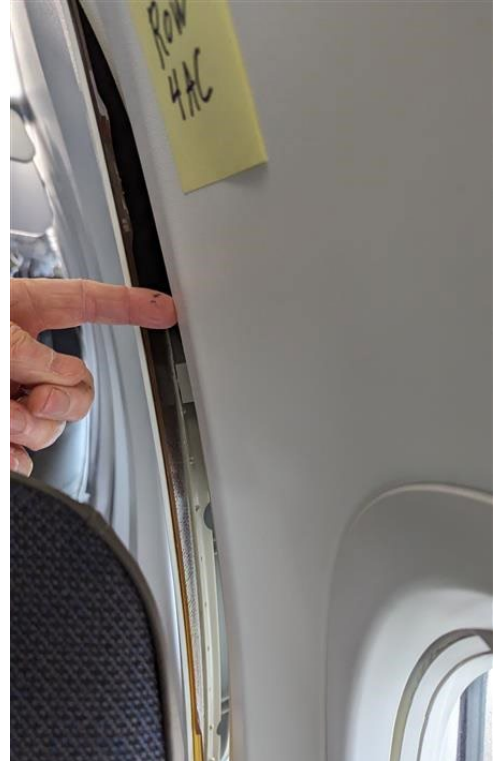
Figure 14. Sidewall panel at row 4AC.

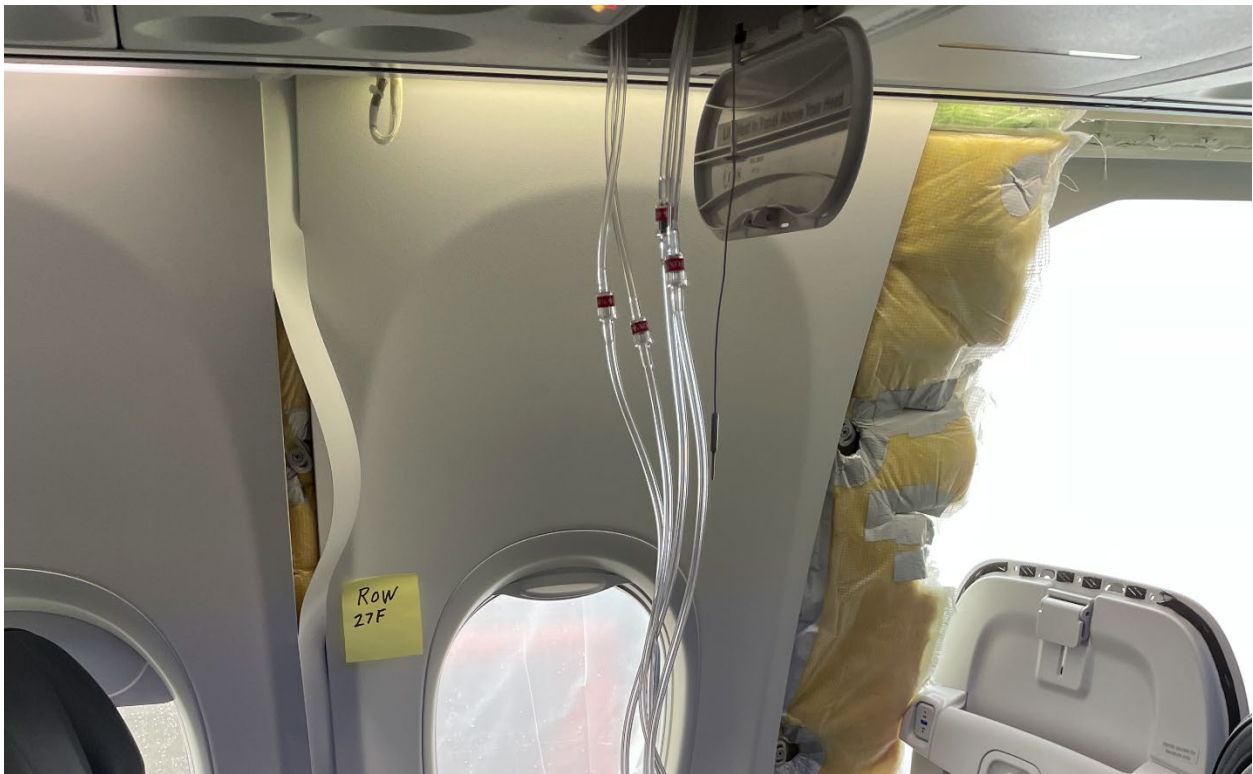
Figure 15. Sidewall trim strip buckled at row 27ABC.

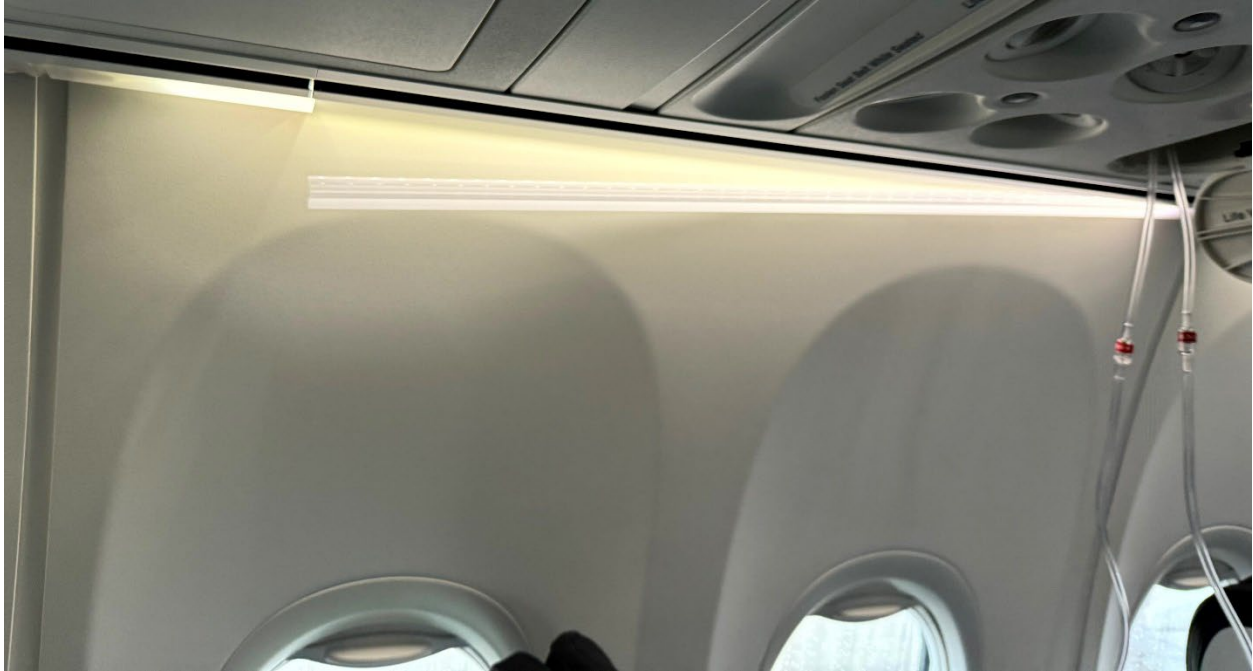
Row 30-31ABC - Sidewall cove light was loose and partially hanging down (attached at 29A and hanging aft). See figure 16.

Figure 16. Loose sidewall cove light at 30-31ABC.

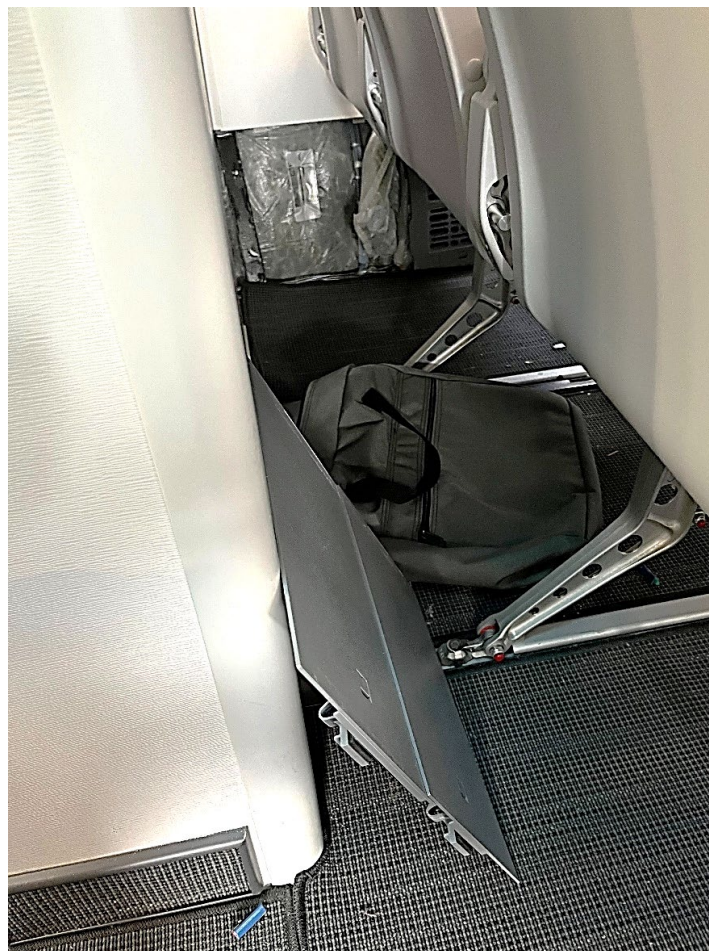
Row 32ABC - Blank filler panel was found propped against the aft lavatory behind 32ABC bulkhead. (The cabin air grille on the lower sidewall at 32ABC had a gap approximately the same size as the panel.) See figure 17.

Figure 17. Blank filler panel behind row 32ABC.

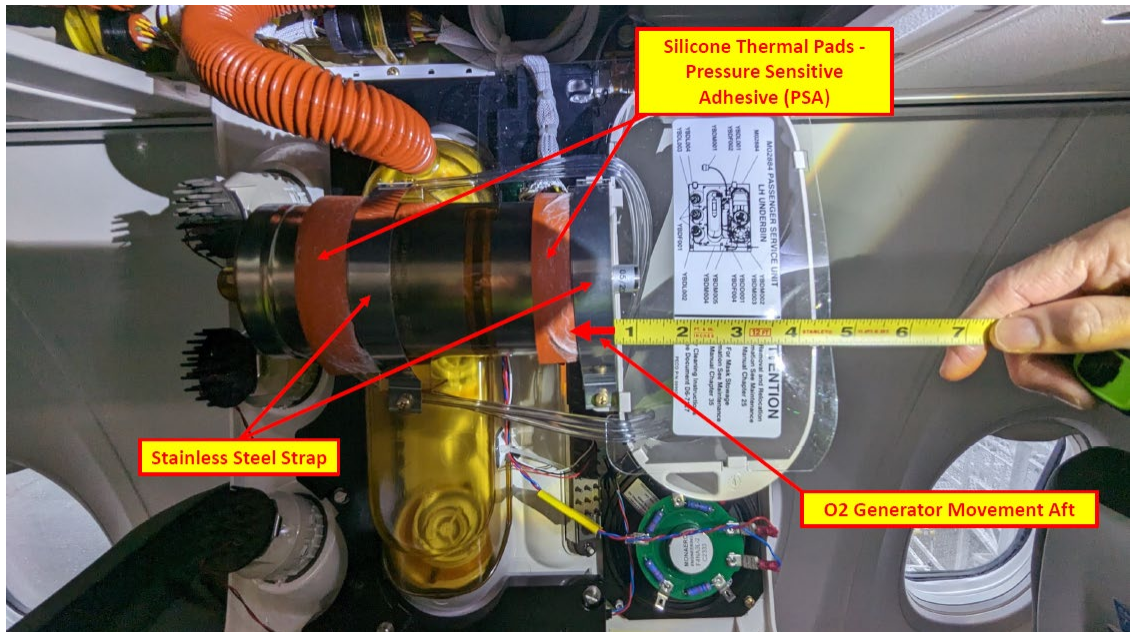
Examination revealed that all but two chemical oxygen generator canisters (1AB and 25DEF) had migrated aft from their properly installed positions inside the PSUs. The canisters were designed to be held in place by two stainless steel straps under which a flat silicone thermal pad was placed. The pads were coated with a pressure sensitive adhesive (PSA) to help prevent movement of the generators due to vibration and acceleration/deceleration. Two different types of silicone thermal pads were noted. One type was a simple flat pad while the other had a c-channel. See figures 21 and 22.

Figure 21. Chemical oxygen generator canister with flat orange silicone thermal pads at seat 2AC. The canister had migrated aft approximately $\frac{3}{4}$ inch.

All of the generators equipped with flat pads migrated aft and some generators migrated far enough aft to be completely free of the forward stainless steel strap; however, no generators disengaged from the oxygen tubing. A second type of silicone thermal pad was found on only two generators - 1AC and 25DEF. This type had a c-channel where the edges of the pad wrapped around the edges of the stainless steel straps. These two generators did not move from their original positions.

On June 17, 2024 Boeing issued multi-operator message MOM-MOM-24-0316-01B to 737MAX/NG to operators notifying them of the published service bulletins (SB 737-35-1210 for the 737 MAX and SB 737-35-1211 for the 737NG) to inspect and replace (as needed) the PSU chemical oxygen generator retention straps on affected aircraft. The MOM also referenced the potential upcoming release of an FAA Immediate Adopted Rule (IAR) Airworthiness Directive (AD).¹³ Finally, the MOM noted that temporary revisions of the 737 NG/MAX Aircraft Maintenance Manuals (AMMs) were targeted for release on June 20, 2024.

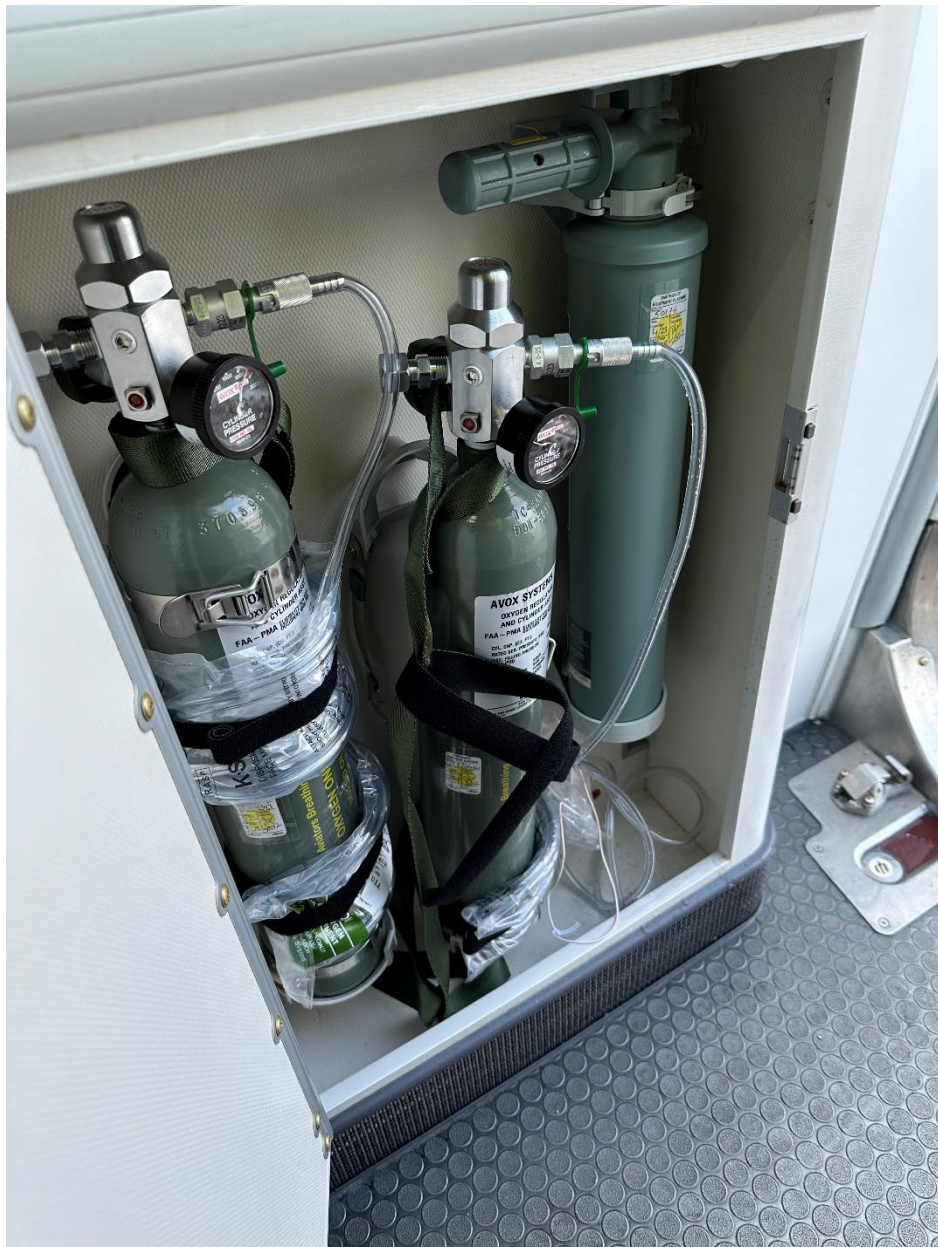
Figure 26. The two POBs in the forward storage location near door L1. The gauge of the unbracketed POB (middle) read 0 psi.

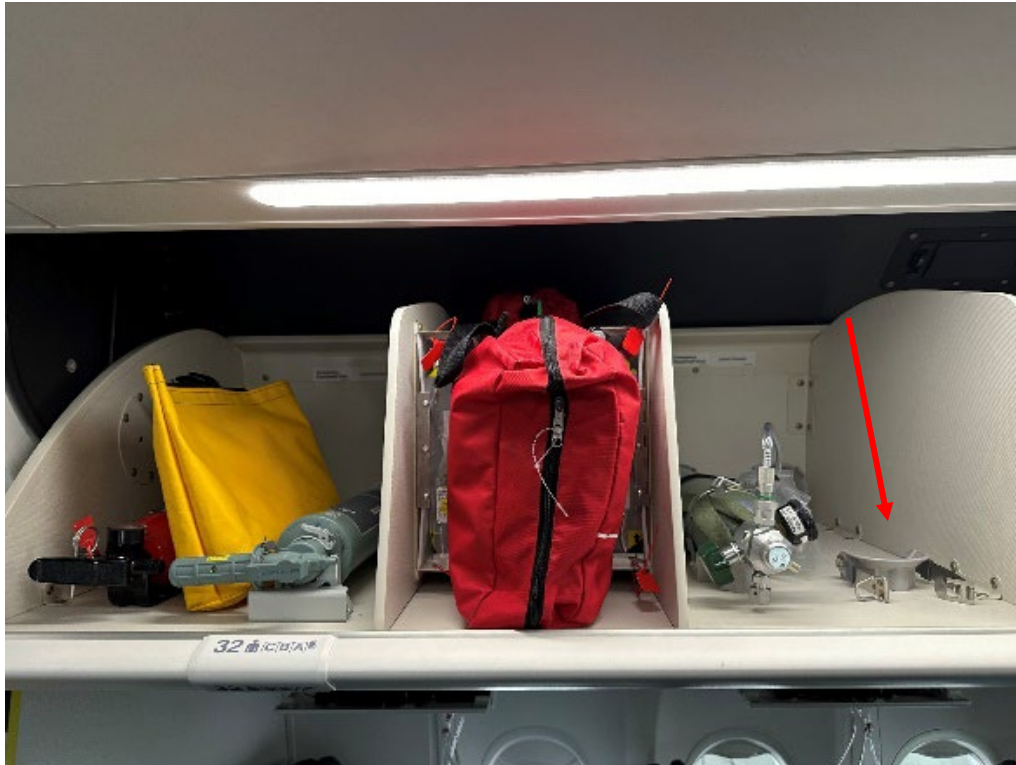
Investigators noted an empty POB bracket in the stowage location above row 32ABC. The other POB in this location was still bracketed. See figure 31. For information about Alaska Airlines' POB procedures, see section 5.2.

Figure 31. Empty POB bracket above row 32ABC.

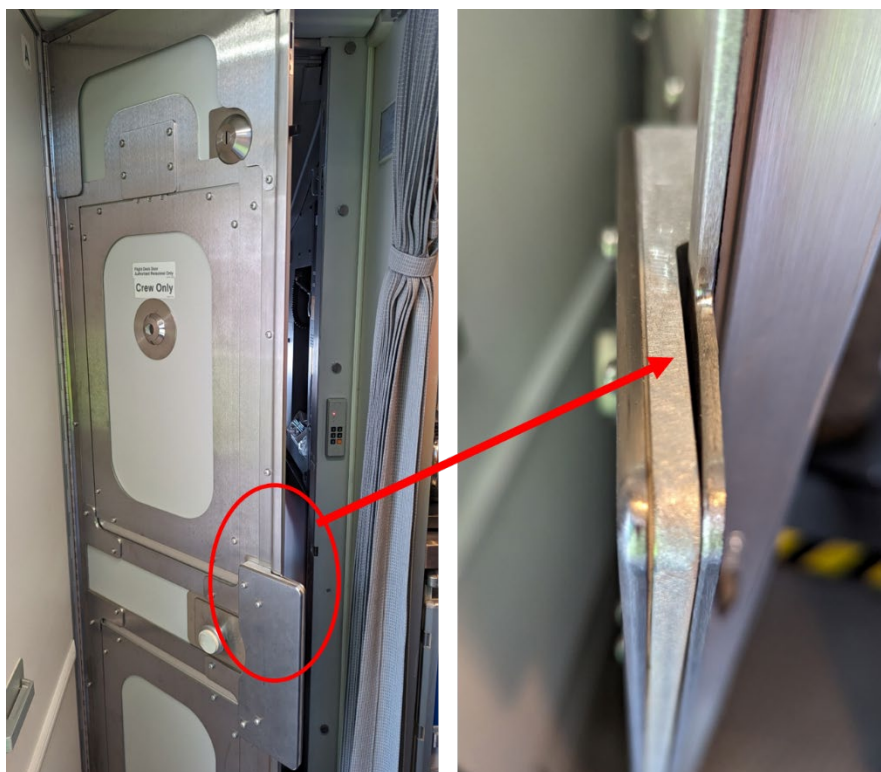
The flight deck door opened aft under cabin decompression loading per design. The door had no external damage with the exception of the door latch security plate that was slightly deformed with a gap between the metal plates. See figure 34. There were no abrasions on the exterior (cabin side) door handle. The door frame was undamaged. The door closed and latched normally but repeatedly failed to lock per design. A pull (from the cabin side) or a push (from the flight deck side) with moderate force caused it to open without difficulty. The door's interior deadbolt locked and unlocked as designed. Both emergency escape decompression panels were present and undamaged. The sliding pins on the door's panels were in the "lock" position and both the top and bottom panels were in proper placement.

Figure 34. Area of deformation to the door latch security plate of the flight deck door.

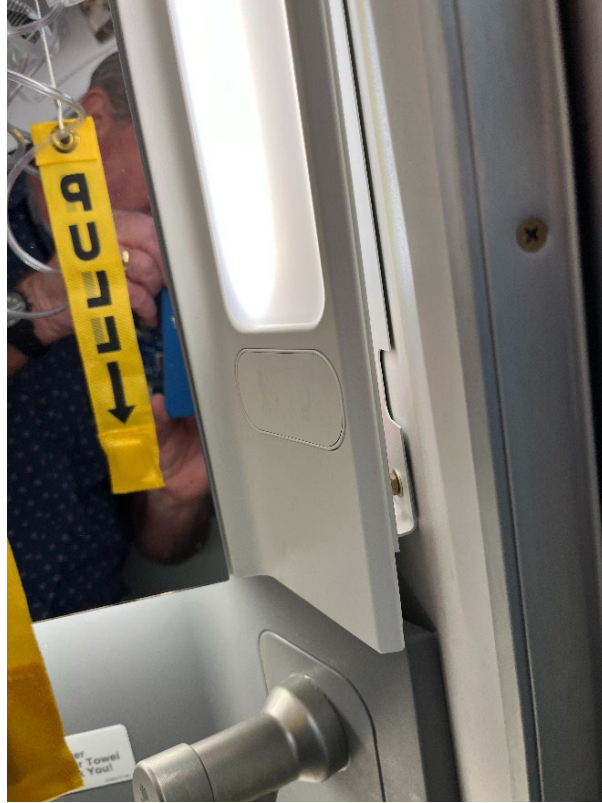
The forward lavatory (Lav A) was found unlocked ("Vacant") with the deadbolt in the stowed position. The deadbolt could not be moved into the locked position and was displaced outboard of the slot. The door was jammed and required more force than normal to open. The upper frame of the door near the deadbolt was deformed about 2cm and the lower door frame had its trim strip separated from its normal position. The lavatory light cover panel was separated 2cm from the wall. See figures 38 and 39.

Figure 38. Separation of the Lav A light cover panel from the wall.

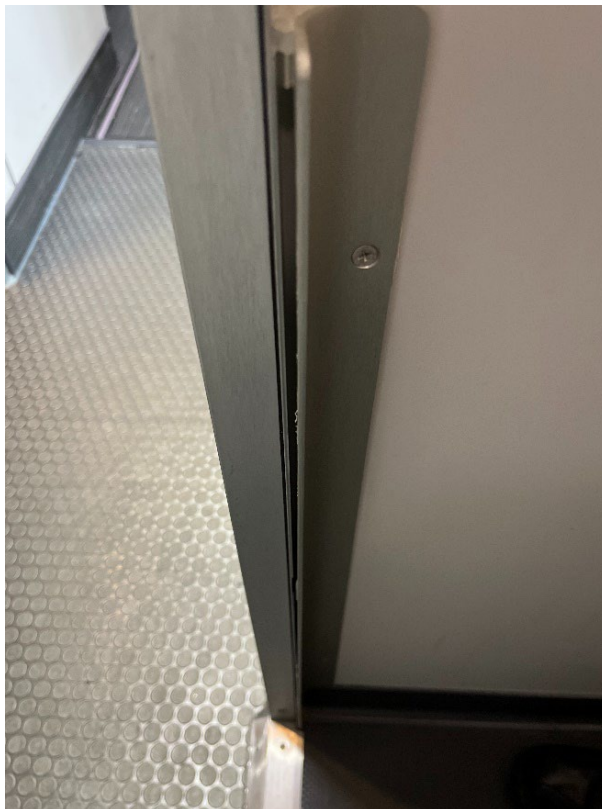
Figure 39. Trim separation from the Lav A door frame.
